Wildfire Ignition Resistant Home Design (WIRHD) Program: Full-scale Testing and Demonstration Final Report

Stephen L. Quarles, Insurance Institute for Business & Home Safety

Melissa Sindelar, Savannah River National Laboratory

December 13, 2011

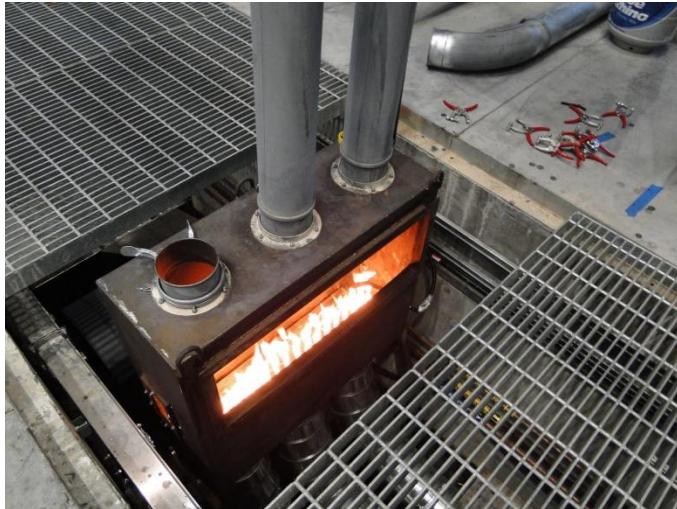
Figure 1. Flames from gas burner at the bottom of the combustion chamber (without mulch mixture).

and out of the chamber into one of three steel ducts that terminated at different distances above grade. The five chambers were uniformly spaced across the inlet to the test chamber. The chambers were located below grade in a five-ft wide pit, as were the fans. Each chamber was loaded with approximately 40 lbs. (18 kg) of combustible bark mulch and wooden dowels. A slotted 1-in. (25 mm) diameter steel pipe, located at the bottom of each chamber, served as a propane gas burner (Figure 1). This burner ignited the bark mulch and wooden dowel raw material mixture, and then the below-grade fan pushed the burning embers up through the vertical ducts and into the wind stream of the wind tunnel (Figure 2).

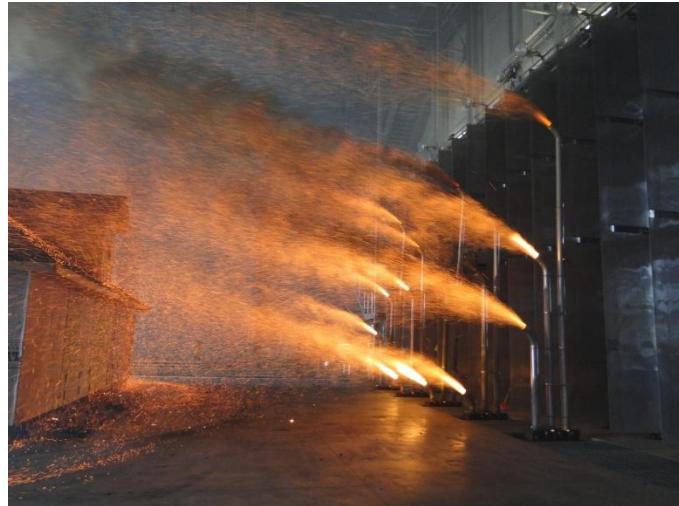
Figure 2. Ember generators discharging during test.

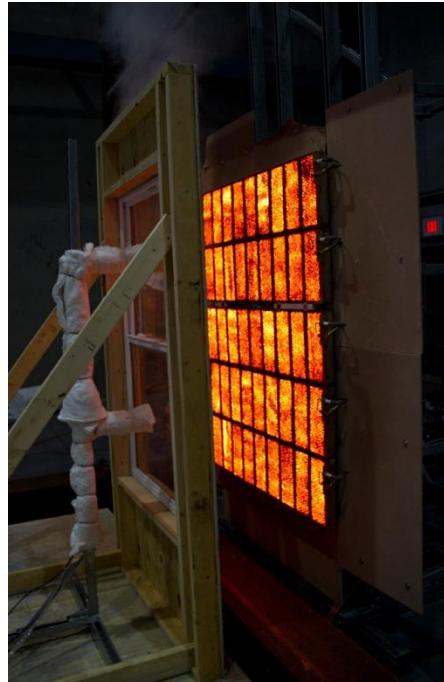
The radiant panel designed and built for use in this project was 50 in. wide (1270 mm) and 63 in. (1600 mm) tall. It consisted of 50 infrared natural gas burner heads arranged in five rows of ten burners each (Figure 3). When ignited, the surface temperature of each burner was approximately 1700°F (925°C). The radiant heat exposure to the target material was adjusted by moving the target closer to or further away from the radiant panel. In order to calibrate the radiant panel, heat flux sensors were embedded in a ceramic fiber, noncombustible rigid panel.

Figure 3. The radiant panel during a window test.

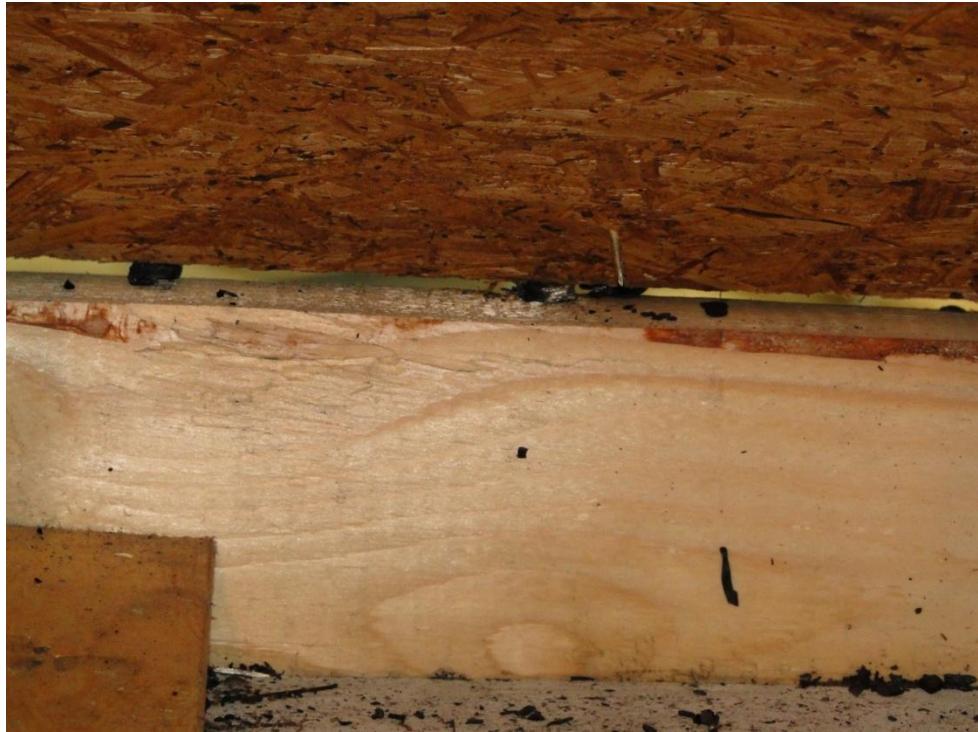
High-definition video was captured for this series of tests with cameras located at selected areas within the attic. Layers of cheesecloth were placed in the eave area of the attic behind the vents to collect embers that entered the attic space. The relative number of embers that entered through a given vent was qualitatively evaluated. According to the video footage, the cheesecloth did not collect a large number of the entering embers. Embers that entered the attic space either landed on the cheesecloth, were carried further back into the attic, thereby missing the cheese cloth, or entered the attic through the gap between top of the fascia and the roof sheathing and dropped on top of the soffit material, again missing the cheesecloth (Figure 4). This latter option occurred with the soffited eave construction.

Figure 4. Trapped embers in the fascia-to-roof sheathing gap.

The size of embers entering the attic was a function of the screen size of the mesh. The physical dimension of an ember entering the attic was never larger than the screen opening, or in the case embers entering through the gap at the roof edge, no larger than that opening. Embers entering through this gap could have come from either one of the five ember generators or ignited debris in the gutter that generated its own embers.

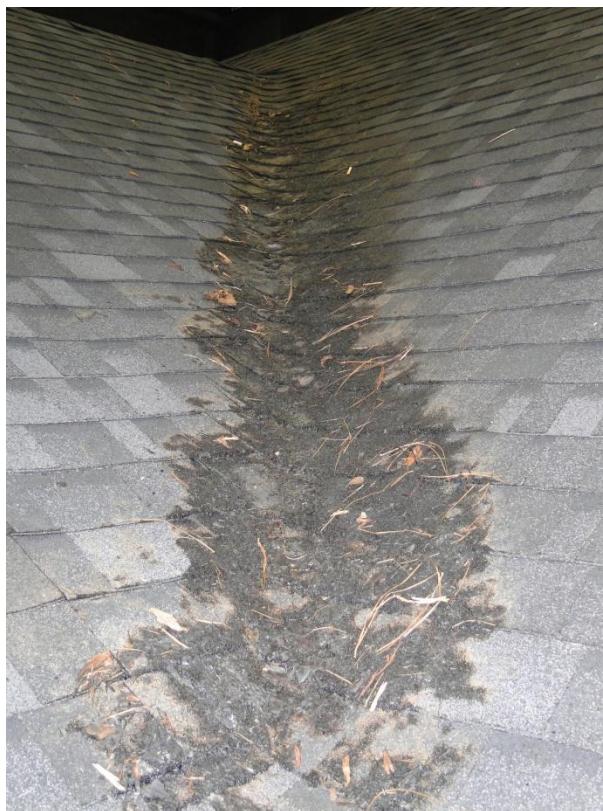
1. The untreated wood shake roof ignited in several locations and burned through the shingle layers and into the underlying roof sheathing before the fire was extinguished.
2. Pine needles in the roof valley were easily ignited by embers, as was the debris on top of and at the entrance to the clay barrel tile roof and at the roof-to-dormer intersection. The asphalt composition shingles were damaged but there was no burn through into the attic (Figure 6).

Figure 6. Damage to the roof covering after ignition of the pine needle debris in the valley.

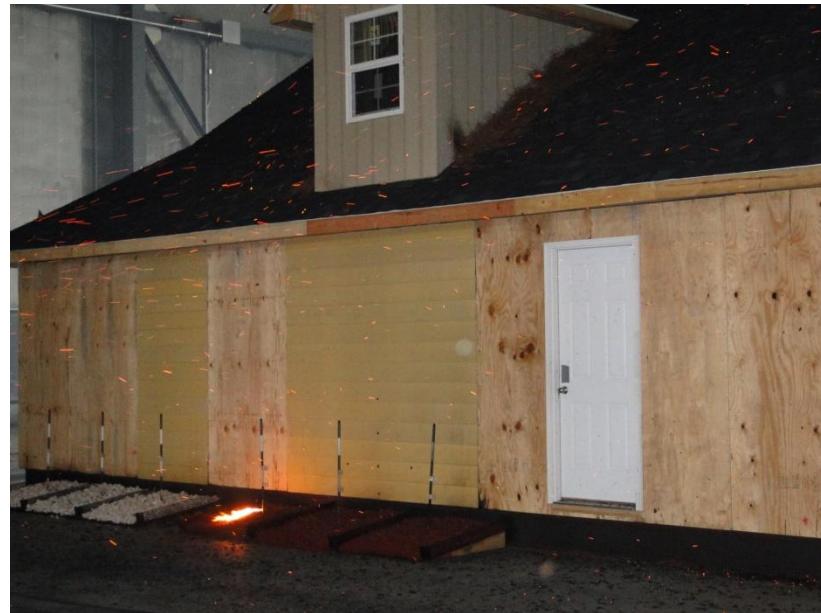
All of the combustible mulch products (recycled rubber, pine needles, and bark) ignited from the ember exposures. As expected, the noncombustible rock mulch did not ignite. Because of the dark smoke that was produced after ignition, the rubber mulch was extinguished shortly after it ignited (Figure 7). The measured heat flux during the rubber mulch burn did not exceed 2 kW/m^2 , and the maximum measured temperature was less than 38°C (100°F). The pine straw was not extinguished and burned quickly. The maximum recorded temperature was 255°C (490°F). The heat flux from one of the sensors in the ember-ignited pine needles is given in Figure 8, and it can be seen that there was a rapid rise and fall of heat flux to the exterior cladding, typical of burning debris and small landscaping vegetation. The maximum heat flux was approximately 80 kW/m^2 , but this level was maintained for only a few seconds. Burning pine needles are shown in Figure 9, and this product was quicker to ignite compared to the bark mulch product to the left of the pine needles. Ignited pine needle debris can also be seen adjacent to the dormer (on the roof).

Figure 7. Ember-started ignition in the recycled rubber mulch bed.

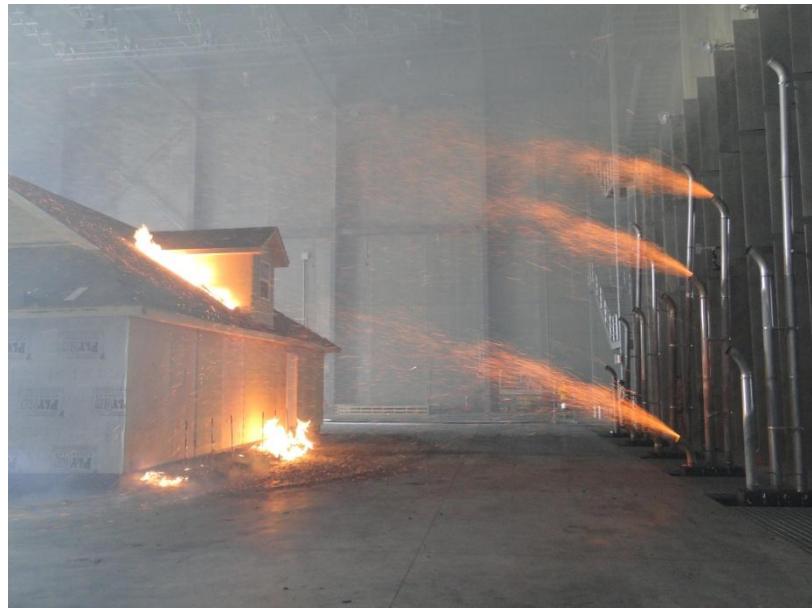
Figure 9. Burning pine needle mulch (center) and bark mulch (left). Pine needle debris next to the roof dormer also ignited.
