Inspection Options for Detecting Various Types of Impact Damage in Composite Structures

SAND2013-7877C

**Dennis Roach, Stephen Neidigk,
Tom Rice, Randy Duvall
Sandia National Labs
FAA Airworthiness Assurance Center**

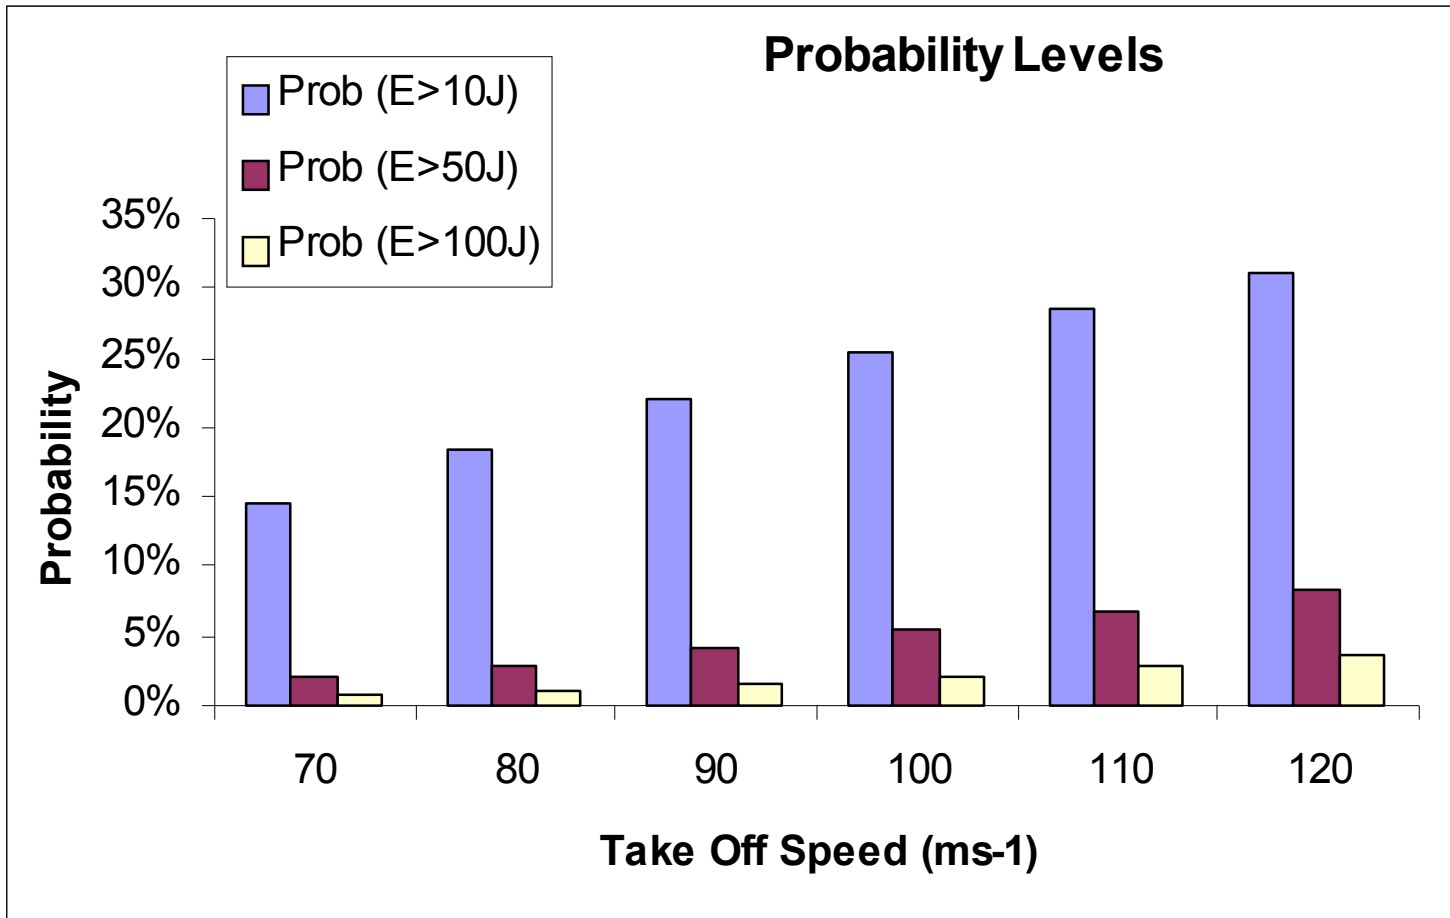
Probability of Impact Energy as a Function of Take-Off Speed

(based on runway debris collected from 4 UK military air bases)

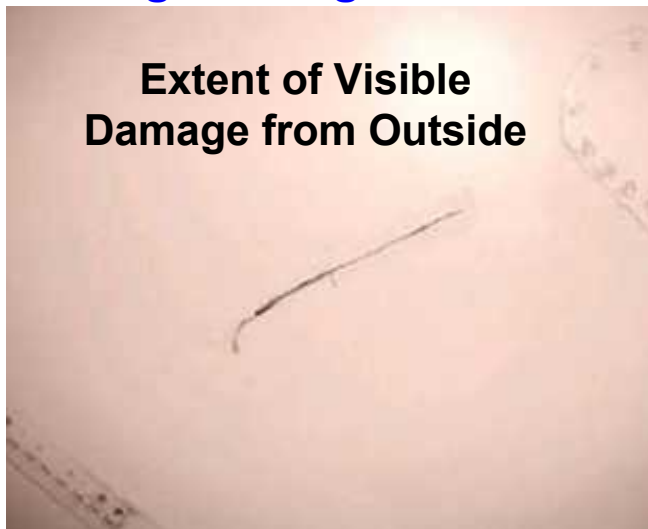
**Extent of Visible
Damage from Outside**

Damage from ground vehicle

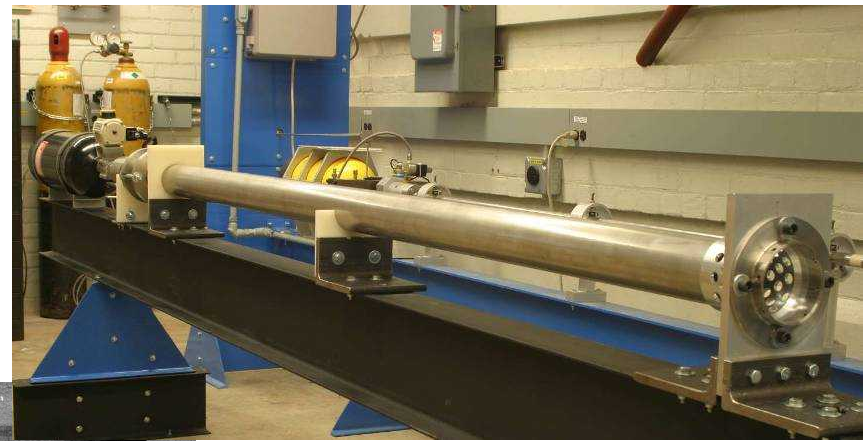
**UCSD High Velocity
Gas Gun**

Ice Impact at UCSD

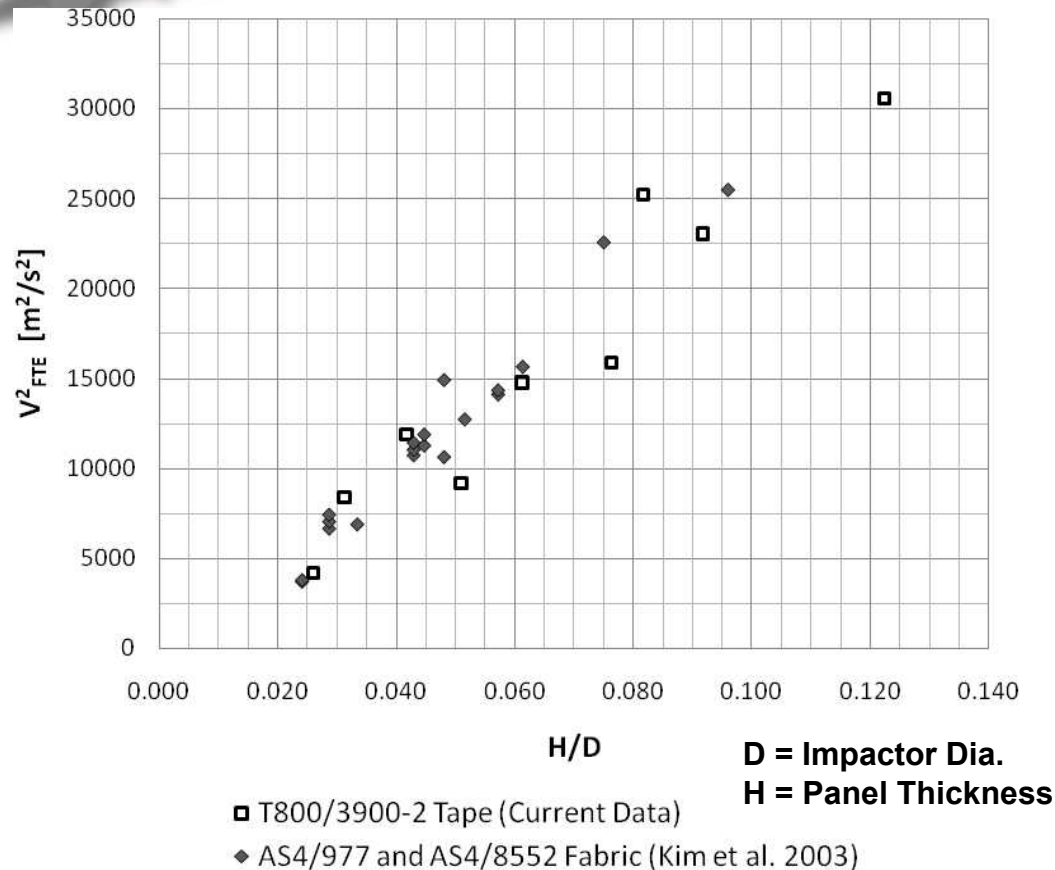
Failure Threshold (Energy) Velocity

Damage in Composite Laminates from Ice Impact

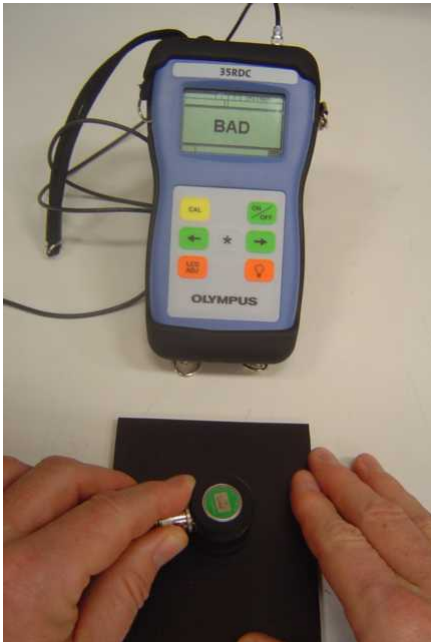
**Damage Check Device
(Pulse-Echo UT)**

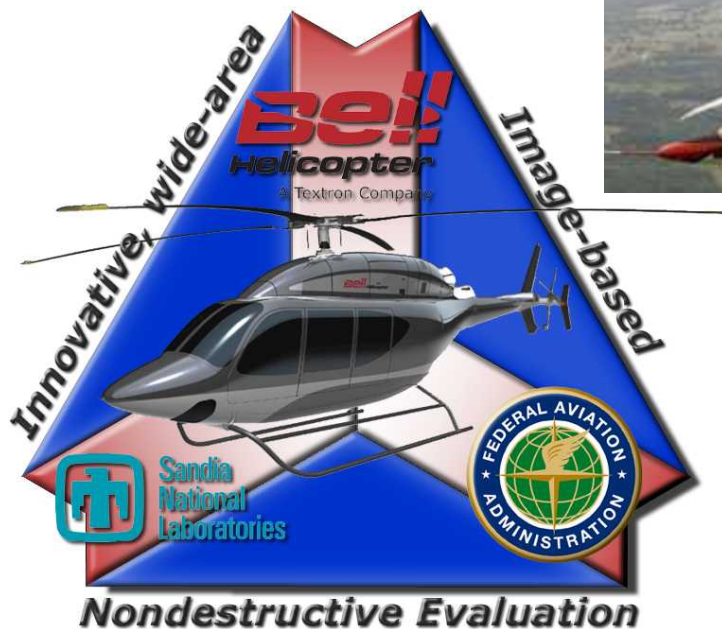
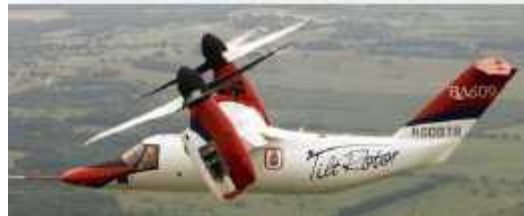
- Support for Bell Helicopter BAA
- Detect and characterize impact damage in full-scale panels
- Impact energies range from 25 to 500 in-lb
- Fast, low-cost, large-area inspection methods – visual based displays
- Screening NDI (“go” – “no go”) for ramp personnel (minimal training)

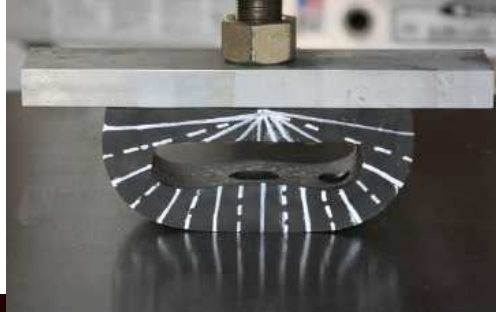
2' X 3' and 4' X 6' Panels With
Substructure Elements

Wide area blunt impact – internal, distributed damage;
high interlaminar shear & failure of co-cured joints

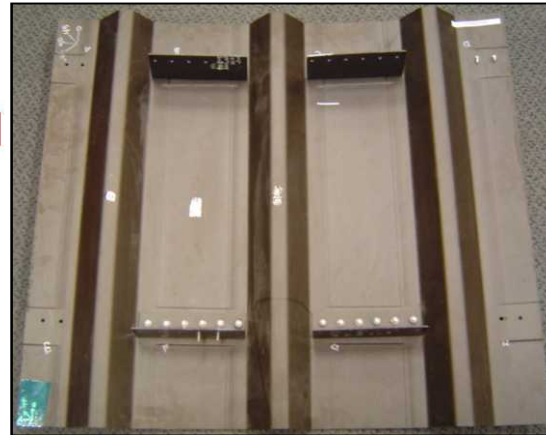
Stringer Fracture

Note: subsurface damage & comparison to visual inspection

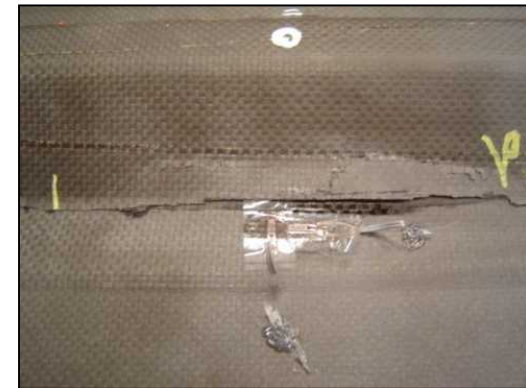
Fracture of Co-Cured Joint at Stringer-Skin Interface

Stringer & shear tie areas that are not yellow correspond to disbonds.

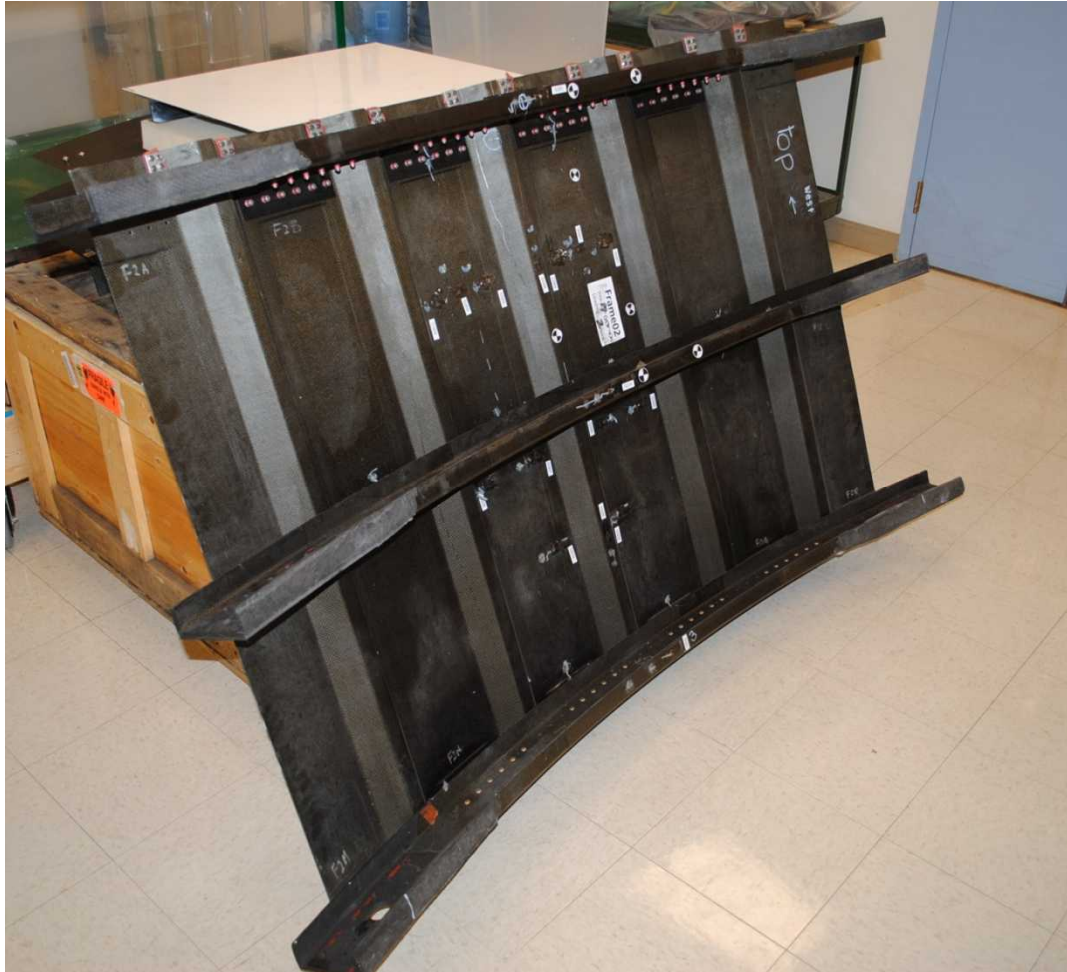
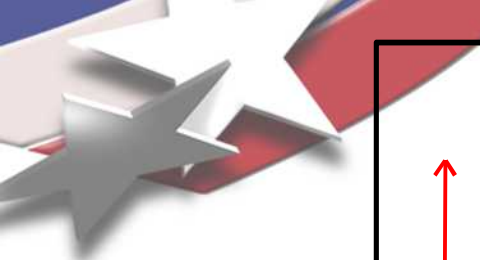
Full-Scale Carbon Aircraft Panels for Impact Assessment

Section A-A

Impact Regions:

- (1) skin between the stringers
- (2) stringer/skin interface
- (3) center of the stringer
- (4) shear-tie/skin interface

Schematic of Impact Damage

Damage location is divided
into “bays” separated by
stringers and frames
(shear-ties) to avoid effect
on neighboring impacts.
