LNG VESSEL CASCADING DAMAGE STRUCTURAL AND THERMAL ANALYSES

Sandia National Laboratories
Albuquerque, New Mexico, USA

Keywords: Cascading Damage, Cryogenic Fracture, Fracture Testing, Flow Analysis, Finite Element Analysis

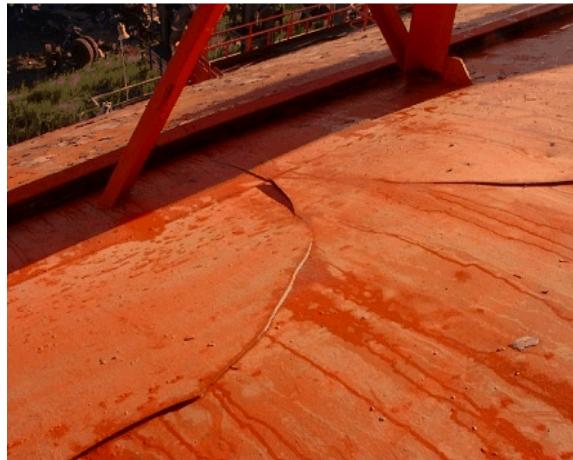
Figure 7. Example of cryogenic damage of steel ship decks from LNG spills

While the previous section described the LNG flow analysis, a series of material tests and large-scale fracture tests were conducted to assess the response of the LNG vessel's steel structure to LNG flow and fire. Structural steels are susceptible to low temperature brittle fracturing and high temperature softening. Figure 7 shows examples of cryogenic fracturing of LNG ship steel deck plates that have occurred from relatively small LNG spills.

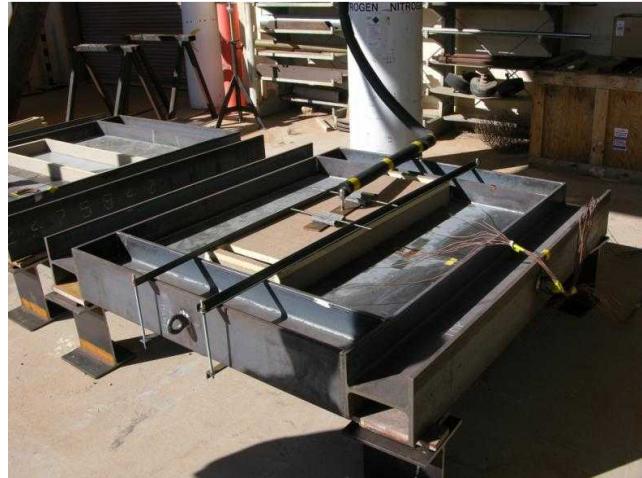
Figure 11. Example Phase II Test Article

The structural fracture test series were designed to induce large thermal stresses in the test plates due to differential thermal contraction while simultaneously lowering their ductility. As previously discussed, liquid nitrogen (LN₂) was chosen as the cryogenic fluid for testing. It is significantly safer to work with and the temperature of LN₂ is slightly colder (-190°C) than LNG (-161°C). The use of LN₂ ensures that the tests could achieve temperatures in the range an actual ship would see during an LNG spill. There were four phases in this test series. Phase I was an initial exploratory stage that provided preliminary data to steel material response to LN₂ (LNG) and insight and direction for the series of larger scale tests. In the Phase II series of tests, larger plates were used, ranging in size from 4 ft square pieces to 6 ft square sections. This phase investigated the cooling rates on the plates and the effect of different notch geometries (stress concentrations were machined into the test articles to initiate brittle fracture) from which a crack would initiate. Phase II was broken in to two sections, Phase II-A and Phase II-B. Phase II-A used standard A36 structural steel, while Phase II-B used marine grade steels. In Phase III, significantly larger 12 ft square

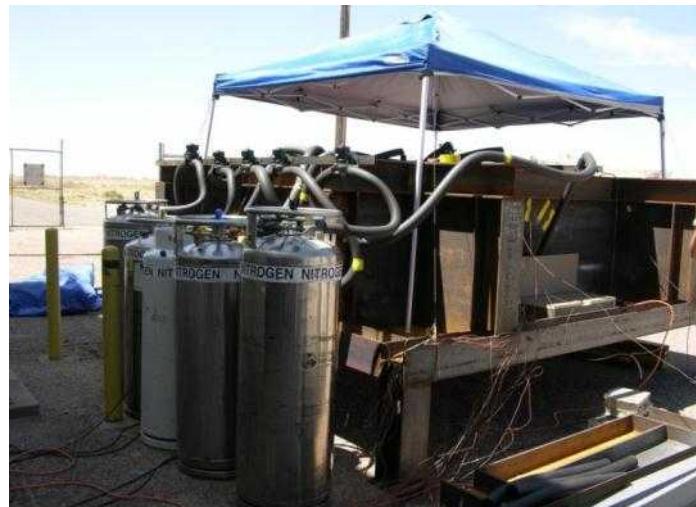
In order to provide validation of the modeling technique and the parameter estimation, larger, and more complex test specimens were fabricated and tested in Phase III with an example shown in Figure 14. As with the Phase II tests, a notch was introduced to facilitate fracture. A finite element model of the test structure was also constructed using 4 inch elements, and the cooling was produced through a heat transfer analysis to drop the temperature in the region cooled in the test. The experimental cracking was compared to the computed element failures as shown in Figure 15.

Figure 14. Phase III Test Structure

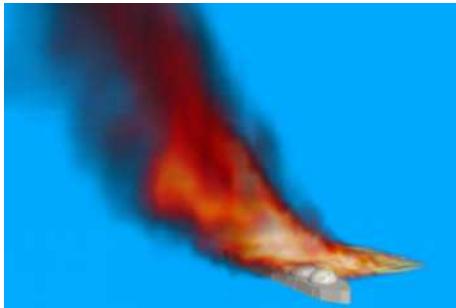
ships for the smaller pool sizes predicted for the larger LNG spills. In both cases, the fire impact extends beyond the diameter of the pool along the length of the vessel due to radiation and the wind makes the fires lay over onto each ship. The boxed region shows where significant heating is expected to occur, which includes the sides and tops of the LNG ships.

Figure 18. Fire impacting the Moss ship (left) and extent of heated region (right).

A wind speed of 9 m/s (20mph) was used for these analyses and it was assumed directed toward the LNG ship. Figures 18 and 19 show the fire simulations and the affected portions of the Moss and Membrane

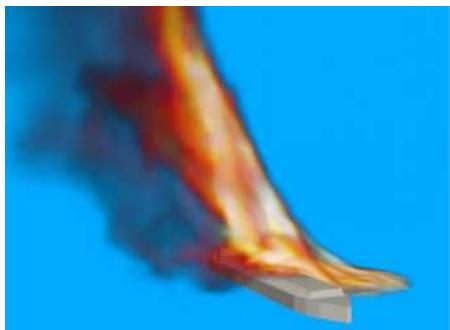
Figure 19. Fire impacting the Membrane ship (left) and extent of heated region (right).
