RADIATION HARDENED ELECTRONICS DESTINED FOR SEVERE NUCLEAR REACTOR ENVIRONMENTS

February 2016

Final Technical Report
Period: Dec. 16, 2013 – Dec. 15, 2015
Submitted to
Office of Nuclear Energy
Department of Energy

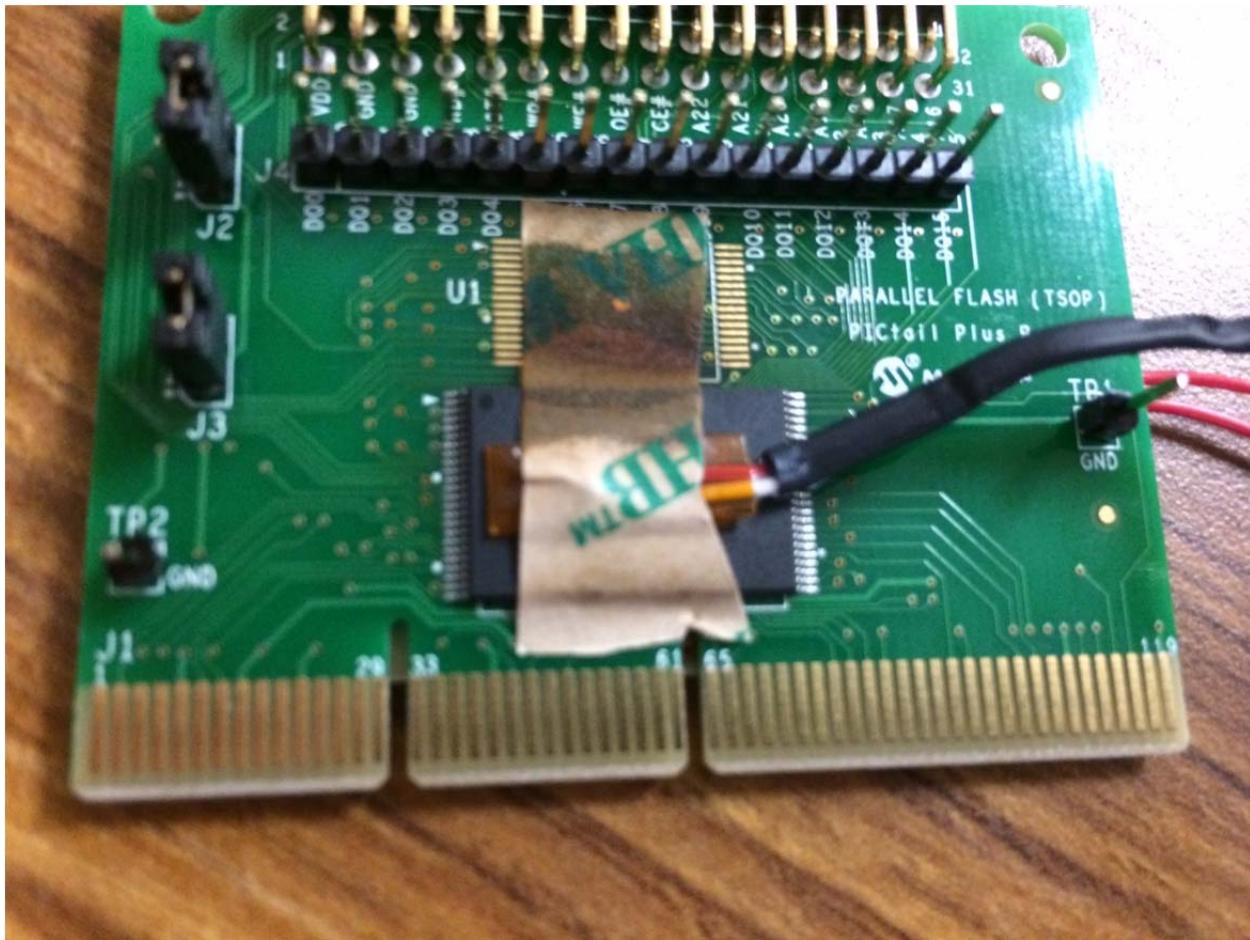
Figure 5. The temperature sensor (an RTD) is directly in contact with the flash memory module on the front side of the board. The two red wires to the resistive heater on the backside of the board can be seen to the right.

To partially assess the performance of the electronics in the post-accident environment, the microcontroller and its flash memory were subjected to elevated-temperature testing. A temperature sensor with pressure sensitive adhesive (PSA) was attached directly to the sensitive electronic device, as shown in Figure 5, and a resistive Thermofoil™ heating element with PSA was sited on the backside of the board opposite the device. Next, a layer of silicone insulating material was placed on both the front and back sides and clamped into place as exhibited in Figure 6. Although the red silicone insulation is rated to 260 °C (500 °F), the PSA is rated to only 150 °C thus motivating the use of the clamp. To ensure temperature stability during the measurements, the assembly was then wrapped in an additional overall silicone insulating blanket, as pictured in Figure 7. An off-the-shelf PID controller was programmed to permit increasing the temperature of the system gradually. According to the manufacturer data [24], the flash memory module has an operating temperature range of 0 °C to +70 °C and an absolute

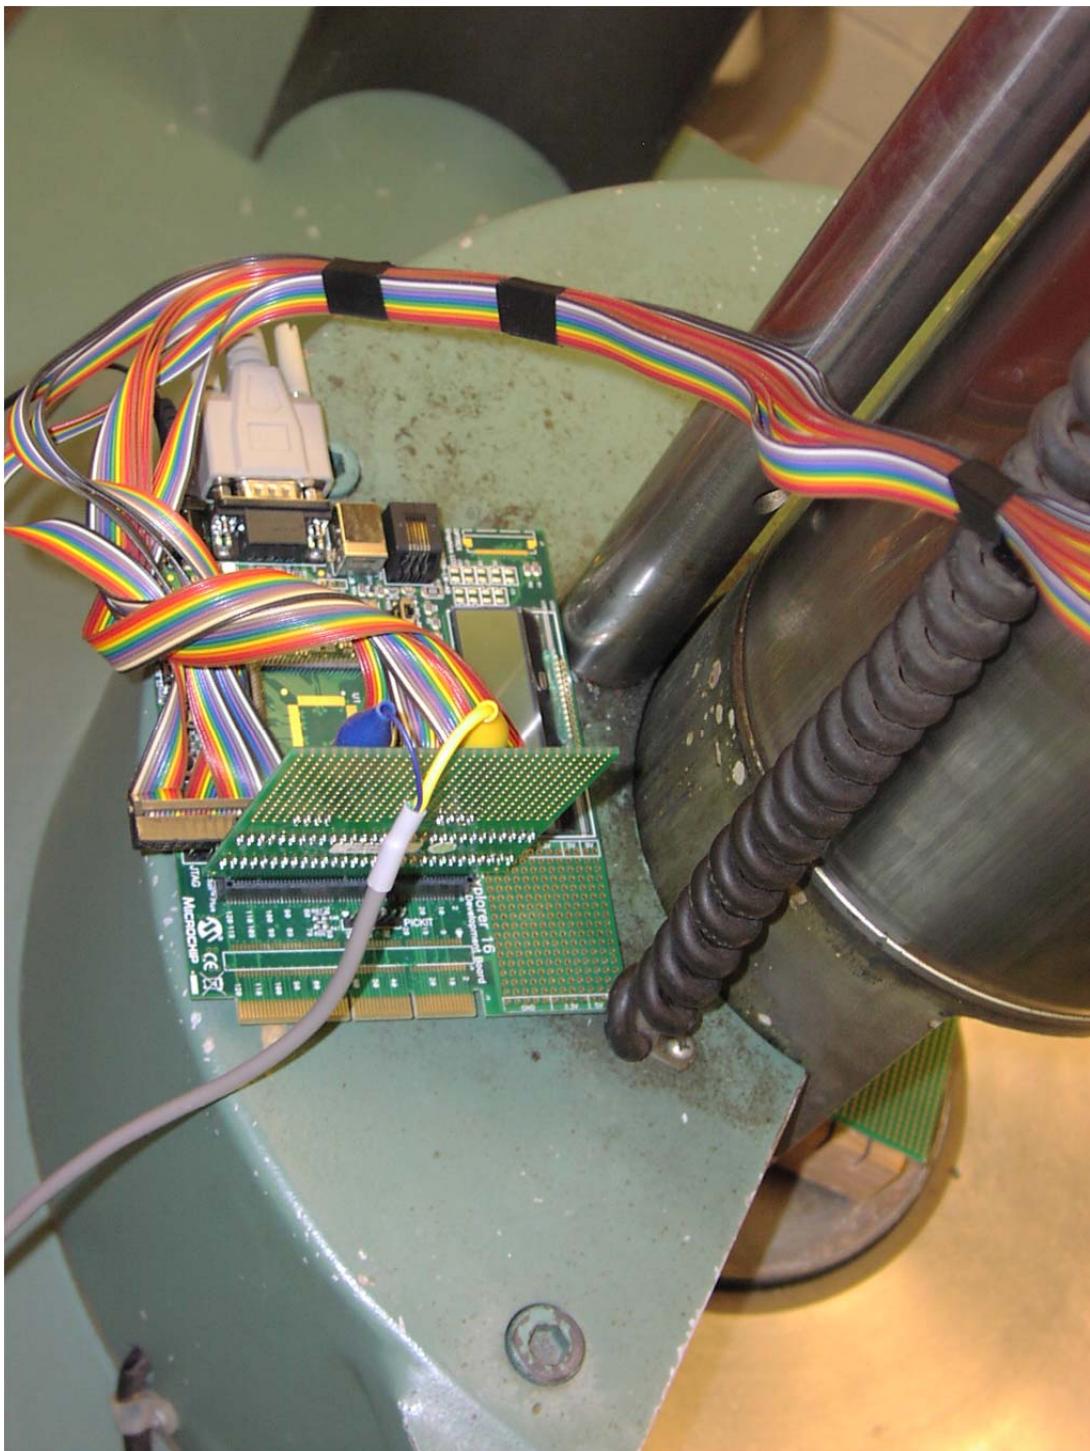
Figure 9. Explorer 16 development board located outside the irradiation chamber with ribbon cables providing signal and power transmission pathways to the device under test.

The total ionizing dose (TID) experiments were carried out in a Gammacell 220 Co-60 self-shielded irradiator. The Gammacell 220 allows feed through of ribbon cables thereby permitting in-situ measurements during irradiation. To accomplish the simultaneous irradiation and system testing, an Explorer 16 development board is located outside the irradiation chamber as shown in Figure 9. The Explorer 16 development board is a low-cost modular development system for Microchip 16-bit and 32-bit microcontrollers, and includes a PICtail Plus daughter card connector for expansion boards. The device under test (DUT) is then placed into a universal development board that is located in the irradiation chamber as pictured in Figure 10. In some experiments, the power to the DUT is supplied via the Explorer 16 (see Figure 11(a)) whereas in

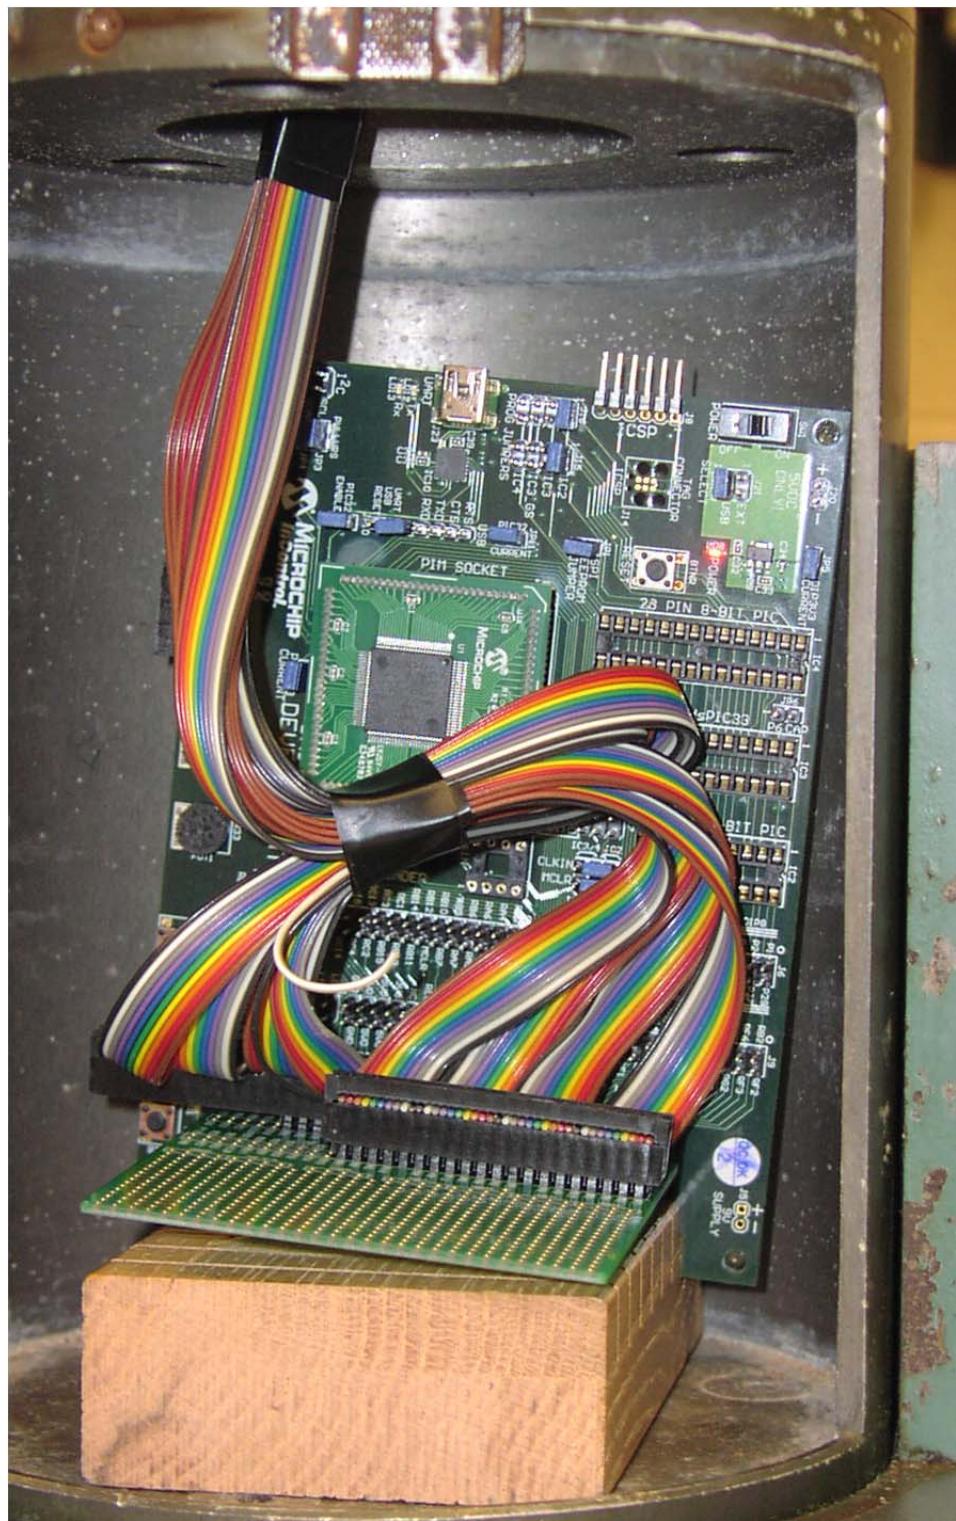
Figure 10. Universal development board with microcontroller placed within the irradiation chamber.
