Treatment of Chlorinated Solvents in Groundwater Beneath an Occupied Building at The Young - Rainey STAR Center (Science, Technology, and Research Center) – 16342

Joe Daniel*, Charles Tabor*, Scott Surovchak**

ABSTRACT

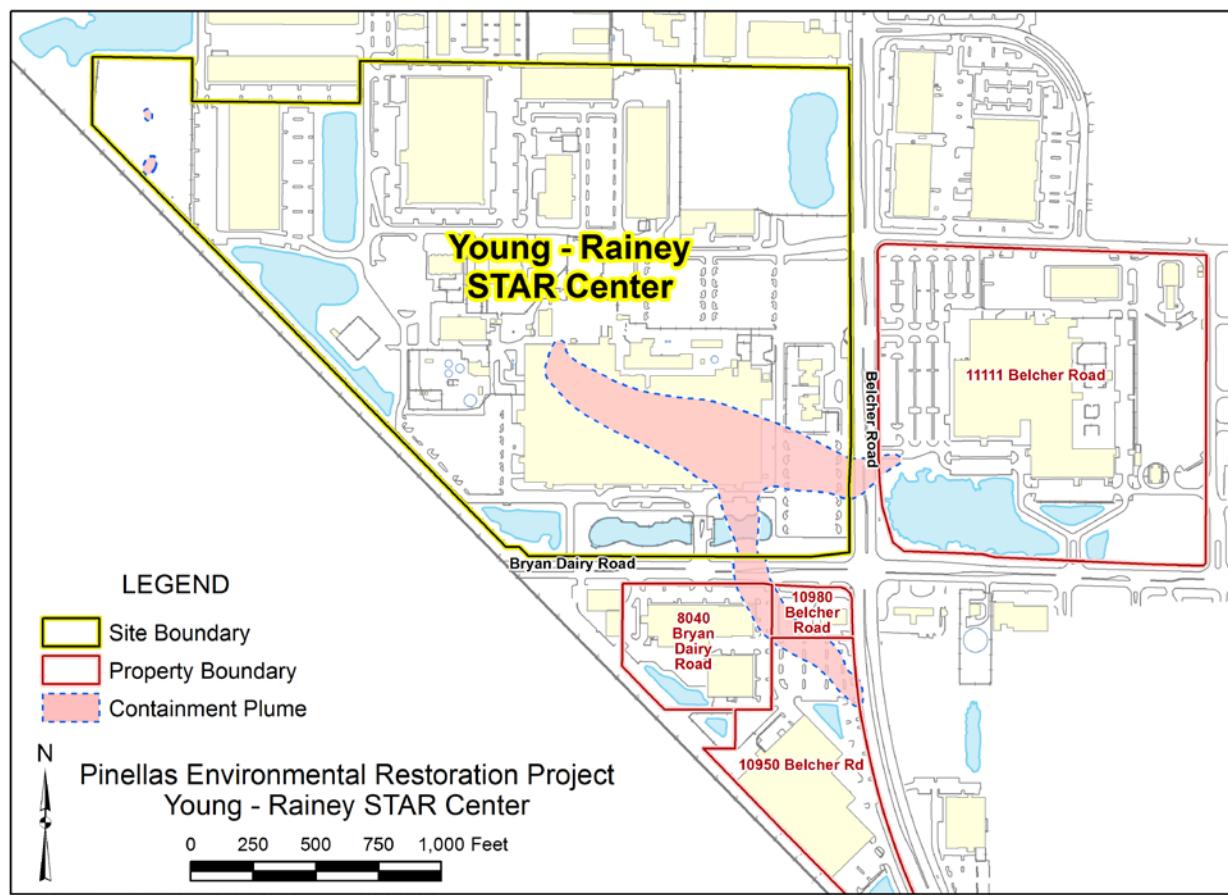
Figure. 1. Map of Groundwater Contaminant Plumes at the Young – Rainey Star Center

We describe an environmental remediation program underway at a Florida site formerly used to develop and manufacture weapons components for the nation's nuclear weapons program. The former Pinellas Plant, now known as the Young - Rainey Star Center (Science, Technology, and Research Center), ceased operations for US DOE in 1997, and DOE and the Pinellas County, Florida, government jointly redeveloped the site for commercial use. Upon discovery of offsite migration of groundwater contamination that originated beneath Building 100 at the site, DOE promptly completed the required notification to the Florida Department of Environmental Protection and voluntary notification to the owners of properties located hydraulically downgradient from the contaminant plume [1]. Following notifications to all stakeholders, DOE worked closely with each party to keep them informed as to potential health risks, hazard controls, and the proposed corrective actions. Subsequent efforts have focused on treatment of the groundwater contaminant sources beneath the building, as well as the dissolved-phase groundwater contamination hydraulically downgradient from the building (Fig. 1) [2].

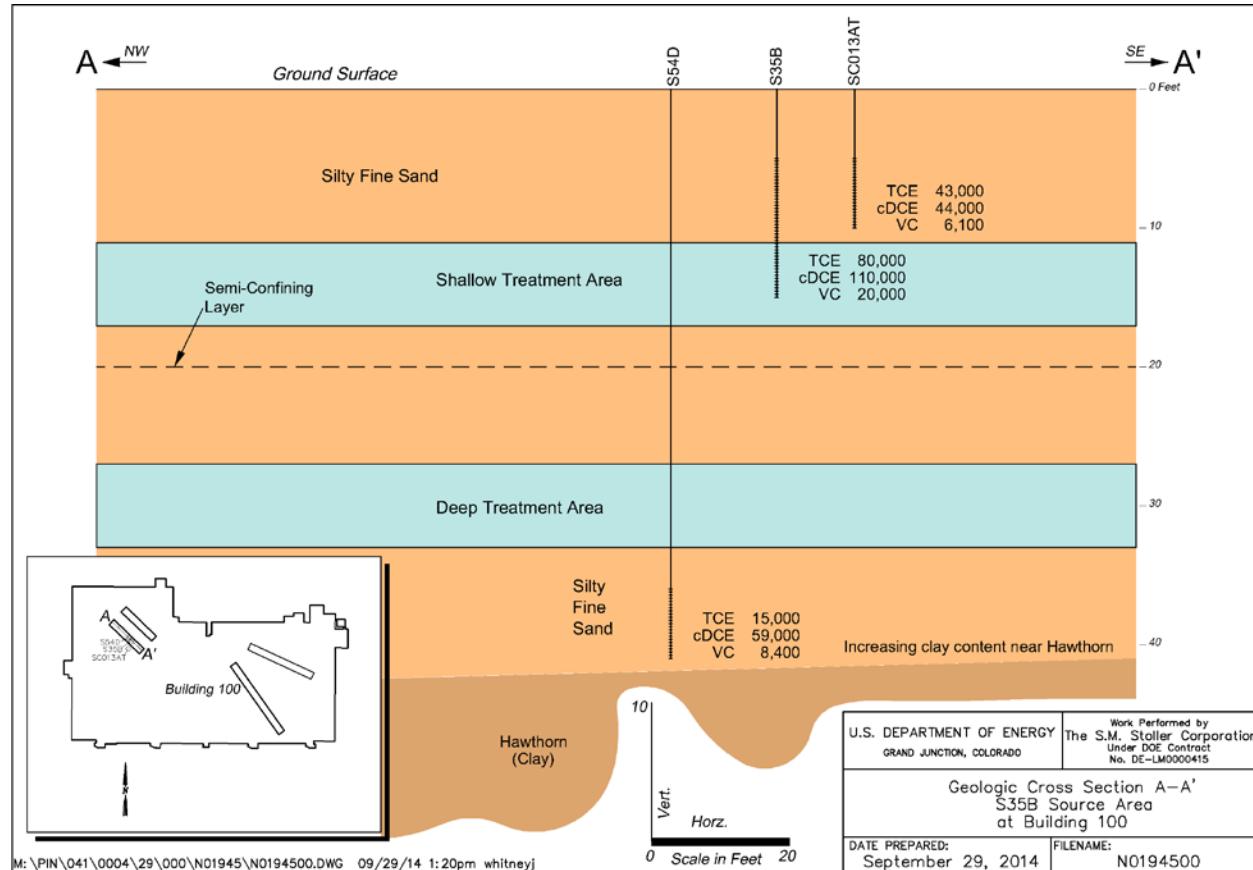
Figure 2. S35B Plume Treatment Area Cross Section A–A' (concentration in $\mu\text{g/L}$)

characterization and delineation methods such as vertical drilling through the floor were ruled out. Instead, DOE reviewed the limited historical data sets from soil borings, monitoring wells, and subslab vapor sampling to focus on areas with high contaminant concentrations and exclude areas known to have little or no groundwater contamination. Cross sections A–A' (Fig. 2), B–B' (Fig. 3), and C–C' (Fig. 4) illustrate the identified treatment target areas in each of four locations beneath the building (contaminant concentrations in micrograms per liter).

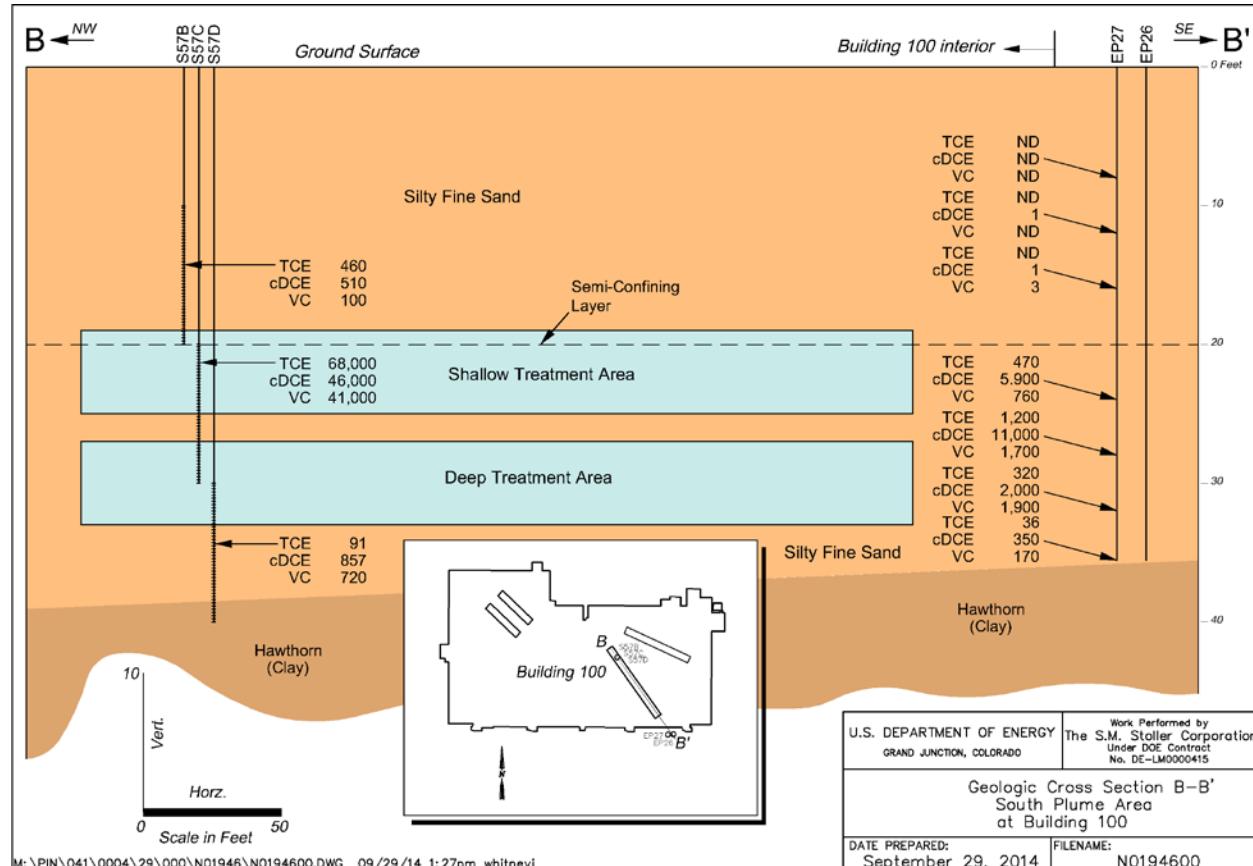
Figure 3. Plume Treatment Area Cross Section B–B' (concentration in $\mu\text{g/L}$)

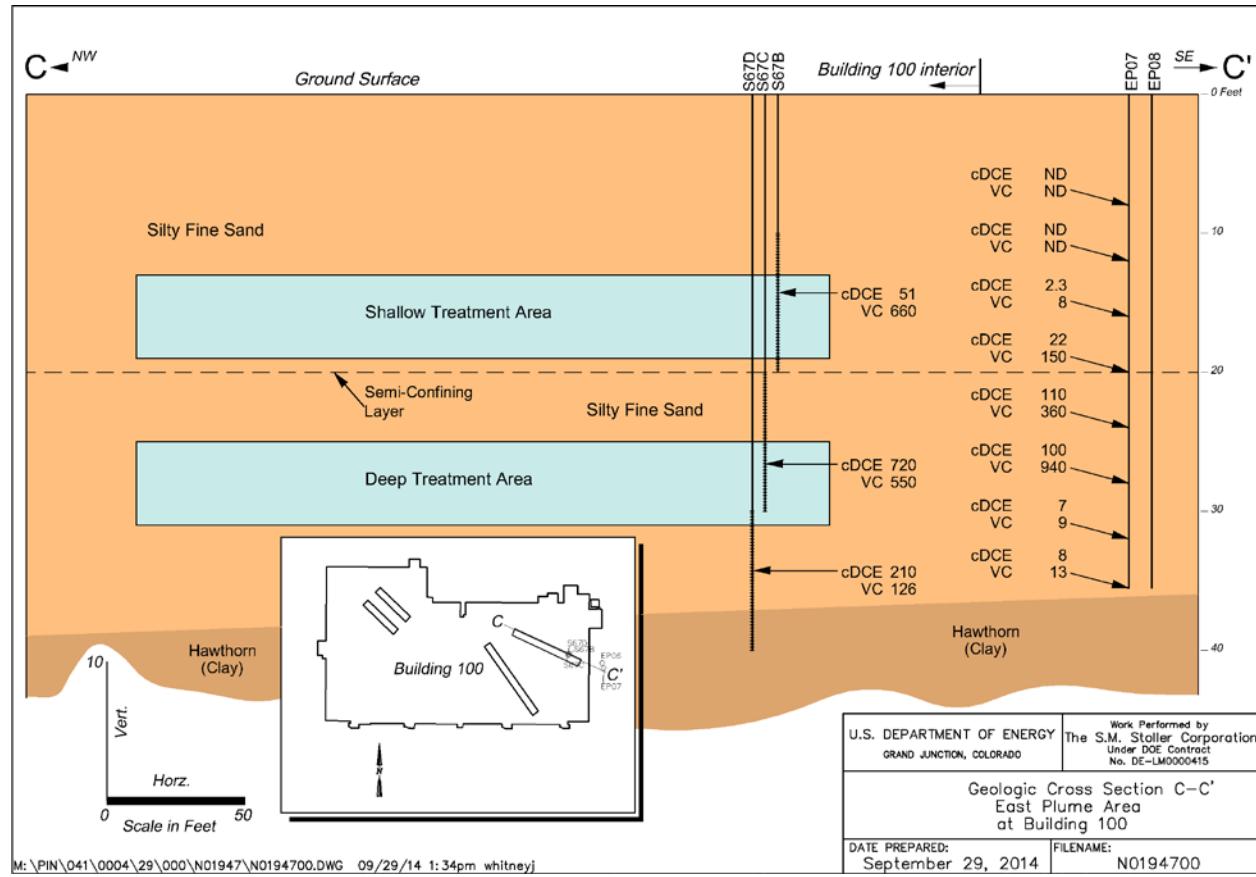
Figure 4. South Plume Treatment Area Cross Section C–C' (concentration in $\mu\text{g/L}$)

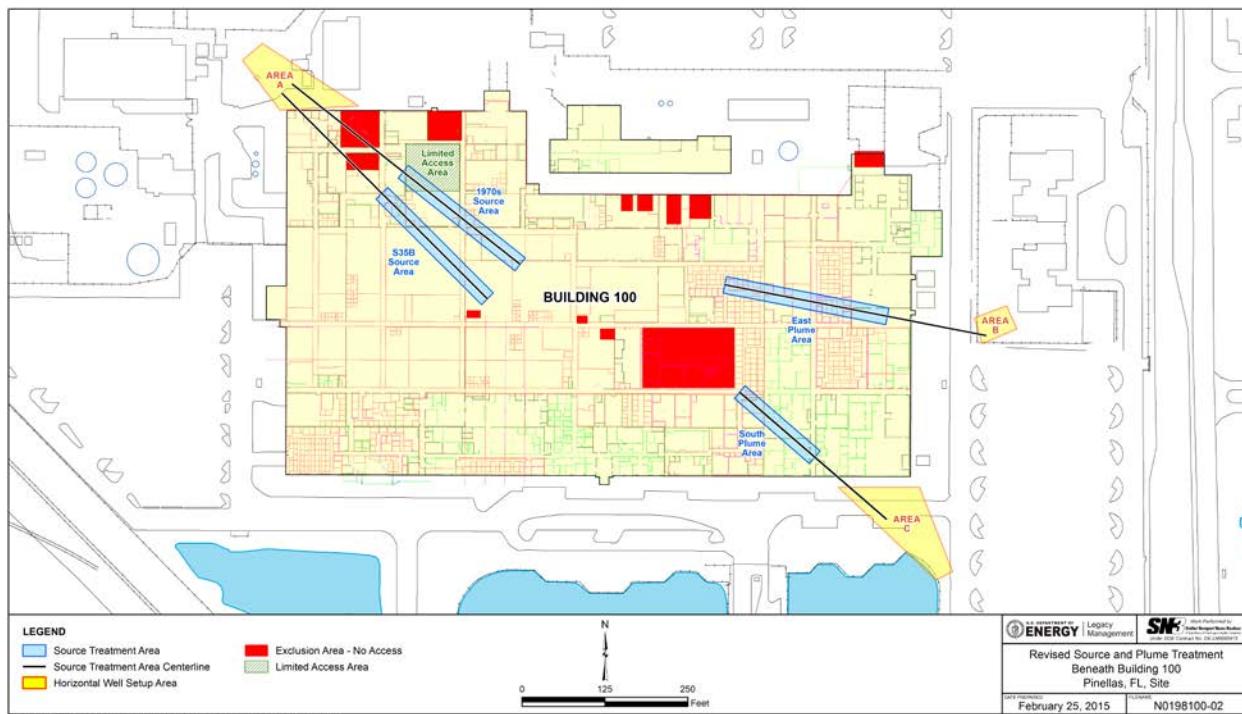
Figure 5. Building 100 Horizontal Injection Well Locations

The decision to install horizontal wells for bioinjection was essentially a process of elimination and was found to be the only viable option due to limited access to the subsurface beneath the building. The data analysis and treatment technology review led to the decision to install four stacked pairs of horizontal wells beneath the building (Fig. 5).

The location and orientation of the wells was primarily driven by the decision to orient the wells somewhat parallel to the long axis of the plumes for maximum contact of the slotted well intervals within the plume. Another factor in locating the wells was the availability of space in close proximity to the four target areas. The second major design consideration was the lack of space to install the wells using an entry–exit technique, which led to the decision to install using a single entry or “blind well” technique. The presence of a horizontal semiconfining layer at approximately 6 m (20 ft) below land surface drove the decision to install stacked pairs, one above and

one below this zone of lower permeability (except at Area C, where the contamination was deeper).

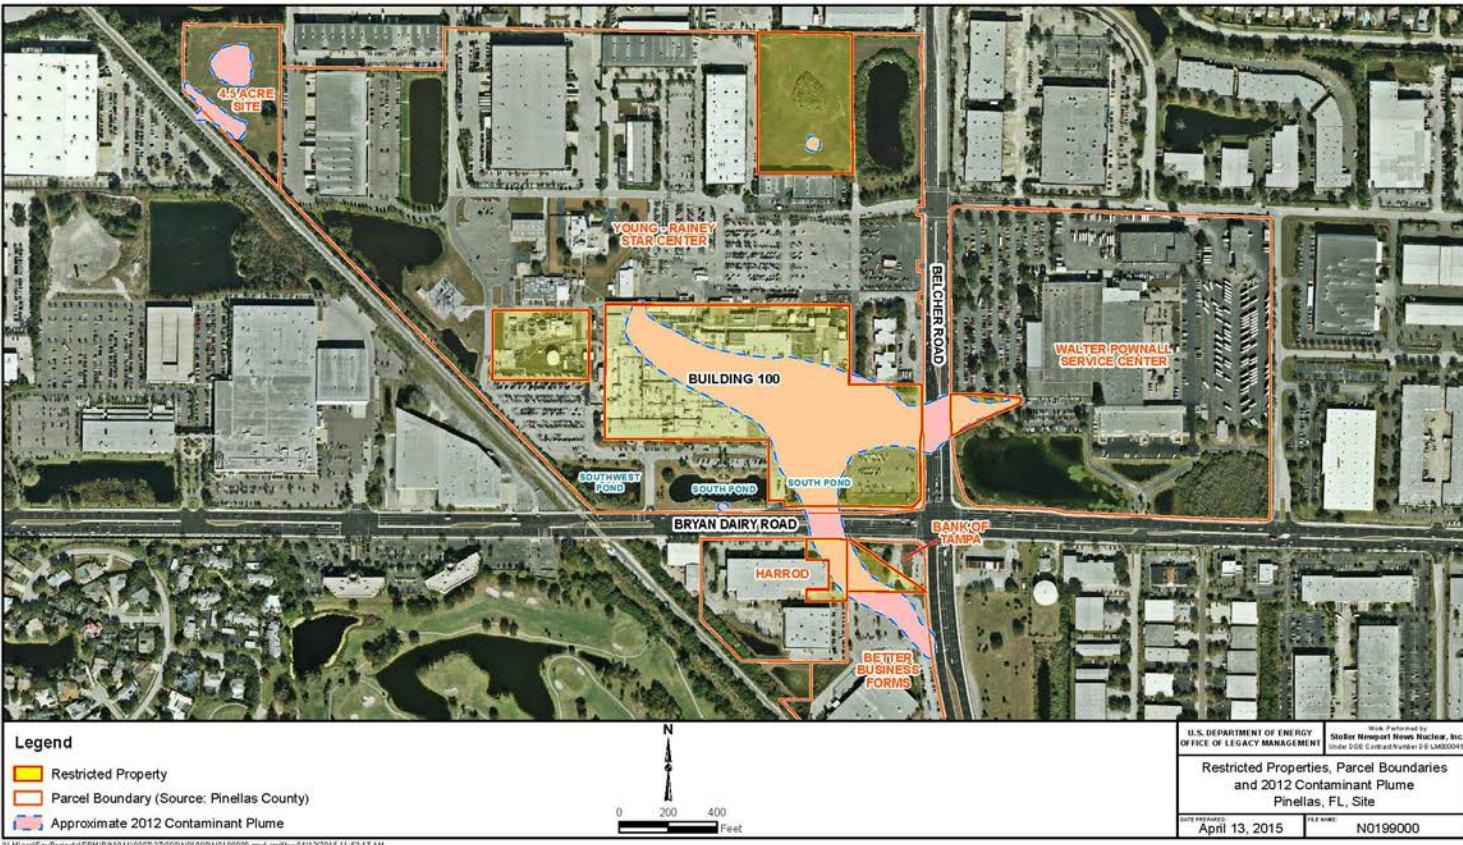
Site Map with Contaminant Plumes

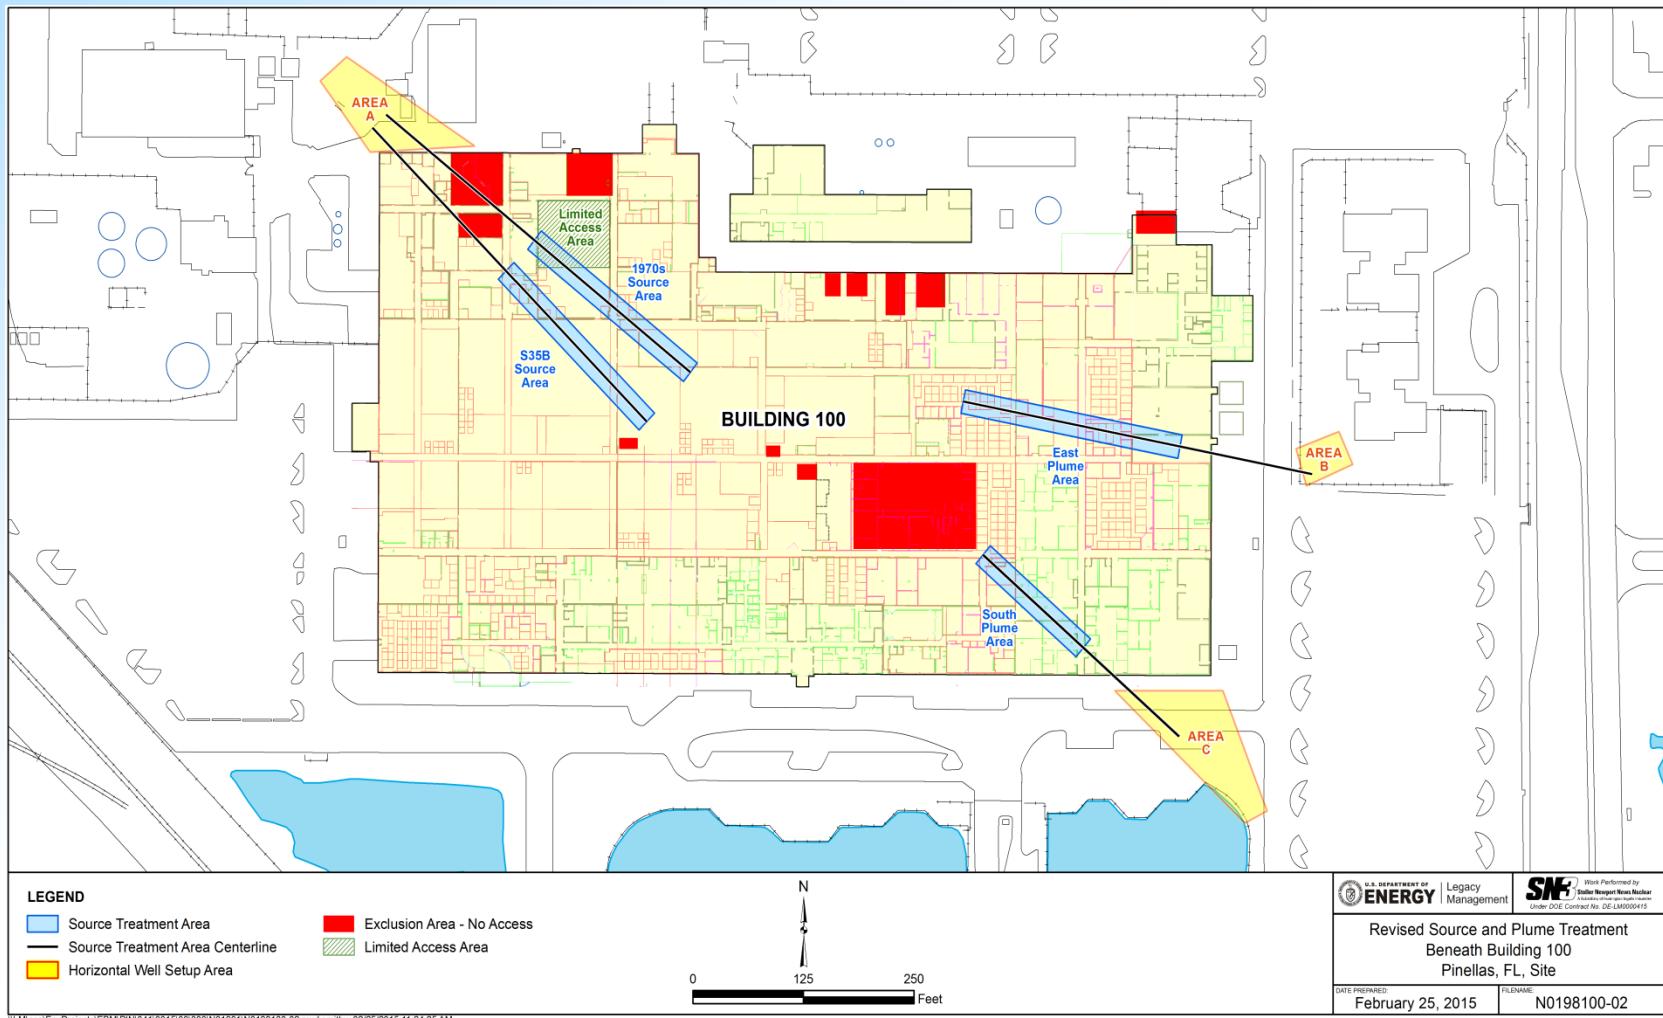
Horizontal Well Location Map

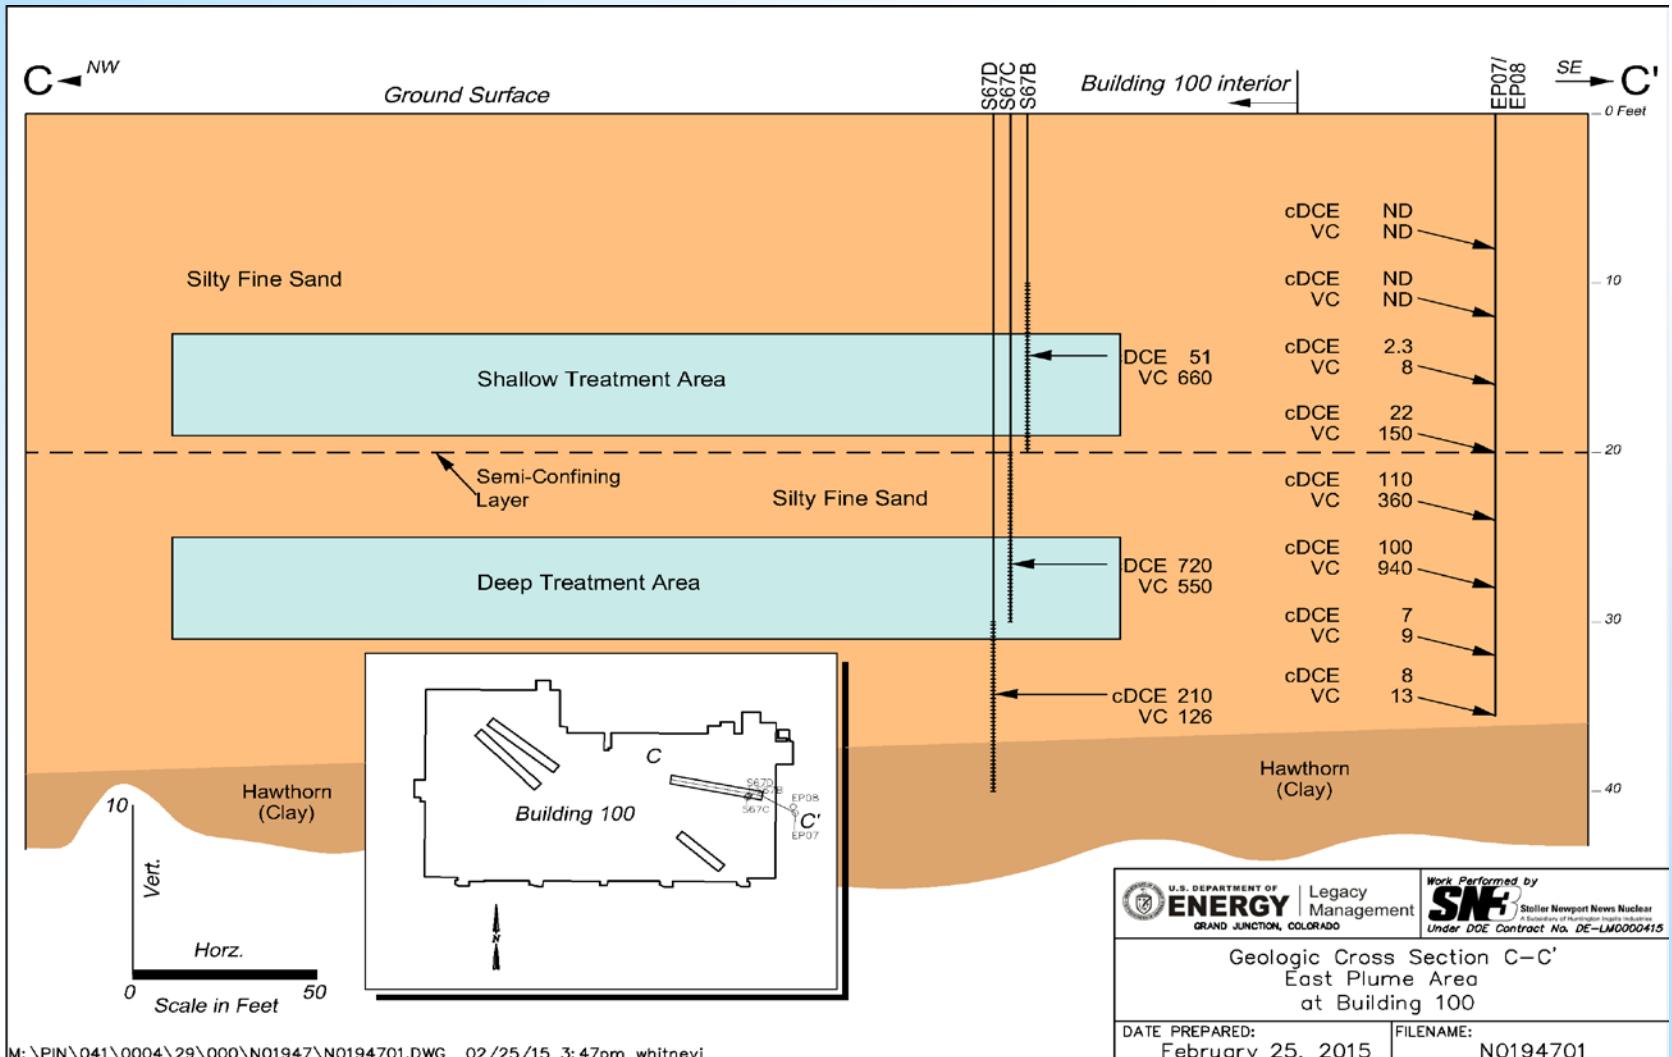
Treatment Area Cross-Section

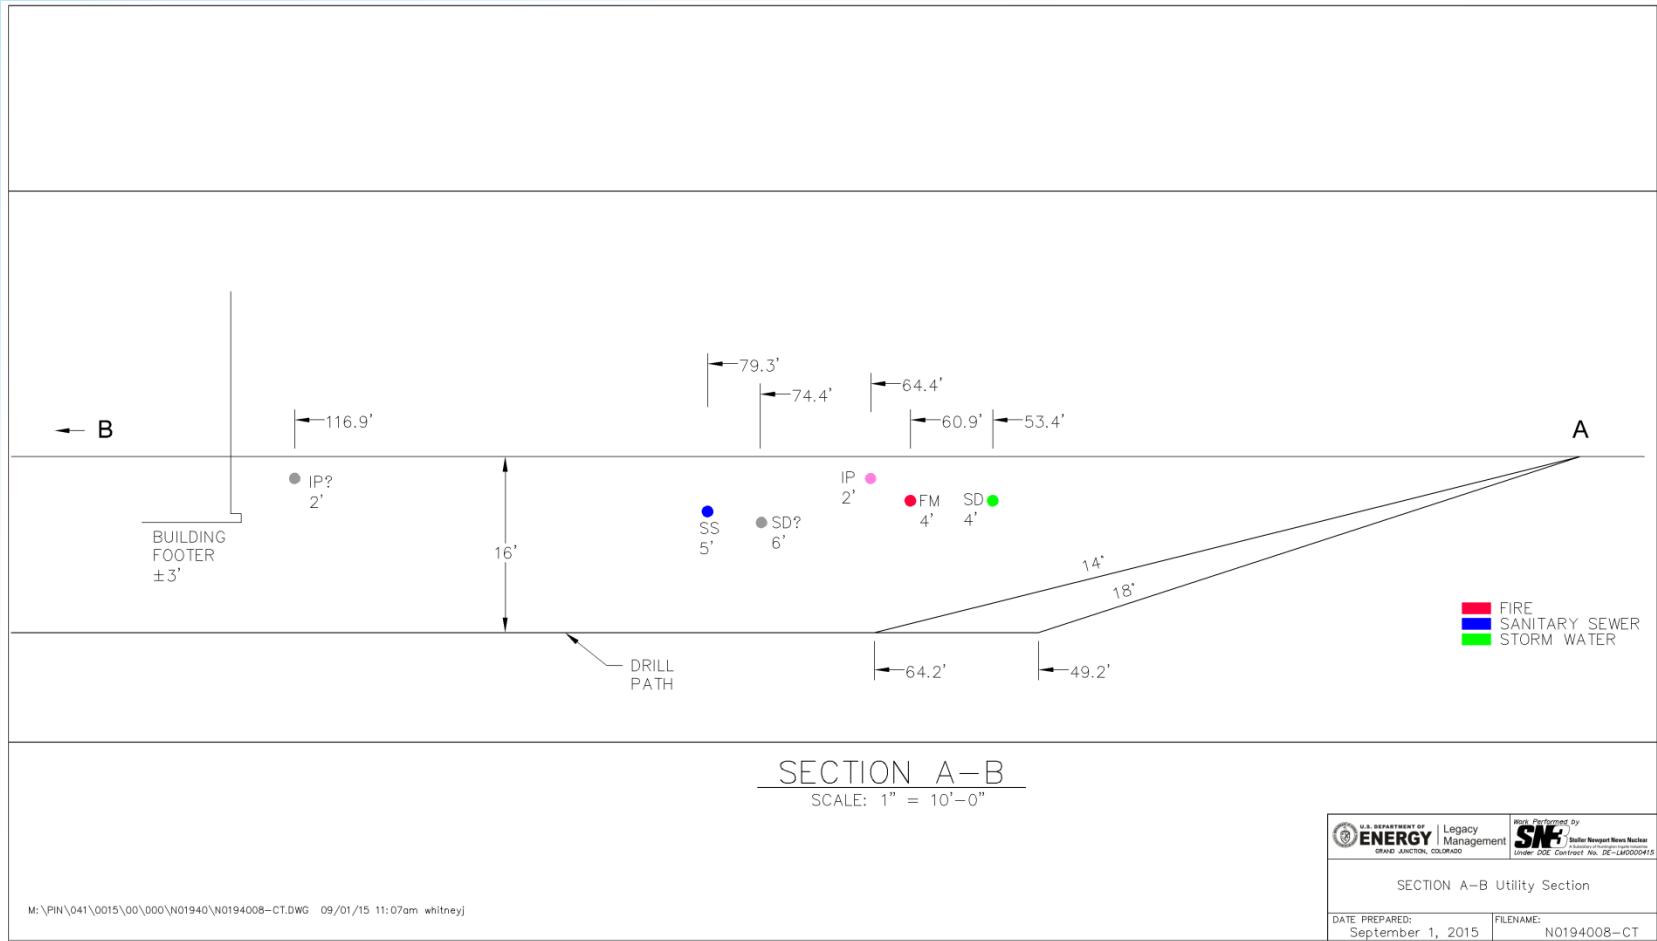
Construction Detail – Utility/Well Bore Cross-Section

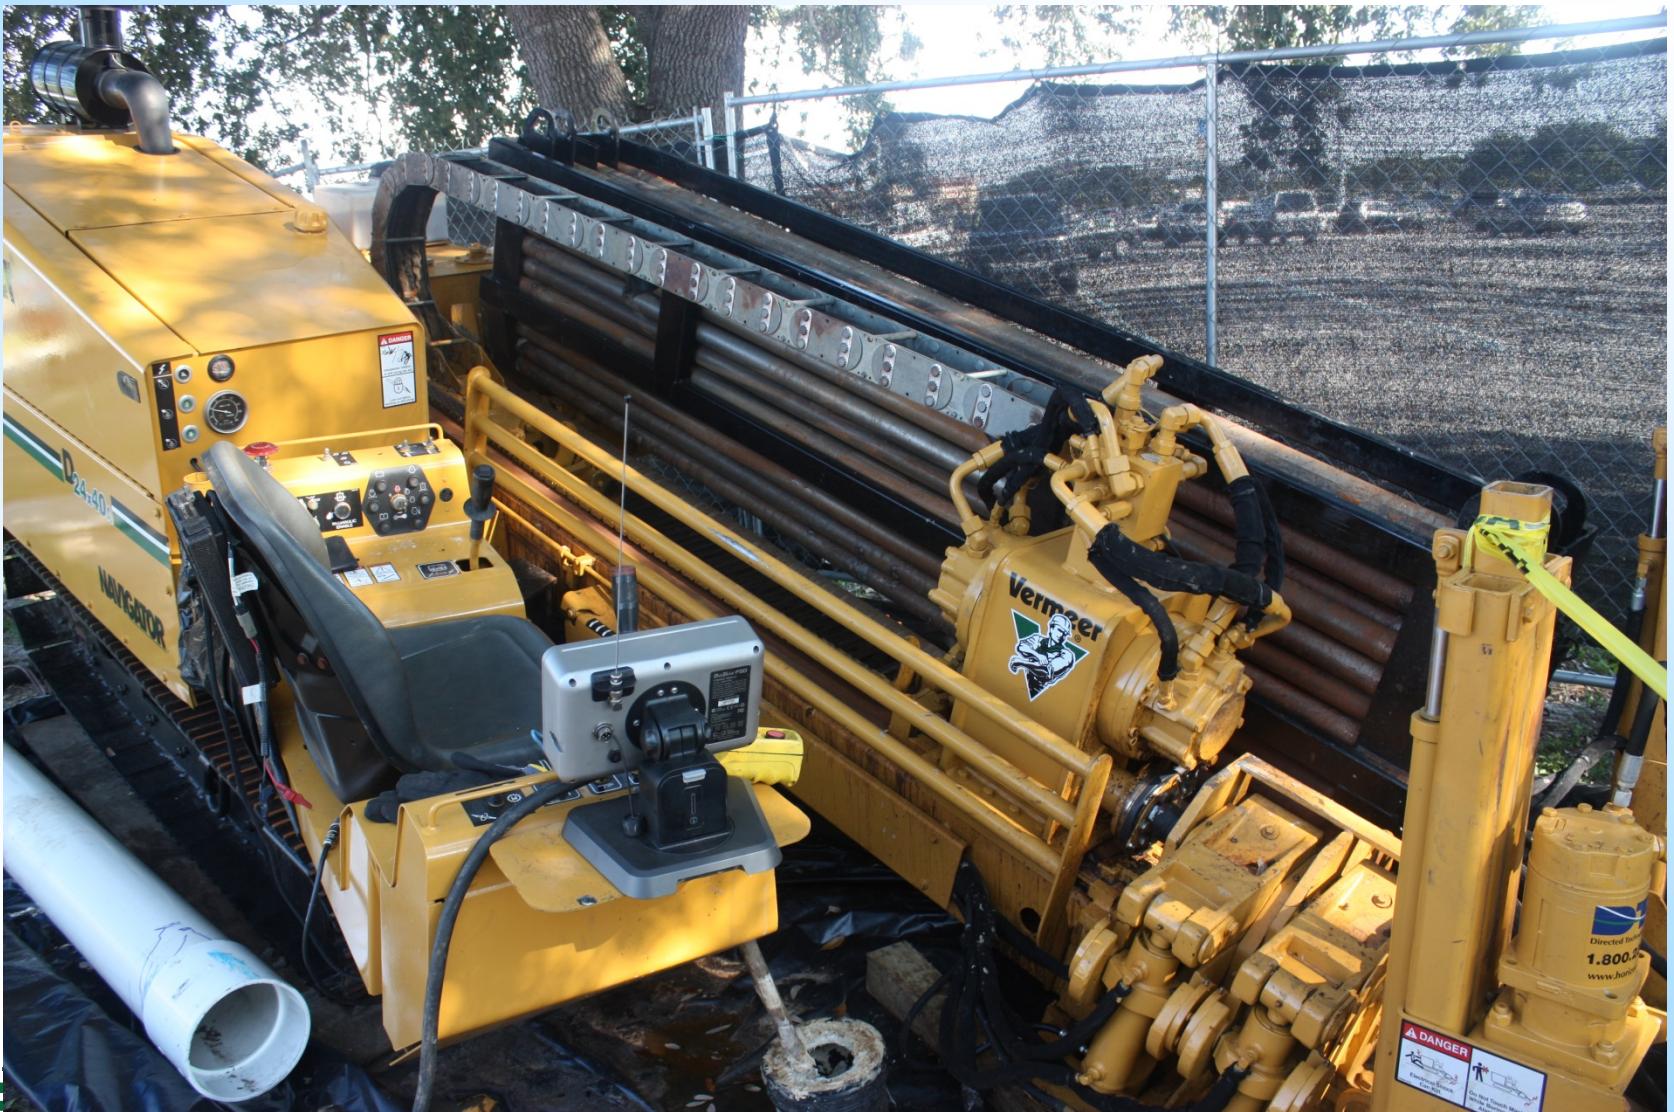
Horizontal Drill Rig

Horizontal directional drilling (HDD) is a technology that was developed in the petroleum industry and adapted for environmental remediation applications beginning in the early 1990s. This technology is typically considered only for special situations due to its higher cost and complexity relative to conventional vertical drilling. DOE solicited HDD experts to design and install the horizontal wells to ensure the success of the project. Some of the challenges during well installation included identifying and locating subsurface utilities (some of which were installed starting in the mid-1950s in undocumented locations) and other infrastructure (e.g., an elevator plunger) that had to be avoided along the bore paths of the wells, navigating the drill bit beneath inaccessible areas in the building, electromagnetic interference that disrupted the navigation equipment, heaving sands, and record rainfall.

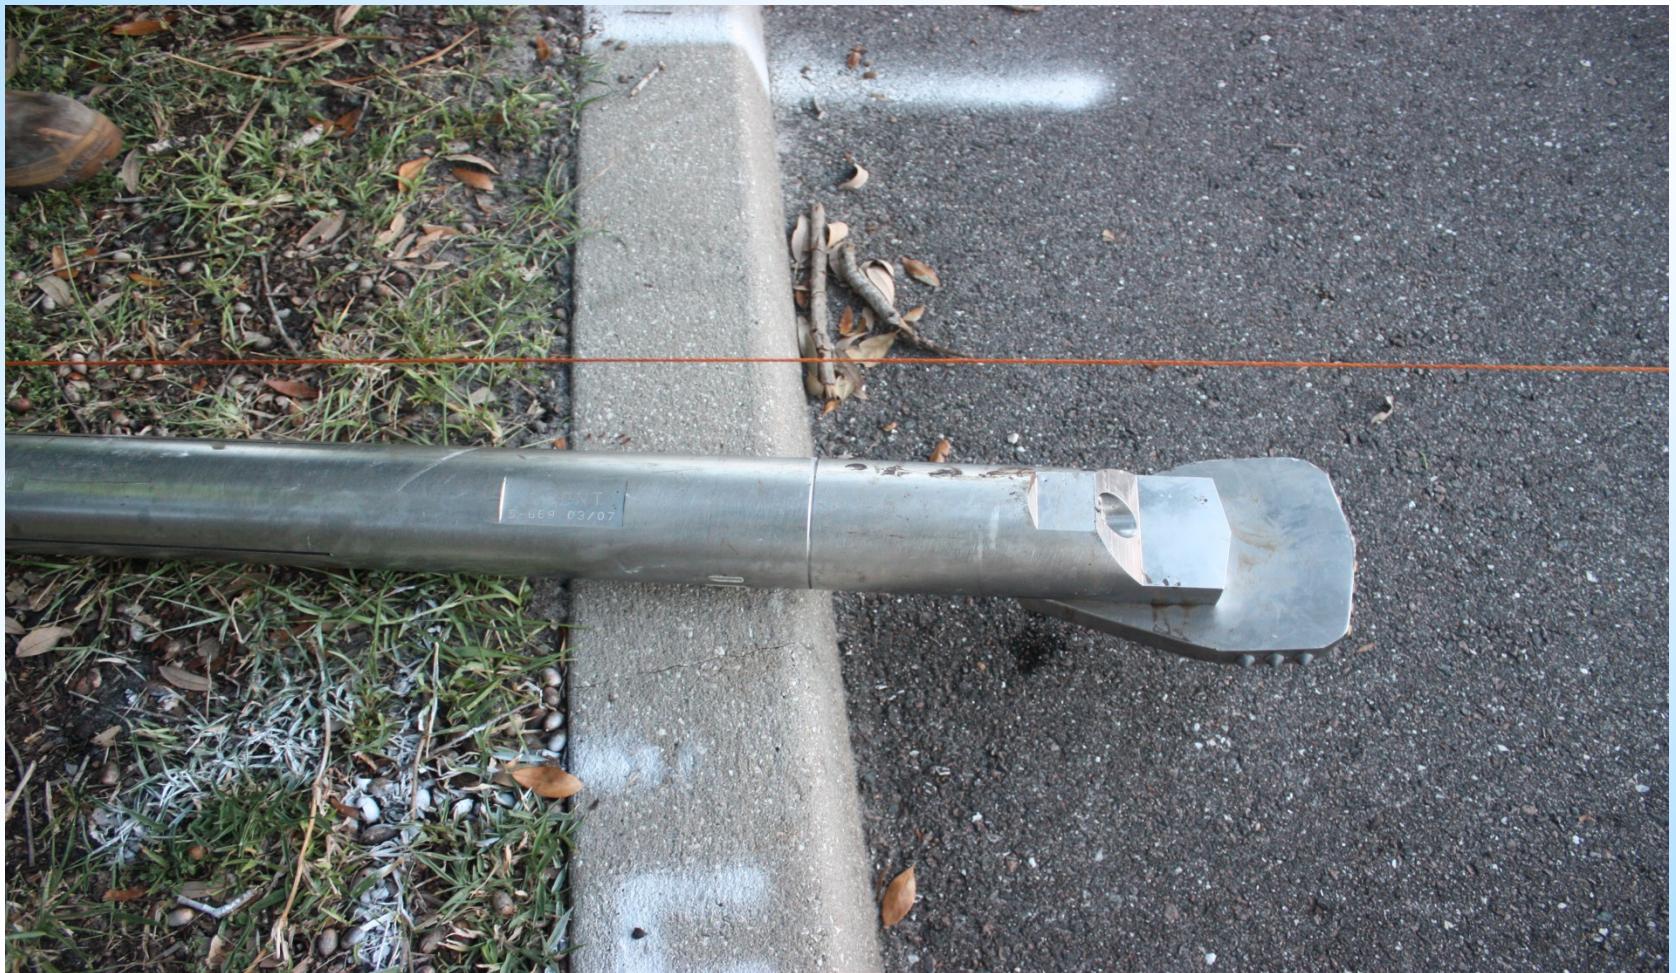
Drill Bit

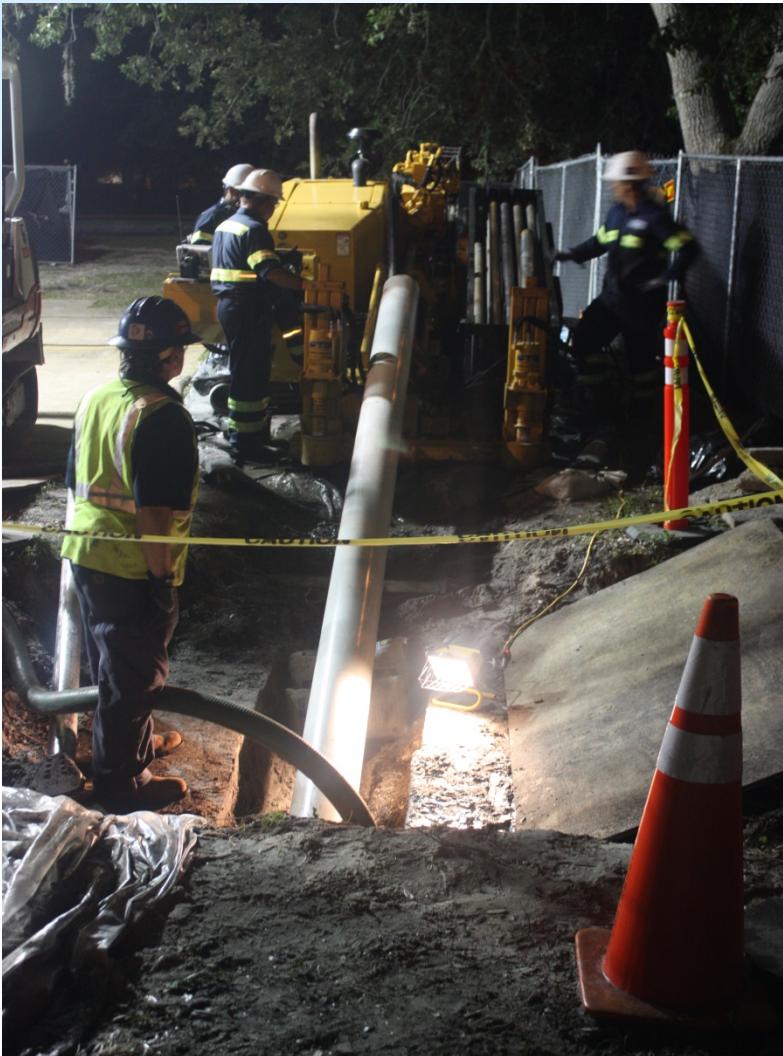
Surface Casing Installation
