HVOF Thermal Spray TiC/TiB₂ Coatings for AUSC Boiler/Turbine Components for Enhanced Corrosion Protection

Final Scientific/Technical Report

DOE Award Number:

DE-FE0008864

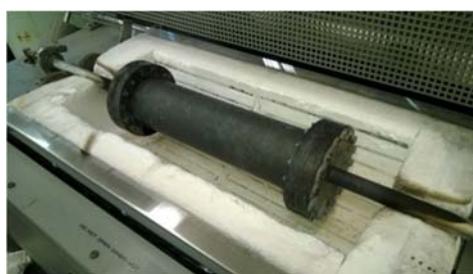
Figure 6. Carbon coating furnace

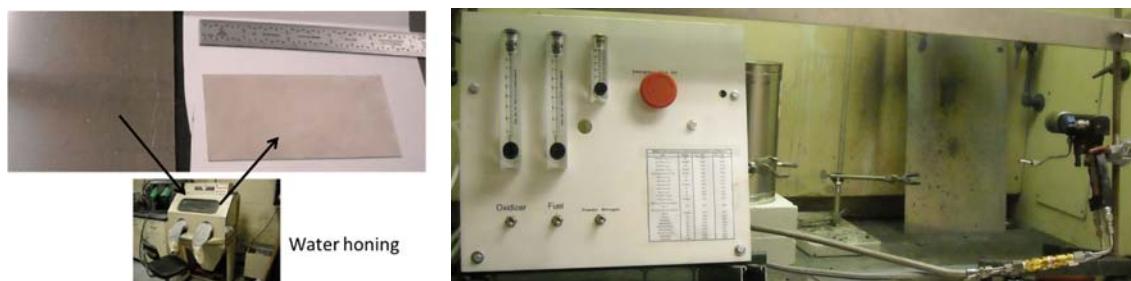
Figure 8. Water Honing.

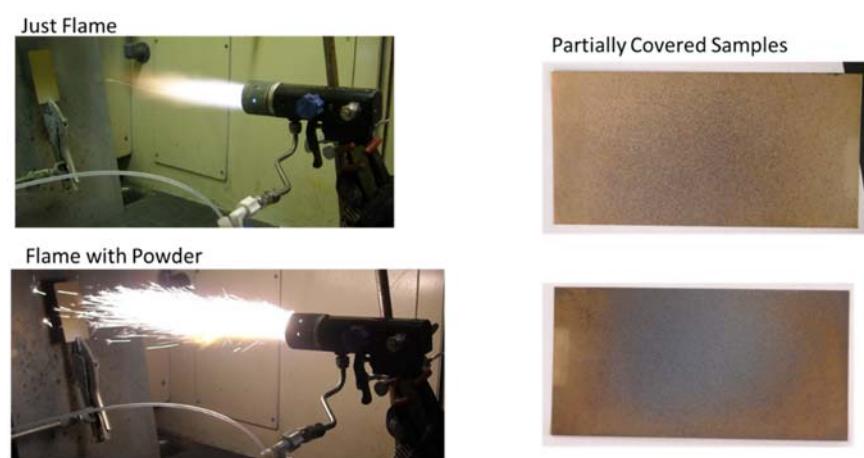
Figure 9. HVOF coating at GTI

The as-prepared TiC and TiB₂ powders were then coated to stainless steel substrates using HVOF thermal spray method at a facility at Gas Technology Institute, Des Plaines, IL. Figure 7 shows the general process of HVOF thermal coating process as well as the design of the gun. Detailed HVOF parameters are as shown in the relevant sections. Surface of the steel substrates was roughened by water honing before HVOF coating for better powder adhesiveness (Figure 8). The as-prepared TiC/ TiB₂ powders were then reacted with various combination of fuel and oxidant, such as: H₂/Air, H₂/O₂ and C₂H₂/Air in the reaction chamber of HVOF system, then coated onto the substrates. Figure 9 shows the HVOF coating process in action and the resulting partially coated samples.

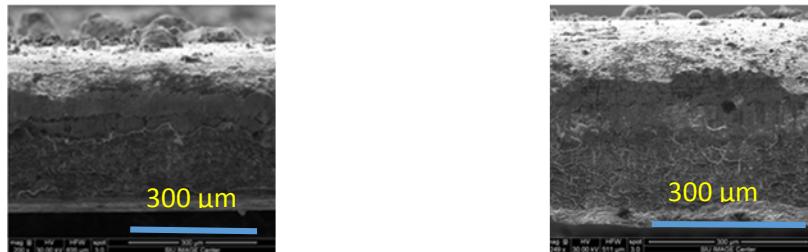
Figure 32. SEM images of the cross section of the two coatings obtained in acetylene and air.

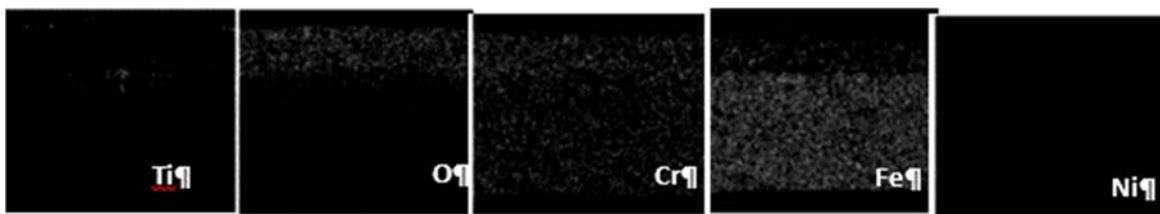
Figure 35. Elemental mapping of the cross section of the as-received sample 11. Coating obtained in acetylene - air flame.

Figure 34 is the sample backscatter image and Figure 35 contains the information on elemental distribution in cross section of the samples.
