Comparison of Electroluminescence Image Capture Methods

Abstract — In the field of photovoltaics, electroluminescence (EL) imaging has proven useful in determining the degradation of solar panels, primarily through use of expensive equipment within a confined lab setting. This study explored the potential of conducting EL imaging using relatively inexpensive equipment. Factors that heavily influenced the quality of EL images included voltage/current settings for the purpose of forward biasing the test panel, camera settings (aperture, shutter speed, and ISO), and amount of external light (not EL) detected by the camera. Once EL images were captured, the images with the best quality were analyzed and modified through image processing and photo editing. The quality of the final images was then validated through comparison with images captured in a controlled lab with higher quality equipment. Moreover, the results of transporting a solar panel are shown to be clearly observable using low-cost EL imaging.

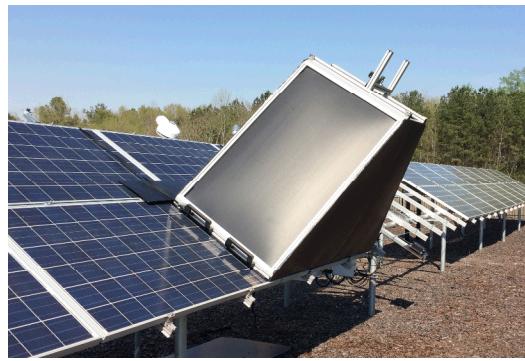
The second method of EL imaging used the same camera equipment of Method 1 in addition to a custom-made hood that could be mounted atop the fielded panel.

Fig. 1. Hood mounting on a fielded solar panel.

Method 2 involved the use of a hood composed of black corrugated sheets inserted into an extruded aluminum frame. These materials were lightweight enough for manual mounting but sturdy enough to remain stable atop a racked solar panel and support camera weight. The base of the hood was sized for a 72 cell panel, but created with inserts to function for a 60 cell panel, and had a foam rubber seal to help block out light. The aluminum frame had a mounting plate for the camera and handles for carrying; nylon straps were used to secure the hood to the PV rack. Ambient light that could leak through the back surface of the solar panel was blocked by corrugated plastic sheets fitted against the back of the panel. Once the hood was mounted and secured with straps, the Sony “Smart Remote Control” phone/tablet app was used to adjust camera settings and capture sets of 8 powered and unpowered RAW images. The panel was powered such that 90% of the panel’s I_{sc} —7.53 A—could be generated. Images were processed using the same technique of Method 1.
