Annual Radioactive Waste Tank Inspection Program - 1998

F. G. McNatt

Westinghouse Savannah River Company
Savannah River Site
Aiken, South Carolina 29808

Annual Radioactive Waste Tank Inspection Program - 1998^(U)

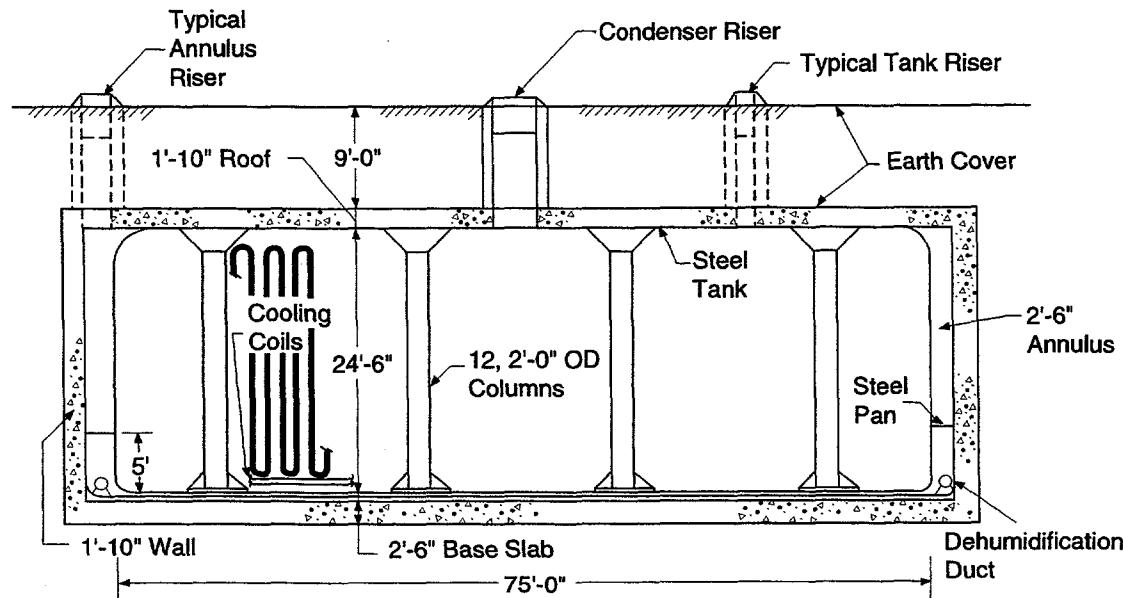
Figure 1. Cooled Waste Storage Tank, Type I (Original 750,000 Gallons).

The 12 original storage tanks constructed between 1951 and 1953 are designated Type I tanks. Tanks 1 through 8 are in F Area and Tanks 9 through 12 are in H Area. Each primary tank has a capacity of 750,000 gallons, is 75 feet in diameter and 24 1/2 feet high. Figure 1 shows the essential features of Type I tanks, including the primary tank, the secondary pan, and the concrete support structure.

A 9-foot layer of earth was placed over the tanks for radiation shielding. Cooling for each type I tank is provided by 36 parallel (water pipe) cooling coils.

A dehumidification duct in the annulus of each tank is routed from the tank top to the bottom of the annulus where it encircles the tank. The duct has distribution outlets and its cross-sectional area decreases as the distance from the air supply increases. Access to the tank interior is provided at eight locations, and to the annular space at four locations, through riser pipes. Each of the 12 riser pipes is capped at the top with a concrete plug. Each plug is provided with two 5-inch-diameter ports equipped with removable plugs. Some of these ports provide access for inspections.

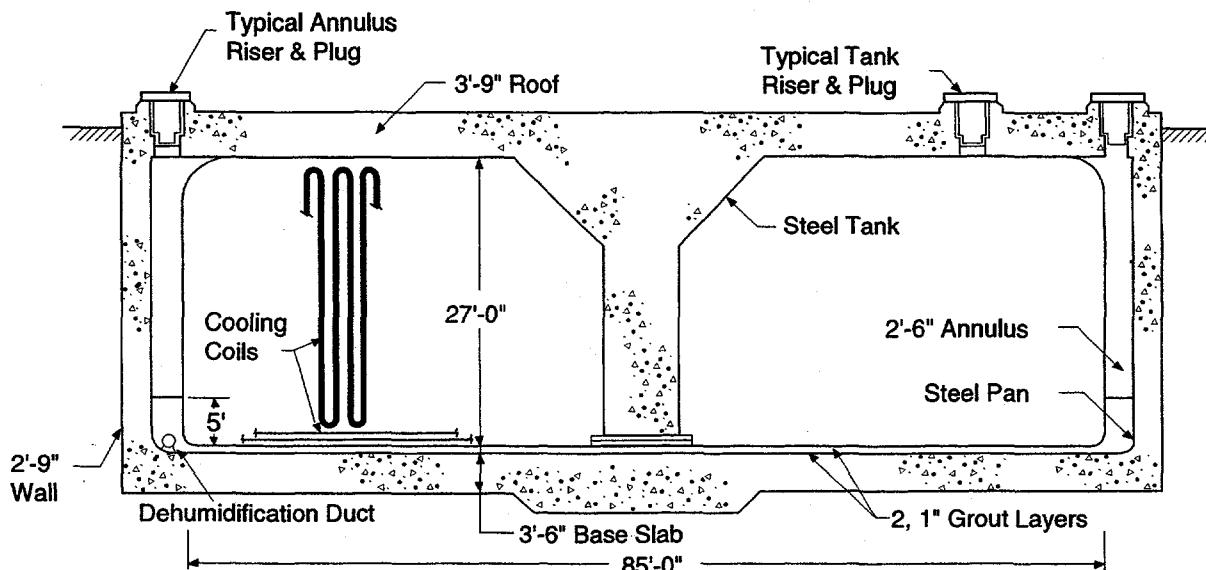
Figure 2. Cooled Waste Storage Tank, Type II (Original 1,030,000 Gallons).

Tanks 13 through 16, constructed in H Area in 1955 and 1956, are designated Type II tanks. Figure 2 is a cross section of this type. Each primary tank has a capacity of 1,030,000 gallons and is 85 feet in diameter and 27 feet high.

The primary tank is set on a 1-inch sand bed within a circular pan of 1/2-inch thick steel plate, 5 feet deep and 5 feet larger in diameter than the primary tank, thus forming an annular space 2 1/2 feet wide. The tank and pan assembly is surrounded by a cylindrical reinforced concrete enclosure with a 33-inch-thick wall and a flat concrete roof that is 45 inches thick. The tank and pan assembly and the surrounding wall are set on a foundation slab that is 42 inches thick. The roof is supported by both the wall and a central concrete column that fits within the inner cylinder of the vessel. The 45-inch-thick concrete roof provides radiation shielding; therefore, no earth overburden is required. Cooling for each Type II tank is provided by 44 parallel (water pipe) cooling coils. Access to the tank interior is provided at eight locations, and to the annular space at four locations, through riser pipes. Each of the 12 riser pipes is capped at the top with a concrete plug. Each plug is provided with two 5-inch-diameter ports equipped with removable plugs. The ports provide access for inspection. In addition to the four annulus risers, other access openings (10 to 14 additional openings per tank) have been drilled into the annulus of each of these tanks to permit inspection of seventy-three to ninety-six percent of the exterior walls of the primary vessels.

A dehumidification duct in the annulus of each tank is routed from the tank top to the bottom of the annulus, where it encircles the tank. The duct has distribution outlets and its cross-sectional area decreases as the distance from the air supply increases.

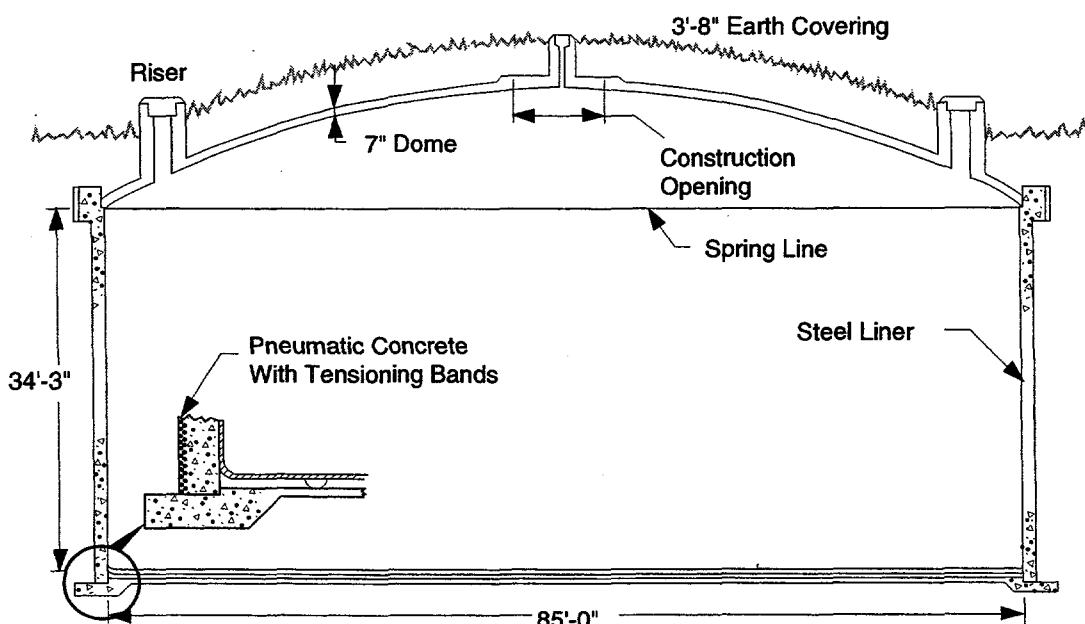
Figure 3. Uncooled Waste Storage Tank, Type IV (Prestressed Concrete Walls, 1,300,000 Gallons).

Tanks 17 through 24 are single-wall, uncooled tanks. These tanks were designed for storage of waste that does not require auxiliary cooling. Tanks 17 through 20 were constructed in F Area in 1958 and Tanks 21 through 24 were constructed in H Area between 1959 and 1961. Each tank has a capacity of 1,300,000 gallons and is 85 feet in diameter and 34 feet high (Figure 3).

Access to the interior of the tank is provided at six locations through riser pipes. Each riser pipe is capped at the top with a concrete plug. Some of these risers provide access for inspection.

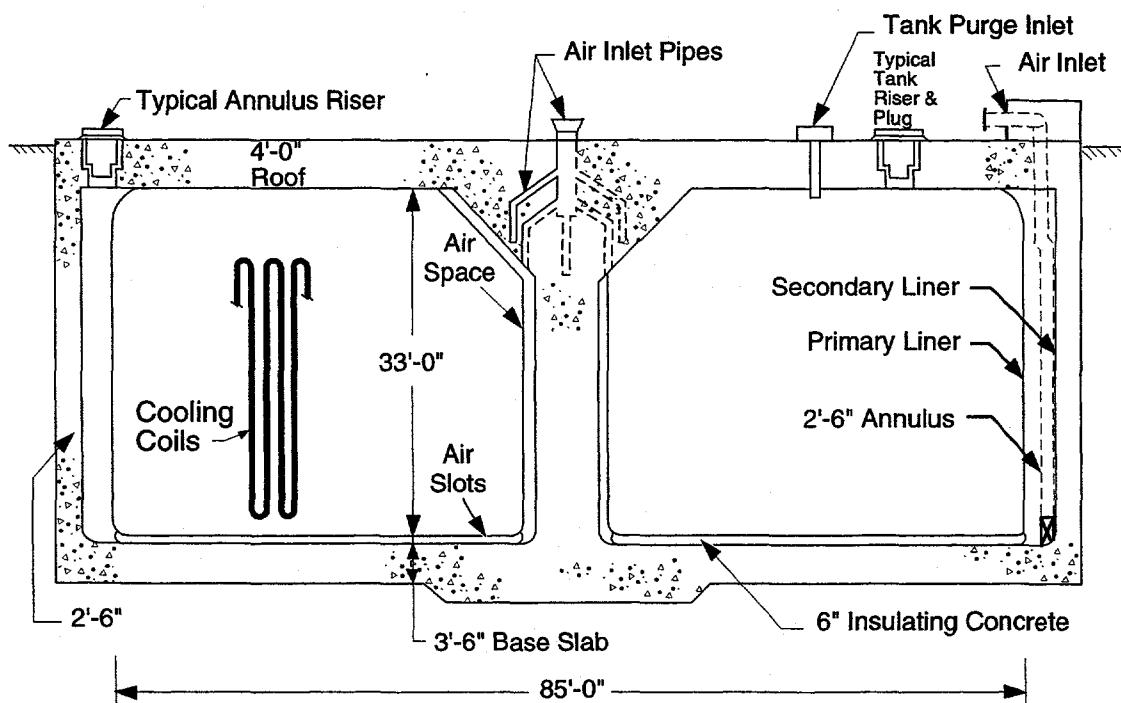
Figure 4. Cooled Waste Storage Tank, Type III (Stress Relieved Primary Liner, 1,300,000 Gallons).

The most recently constructed tanks are designated as Type III tanks (Figure 4). Twenty-seven tanks were built between 1967 and 1981. Tanks 25 through 28, 33 and 34, and 44 through 47 are located in F Area. Tanks 29 through 32, 35 through 43 and 48 through 51 are located in H Area.

The Type III tank design was developed after an investigation into the causes of the leaks from the primary vessel of the Type I and Type II tanks. The study concluded that the leak-producing mechanism was nitrate-induced, stress-corrosion cracking at sites in or near the weld seams, and that stress relieving after fabrication should eliminate the cracking. For the type III tanks, means were provided for heating each finished tank to relieve the stresses generated during fabrication. In addition, some stress patterns were avoided, or minimized, by mounting the roof supporting column on the foundation pad rather than on the bottom of the primary tank (as in Types I and II), and by providing an annular clearance around the roof supporting column.

The primary tank is set on a 6-inch bed of insulating concrete within the secondary containment vessel. The concrete bed is grooved radially so that ventilating air can flow from the inner to the outer annulus. If any waste were to leak from the tank bottom or center annulus wall, liquid
