MAINTAINING CONTINUITY OF KNOWLEDGE (COK) OF SPENT FUEL POOLS: FIELD TESTING

Abstract:

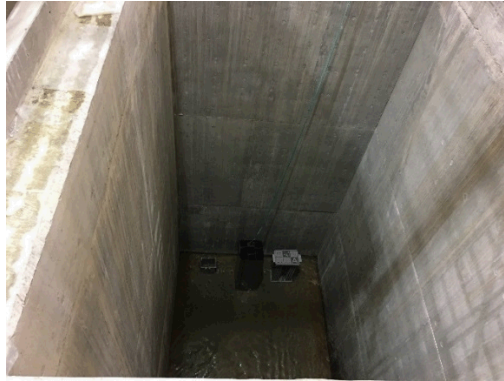
Figure 4: Floor vault as it is filled with water. Left object is facility equipment, center is the BWR storage rack with a mockup BWR assembly, right is facility equipment with two metal plates containing engraved characters on its top. Camera view is from opposite side of pool from targets.

The test was conducted in a floor vault at a facility at SNL New Mexico. The floor vault is a 3.0 m (W) × 4.6 m (L) × 7.6 m (D) concrete-lined dry vault. The depth in feet is approximately 24.9 feet. For the test, the vault was filled with water from a nearby fire hydrant.

The height of the storage rack with the MFA is approximately 5 feet, which allows approximately 20 feet of water above these items. As many spent fuel pools have at least 20 feet of water above spent fuel assemblies, we purposefully truncated the item heights to be most representative of an actual spent fuel pool.

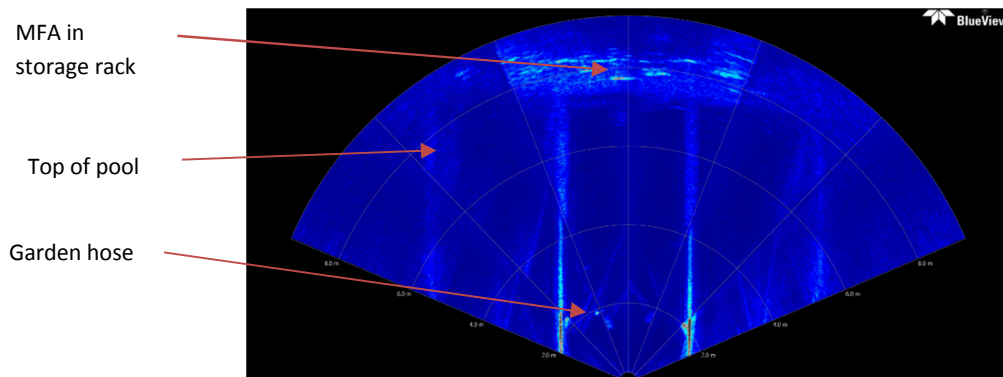
Figure 6: Sonar head is located at end of pool, opposite of targets. Sonar head is 2250kHz. A standard garden hose can be seen at approximately 2 meters from the sonar head. The sets of lines are the top of the pool (outer lines), and the bottom of the pool. Reflective artifacts can be seen on the wall edges. Target is visible at approximately the 8.0-meter mark. Red is the strongest intensity, with blue lowest.

Initial testing consisted of collecting baseline information. The pan/tilt was adjusted until the best image of the targets was acquired, for both the 900kHz and the 2250kHz heads. During the baseline testing, we noticed high levels of noise in the imagery. Acoustic reflections and artifacts can be seen on the side walls of the pool. Lights were turned off during testing, with no change to the image, as expected.

The metal plates with engraved characters were not readable in any configuration of the imaging sonar system (see Figure 6 and Figure 7). It was determined that reading the engravings was not possible; however, it is unknown whether this was due to excessive acoustic noise or simply not enough resolution.

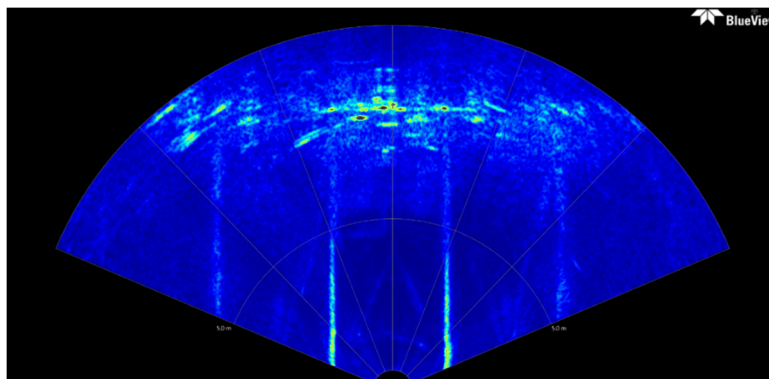
Figure 7: Sonar head is located at end of pool, opposite of targets. Sonar head is 900kHz.

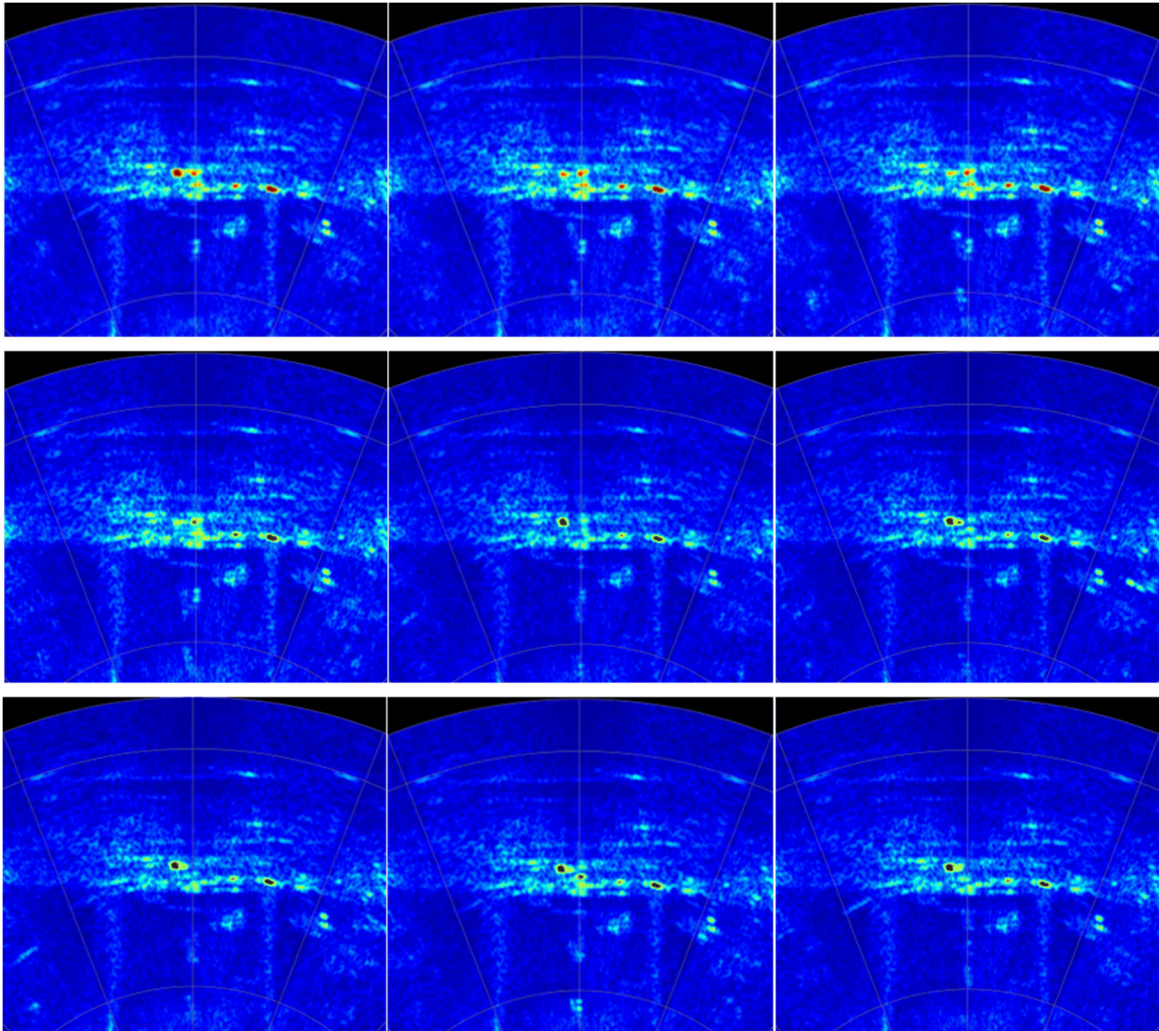
Figure 10: Sonar is 65" from target wall. Settings: 900kHz. MFA is moved out of storage rack, and placed back into same location. Intensity varies during process; however, shown in the Figure are pings separated in time during process. (Sequence is read from top left to right, then down to next rows)

Diversion was tested by using an overhead crane to lift the MFA out of the storage rack and back to either the same location or another location. We expected to see the full MFA geometry as it was moved, e.g. a long red shape in the imagery; however, we only saw a high intensity red region of the image move from one location to another. We were able to see the crane rigging in the water, or possibly the rigging making movements in the water. Before we performed the MFA movements, we moved the sonar to a closer location, approximately 65” from the wall with the target’s below.

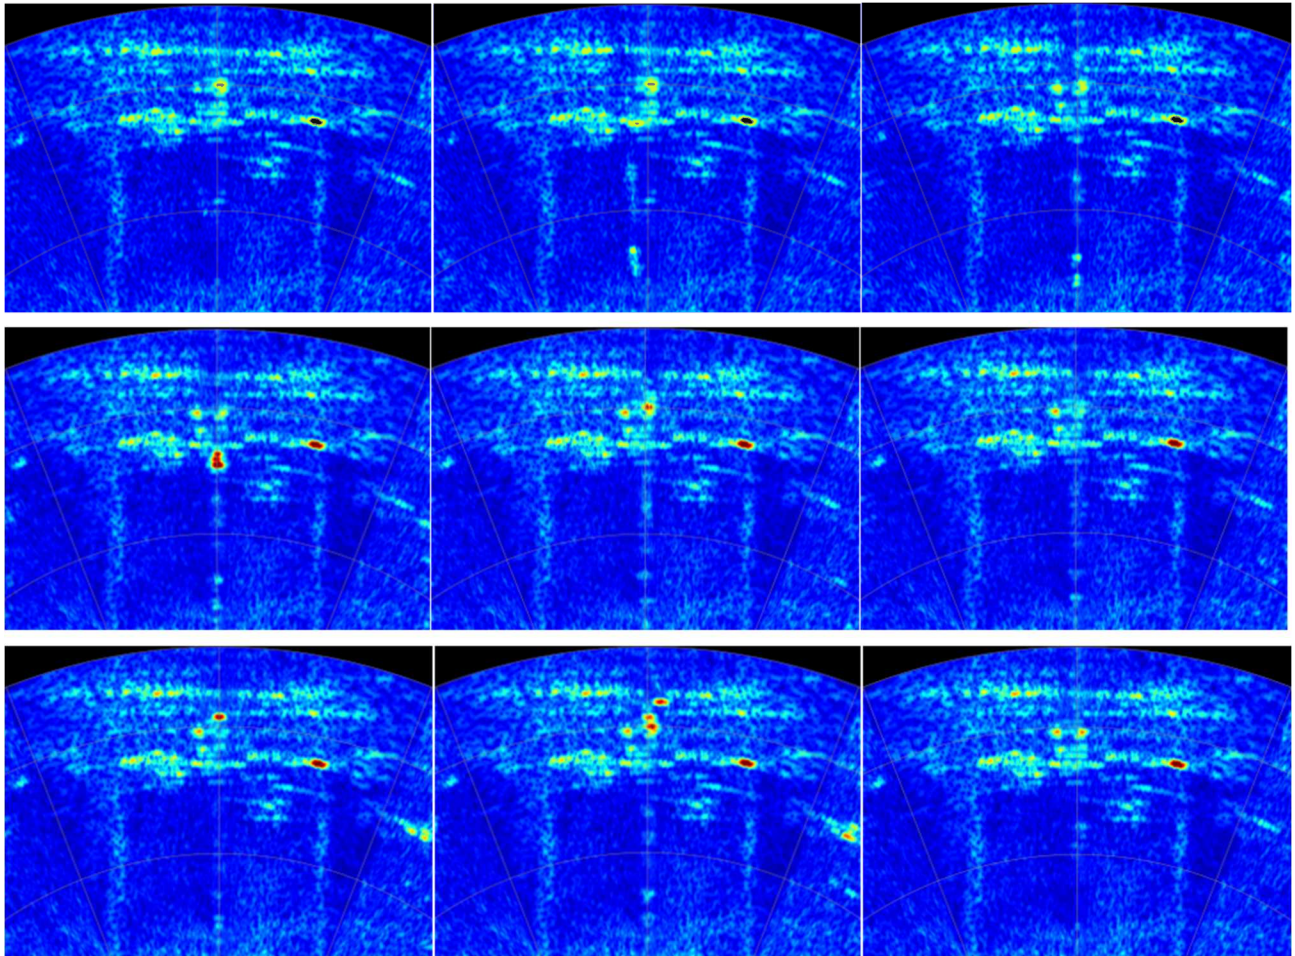
Figure 11: Sonar is 7' 2" from target wall. Settings: 900kHz. MFA is moved out of storage rack, and into another location.

We also used the pan/tilt accessory to change the angle of the FOV of the imaging sonar. Using the 900kHz head at the position of 7' 2" from the target wall, the optimal pan/tilt angles were -15.6° pan and 59.3° tilt. The limits for recognizing features of the target were between -6.7° and -31.5° pan and 49.3° and 64° tilt.
