# Studies of Dynamic Failure of Steel Pipes Using X-Ray Radiography

## STUDIES OF DYNAMIC FAILURE OF STEEL PIPES USING X-RAY RADIOGRAPHY

**Abstract.** We describe an experiment which observed the failure of a steel pipe subjected to shock loading caused by the detonation of high explosive inside the pipe. The failure was observed using a variety of diagnostic probes, including optical and x-ray imaging. We describe and analyze the x-ray images in detail. Although the radiographs were damaged by fragment penetration, we see evidence that most of the fractures were due to shear failure rather than brittle failure. We also compare the static radiographs, taken just before the experiment, with simulations and do not yet see perfect agreement between them. The sources of this current lack of agreement are discussed, as well as the future work planned.

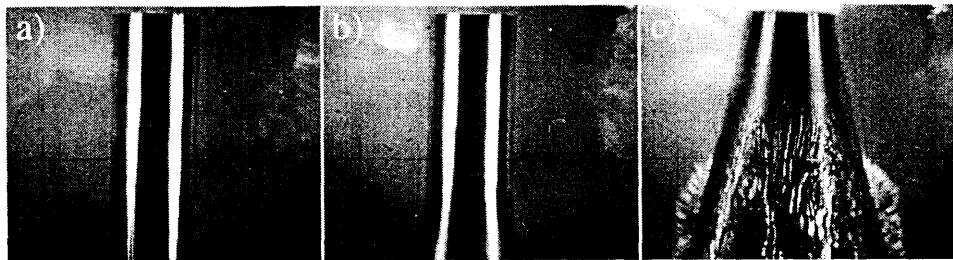
**Figure 1** Optical images of the cylinder expansion. Initial image (a), image at 16.5  $\mu$ s (b), and image at 26.4  $\mu$ s (c). Times b) and c) correspond to the times at which the radiographs were taken. Note the break-up is definitely visible in (c).

The steel cylinder had been heat-treated to make the steel harder and it was polished to a 32  $\mu$ inch finish. Optical images are displayed Figure 1. The shine of the pipe before high explosive detonation in Figure 1a) attests to the finish. Figure 1b) shows the pipe when the detonation front is roughly 1/3 of the way up the pipe at which time the first radiograph was taken. Figure 1c) shows the pipe when the detonation front is roughly 2/3 of the way up the pipe, at which time the second radiograph was taken. Cracks are definitely visible in the third image, while there are hints of cracks in the second image. A bright flash is visible at the top of the cylinder in Figure 1c), which is light from the reaction front shining out of the top of the cylinder.

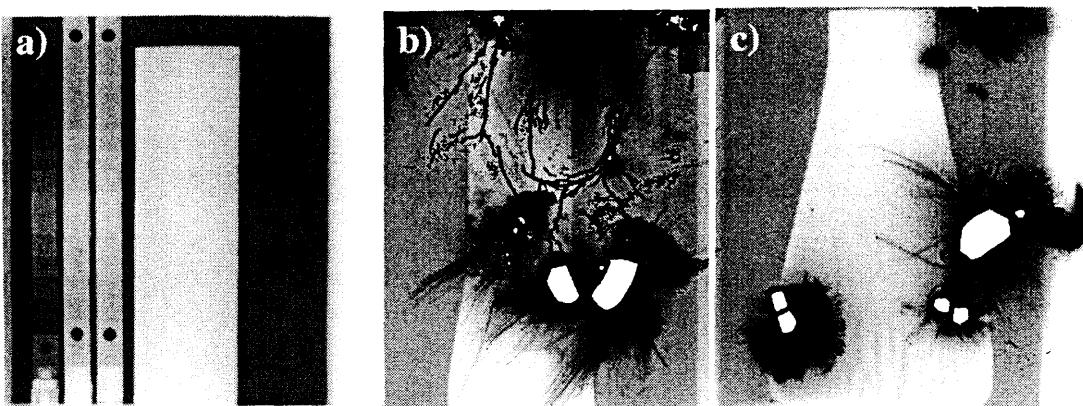
**Figure 2 Radiographs of the pipe before the detonation (a), 16.5  $\mu$ s after the detonation (b), and 26.4  $\mu$ s after detonation (c).** Step wedges were included in the static radiograph (a), but removed before detonation. The white regions in (b) and (c) are where the film was punctured by the fragments. Damage to the film can be seen to extend far beyond the actual penetration points.

The images shown in Figure 2 are the result of the microdensitometer scans. As noted above, unexposed film was also scanned. It was found that the fog level of the film was 0.245 optical density units. The static image (Figure 2a)) had film densities ranging from 0.8 to 2.9. The unobscured regions of the image had densities ranging from 2.5 to 2.9. The center of the pipe had densities on the order of 1.0, so that our signal is well above the film fog background. Similar film densities were measured in the parts of the two dynamic images which are farthest from the fragment damage.

There is evidence that the film was darkened as a result of the fragment penetration, as well as from the x-rays. This darkening occurred over a much broader region than just the immediate vicinity of the penetrations. Evidence for this effect can be seen in lineouts of the Figure 2c) along the symmetry axis of the cylinder. Near the bottom and

top of the radiograph the film density has a value of approximately 1. The constancy of this value is not surprising, because the x-rays still have to pass through the same amount of cylinder material, even if it is expanded. Between the two clusters of fragment penetrations, however, the film density increases to 1.5. The film has been darkened either because of a pressure pulse hitting the film, or because the Lanex screens have produced extra light in response to the pressure pulse. This effect limits our ability to quantify the depth of the cracks in the image. However, we can still count the cracks that are visible and examine their properties. We also can analyze the static image, in order to see how well we can quantify future radiographs in which the fragments do not hit the film.

A measure of the expansion of the cylinder is given by the strain, which is the ratio of the change in radius of the cylinder to the original cylinder radius. In Figure 2b), the largest strain occurs near the bottom of the image, and has a value of 0.41+/- 6%. In Figure 2c), the largest strain is 1.13 +/- 4%, again seen near the bottom of the image.

We included a series of step wedges in the static image, Figure 2a). The rightmost wedge was a steel wedge, the leftmost wedge was lexan, and the middle wedge was steel in front and lexan in back. Steel was used to study the attenuation properties of the steel pipe. Lexan was a surrogate for the high explosive. The two materials were combined in the middle wedge in order to see how the combination of materials affected attenuation. The thicknesses of the step wedges are listed in Table 1. Each wedge was designed in a “ziggurat” style, with the thickest step near the center of the wedge and thinner steps alternating above and below this step. Starting from the top of the image, the order of the steps is 1, 4, 6, 8, 10, 9, 7, 5, 3, and 2.

We have analyzed the static image in more detail, because it was not compromised by fragment damage. The static image was taken using a single flash from each x-ray head. In Figure 2a), the neighboring source produced an image further to the left on the film. The steel collimator strongly reduced the contribution of the neighboring source to the field of view shown in Figure 2a). However, scattering from this neighboring radiographic view was seen on the left side of the image. This contribution was fit and subtracted from the image, after the fog level also was subtracted. Next, the beam profile was fit using roughly 40 points in the image, which were unobscured by the wedges or cylinder. This beam fit was then divided out of the image, resulting in an  $I/I_o$  image. Figure 2a) is the result of this postprocessing.

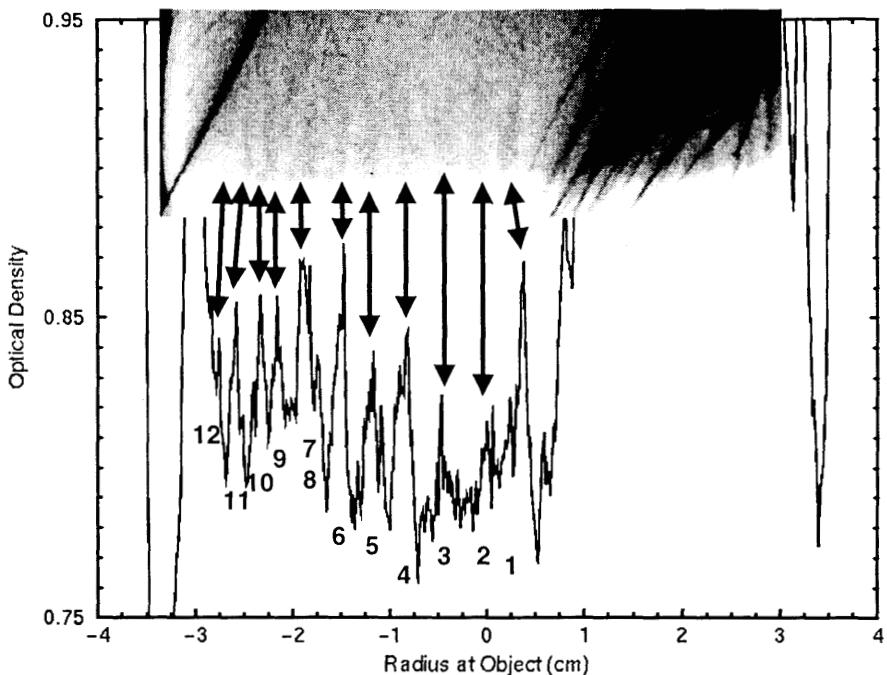
**Figure 3** Close-up of first dynamic image and plot of the average of ten image rows across the image. The left edge of the pipe is seen at far left. The black regions are damage from fragments. Note the sharpening of the peaks as the view into the pipe becomes more oblique.

Both radiographs show evidence of the failure of the pipe in the form of a series alternating dark and light stripes roughly parallel to the pipe symmetry axis in the region of maximum strain for each image. There are no similar features in the static radiograph. The very dark region on the right side of the image is the start of bad damage from fragment penetration. In Figure 3, we display a portion of the early time dynamic radiograph centered on the region of maximum strain. The left edge of the pipe is visible on the far-left side of the image. The dark band near the left edge of the image is another artifact of fragment damage. The vertically oriented striations are clearer. In addition, we display an average of 10 contiguous rows near the center of this image. In this plot, the optical density in the image is plotted versus the radial location in the plane of the pipe. In this horizontal lineout, the cracks are clearly visible as regions of greater optical density. Twelve distinct cracks are labeled across the lineout. The two peaks just to the right of crack number one are artifacts from fragment damage and are not counted as cracks.

A striking feature of the image is that the sharpest cracks are near the limb (radius far from zero) of the cylinder, rather than near the center (radius near zero). This is somewhat surprising, because, with radiography, features in a pipe are usually best seen

this back to the original pipe radius, we are able to estimate a crack frequency for each image. From Figure 3, we estimate that a crack occurred every 0.5 cm around the original pipe. From Figure 4, we estimate that a crack occurred every 0.6 cm around the original pipe. The uncertainty in these estimates is large enough that the values are consistent. We estimate an uncertainty in the number of counted cracks to be one to two cracks, because it is occasionally not clear whether two close cracks, or one single large crack, are being observed. Another source of uncertainty is whether we are completely missing crack oriented in the maximally indistinct orientation.

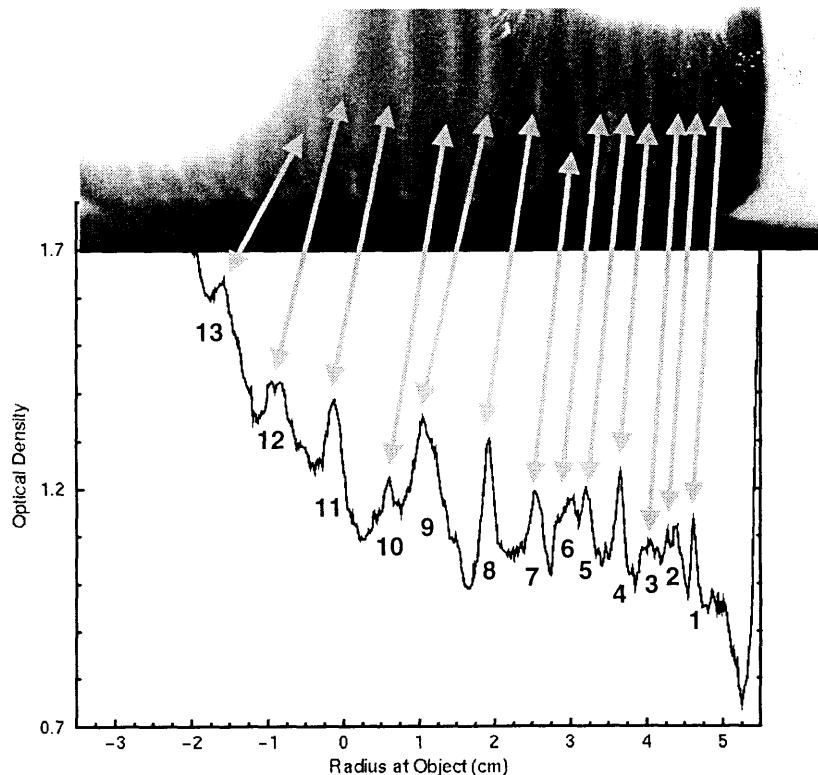
**Figure 4 Close-up of second dynamic image and plot of the average of ten image rows across the image. The right edge of the pipe is seen at far right. The black regions are damage from fragments. Note the sharpening of the peaks as the view into the pipe becomes more oblique.**

In Figure 4, we look in detail at the later dynamic image, near the region of maximal strain. In this image, we see more of the right side of the cylinder. The right edge of the pipe can be seen on the far right of the image. Fragment damage blots out those in Figure 3, although the sharpening of the cracks at oblique views is not as striking. It may be that the cracks are pointed away from this field of view. In this image, we see thirteen cracks.
