Characterization of Fire Hazards of Aged Photovoltaic Balance-of-System Connectors

Eric Schindelholz¹, Benjamin Yang², Kenneth Armijo¹, N. Robert Sorensen¹, Olga Lavrova¹

¹ Sandia National Laboratories, ² Georgia Tech Research Institute

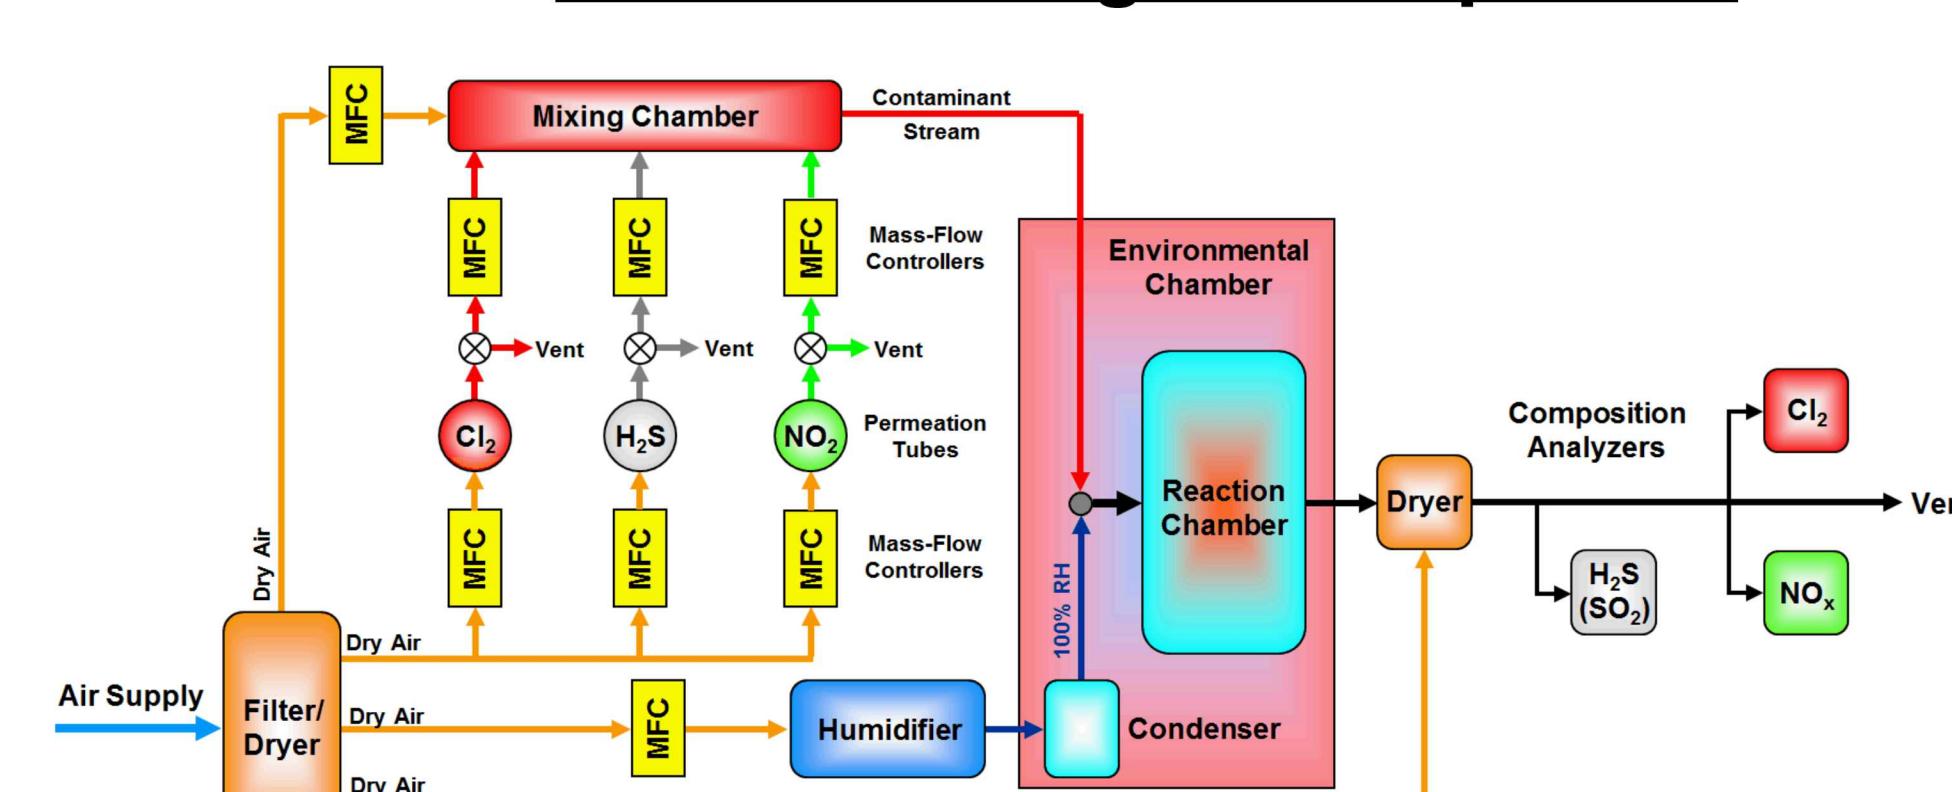
Mixed Flowing Gas Exposure

Corrosion of plating, but connectors overall robust to accelerated tests

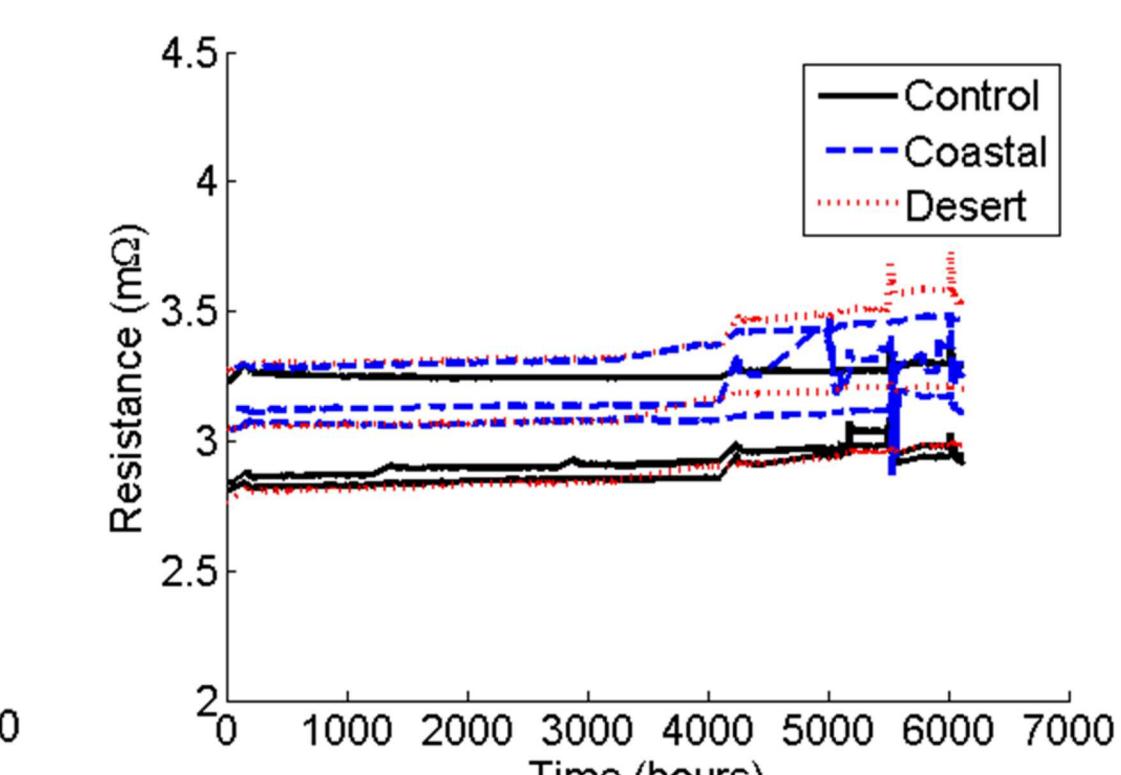
85°C/85%RH Damp Heat

No discernable difference between non-contaminated (control) and coastal or desert-simulating contaminants

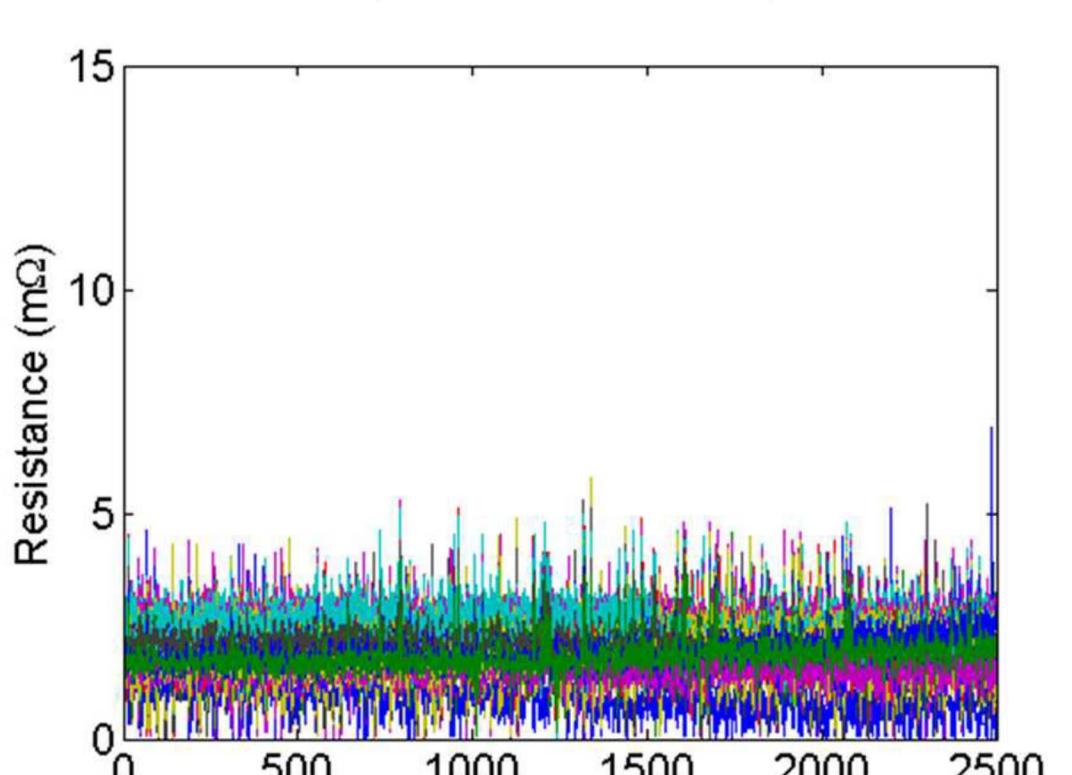
No failures observed in 2500 hours of 51 connectors; test is ongoing

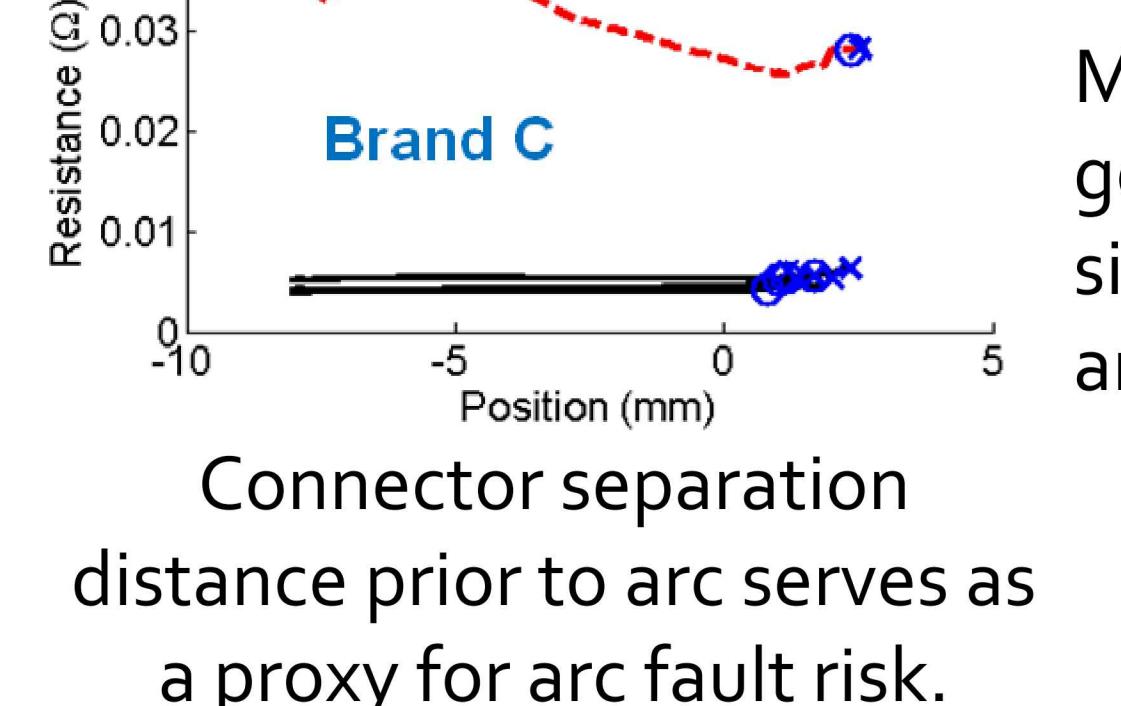
Connector separation distance prior to arc serves as a proxy for arc fault risk

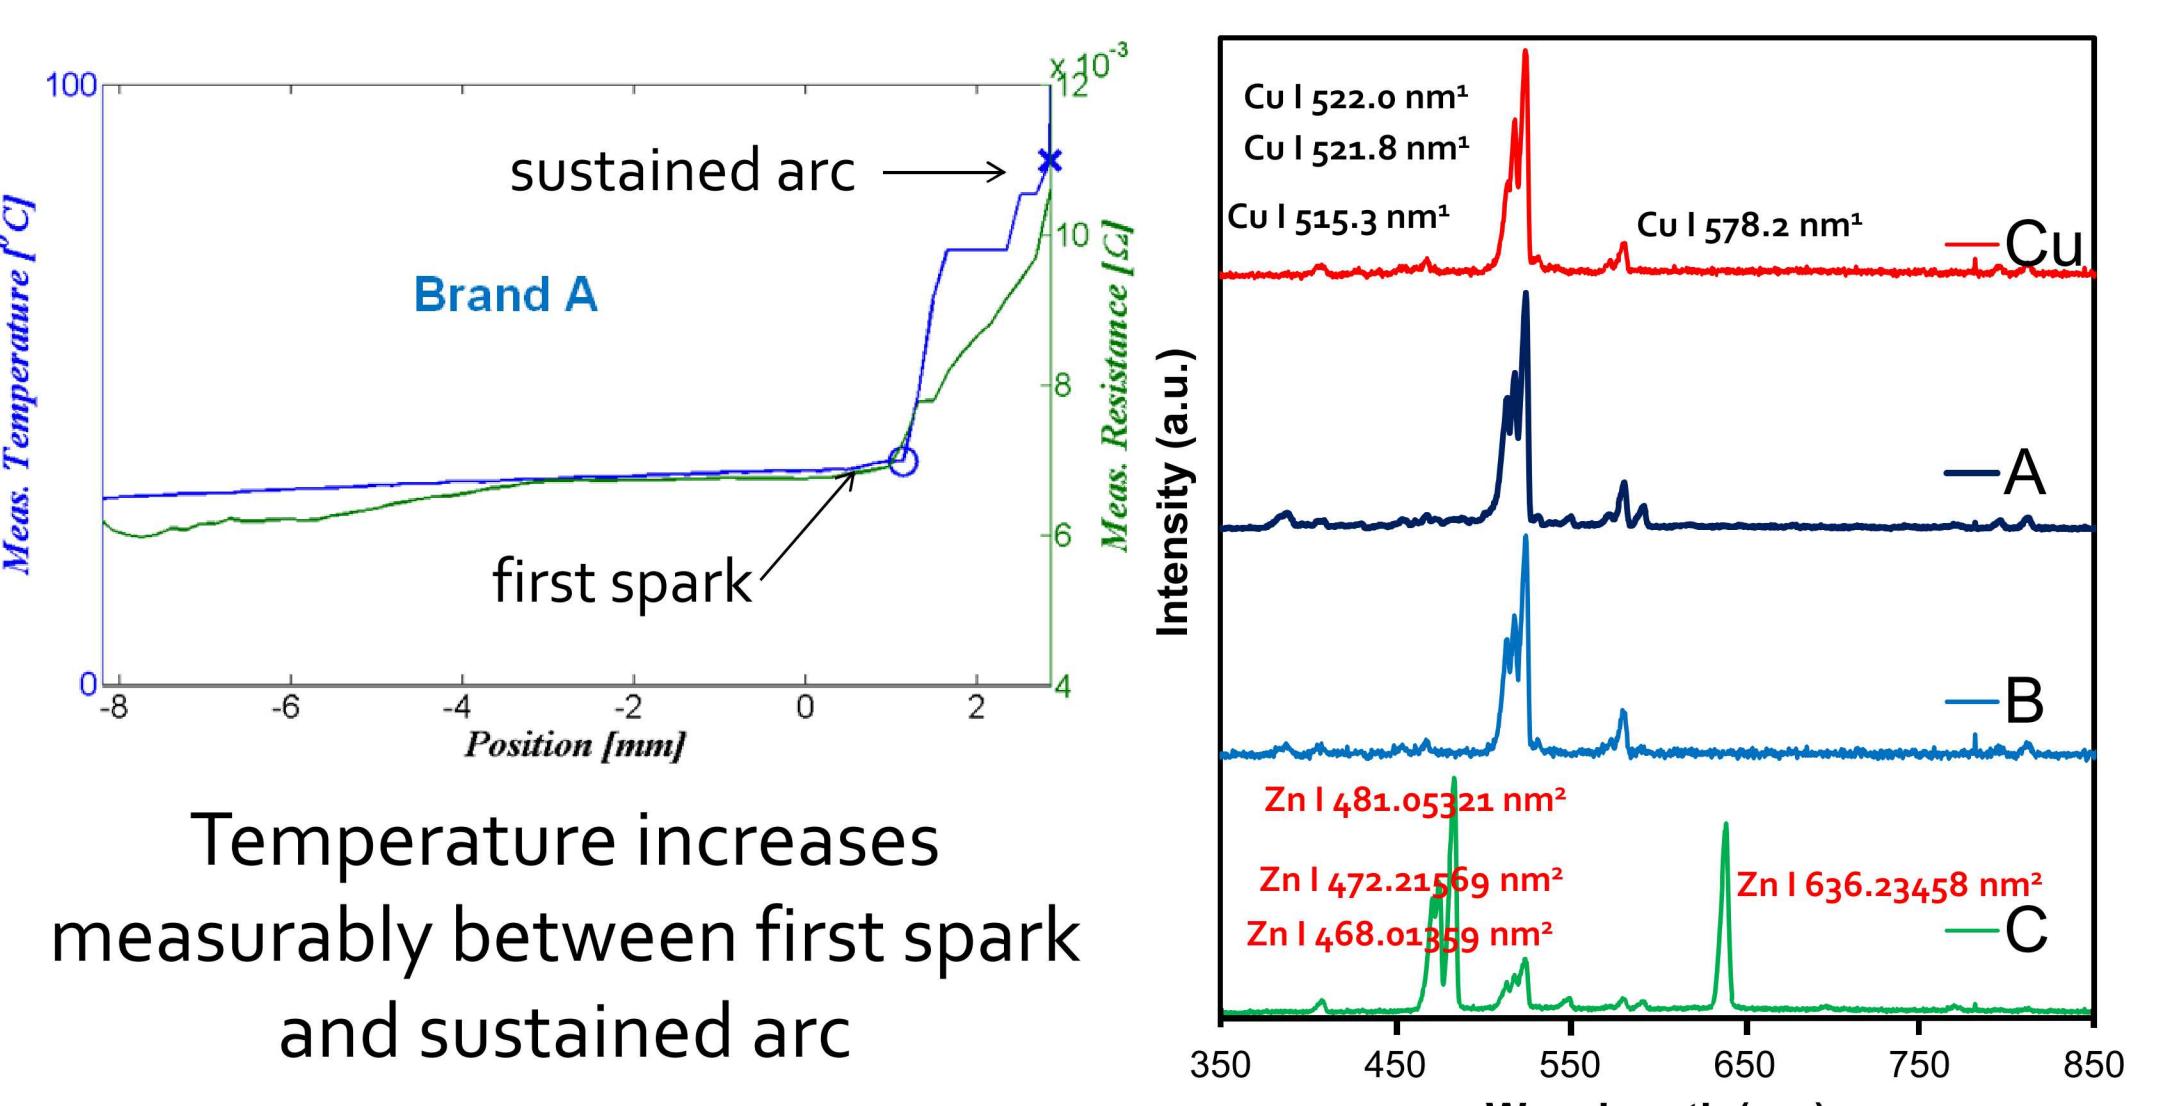
OES Analysis

Spectra can identify connectors with similar composition (A and B) vs. one containing other elements (C). Can potentially measure electron plasma temperature
