Evaluation of Fracture Toughness for Hybrid Aluminum to Fiber Reinforced Polymer Composite Joints

18th International Conference on Experimental Mechanics

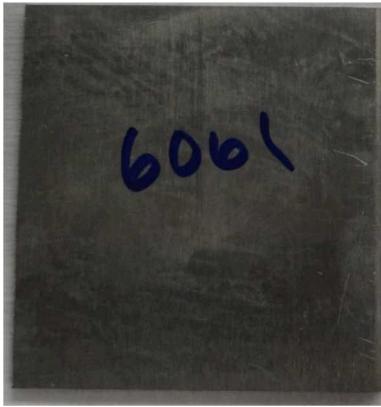
As-received

Aluminum Anodization

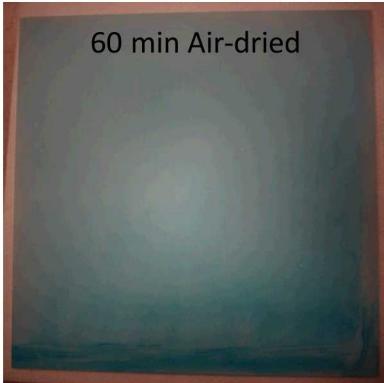
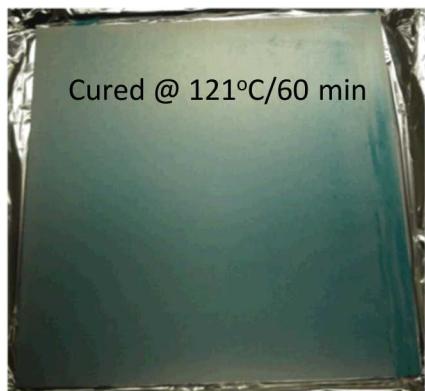
BR[®] 252

- **2** spray cross coats
- Thickness – **0.24 ± 0.08** mils
- Recommended – 0.15 – 0.3 mils

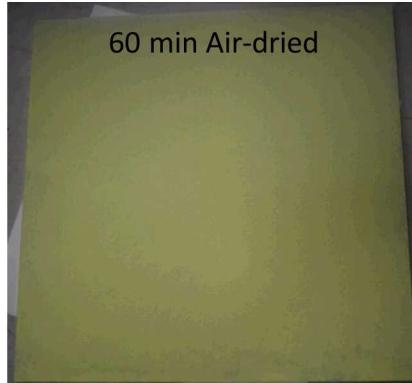
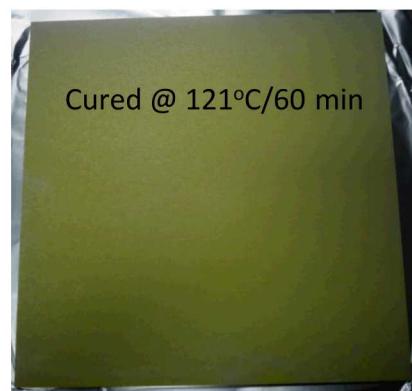
BR[®] 6700-1

- **1** spray cross coat
- Thickness – **0.37 ± 0.1** mils
- Recommended – 0.15 – 0.3 mils

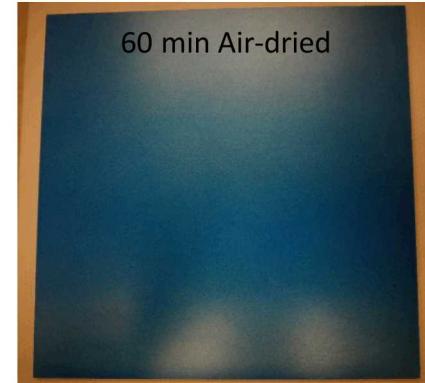
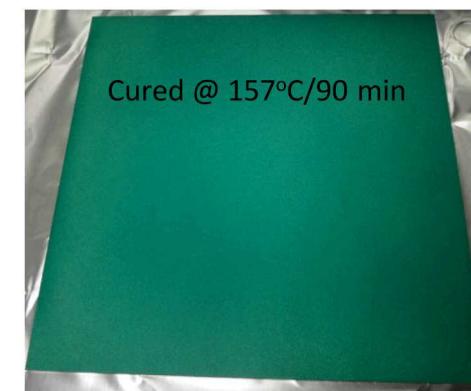
Hysol[®] 2000

- **4** spray cross coats
- Thickness – **0.27 ± 0.07** mils
- Recommended – 0.15 – 0.3 mils

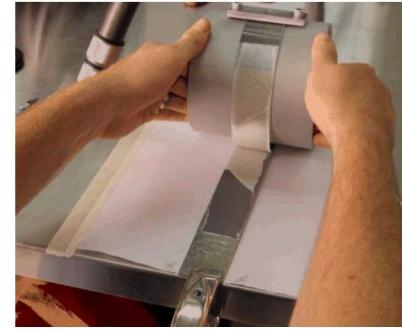
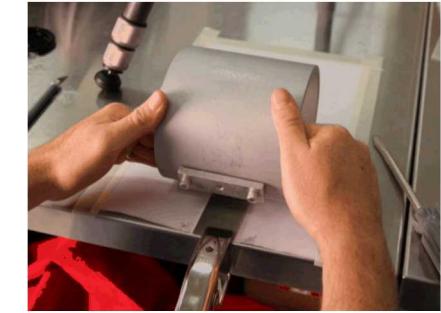
Primer Downselect

- Cobonded aluminum to GFRP panels
 - Phosphorically anodized
 - Each of the candidate primers used
- Rapid Adhesion Testing Performed (RAT)
 - Similar to a climbing drum peel
 - Qualitative – determines fracture mode
 - Quick and simple to perform
- All panels failed cohesively within the GFRP
- Hysol 2000 was selected on input from application team

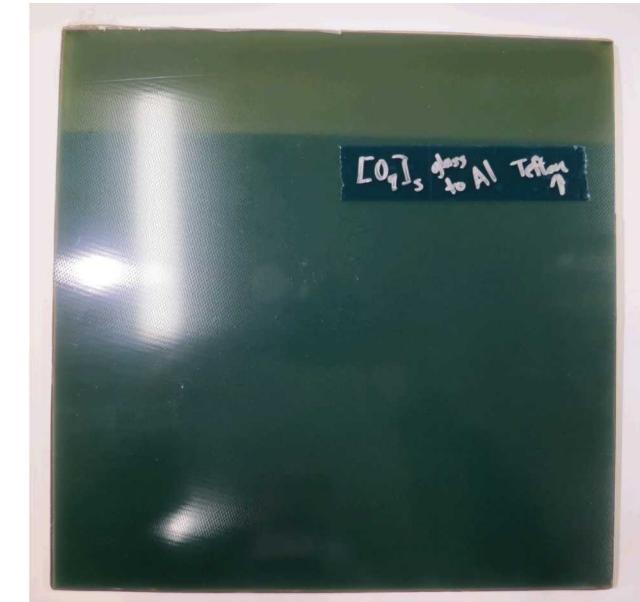
DCB Testing

- Specimens
 - Aluminum 6061-T6/GFRP[0₇]_s – cobonded
 - Aluminum 6061-T6/GFRP[0₇]_s – secondary bonded with infusion resin (INFI14/HT251)
- Instron 5989 electromechanical test frame
- Constant displacement (1mm/min)
- Tested across wide temperature range
 - -50°C
 - 21°C
 - 70°C
- Strain energy release rate calculated using beam theory
