Sandia  
National  
Laboratories

SAND2019-11645C

# Corrosion of Additively Manufactured Stainless Steels – Process, Structure, and Performance

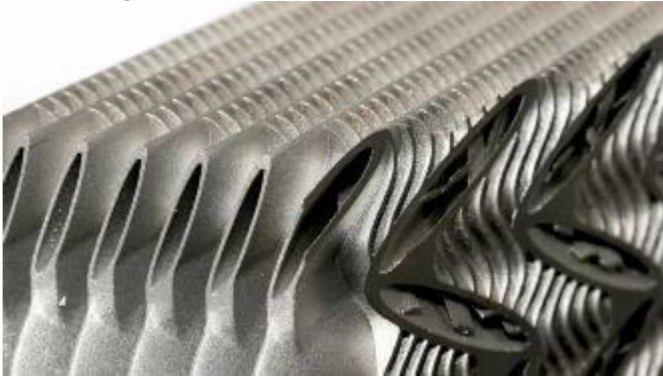
Heat exchanger

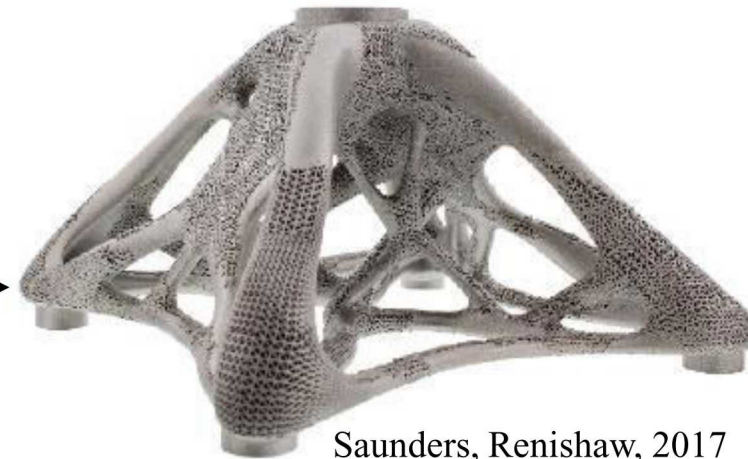
Topology optimized design

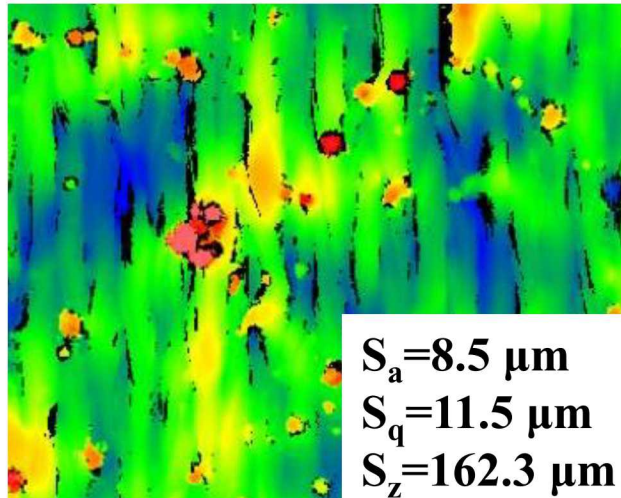
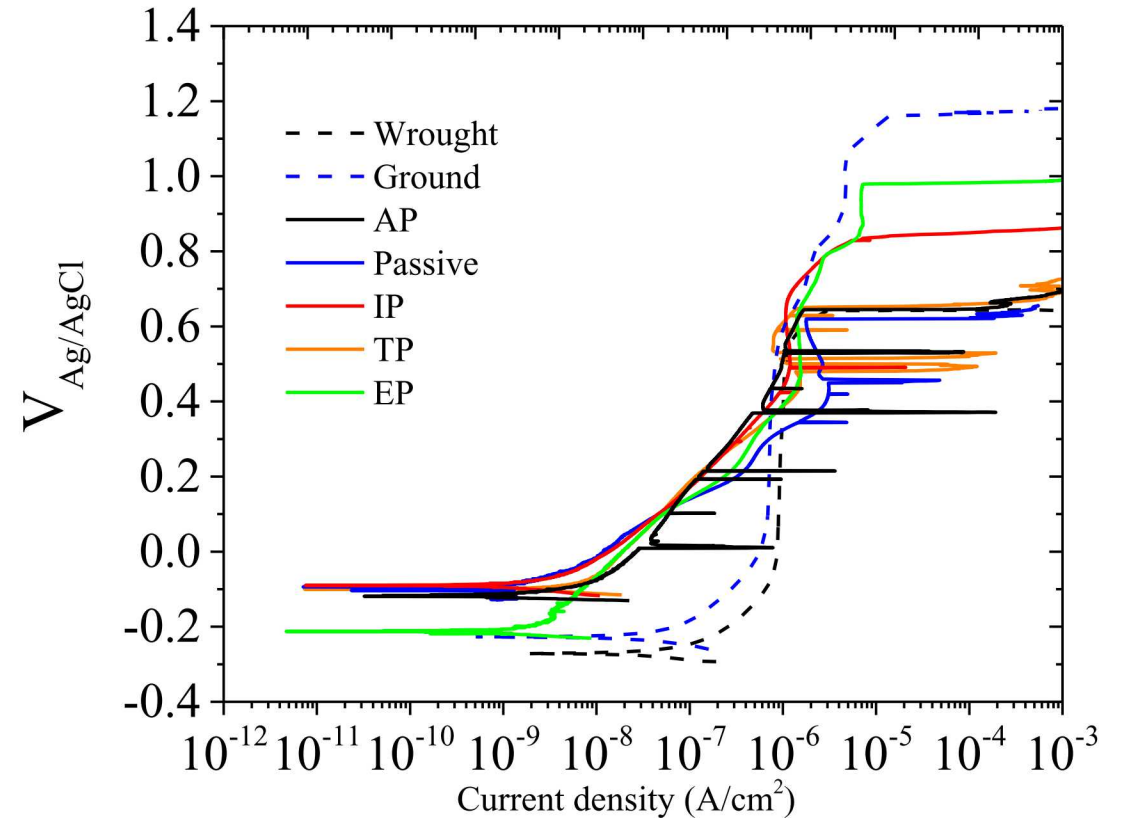
Optical white light profilometry and SEM for surface roughness.

Anodic potentiodynamic polarization in quiescent 0.6 M NaCl – after 1 hour open circuit potential.

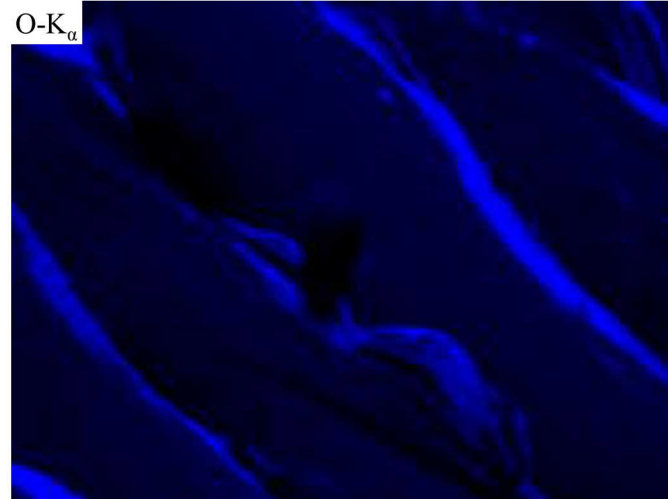
# EDS maps of AP Top surface showing oxide in between layers.

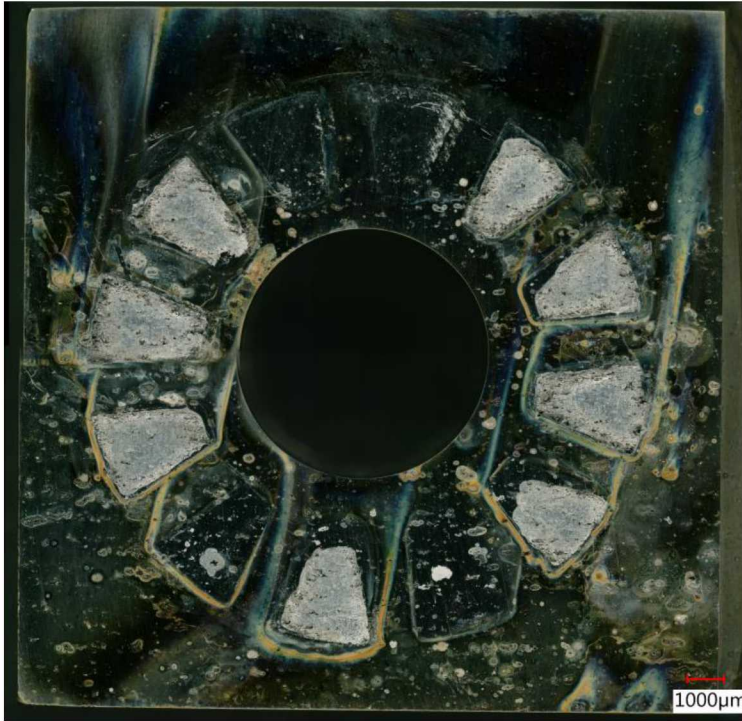
# Why we initially looked into melt pool boundary attack: **crevice corrosion of PBF 316L**

Observed local corrosion at crevice sites, this is from the high porosity sample, but melt pool boundary (MPB) attack was seen for both dense and porous samples under an alumina crevice former.

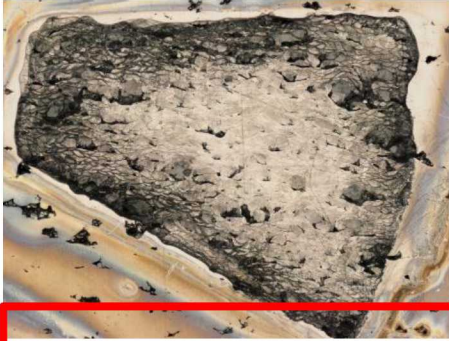
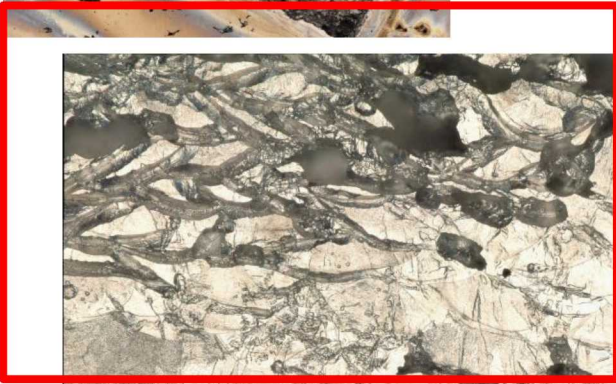
# Crevice corrosion of PBF 316L

Local corrosion at melt pool boundaries of AM material, primarily located in deep crevice region (not center of tooth).

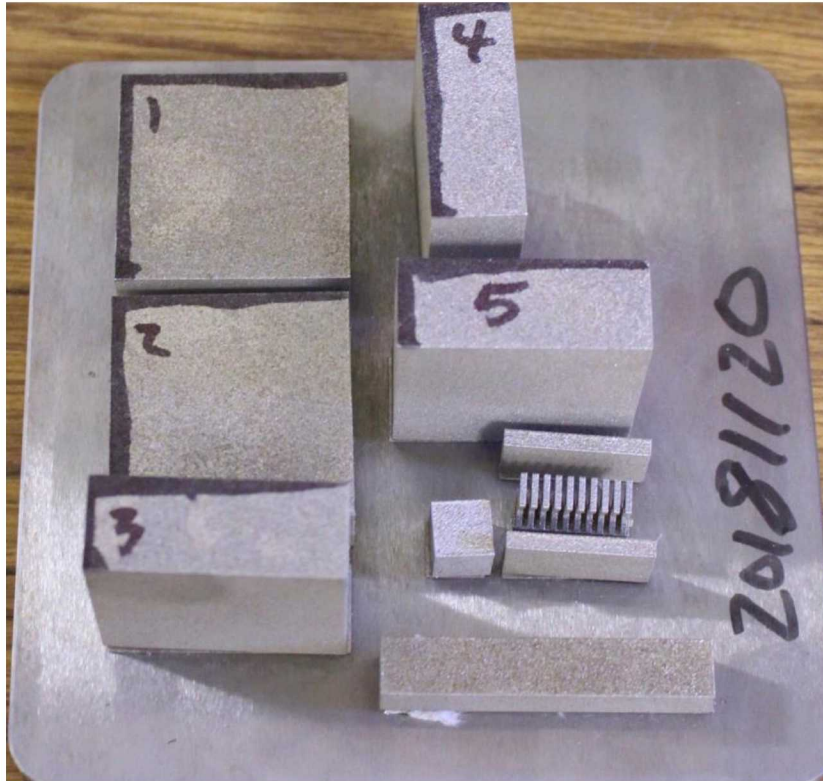
# PBF 316L samples

**Samples taken from  
this orientation**

wt.%	C	Cr	Cu	Fe	Mn	Mo	N	Nb	Ni	O	P	S	Si
AM316L - Dense	0.016	17.0	0.14	67.8	1.06	2.1	0.093	0.008	10.86	0.065	0.017	0.009	0.64

YS (MPa)	UTS (MPa)	Elongation to failure (%)	Density (g/mL)	Hardness (B)	Charpy Toughness (ft-lb)
AM316L - Dense	430.1	575.0	61.3	7.94	92.3	79

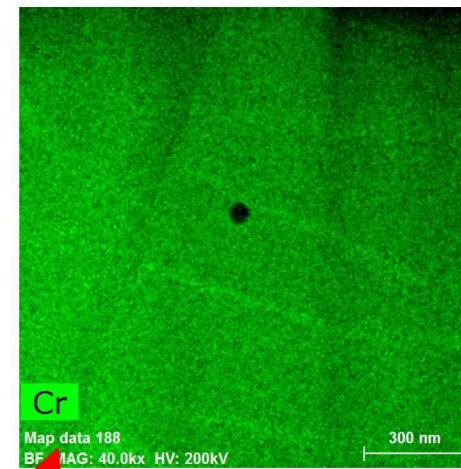
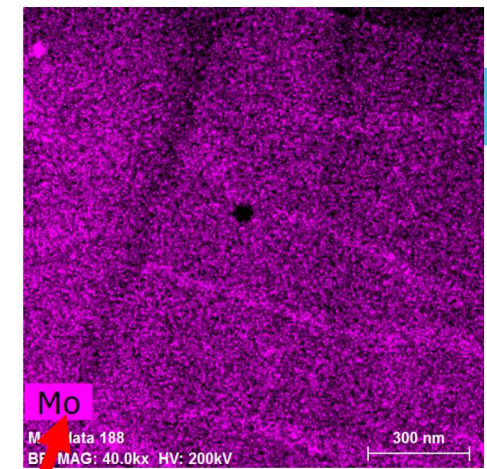
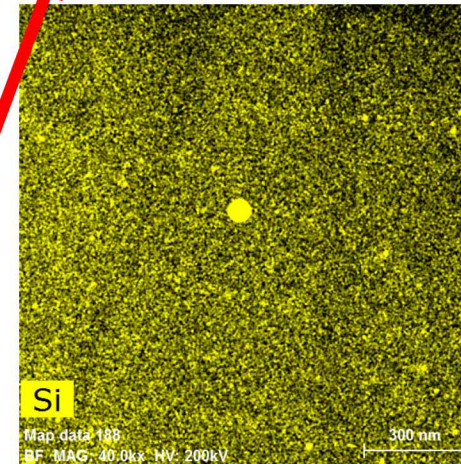
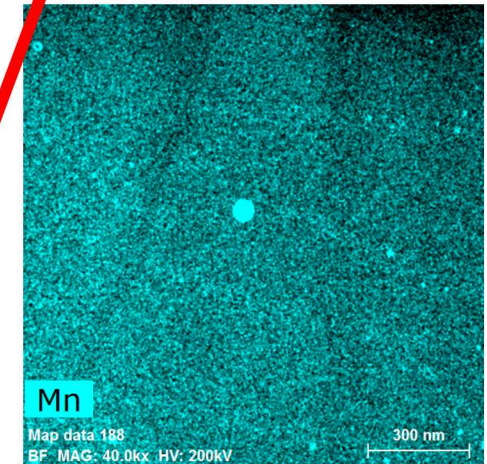
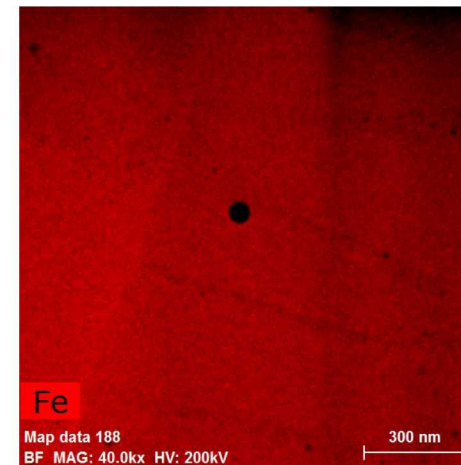
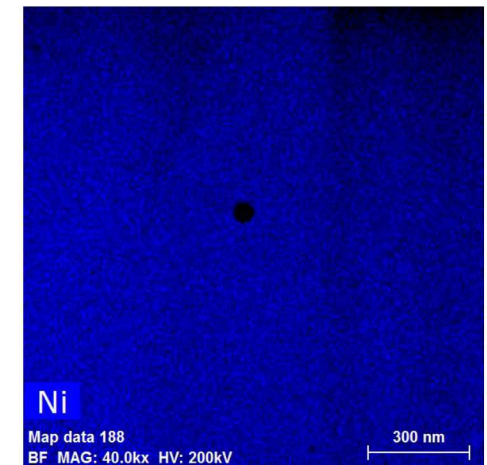
There is depletion of Cr, Mo, Mn, Si here and enrichment of Fe.

Also shown for another MPB back in May.

- Solute (Cr/Mo) depletion is likely the reason for MPB corrosion susceptibility.
- Minimal grain orientation change was shown across MPBs, epitaxy across these boundaries was very common.
- Few nanoscale oxide inclusions were found on the MPBs.
- No localized strain associated with MPBs.
