Overview of Groundwater Monitoring at Sandia National Laboratories

Michael Skelly
SNL/NM
Department 6234
mfskell@sandia.gov

Sandia National Laboratories
New Mexico
Groundwater Investigations

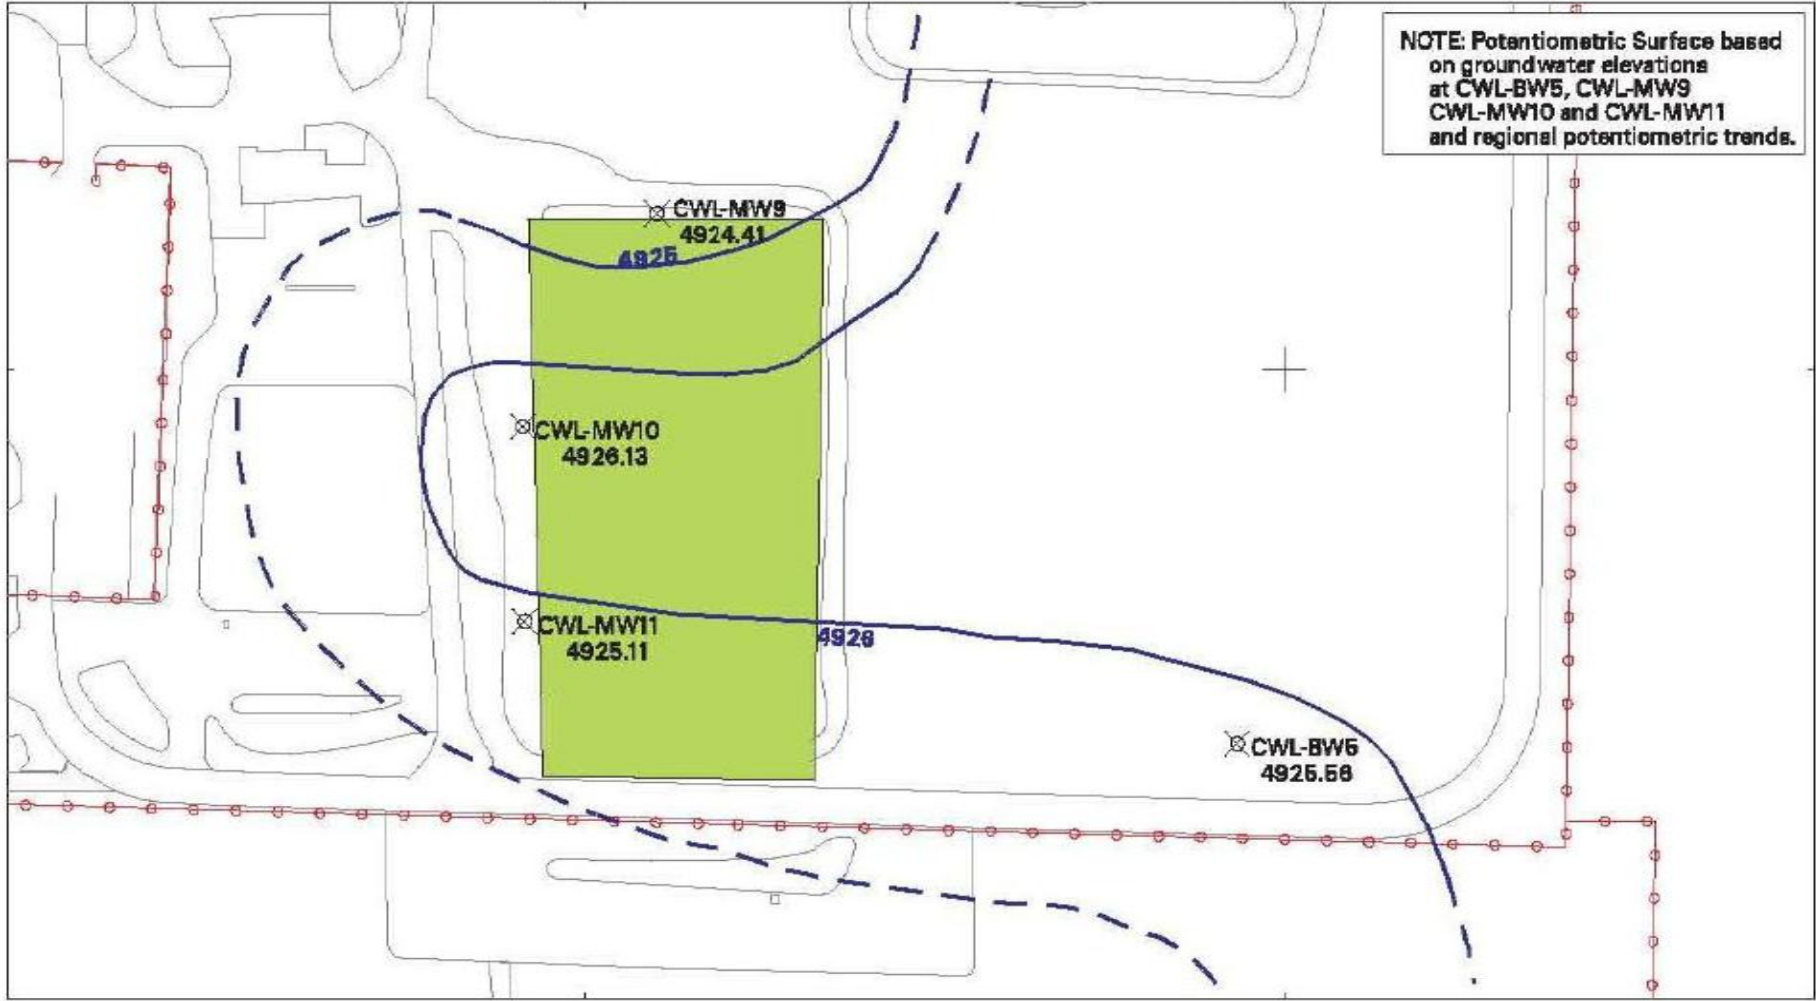
Chemical Waste Landfill

NOTE: Potentiometric Surface based on groundwater elevations at CWL-BW6, CWL-MW9, CWL-MW10 and CWL-MW11 and regional potentiometric trends.

Potentiometric surface contour, feet above Mean Sea Level, dashed where inferred
-

- 1.9 acre landfill, operational from 1962 to 1981
- TCE discovered in 1990 in groundwater prompted remediation via soil-vapor extraction and excavation of contaminated soils and debris.
- Currently regulated under a Post-Closure Care Permit
- 4 groundwater monitoring wells sampled semiannually, no analytes above regulatory standards
- 5 soil-vapor monitoring wells sampled annually
- Data reported annually to the NMED in the Annual Groundwater Monitoring Report

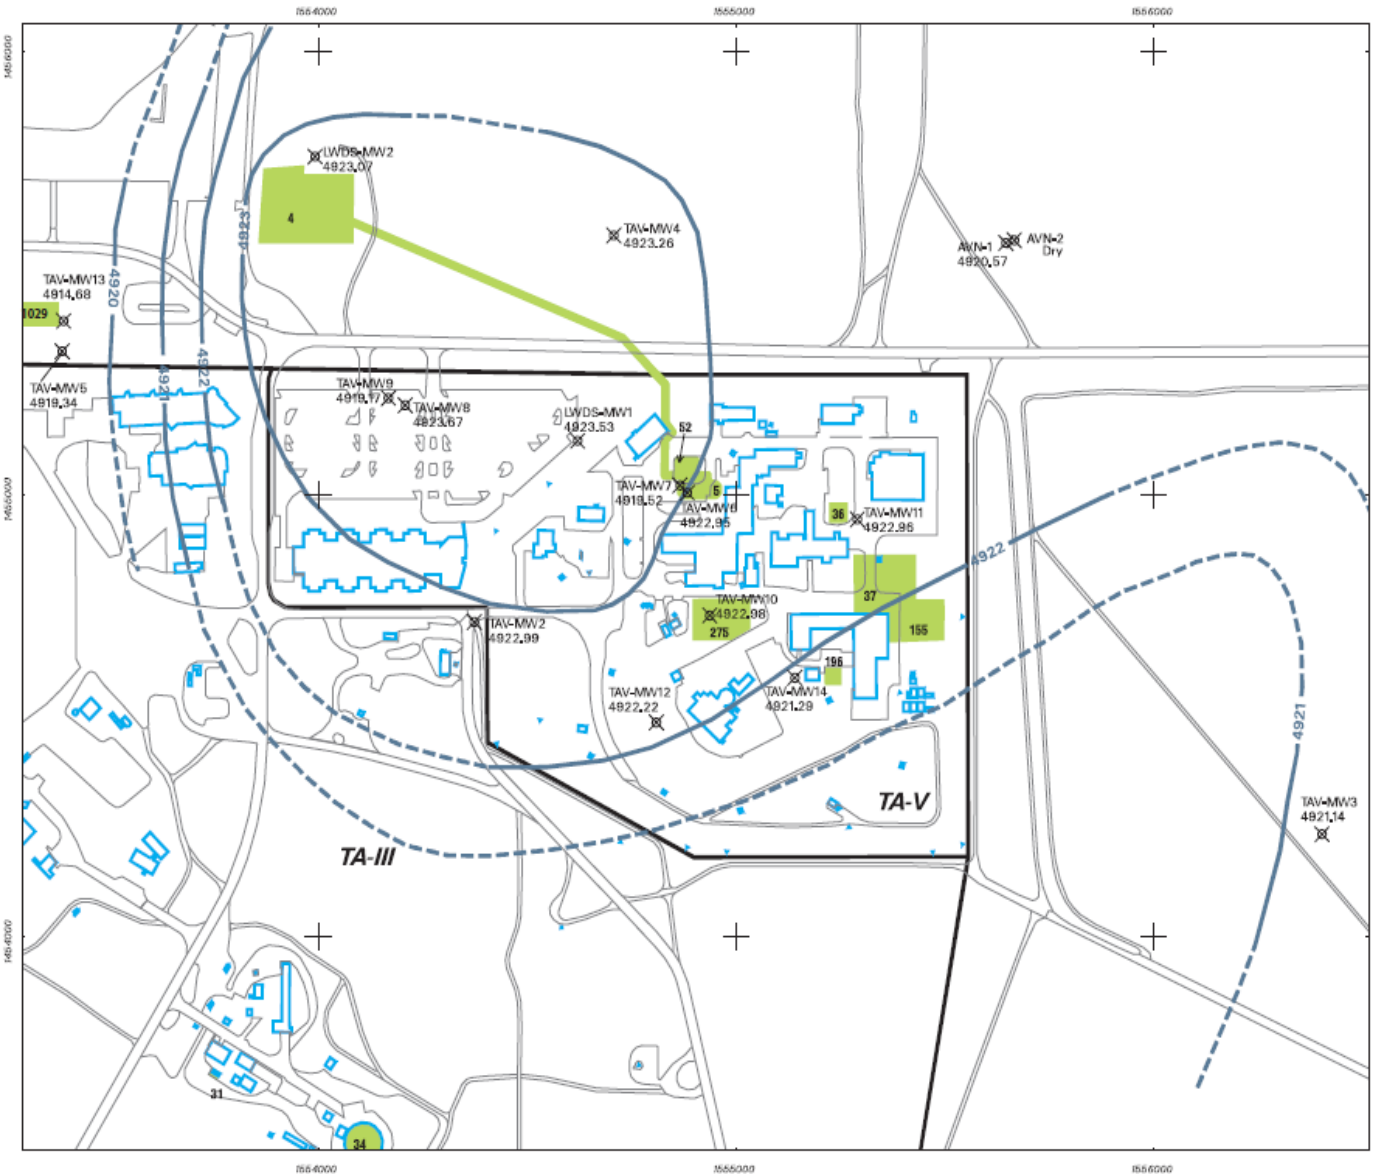
Monitoring well, groundwater
 Groundwater elevation, feet amsl,
 October 2011
 4921.44
-

Potentiometric surface contour
 feet amsl, dashed where Inferred
-

Notes:
 1) Wells AVN-1, TAV-MW7, and TAV-MW9 are completed below the water table, and were not contoured

- Groundwater monitored since 1992
- Groundwater occurs ~500 ft deep in unconsolidated sediments
- Contaminated with nitrate and TCE
 - Nitrate: 0 to 14 ppm (regulatory standard is 10 ppm)
 - TCE: 0 to 19 ppb (regulatory standard is 5 ppb)
- Suspected sources include high-volume waste-water disposal systems
- Small plume very far away from drinking-water supplies
- 16 groundwater monitoring wells sampled four times per year
- 3 soil-vapor monitoring wells sampled four times per year—low-level detections of TCE in vapor phase
- Data reported annually to the NMED in the Annual Groundwater Monitoring Report
