# Low cost carbon fiber as potential lightning strike protection for wind turbine blades

## Abstract

**Keywords:** Low Cost Carbon Fiber, Lightning Strike Protection, Wind Turbine, Electrically Conductive.

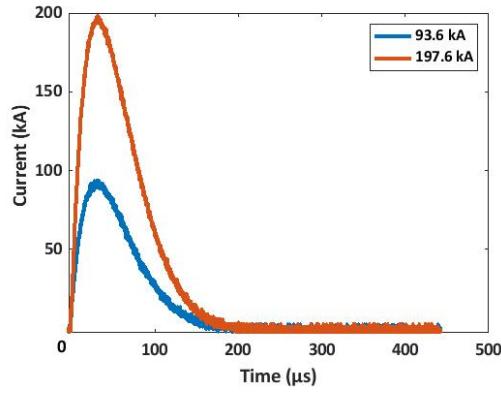
**Fig. 1.** Simulated lightning strike test setup (a) applied component A of lightning waveform (b) current discharge electrode (c) circuitry for the artificial lightning generation.

article. The generator is charged by a DC power source up to 44 kV for each capacitor that can store 50 kJ electrical energy to vary the current amplitude of the strike and generating the standard waveform of lightning. In this study, component A of the lightning strike waveform was generated, and current discharges of 93.6 kA and 197.6 kA were used as shown in the figure. The simulated lightning current is in accordance with component A of the SAE standard lightning waveform which can be up to 200 kA and should be less than 500  $\mu$ s. So, it is suitable for lightning strike damage analysis. The samples were grounded to a steel plate with copper strips, steel strips, and braided wires. The braided wires were wrapped around the edges and the copper and steel strips were tight into the sheet of steel with nuts and bolts to hold the sample and make a path for discharged current to the ground. The test apparatus was placed face down on the top of the impulse generator's discharge electrode and struck by simulated lightning strike [10].

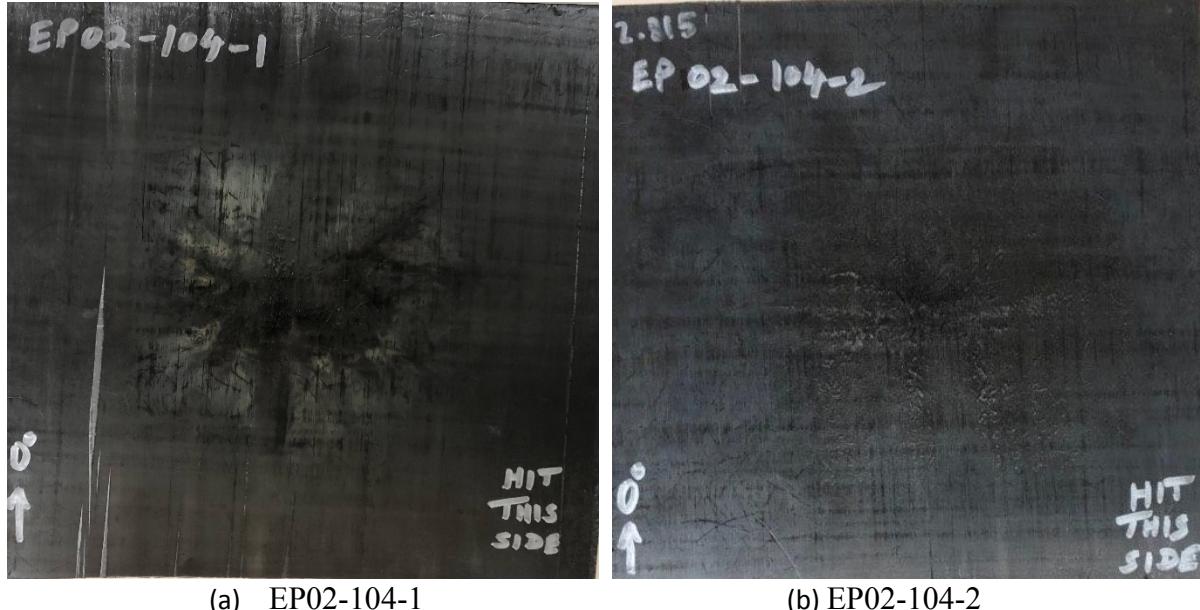
**Fig. 2.** Visual damage inspection of LCCF-composite panels after lightning strike test of (a) 100 kA and (b) 200 kA.

**Visual Damage Inspection:** The visual inspection of the panels after lightning strike confirmed that there was no fiber breakage, resin evaporation or delamination in the composite panels after the lightning strike test. Small discoloration and some fiber fuzziness around the lightning attachment location (center of the panel) was observed. This is significant finding as without any additional LSP these panels exhibited remarkable resilience to the lightning damage. In the literature, there is no report of epoxy based CFRP composites surviving such a high lightning

currents without undergoing any visual damages. This behavior can be assigned to the inherent high electrical conductivity of LCCF-composites compared to the other traditional epoxy-composites.

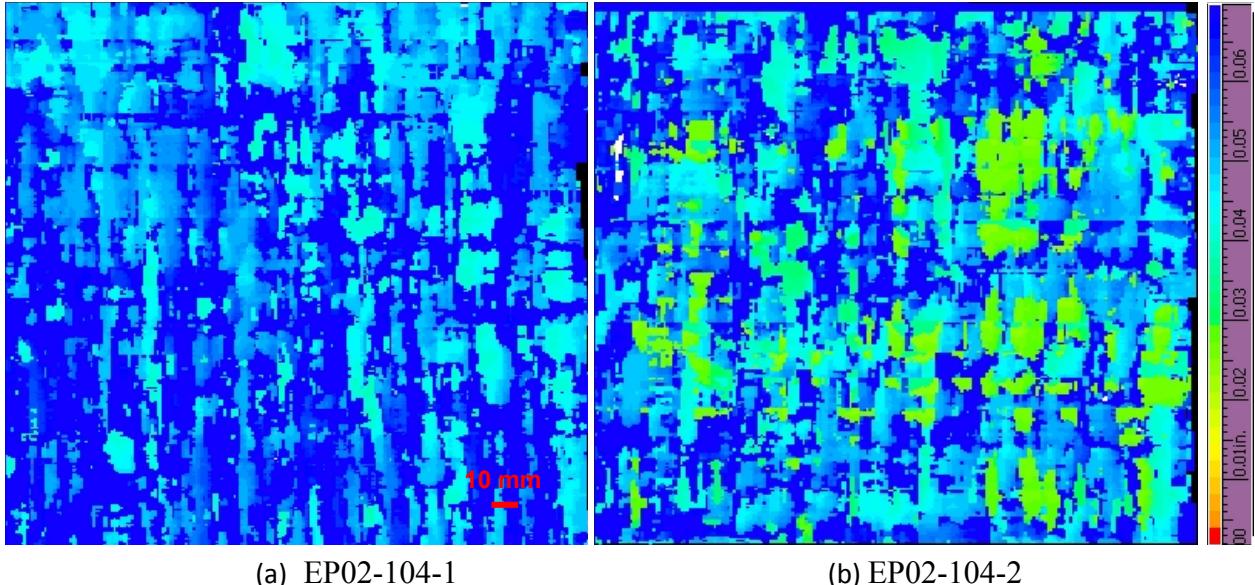
**Fig. 3.** C-scan images for panels EP02-104-1 and EP02-104-2 obtained before the simulated lightning strike test.

**Ultrasonic Inspection Images:** Fig. 3 shows the C-scan images for composite EP02-104-1 and EP02-104-2 obtained before the simulated lightning strike test. Defects are uniformly present in both panels which could be due to the surface roughness or voids caused during the manufacturing process. For EP02-104-1, the color indicating the defects is slightly lighter than blue (see the color legend shown in Fig. 3, unit in inches), which implies that more defects are present near the laminate surface and could have been caused by the surface roughness. While for EP02-104-2, areas with more greenish color can be observed, which indicates that the defects are not only on the surface but also are generally present in more in-depth locations possibly due to voids.

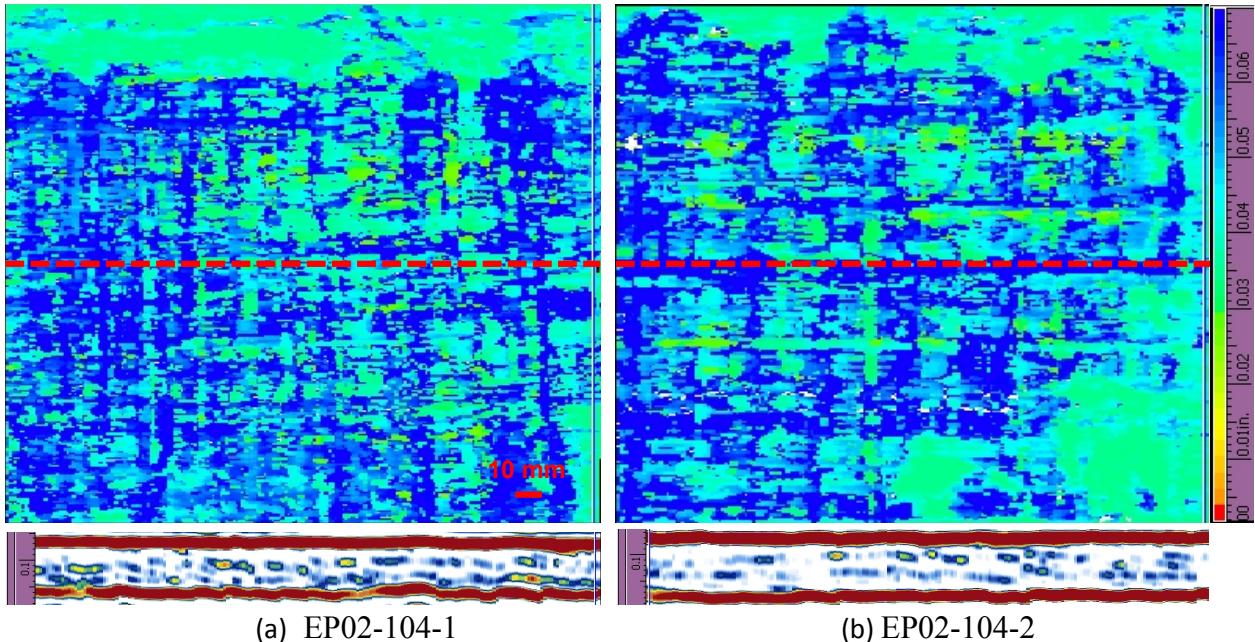
**Fig. 4.** C-scan and B-scan images for panels EP02-104-1 and EP02-104-2 obtained after the simulated lightning strike test.

Fig. 4 shows both C-scan and B-scan images for panels EP02-104-1 and EP02-104-2 after the simulated lightning strike test. Note that the scanning parameters (e.g., focus depth) used for the C-scan before and after the simulated lightning strike test are slightly different. As one can see, the defects are still quite uniform and present almost everywhere within the composite panels. The B-scan images shown below the C-scan images in Fig. 4 were obtained by scanning along the paths in the centerline of the composite panels, as indicated by the red dashed lines in the figure. It can be observed that defects are present at multiple locations across the thickness of the panels.

and it appears that more defects exist in panel 1 at the centerline paths that were scanned. Overall, the C-scan and B-scan images are not enough to show any clear trends about any damage due to the lightning strikes.
