Sandia National Laboratories

August 2011

DOE/Sandia Responses to NMED's "Notice of Disapproval: Mixed Waste Landfill Corrective Measures Implementation Report, January 2010"

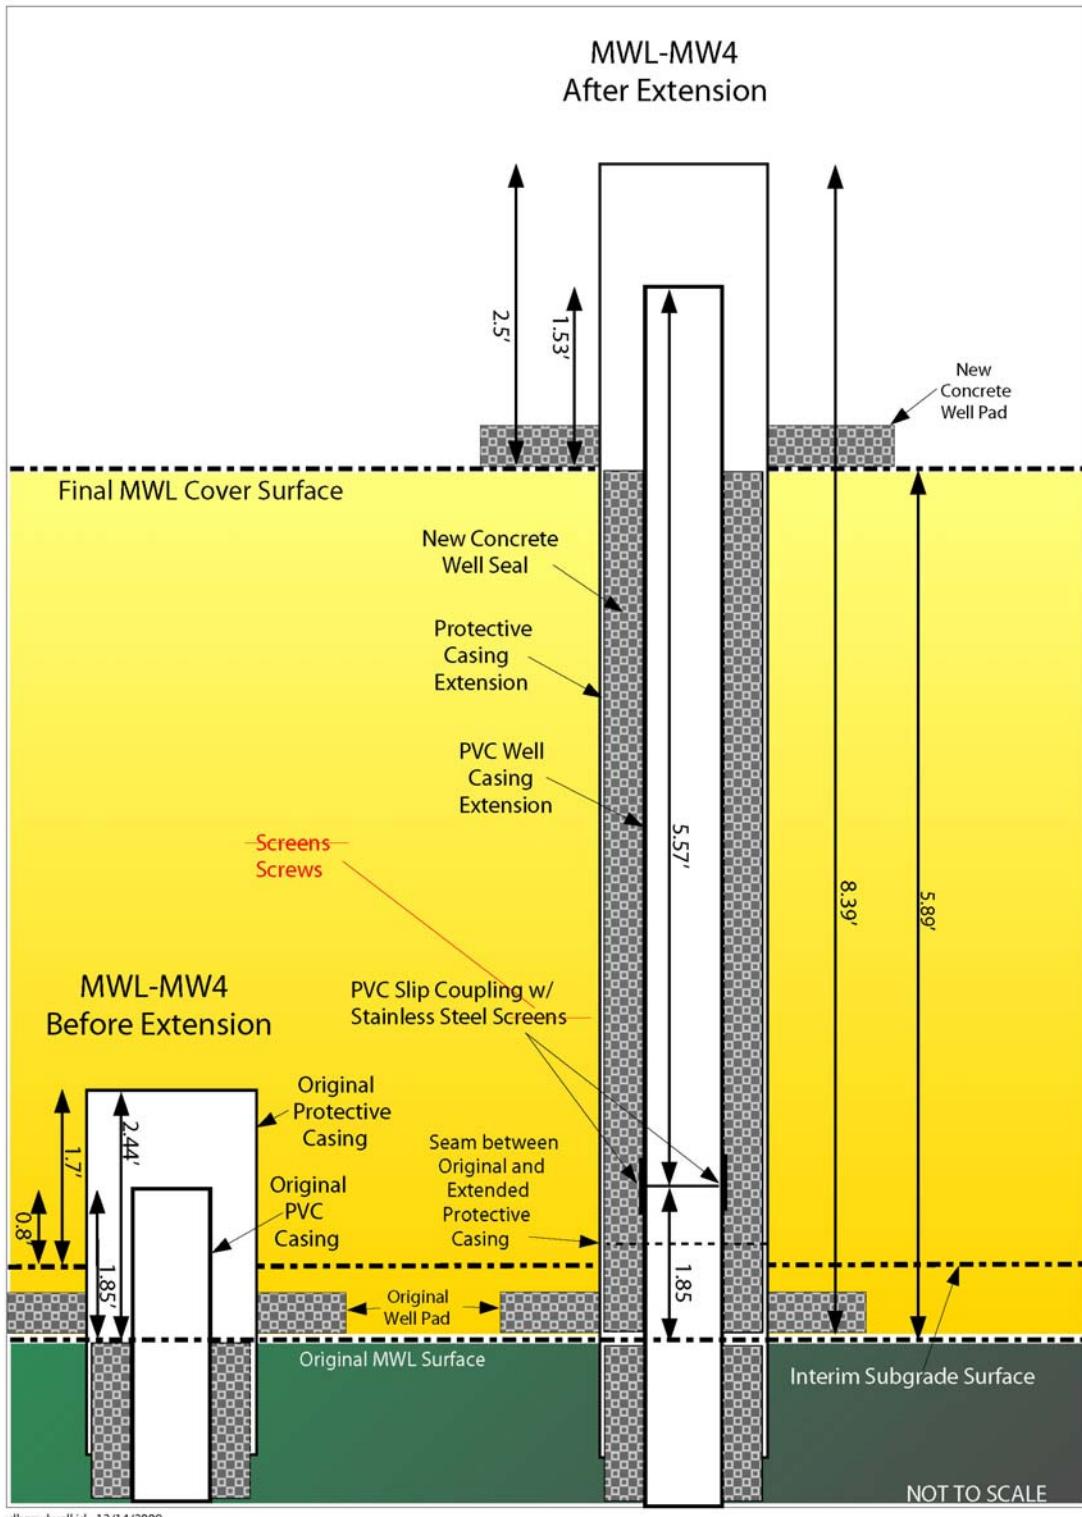
Figure 2-5
Schematic MWL-MW4 PVC Well Casing and Protective Surface Casing Extension Diagram

CQA Report, Attachment 8, Figure 2-5, center of figure: "PVC Slip Coupling w/ Stainless Steel Screens" should read "PVC Slip Coupling w/Stainless Steel Screws".

Response: The error in Figure 2-5 of Attachment 8 in the CQA Report (Appendix A of the CMI Report, Volume 2), has been corrected. The associated revision to the CQA Report is tracked in Table 1 and documented in redline-strikeout format in Attachment 1. Attachment 2 of this comment response document provides the replacement page, and the revised figure is incorporated into the electronic version of the CMI Report (January 2010, Revision 1) provided on both CDs.
