**Testing Korean Cables:
Electrical Degradation and Failure Associated with Radiant Heating**

Revision: November 11, 2010

Prepared by:
Francis J. Wyant, Jason W. Brown, and Steven P. Nowlen
Risk and Reliability Analysis Department 6231
Sandia National Laboratories
Albuquerque, New Mexico

Prepared for:
KEPRI
Agreement No. FI 067100625
Korean Cable Fire Tests

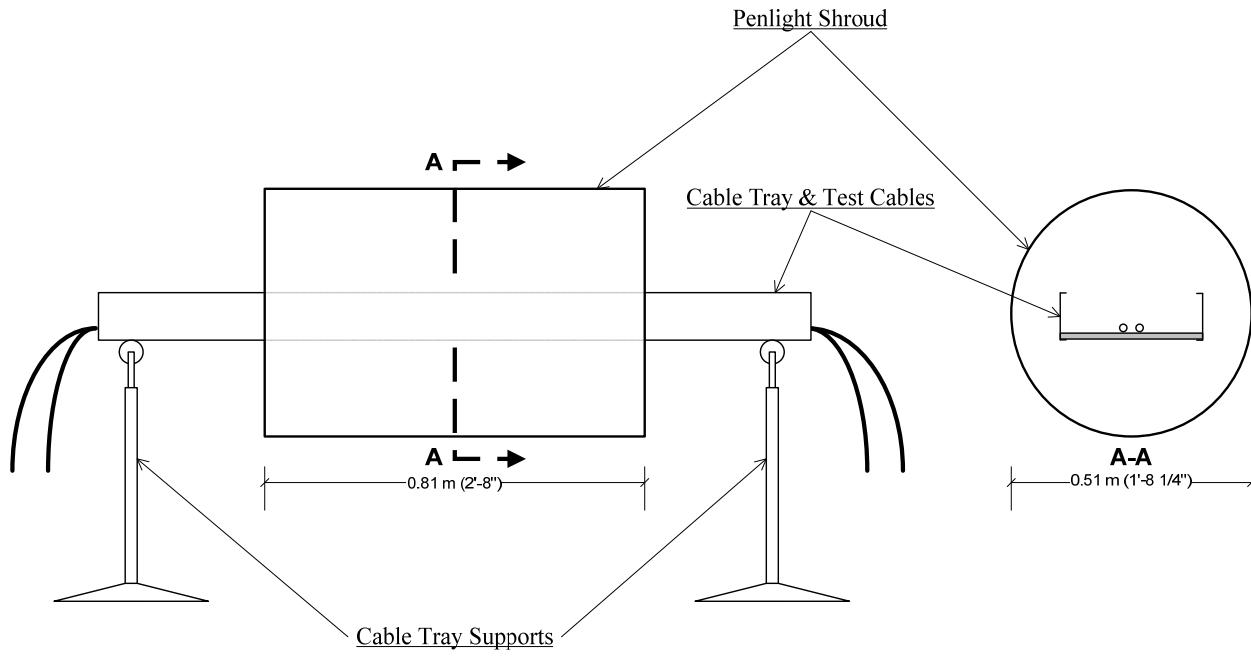
Figure 1: Penlight testing apparatus.

The Korean cable testing program utilized the SNL radiant heat exposure device called Penlight. This facility is described in detail in Volume 2 of NUREG/CR-6931 [2]. The planned exposure geometry is shown in Figure 1. The same general test protocol established for CAROLFIRE was followed for these tests. Essentially, two cables were used during each test: one for monitoring the thermal response, the other for monitoring the cable electrical response to determine the primary failure mechanisms. The cable heating procedure, however, conformed to the needs of this particular test series. Note that the cable lengths shown in Figure 1 have been exaggerated to illustrate positions in the tray.

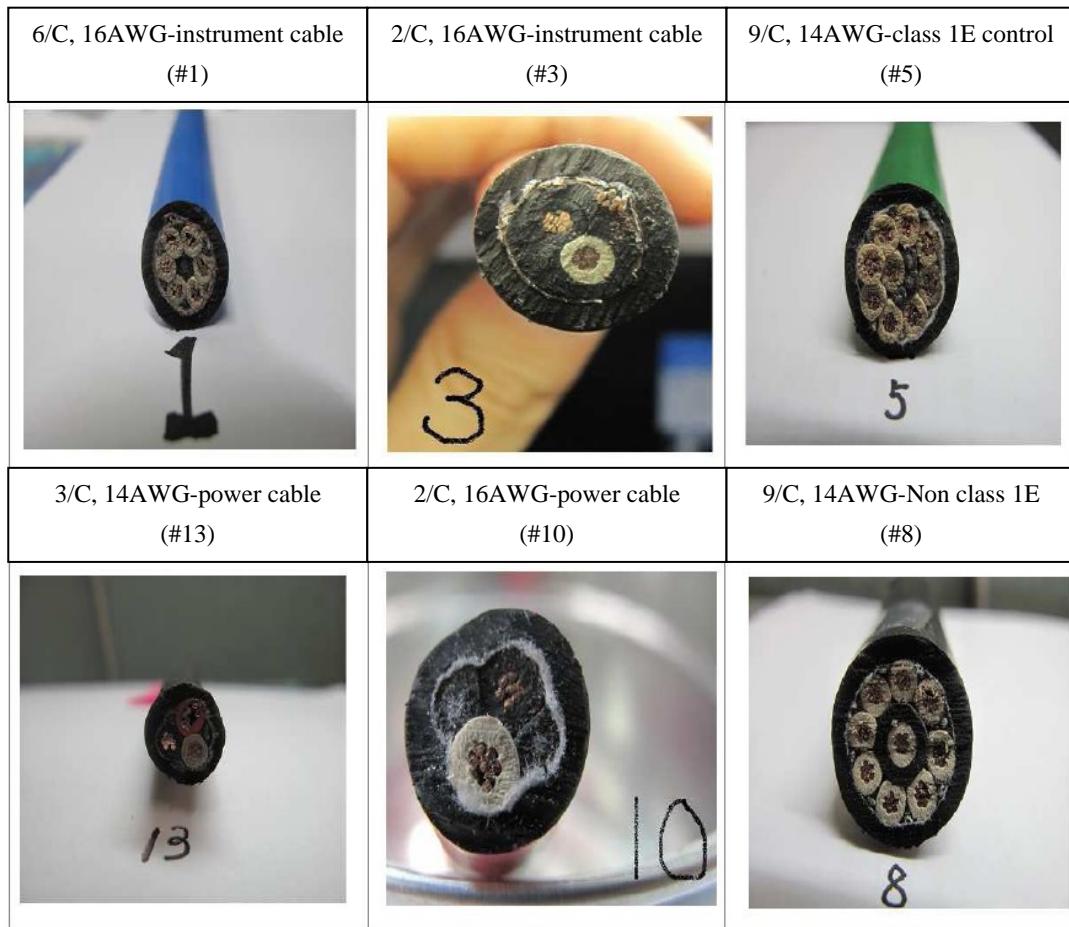
Figure 2: Cross-sectional views of the Korean test cables.

KEPRI agreed with the Sandia recommendations and provided samples of each of the cable types listed in Table 1. Figure 2 provides cross-sectional views of each of the cable types tested in the Korean Cable Test Program. One unusual characteristic of the cable samples is that the total lengths of each cable type were very limited. Consequently, each of the Penlight tests was conducted with one 1-meter (3 foot) length of cable instrumented with thermocouples to provide the cable temperature measurements and one 2-meter (6 foot) length of cable connected to the electrical monitoring device, either IRMS or SCDU. Figure 3 shows the cable arrangement as installed in Penlight for testing. Connections made to the electrically monitored test cables were accomplished using standard wire nuts instead of being connected to the instrument lead cables through a junction box, as was done during the DESIREE-Fire tests.

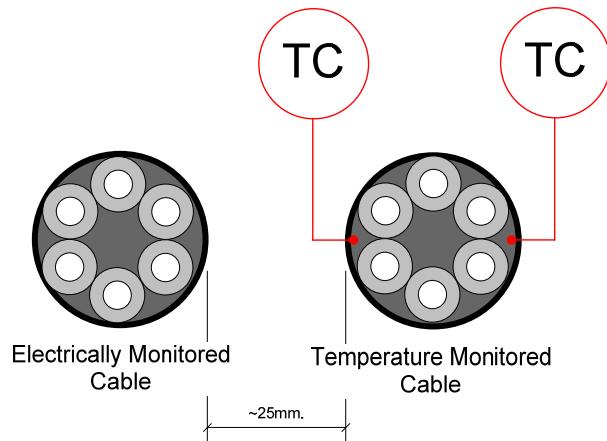
Figure 4: Example thermocouple arrangement for temperature monitoring of a 6-conductor cable located near the electrically monitored cable in tray

As noted for CAROLFIRE, it is not appropriate to instrument any single cable for both thermal and electrical response. This is because installation of a thermocouple on, or within, a cable could impact the electrical failure behavior. Instead, the approach applied involves mirroring a cable being monitored for electrical performance with a second cable (in an adjacent or symmetric location) monitored for thermal response. Figure 4 provides a graphical depiction of this dual-cable setup.

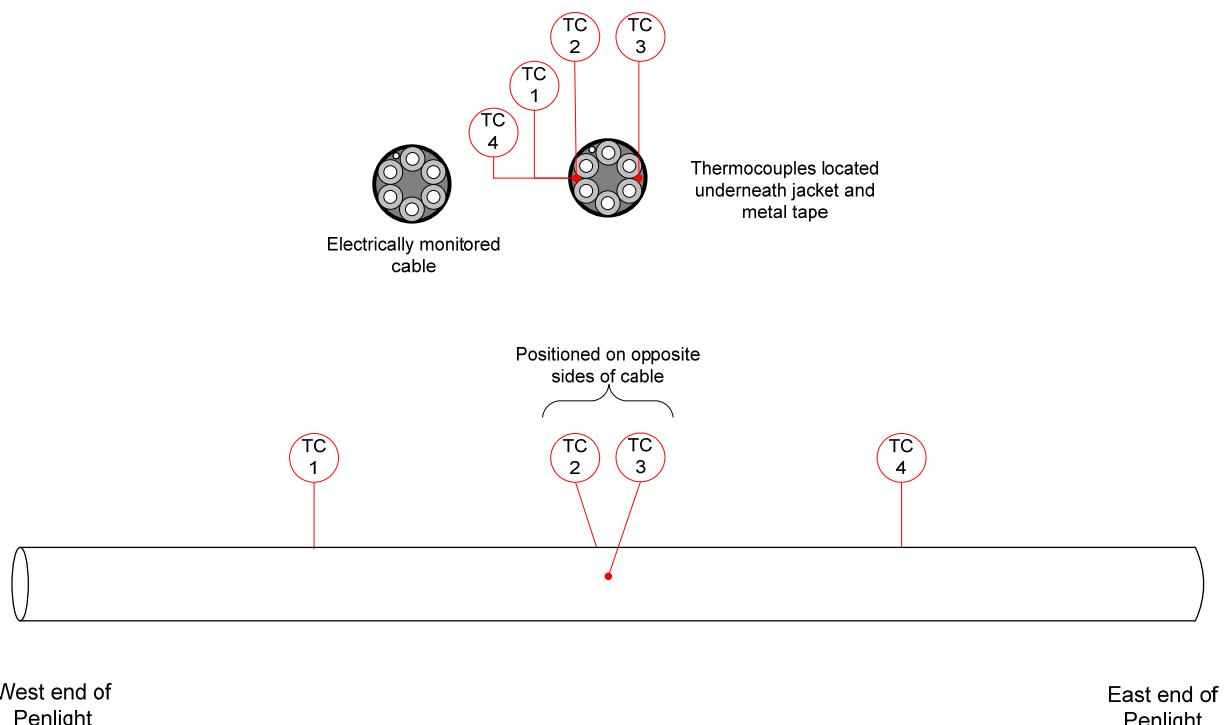
Map for placement of thermocouples inserted within the thermally monitored cable during Test #1.

Two cables were included in Test #1, one electrically monitored, one thermally monitored. The cable had a blue jacket and white conductor insulation with printed numbers. A metal tape surrounded the conductor bundle and was grounded during the test.

Thermo-couple Name	Location
TC1	Within cable just below cable jacket and metal tape, to the West of the center position
TC2	Within cable just below cable jacket and metal tape, at center position
TC3	Within cable just below cable jacket and metal tape, opposite side from Cable 2, center position
TC4	Within cable just below cable jacket and metal tape, to the East of the center position

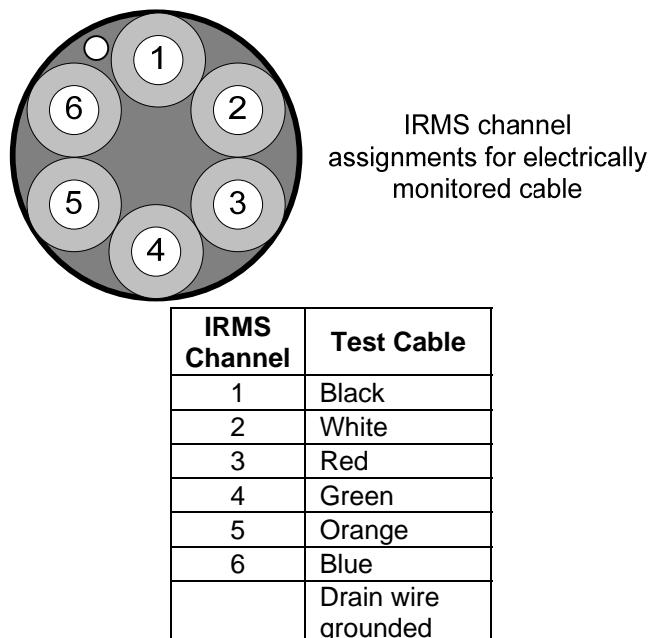
Six of the seven available IRMS channels were connected to the electrically monitored test cable.

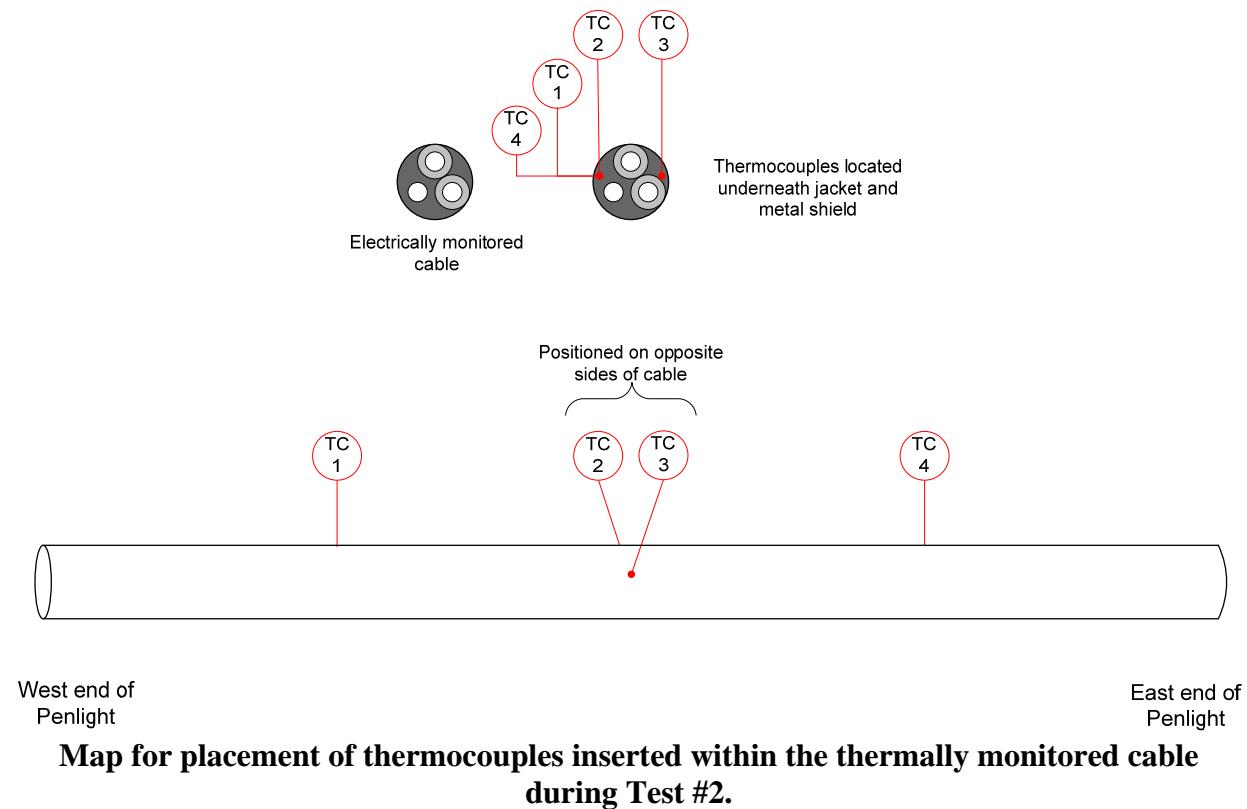
Two cables were included in Test #2, one electrically monitored, one thermally monitored. The test cables had a red jacket and black and white conductor insulation. The drain wire was not insulated and was grounded.

Thermo-couple Name	Location
TC1	Within cable just below cable jacket and shield, to the West of the center position
TC2	Within cable just below cable jacket and shield, at center position
TC3	Within cable just below cable jacket and shield, opposite side from Cable 2, center position
TC4	Within cable just below cable jacket and shield, to the East of the center position

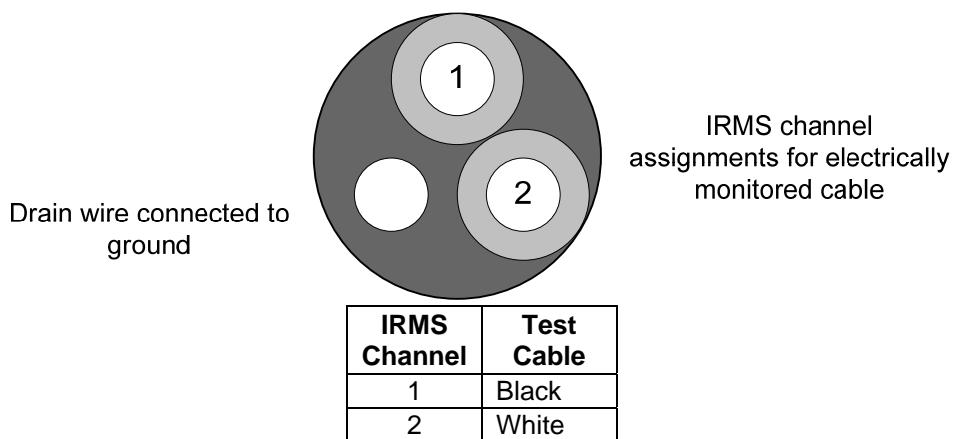
Two of the available IRMS channels were connected to the electrically monitored test cable.

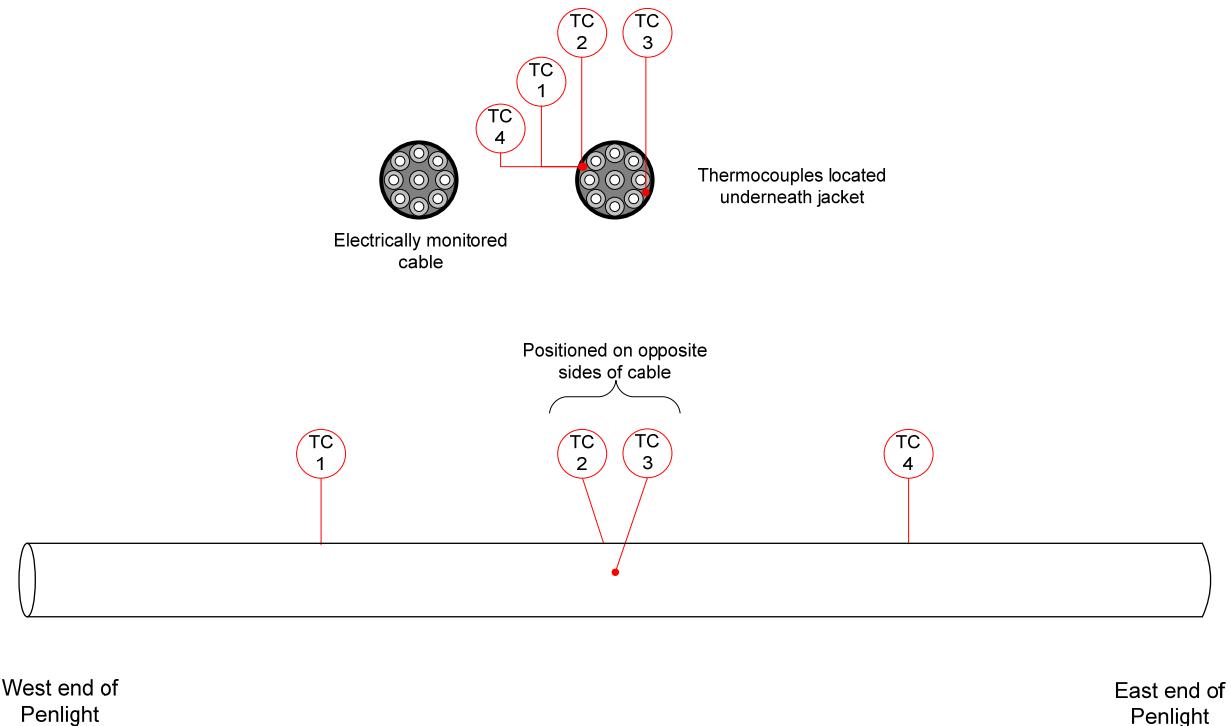
Two cables were included in Test #3, one electrically monitored, one thermally monitored. The test cables had a green jacket and white conductor insulation with printed numbers. Two conductors were connected to each of IRMS channels 2, 3, 4 & 5.

Thermo-couple Name	Location
TC1	Within cable just below cable jacket, to the East of the center position
TC2	Within cable just below cable jacket, at center position
TC3	Within cable just below cable jacket, opposite side from Cable 2, center position
TC4	Within cable just below cable jacket, to the West of the center position

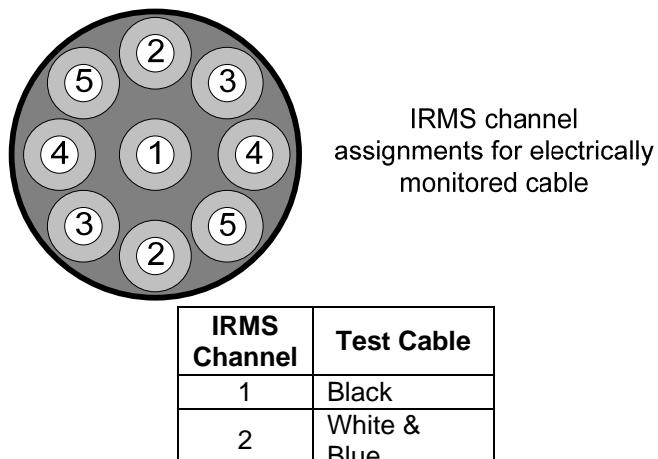
Five of the IRMS channels were connected to the electrically monitored test cable.

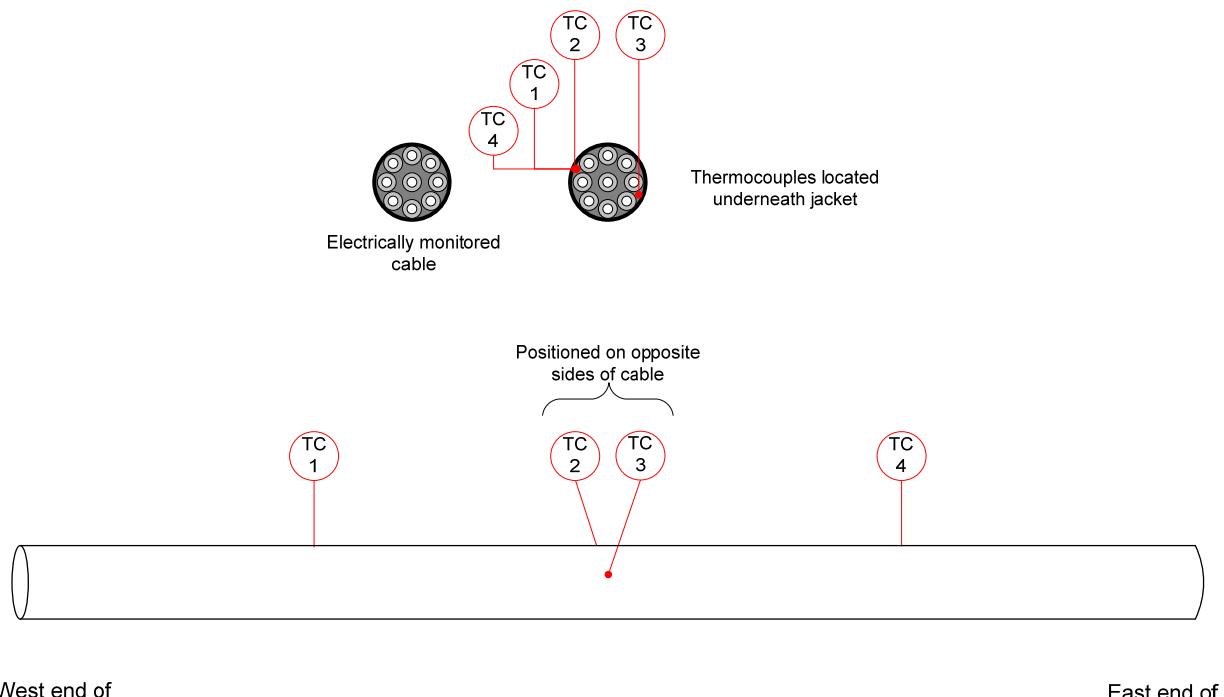
Map for placement of thermocouples inserted within the thermally monitored cable during Test #4.

Two cables were included in Test #4, one electrically monitored with the IRMS, one thermally monitored. The cable had a black CR jacket and a black insulated center conductor and eight white insulated other conductors with printed numbers.

Name	
TC1	Within cable just below cable jacket, to the West of the center position
TC2	Within cable just below cable jacket, at center position
TC3	Within cable just below cable jacket, opposite side from Cable 2, center position
TC4	Within cable just below cable jacket, to the East of the center position

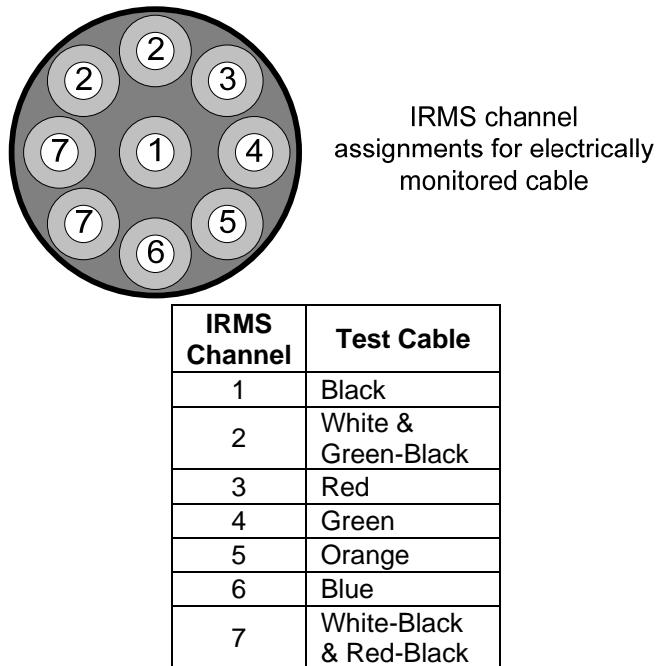
All seven of the available IRMS channels were connected to the electrically monitored test cable.

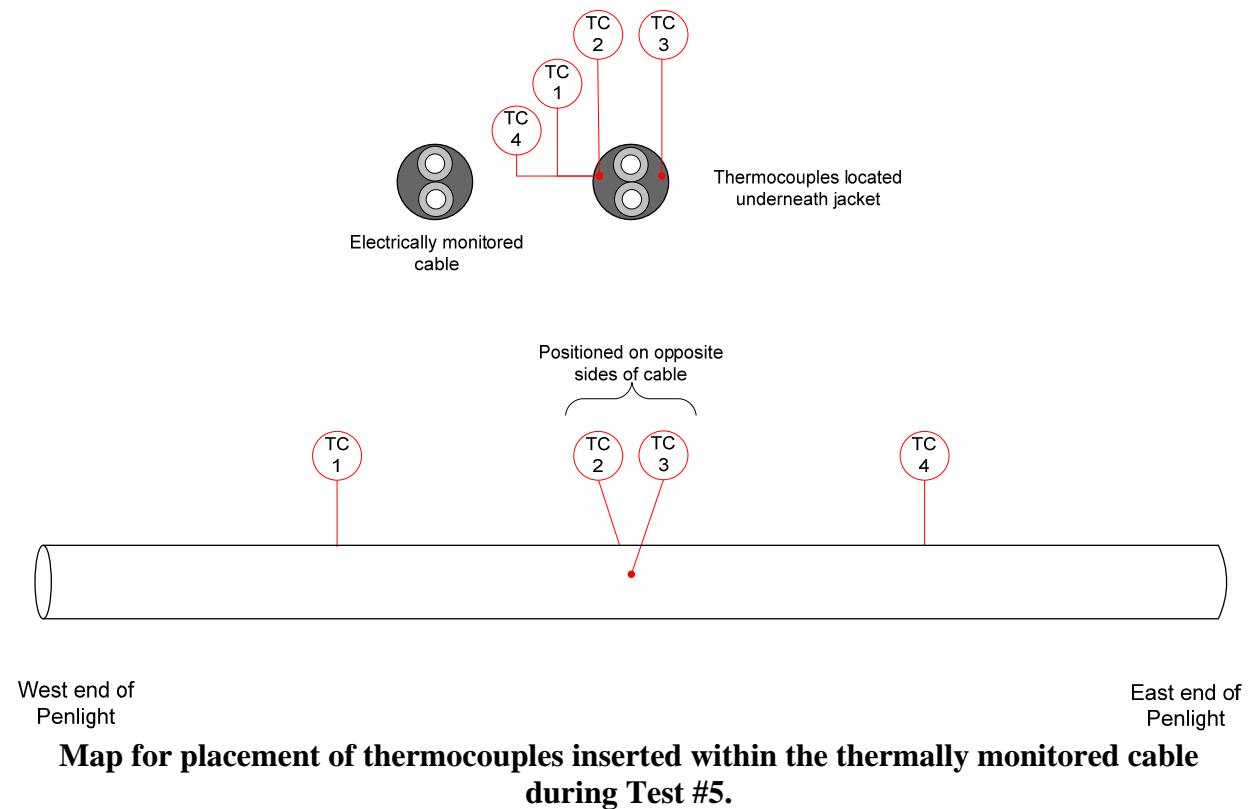
Two cables were included in Test #5, one electrically monitored, one thermally monitored. The cables had red jackets and black and white conductor insulation. This type of cable did not have a metal shield or drain wire.

Thermo-couple Name	Location
TC1	Within cable just below cable jacket, to the West of the center position
TC2	Within cable just below cable jacket, at center position
TC3	Within cable just below cable jacket, opposite side from Cable 2, center position
TC4	Within cable just below cable jacket, to the East of the center position

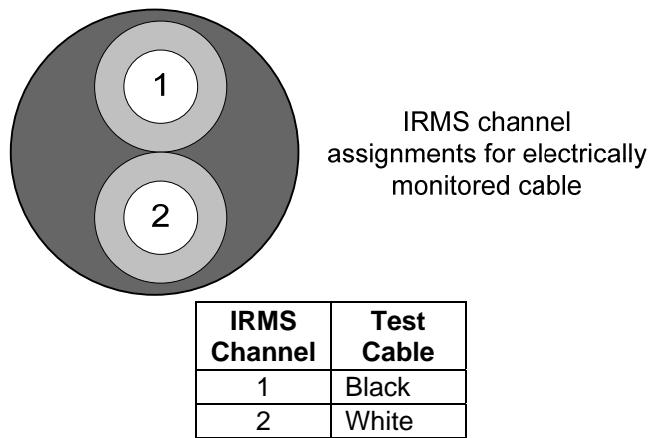
Two IRMS channels were connected to the electrically monitored test cable.

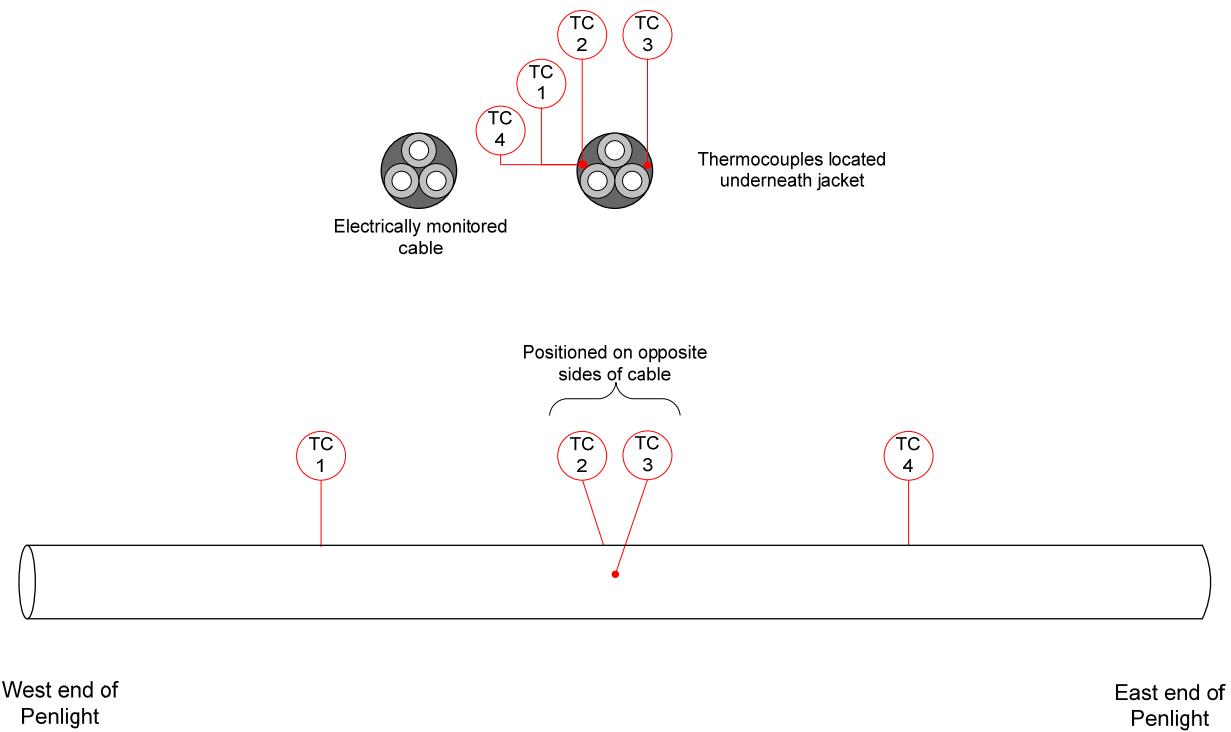
Map for placement of thermocouples inserted within the thermally monitored cable during Test #6.

Two cables were included in Test #6, one electrically monitored, one thermally monitored. The test cables had a black jacket and black, white, and red conductor insulation.

Thermo-couple Name	Location
TC1	Within cable just below cable jacket, to the West of the center position
TC2	Within cable just below cable jacket, at center position
TC3	Within cable just below cable jacket, opposite side from Cable 2, center position
TC4	Within cable just below cable jacket, to the East of the center position

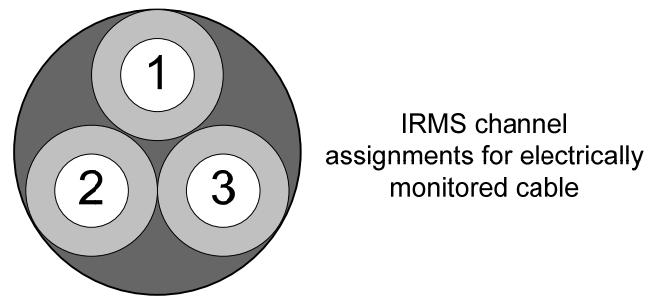
Three of the IRMS channels were connected to the electrically monitored test cable.

IRMS Channel	Test Cable
1	Black
2	White
3	Red

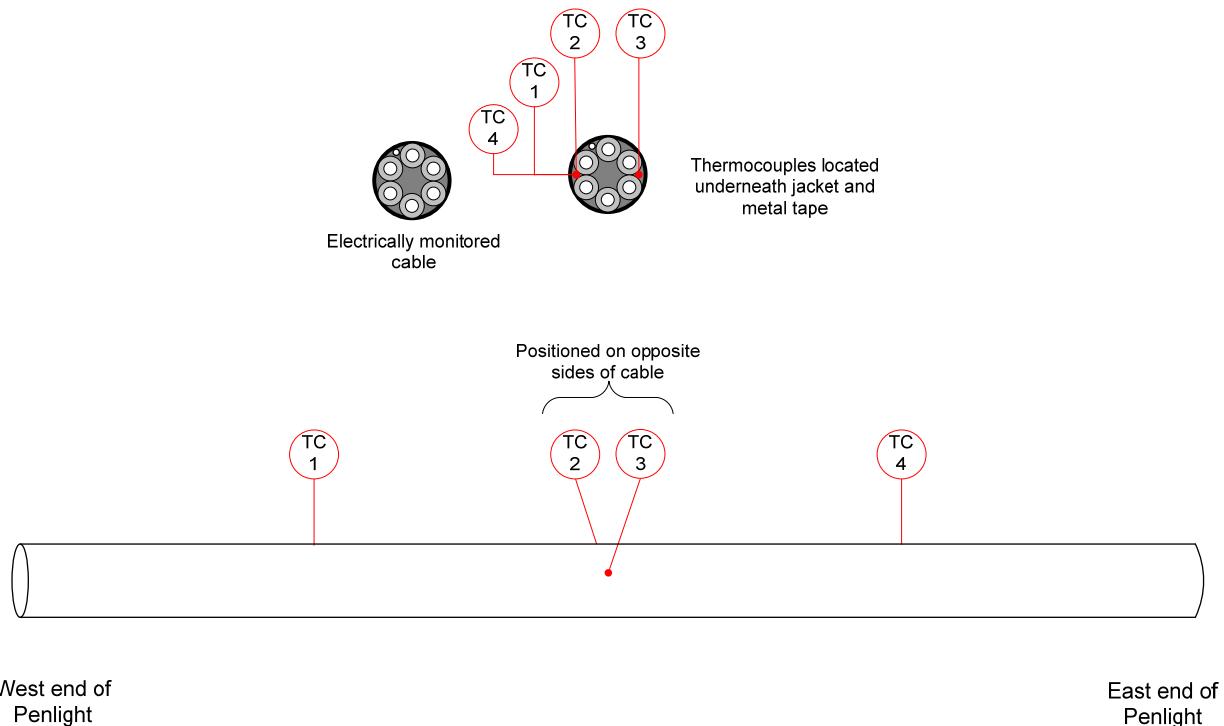
Map for placement of thermocouples inserted within the thermally monitored cable during Test #7.

TC1	Within cable just below cable jacket and metal tape, to the West of the center position
TC2	Within cable just below cable jacket and metal tape, at center position
TC3	Within cable just below cable jacket and metal tape, opposite side from Cable 2, center position
TC4	Within cable just below cable jacket and metal tape, to the East of the center position

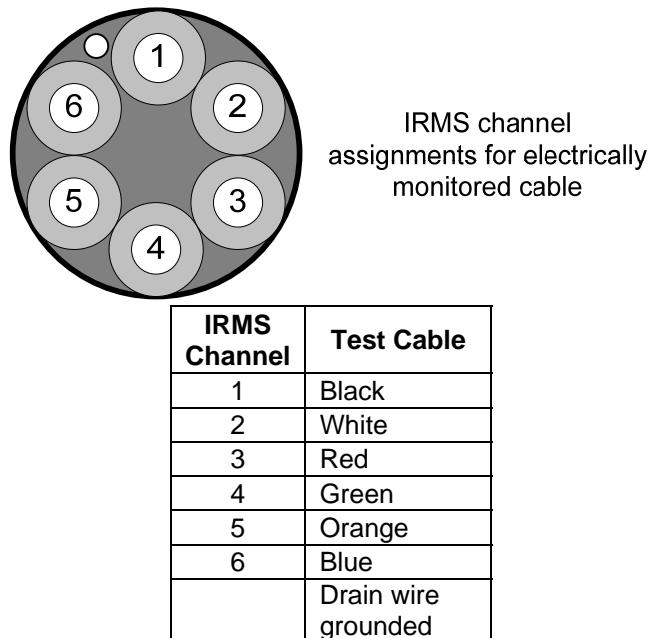
Six of the seven available IRMS channels were connected to the electrically monitored test cable.

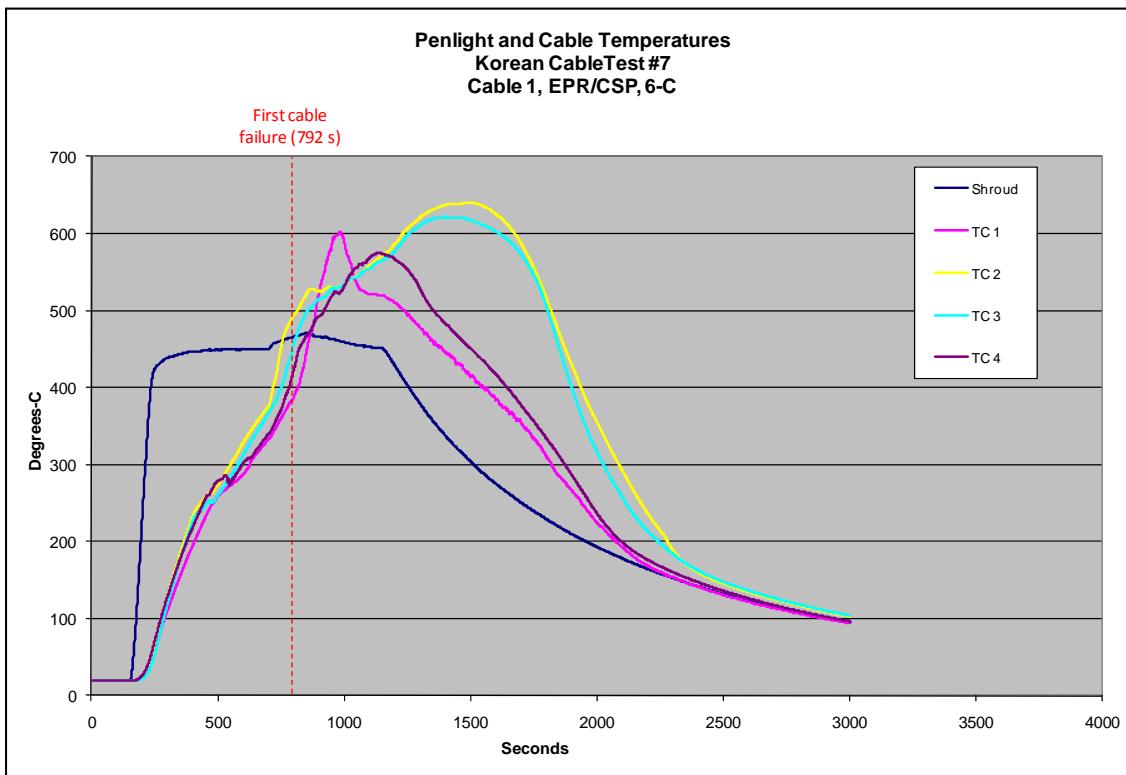
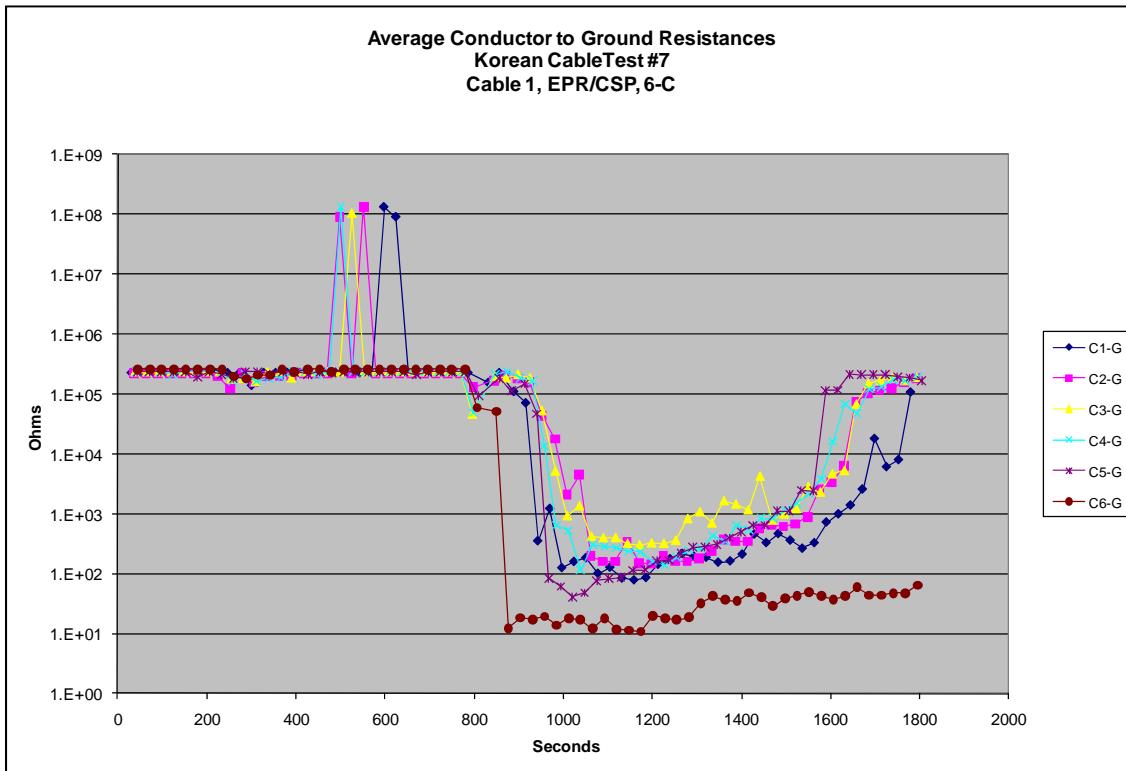
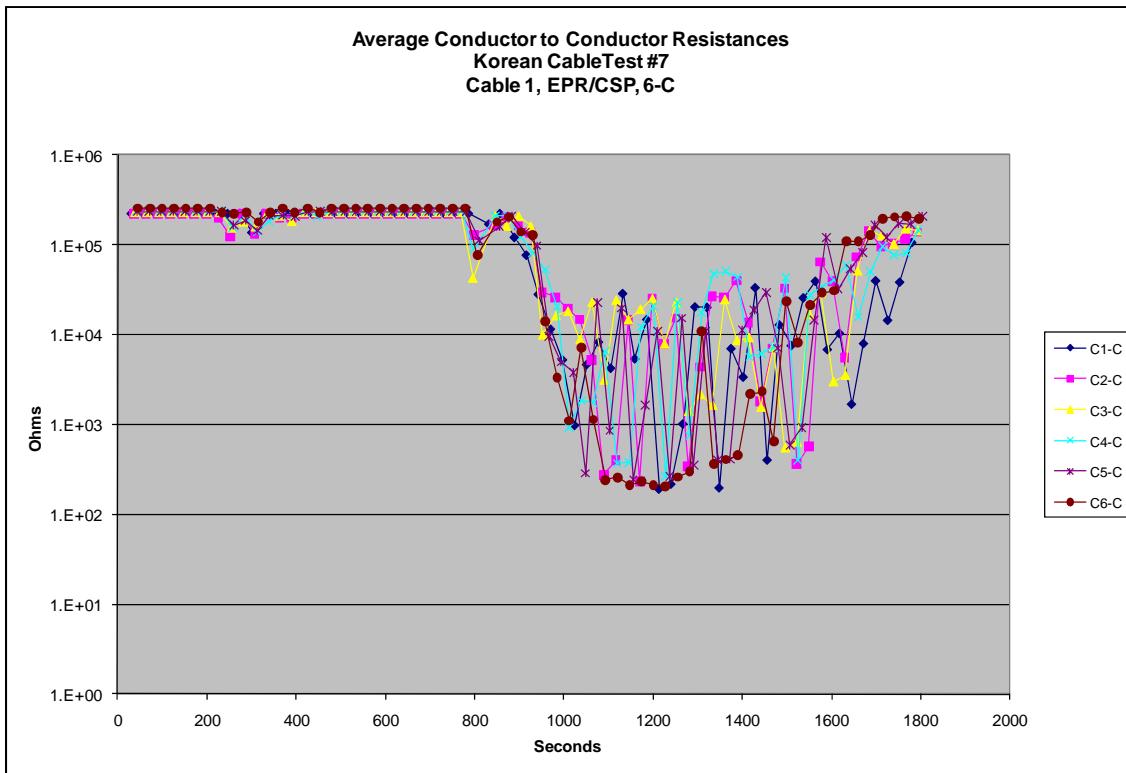
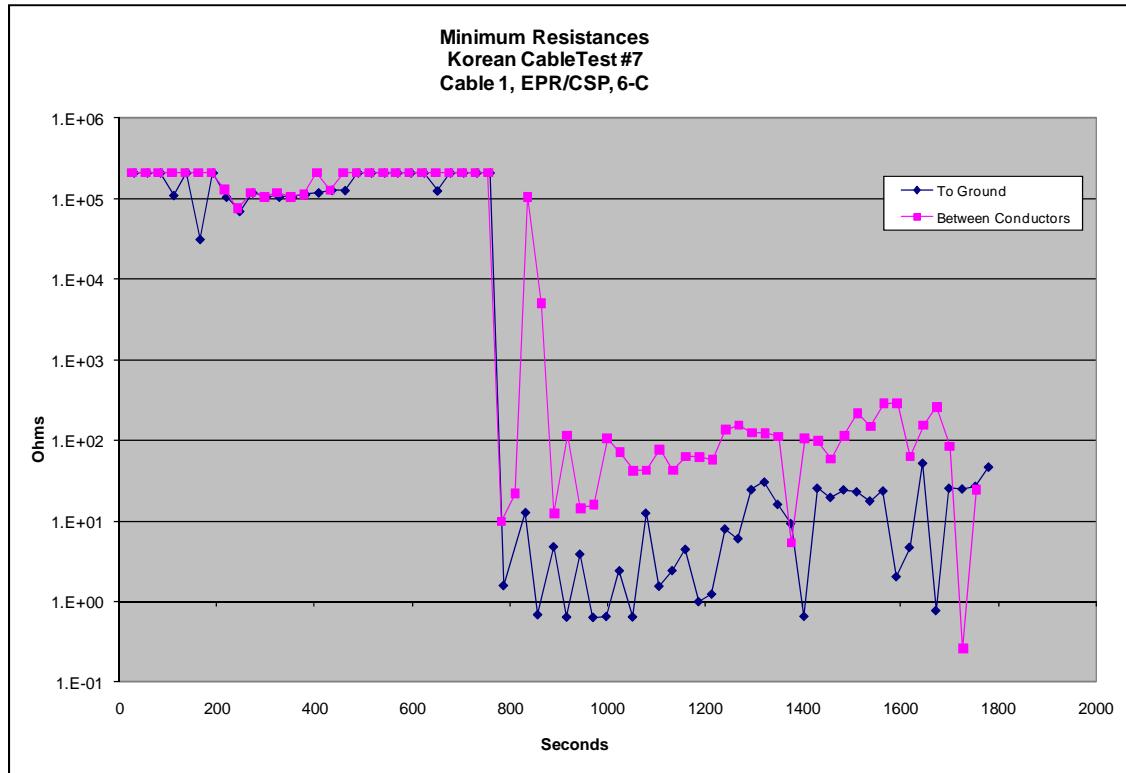
Summary of Observed Faulting Behavior for Korean Cable Test #7		
Time (s)	Event	Comments
153	Penlight On; set at 450C (12.6 kW/m ²)	
792-807	Conductor 2 shorts to conductor 3 at less than 100 ohms; conductor 2 shorts to conductor 6 at less than 1000 ohms. Conductor 3 shorts to conductors 4, 5 & 6 at less than 1000 ohms. Conductor 4 shorts to conductors 5 & 6 at less than 1000 ohms.	Initial failure is by conductor to conductor shorting; average cable temperature 468C at center
798-807	Conductors 2, 3, 4 & 6 short to ground at less than 1000 ohms. Conductor 5 shorts to ground at less than 100 ohms.	
850	Conductor 6 shorts to ground at less than 100 ohms.	Shorting path may be through ground (tray)
889-898	Conductor 1 shorts to ground at less than 1000 ohms. Conductor 2 shorts to ground at less than 100 ohms.	All conductors are shorted to ground

916	Conductor 1 shorts to ground at less than 100 ohms	
964	Conductor 1 shorts to conductor 5 at less than 1000 ohms	
989	Conductor 1 shorts to conductors 4 & 6 at less than 100 ohms

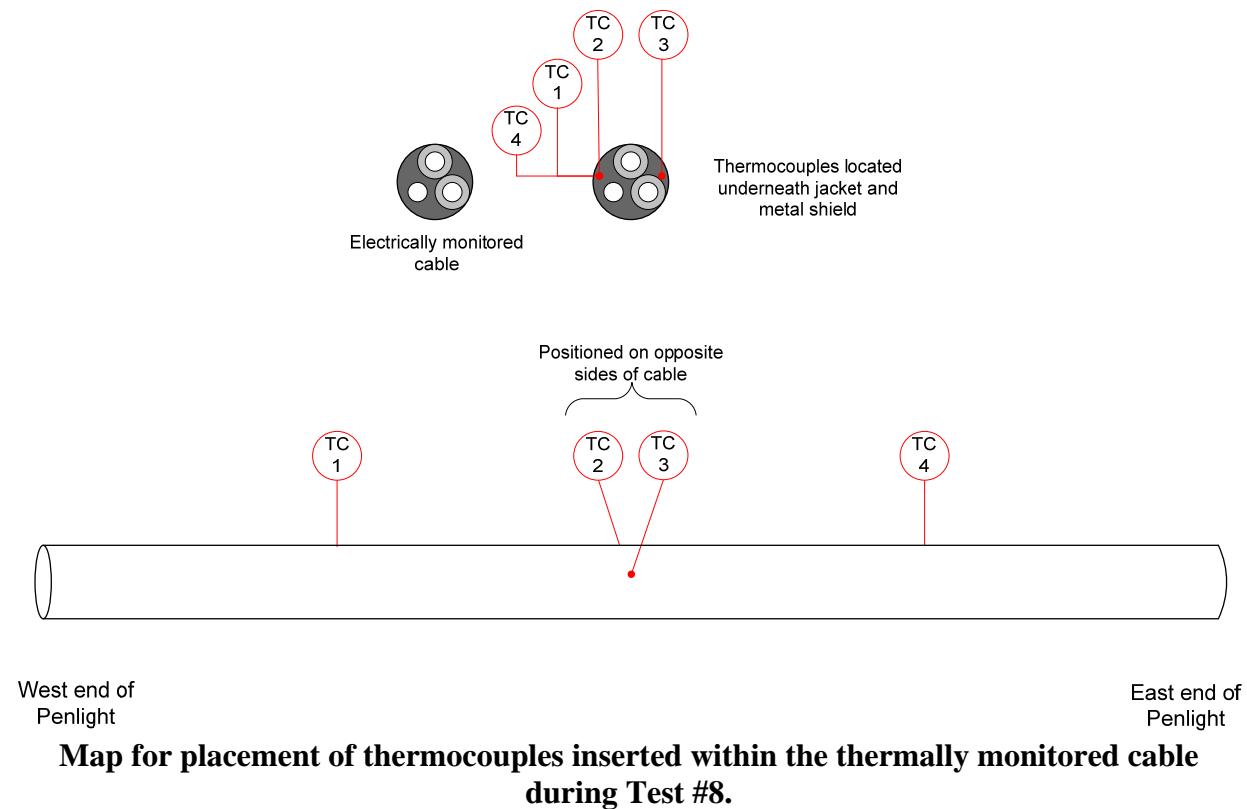
Thermo-couple Name	Location
TC1	Within cable just below cable jacket and shield, to the West of the center position
TC2	Within cable just below cable jacket and shield, at center position
TC3	Within cable just below cable jacket and shield, opposite side from Cable 2, center position
TC4	Within cable just below cable jacket and shield, to the East of the center position

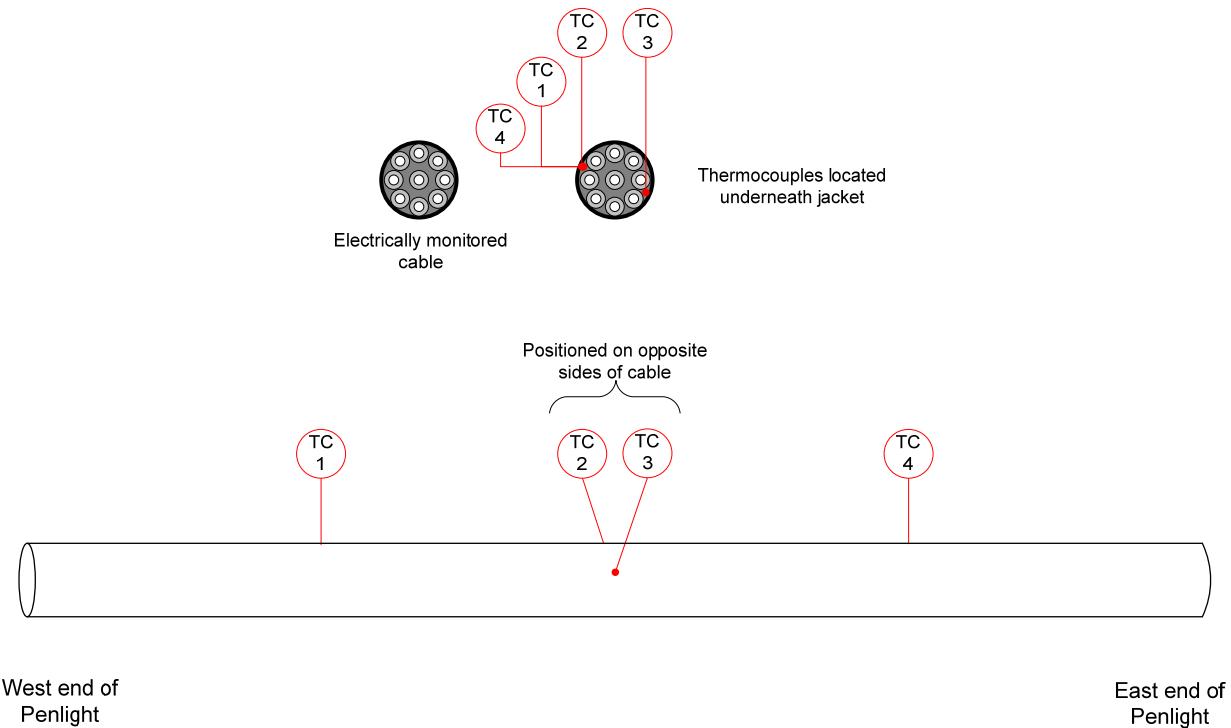
Map for placement of thermocouples inserted within the thermally monitored cable during Test #9.

Thermo-couple Name	Location
TC1	Within cable just below cable jacket, to the East of the center position
TC2	Within cable just below cable jacket, at center position
TC3	Within cable just below cable jacket, opposite side from Cable 2, center position
TC4	Within cable just below cable jacket, to the West of the center position

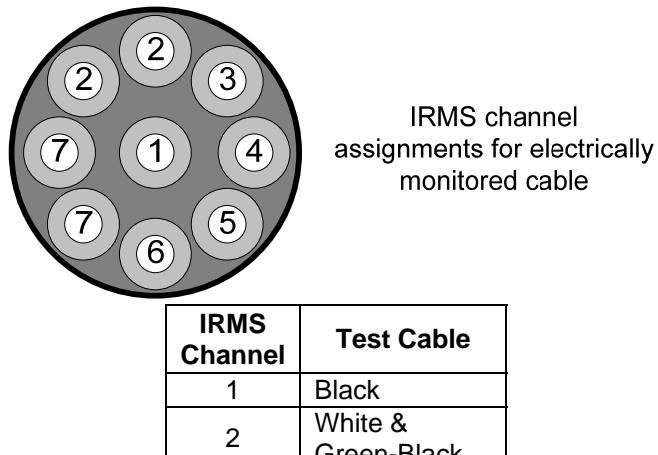
All seven of the IRMS channels were connected to the electrically monitored test cable.

3	Red
4	Green
5	Orange
6	Blue
7	White-Black & Red-Black

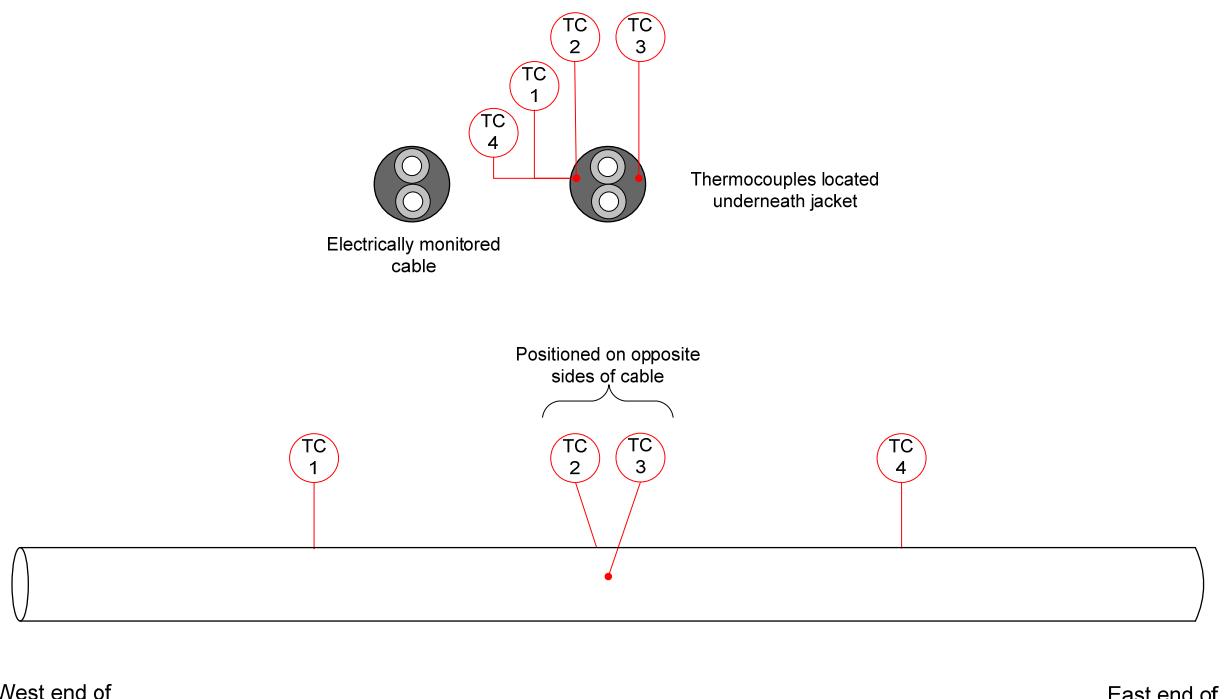
Map for placement of thermocouples inserted within the thermally monitored cable during Test #11.

Name	
TC1	Within cable just below cable jacket, to the West of the center position
TC2	Within cable just below cable jacket, at center position
TC3	Within cable just below cable jacket, opposite side from Cable 2, center position
TC4	Within cable just below cable jacket, to the East of the center position

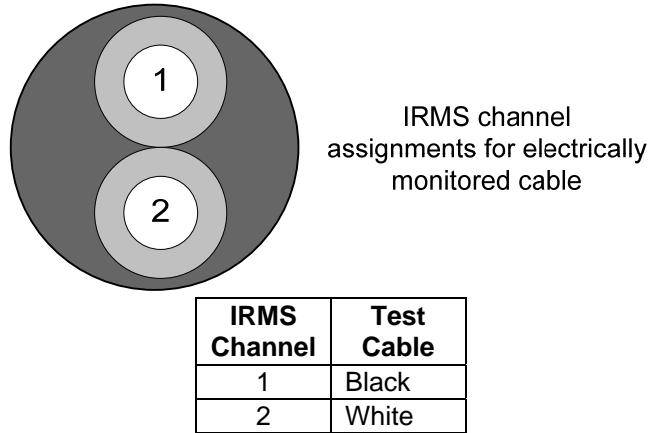
Two IRMS channels were connected to the electrically monitored test cable.

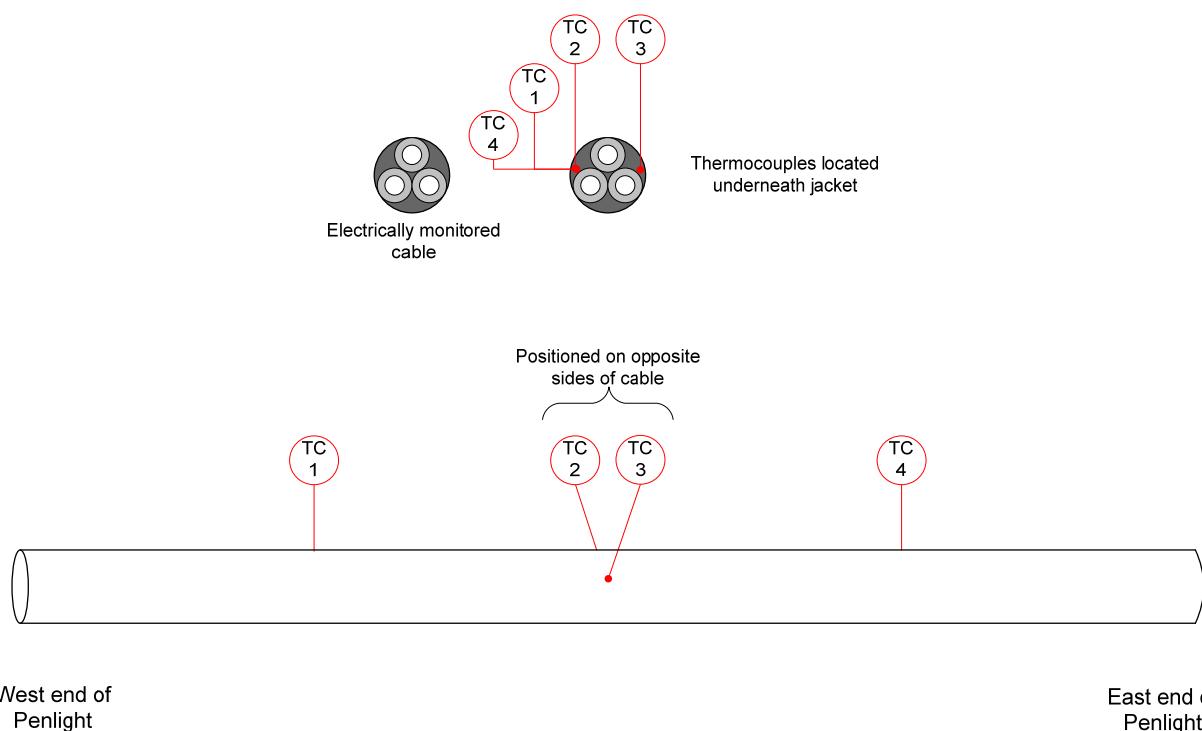
Map for placement of thermocouples inserted within the thermally monitored cable during Test #12.

Thermo-couple Name	Location
TC1	Within cable just below cable jacket, to the West of the center position
TC2	Within cable just below cable jacket, at center position
TC3	Within cable just below cable jacket, opposite side from Cable 2, center position

TC4	Within cable just below cable jacket, to the East of the center position
-----	--

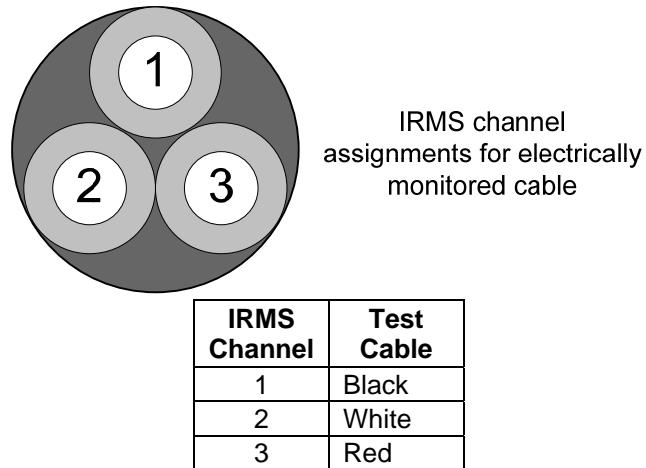
Three of the IRMS channels were connected to the electrically monitored test cable.

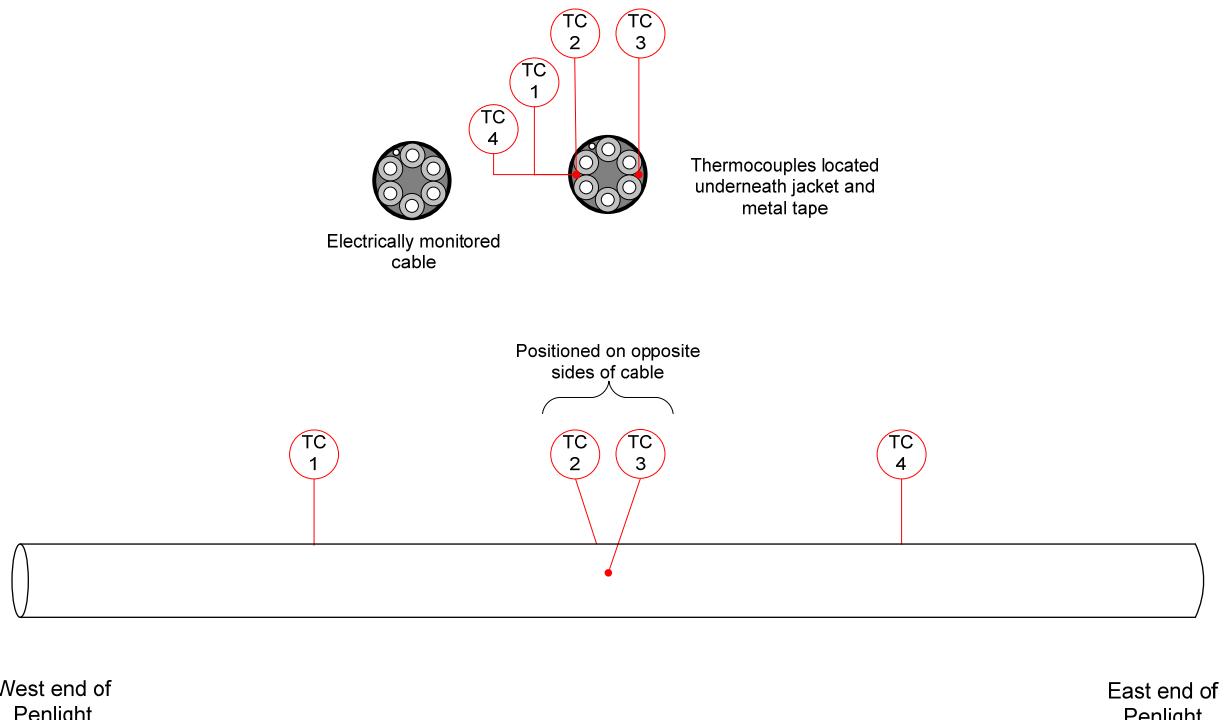
Map for placement of thermocouples inserted within the thermally monitored cable during Test #13.

TC1	Within cable just below cable jacket and metal tape, to the West of the center position
TC2	Within cable just below cable jacket and metal tape, at center position
TC3	Within cable just below cable jacket and metal tape, opposite side from Cable 2, center position
TC4	Within cable just below cable jacket and metal tape, to the East of the center position
