**Testing Korean Cables:
Electrical Degradation and Failure Associated with Radiant Heating**

Revision: November 11, 2010

Prepared by:
Francis J. Wyant, Jason W. Brown, and Steven P. Nowlen
Risk and Reliability Analysis Department 6231
Sandia National Laboratories
Albuquerque, New Mexico

Prepared for:
KEPRI
Agreement No. FI 067100625
Korean Cable Fire Tests

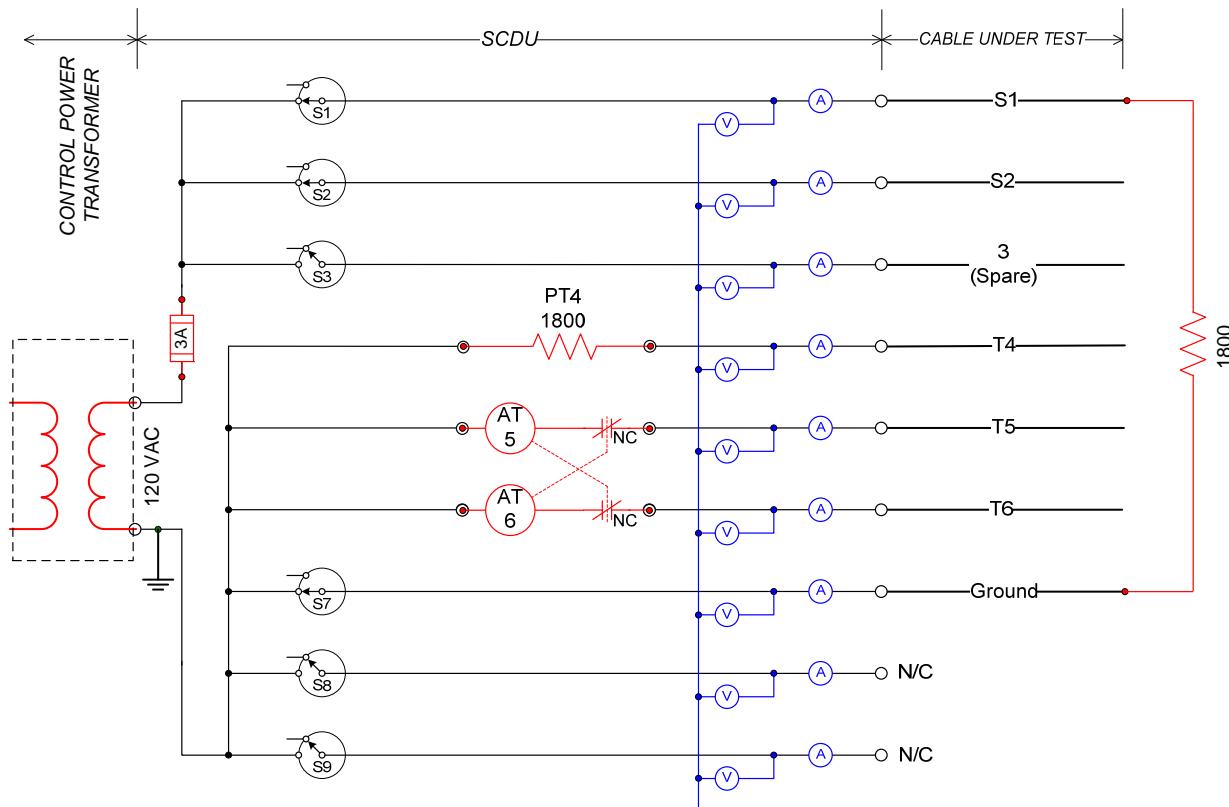
All of the seven available SCDU circuit paths were connected to the electrically monitored test cable.

Cable conductor connections to SCDU during Test #13

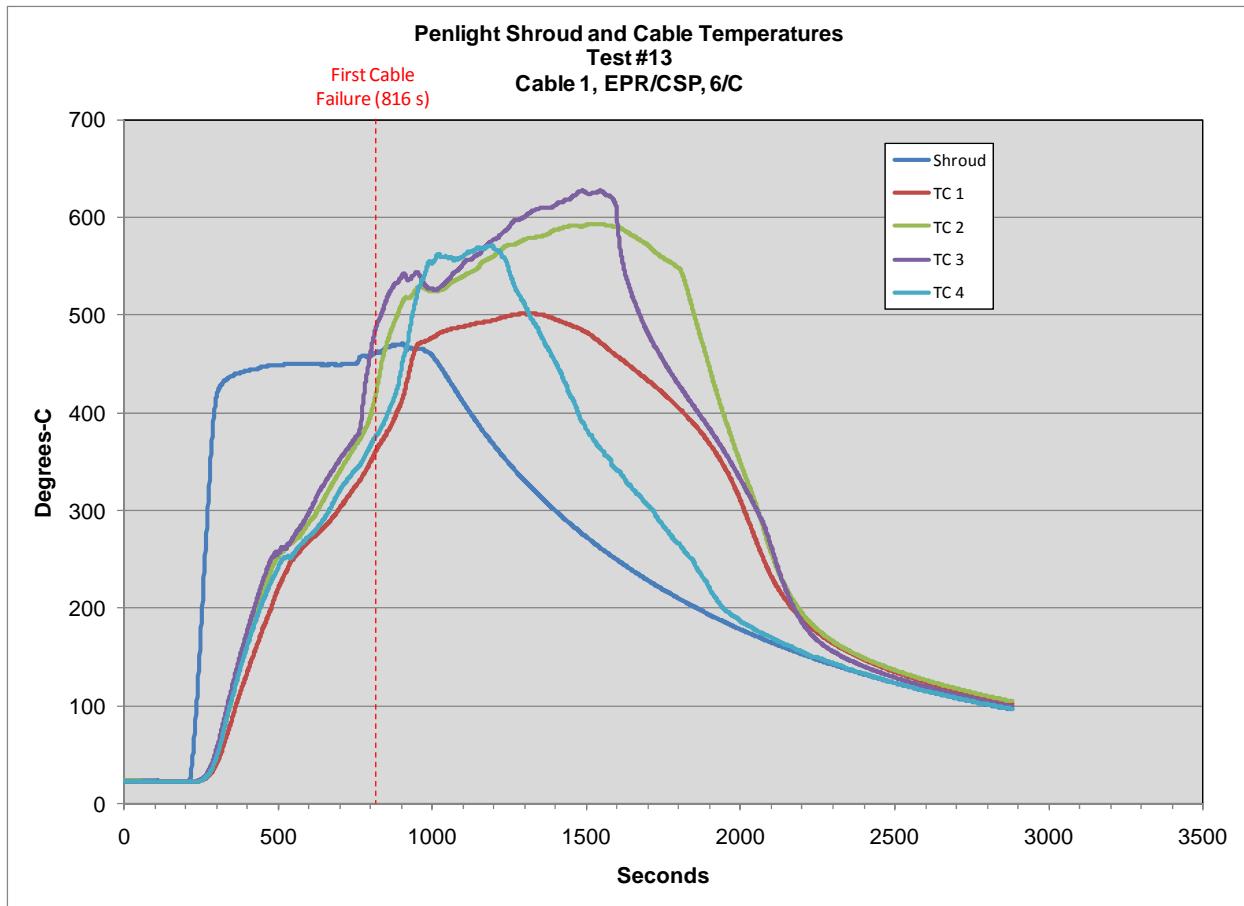
Summary of Observed Faulting Behavior during Korean Cable Test #13		
Time (s)	Event	Comments
213	Penlight On; set at 450C (12.6 kW/m ²)	
816-840	Spurious actuation of T6 due to hot short from S2	Initial failure manifest as a spurious actuation due to hot short (24 s duration); 451C average cable temperature
817	Hot short on T5 from S2	No spurious actuation because T5 is locked out by T6
839-840	Hot short on T4 from S2	
840-846	Spurious actuation of T5 due to hot short from S2	
842-845	Hot short on T6 from S2	No spurious actuation because T6 is locked out by T5
843-845	Hot shorts on T4 from S2	
927-931	T5 coil chattering	Insufficient voltage for coil pickup
939-943	T5 coil chattering	
964-967	T5 & T6 coils chattering	
967	Fuse clears

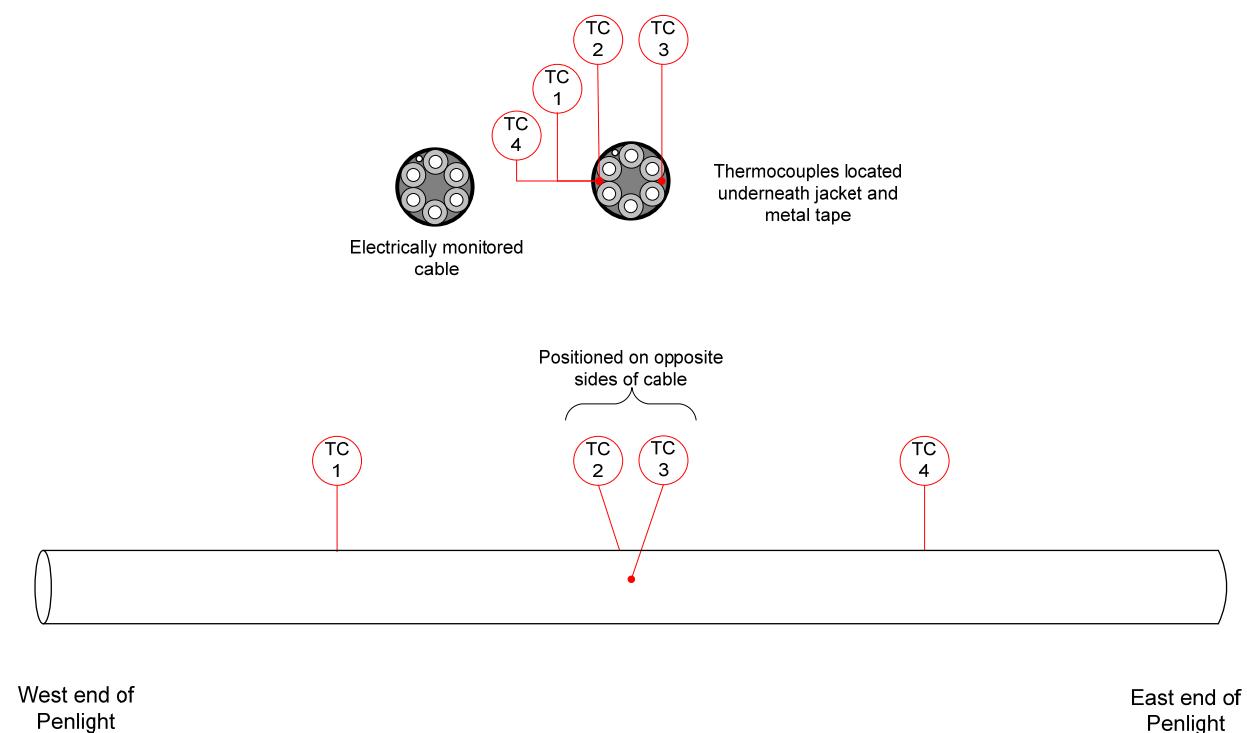
Map for placement of thermocouples inserted within the thermally monitored cable during Test #14.

Thermo-couple Name	Location
TC1	Within cable just below cable jacket and metal tape, to the West of the center position
TC2	Within cable just below cable jacket and metal tape, at center position
TC3	Within cable just below cable jacket and metal tape, opposite side from Cable 2, center position

TC4	Within cable just below cable jacket and metal tape, to the East of the center position
-----	---

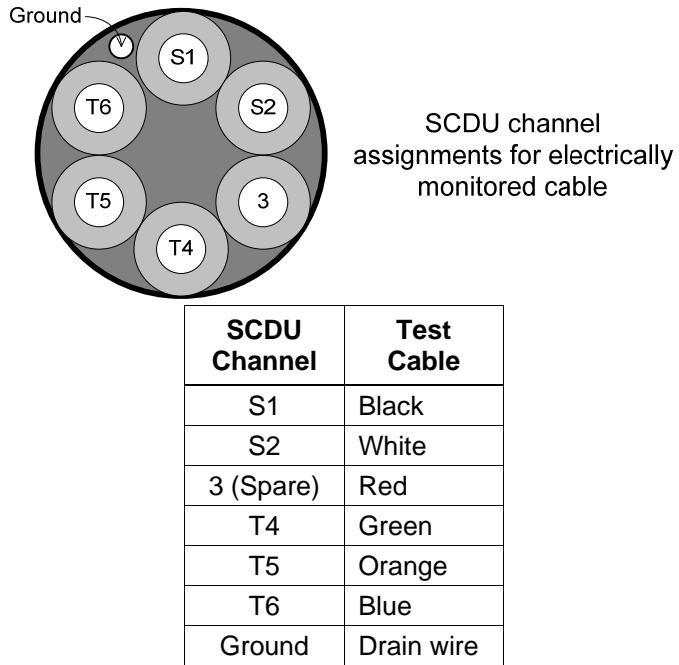
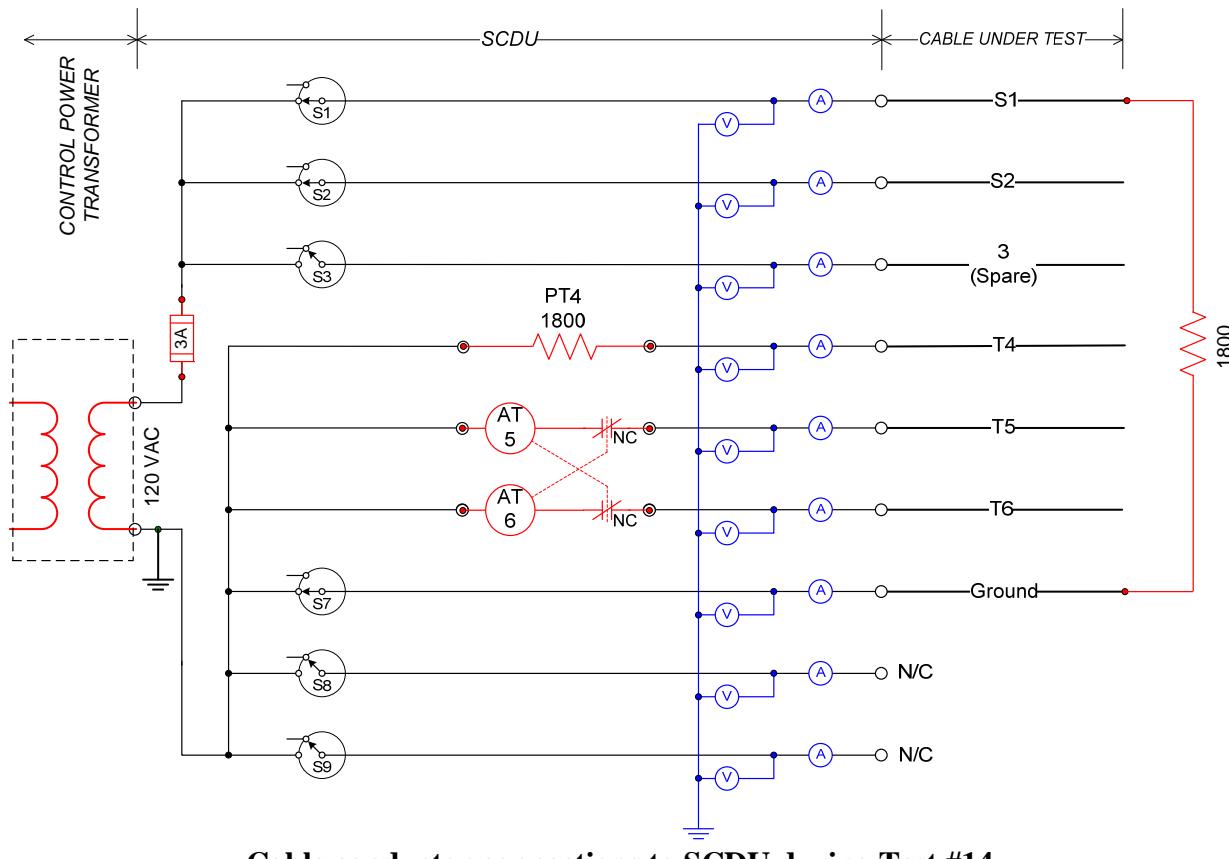
All of the seven available SCDU circuit paths were connected to the electrically monitored test cable.

Cable conductor connections to SCDU during Test #14

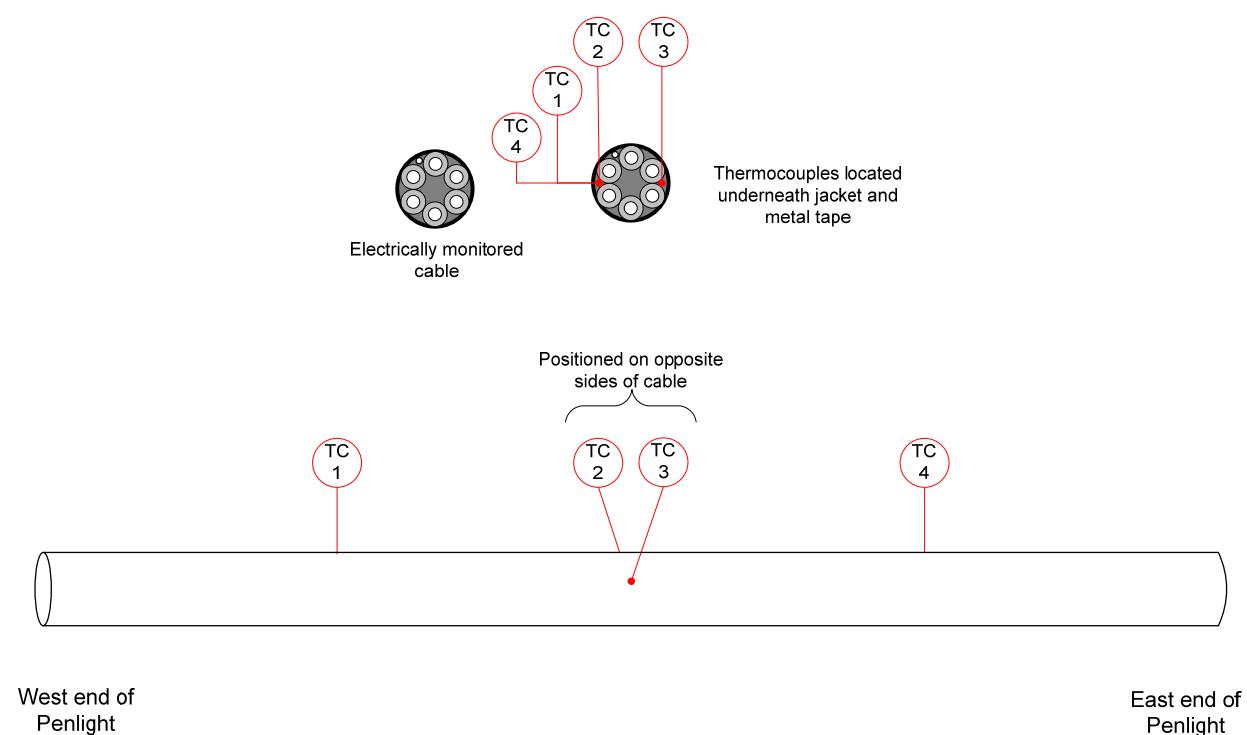
Map for placement of thermocouples inserted within the thermally monitored cable during Test #15.

Thermo-couple Name	Location
TC1	Within cable just below cable jacket and metal tape, to the West of the center position
TC2	Within cable just below cable jacket and metal tape, at center position
TC3	Within cable just below cable jacket and metal tape, opposite side from Cable 2, center position

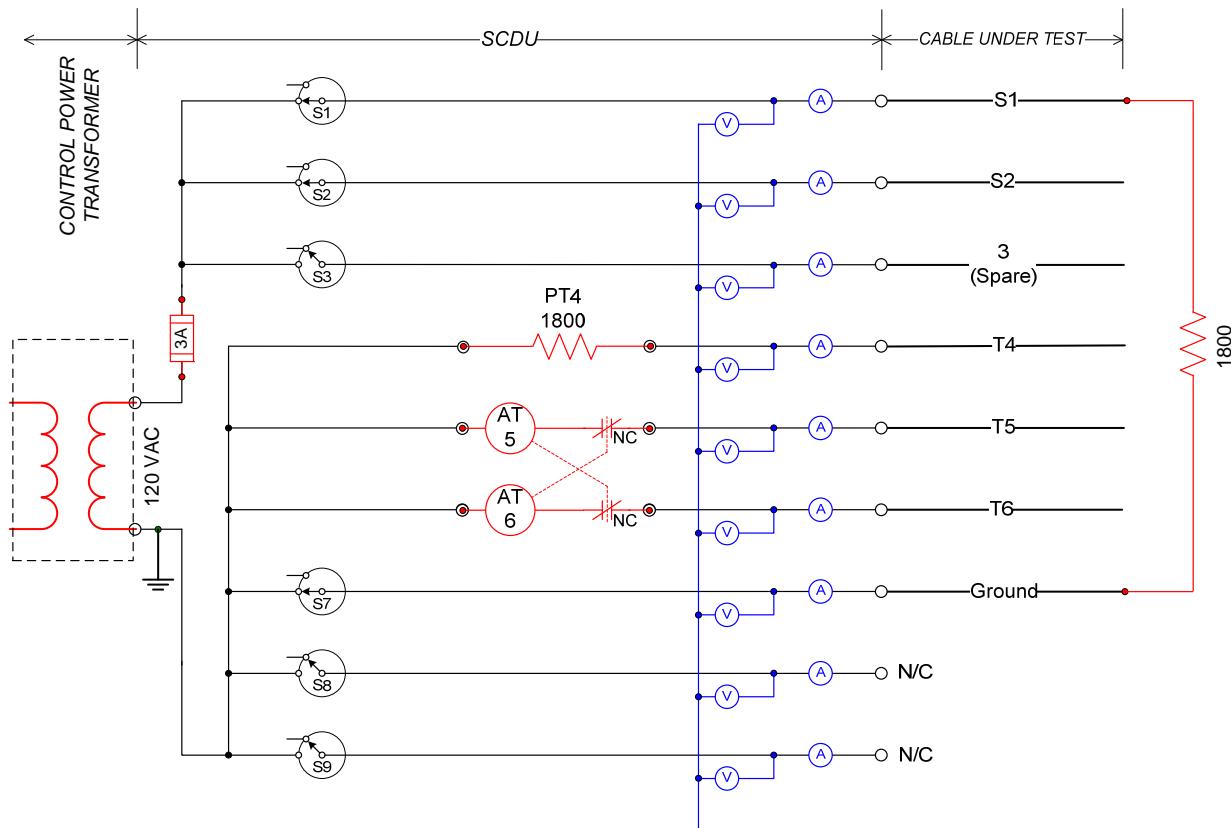
All of the seven available SCDU circuit paths were connected to the electrically monitored test cable.

Cable conductor connections to SCDU during Test #15

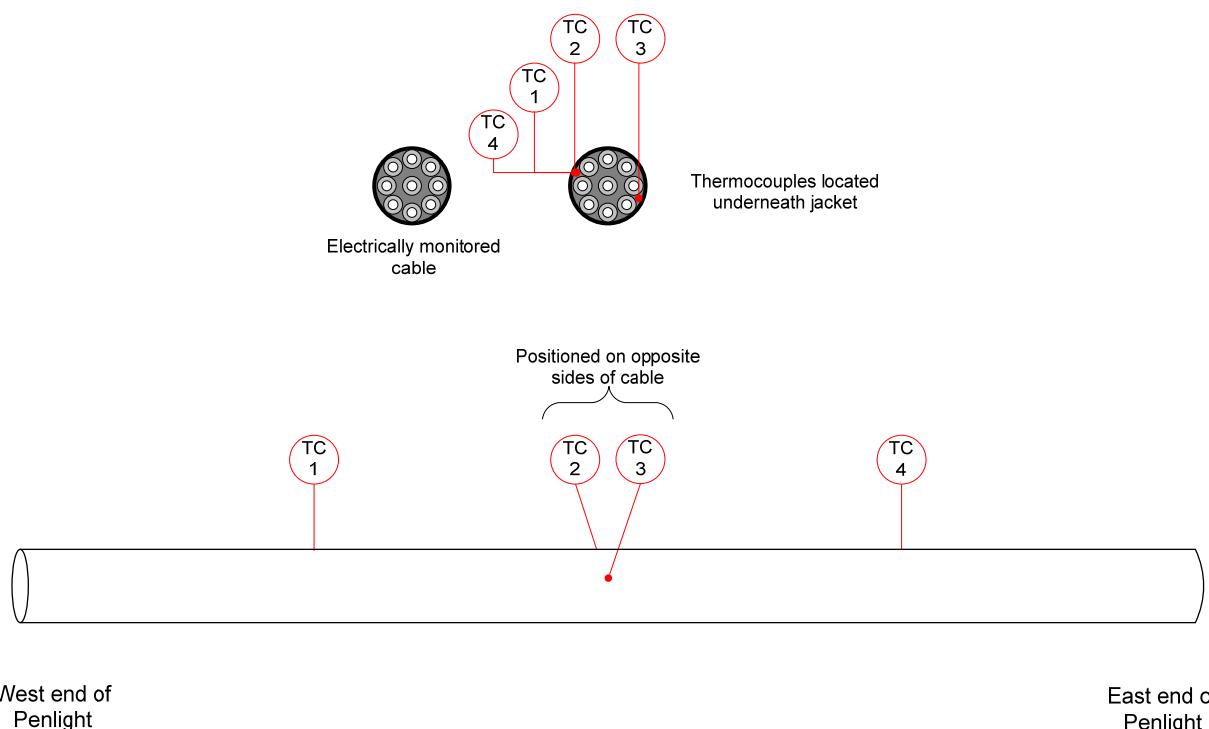
Map for placement of thermocouples inserted within the thermally monitored cable during Test #16.

Thermo-couple Name	Location
TC1	Within cable just below cable jacket, to the East of the center position
TC2	Within cable just below cable jacket, at center position
TC3	Within cable just below cable jacket, opposite side from Cable 2, center position
TC4	Within cable just below cable jacket, to the West of the center position

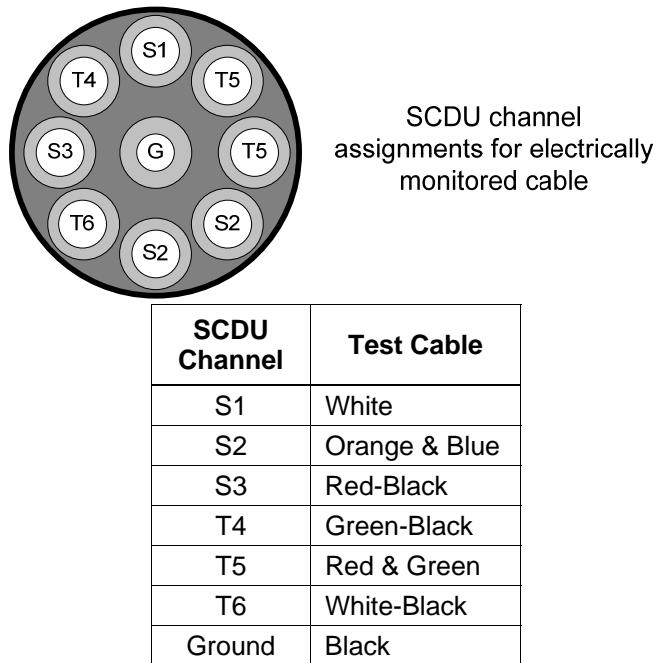
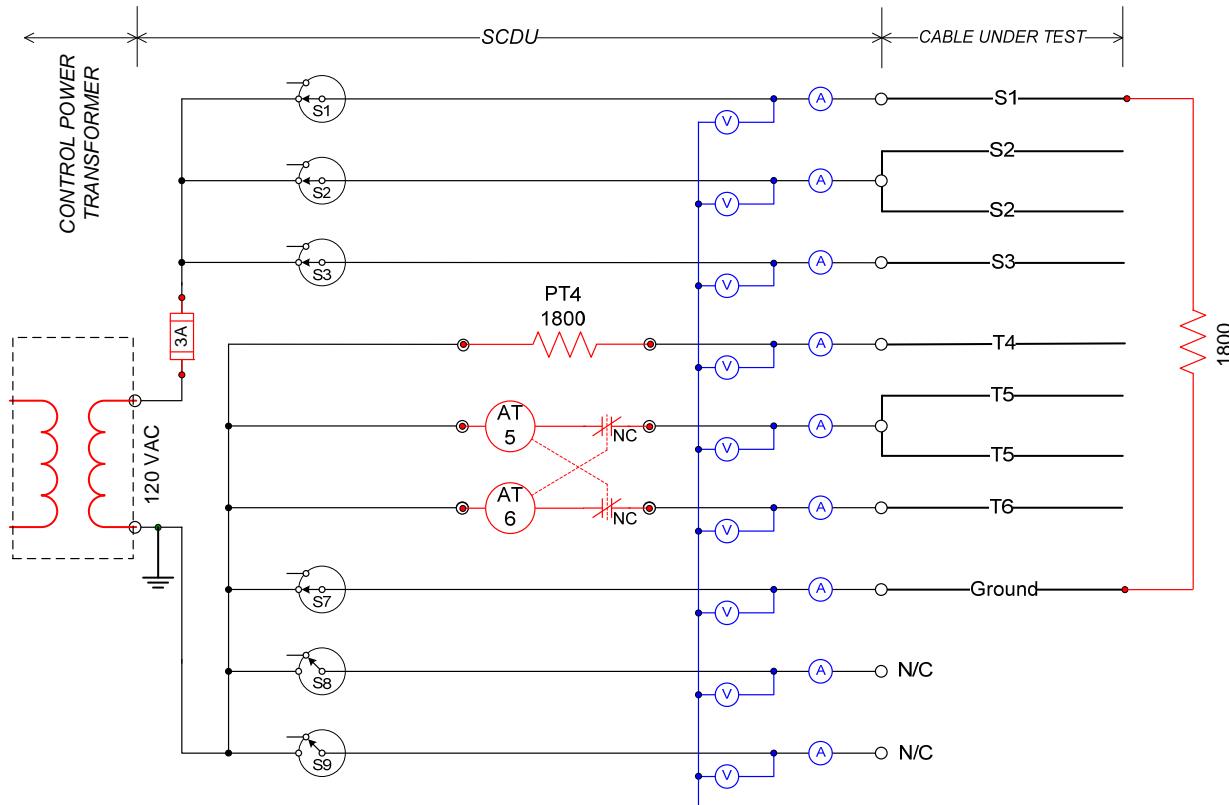
All of the seven available SCDU circuit paths were connected to the electrically monitored test cable.

Cable conductor connections to SCDU during Test #16

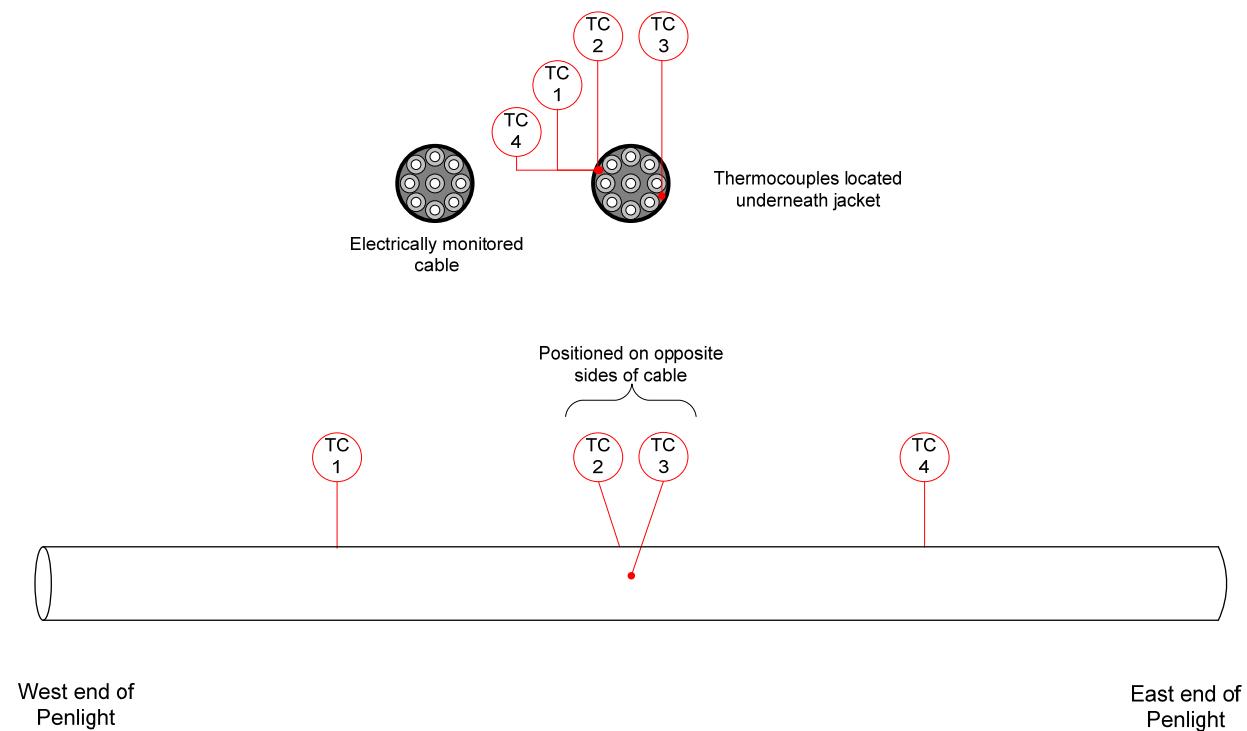
Map for placement of thermocouples inserted within the thermally monitored cable during Test #18.

Thermo-couple Name	Location
TC1	Within cable just below cable jacket, to the East of the center position

TC2	Within cable just below cable jacket, at center position
TC3	Within cable just below cable jacket, opposite side from Cable 2, center position
TC4	Within cable just below cable jacket, to the West of the center position

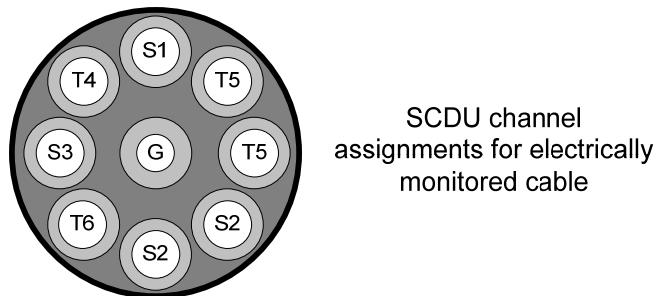
All of the seven available SCDU circuit paths were connected to the electrically monitored test cable.

SCDU Channel	Test Cable
S1	White
S2	Orange & Blue
S3	Red-Black
T4	Green-Black
T5	Red & Green
T6	White-Black
Ground	Black

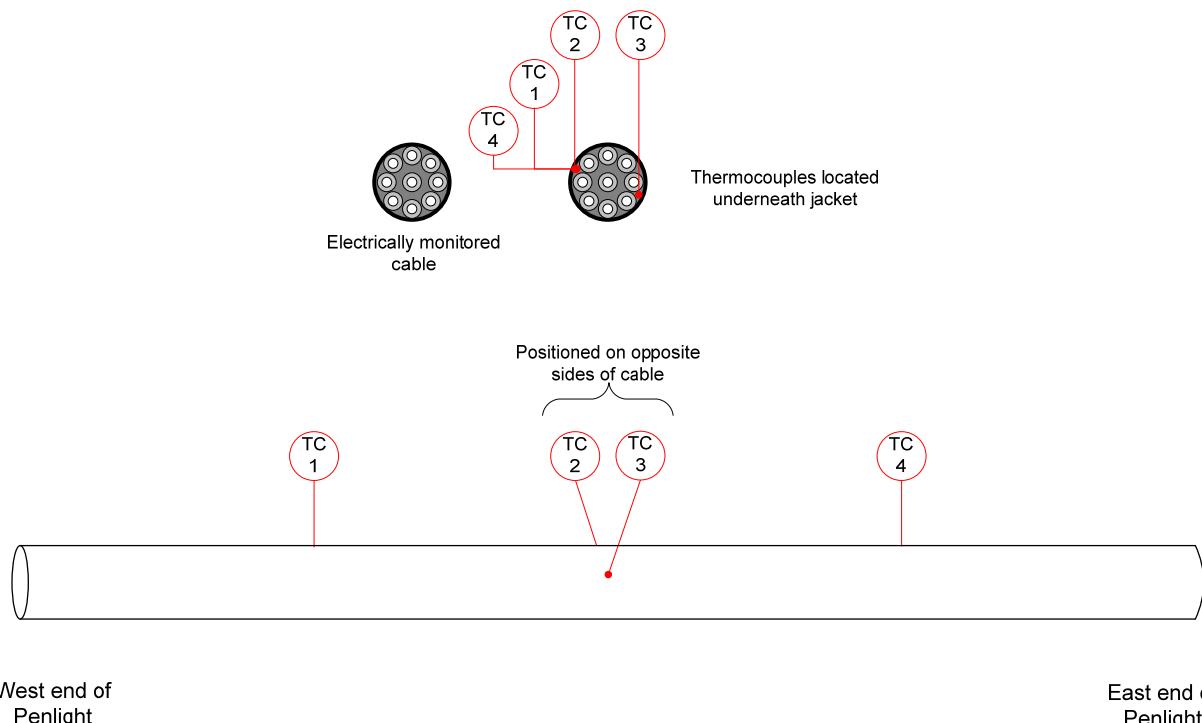
Map for placement of thermocouples inserted within the thermally monitored cable during Test #19.

TC1	Within cable just below cable jacket, to the East of the center position
TC2	Within cable just below cable jacket, at center position
TC3	Within cable just below cable jacket, opposite side from Cable 2, center position
TC4	Within cable just below cable jacket, to the West of the center position

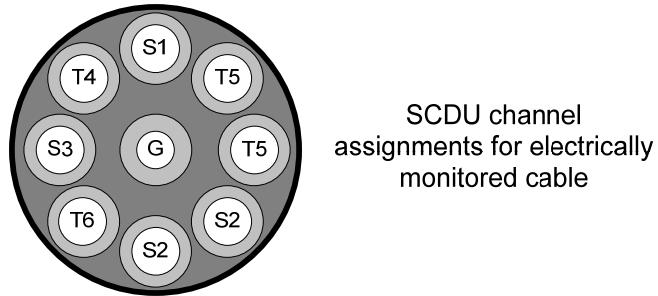
SCDU Channel	Test Cable
S1	White
S2	Orange & Blue
S3	Red-Black
T4	Green-Black
T5	Red & Green
T6	White-Black
Ground	Black

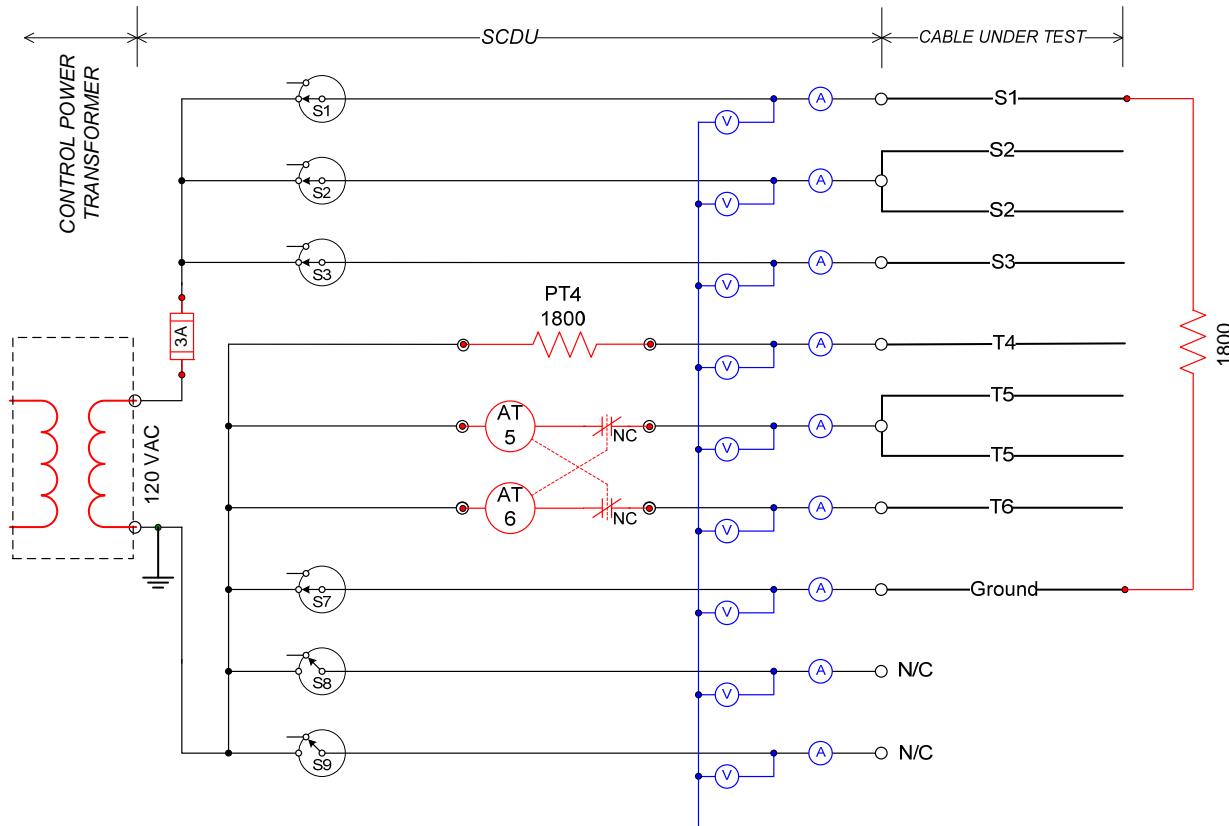
All of the seven available SCDU circuit paths were connected to the electrically monitored test cable.

Cable conductor connections to SCDU during Test #19

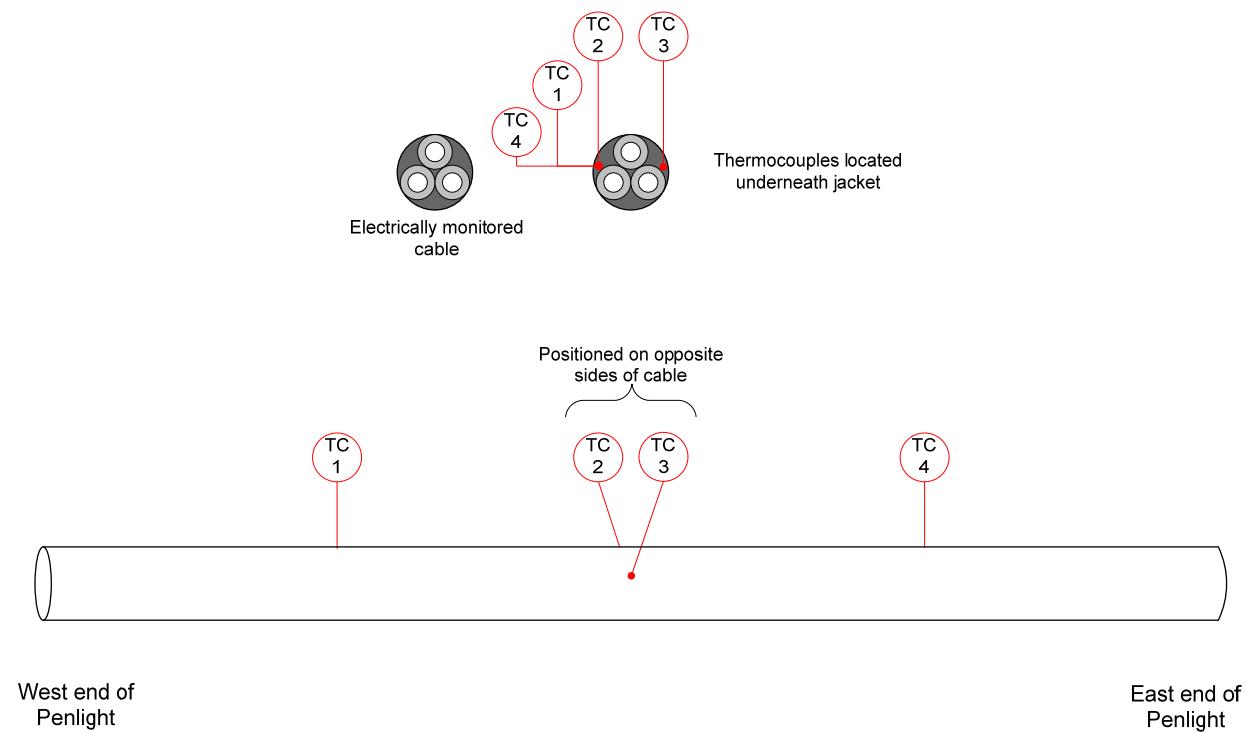
Map for placement of thermocouples inserted within the thermally monitored cable during Test #20.

Thermo-couple Name	Location
TC1	Within cable just below cable jacket, to the West of the center position
TC2	Within cable just below cable jacket, at center position
TC3	Within cable just below cable jacket, opposite side from Cable 2, center position
TC4	Within cable just below cable jacket, to the East of the center position

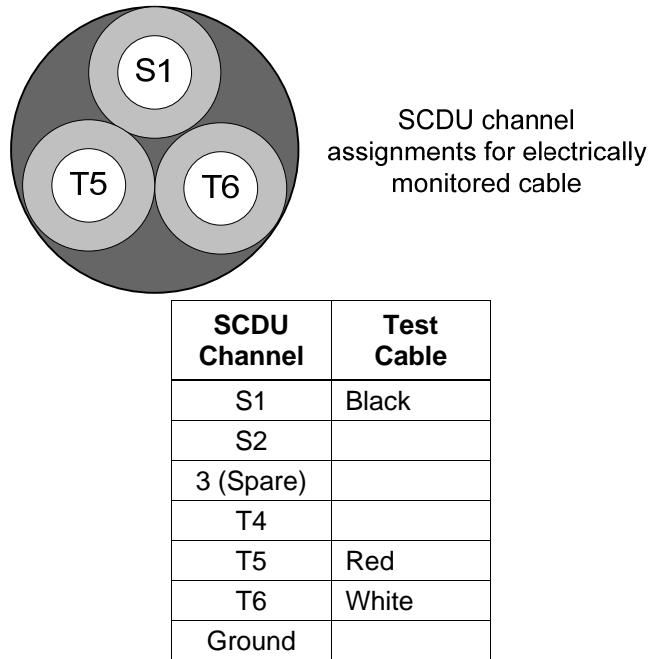
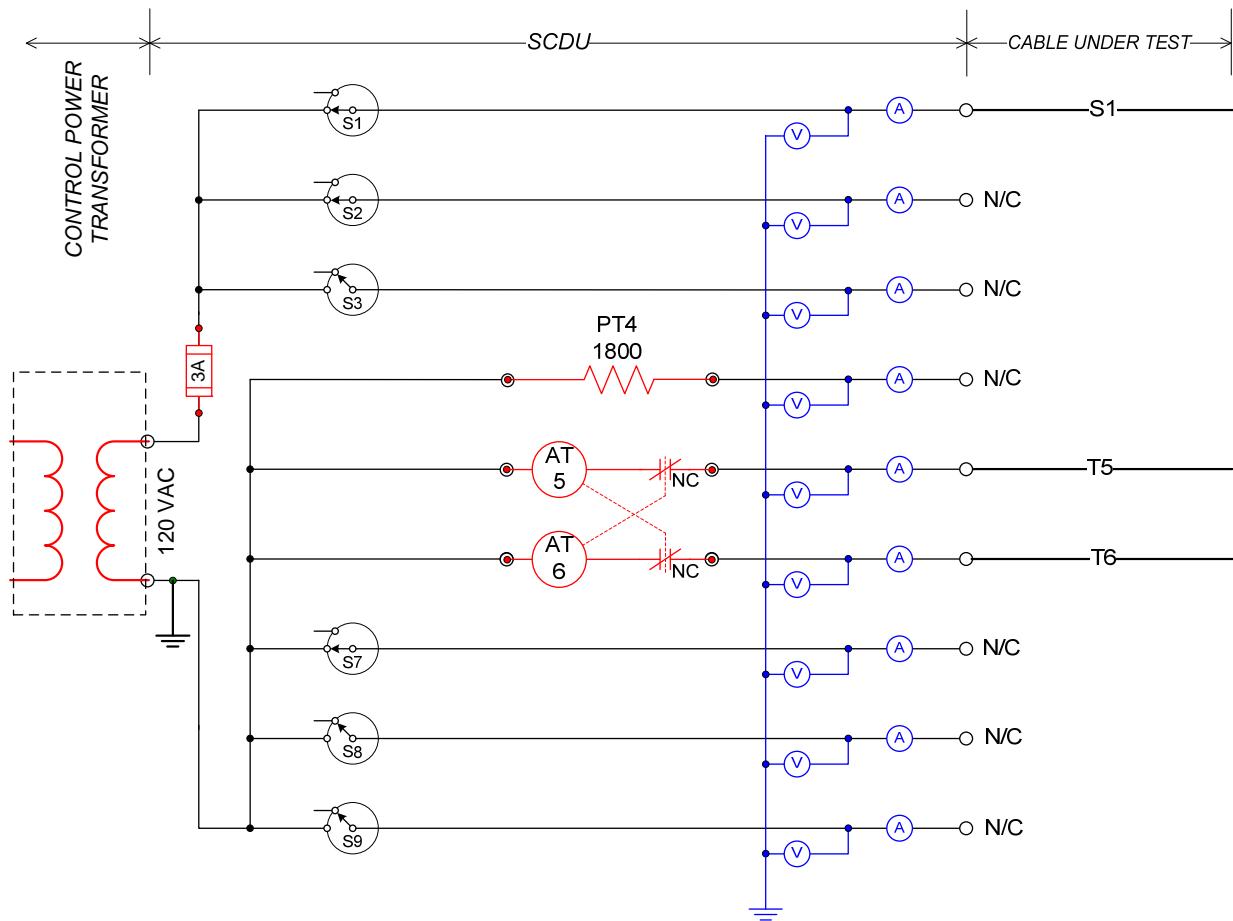
Three of the seven available SCDU circuit paths were connected to the electrically monitored test cable.

Cable conductor connections to SCDU during Test #20

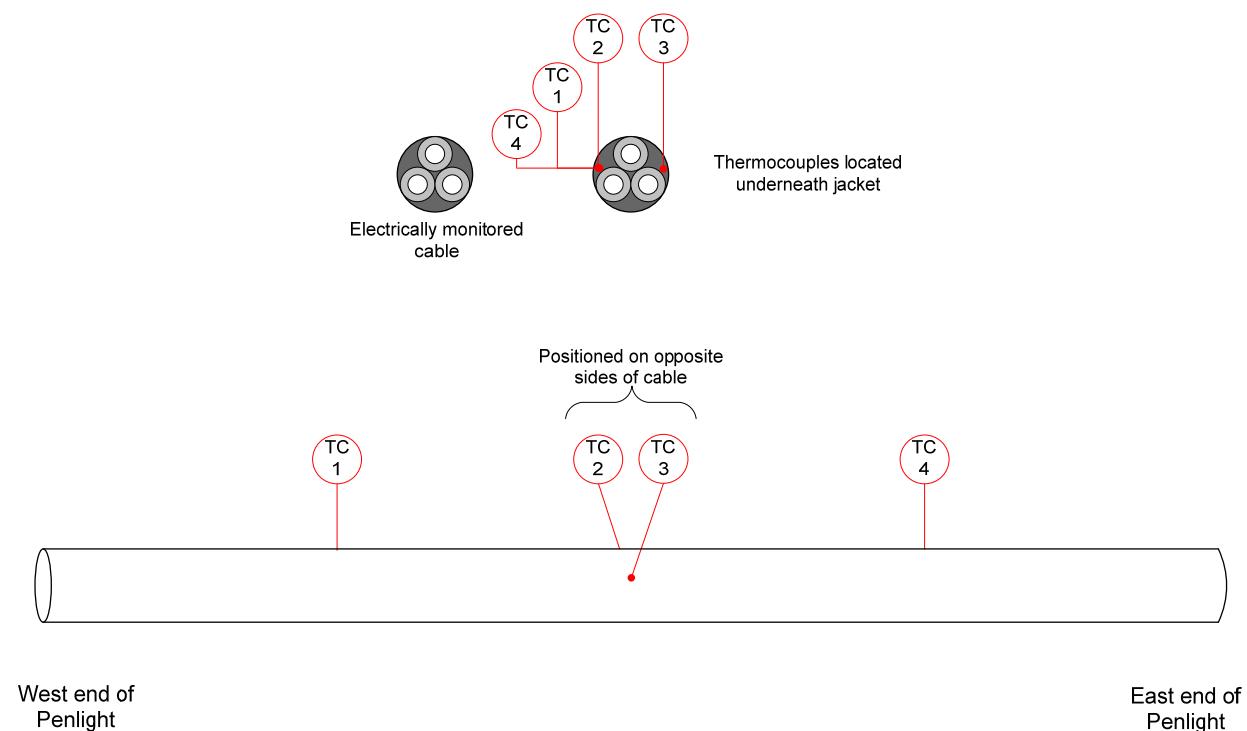
Map for placement of thermocouples inserted within the thermally monitored cable during Test #21.

Thermo-couple Name	Location
TC1	Within cable just below cable jacket, to the West of the center position
TC2	Within cable just below cable jacket, at center position
TC3	Within cable just below cable jacket, opposite side from Cable 2, center position
TC4	Within cable just below cable jacket, to the East of the center position

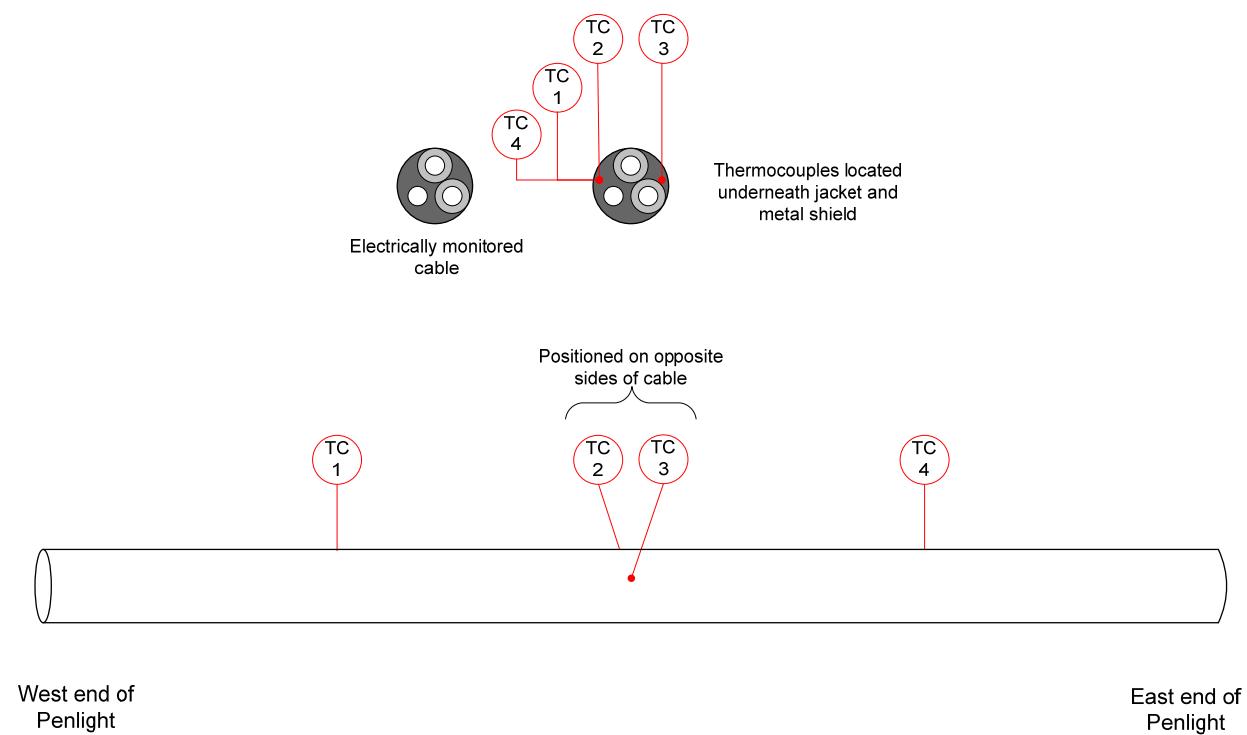
Map for placement of thermocouples inserted within the thermally monitored cable during Test #22.

Thermo-couple Name	Location
TC1	Within cable just below cable jacket and shield, to the West of the center position

TC2	Within cable just below cable jacket and shield, at center position
TC3	Within cable just below cable jacket and shield, opposite side from Cable 2, center position
TC4	Within cable just below cable jacket and shield, to the East of the center position

Thermal response monitoring: Shroud temperature and four cable temperatures (see thermocouple map).

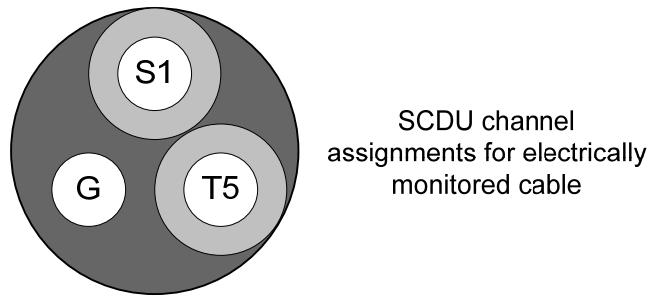
Three of the seven available SCDU circuit paths were connected to the electrically monitored test cable.

SCDU Channel	Test Cable
S1	Black
S2	
3 (Spare)	
T4	
T5	White
T6	
Ground	Drain wire

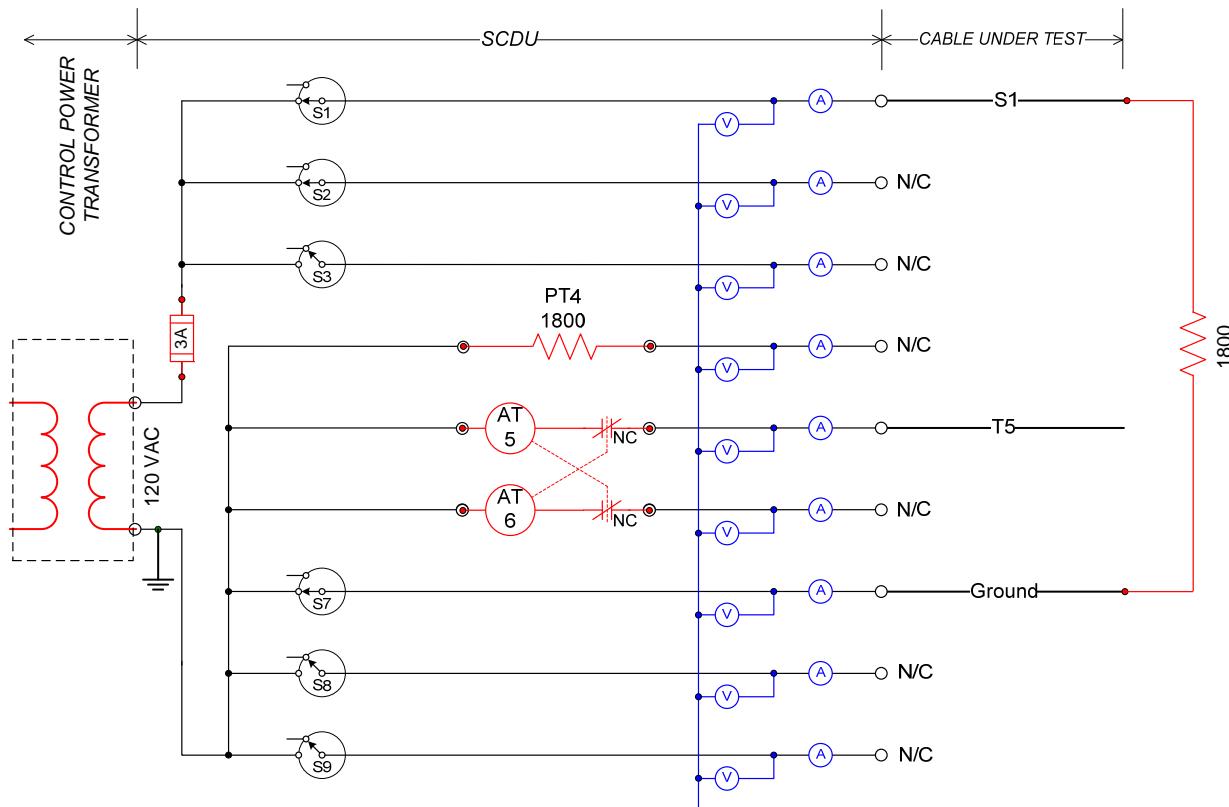
Cable conductor connections to SCDU during Test #22

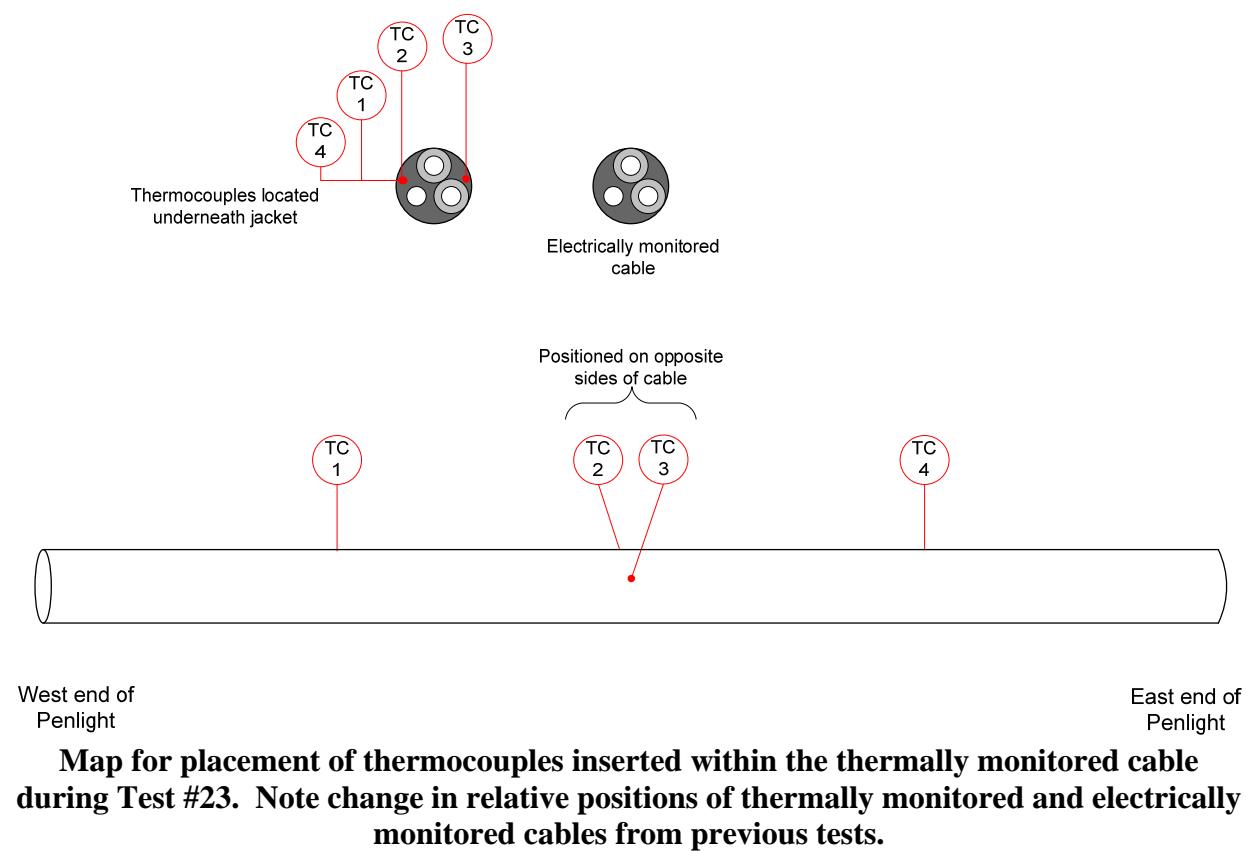
Thermo-couple Name	Location
--------------------	----------

TC1	Within cable just below cable jacket and shield, to the West of the center position
TC2	Within cable just below cable jacket and shield, at center position
TC3	Within cable just below cable jacket and shield, opposite side from Cable 2, center position
TC4	Within cable just below cable jacket and shield, to the East of the center position

Thermal response monitoring: Shroud temperature and four cable temperatures (see thermocouple map).

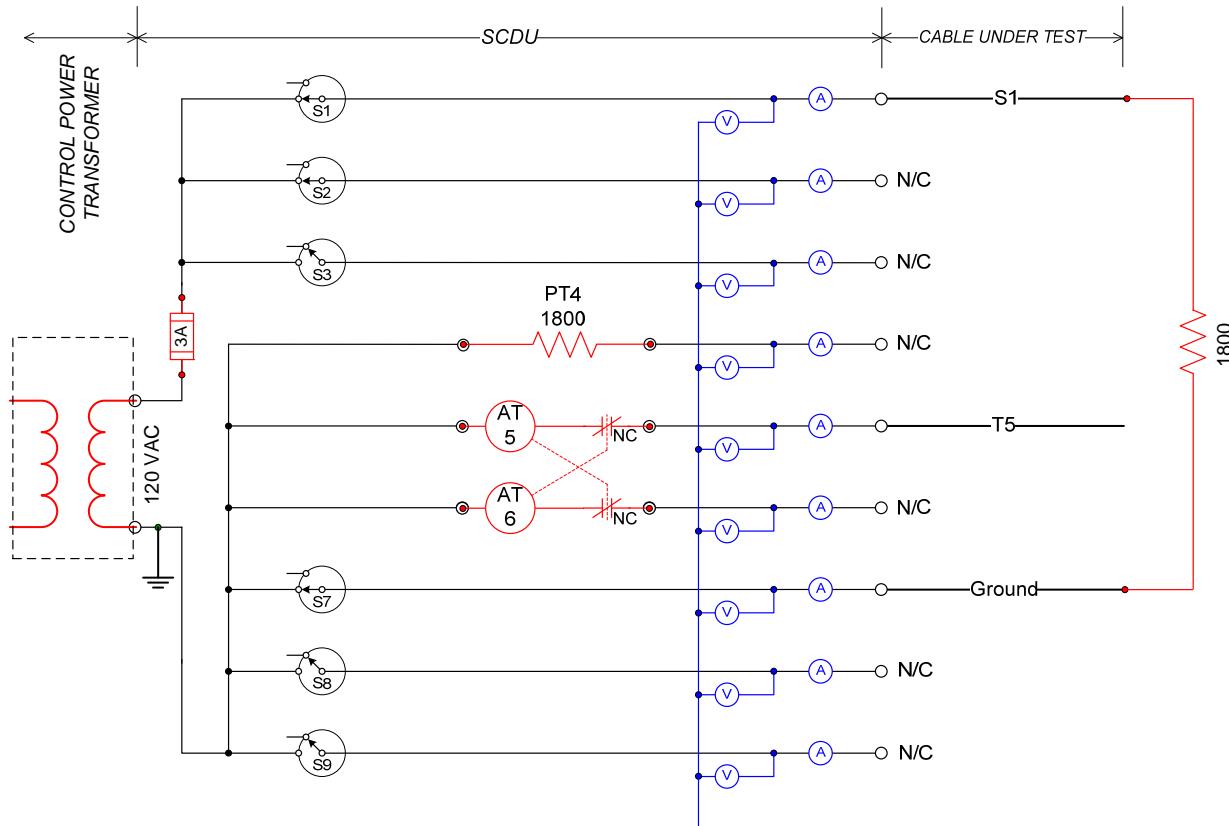
Cable conductor connections to SCDU during Test #23

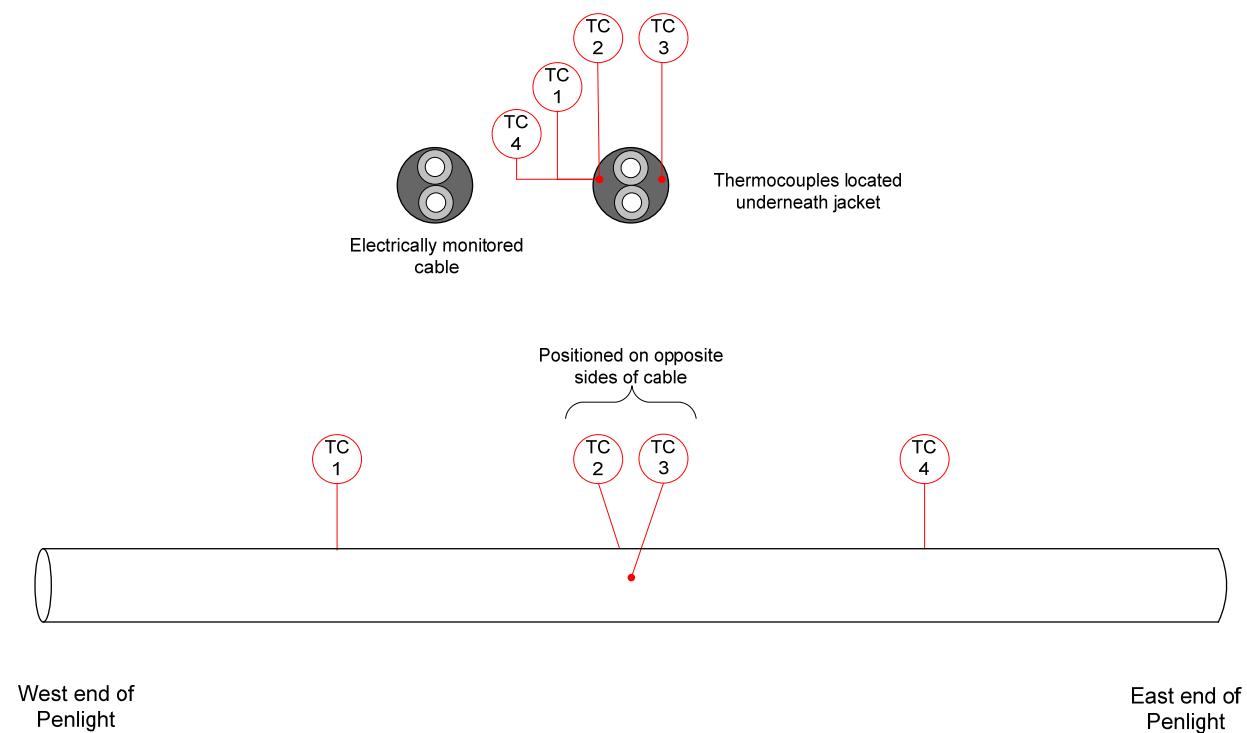
Map for placement of thermocouples inserted within the thermally monitored cable during Test #24.

Thermo-couple Name	Location
TC1	Within cable just below cable jacket, to the West of the center position
TC2	Within cable just below cable jacket, at center position

TC3	Within cable just below cable jacket, opposite side from Cable 2, center position
TC4	Within cable just below cable jacket, to the East of the center position

Thermal response monitoring: Shroud temperature and four cable temperatures (see thermocouple map).

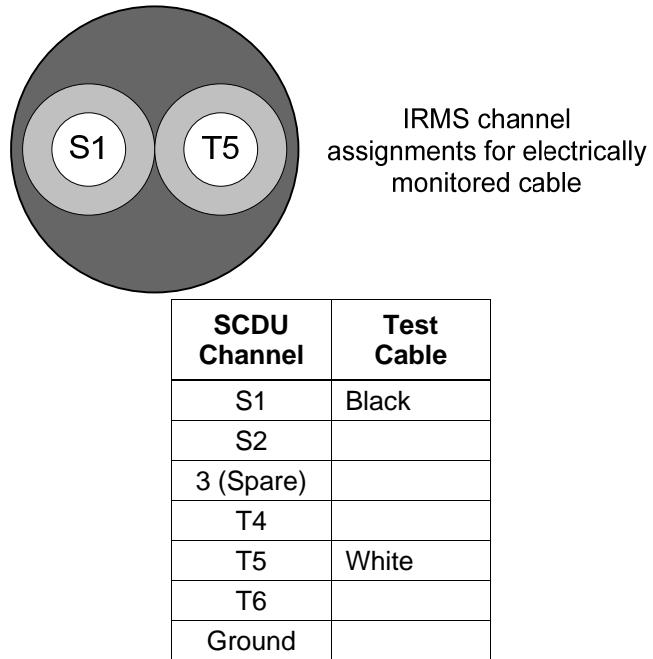
Two of the seven available SCDU circuit paths were connected to the electrically monitored test cable.
