**Testing Korean Cables:
Electrical Degradation and Failure Associated with Radiant Heating**

Revision: November 11, 2010

Prepared by:
Francis J. Wyant, Jason W. Brown, and Steven P. Nowlen
Risk and Reliability Analysis Department 6231
Sandia National Laboratories
Albuquerque, New Mexico

Prepared for:
KEPRI
Agreement No. FI 067100625
Korean Cable Fire Tests

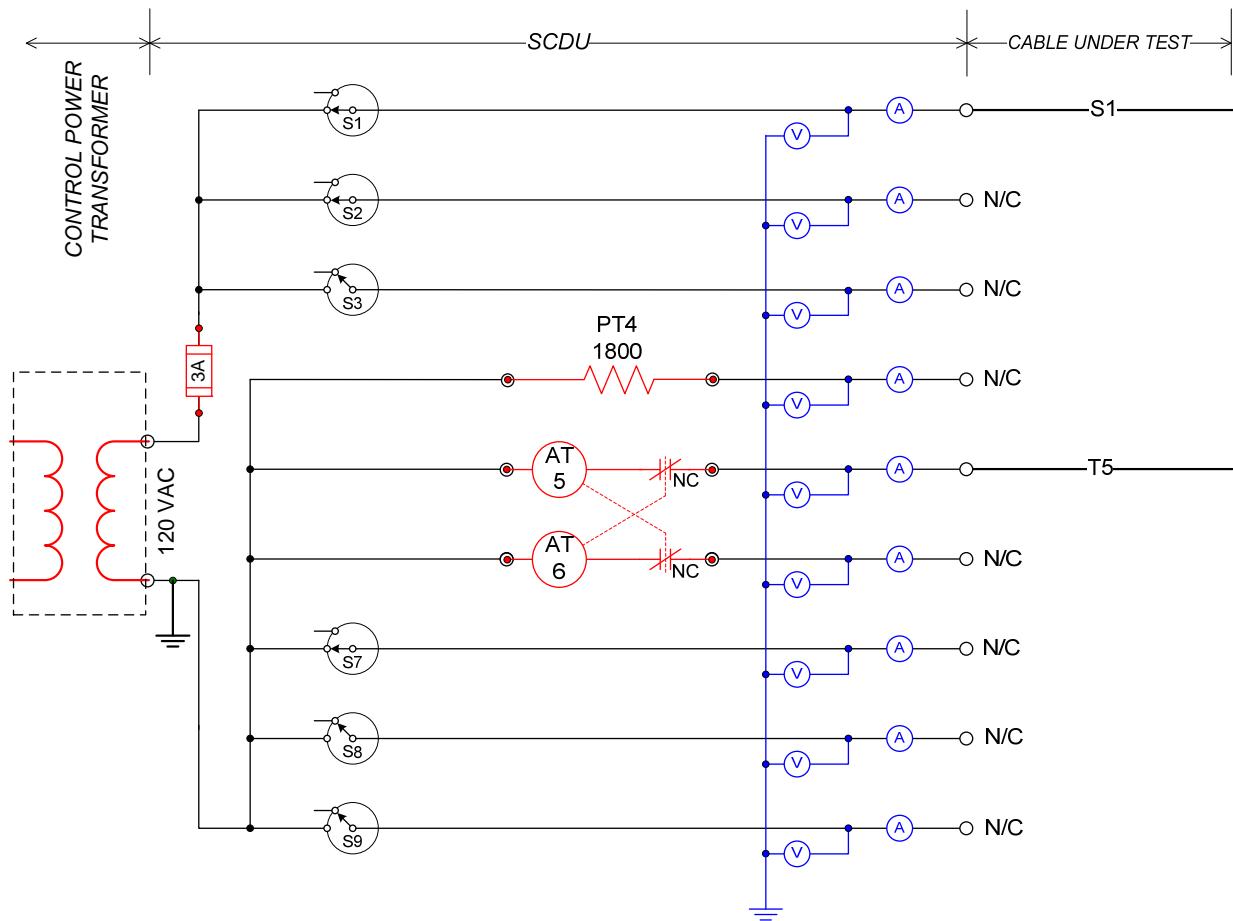
Cable conductor connections to SCDU during Test #24

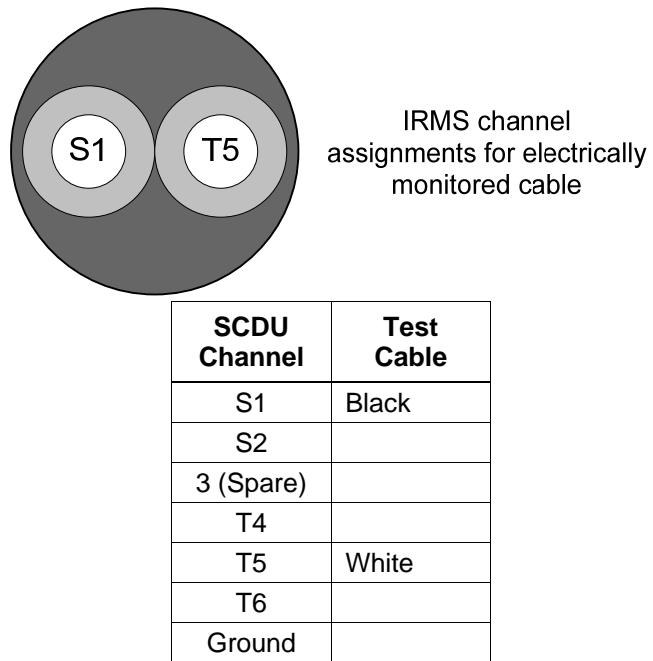
Two of the seven available SCDU circuit paths were connected to the electrically monitored test cable.
