# Interrogating atomic- and nanoscaled defects of structural metals using advanced microscopy techniques

SAND2020-0536PE

Presented by:  
Julian E.C. Sabisch

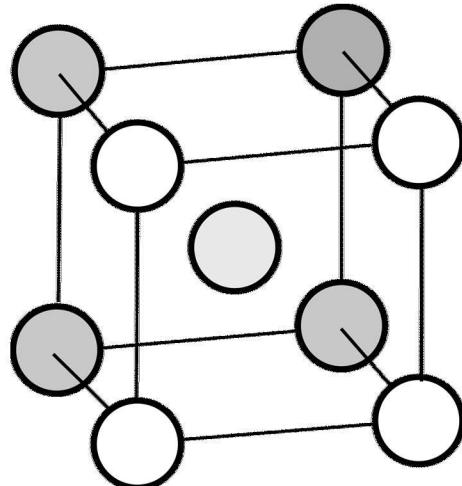
Body Centered Cubic:  
(BCC)

Pure Iron, W, Cr  
 $\alpha$ -Martensite

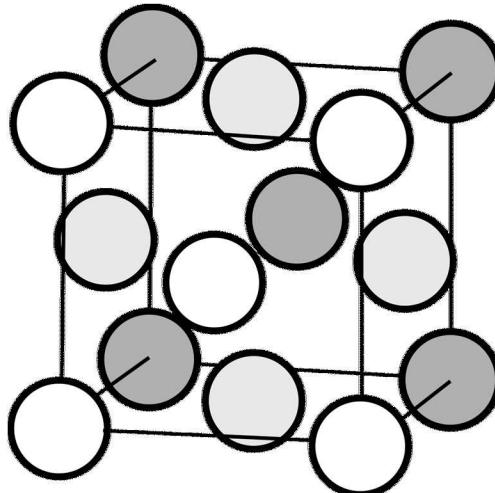
Face Centered Cubic:  
(FCC)

Cu, Au, Ag, Stainless  
Steels  
 $\gamma$ -Austenite

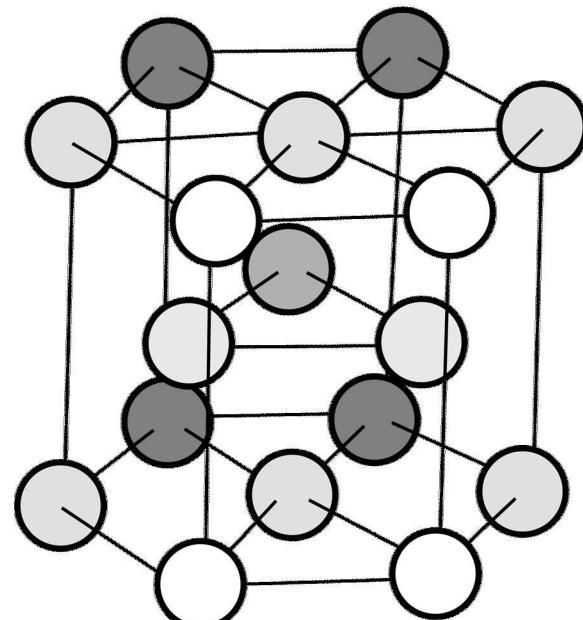
Hexagonal Close-Packed:  
(HCP)

Re, Mg, Ti  
 $\epsilon$ -Martensite

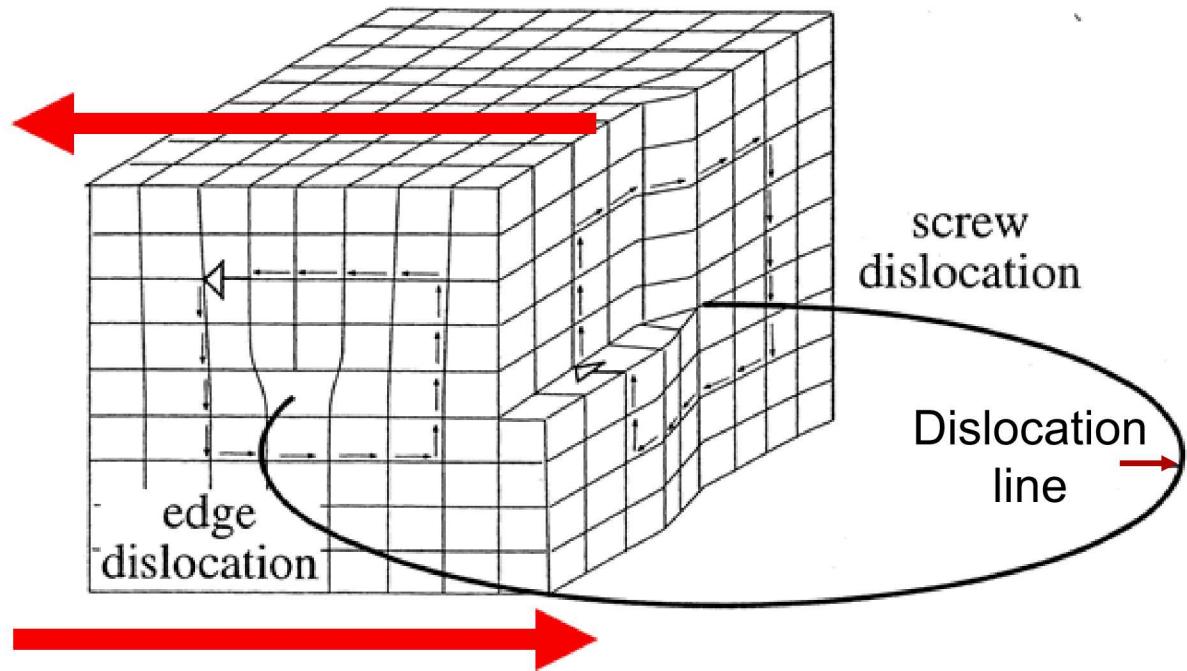
- Plastic deformation in metals is largely accommodated through dislocations.
- Deformation characteristics can change based on dislocation character.
- Dislocations can have edge, screw, or mixed type.

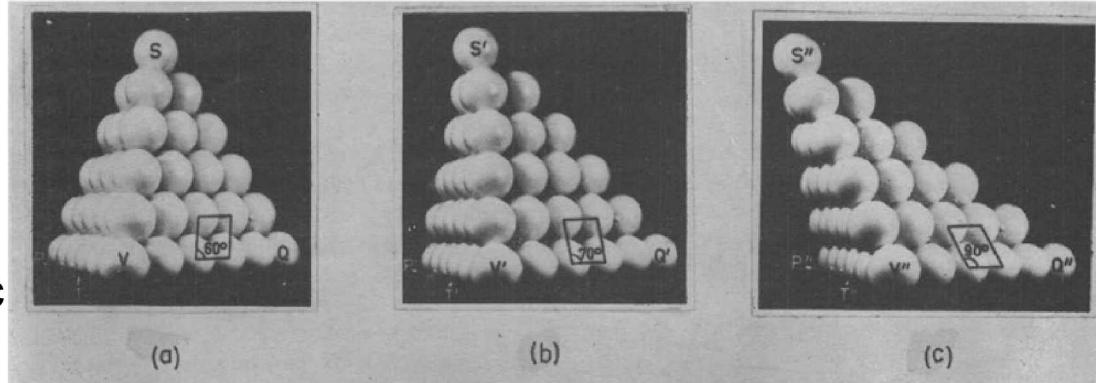
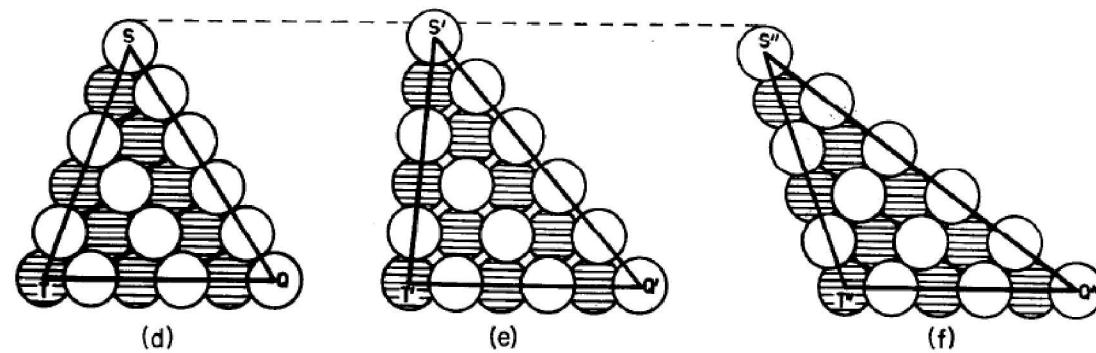
FIG. 2. Normal twin shear in a cubic close-packed arrangement of spheres. The horizontal  $\{111\}$  planes are sheared in the  $\langle 112 \rangle$  direction perpendicular to PV.

- Many metals can also deform through twinning.
- Twinning is when one part of a crystal is oriented with respect to another through a crystallographic symmetry operation.
- In the case of Austenitic Steels twinning is induced through Deformation and produces a Mirror symmetry along  $\{111\}$  planes.
- A  $\langle 112 \rangle$  shear along every  $\{111\}$  plane produces a twin, the shear spread to every other  $\{111\}$  plane produces an HCP structure

(a) Original tetrahedral arrangement with four  $\{111\}$  planes.

(b) Intermediate position after  $1/3$  of normal twin shear. The distance between successive  $\{111\}$  planes parallel to  $P'V'S'$  and  $P'V'Q'$  has increased by  $5.4\%$ .

(c) Final position after complete twin shear.

(d-e-f) Cross section through the  $\{110\}$  plane TQS perpendicular to PV.

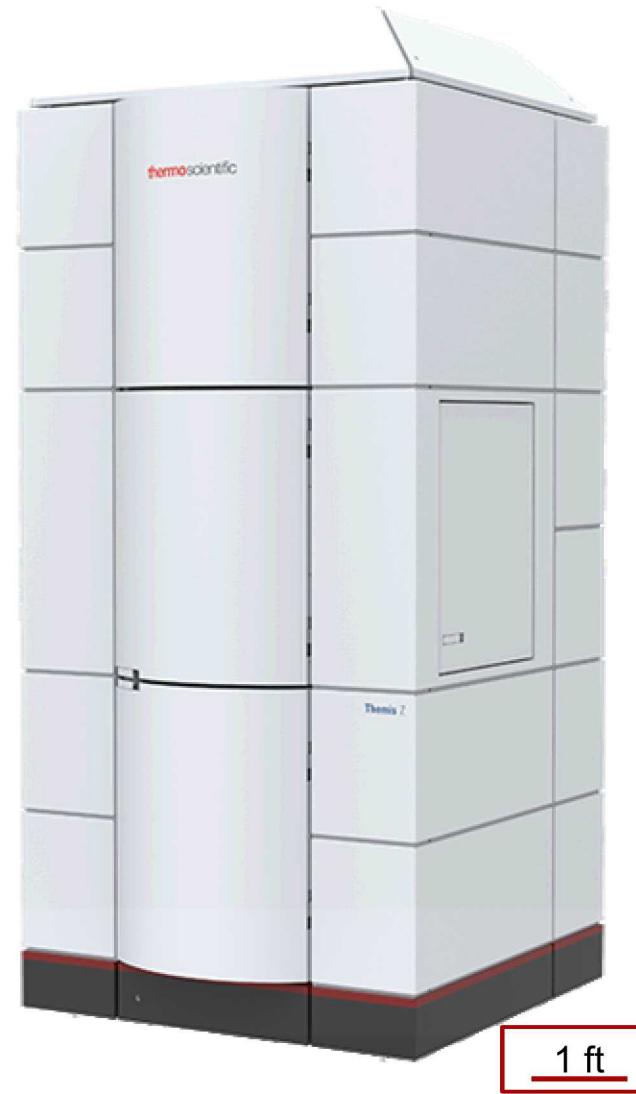
- Experiments (observations) were performed on Sandia CA's Thermo Fisher Themis Z probe corrected STEM/TEM.
- Will skip exact technical specifications here, however can perform:
  - High-Resolution(HR)-STEM
  - Nanoprobe-Diffraction
  - HRTEM
  - EDX
  - EELS
  - High Temperature Specimen Holders
  - Tomography Holders

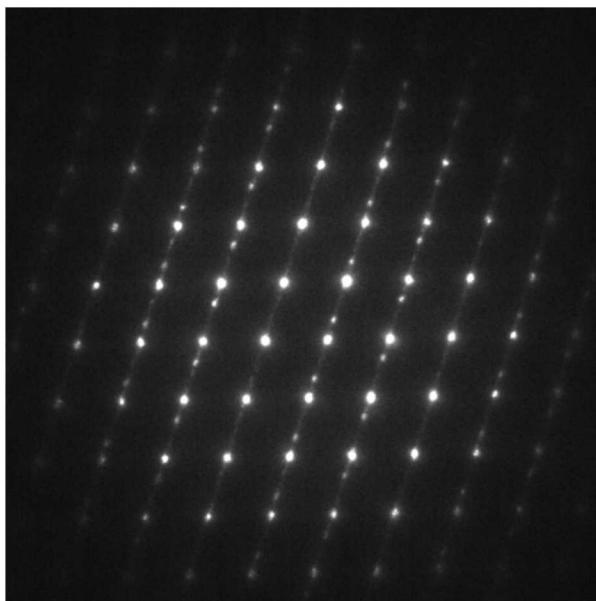
## Nanobeam Diffraction

All imaging types contain the same information, however the imaging condition will determine which is readily interpretable.

0.2 mRad Probe  
230mm Camera Length

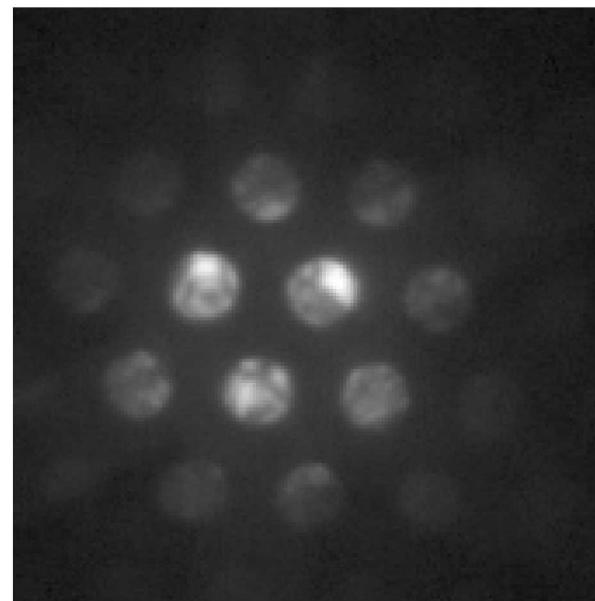
## DC-STEM

3 mRad Probe  
230mm Camera Length

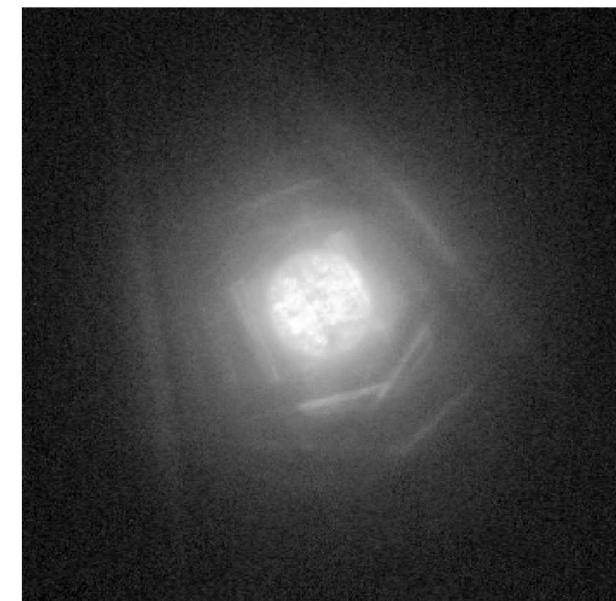
## HRSTEM

25.2 mRad Probe  
115mm Camera Length

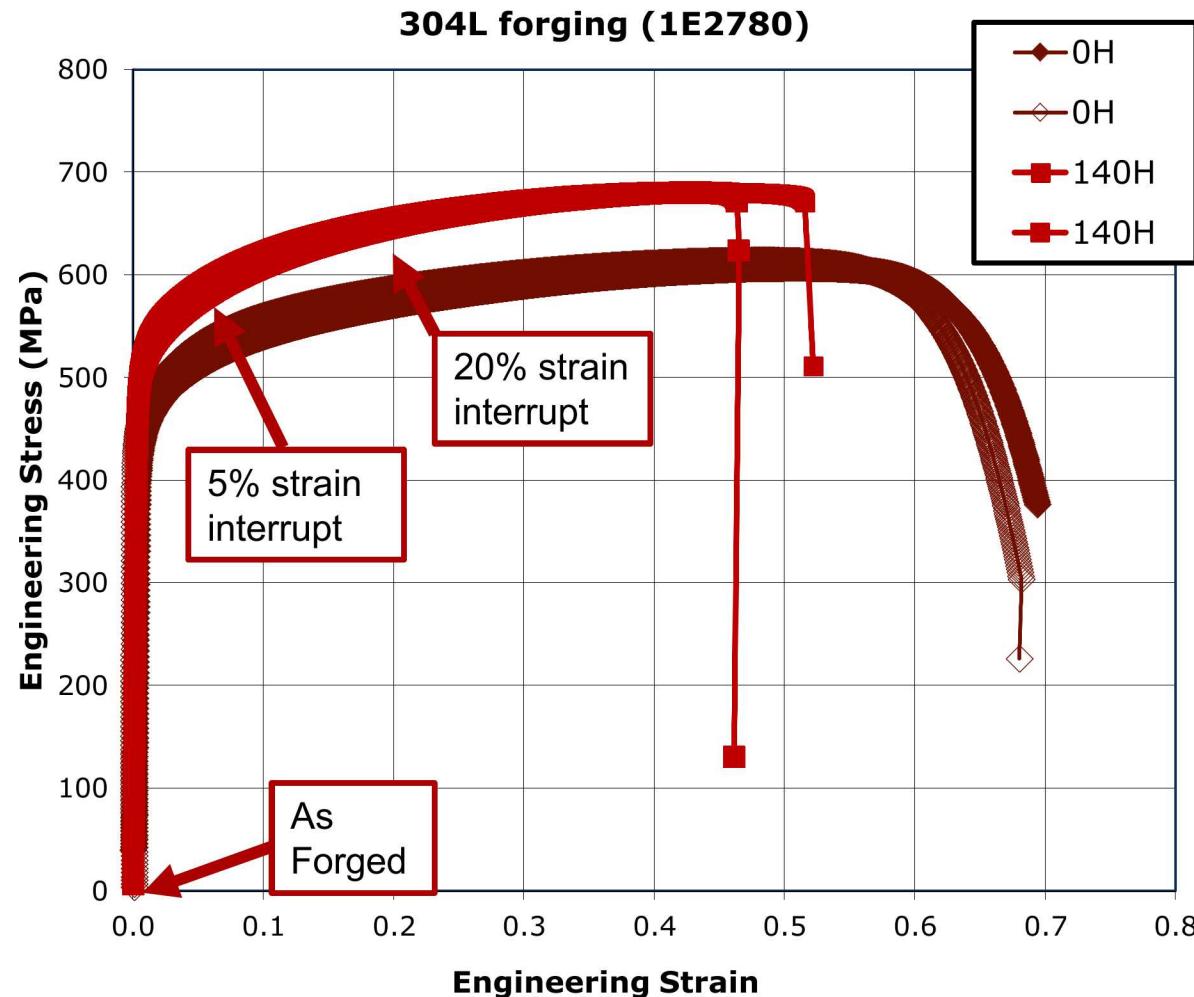
# Composition and Mechanical Data

- Several samples were deformed to fracture as well as intermittent strains.
- Initial as-forged microstructure taken from the grip region of tensile samples.
- Both HC and NC samples were deformed to 5% and 20% strain true strain.
- The samples were then sectioned using a diamond blade, mechanically thinned up to 4000 grit sandpaper, and electrochemically polished.

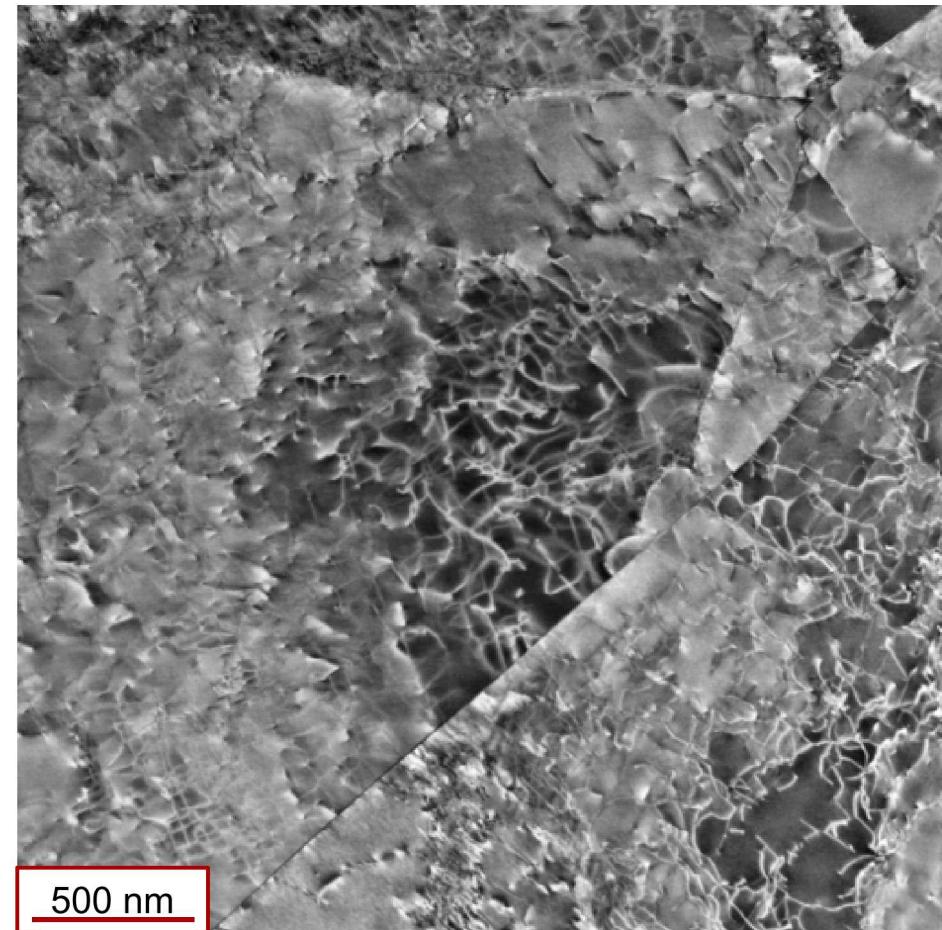
Forged H-Non-Charged

# As Forged Microstructures

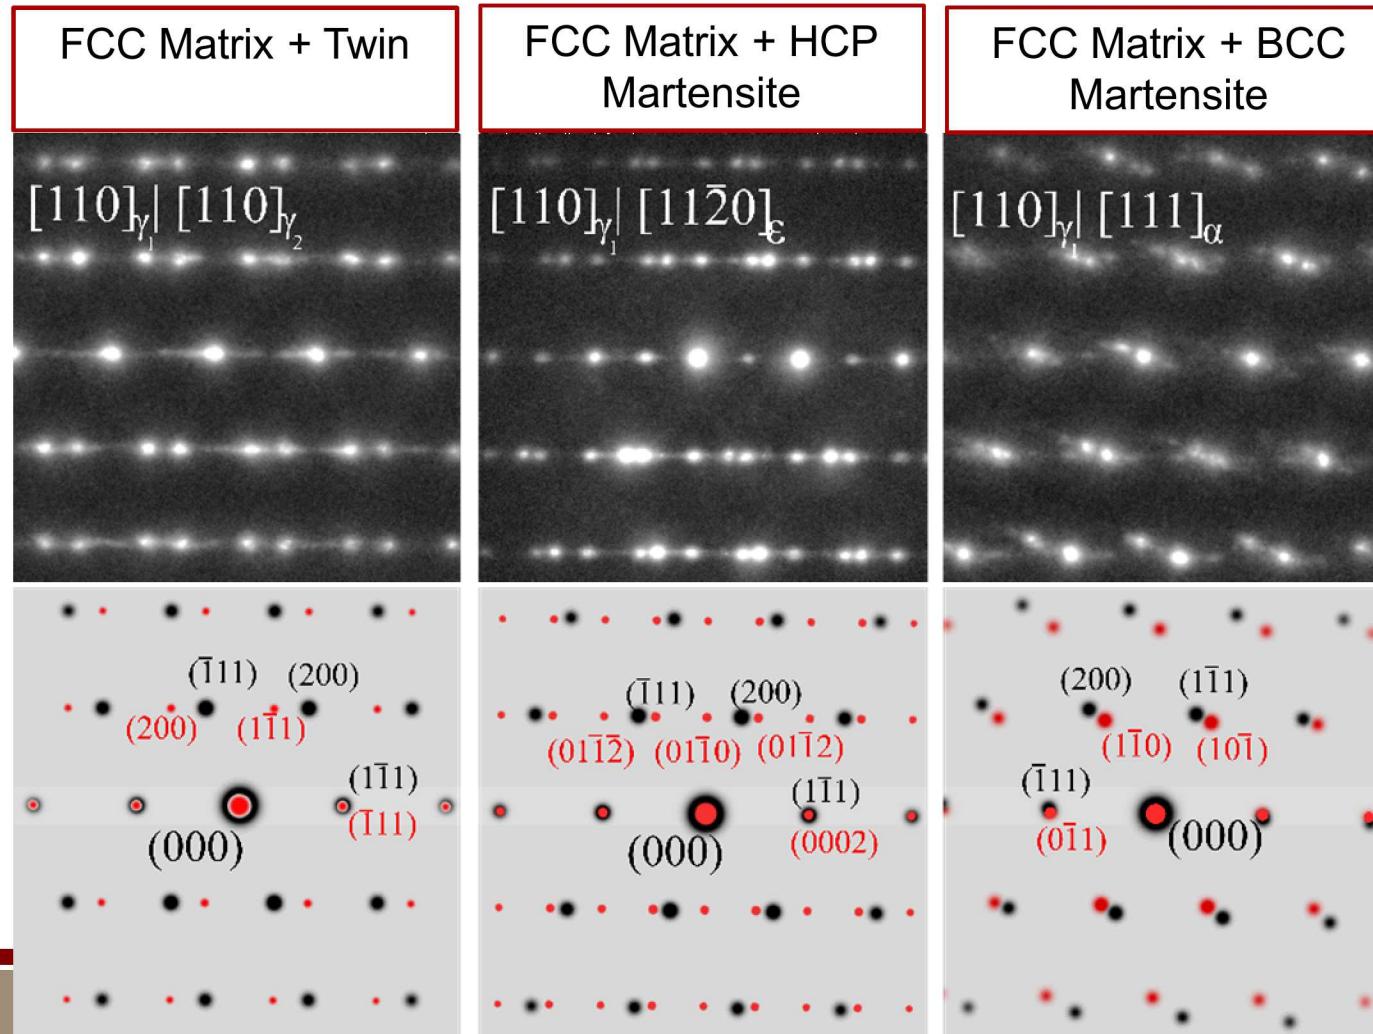
# Phases in 304L Steel

- Simulations and experimental diffraction patterns for the common structures in 304L steel.
- These are superpositions of diffraction patterns from parent  $\gamma$ -austenite (FCC) and twinning (FCC),  $\epsilon$ -martensite (HCP), or  $\alpha'$ -martensite (BCC).

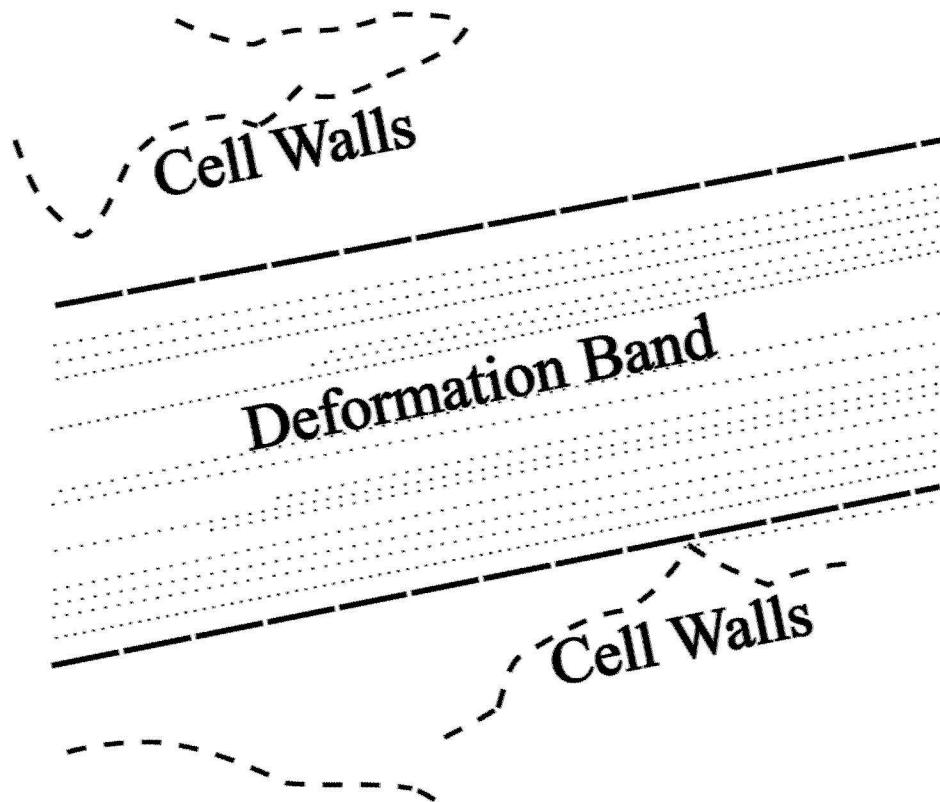
Schematic of Defect Structure

# 5% Strain Non-Charged Deformation Band

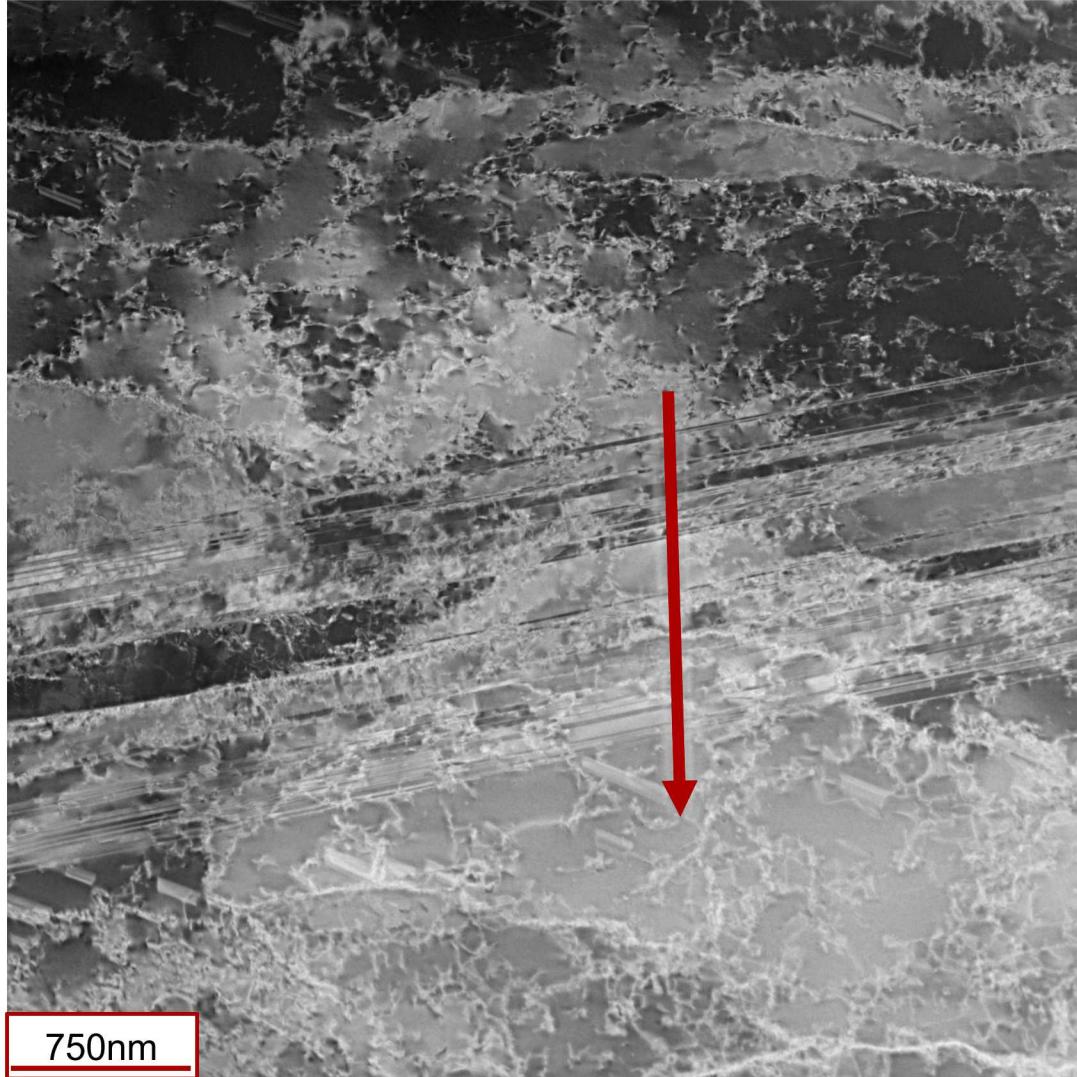
DC-STEM Micrograph

# Deformation Band Diffraction Scans

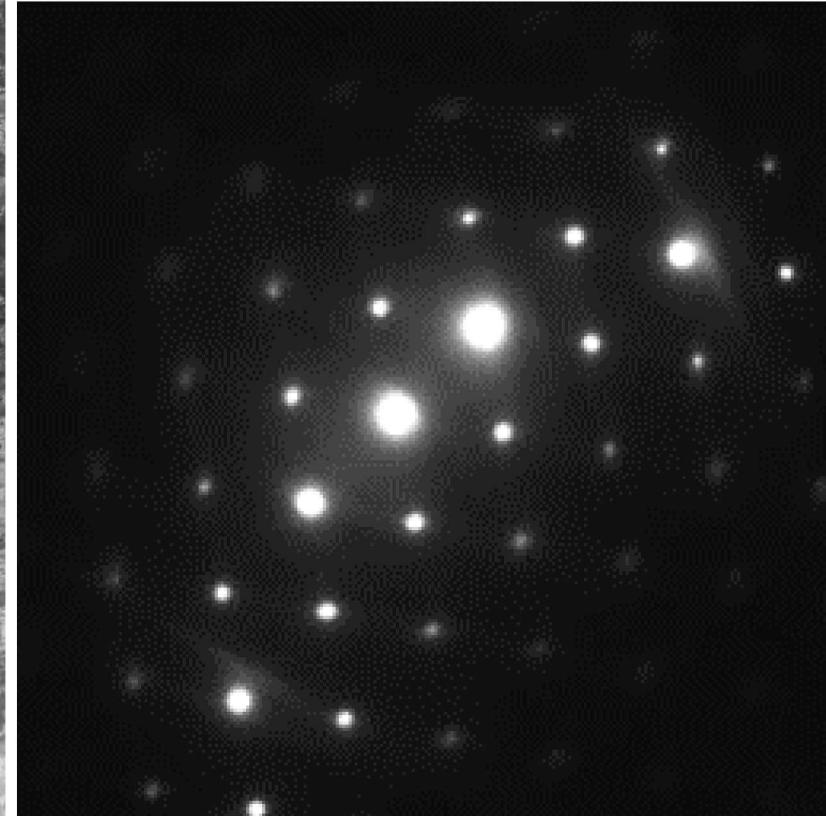
Single Line Scan 350 Patterns

Typical deformation bands contain twins, with stacking faults (SFs) appearing as heavier streaking along  $\{111\}$  reflections.

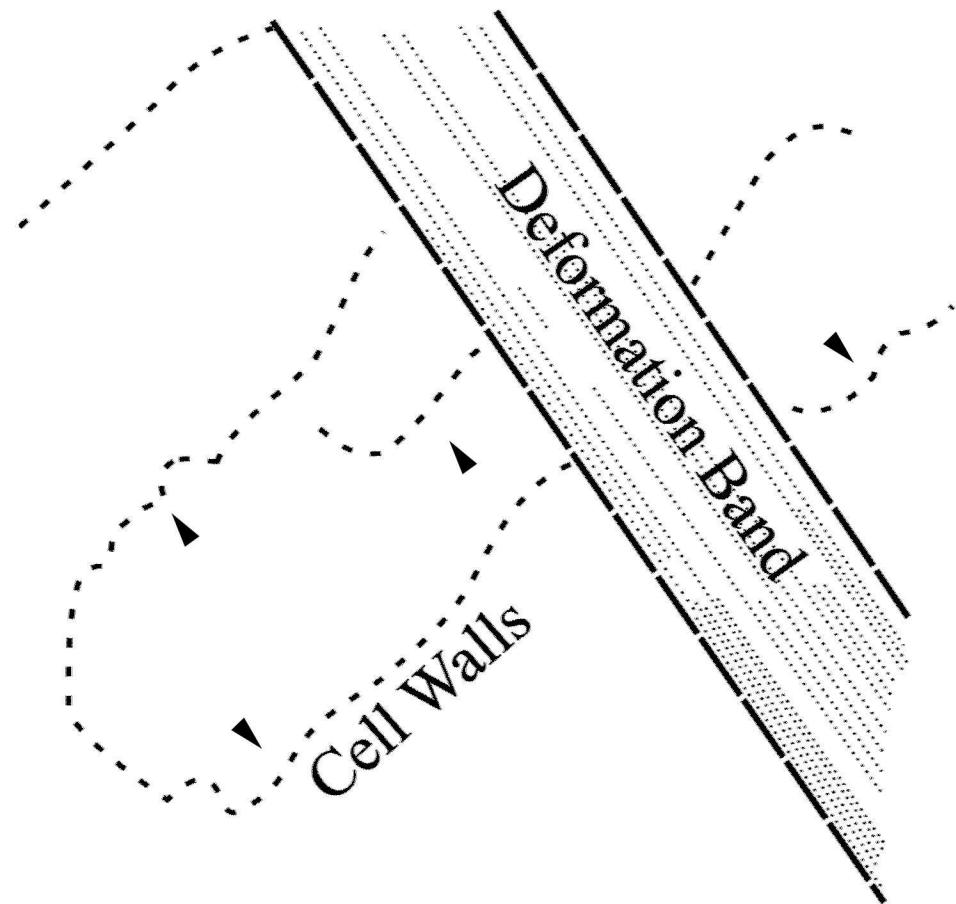
Schematic of Defect Structure

# 5% Strain H-Charged Deformation Band

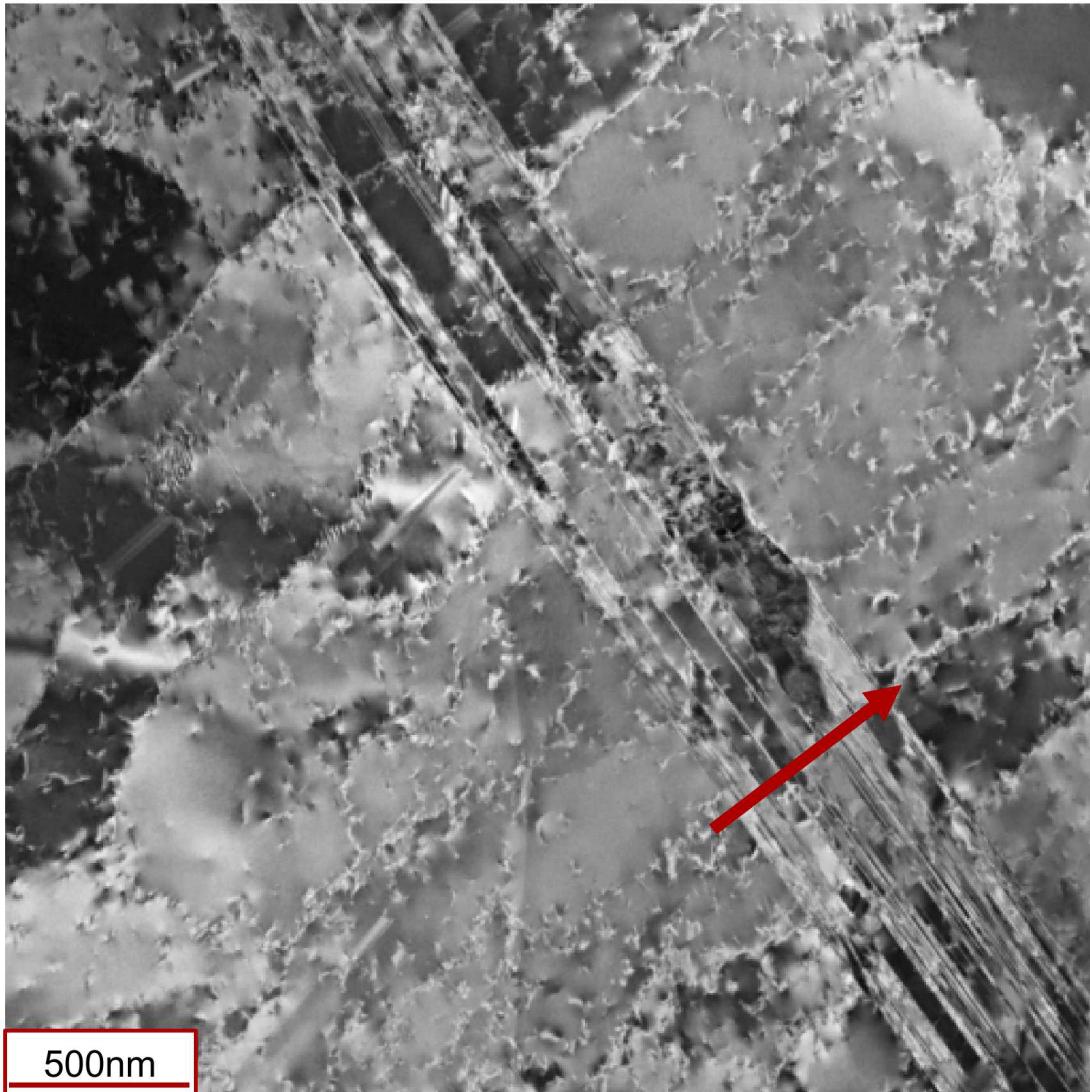
DC-STEM Micrograph

# Deformation Band Diffraction Scans

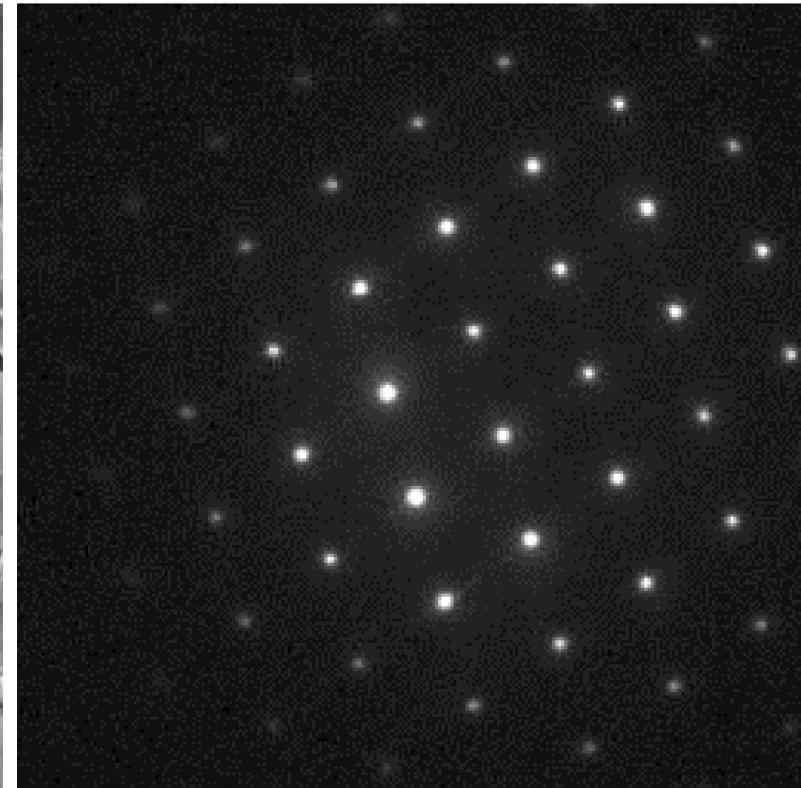
Single Line Scan ~200 Patterns

In HC samples  $\varepsilon$ -martensite dominates within the deformed region, with little dislocation content observed.

- Hydrogen thermal precharging had a large effect on the defect substructure within deformation bands of 304L stainless steel.
- While NC samples are mediated by the formation of deformation twinning at strains below 20%, HC samples favor  $\varepsilon$ -martensite formation at all observed strain levels.
- With the sufficient development of  $\varepsilon$ -martensite laths, HC specimen also form  $\alpha'$ -martensite at the intersections of two  $\varepsilon$ -martensite laden deformation bands, consuming  $\varepsilon$ -martensite to form  $\alpha'$ -martensite.
- While  $\alpha'$ -martensite is often attributed to be a main cause of the deleterious effects of hydrogen within steel,  $\alpha'$ -martensite nucleation is only a secondary effect of the enhanced prevalence of  $\varepsilon$ -martensite within the microstructure.

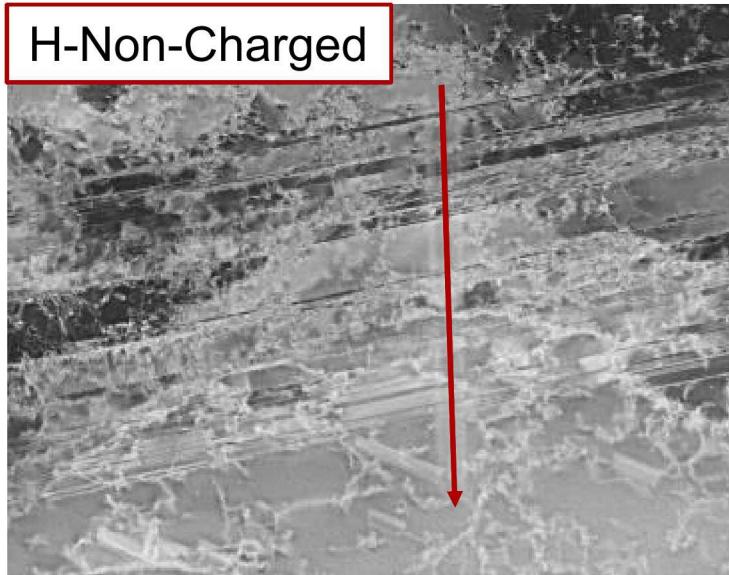
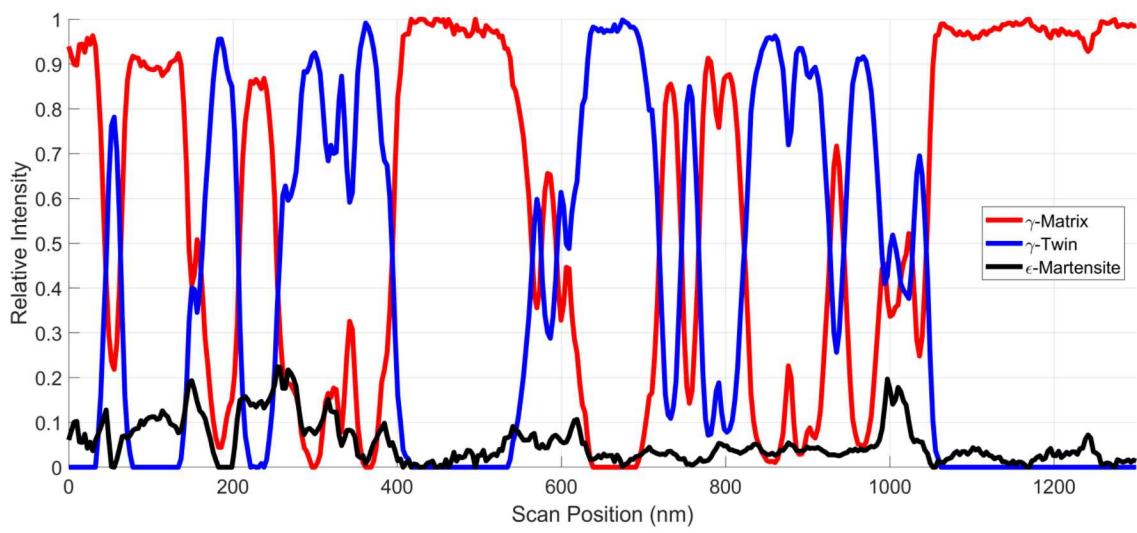
H-Non-Charged

# Quantitative Phase Measurements

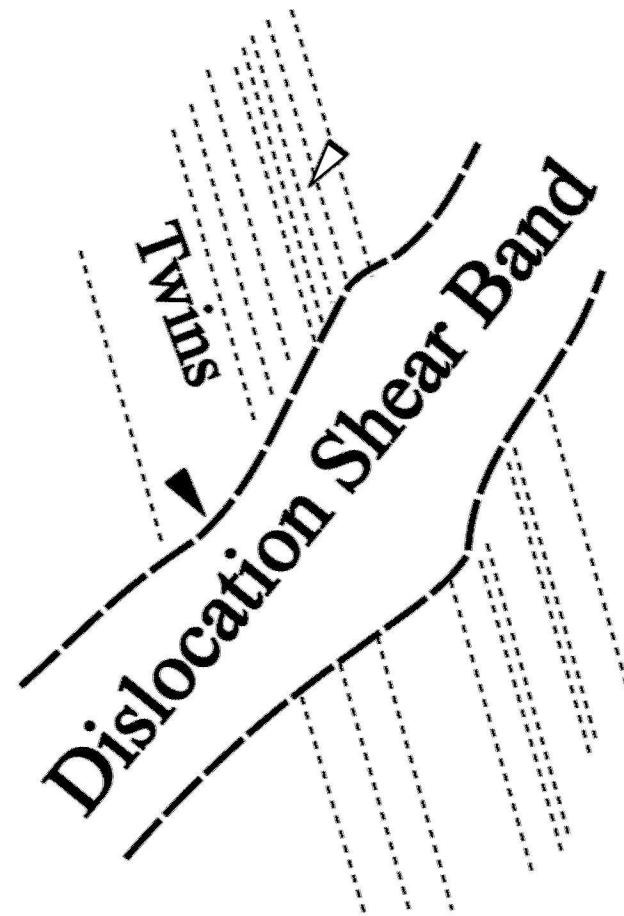
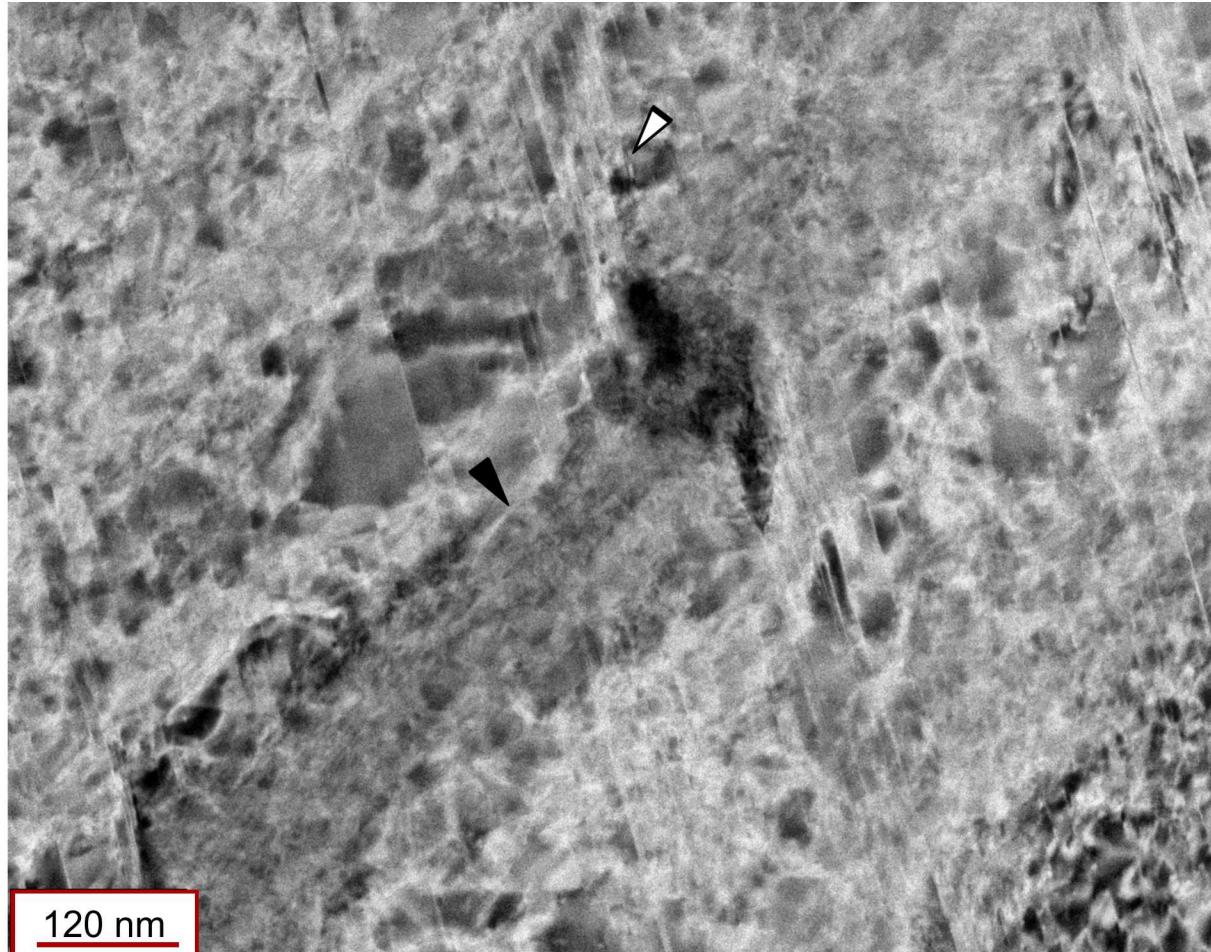
# Deformation Bands in NC 20% Strain

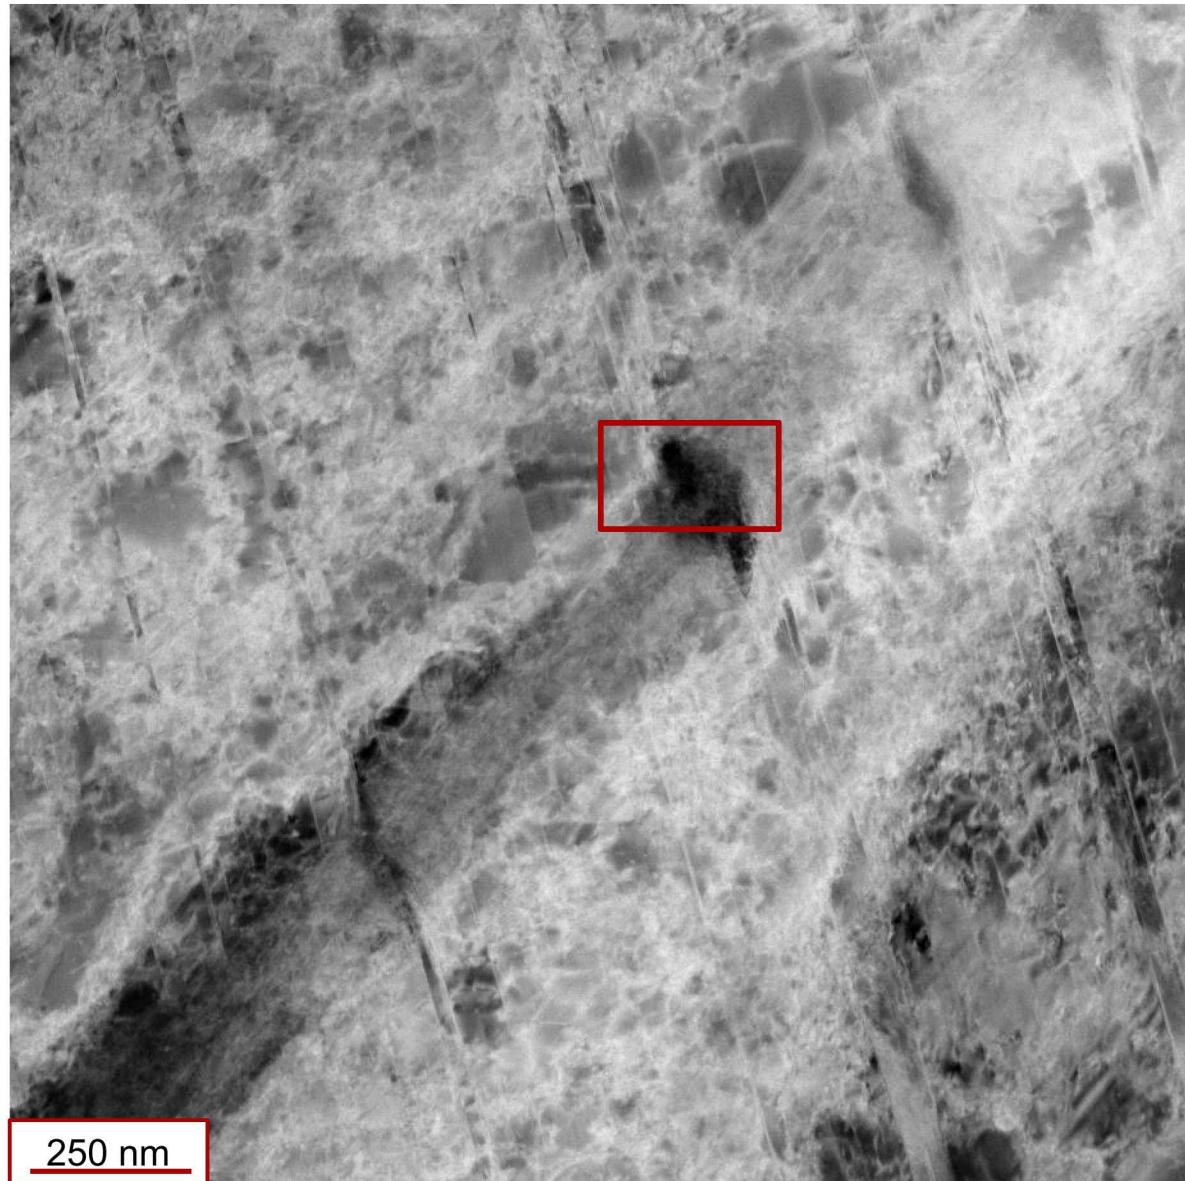
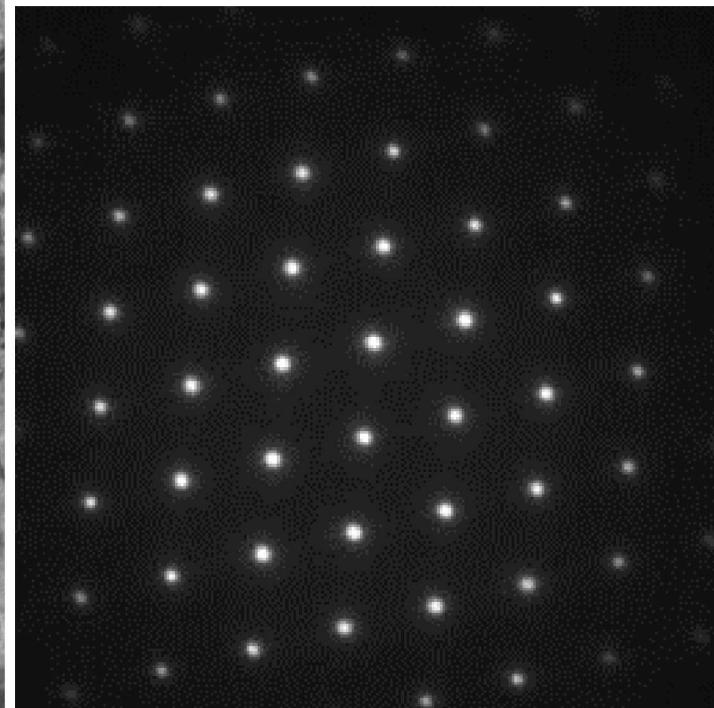
# Deformation Bands in NC 20% Strain

Throughout the double shear band intersection in non-charged samples, only some twin spots appear and no  $\alpha'$ - or  $\epsilon$ -martensite phase spots.

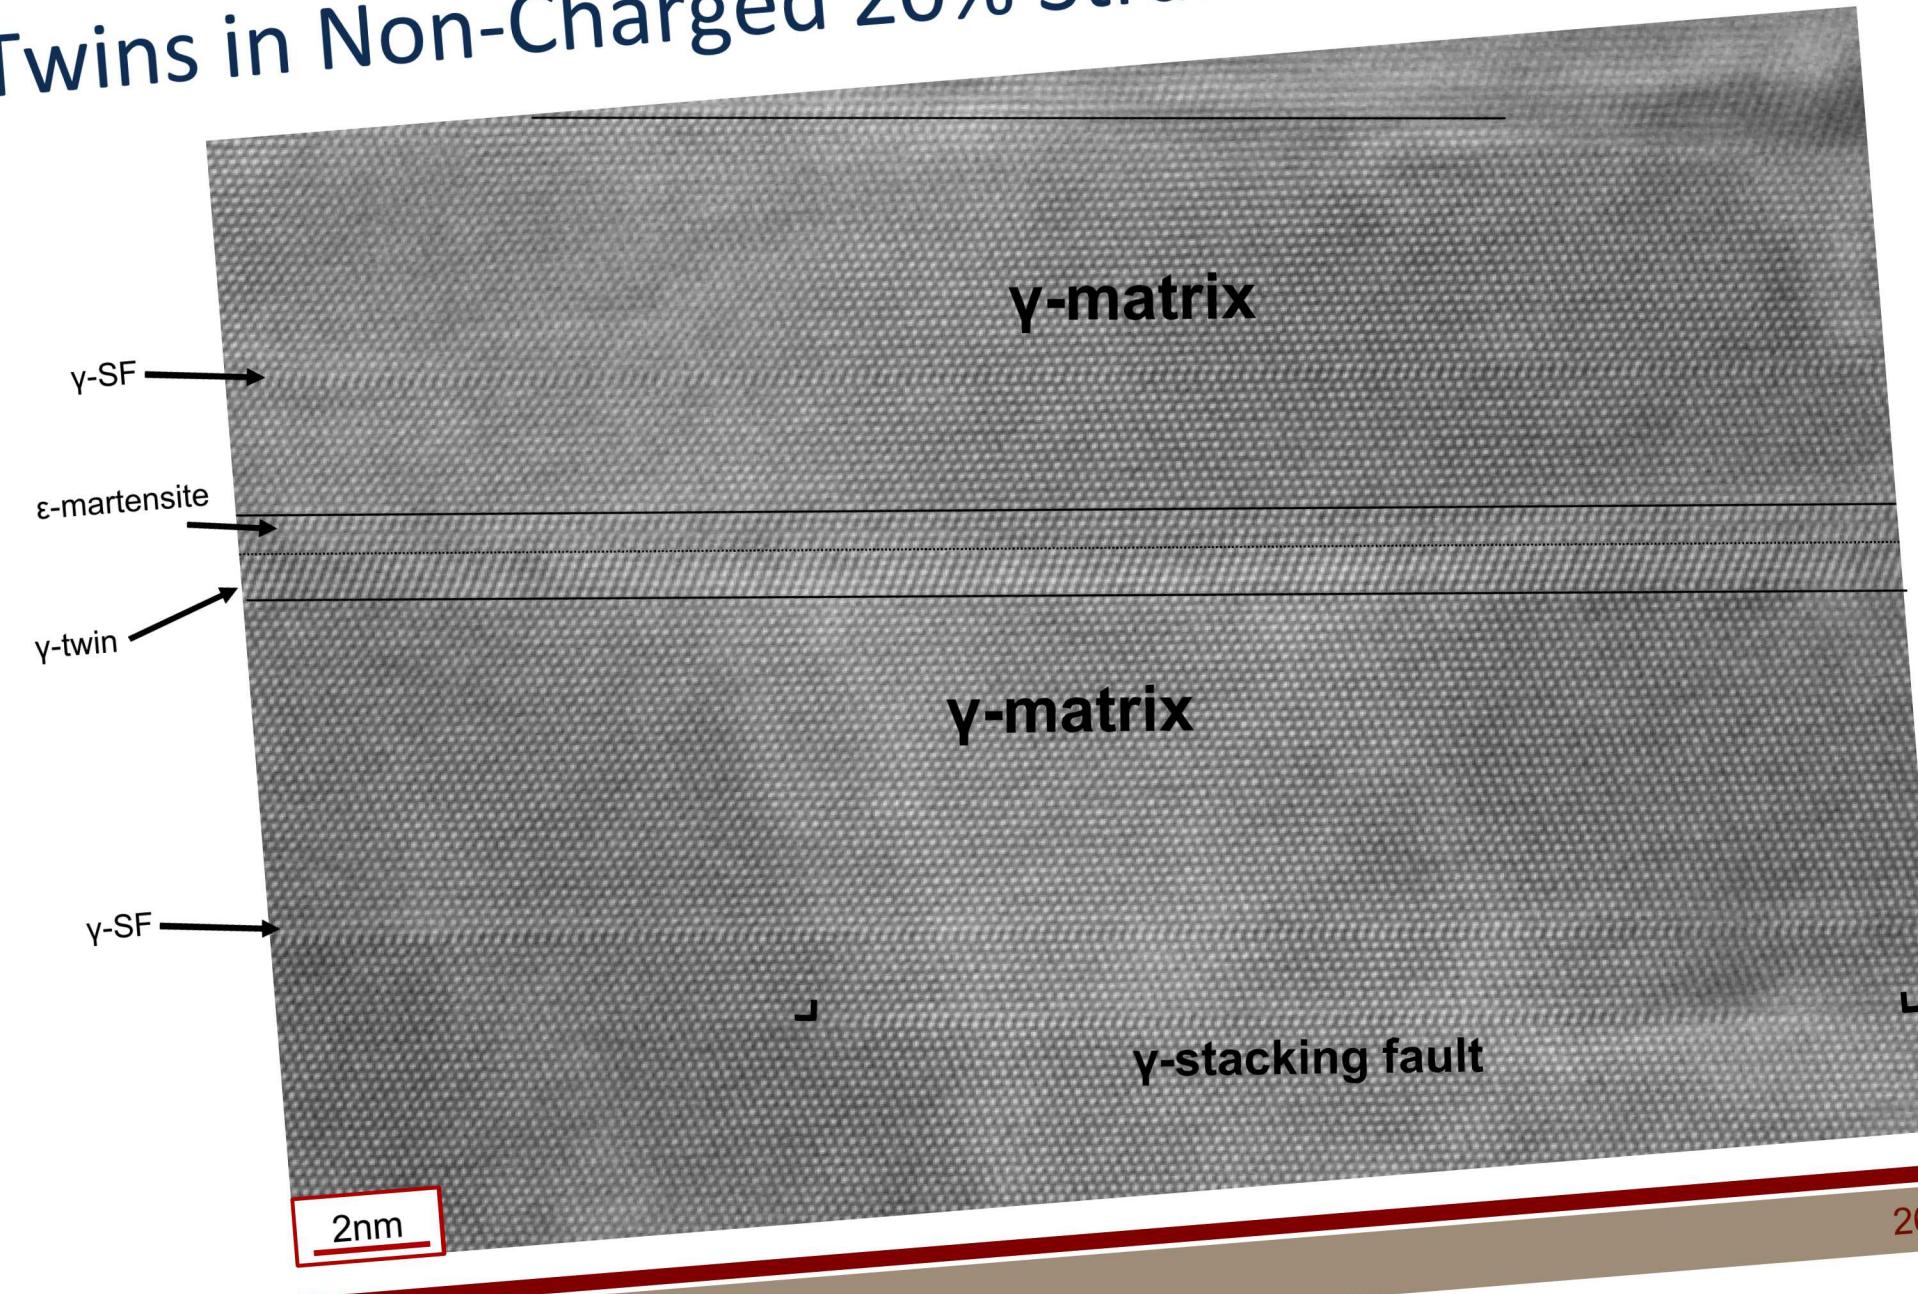
# Twins in Non-Charged 20% Strain

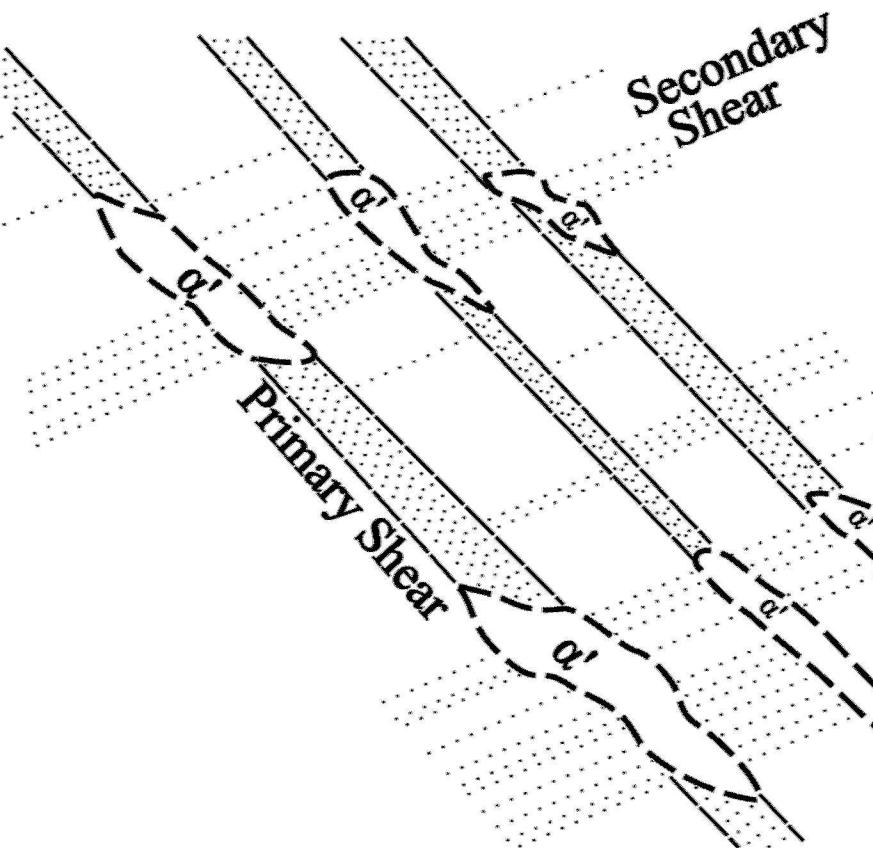
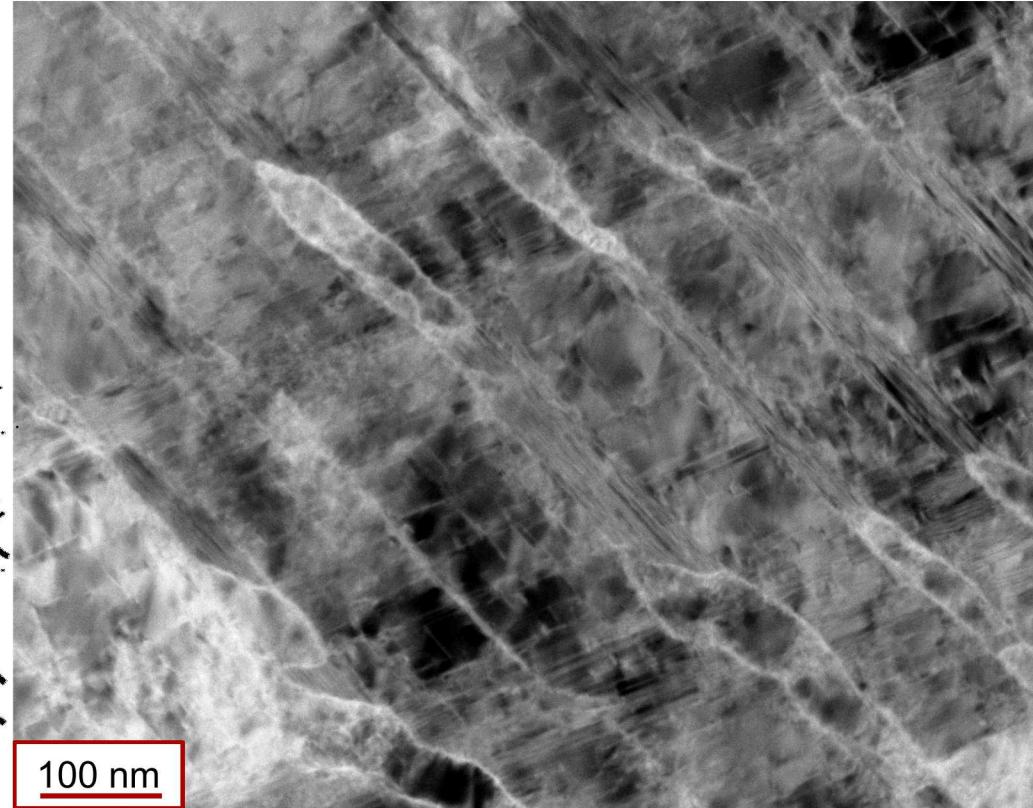
# Deformation Bands in H-Charged 20% Strain
