# Interrogating atomic- and nanoscaled defects of structural metals using advanced microscopy techniques

SAND2020-0536PE

Presented by:  
Julian E.C. Sabisch

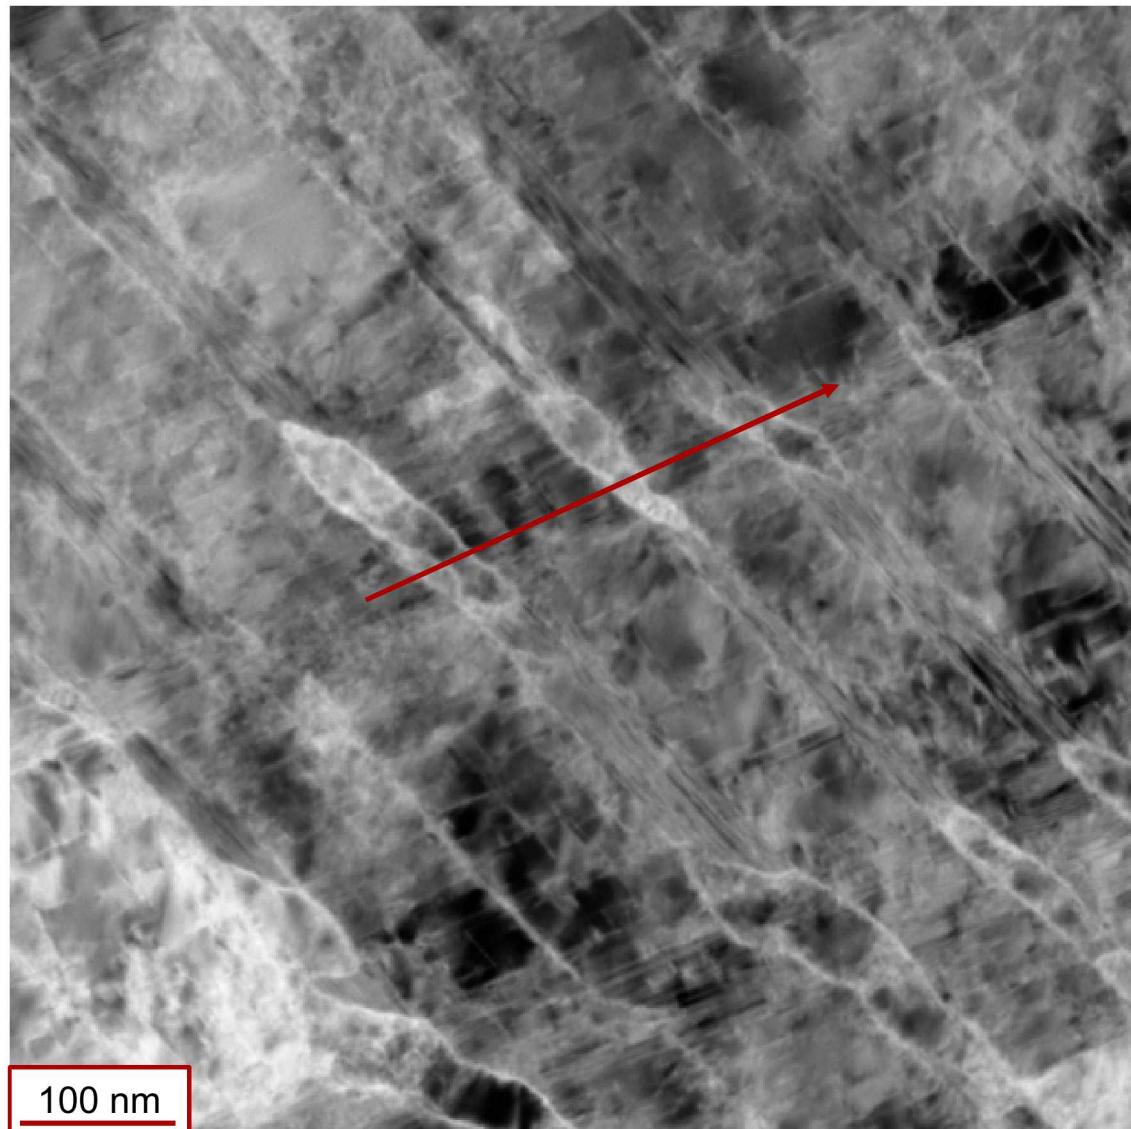
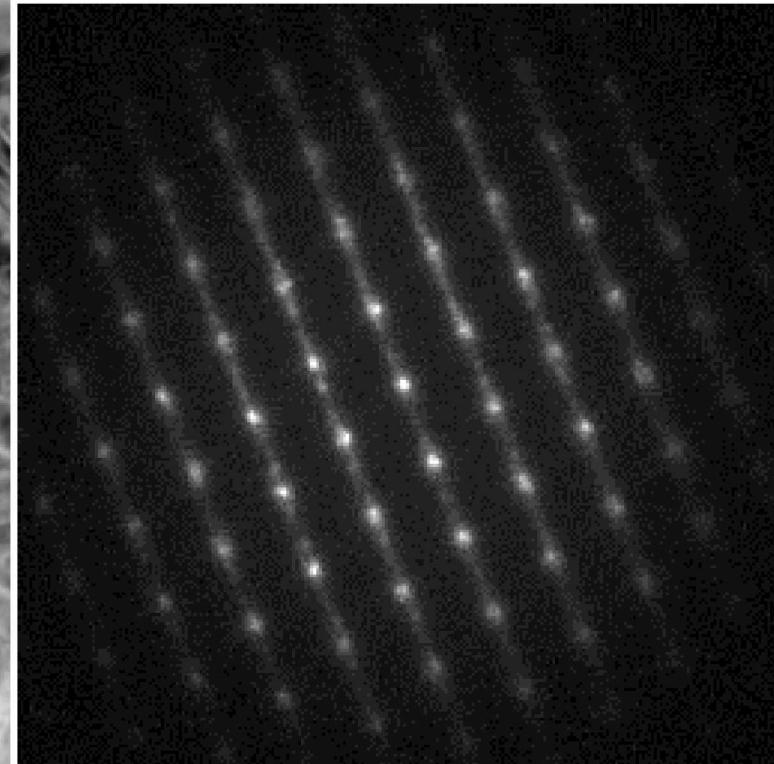
# Deformation Bands in H-Charged 20% Strain

Here large regions of  $\alpha'$ -martensite are formed, growing along the shear bands containing large amount of  $\varepsilon$ -martensite.

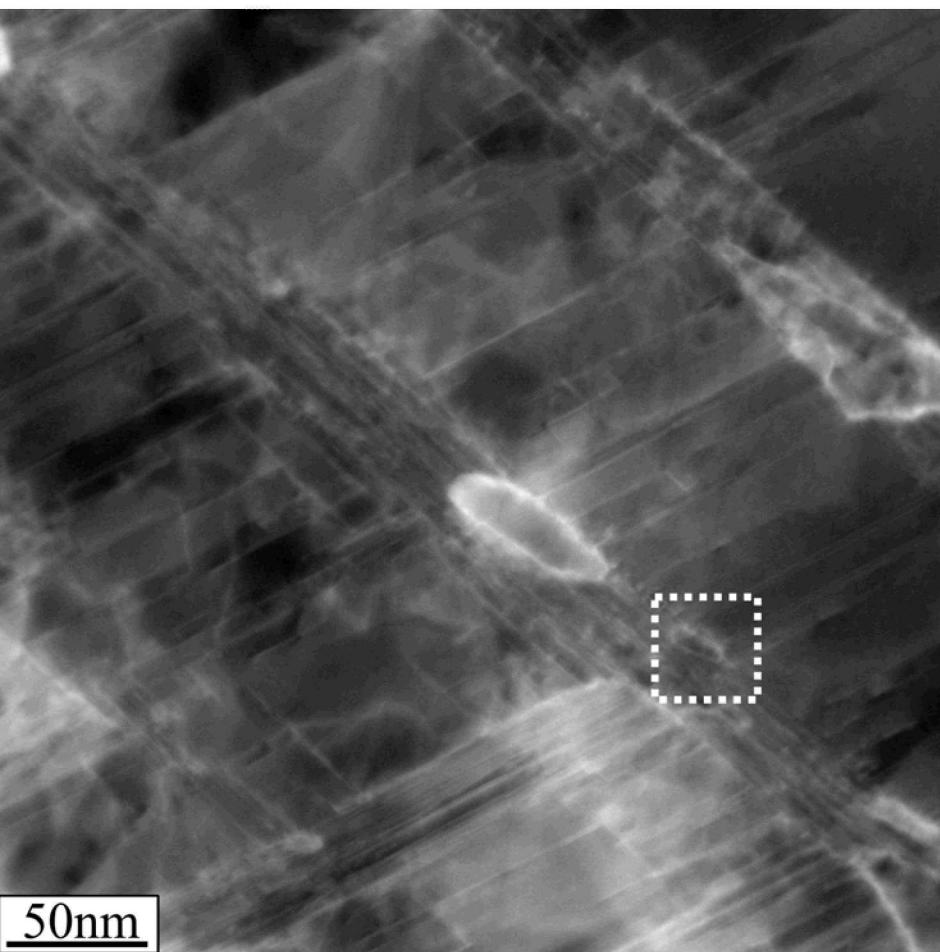
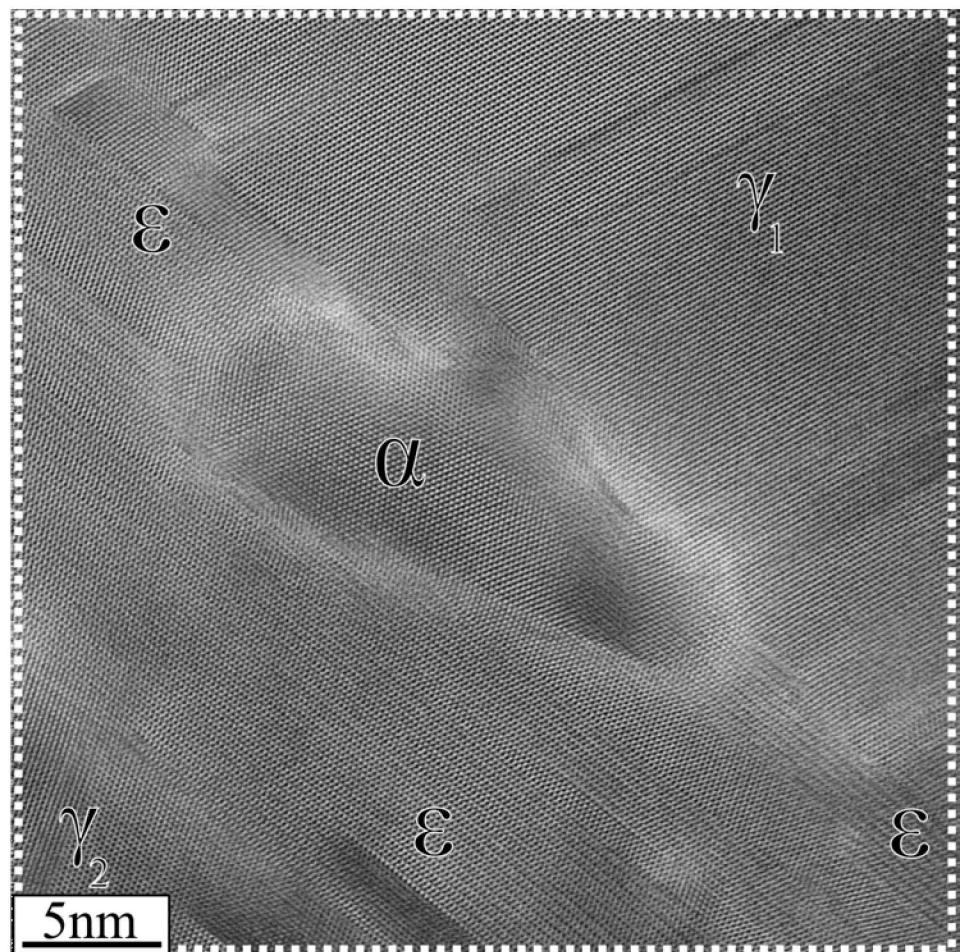
# $\alpha'$ -Martensite in H-Charged 20% Strain

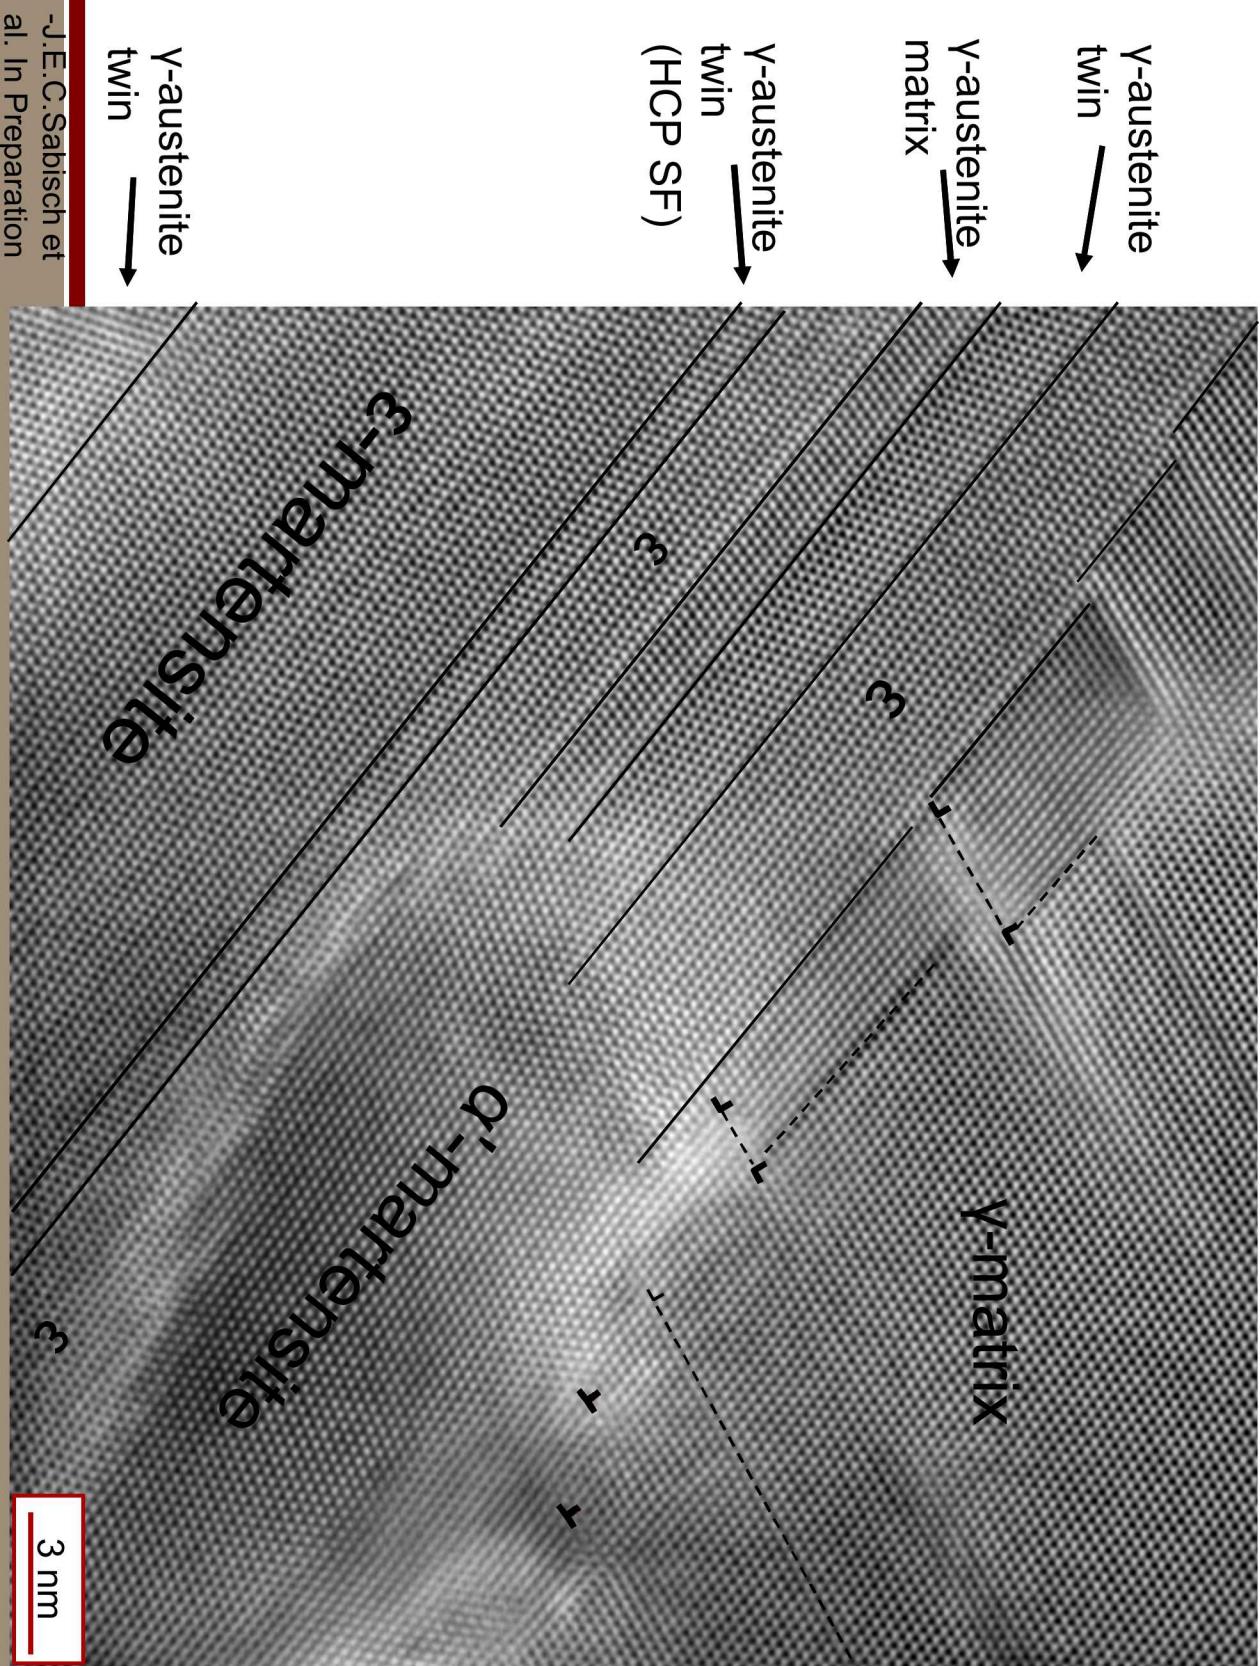
# $\alpha'$ -Martensite Nucleus Structure

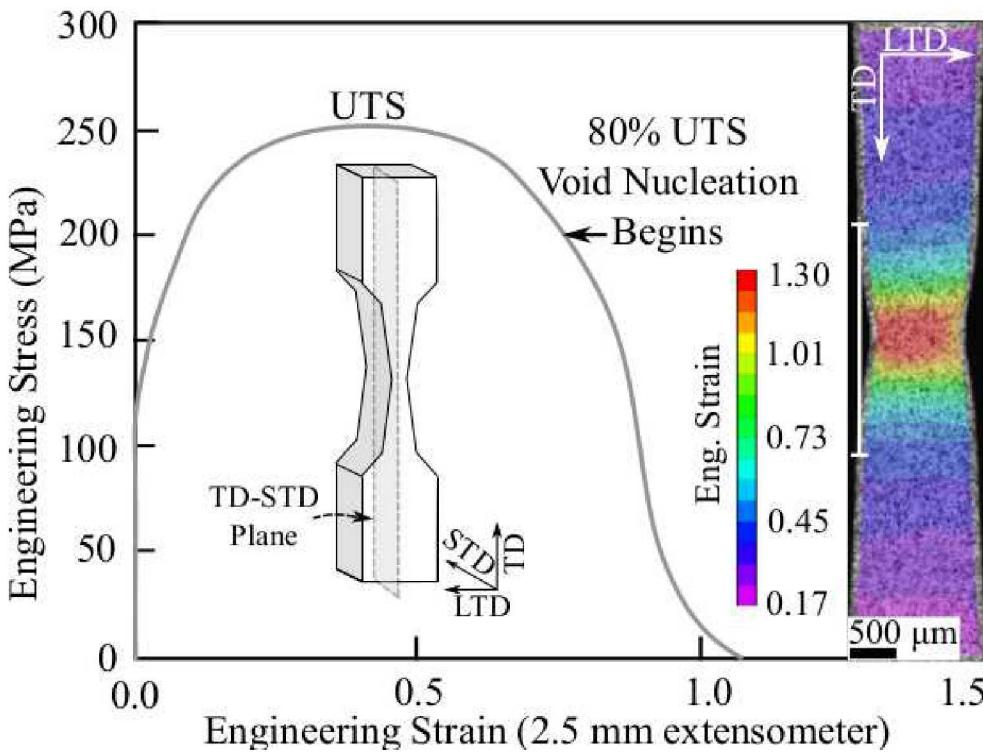
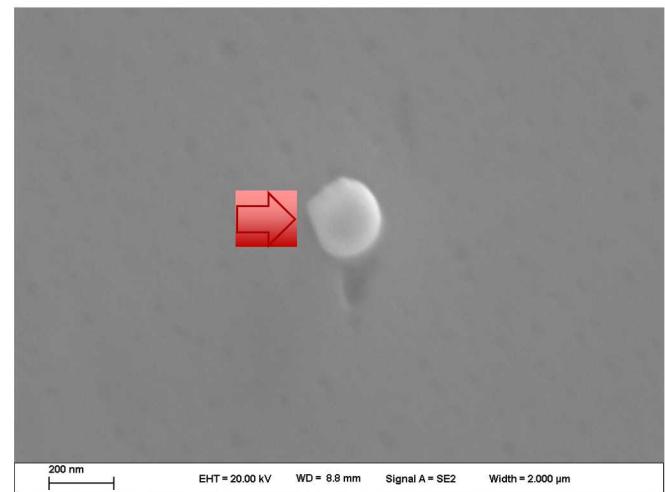
# Experimental Approach

- Interrupted tension tests performed on a 99.9% Cu sheet material that contained ~200 nm CuO inclusions (area density of ~1 per  $200 \mu\text{m}^2$ )
  - Void nucleation began at ~80% of the UTS. Most analysis performed on specimens interrupted at 60% of the UTS. Only voids that nucleated in the diffuse neck (before a shear band developed) were examined
  - More information on the fracture behavior of this material provided in Noell *et al.*, 2018, *Acta Materialia*

A ~200 nm CuO inclusion is shown

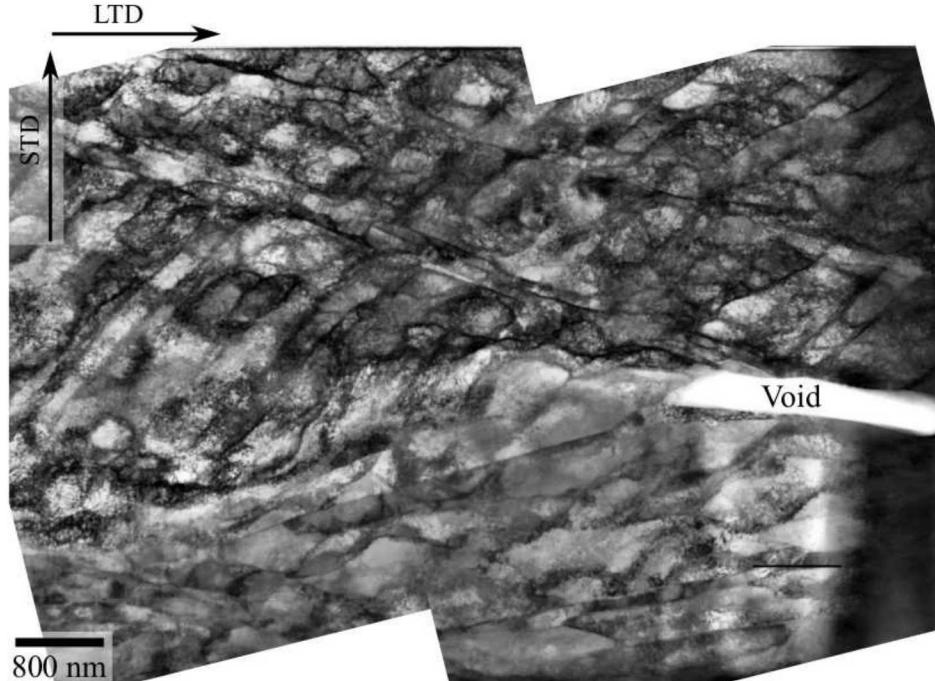
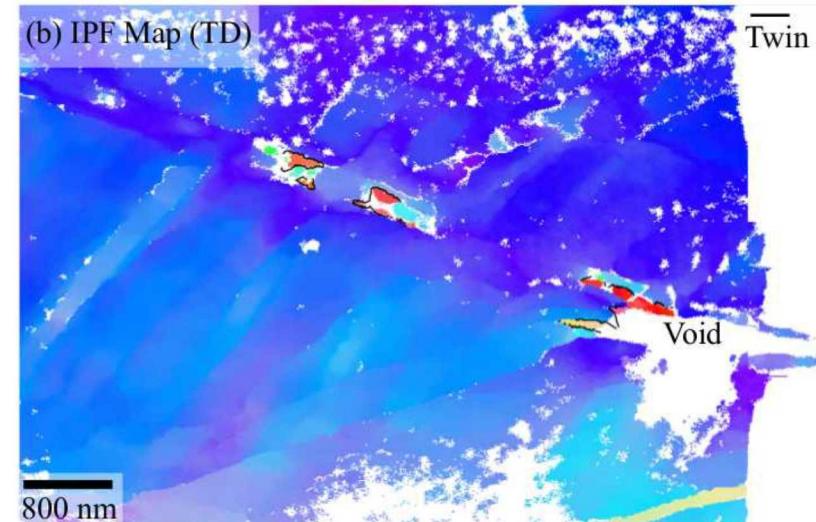
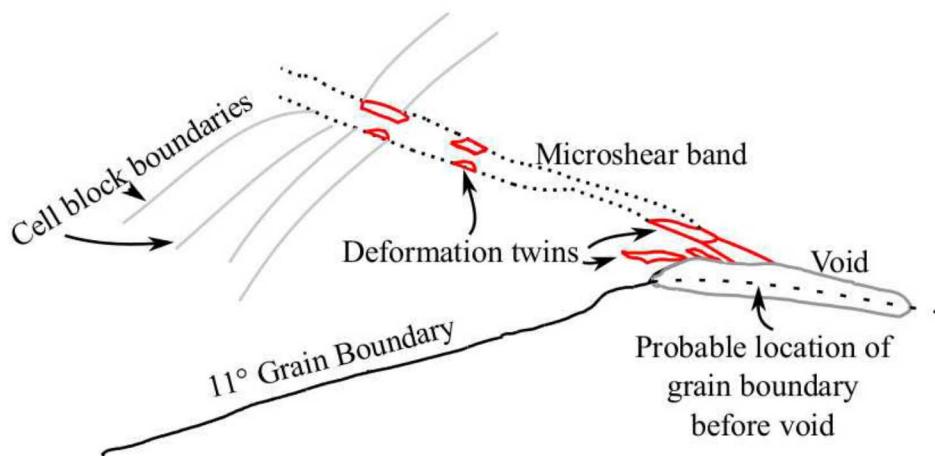
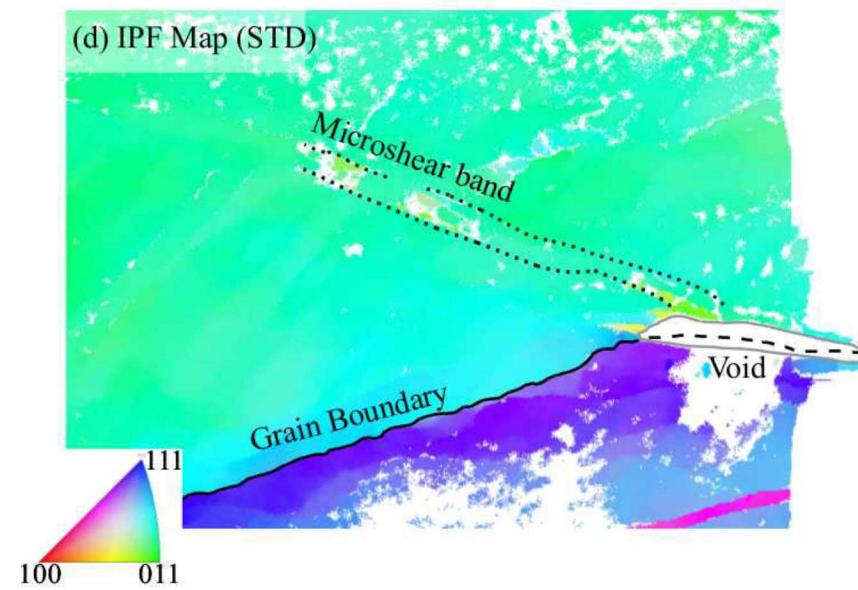
# Deformation induced Voids

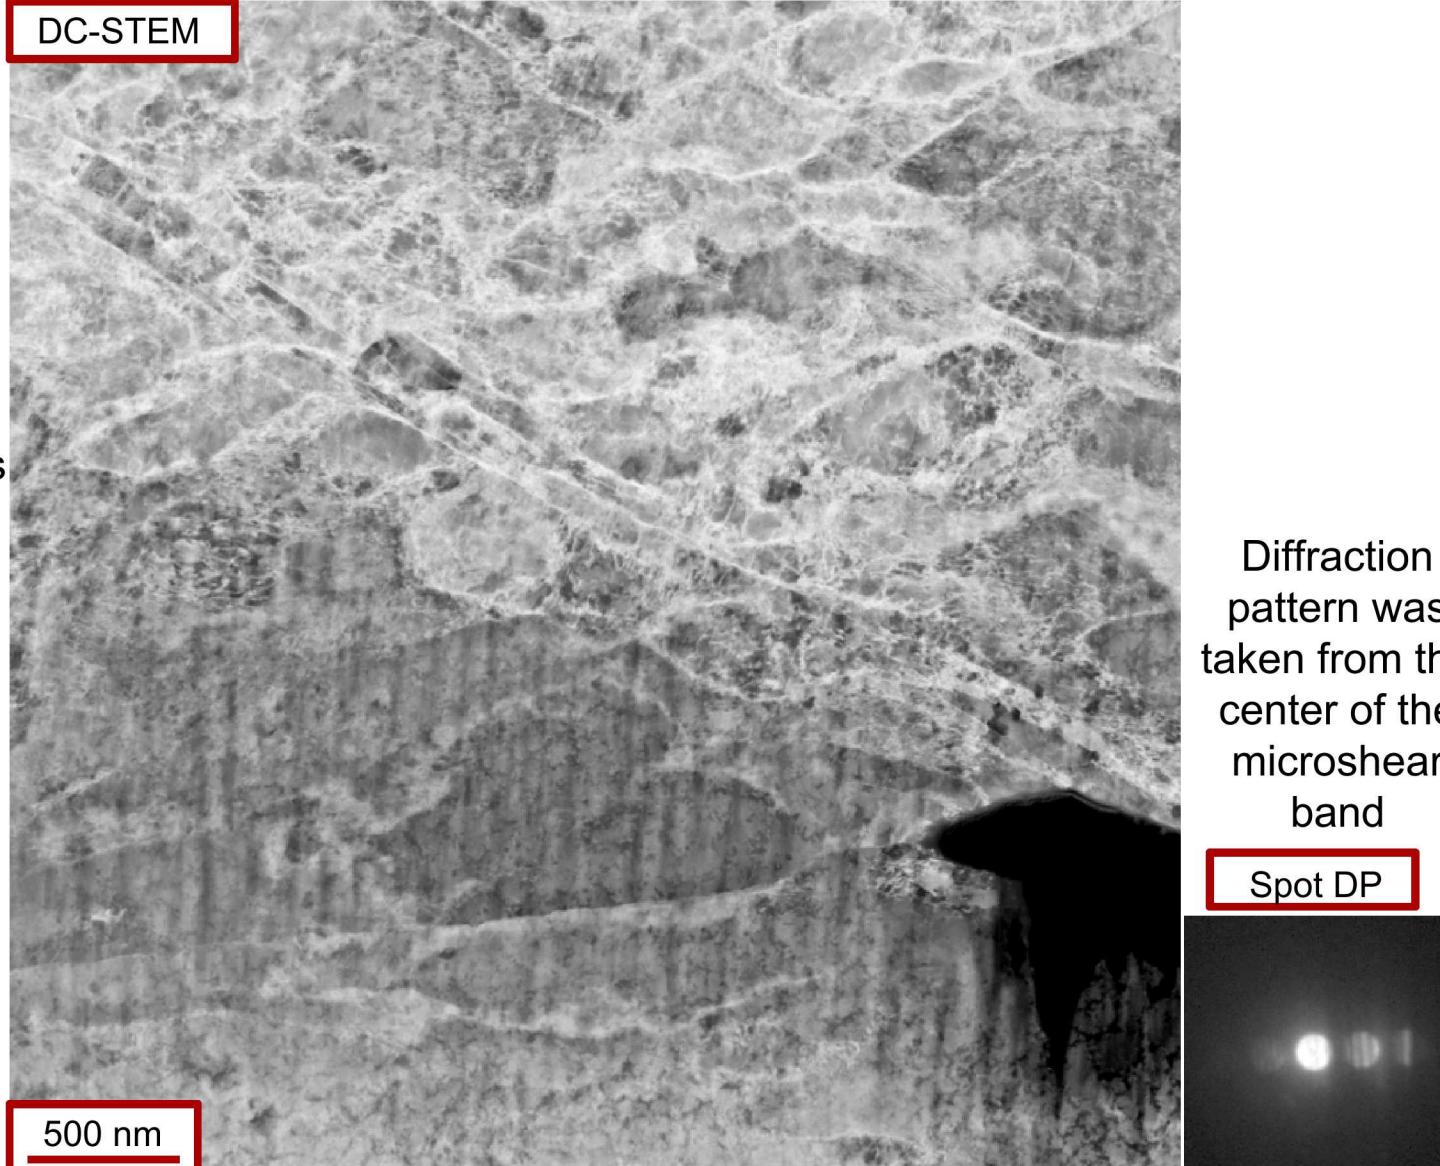
DC-STEM of  
microshear band

# DC-STEM of Microshear Band

No particular zone was used in order to get the same nominal imaging condition as TKD. The TKD orientation maps maps are oriented normal to the foil generally.

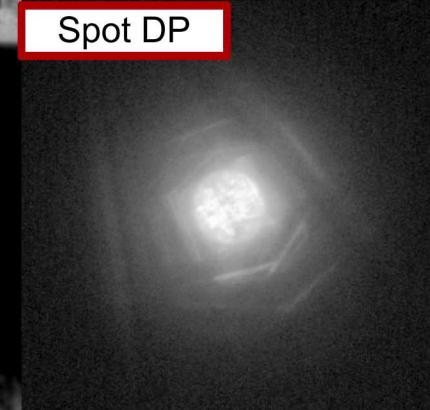
Spot DP

# HAADF STEM of Microshear Band

No particular zone was used to get the same nominal imaging condition as was used for TKD. The maps are oriented normal to the foil generally.

Stripes seen on the sample are due to thickness variations due to "curtaining" typical in FIB prepared samples

Dark spots are due to lack of material, ie voids.

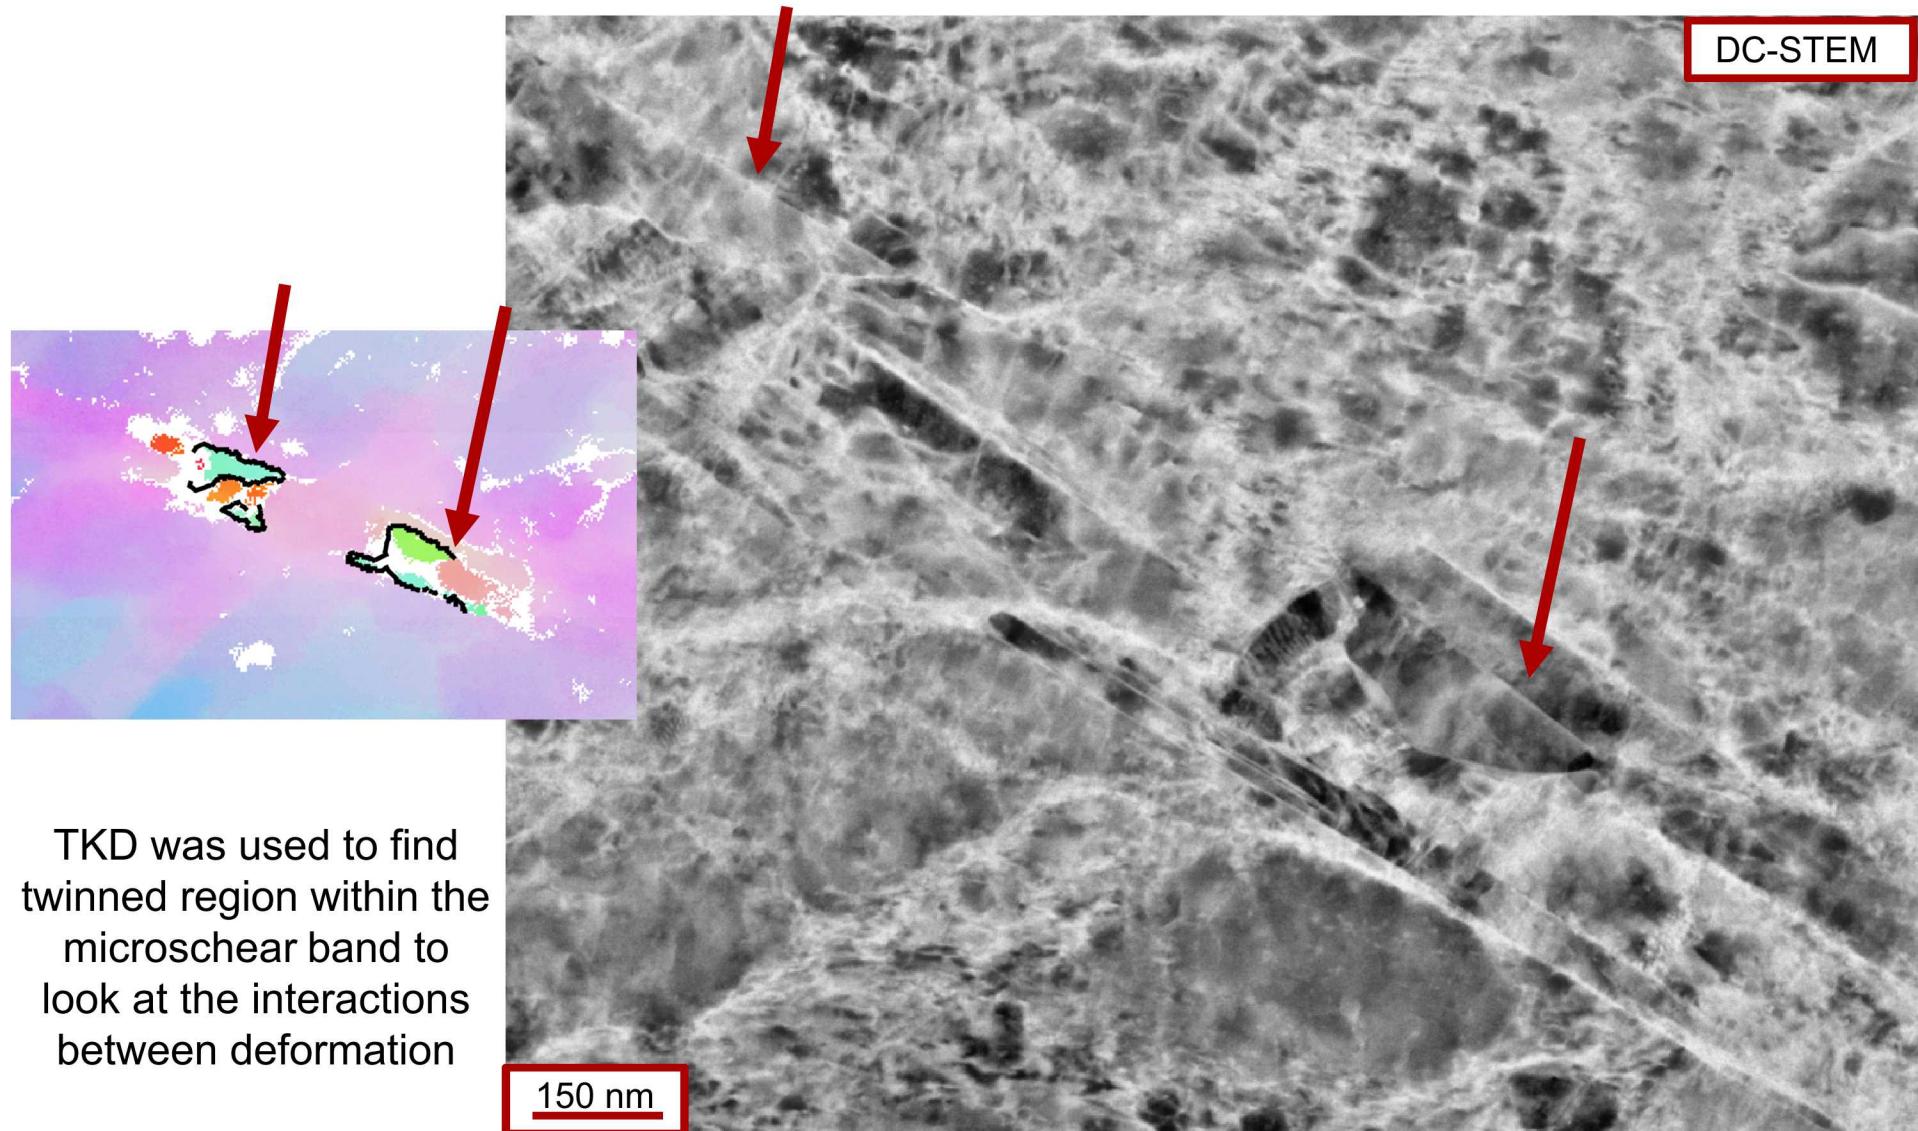
# STEM Correlation to TKD

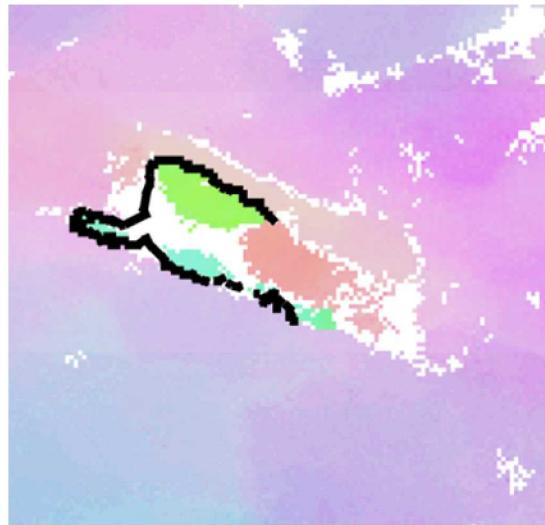
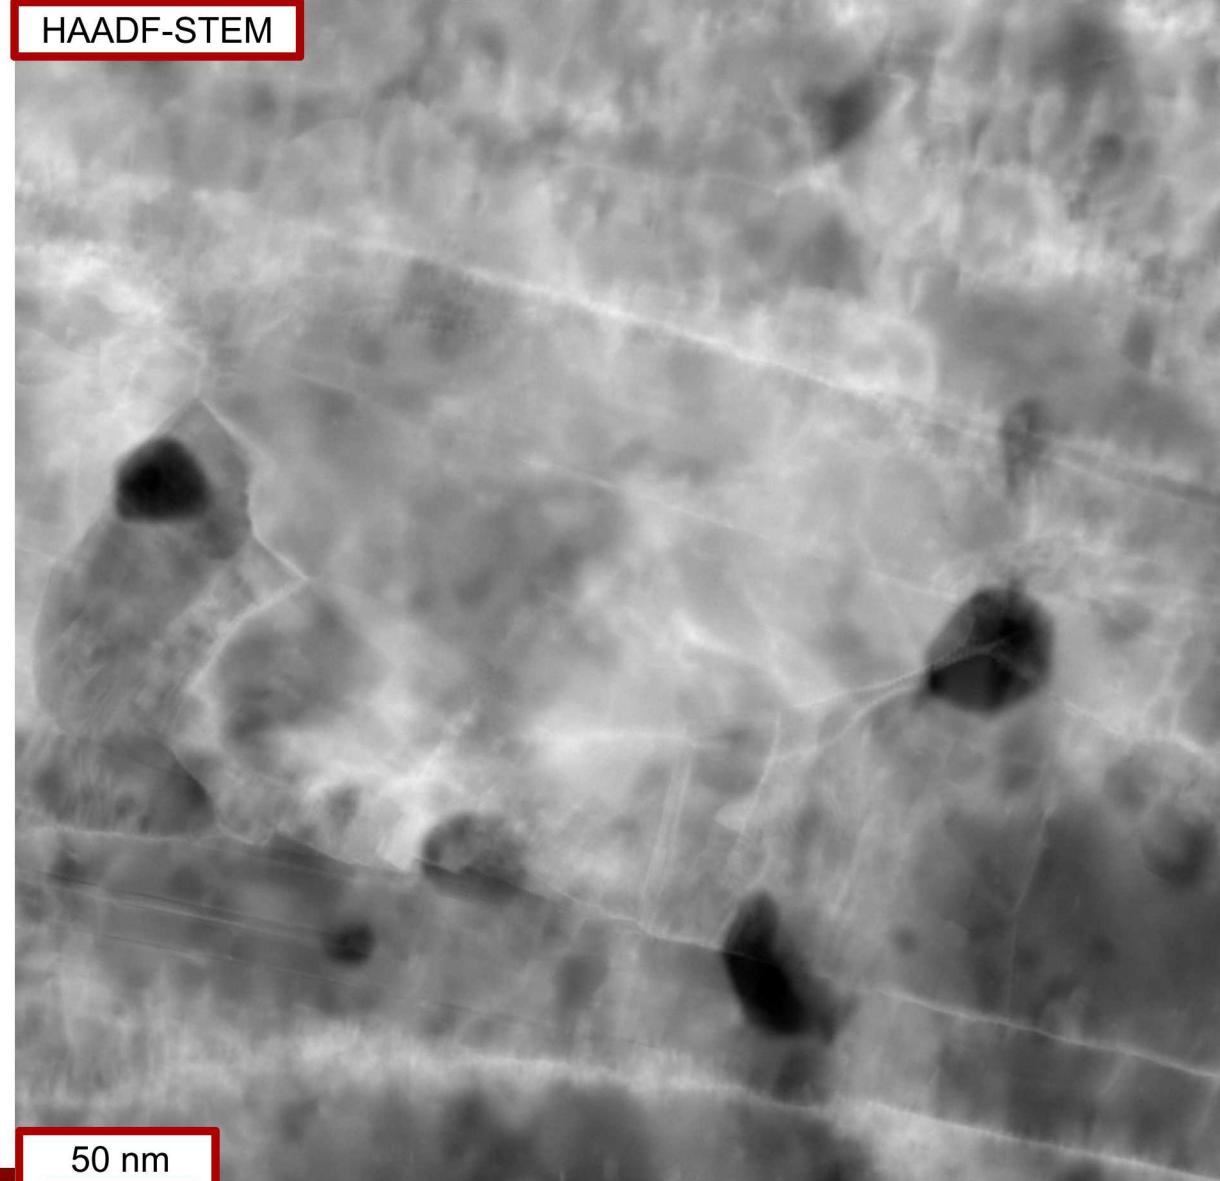
# HAADF STEM Mass-Thickness Contrast

Using the HRSTEM probe (mass thickness contrast) multiple voids are visible surrounding the twin. The imaging condition is a [110] zone, with the twin boundaries parallel to the optic axis. The voids often appear at the intersections between twins, ie at the boundaries.

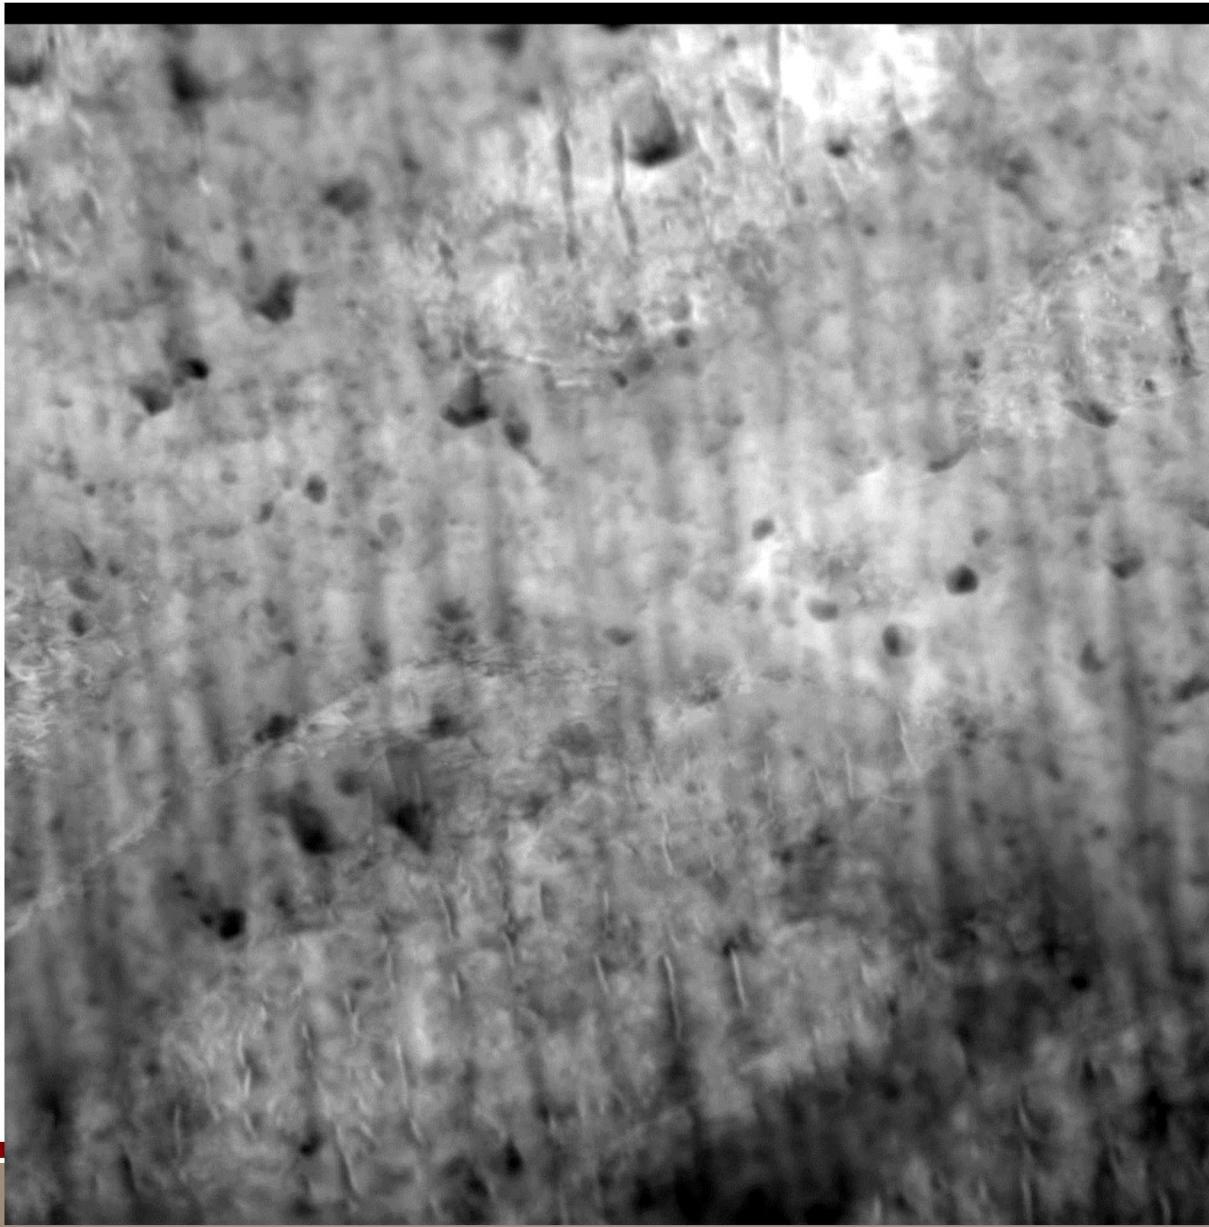
# Mass-Thickness Void Tomography

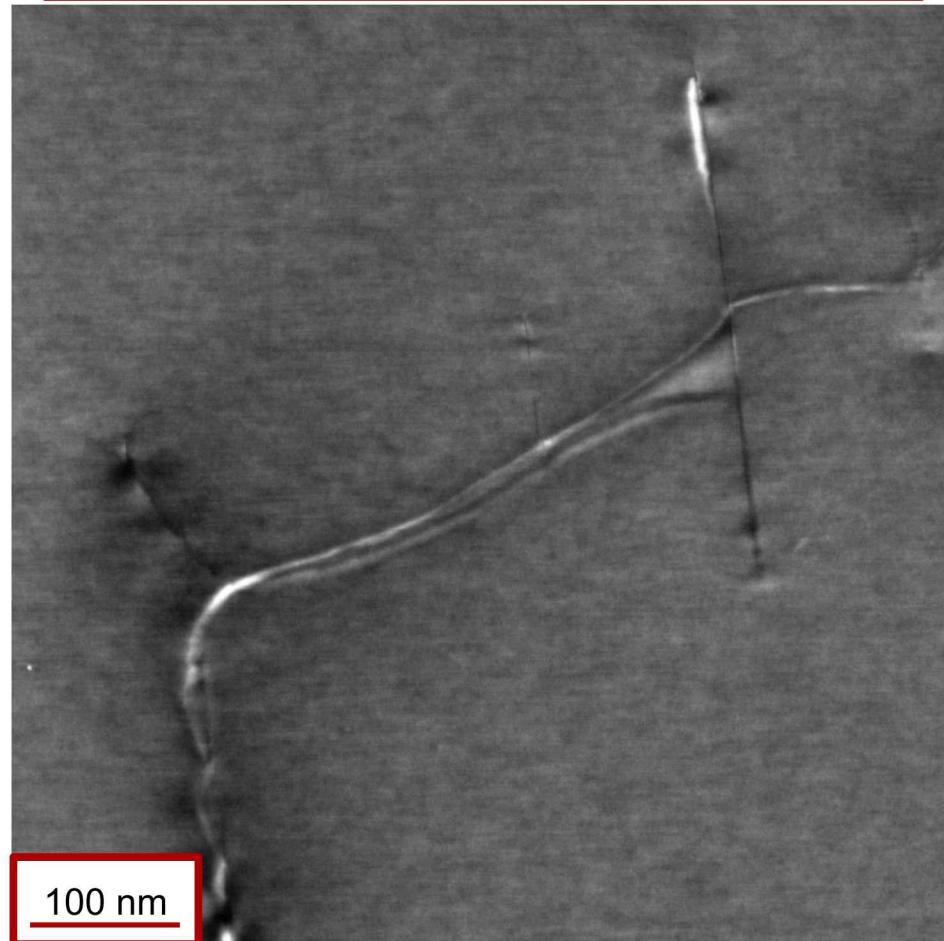
304L Dislocation situated along a twin boundary

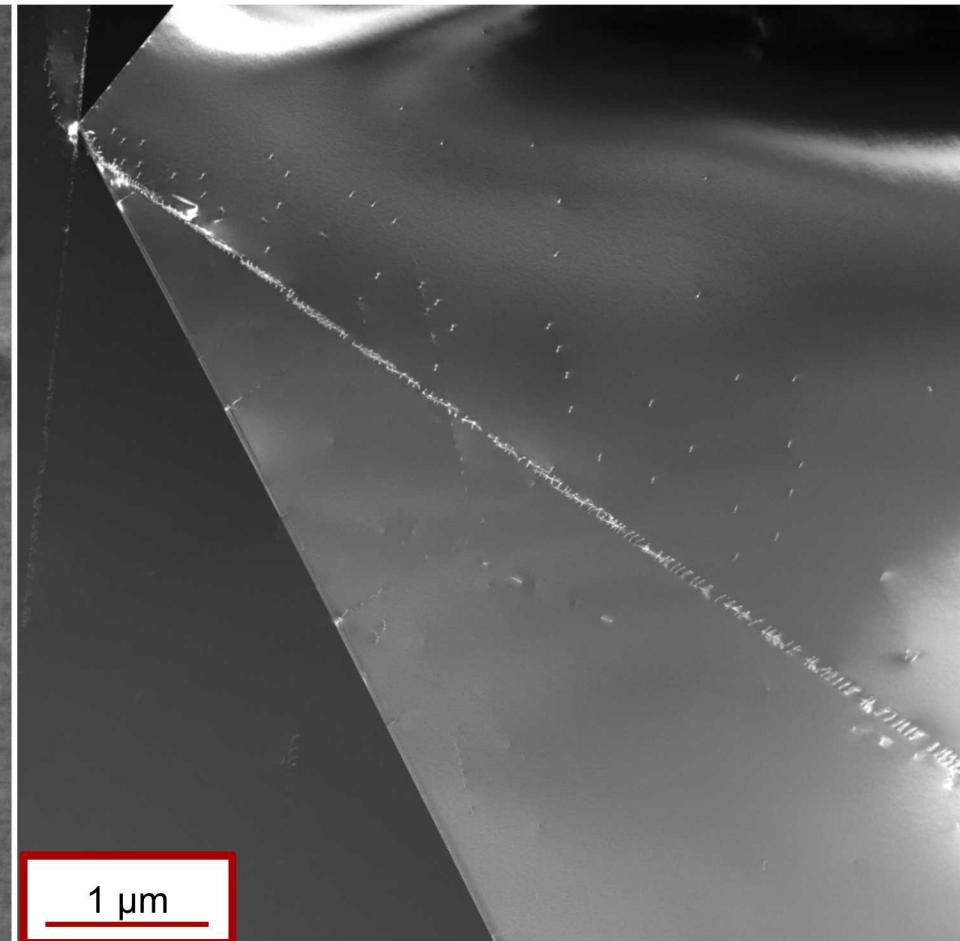
316L Dislocation pileup intersecting a grain boundary

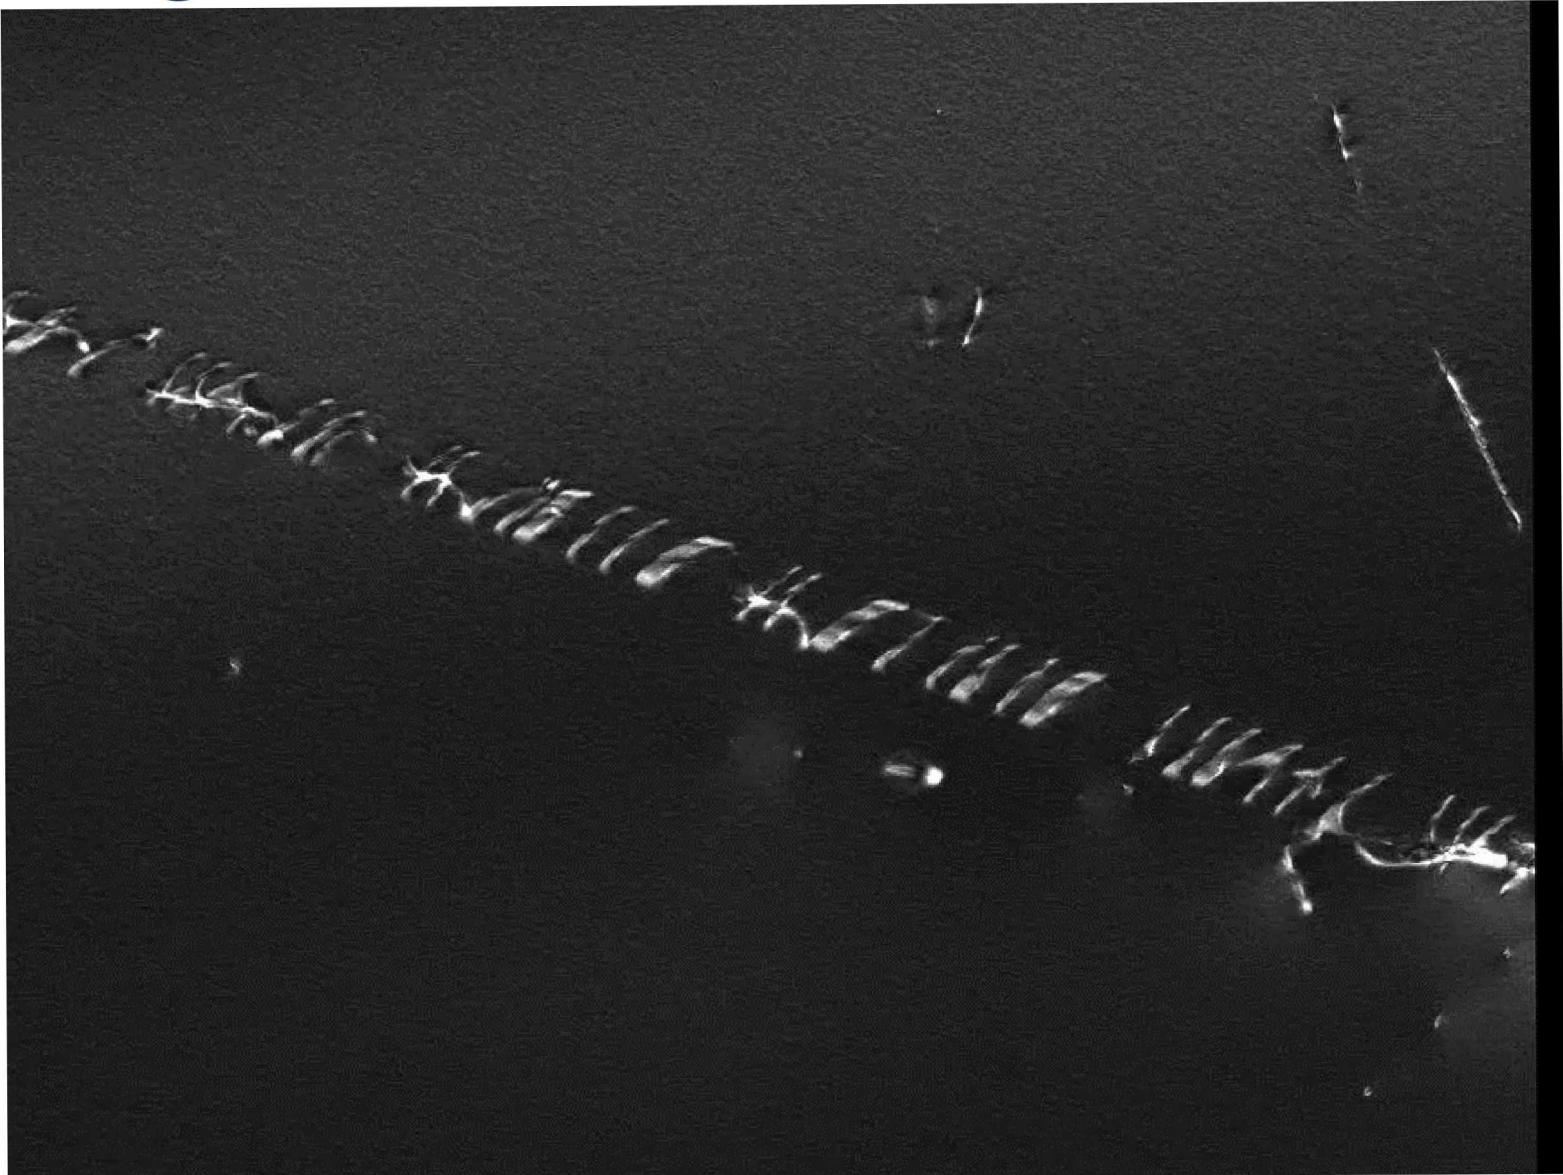
# Continuing Dislocation Tomography

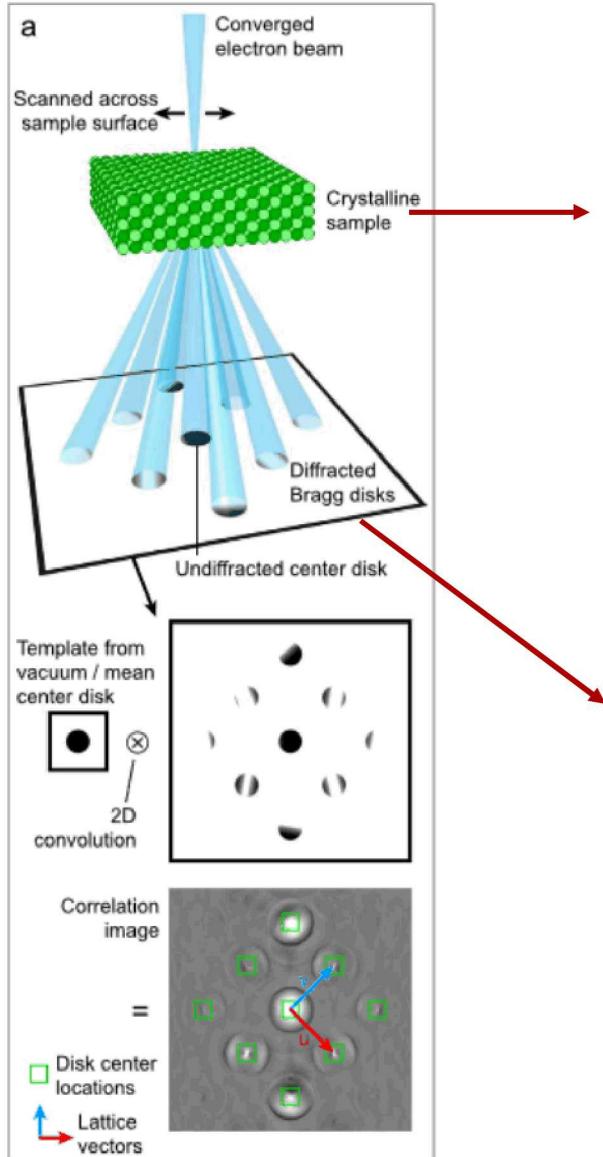
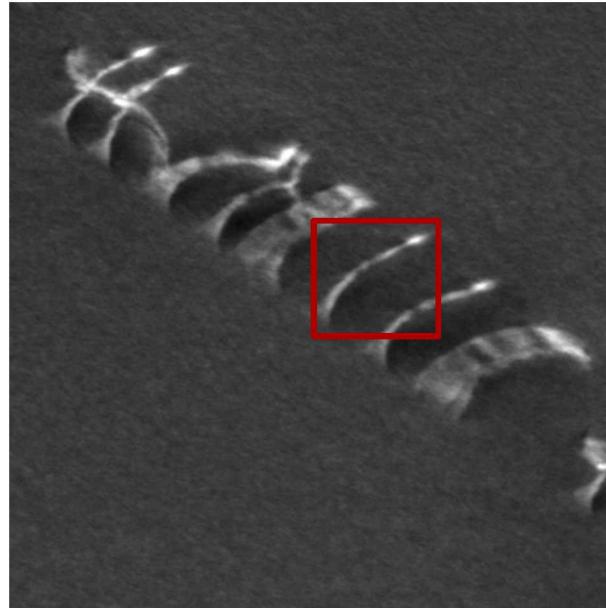
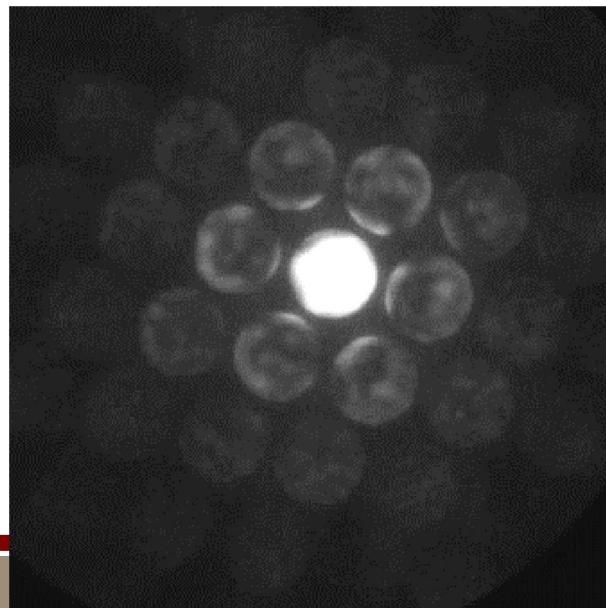
# In-Situ 4DSTEM Measurements

Samples of steel were exposed to hydrogen *in-situ* in a ThermoFisher FEI Titan ETEM at CINT.

These resulting diffraction patterns are to be used to determine the local strain around dislocation cores with and without hydrogen.

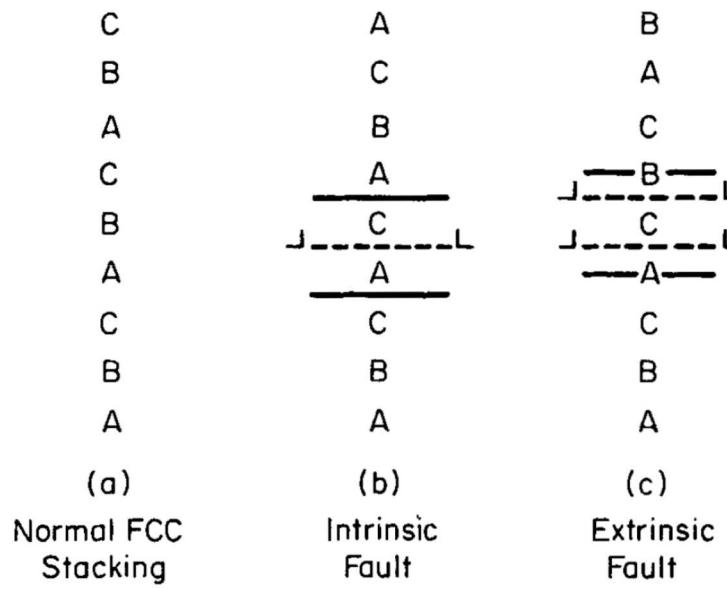
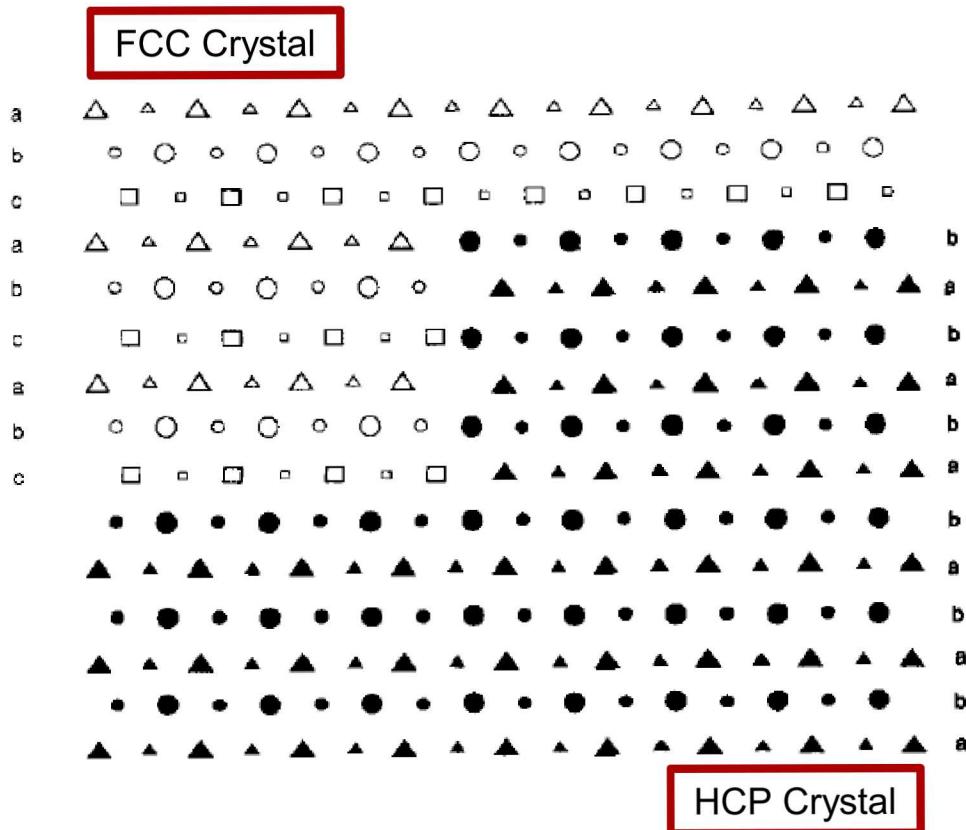
# Background on $\epsilon$ -Martensite Formation
