# Interrogating atomic- and nanoscaled defects of structural metals using advanced microscopy techniques

SAND2020-0536PE

Presented by:  
Julian E.C. Sabisch

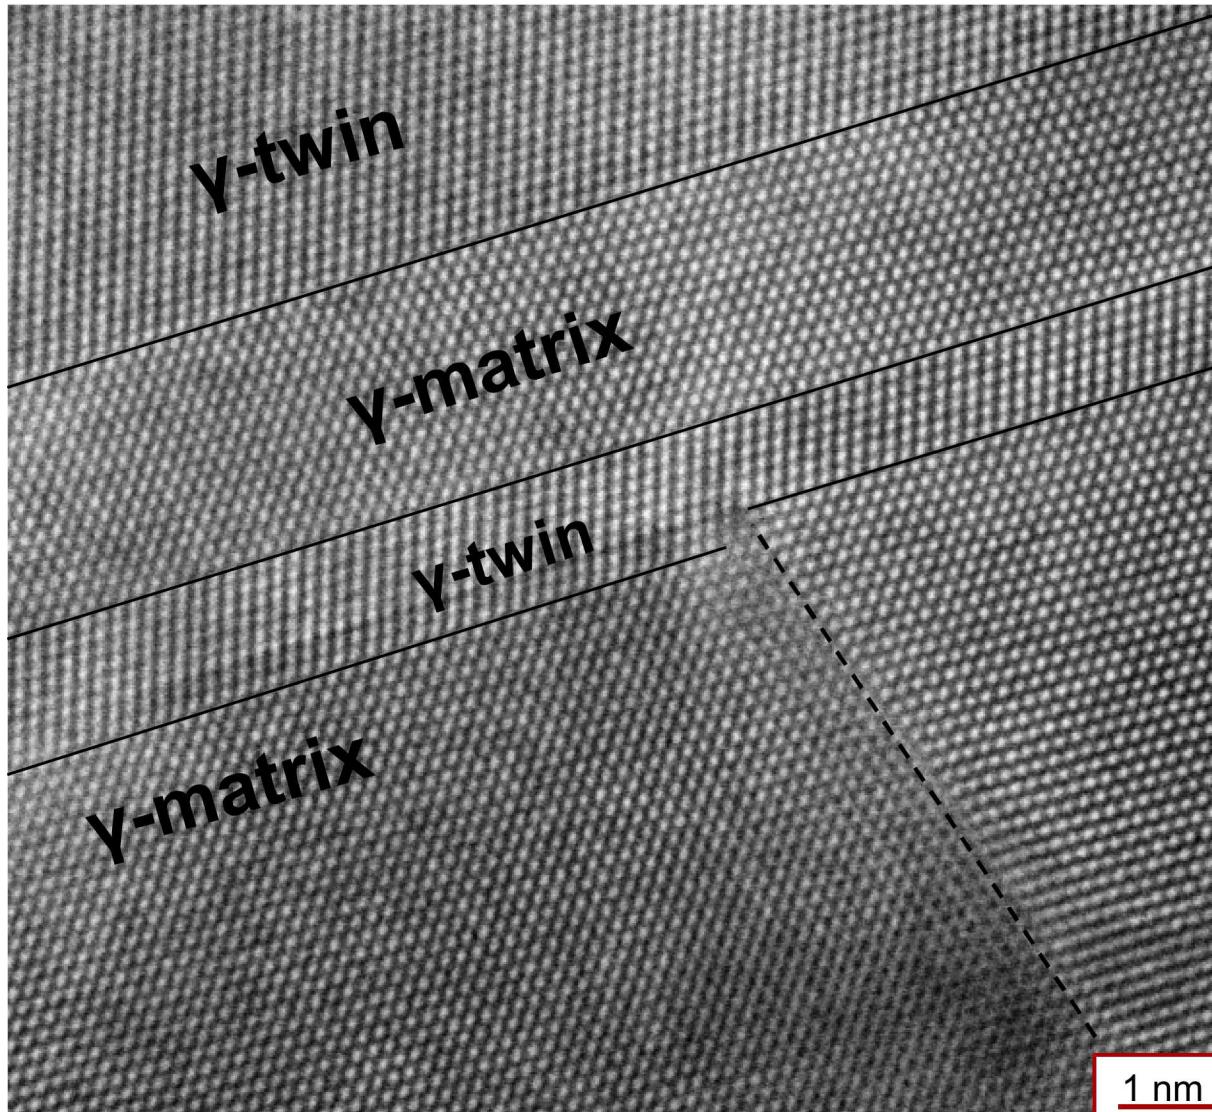
# 5% NC HRSTEM

Characteristic 5% NC HR-STEM image showing Twins and Dislocations

The two dislocations are  $\frac{1}{6}\langle 112 \rangle$  and  $\frac{1}{3}\langle 111 \rangle$ .

HRSTEM shows streaking in DP's are due to stacking faults near the twin boundaries.

Twins and twin vary in thickness, from a few atomic planes to larger regions 1-100 nm thick.

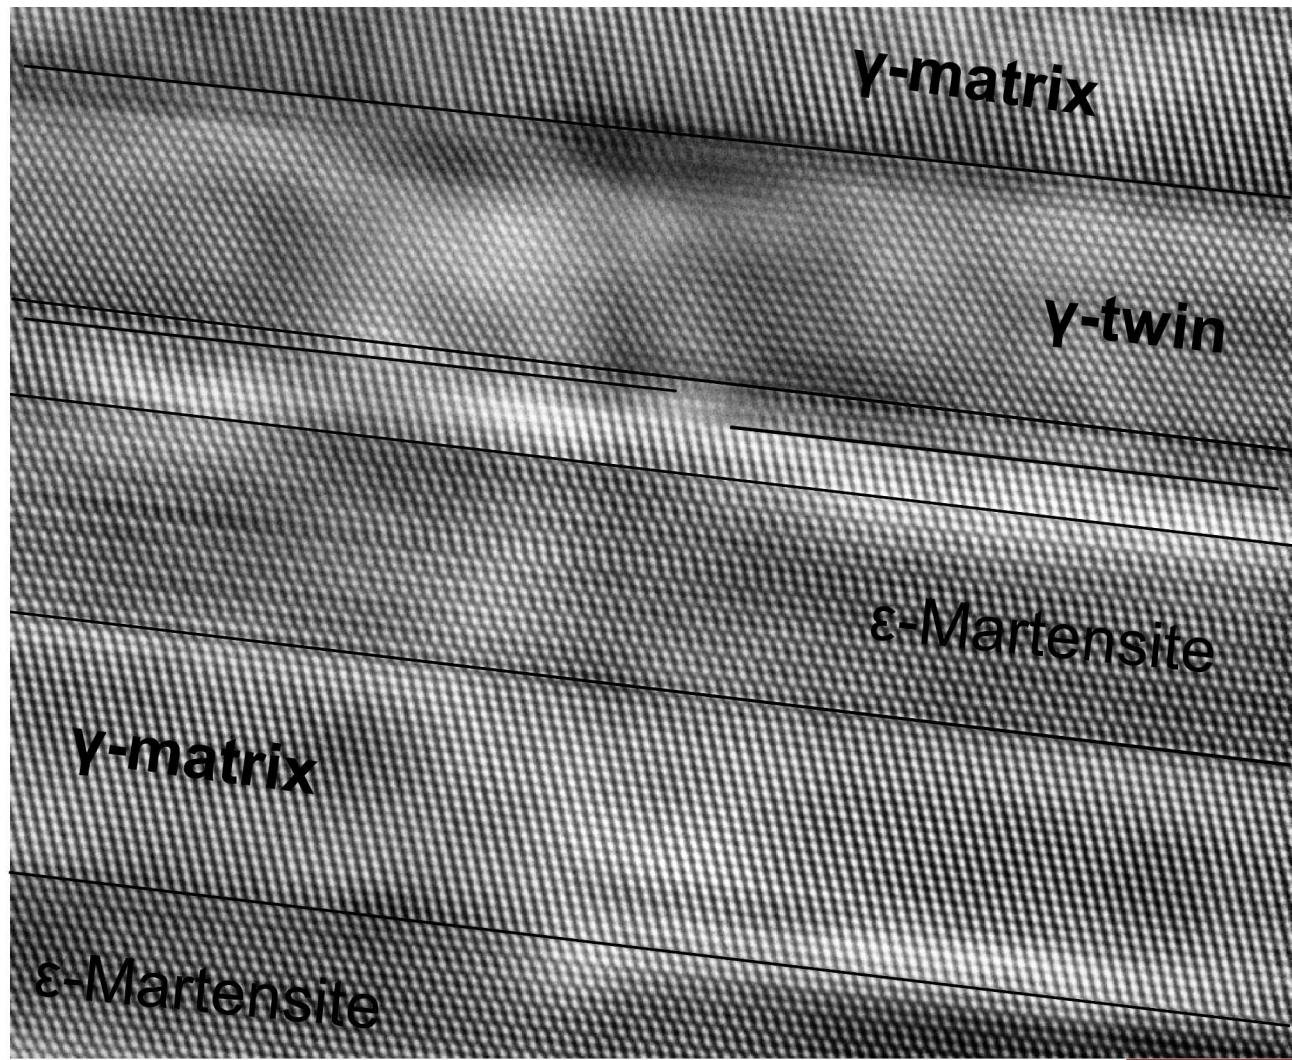
# 5% HC HRSTEM

Characteristic 5% HC HR-STEM image shows  $\varepsilon$ -Martensite and twinning intermixed.

$\varepsilon$ -Martensite is more common here than twinning, as seen in nanobeam diffraction.

Twins and  $\varepsilon$ -martensite are generally very thin (less than  $\sim 20$   $\{111\}$  planes) while spanning through most of the grain.

Twins also appearing within faulted  $\varepsilon$ -martensite.

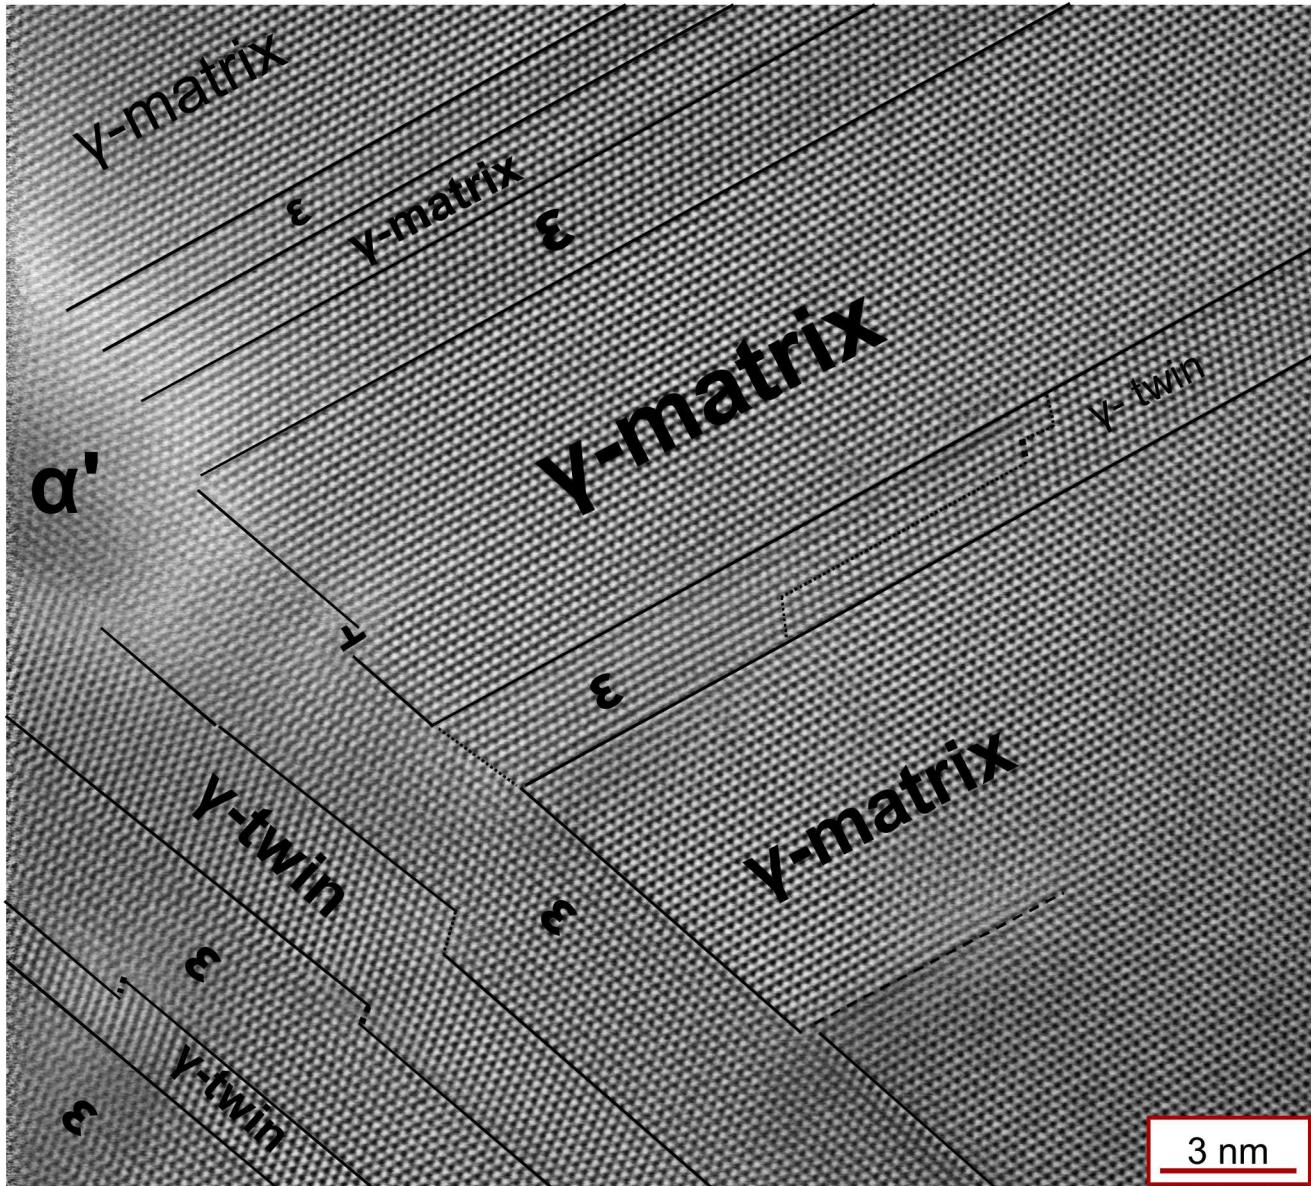
Interfacial dislocations are seen at the boundaries between austenite and  $\epsilon$ -martensite.

Interfacial dislocations appear to be the same as in the 5% strain sample.

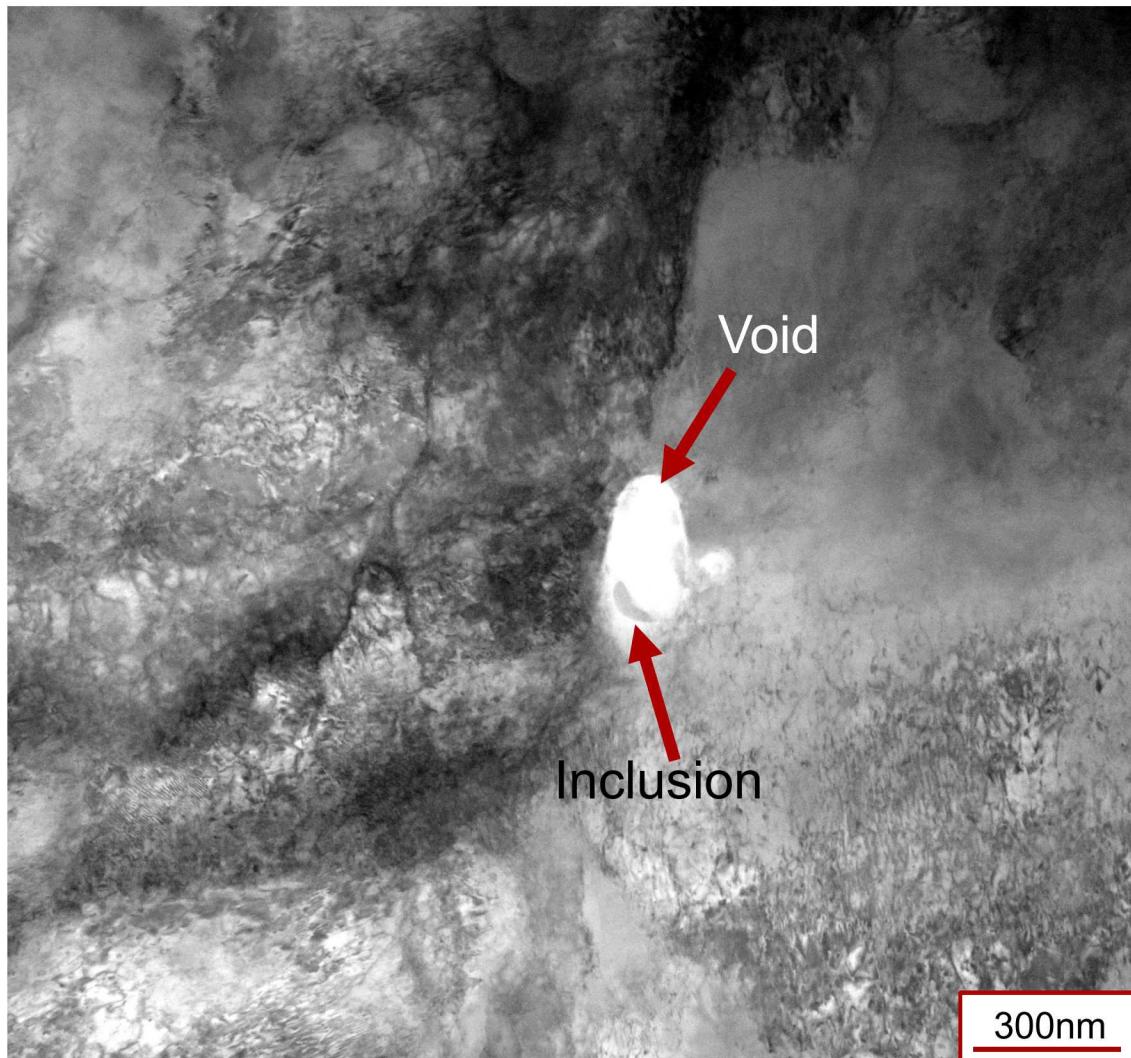
# Void nucleation at 2<sup>nd</sup>-phase particles

- Select diffraction patterns were chosen in order to manually identify the misorientation change surrounding the void.
- Cell block boundaries appear likely to become “diffuse” (not seen a few microns from the void).
- Diffuse boundaries show large misorientation changes ( $>6^\circ$ ) over the span of a few hundred nanometers.
- Misorientations appear larger further from the void.
- Void walls are orthogonal to the {224} and {111} reflections.
- Evidence of a copper oxide particle at the center of a void (discuss with Julian)

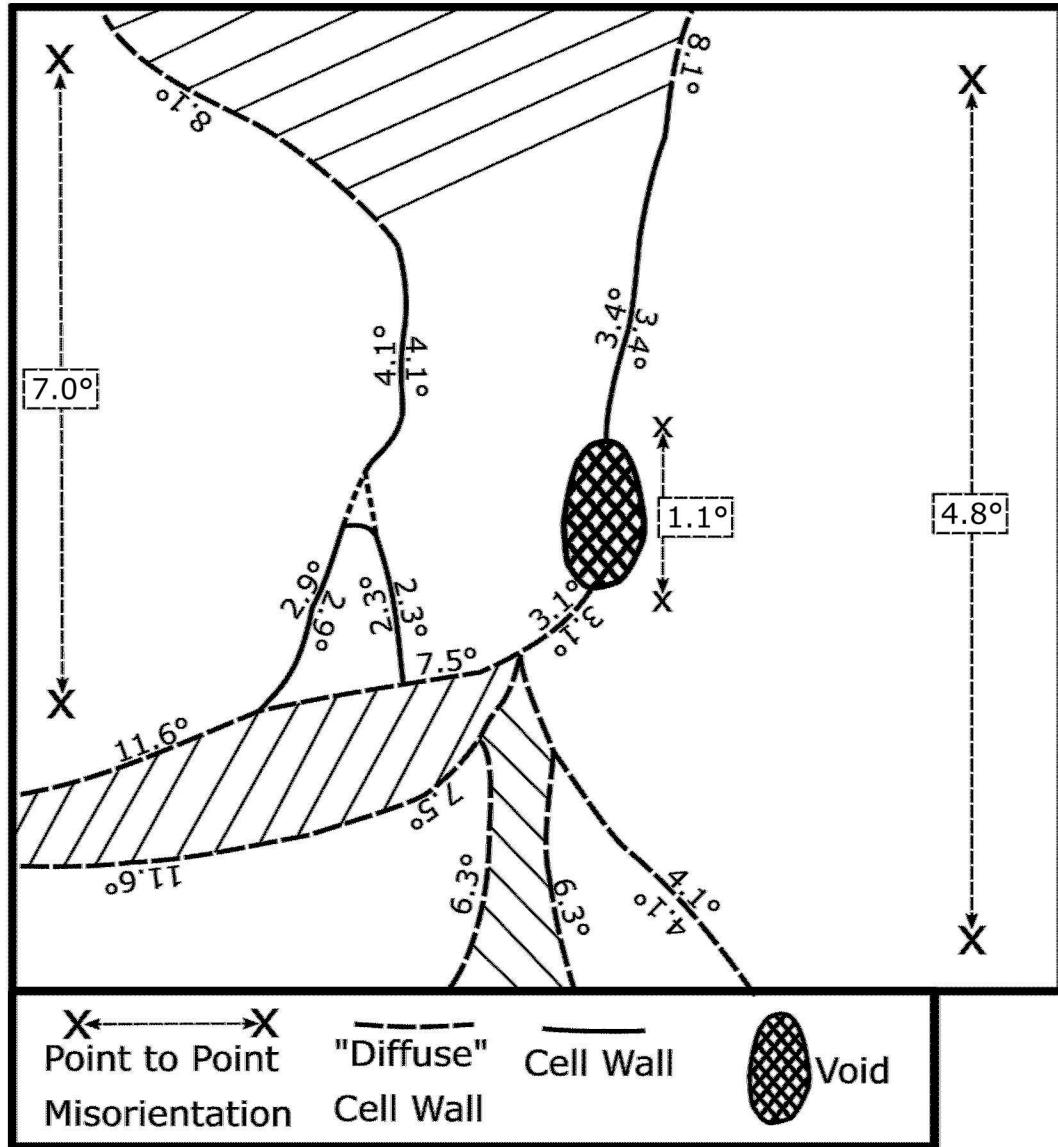
# Void nucleation at 2<sup>nd</sup>-phase particles

- Select diffraction patterns were chosen in order to manually identify the misorientation change surrounding the void.
- Cell block boundaries appear likely to become “diffuse” (not seen a few microns from the void).
- Diffuse boundaries show large misorientation changes ( $>6^\circ$ ) over the span of a few hundred nanometers.
- Misorientations appear larger further from the void.
- Void walls are orthogonal to the  $\{224\}$  and  $\{111\}$  reflections.
- Evidence of a copper oxide particle at the center of a void (discuss with Julian)

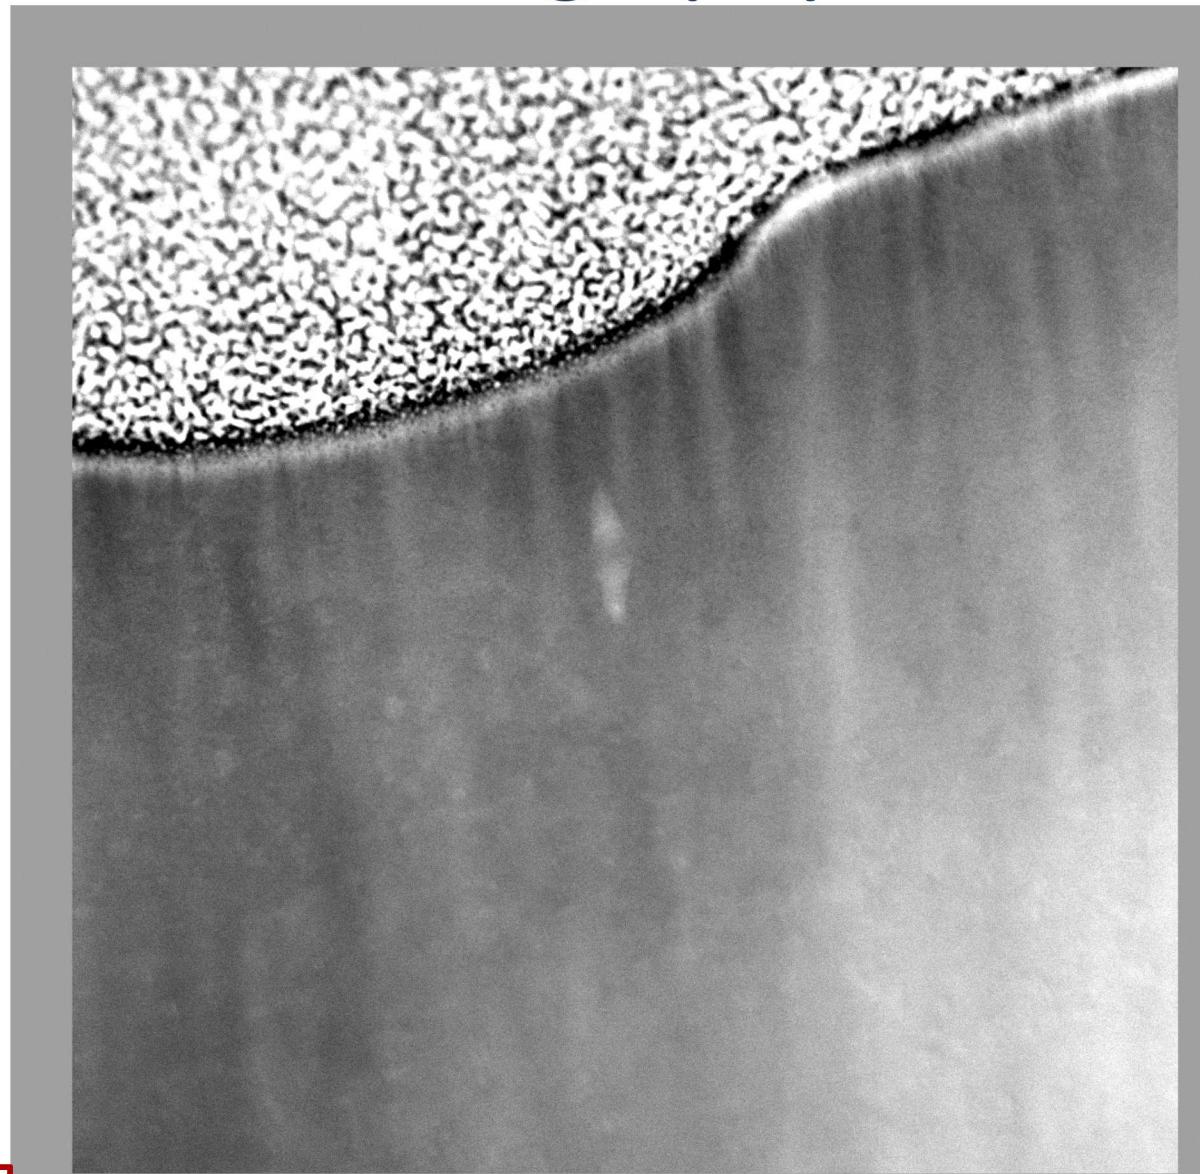
# Fillet Sample Control Tomography

Fillet samples show extremely little mass-thickness contrast. Some surface damage is visible at the extreme tilts. The feature in the center is due to the beam depositing some material.

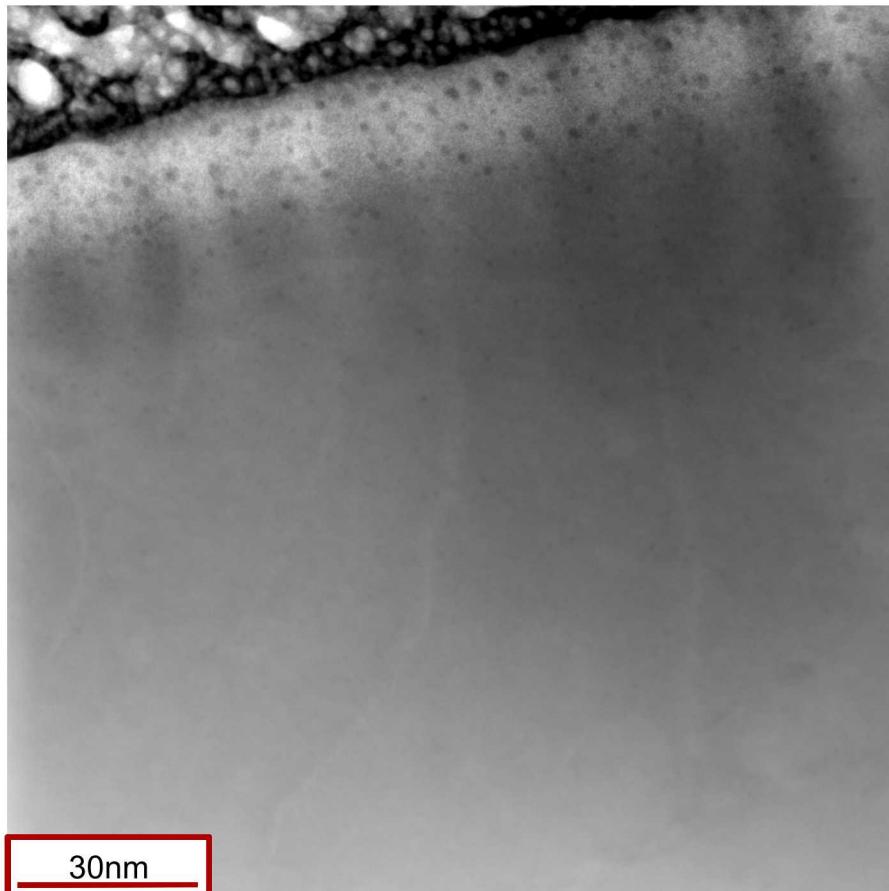
Sample A Neck

Small (~3nm) voids-like contrast appears in the  $\text{Ga}^+$  rich surface region for both Fillet control samples and samples from the Neck.
