Mechanical Behavior of D-Shaped Hipercó Specimens under Tension Measured by Digital Image Correlation

Edward Chu, Jay Carroll, Aron Robbins
Sandia National Laboratories

Abstract

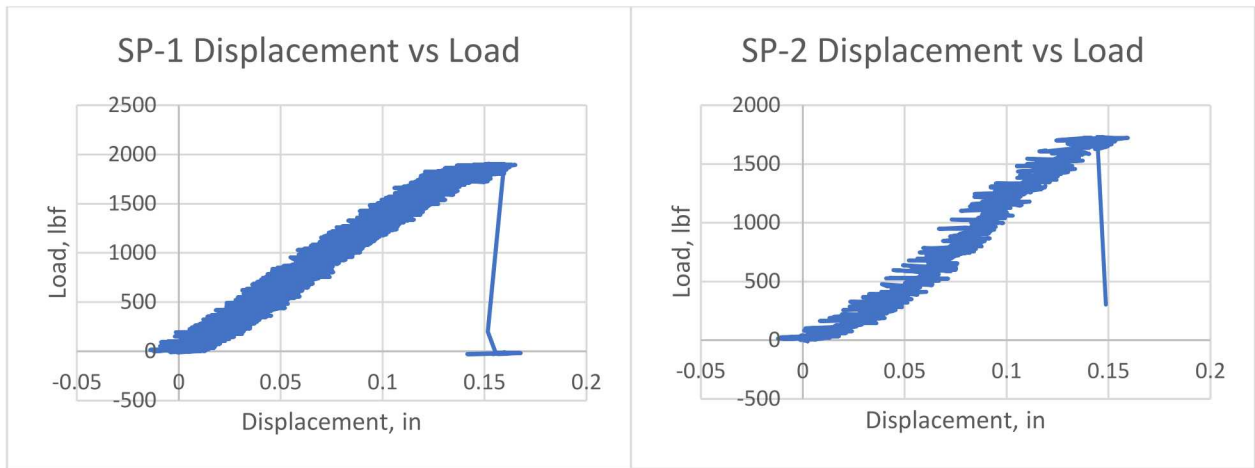
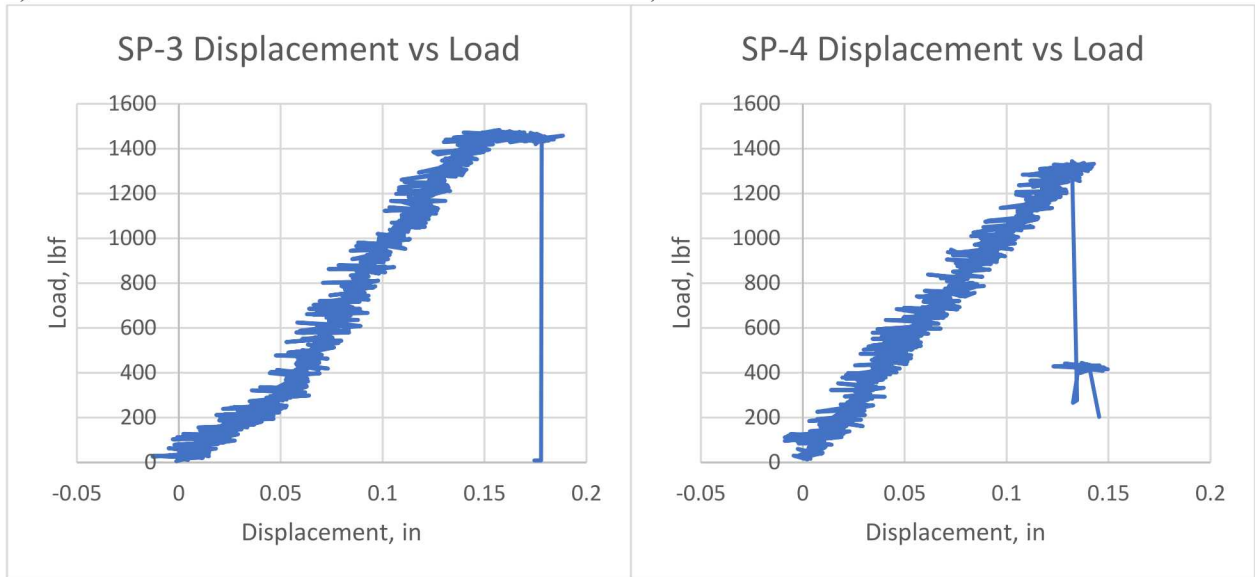
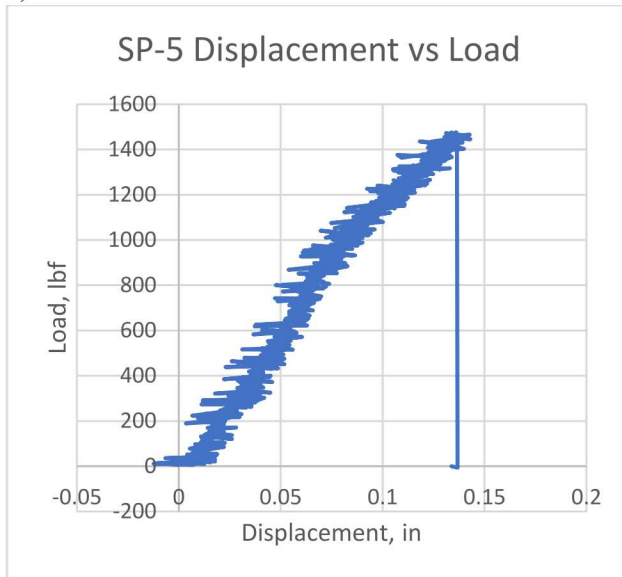
Figure 9. Displacement-load curves.

Because stress and strain are not easily quantifiable in these experiments, machine displacement vs. load curves taken directly from load cell data are given below as analogs.
