NUREG/CR-6340
BNL-NUREG-52463

Aging Assessment of Surge Protective Devices in Nuclear Power Plants

Prepared by
J. F. Davis, M. Subudhi, D. P. Carroll

Brookhaven National Laboratory

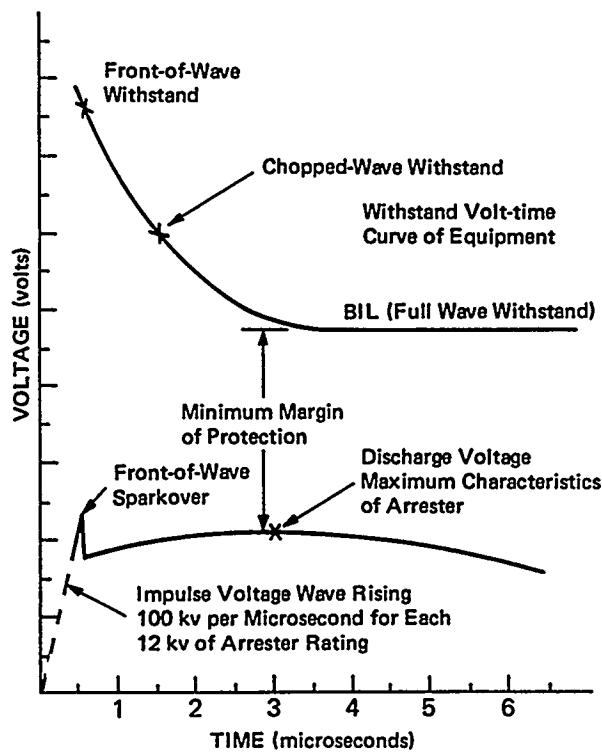
Figure 2.1 Typical transformer BIL vs. arrester operation

Figure 2.1 (Ref. 2.4) is typical of the arrester protection afforded to a high voltage transformer by a gapped silicon-carbide arrester. The transformer insulation has to withstand the impulses of lightning surges, switching surges, and temporary overvoltages. Its insulation strength is expressed in terms of the withstand voltage that it can resist without failing, and is commonly referred to as the basic impulse insulation level (BIL). The arrester discharge characteristic as a function of voltage (which may only be 20% higher than nominal voltage before it conducts) as a function of time in microseconds is shown below the insulation withstand curve. The difference between the curves is the level, or margin, of protection. There is some flexibility in specifying the level of protection in the actual design of transformer insulation and protection requirements of the arrester.

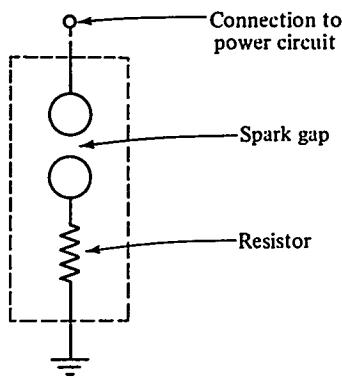
Figure 2.2 A basic surge arrester

The resistor limits the current flow, avoiding the effect of a short circuit. When the overvoltage condition has passed, the arc in the gap ceases, thus disconnecting the arrester from the circuit. If the arc does not go out, current continues to flow through the resistor, and both the resistor and the gap may be destroyed.

Surge arresters, also known as lightning arresters, are devices that protect electrical equipment by limiting overvoltages from lightning strikes (Ref. 2.20). Ideally, a surge arrester is off-line under normal operation, switches on-line when the transient voltage is approximately 20% above normal value to ensure that it does not exceed this value regardless of the nature or source of the overvoltage, and switches off-line when the disturbance is past and normal voltage has been restored. The basic form of a surge arrester consists of a spark gap connected in series with a resistor (Figure 2.2). The gap is set at a sparkover value greater than the normal line voltage; hence, the gap is normally non-conducting. When an overvoltage occurs, the gap sparks over, and then the voltage across the arrester terminals is determined by the current flowing through resistance of the arrester.

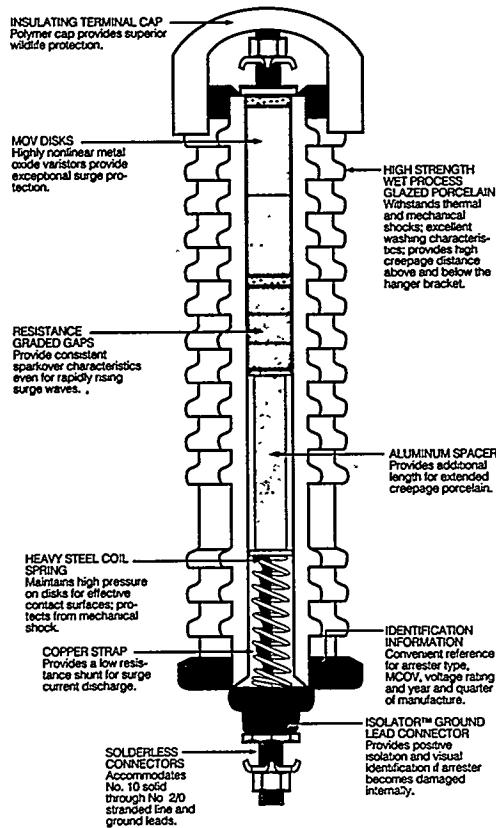
Figure 2.3 Design features of typical distribution-class surge arrester
(Permission to use copyrighted material granted by Cooper Power Systems)

Figure 2.3 shows various components of a distribution-class gapped metal-oxide varistor surge arrester (Ref. 2.21). The arrester is structurally supported by the bracketed porcelain housing which also protects the internal parts from the atmosphere and acts as external insulation. Internally, valve arresters consist of a resistance-graded gap and valve material (the word "valve" is so named because it exhibits a valving action to the flow of system current; arresters using such valve blocks are called valve arresters). The resistance-graded gap provides a consistent sparkover characteristic from the various surge wavefronts it confronts and insulates the line from the ground under normal operating conditions. The valve material can carry high lightning-surge current with a resulting low discharge voltage; however, it offers high impedance to power-frequency follow current.

When a lightning strike produces a transient voltage surge on the line conductors, the air in the arrester gap becomes ionized. When the air's dielectric strength breaks down, the resistance of the gap drops to zero, the gap sparks over, the surge voltage is placed across the valve blocks, which exhibit low resistance at high voltage, allowing surge current to pass easily to ground.

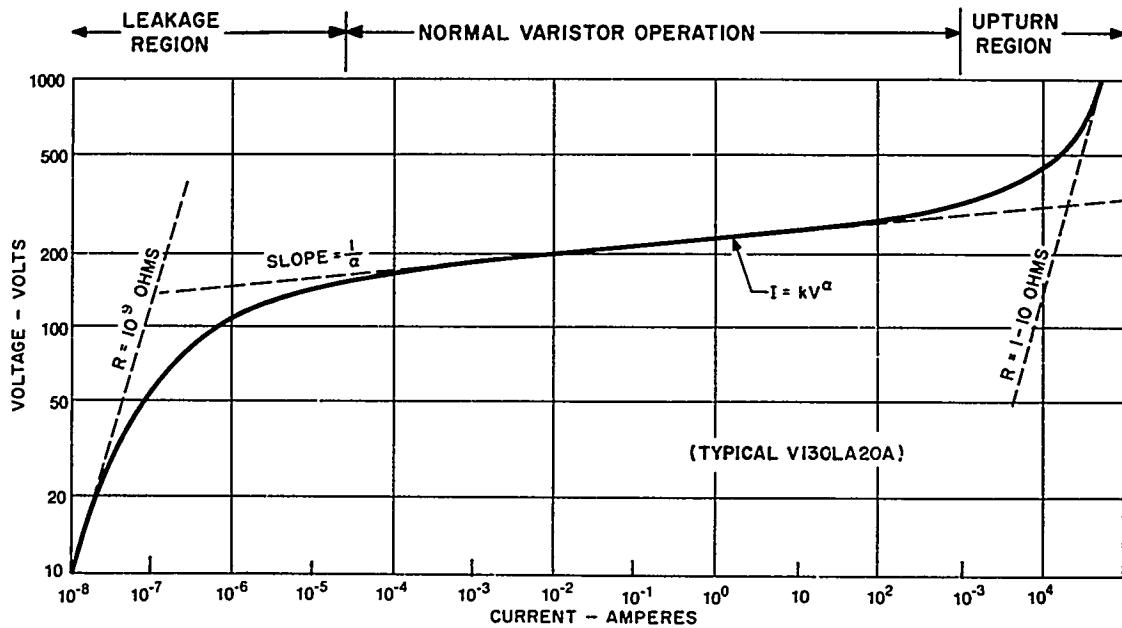
Figure 2.4 Typical V-I curve for metal-oxide arrester plotted on log-log scale
(Permission to use copyrighted material granted by HARRIS Corporation, 1995)

Figure 2.4 shows a typical voltage-current (V-I) characteristic curve of a metal-oxide surge arrester (Ref. 2.22). At normal voltage, the arrester behaves like a simple resistor with a very small leakage current (less than 0.1 mA). At very high voltages, its response is dominated by the bulk resistance of the device. In between, it obeys the voltage-current relationship, $I=kV^\alpha$. The value of α characterizes the nonlinear V-I characteristic. An ordinary resistor would have $\alpha=1$. Mixed-oxide arresters have values of α between about 25 and 60, while silicon carbide arresters are around 4. A general rule, the greater the value of α , the better the arrester.

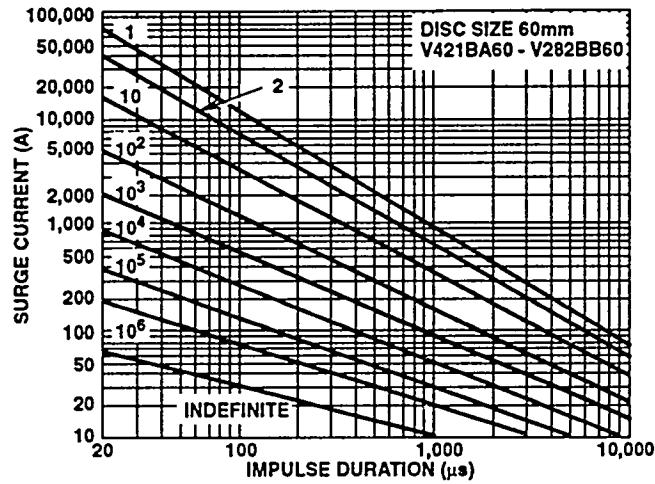
Figure 2.5 Pulse ratings for metal-oxide varistor plotted on log-log scale
(Permission to use copyrighted material granted by HARRIS Corporation, 1995)

The lifetime of a varistor, whether a gapped silicon carbide or a gapless metal-oxide, is a function of the accumulated energy absorptions it was "pulsed" with before it fails its warranty. A plot of peak pulse current against impulse duration for a typical metal-oxide varistor is shown in Figure 2.5 (Refs. 2.22, 2.23). The model varistor shown can take a single peak pulse current of 80,000 A for 20 microseconds, or about 1000 pulses of 2,000 A for 20 microsecond impulses. Although the engineer has some latitude in determining the pulse lifetime for the calendar life of the varistor, the limiting requirement is likely to be the specification of lightning surges rather than switching transients.

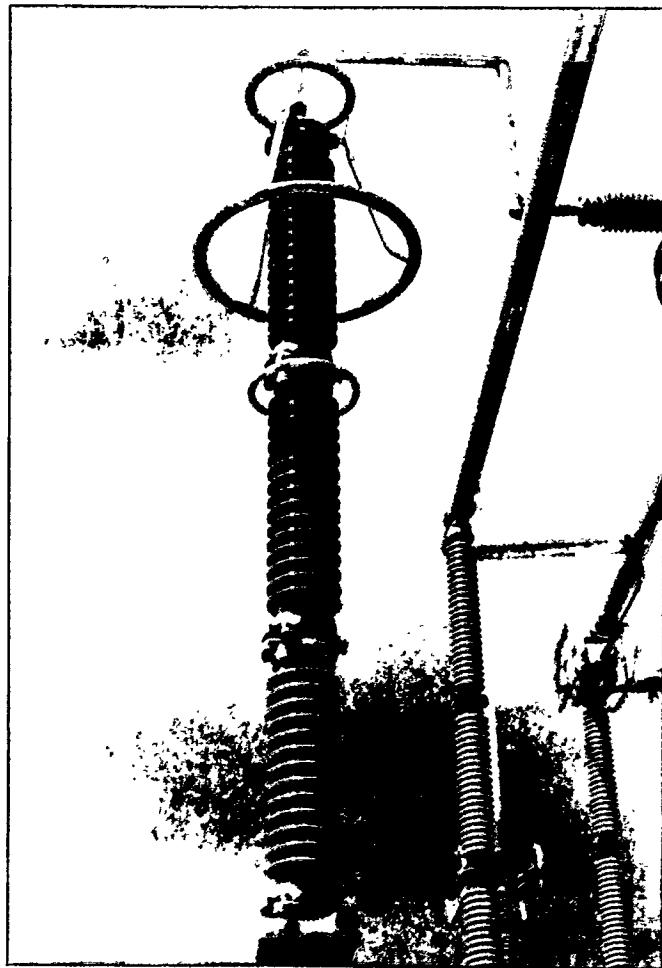
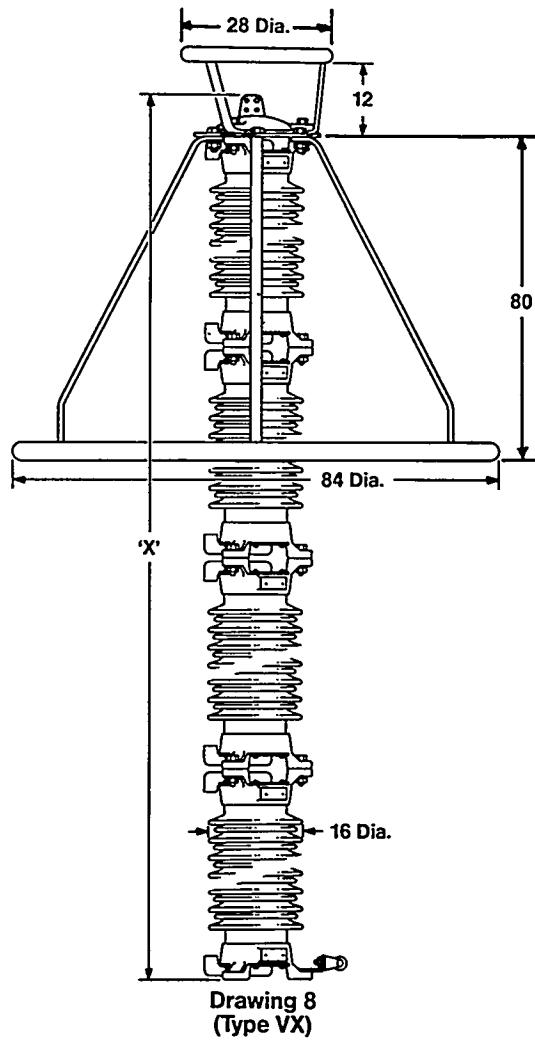
Figure 2.6 Typical porcelain-housed station class metal-oxide surge arrester
(Permission to use copyrighted material granted by Hubbell/The Ohio Brass Company)

As identified at the bottom of Table 2.2, only two types of surge arresters are found at nuclear power plants: (1) gapped silicon carbide surge arresters; and, (2) metal-oxide surge arresters. A typical station class arrester is shown in Figure 2.6 (Ref. 2.24).

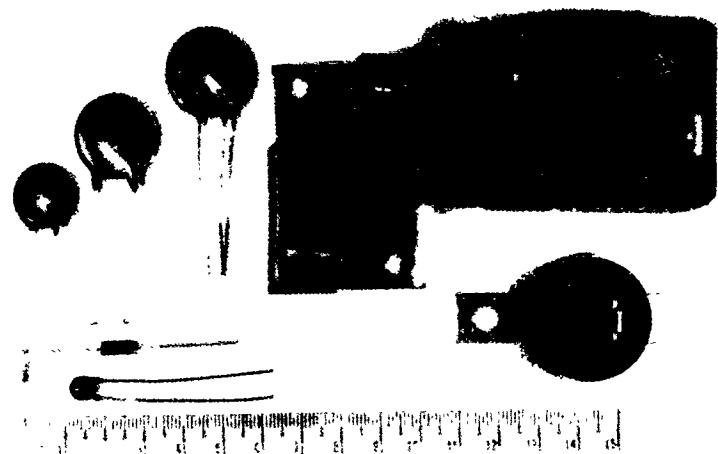
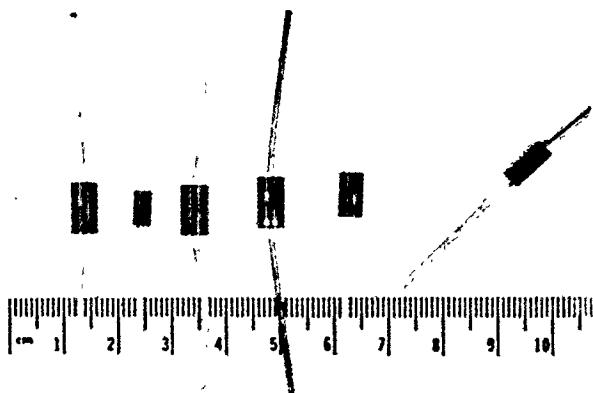
**Metal-Oxide
Surge Suppressors**

Avalanche Diodes

Spark Gaps

Figure 2.7 Typical surge suppressors
(From Protection of Electronic Circuits from Overvoltages,
Ronald B. Standler, John Wiley & Sons, 1989 Reprinted by
Permission of John Wiley & Sons, Inc.)

Table 2.2 shows that there are many types of surge suppressors in nuclear power plants; typical examples are shown in Figure 2.7 (Ref.2.9). In low-voltage surge protection there are two major categories of transient suppressors: (a) those that attenuate transients, thus preventing propagation into the sensitive circuits; and (b) those that divert transients away from sensitive loads to ground and so limit the residual voltages. The filter, generally of the low-pass type, attenuates the transient (high frequency) and allows the signal or power flow (low-frequency) to continue undisturbed. A filter is an example of an isolator device. Diverting a transient to ground is accomplished with a voltage-clamping device or with a crowbar type device. With the former, the circuit is unaffected by the presence of the device before and after the transient for any steady-state voltage below the clamping level; typical devices are metal-oxide varistors, avalanche diodes or avalanche junction semiconductors, switching and rectifier diodes (as shown in Table 2.2) and also silicon carbide varistors, reverse selenium rectifiers, and zener diodes. Crowbar-type devices involve a switching action, either the breakdown of a gas between electrodes or the turn-on of a thyristor. After switching on, they offer a very low impedance path which diverts the transient away from the parallel-connected load. Gas tubes (also called "spark gaps") are carbon-block protectors that belong to this type and have been widely used in the communication field where power-follow current is less of a problem than in power circuits. In some applications, a clamp and crowbar may be used to protect an electronic circuit, e.g., by combining a spark gap in series with a silicon carbide varistor to obtain a tight clamping voltage.

VDC. The metal-oxide varistors and avalanche junction semiconductor surge suppressors (which are clamps) simply limit the voltages, whereas the gas tube arresters (which are crowbars) exhibit steep negative-resistance characteristic clamp voltages well below their striking potentials. The current capability distinction between clamps and crowbars has important implications in circuit design. Crowbars cope with extremely high surge currents, while clamps are generally less well equipped to deal with them. But crowbars reflect a higher percentage of incident energy back into the circuit, while clamps dissipate more energy on the spot.

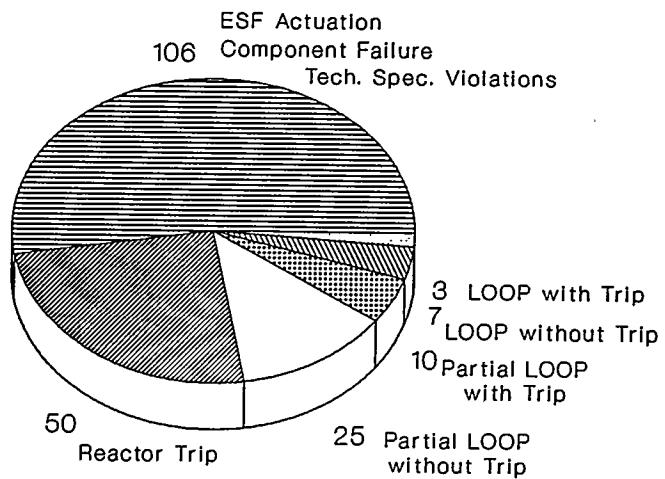
**Figure 3.1 Effect of lightning strikes on nuclear power plants
LERS and NPRDS: 1980-1994**

In Appendix A, Tables A.1 through A.7, there are 201 events obtained from LERs and NPRDS records from 1980 to 1994 that are related to lightning; Figure 3.1 summarizes this information. Of the 201 events, there were: (a) 10 losses of all offsite power (LOOP) and 3 of which caused reactor trips; (b) 35 partial losses of offsite power with 10 resulting in reactor trips; (c) 50 reactor trips without prior loss of offsite power; and, (d) 106 engineered safety-feature actuations or technical specification reporting requirements for failures (usually environmentally related), or component failures or upsets not requiring an LER report. Sixty-three reactor trips were attributable to lightning from 1980 till the end of 1994 and 45 complete and partial losses of offsite power. The distributions are shown in Figures 3.2 and 3.3. Figure 3.4 overlays the reactor trips that occurred concurrently with losses of offsite power using the combined totals of complete and partial LOOPS. During the 15 year period, 1980 to 1994, there was a 30% chance the reactor would trip given a complete LOOP, and a 29% chance that the reactor would trip given a partial LOOP. Hence, there is about a 30% chance the reactor would trip given any type of LOOP caused by lightning. (Other weather-related correlations may be different).

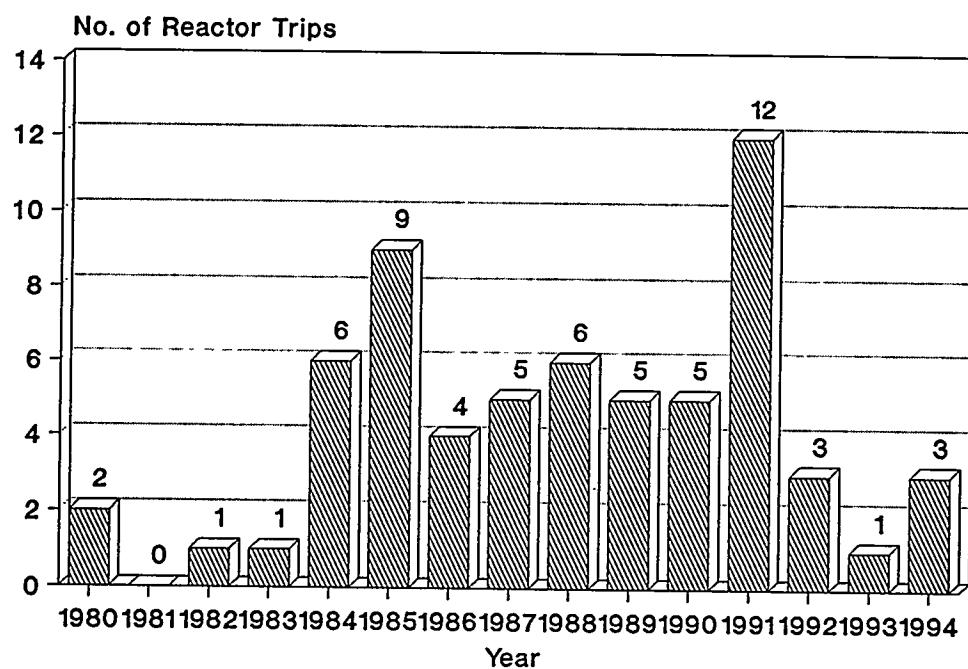
Figure 3.2 Lightning caused reactor trips (1980-1994)

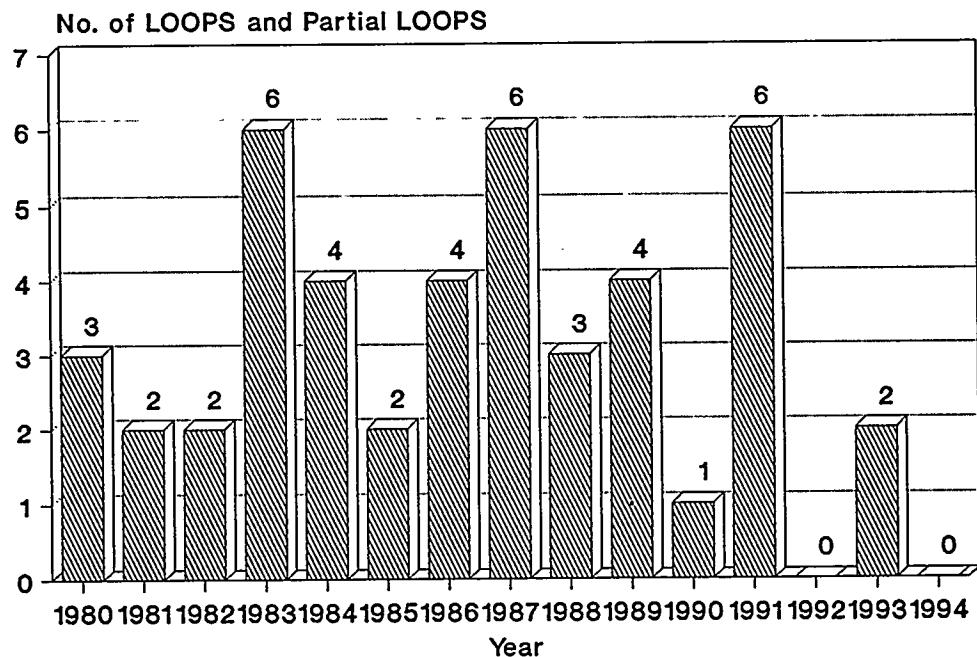
Figure 3.3 Lightning caused losses of offsite power (1980-1994)

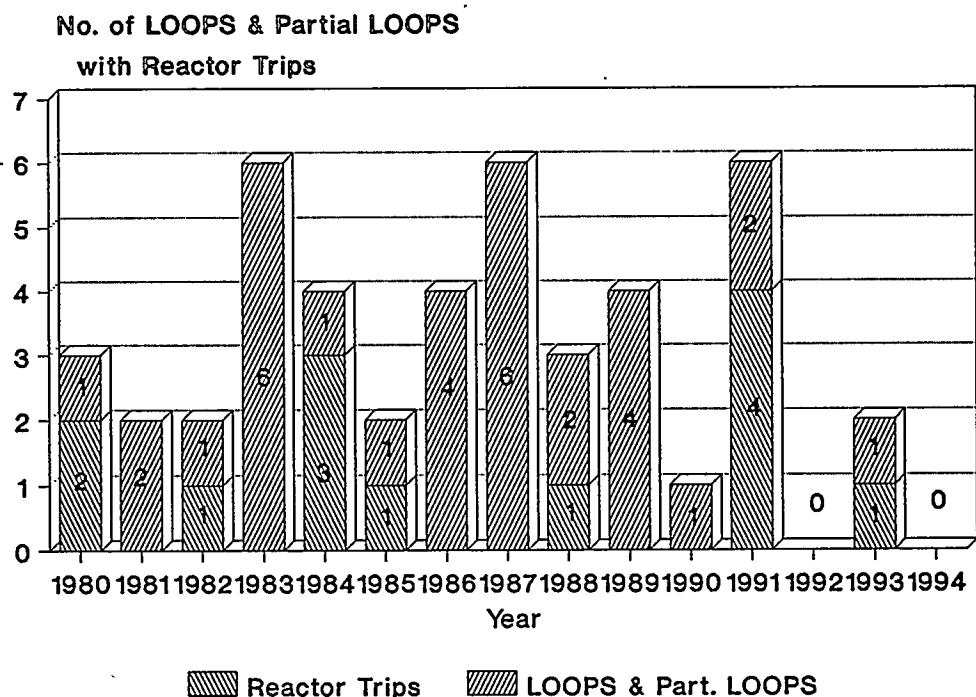
Figure 3.4 Coincident reactor trips with losses of offsite power

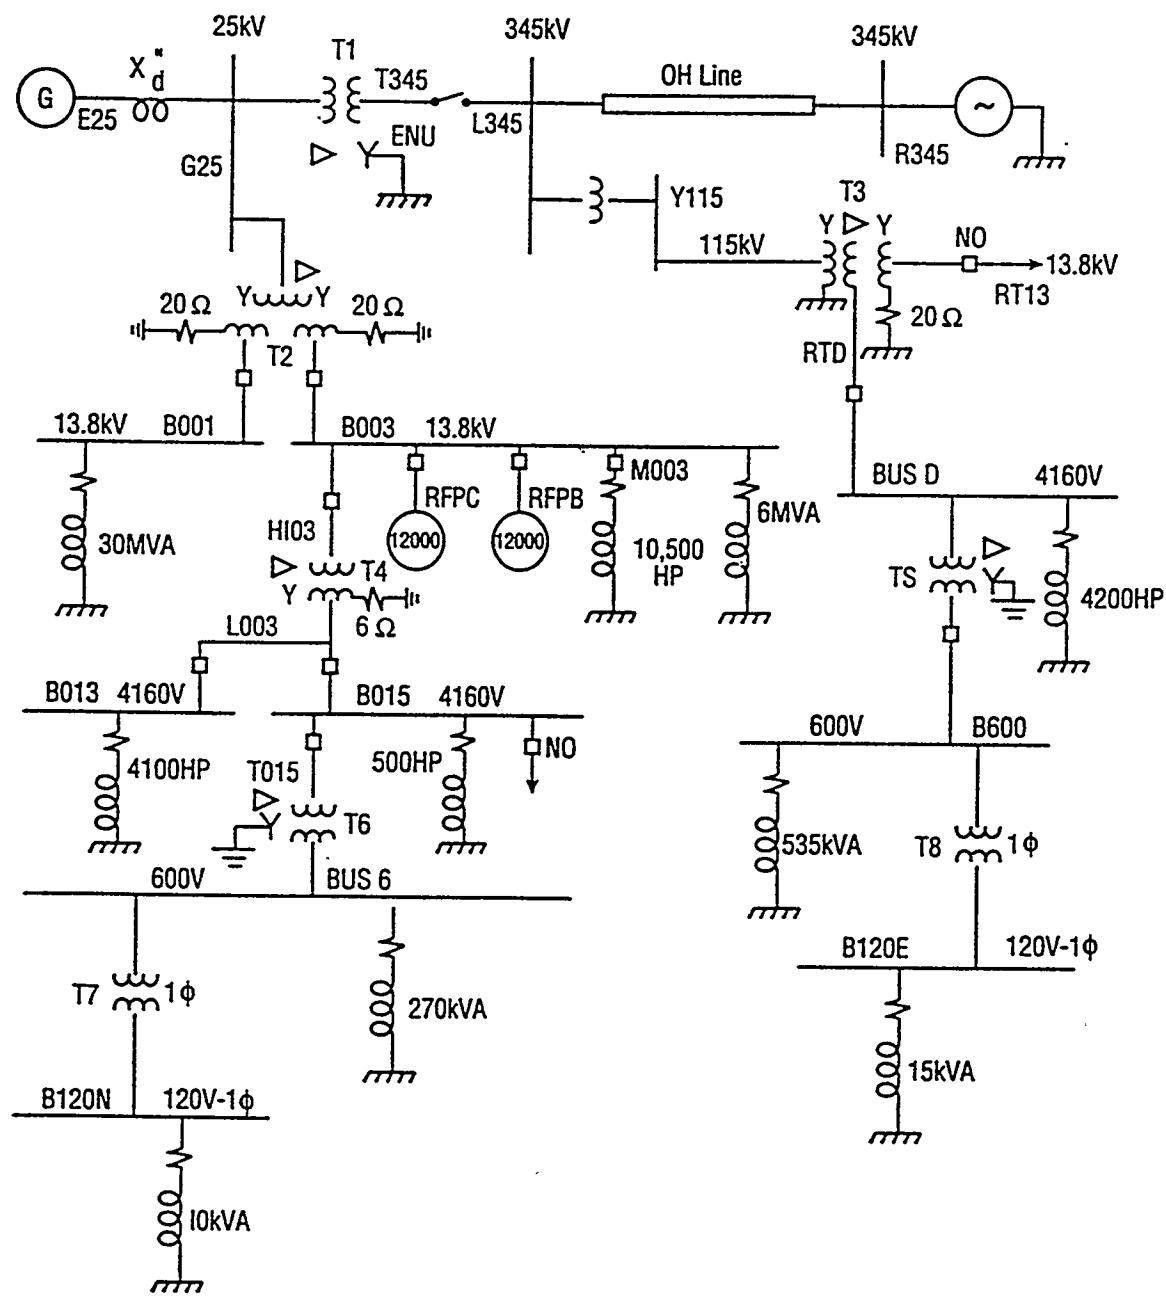
Figure 5.1 EMTP simulation model

Figure 5.1 is a simplified EMTP simulation model used in the surge arrester operation studies (Ref. 5.2), and represents the essential features of both safety and non-safety related systems. The normal operating system configuration includes the normal station-service transformer which feeds the non-safety related network, and the reserve station-transformer feeding the safety-related emergency system. Both the normal and reserve transformers were modelled in full three-phase winding detail, including losses, leakage reactance, winding capacitance, and magnetic saturation. Though the two systems are not coupled; the potential for coupling is provided at the transmission level in the offsite power system.

For the non-safety related system, the normal station-service transformer feeds the 13.8 kV buses B001 and B003. Bus B003 supplies two 12,000 HP pump motors, a static equivalent of several other motors, and a static equivalent of several 600 V loads connected through the 13.8 kV/600 V delta-wye transformers. The 12,000 HP motors are modelled in full transient detail as three-phase rotating machines, including losses, magnetizing current, and rotor/load inertia. Bus B003 also feeds two 4.16 kV buses (Bus B013 and B015) through a delta-wye transformer. These buses are loaded with static

equivalents of several additional motors, and Bus B015 also feeds a 600 V bus (BUS6) through another delta-wye transformer. In turn, BUS6 supplies a 270 kVA static equivalent load, and feeds a 120/240 V bus (B120N) through a single-phase transformer, which supplies power to fire protection panels and miscellaneous control circuits.

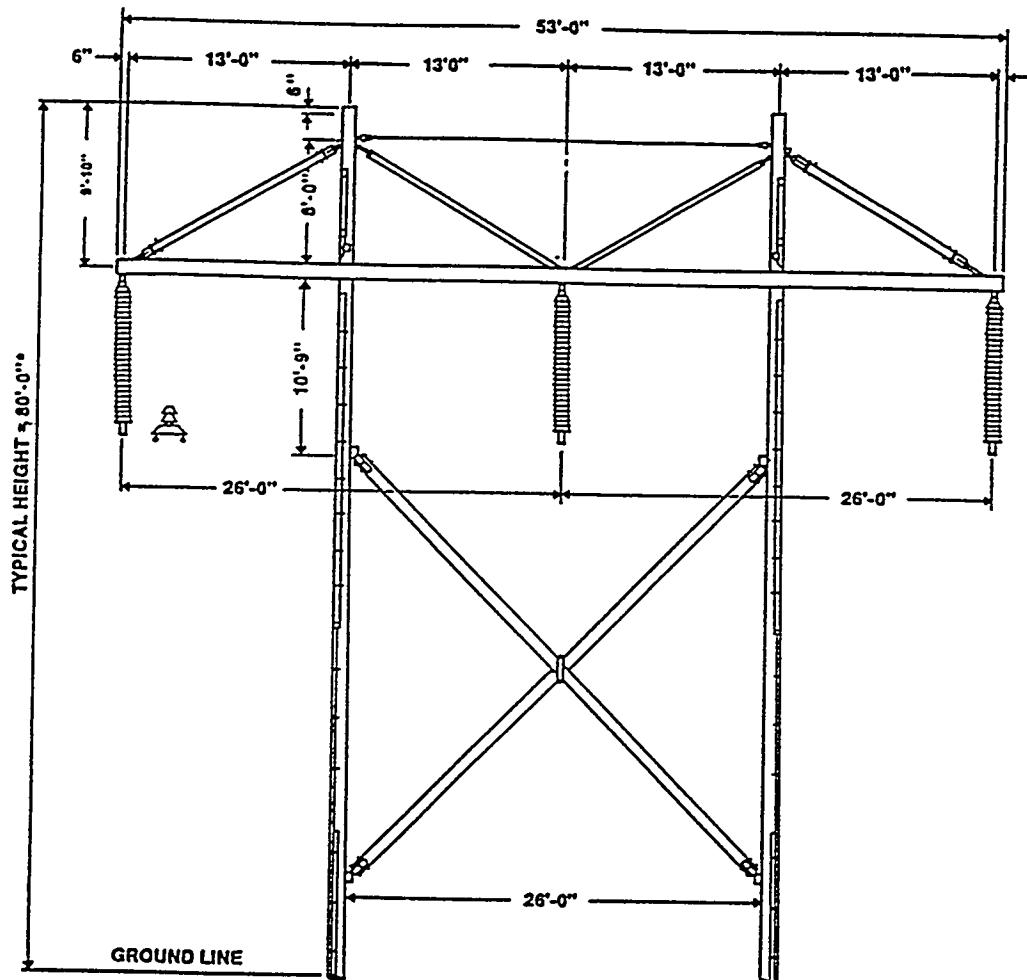
Fig. C-1. Typical 345 Kv transmission tower and conductor layout.

ACSR conductor data: Twin bundle per phase (18" separation)
1.302" outside diameter (Bunting 45/7)
0.326" core diameter
21 ft sag at midspan
0.0787 ohm/mi dc resistance

Shield wire data: 7/16" outside diameter (EHS steel)
10.7 ft sag at midspan
4.61 ohms/mi dc resistance

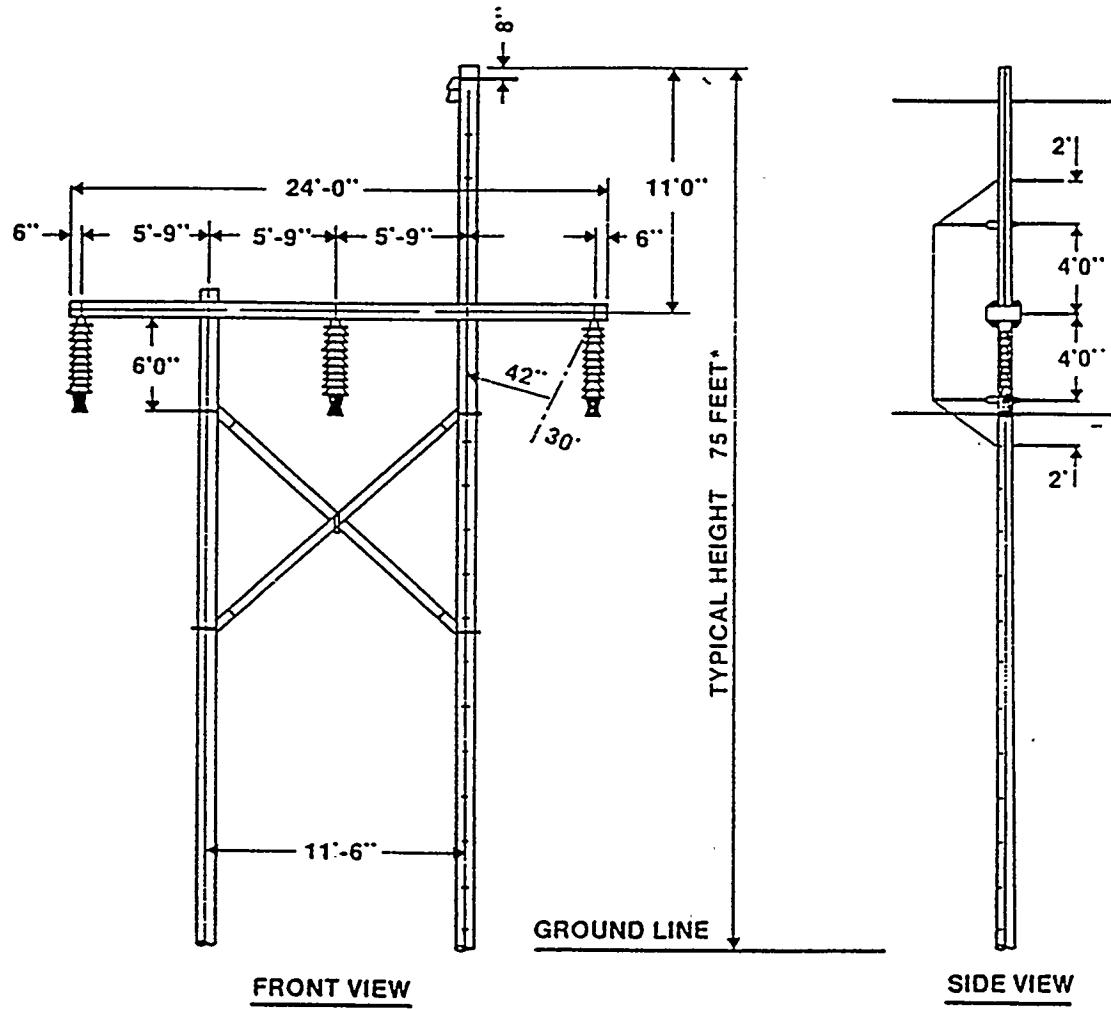
Fig. C-2. Typical 115 kV transmission tower and conductor layout.

ACSR conductor data: 1.108" outside diameter
 0.408" core diameter
 16 ft sag at midspan
 0.1180 ohm/mi dc resistance

Shield wire data: 3/8" outside diameter (HS steel)
 8 ft sag at midspan
 6.51 ohms/mi dc resistance

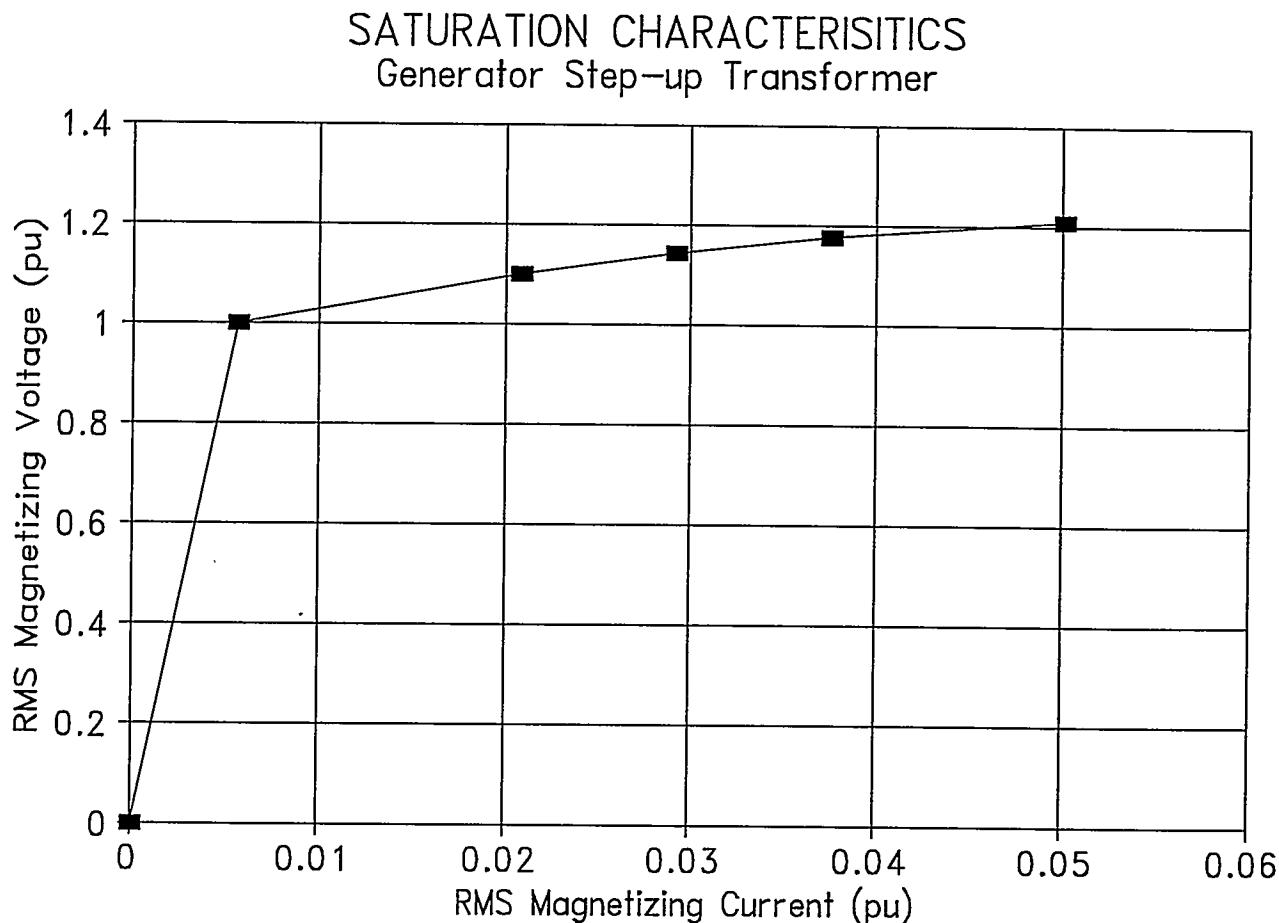
Fig. C-3. Saturation characteristics of generator step-up transformer.

Transformer rating: 408/457 MVA per phase (OA/FA), 345/23.85 kV

- $R_1 = 0.00136 \Omega$, $X_1 = 0.1115 \Omega$ (LV winding)
- $R_2 = 0.095 \Omega$, $X_2 = 7.7792 \Omega$ (HV winding)
- $R_{mag} = 2148 \Omega$ (core losses)
- $I_{mag} = 137 \text{ A}$ (peak magnetizing current at knee)
- $\lambda_{mag} = 89.467 \text{ V-s}$ (peak flux linkage at knee)
- Magnetizing branch on LV winding
- $C_{hg} = 10 \text{ nF}$, $C_{lg} = 10 \text{ nF}$, $C_{hl} = 15 \text{ nF}$

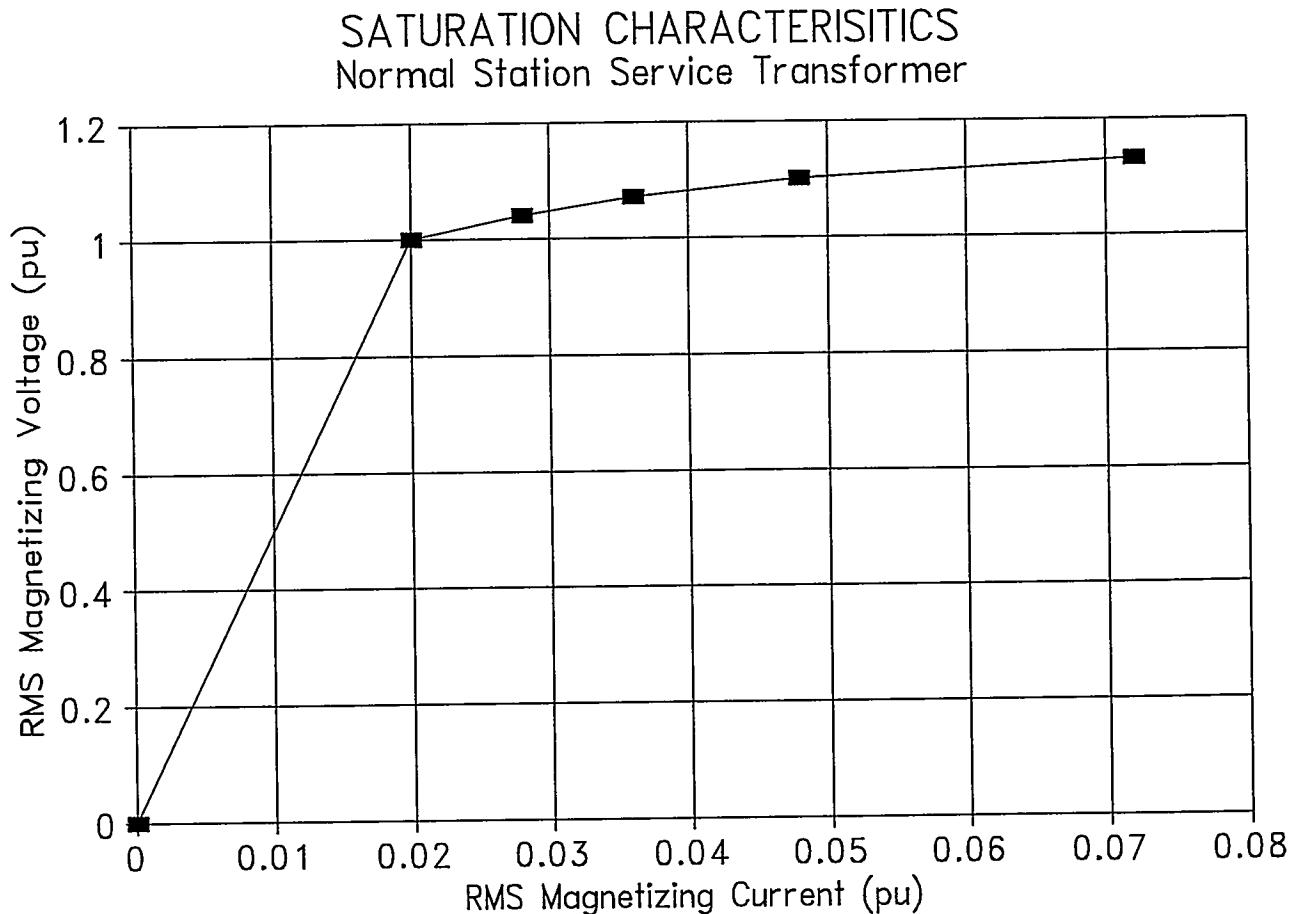
Fig. C-4. Saturation characteristics for normal station service transformer.

Transformer rating: 100 MVA (FOA), 24.9/13.8 kV

Model parameters: $R_1 = 0.0279 \Omega$, $X_1 = 0.664 \Omega$ (HV winding)
 $R_2 = R_3 = 0.00286 \Omega$, $X_2 = X_3 = 0.068 \Omega$ (LV windings)
 $R_{mag} = 14703 \Omega$ (core losses)
 $I_{mag} = 37.87$ A (peak magnetizing current at knee)
 $\lambda_{mag} = 93.4$ V-s (peak flux linkage at knee)
Magnetizing branch on LV winding
 $C_{hg} = 10$ nF, $C_{lg} = 10$ nF, $C_{hl} = 15$ nF

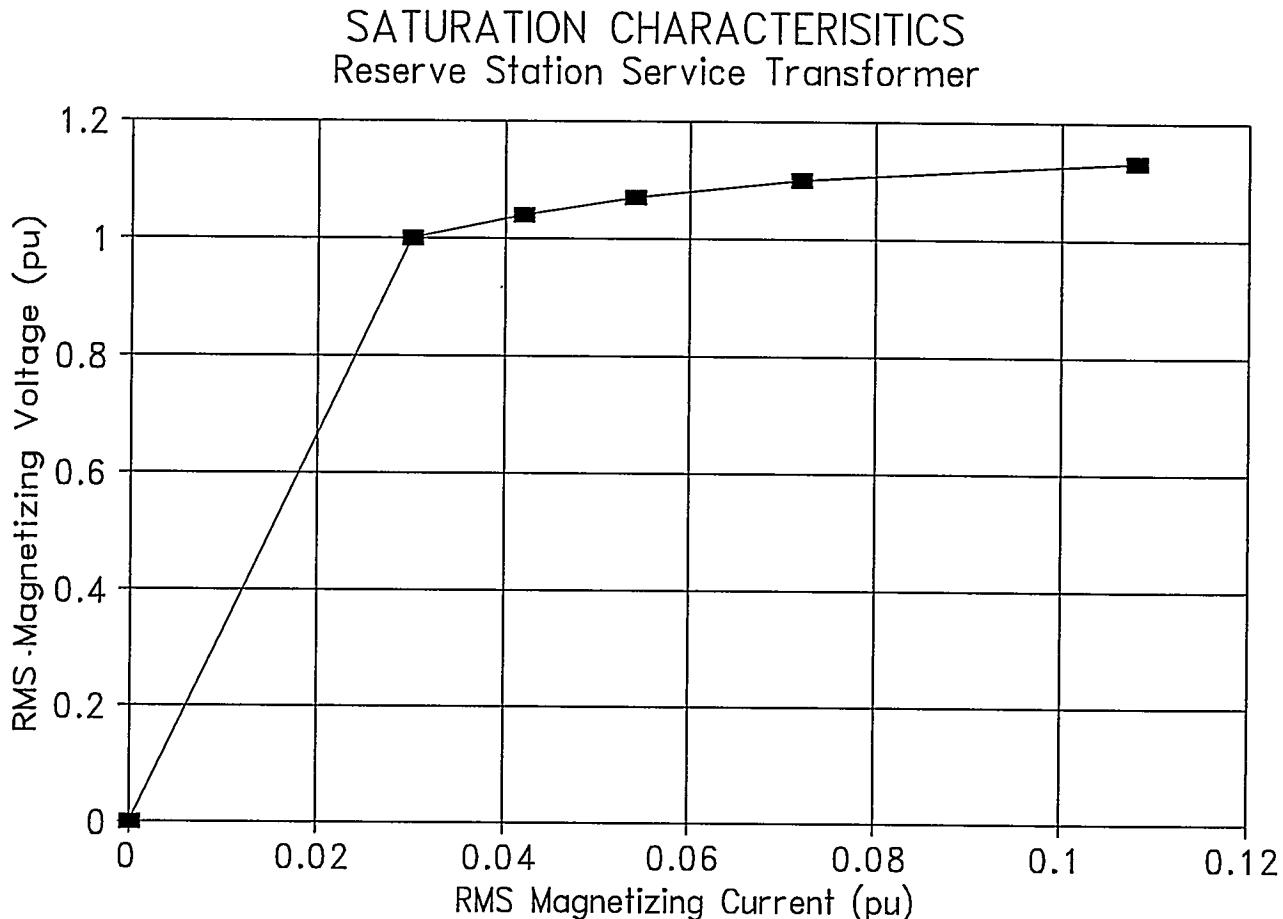
Fig. C-5. Saturation characteristics for reserve station service transformer.

Transformer rating: 42/56/70 MVA (0A/FA/FOA), 115/13.8/4.16 kV

$R_1 = 0.00229 \Omega$, $X_1 = 0.0421 \Omega$ (4.16 kV winding)
$R_2 = 0.5825 \Omega$, $X_2 = 10.72 \Omega$ (115 kV winding)
$R_3 = 0.00839 \Omega$, $X_3 = 0.1544 \Omega$ (13.8 kV winding)
$R_{mag} = 681 \Omega$ (core losses)
$I_{mag} = 142.79 \text{ A}$ (peak magnetizing current at knee)
$\lambda_{mag} = 15.605 \text{ V-s}$ (peak flux linkage at knee)
Magnetizing branch on 4.16 kV winding
$C_{hg} = 8 \text{ nF}$, $C_{lg} = 10 \text{ nF}$, $C_{hl} = 15 \text{ nF}$

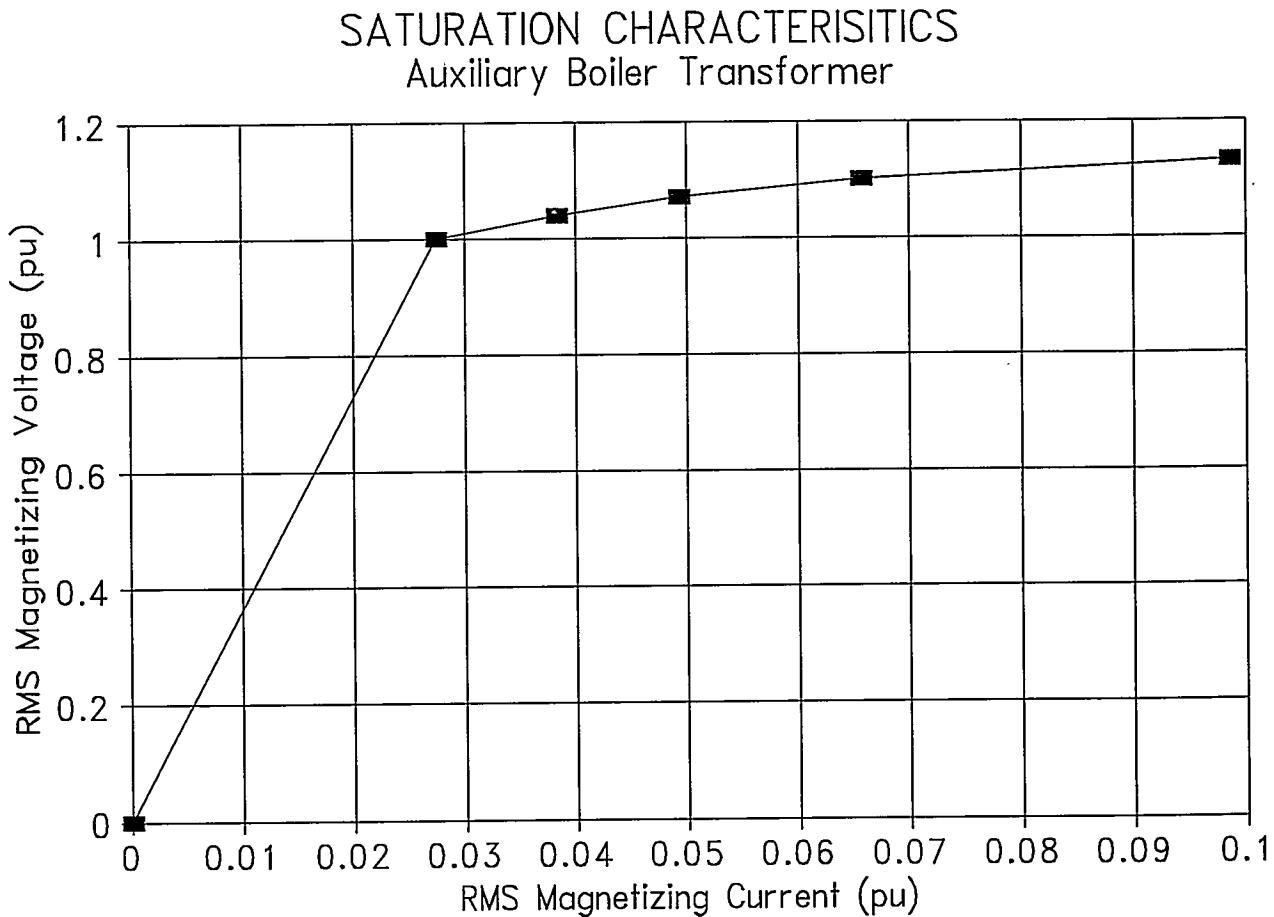
Fig. C-6. Saturation characteristics for auxiliary boiler transformer.

Transformer rating: 16.6/22.08/27.56 MVA (0A/FA/FOA), 115/13.8/4.16 kV
