# Effects of Lightning on Pultruded Carbon Fiber Wind Blades

**M Williams<sup>1</sup>, J N Tilles<sup>1</sup>, J Paquette<sup>1</sup>, D Samborsky<sup>2</sup>, and P Clem<sup>1</sup>**

<sup>1</sup>Sandia National Laboratories, New Mexico, 1515 Eubank SE, Albuquerque, NM 87123, USA

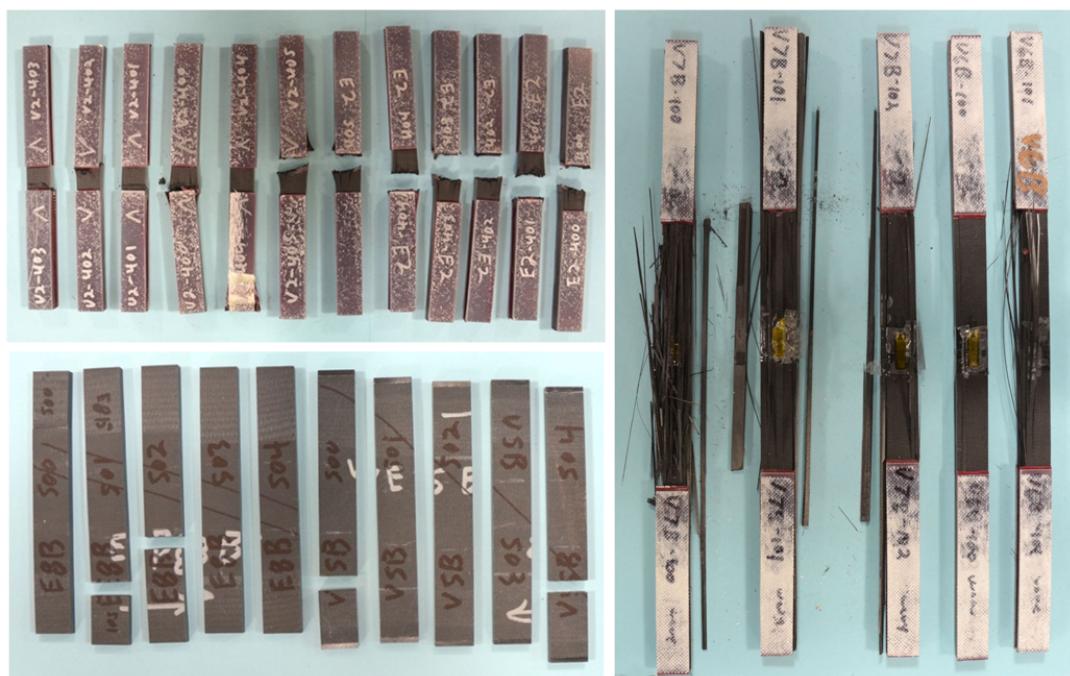
Figure 10: Strength vs. action integral (energy per unit resistance, with 95% CI) plots for compression testing (left), and transverse tension (right). Controls (no impulse testing) listed at 0 energy and largest energy input into specimen towards the right of the plot.

Transverse tension specimens were limited, and due to the width of the original specimen, were shorter than acceptable per ASTM D3039 [13]. These specimens experienced typical failures primarily focused around the grip region. Fiber waviness may also be affecting test results, so transverse tension results are preliminary (Figure 10).

Compression specimens also show a high number of grip failures and localized crushing. However, compression results do appear to indicate a decreased ultimate compressive strength in the epoxy-matrixed specimens tested at the 30-microsecond, 200kA test case (Figure 10). This result is interesting because the test case represents the largest energy input into the specimen; a larger energy input results in a greater heating of the specimen. The 30-microsecond pulser is applying a roughly 30x longer duration current than the 1-microsecond pulser, with delayed cooling due to the slower decay back to 0 Amps (top green plots, Figure 3).
