Evaluate corrosion susceptibility in accelerated ASTM chloride environments of Laser Beam-Powder Bed Fusion (LB-PBF) 316L stainless steel & cold-sprayed nickel-based alloys on 304 stainless steel. **What factors influence the corrosion behavior?**

Laser Beam-Powder Bed Fusion 316L

Cold Sprayed, Nickel-Based Alloy Coatings

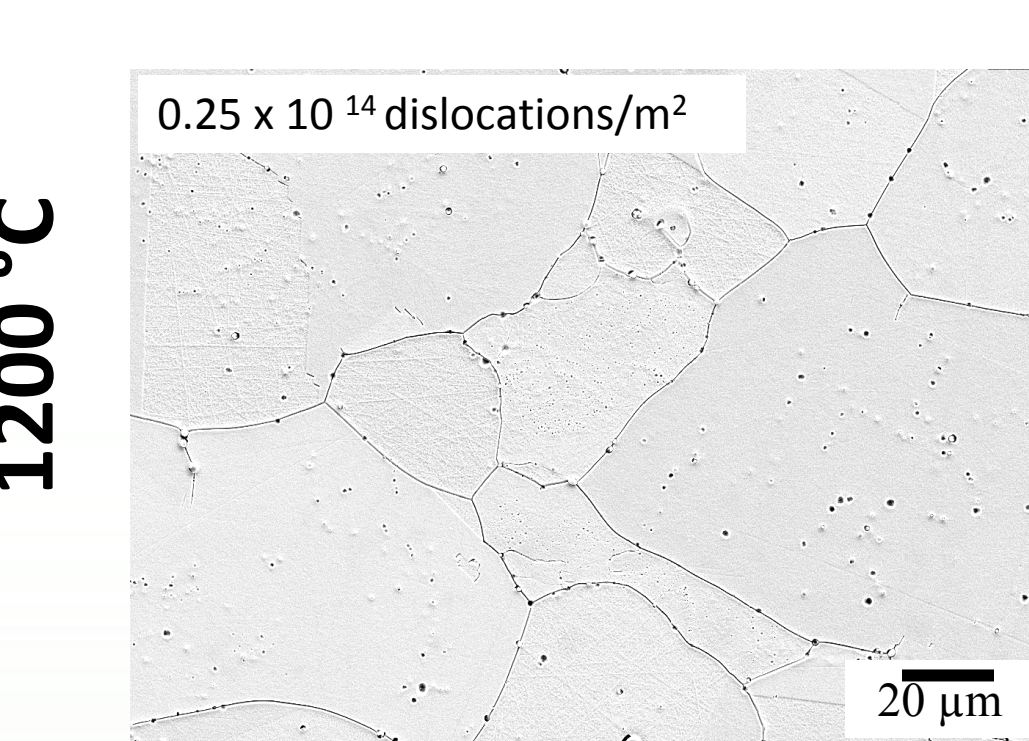
Heat-Treated Microstructure

As-Built

- Height & heat treatment affect residual stress
- All as-built samples cracked in 24 hours
- < 10 mm as-built show oriented cracking
- Oriented cracking: perpendicular to melt tracks
- More cracking in higher tensile residual stress areas (based on modeling results)
- 600 °C, 4 mm sample still showed cracking
- 800 °C eliminated SCC even in 15 mm sample
- 800 °C shows recovery of some dislocations, formation of new grain boundaries
- 1200 °C shows recrystallization

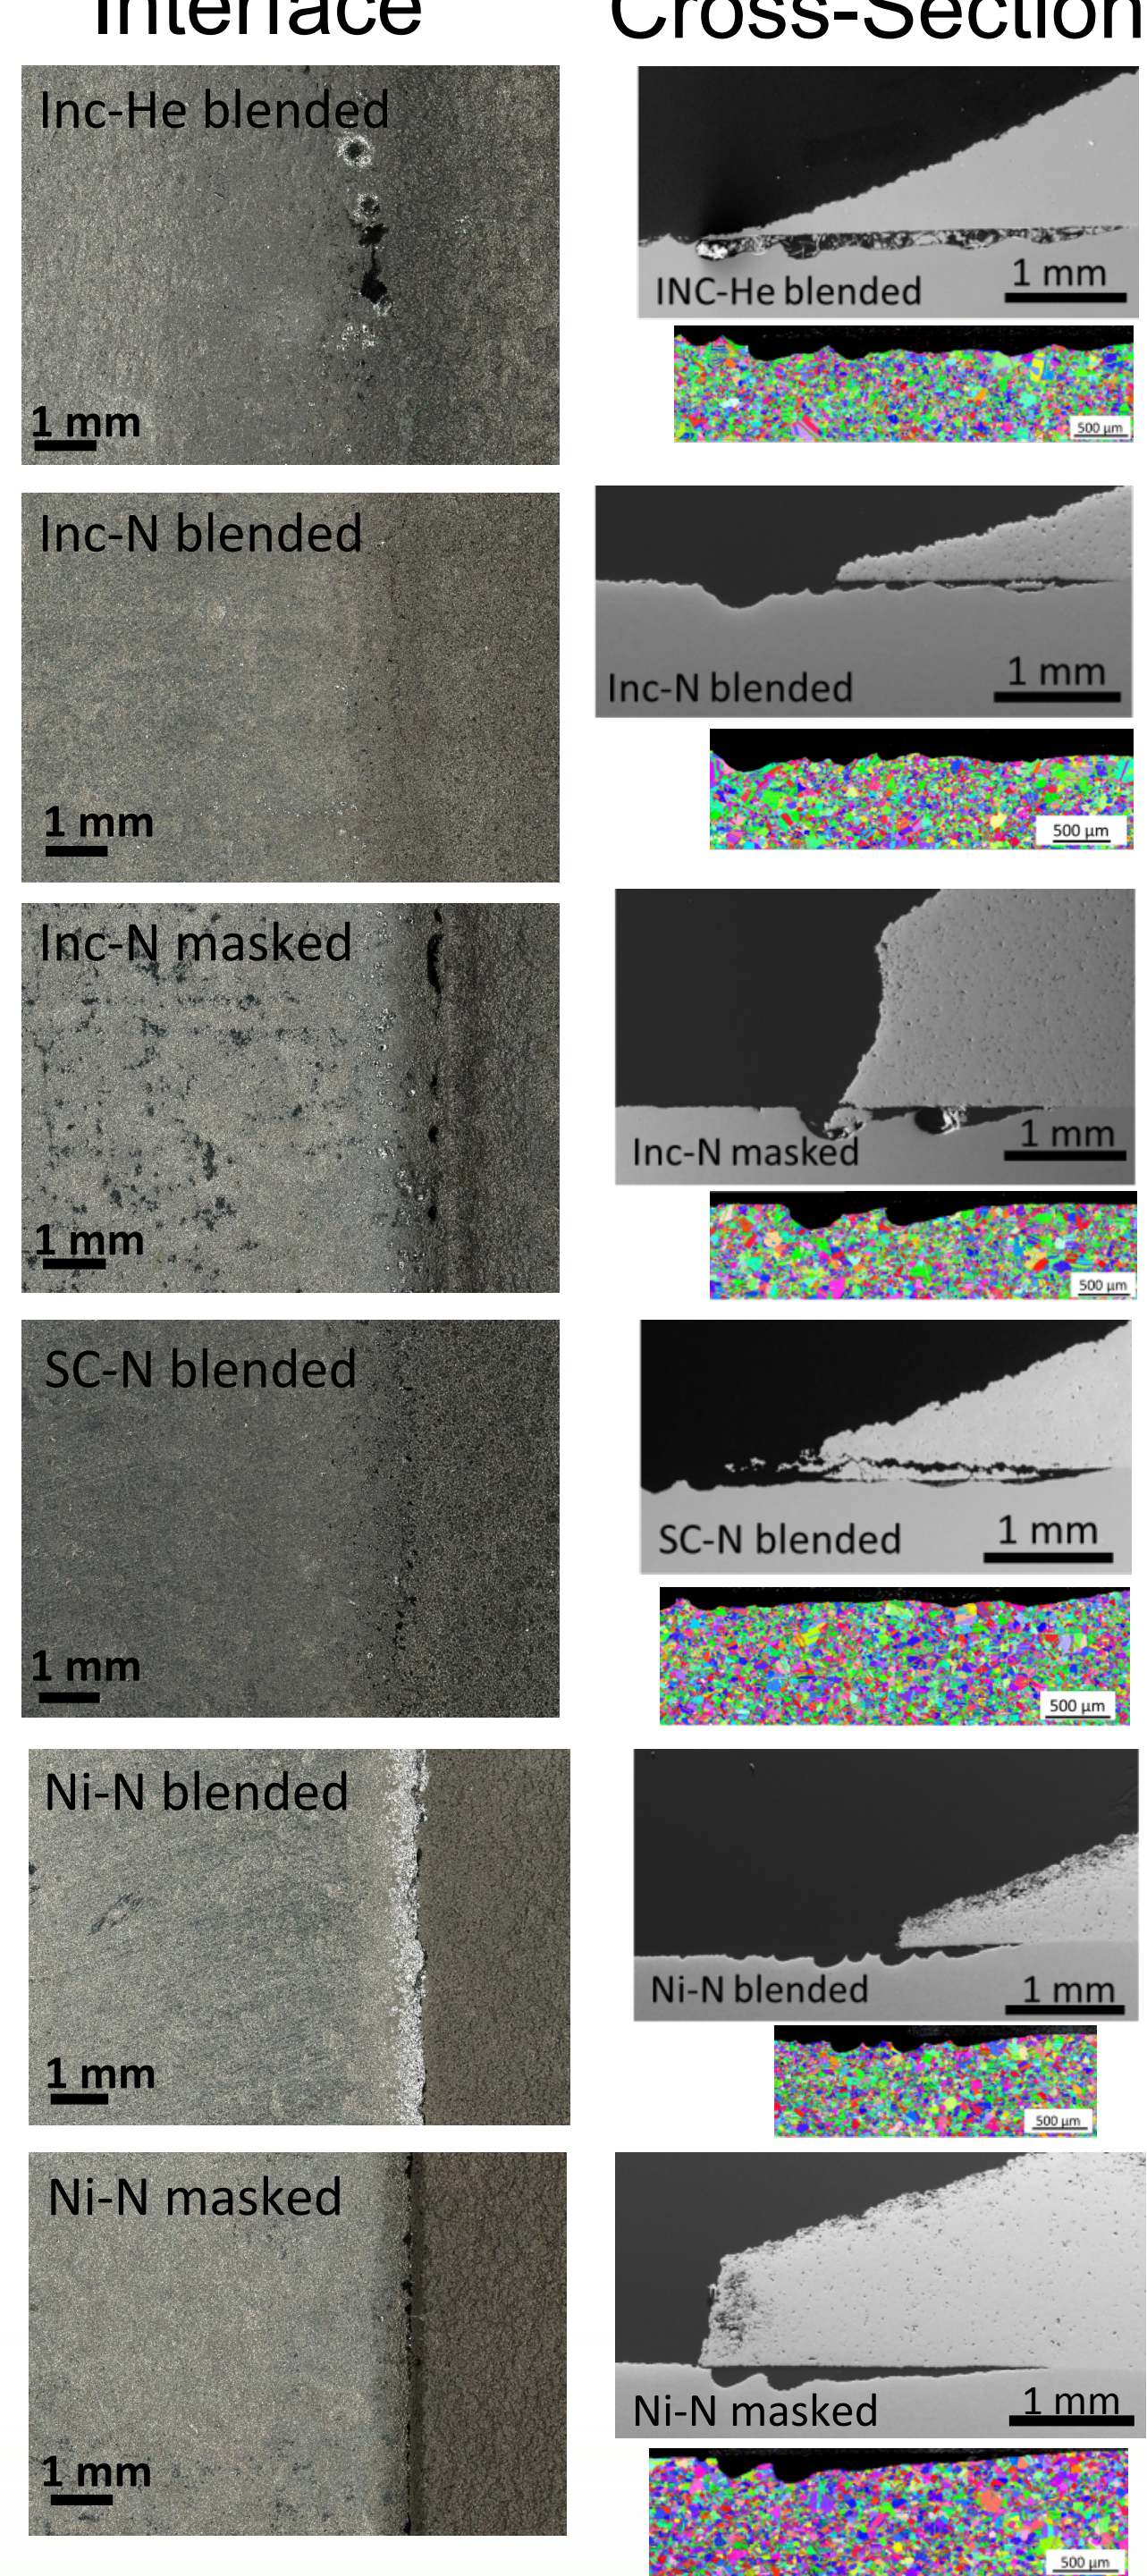
Ferric Chloride Test

Interface

- Results
- Top-down, nickel samples show more damage in cold spray and at the interface
- Amount of damage seen top-down doesn't correlate with the amount of damage seen in cross-section
- In cross-section, all samples have damage in substrate, some have damage in cold-spray (porosity dependent?)
- Reducing roughness minimizes metastable pitting
- He processed has less metastable pitting (porosity related?)

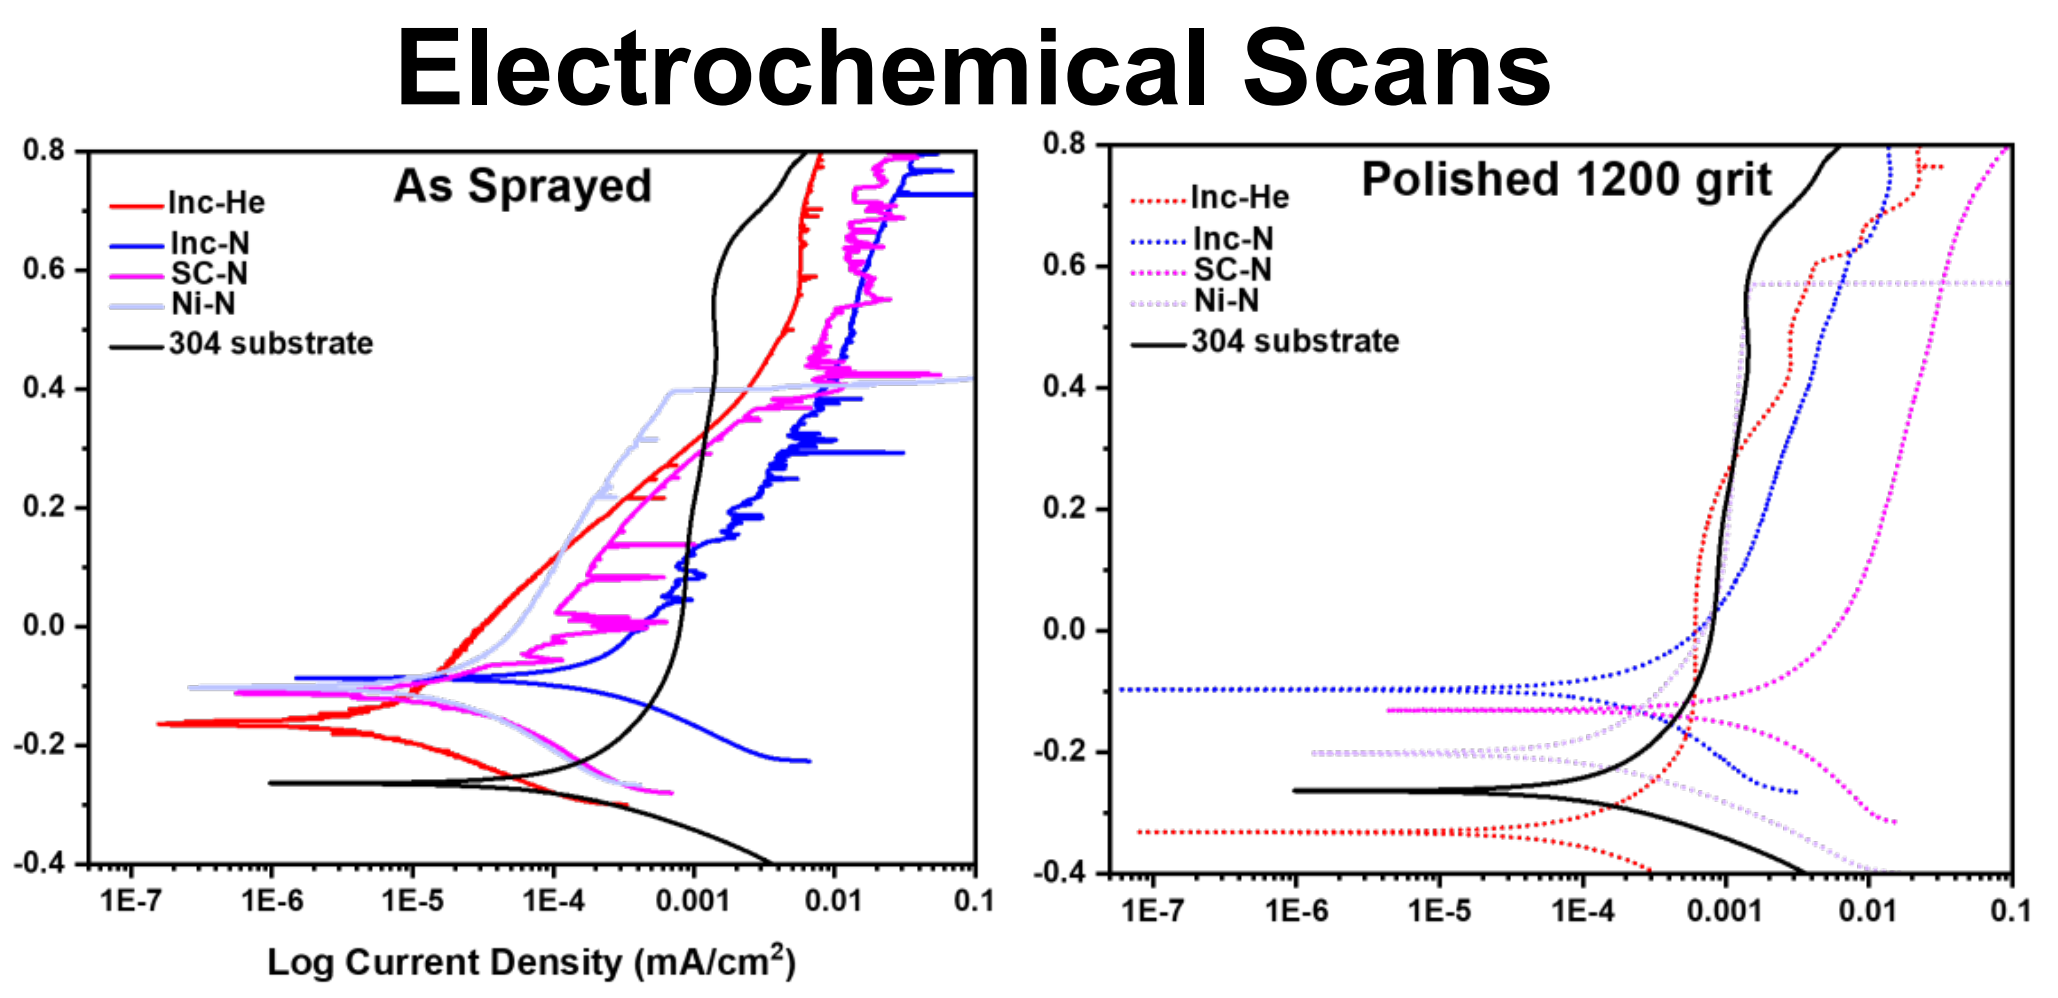
Uncorroded Substrate Microstructure Under Cold Spray

- Conclusions
- Gas selection impacts porosity, location of damage in cross-section, and metastable pitting
- Interface changes how crevice corrosion presents (top-down)
- Material selection influences breakdown potential, corrosion morphology
- Top-down damage not indicative of damage between substrate and cold spray (cross-section)
- Electron backscatter diffraction shows deformation layer in substrate is thinner than corrosion damage layer
