# Opportunities and Challenges of Ultra Short Pulsed Lasers with Dual Focused Ion Beams for Characterization of Full-Scale Electronic Devices

Microscopy and Microanalysis Conference

# Laser Plasma Focused Ion Beam (PFIB)

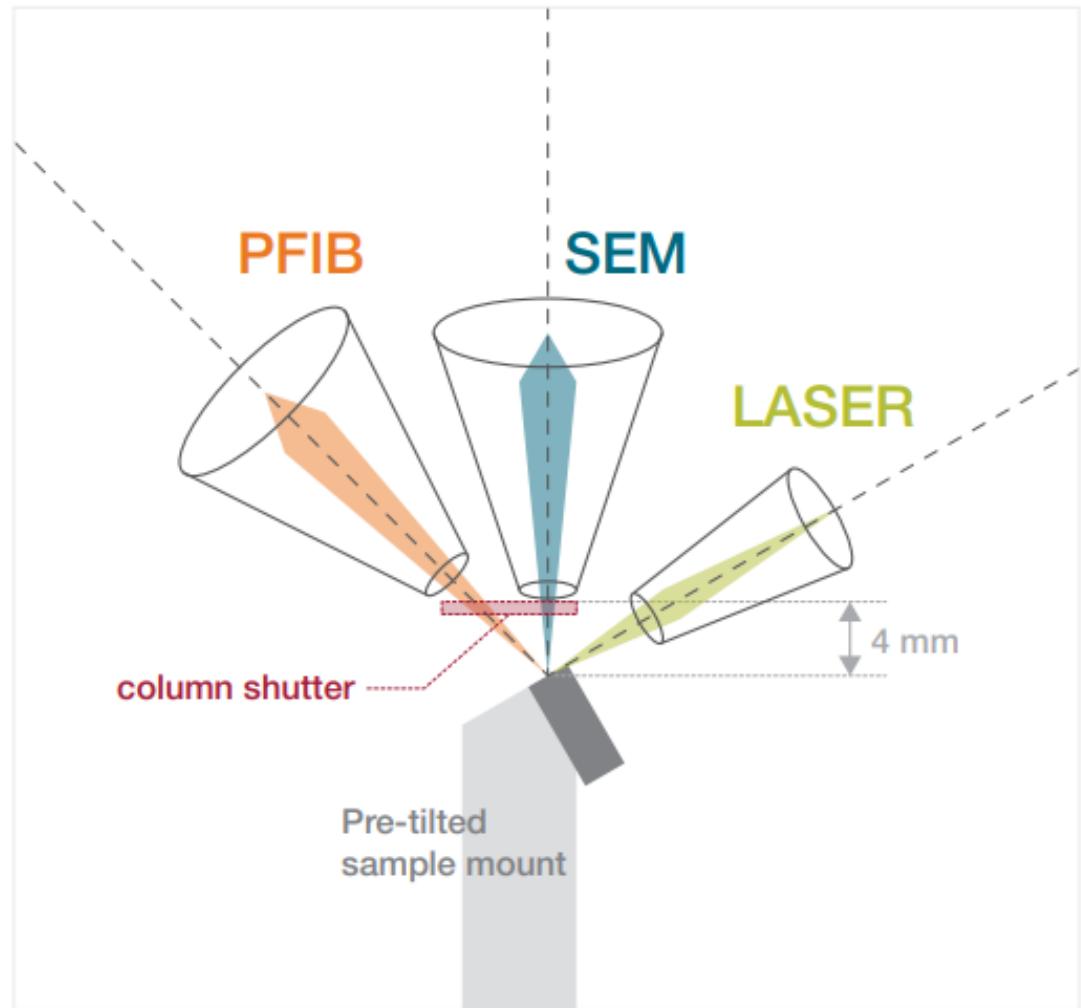
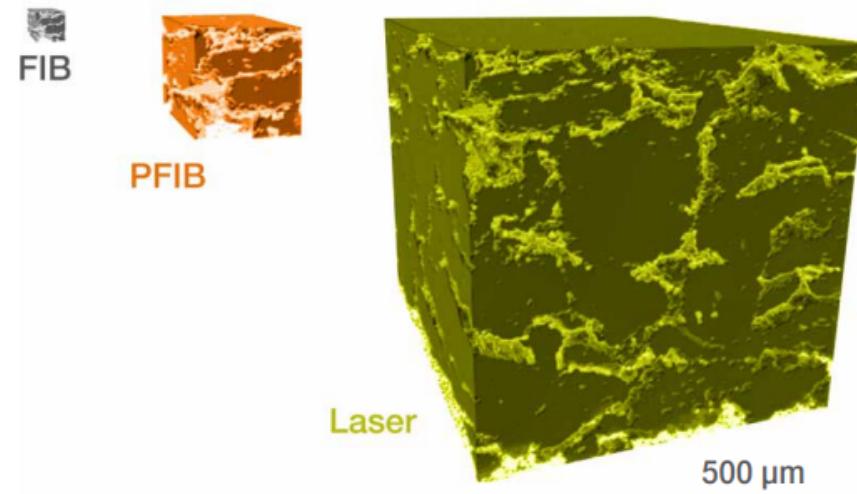
Helios G5 Laser Plasma FIB

- New laser capability on plasma focused ion beam (PFIB) makes characterization of volumes up to  $4 \times 2 \times 1 \text{ mm}^3$  possible
- Unique combination of nanoscale characterization over large length scales – usually is a tradeoff between spatial resolution and area/volume available to characterize

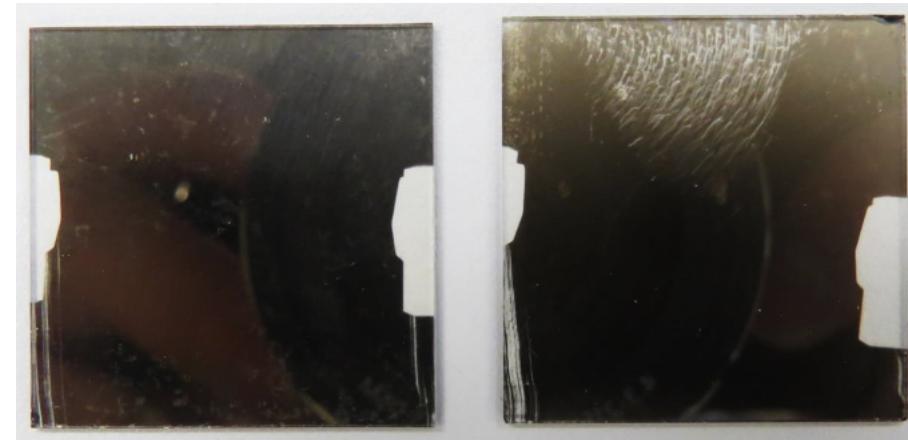
Glass slip after laser milling

Glass slip between laser and chamber prevents ablated material going back into the laser column

Must be changed periodically through cross-sectioning milling

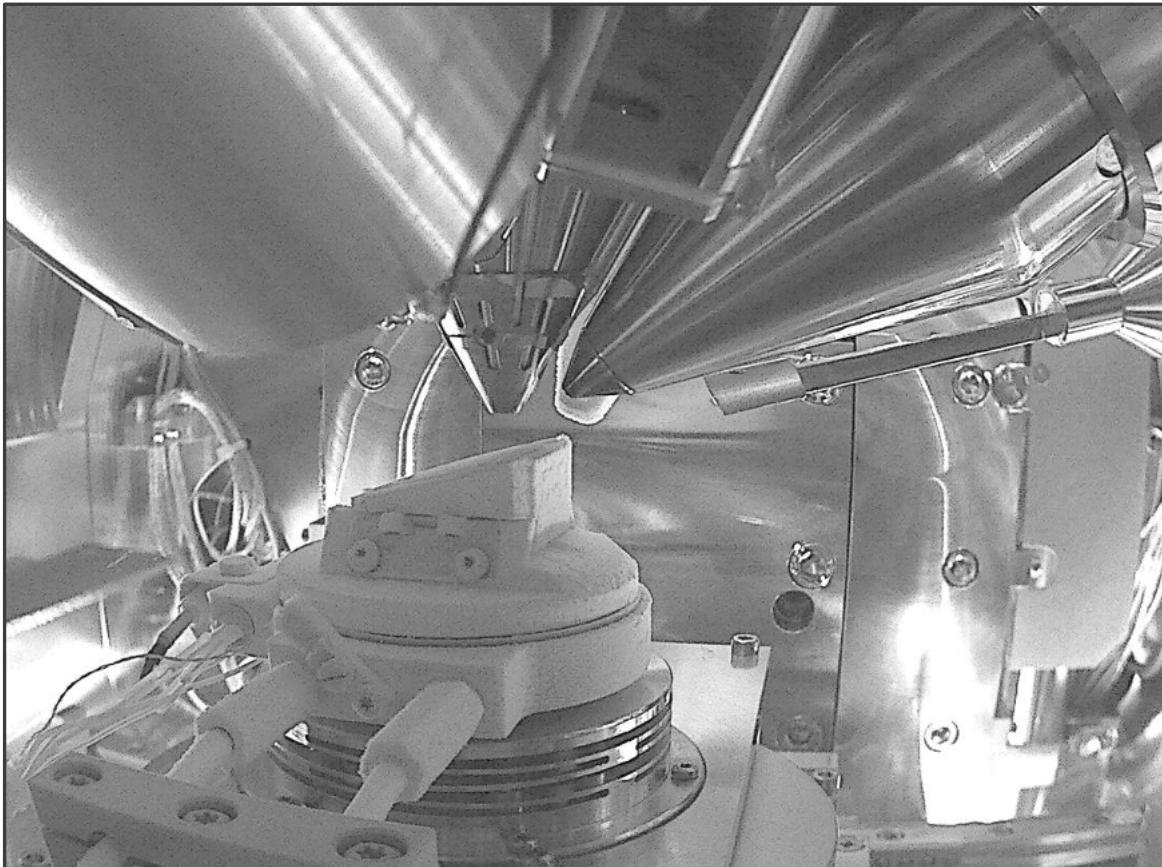
The result...

- When opening the chamber, frost builds on sample from outside moisture
- Using a glove bag with nitrogen partially mitigates the issue
  - House nitrogen still has enough moisture for some frost buildup
  - UHP nitrogen does not lead to frost buildup but we run out rather quickly...
  - Next step to try purifier for house nitrogen

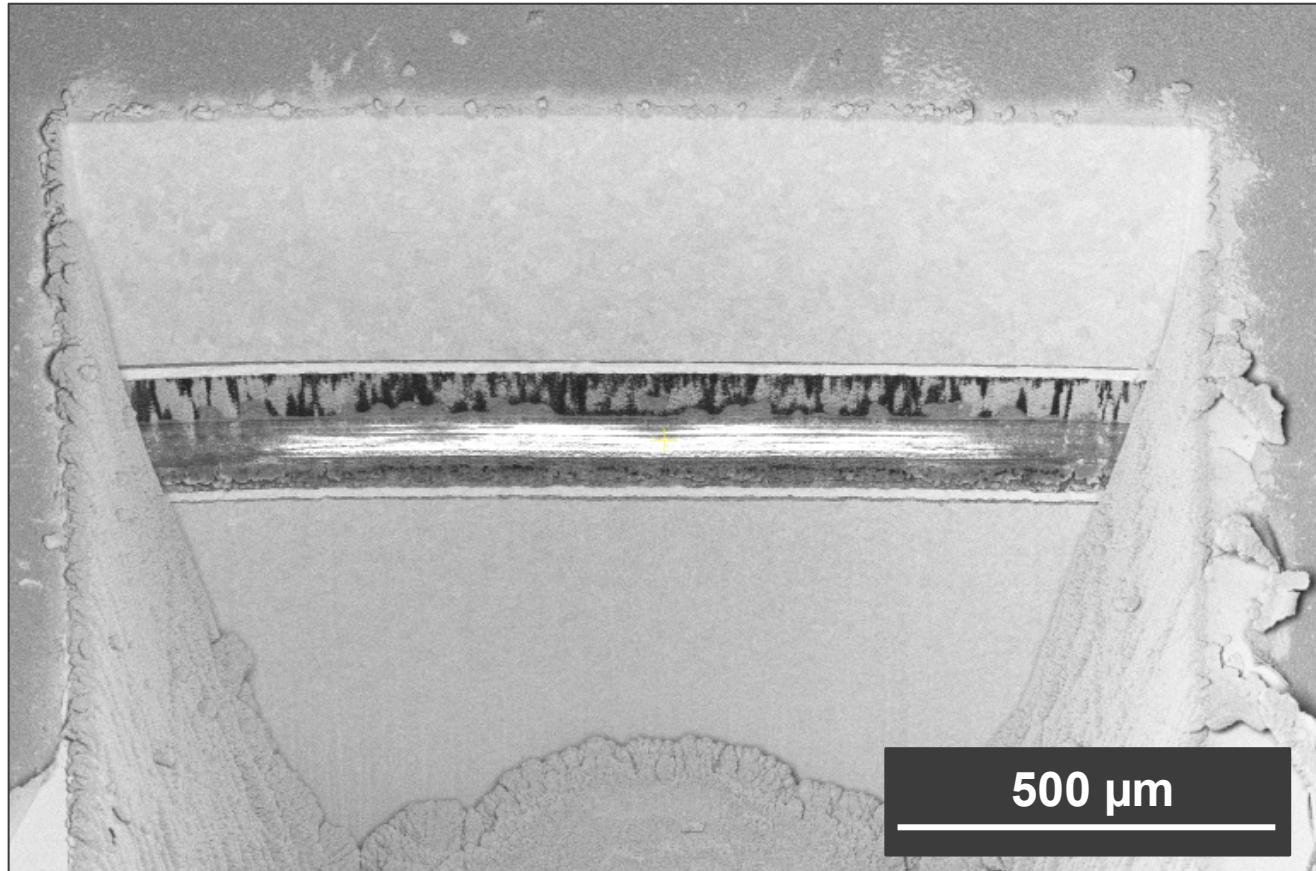
- **Charging**
  - Depositing from multichem challenging at cryogenic temperatures
    - Putting multichem in halfway helps somewhat
  - Easylift Needle doesn't help with porous material
  - Imaging with lower AV and current helps, but not ideal for collecting EDXS data

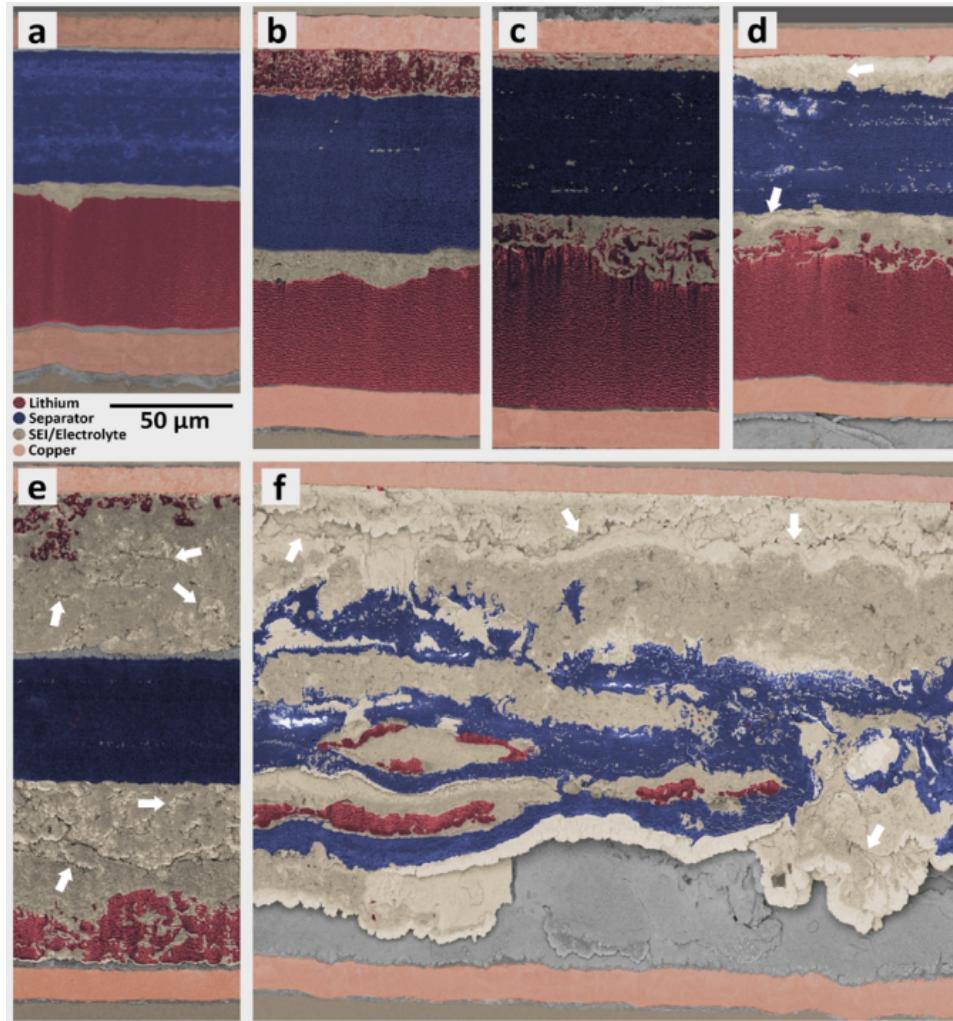
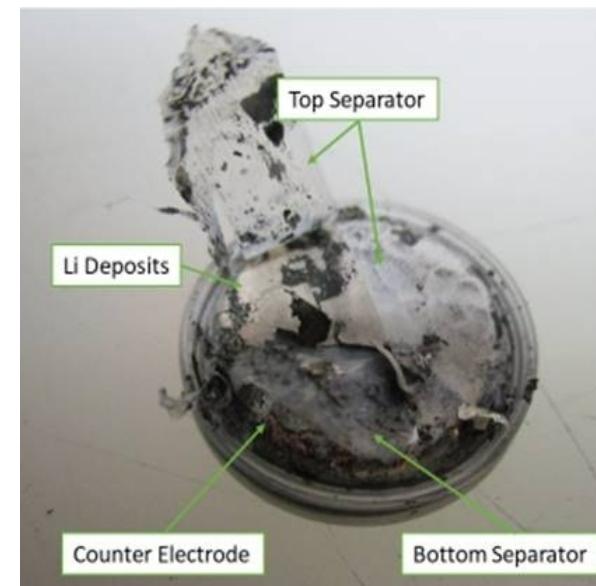
# Failure after Cycling

- Cryo laser PFIB can image intact coin cells without disassembly, characterization provides:
  - Structure of the separator-Li interface
  - Quantify Li inventory, Li morphology, cracking in SEI, and SEI thickness
  - Under high-rate cycling: Separators are damaged or destroyed
    - Li and SEI grow between separators and tri-layers of separators

2.8 M LiFSI in DME  
 Two Celgard 2325 separators  
 Cycled at 1.88 mA/cm<sup>2</sup>  
 Capacity: 1.88 mAh/cm<sup>2</sup>

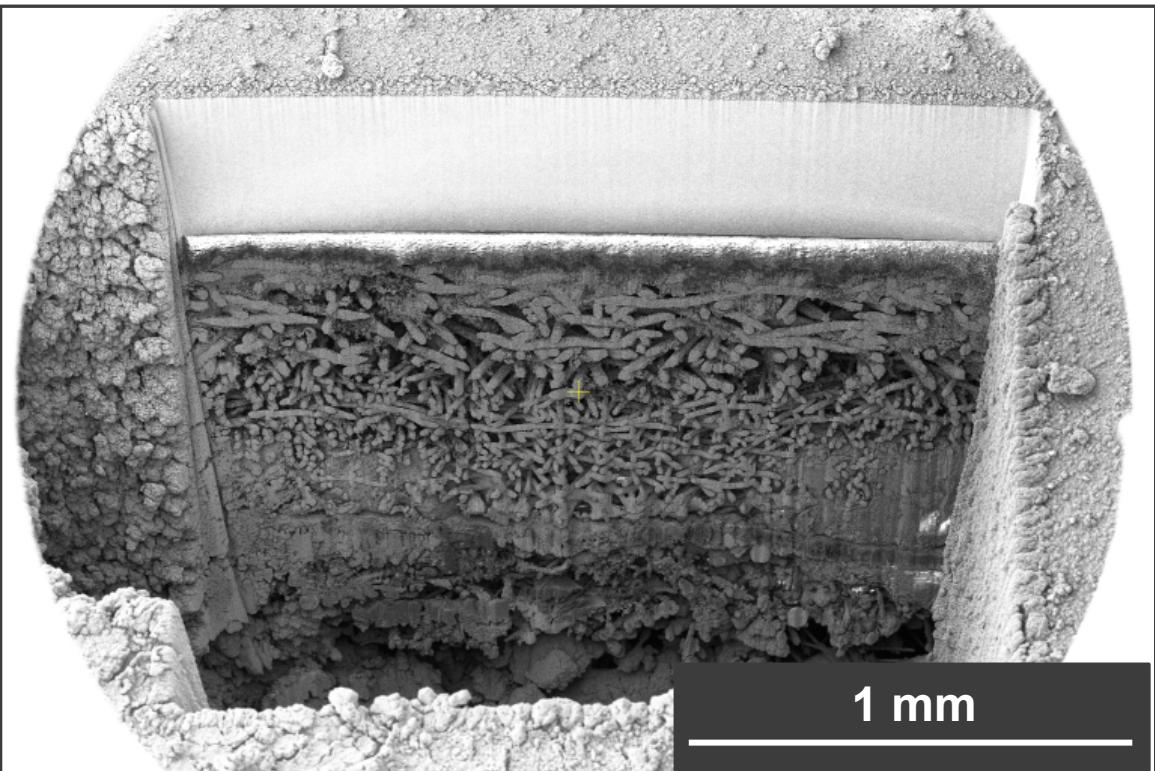
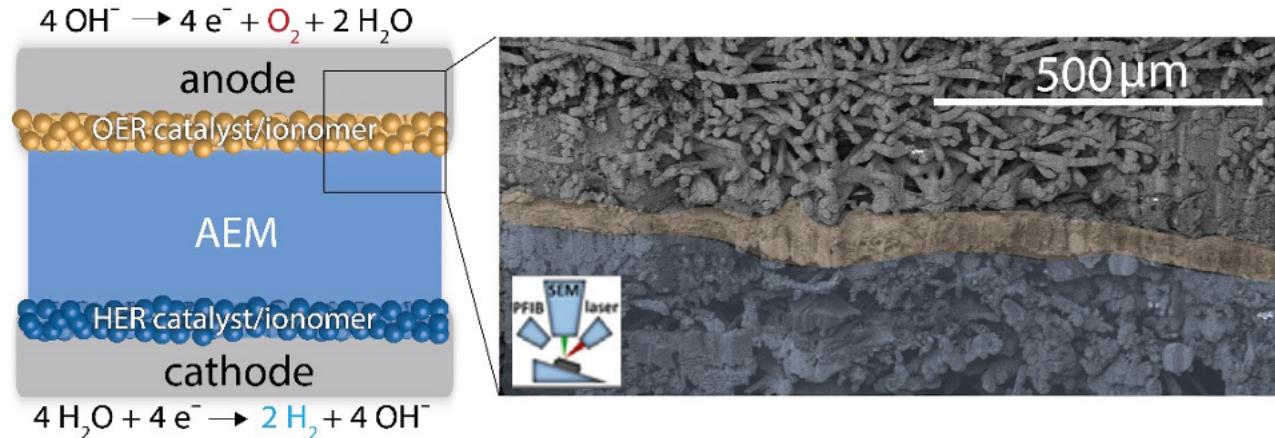
# Electrolyser Samples

- Can distinctly image various layers in AEM (anion exchange membrane) electrolyser devices
- Challenging to reach layers more than 1mm below surface of the sample
  - Dynamic focus not effective across such large z values
  - Material in front blocks view
  - EDXS shadowing
- 515 nm clean up with laser after 1030 nm bulk trenching

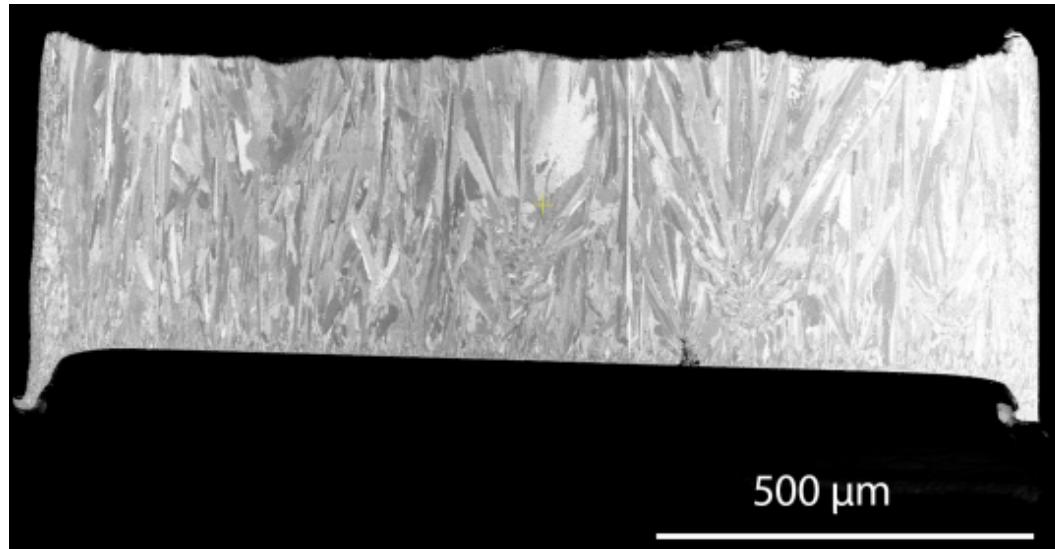
Laser prepared cross section of electroplated Pb

Total milling time was about 5 minutes at room temperature using 1030 nm laser wavelength.

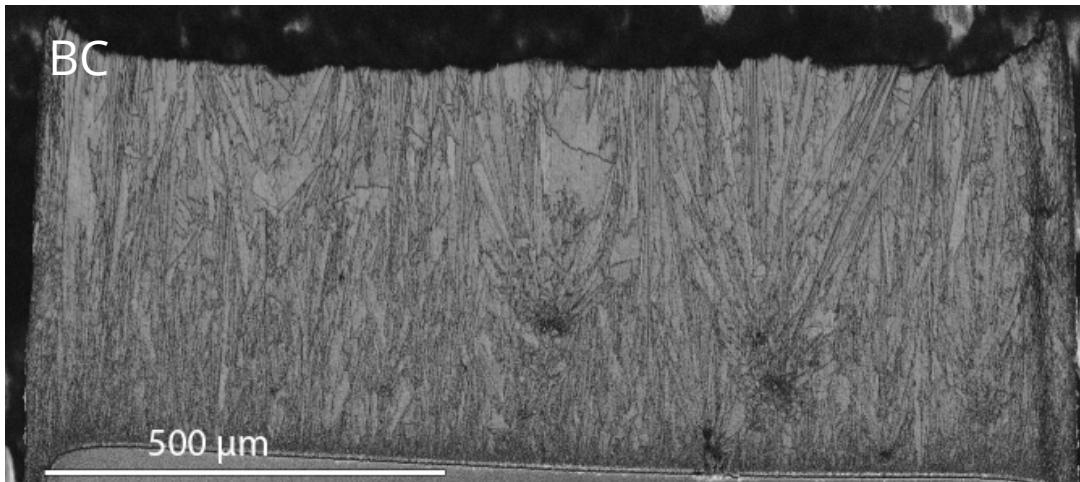
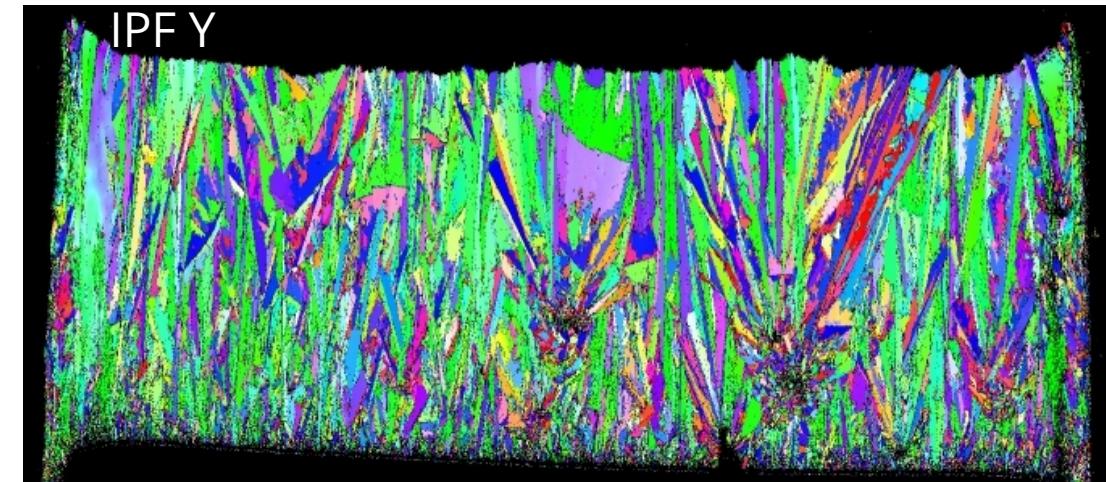
Laser prepared surface great for imaging or EBSD directly with no further preparation!

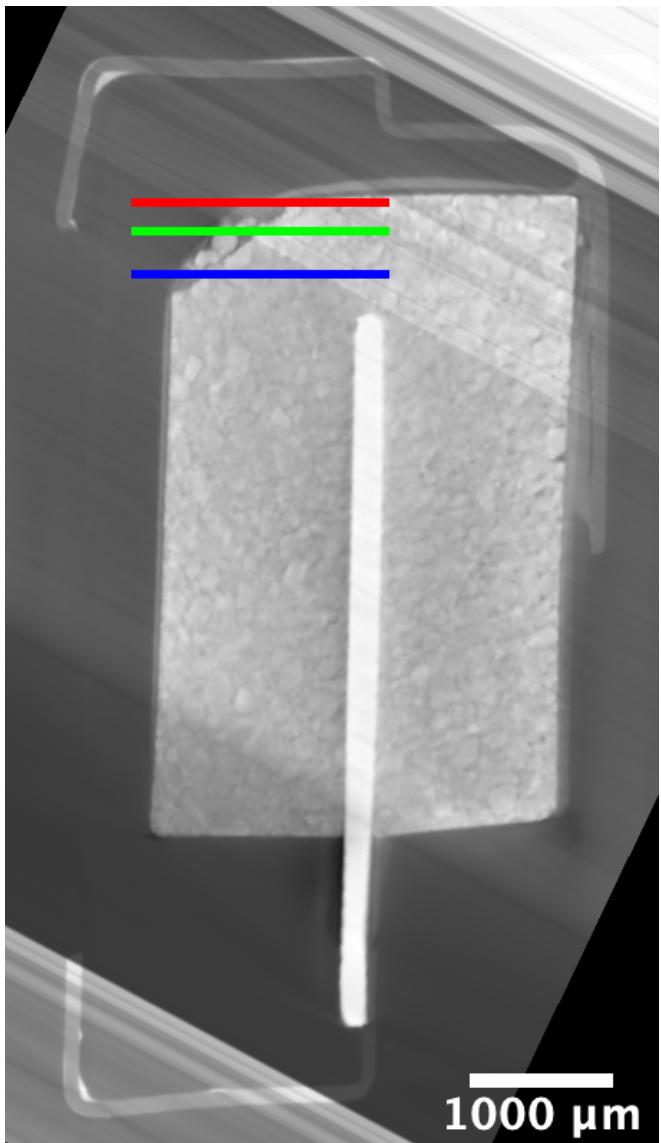
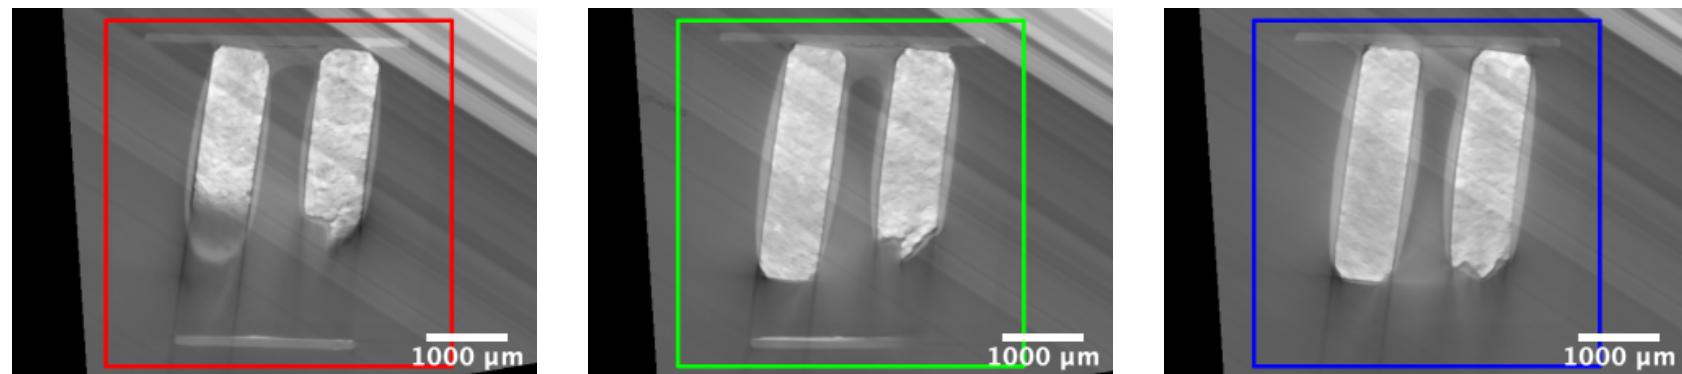
# Ta Capacitor Failure

- Failed Ta capacitor was investigated with microCT which identified multiple regions of further interest
- To address this gap, automated 3D serial sectioning with the laser necessary

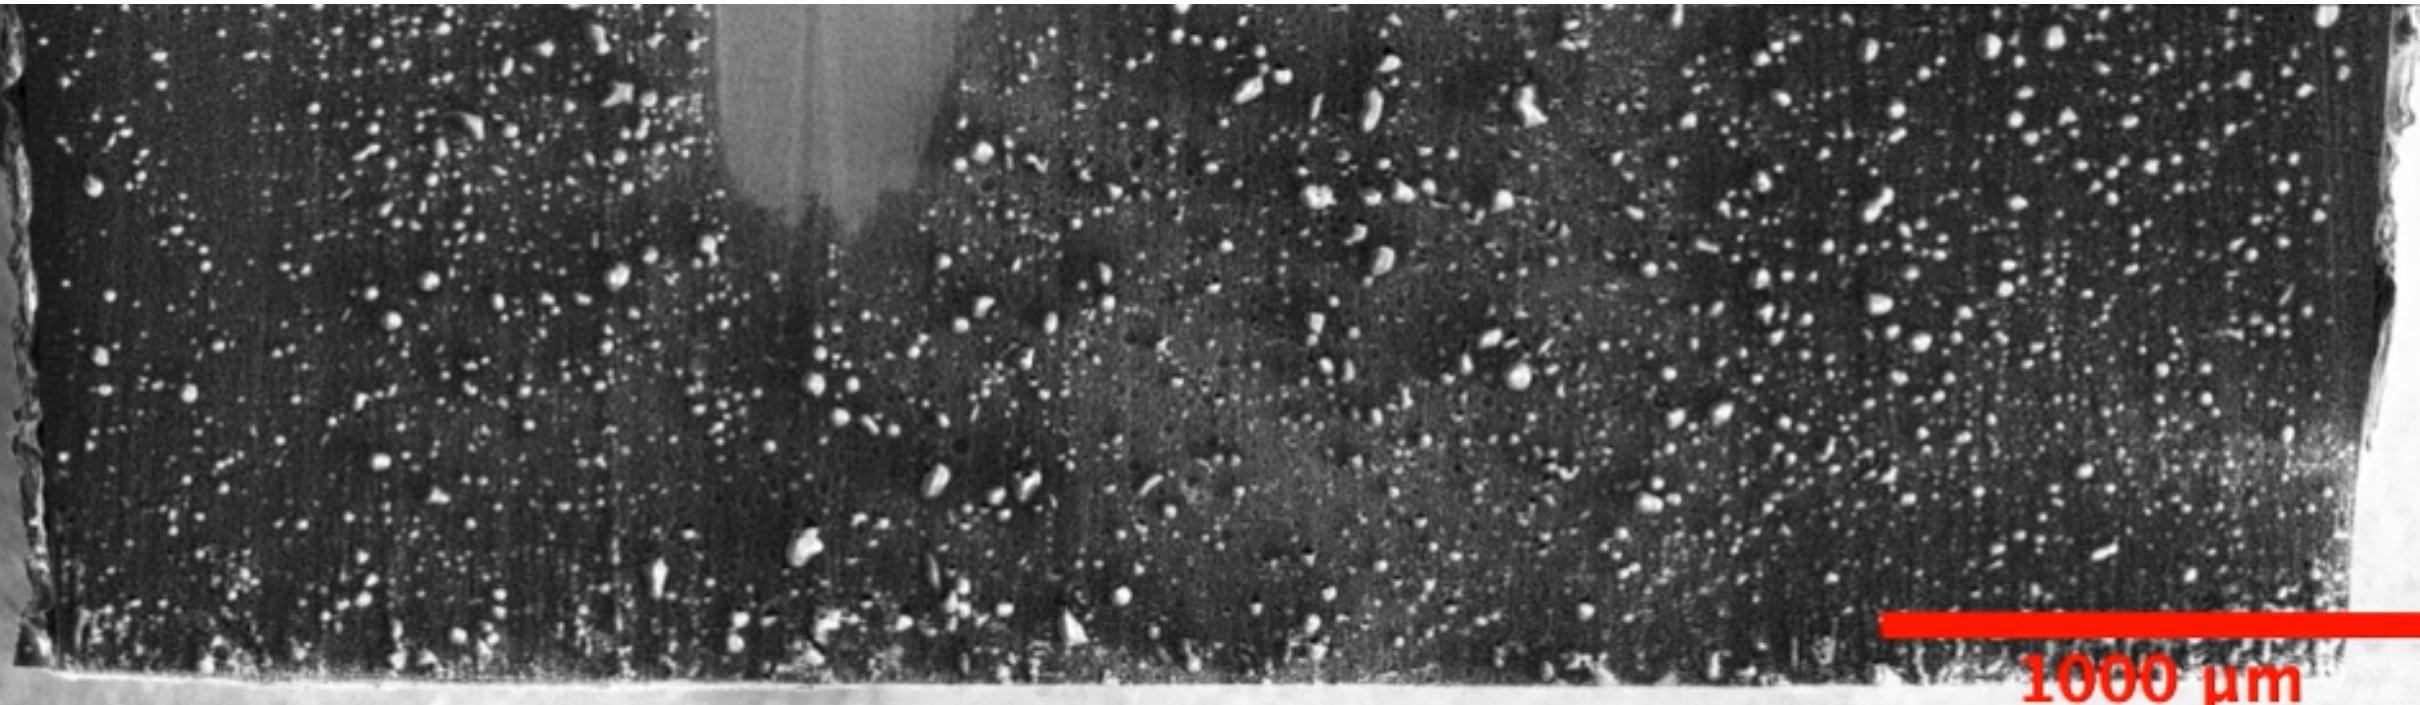
- Automated routine developed using iFAST scripting on laser PFIB
- Max width approx. 1.5 mm, so multiple slices were taken and resulting images stitched together to obtain large field of view
- 2 micron slice thickness, ~400 nm resolution in plane, 720  $\mu\text{m}$  total sectioning depth

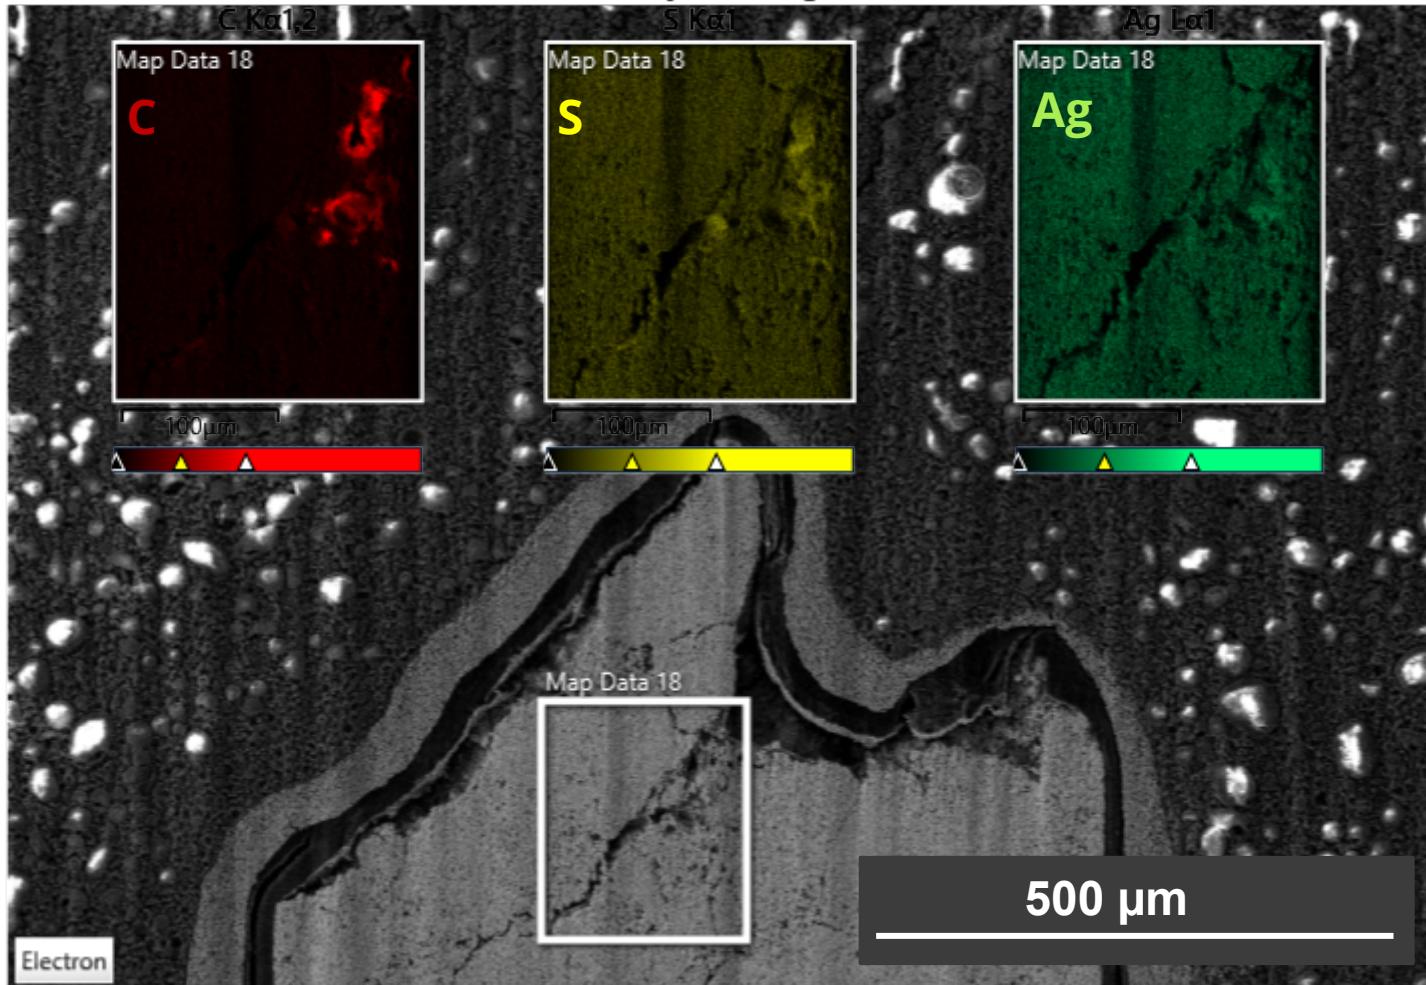
# EDXS at Various Slices

- With iFast scripting, not able to get automated EDXS data collection
- Arrested automation at various slices within regions of interest identified via microCT
- Currently working on Python code to automate this step
- In slice shown here, silver and sulfur found in one of the prominent cracks – potentially a melted region

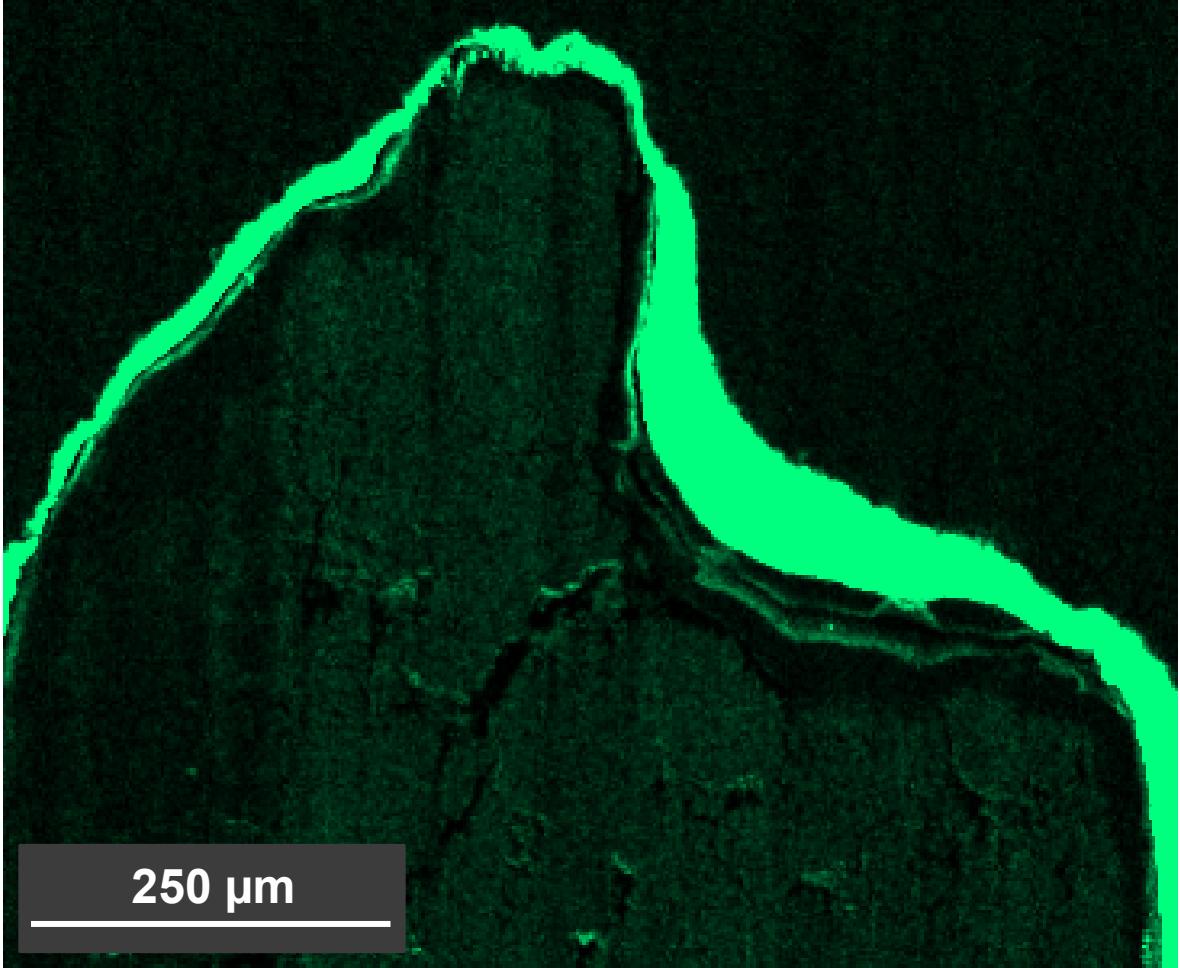
Ag, slice 210

- Noted silver incursions just after cutting through the silver and PEDOT layers
- May be related to failure mechanism
- Attempting again on separate failed capacitor with different CT results and Python automated scripting
