# 7<sup>th</sup> Annual Tritium Science Technical Exchange

## In situ quantification of the Effect of Ni Surface Impurities on Hydrogen and Deuterium Adsorption Using Environmental-XPS

Farid El Gabaly  
Hydrogen and Materials Science, SNL/CA

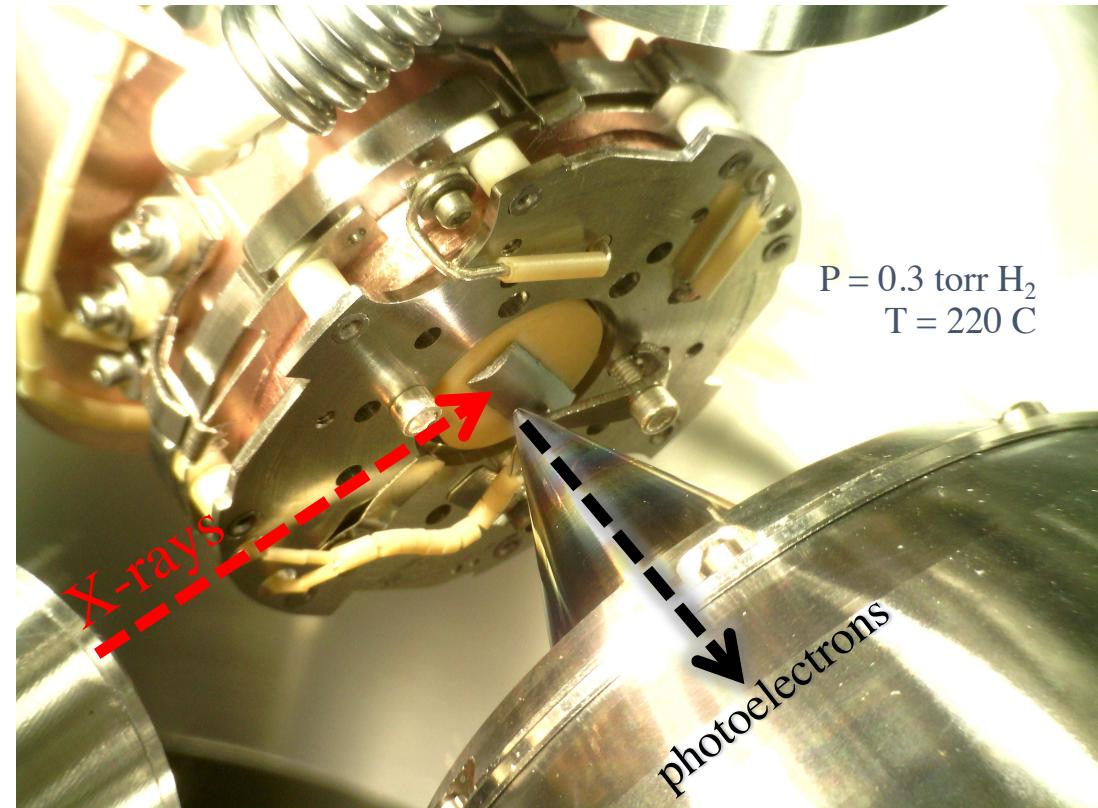
Coated cladding at the environmental XPS at SNL/CA

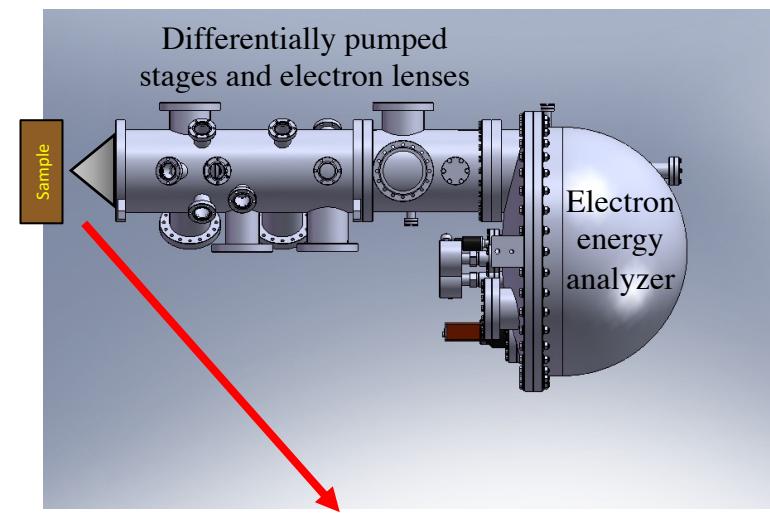
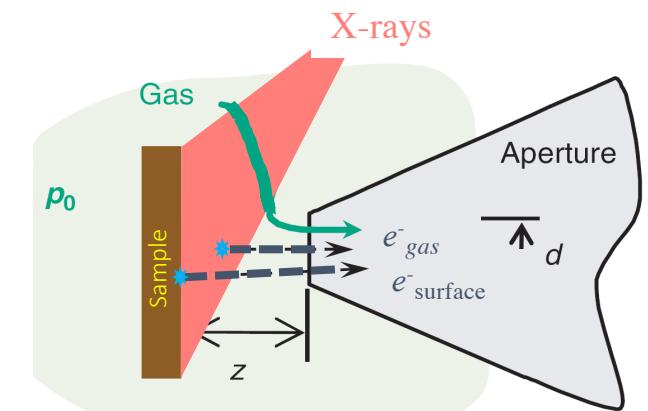
## Environmental XPS

- What is the effect on hydration of surface oxidation and ever-present surface impurities such as carbon?
- Environmental X-ray Photoelectron Spectroscopy (eXPS) overcomes the pressure limitations of traditional XPS and allow **characterizing Ni coating surface, oxidation products, and impurities under hydrogen**
- Sample provided: a prototypical coated cladding sample:
  - Nickel-plated zircaloy tube

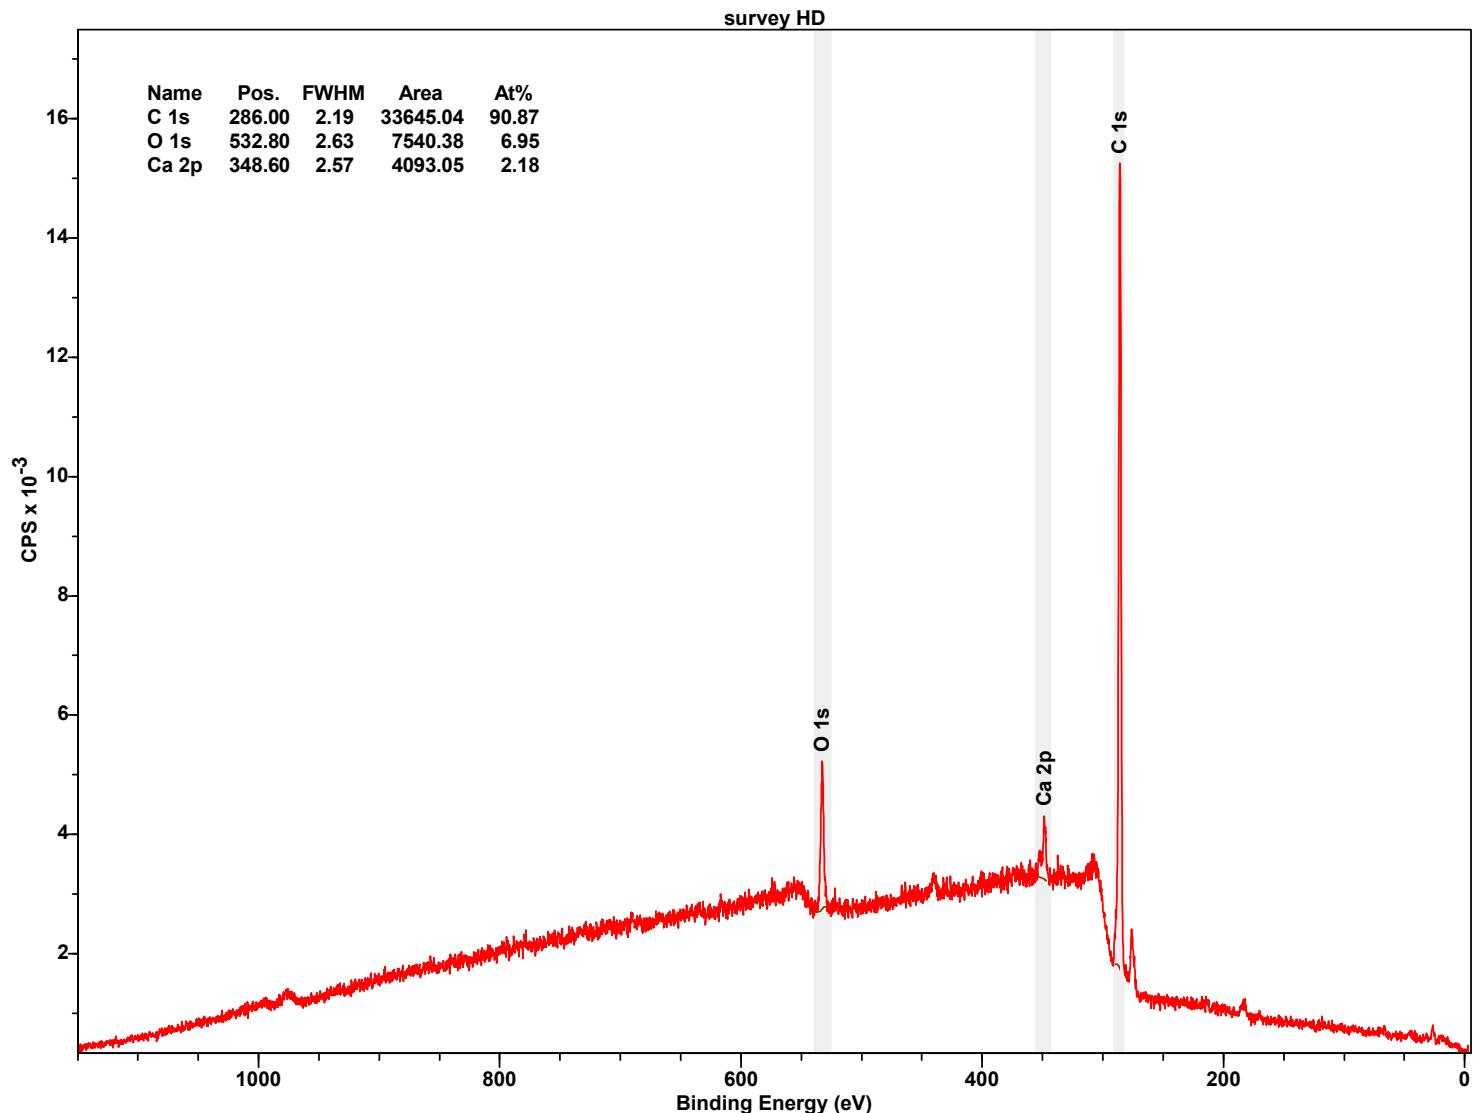
# Sample surface chemistry as received

- Almost completely covered by carbon (91%)
- 7% surface oxygen
- Calcium detected
- Zr and Ni not detected (<<1%)

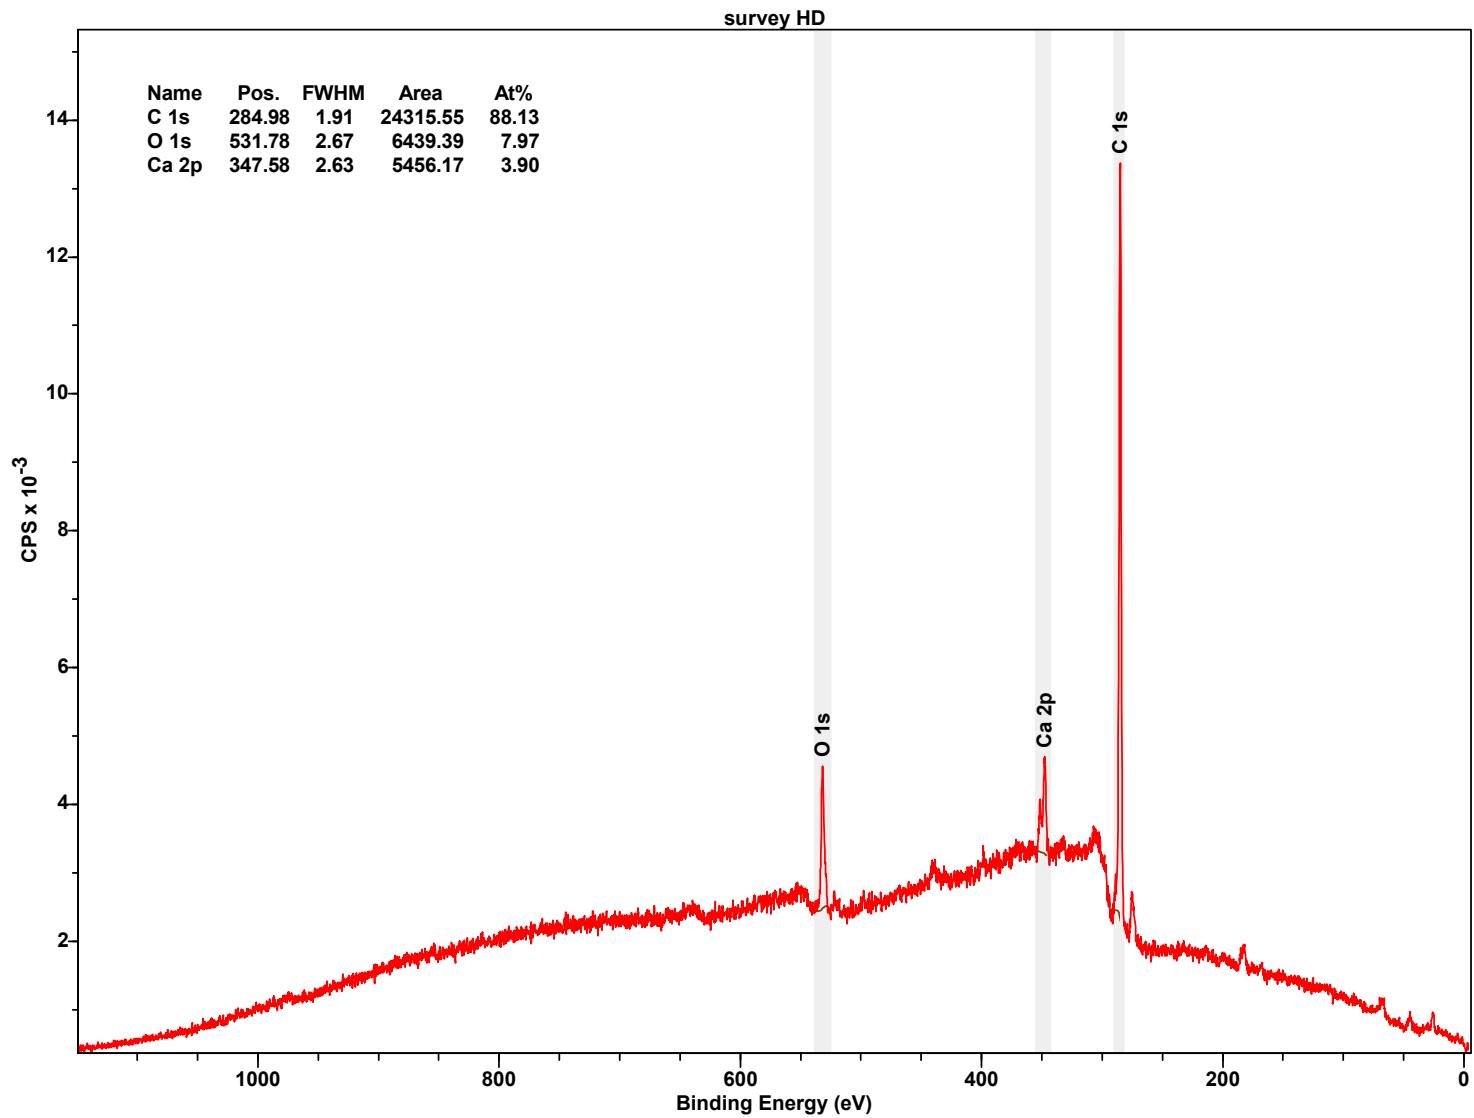
# Sample surface: T= 220 C, P= 300 mtorr of H<sub>2</sub>

- No substantial changes under hydrogen environment
- Carbon is unreactive to hydrogen at 220 C

1. Severe surface carbon contamination coats the surface. The carbon is much thicker than the penetration of XPS (3-8 nm).
2. 300 mTorr of hydrogen at 220 C did not affect this surface, suggesting that the surface has been effectively passivated by carbon.
3. Sputtering with  $\text{Ar}^+$  allowed us to access the Ni coating layer and monitor its surface chemical state.
4. Bulk impurities like C, Ca, Na, and oxides are present after sputtering cleaning, suggesting bulk contamination.

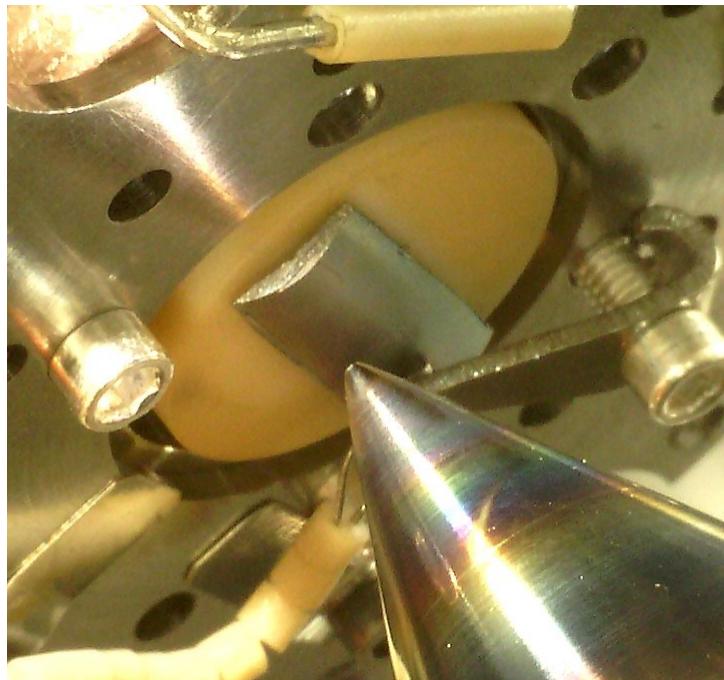
Before sputtering

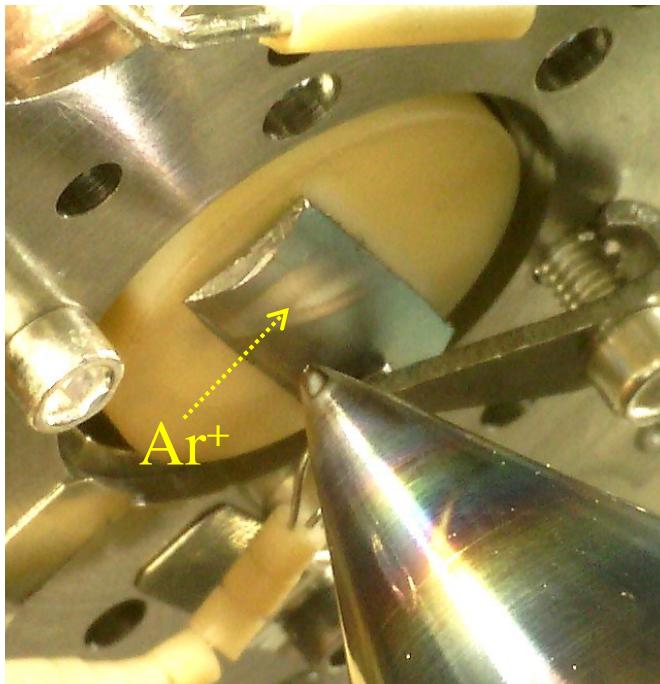
We sputtered the surface with Ar<sup>+</sup> ions to remove surface carbon

After Ar<sup>+</sup> sputtering  
(3 kV, 30 mA)

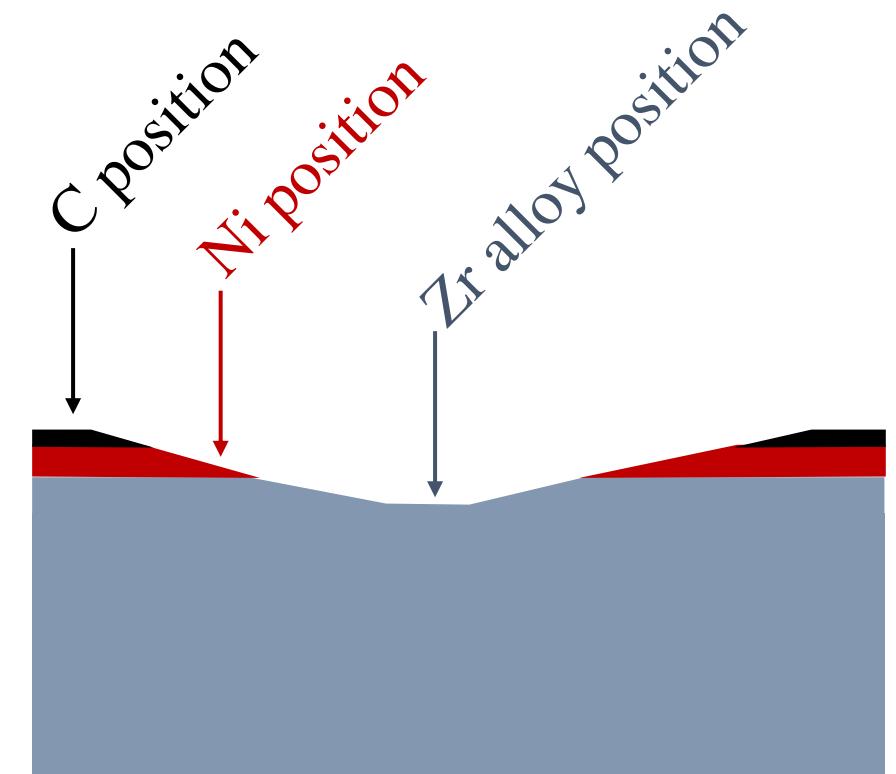
Sample side view after Ar<sup>+</sup> sputtering

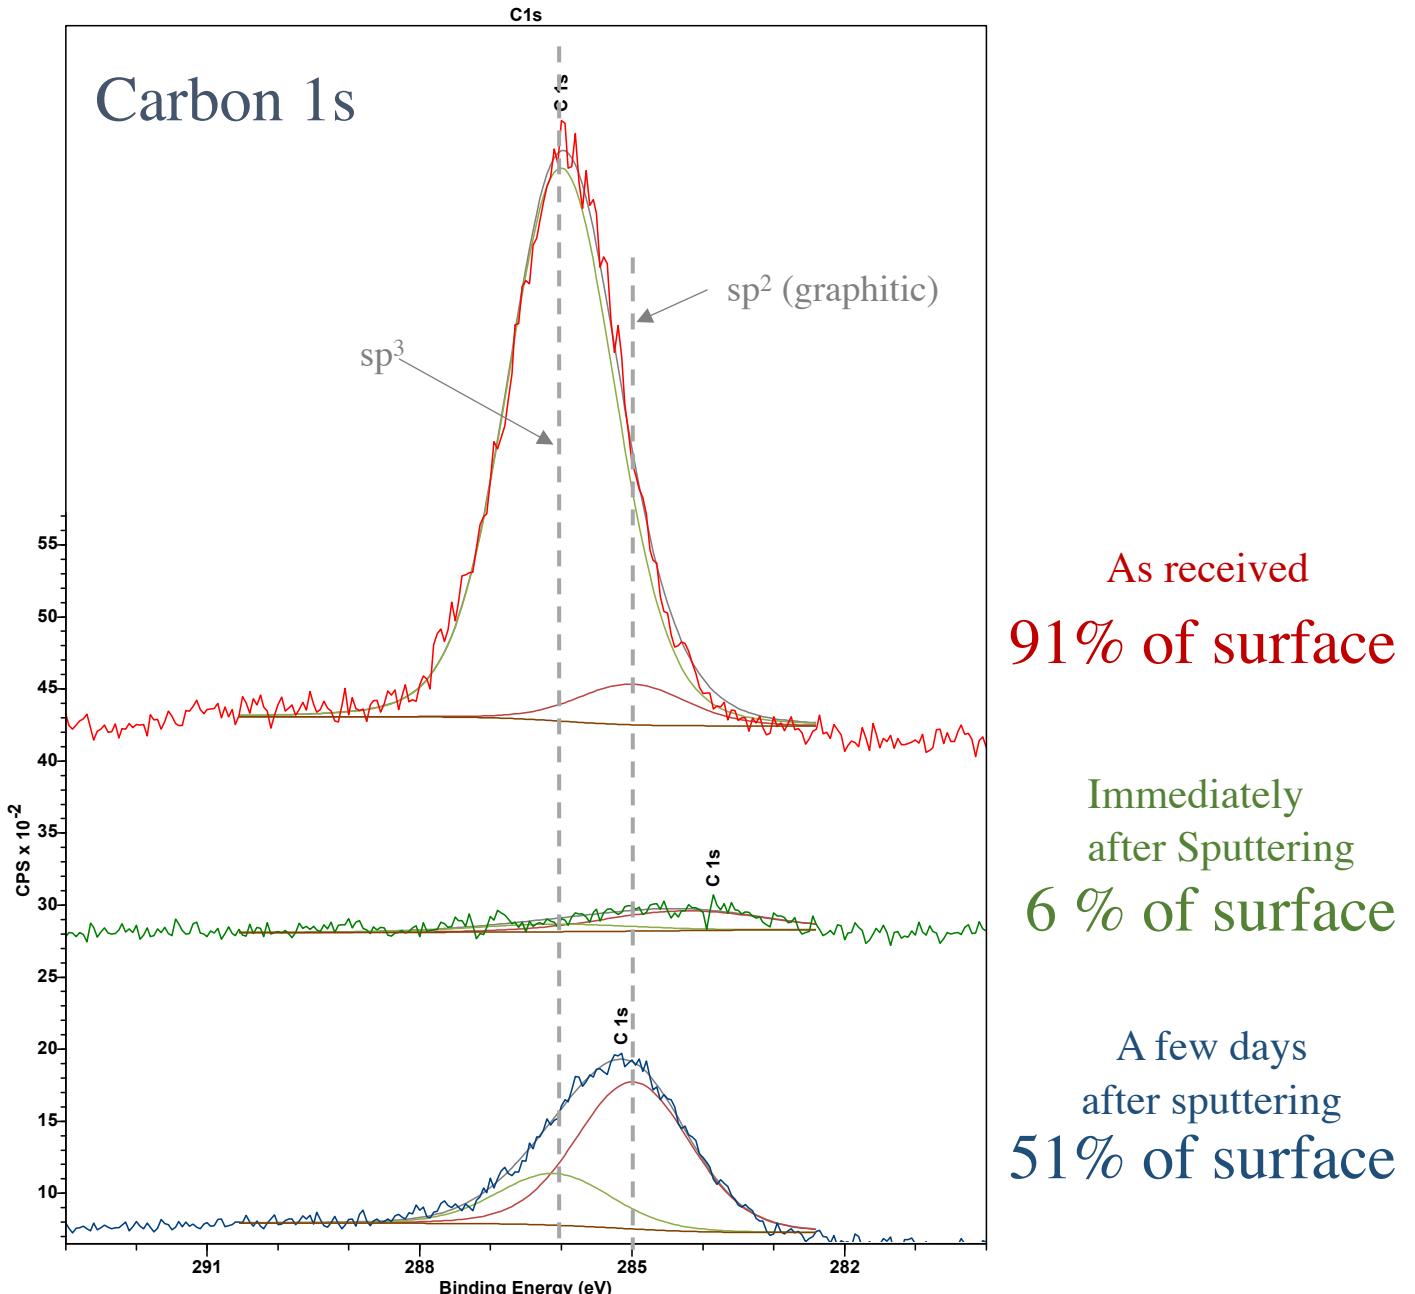
# Evolution of Carbon

1. Ar<sup>+</sup> sputtering removes most of the carbon
2. Carbon slowly (days) segregates to the surface after sputter cleaning.
3. The Ni coating must have considerable amount of dissolved carbon in the near-surface region. Nickel can dissolve and store carbon in the bulk if exposed to carbon at high T.
4. Even a very small amount of carbon impurity in the bulk of Ni can result in high C surface coverages after segregation. A clean nickel surface becomes unstable if there is bulk carbon.

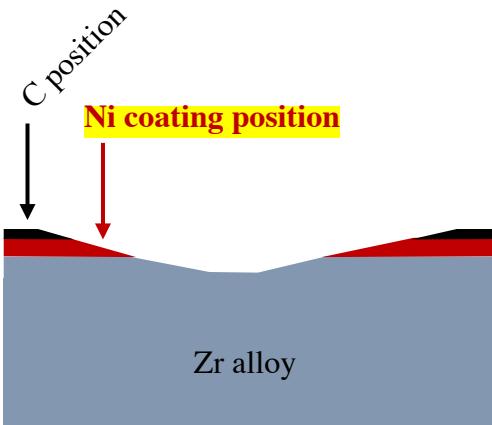
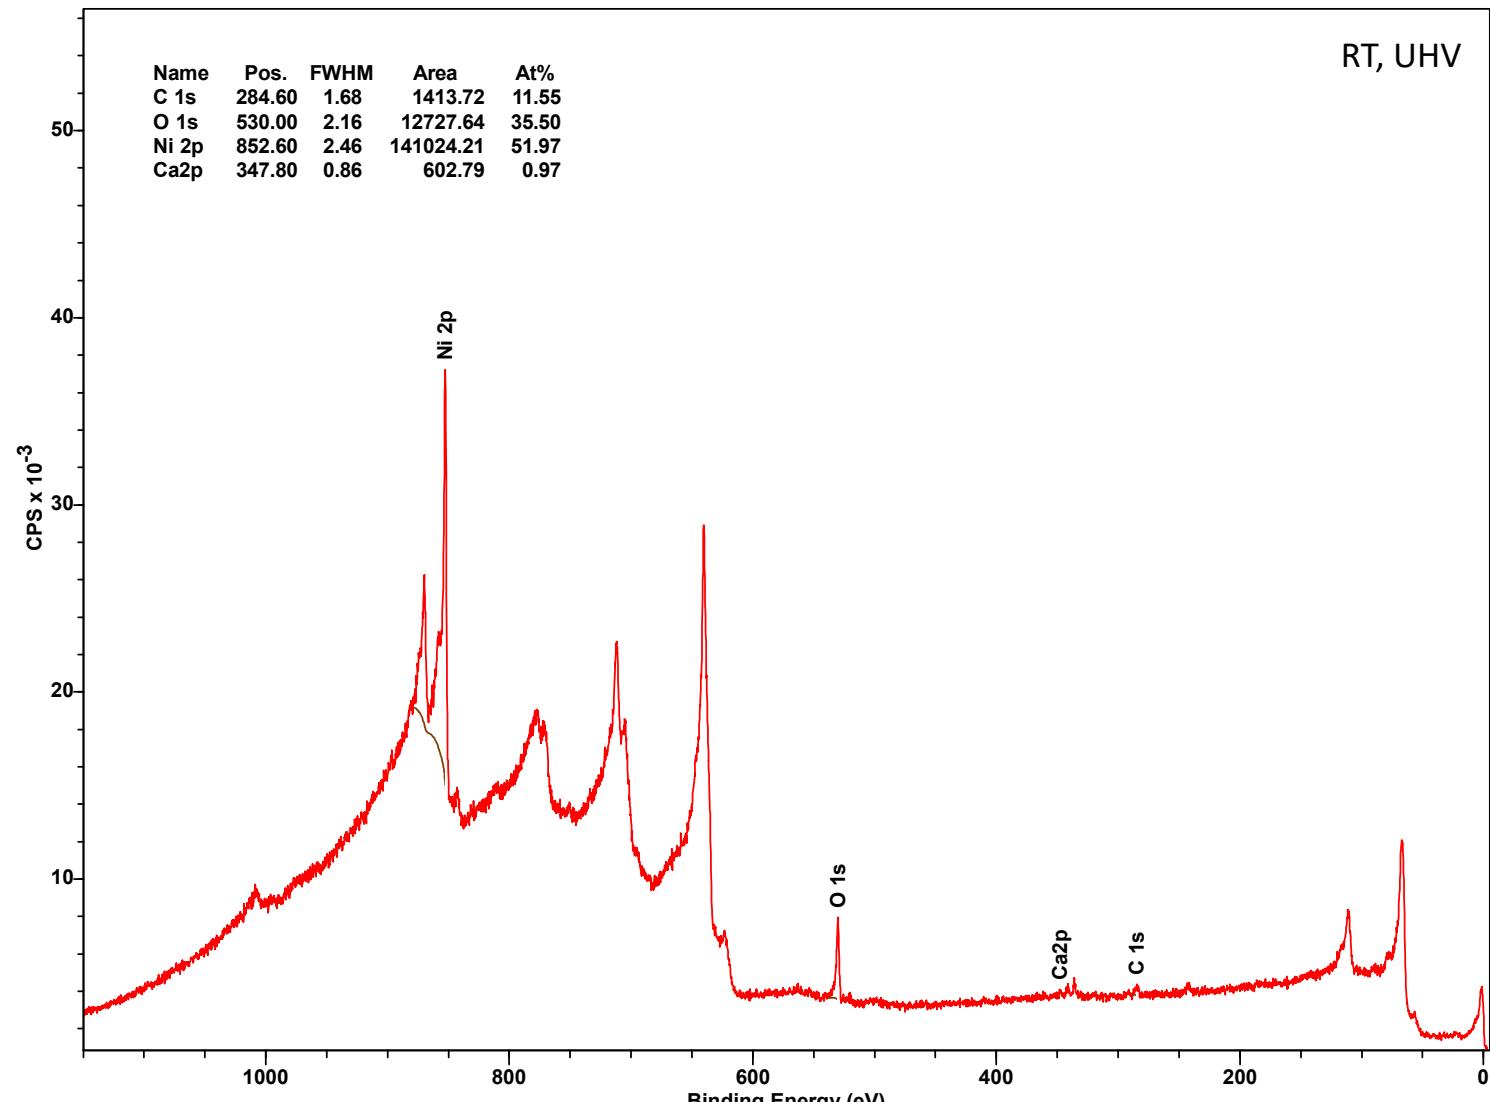
# Sample after sputtering: Ni coating position

- Nickel: 52 %
  - 92.8% Ni metal
  - 7.2%  $\text{Ni(OH)}_2$
- Oxygen: 35.5%
- Carbon: 11.5%
- Calcium contamination detected (1%)
- Oxygen probably bonded to carbon and  $\text{Ni(OH)}_2$

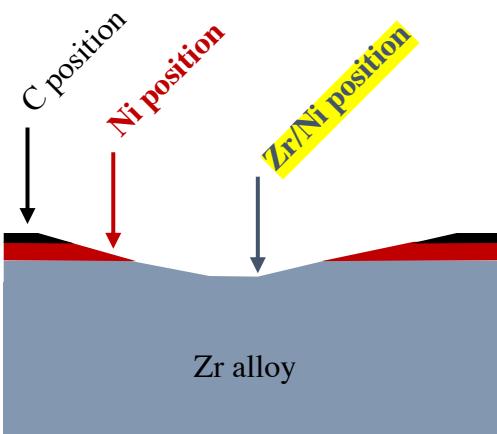
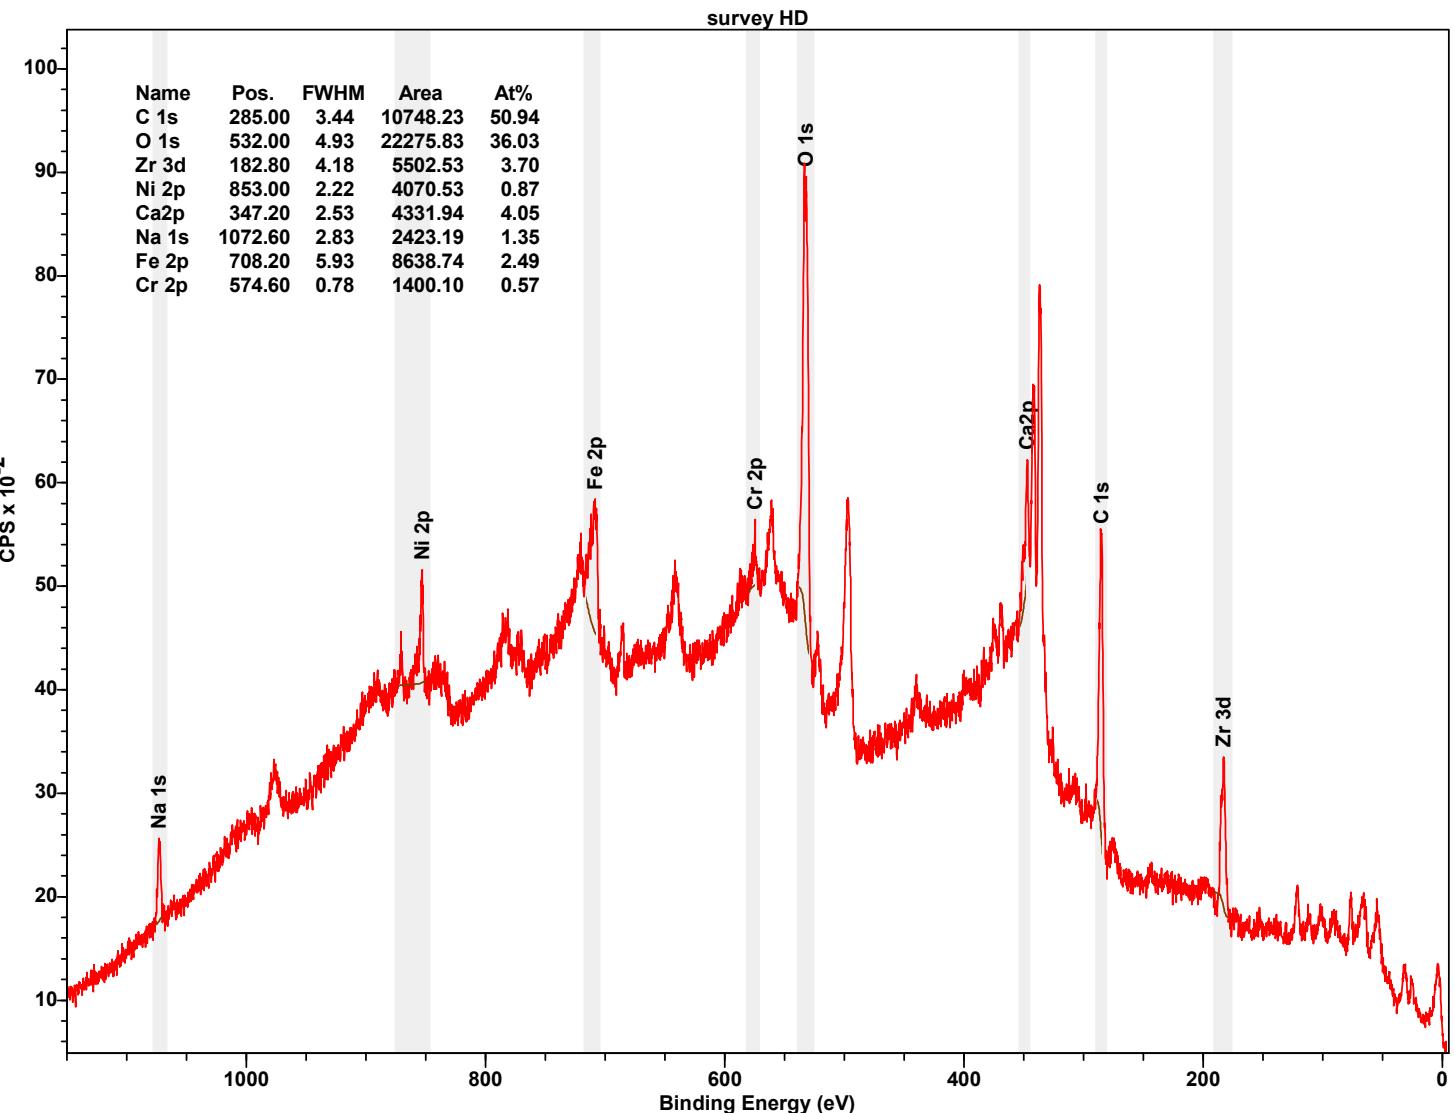
## Zr position RT, UHV

- Multitude of impurity elements:
  - Carbon (50%)
  - Calcium (4%)
  - Sodium (0.5%)
  - Oxygen remains at ~36%

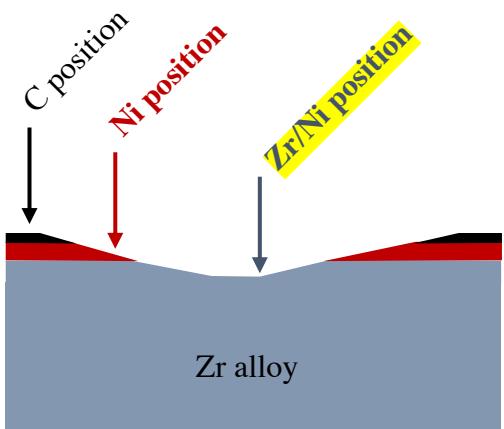
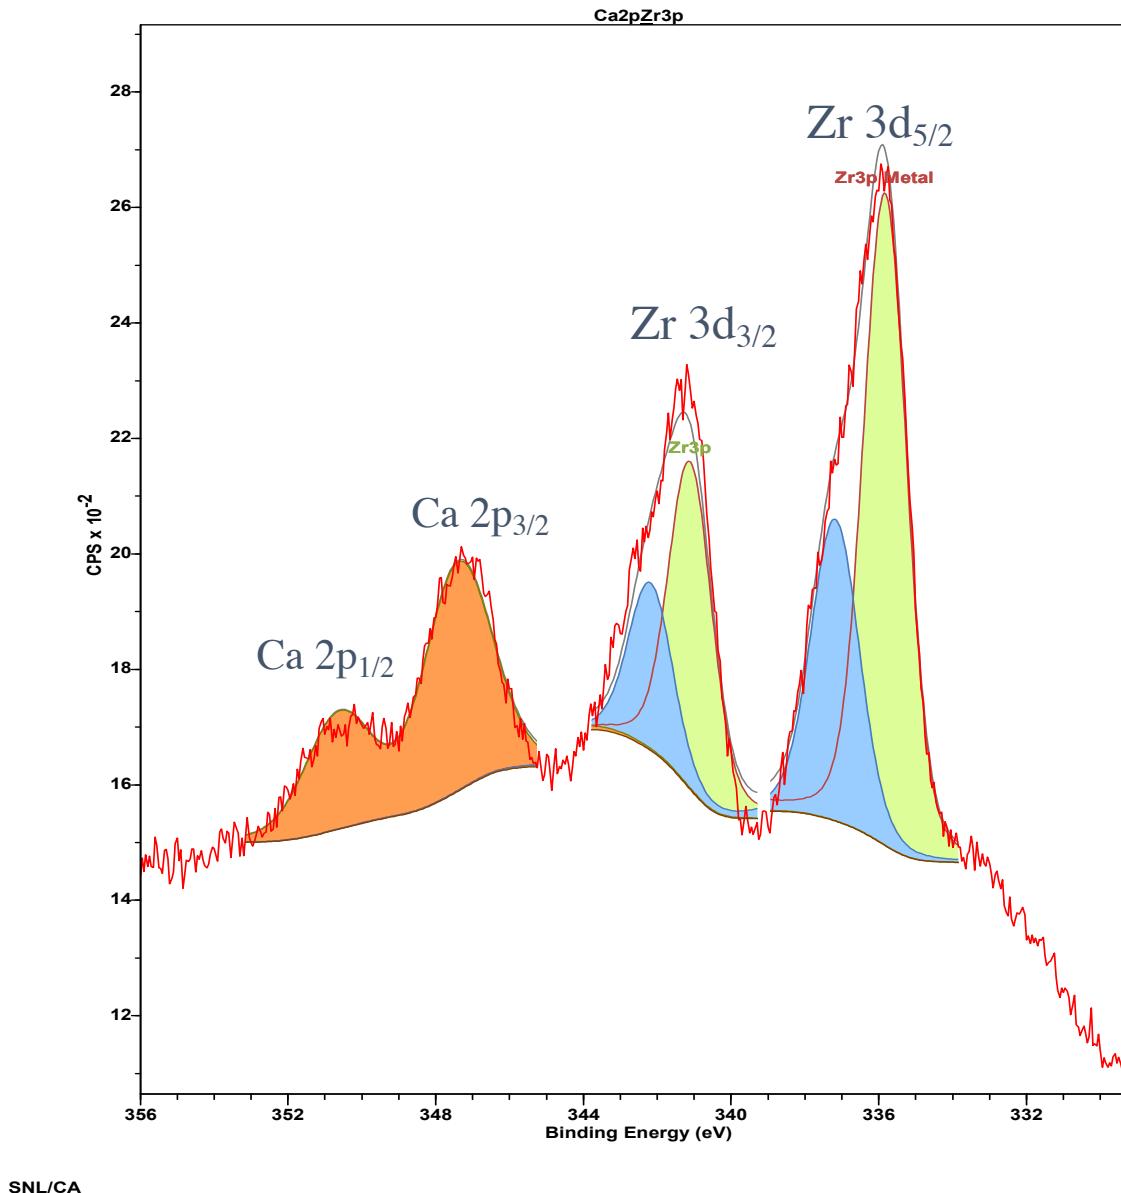
Sample after sputtering:  
Zr/Ni position  
RT, UHV

Zr 3d, Ca 2p detailed peaks:

- Zr:
  - 66% Zr metal/alloy
  - 33%  $\text{ZrO}_2$
- Ca: 100%  $\text{CaCO}_3$
