Blade Reliability Collaborative Meeting

Blade Durability and Damage Tolerance Project

Produce computational tools, experimental datasets, and technical innovations that will allow blade designers, manufacturers, owner-operators, and service personnel to improve and optimize their approach to building and operating wind blades

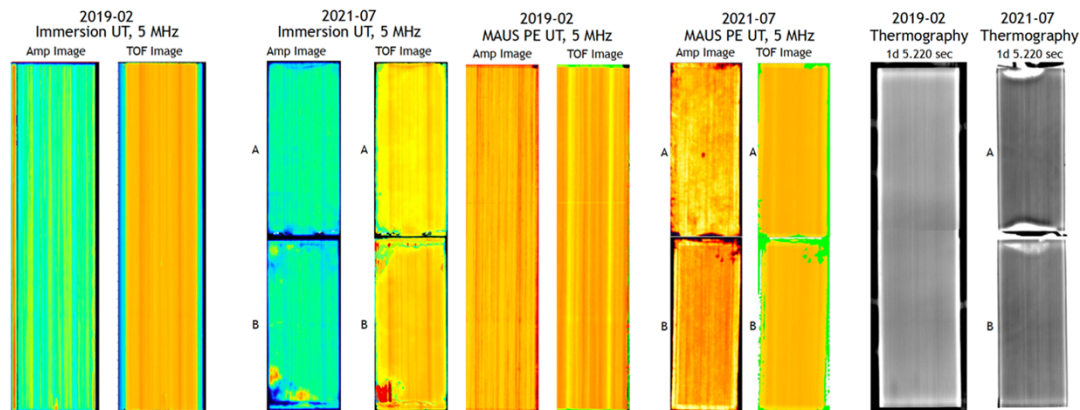
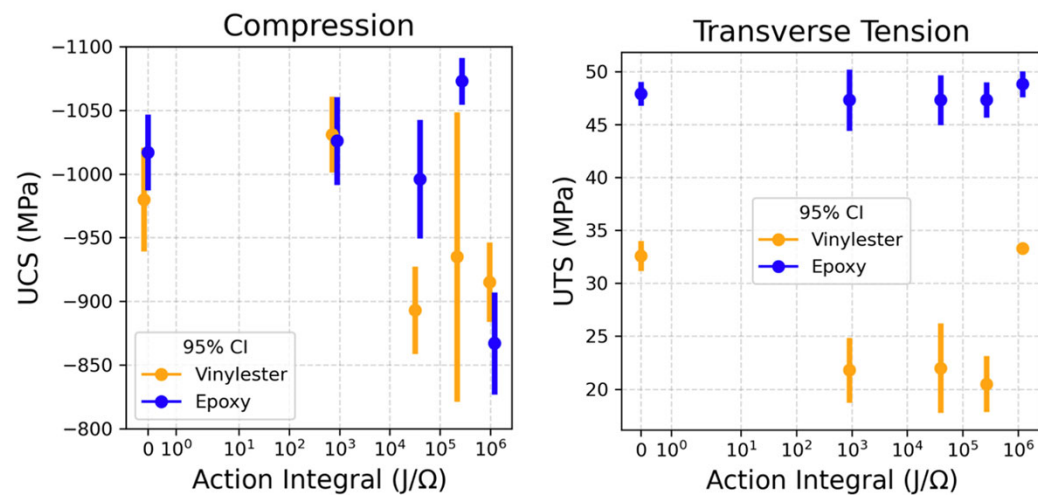
Strength vs action integral (energy per unit resistance, 95% CI)

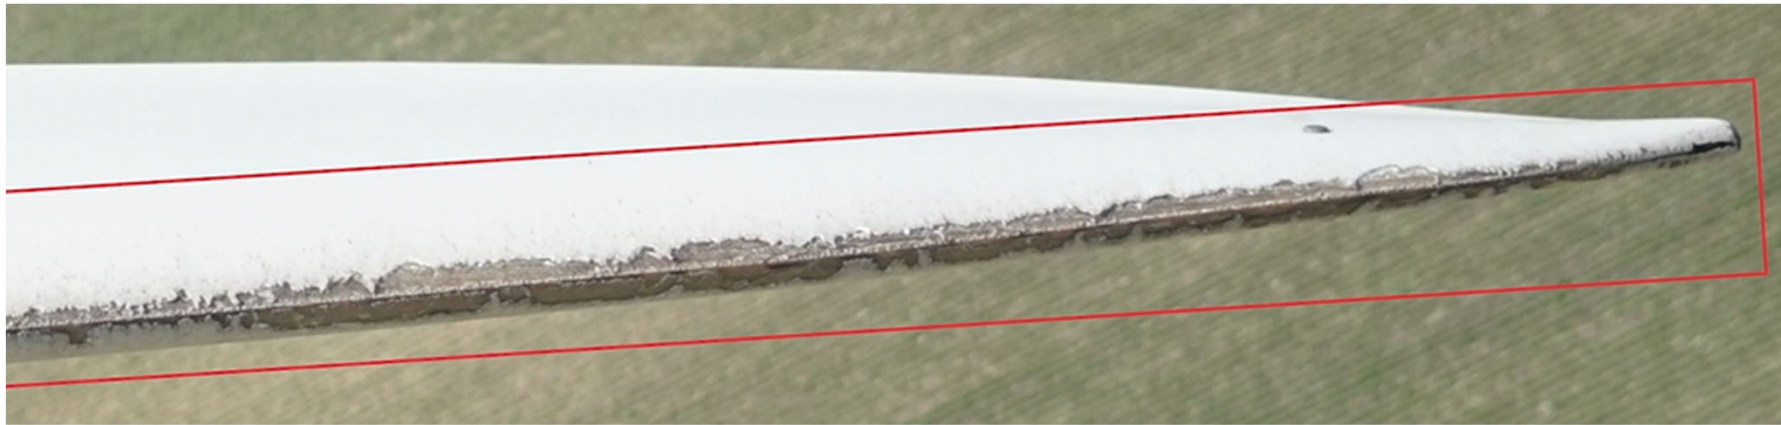
Erosion Classification System Example

- Participants were asked to test the draft classification system on a sample of images.

Information to Categorize	Erosion Class	Note
Visual data definition	4	Large exposed surfaces of fiberglass. Signs of damage to the underlying fiberglass.
Mass-loss or Depth	4	
Aerodynamics/Performance	4	
Structural	3

Parameter (Specified by Service Provider)	Value
Material	Laminate
Blade Length	37 m
Distance from Root	37.3 m
Length of damage	4.1 m
Width of damage	0.15 m

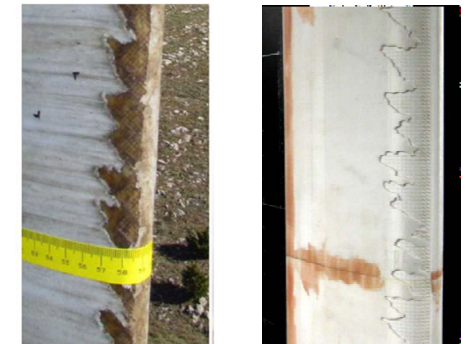
Category 4 erosion wind tunnel tests

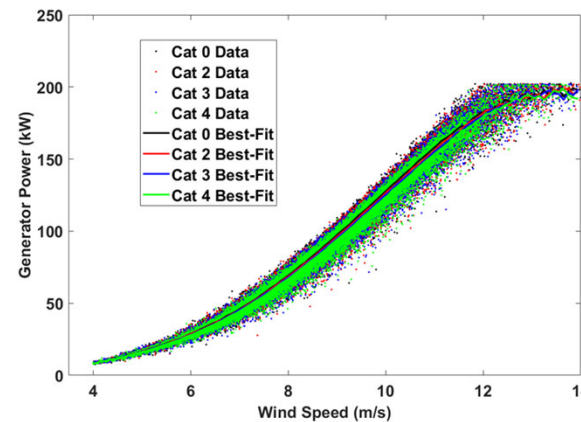
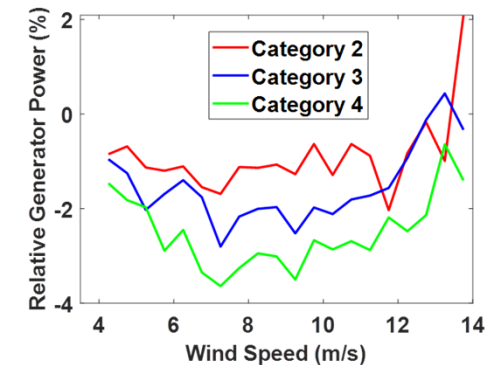
Probabilistic power curve model of erosion, categories 2-4^[3]

- A probabilistic model of the power loss due to erosion has been developed based on wind tunnel tests of simulated eroded airfoils
- The present work aims to validate the loss predicted in this model through the comparison of turbines with unrepaired LEE damage to repaired turbines with protection tape
- Local met tower data and archival wind plant SCADA data used from turbines classified as having undergone Category 4 erosion

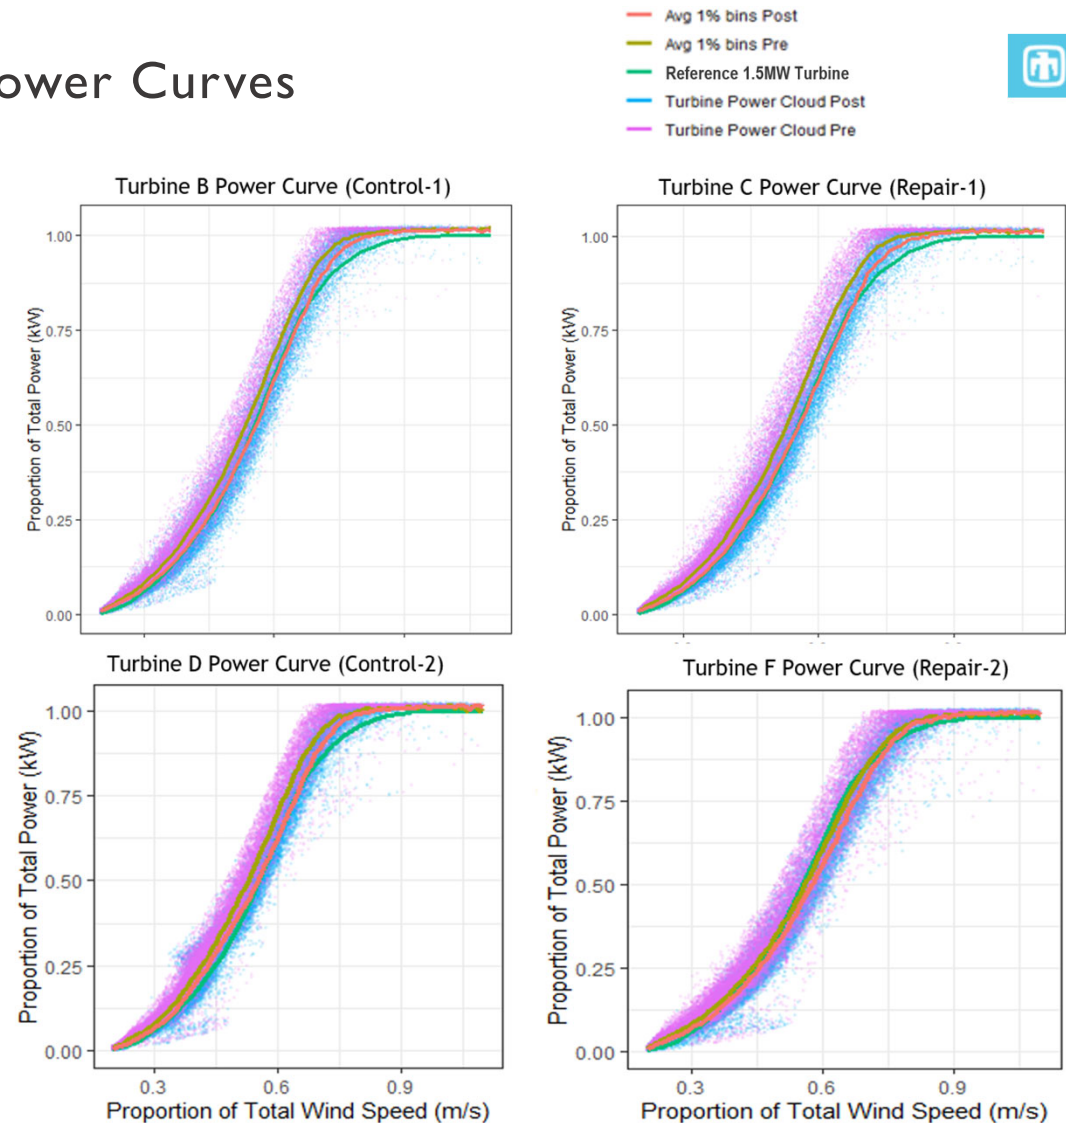
Comparing Turbine Pairs– Overall Power Curves

- While power curves for turbine look similar, slight differences in overall area toward region 3 contribute to greater differences in power performance
- Overall, turbines generated less power after the repairs to turbines C and F
 - Therefore we must compare the relative power loss for both turbines
- If turbines C and F had better relative performance, we can conclude the repair was effective
- For each month, power curves graphed for each turbine and fitted using three-parameter logistic function

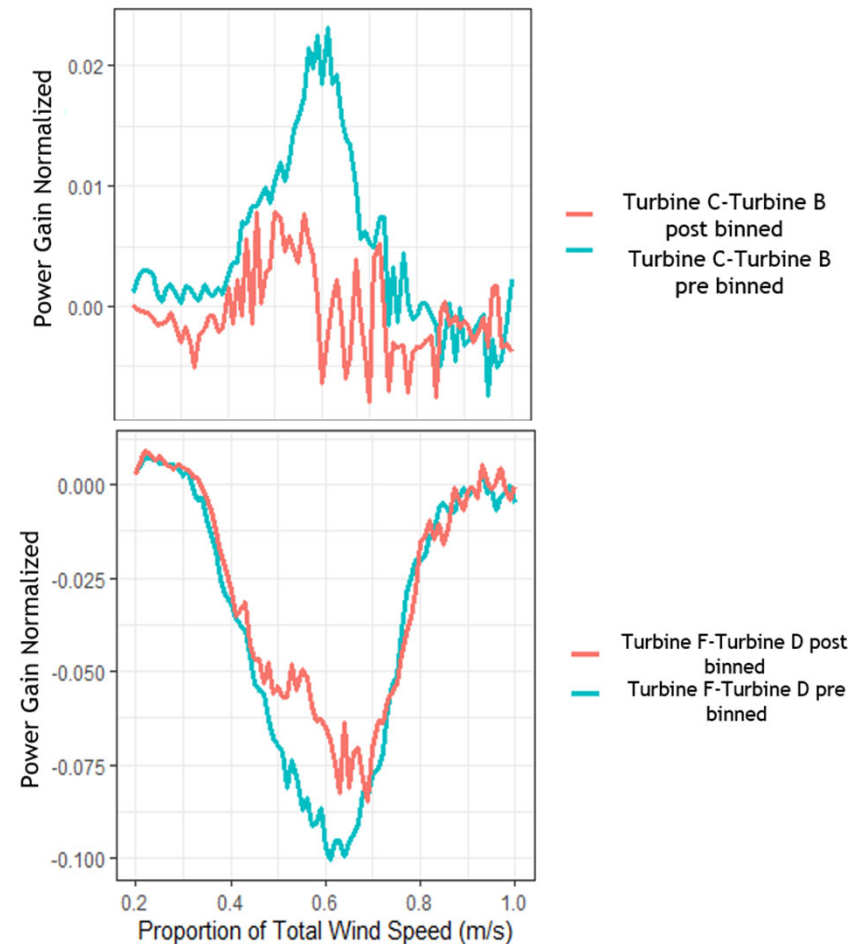
Comparing Turbine Pairs– Relative Power Differences

- Turbine C was generating 1-2% more power for the same wind speed in middling wind speeds, with approximately equal production at the extremes
 - After repairs that advantage largely disappeared, resulting a net loss in relative power gain
- Turbine F was generating 5-8% less power for the same wind speed in middling wind speeds, with approximately equal production at the extremes
 - After repairs that disadvantage was mitigated slightly, resulting a net gain in relative power gain of 1-2% across middling wind speeds
