# Status Report: Intergranular Stress Corrosion Cracking of BWR Core Shrouds and Other Internal Components

Manuscript Completed: March 1996  
Date Published: March 1996

**Division of Engineering  
Office of Nuclear Reactor Regulation  
U.S. Nuclear Regulatory Commission  
Washington, DC 20555-0001**

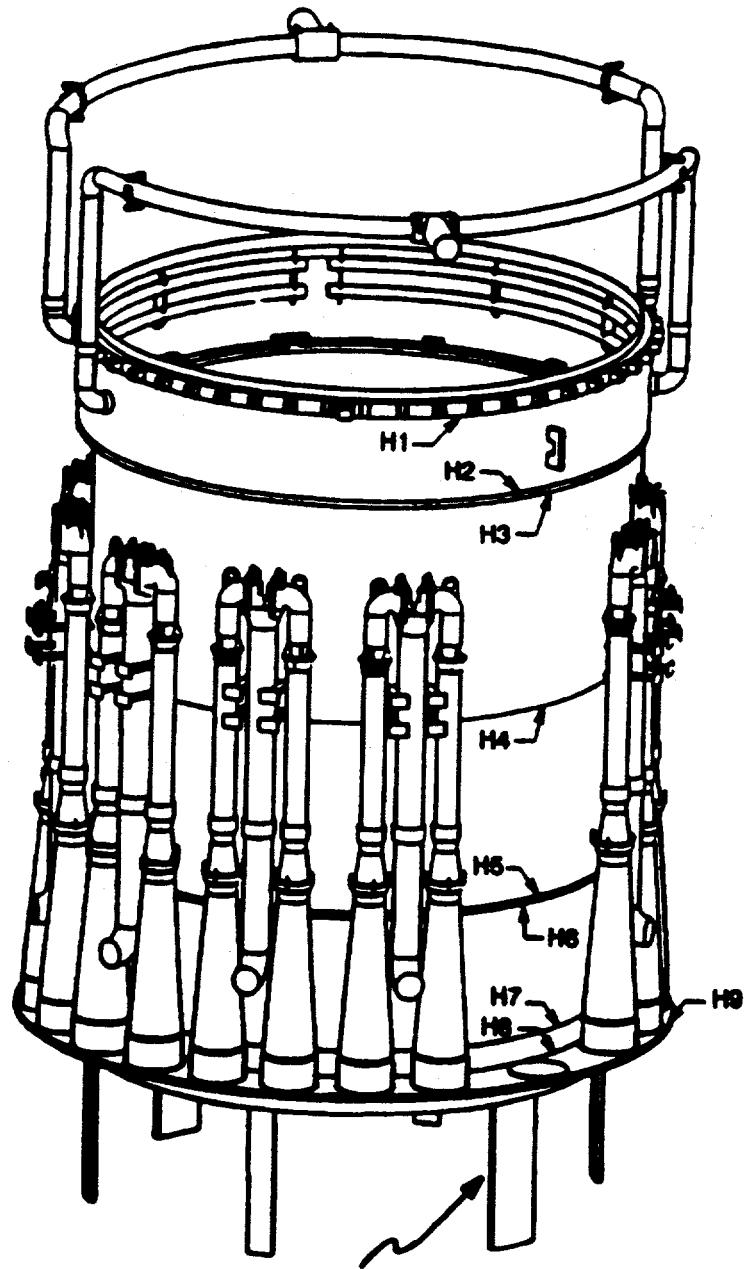
**Figure 2.2-1 Structural Configuration Typical of GE BWR-3, BWR-4, BWR-5, and BWR-6 Core Shroud Designs**

shielded metal arc welding (SMAW), automated submerged arc welding (SAW), automated gas tungsten arc welding (GTAW), automated gas metal arc welding (GMAW), or a combination of these welding techniques. Figure 2.2-1 illustrates the structural configuration that is typical of GE BWR-3, BWR-4, BWR-5 and BWR-6 core shroud designs. Figure 2.2-2 illustrates the locations of circumferential welds that are typical of these designs, although the exact number and numerical notation of the shroud welds may vary from plant to plant. The structural configuration of core shrouds in GE BWR-2 designs is similar to later designs, with the exception that the shroud is supported by a truncated conical support plate.
