## MICROSTRUCTURE OF GaN GROWN ON (111) Si BY MOCVD

D. M. Follstaedt, J. Han, P. Provencio and J. G. Fleming

Sandia National Laboratories, Albuquerque, NM 87185-1056

Cite this article as: MRS Internet J. Nitride Semicond. Res. 4S1, G3.27 (1999)

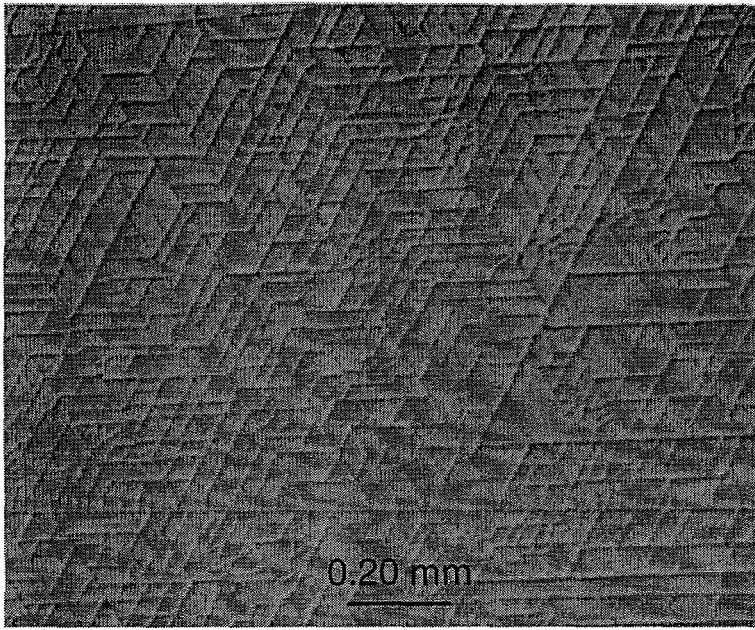
Figure 1. Nomarski optical micrograph showing cracking of GaN on (111) Si along {1-100} planes.

separations from 20 to 100  $\mu\text{m}$  was found along {1-100} planes, as seen in Figure 1. The GaN layer is expected to have relaxed fully at the growth temperature, as found for growth on  $\text{Al}_2\text{O}_3$  using in situ stress monitoring techniques [4]. The greater thermal expansion coefficient of GaN as compared to that of Si ( $5.6 \times 10^{-6}/\text{K}$  vs.  $2.6 \times 10^{-6}/\text{K}$ , respectively) then explains cracking since the GaN layer would be put into tension upon cooling. In spite of cracking, the GaN layer adhered to the substrate. X-ray diffraction of such layers gives (0002) GaN reflections with FWHM of 900 arcsec, similar to those found previously [2].

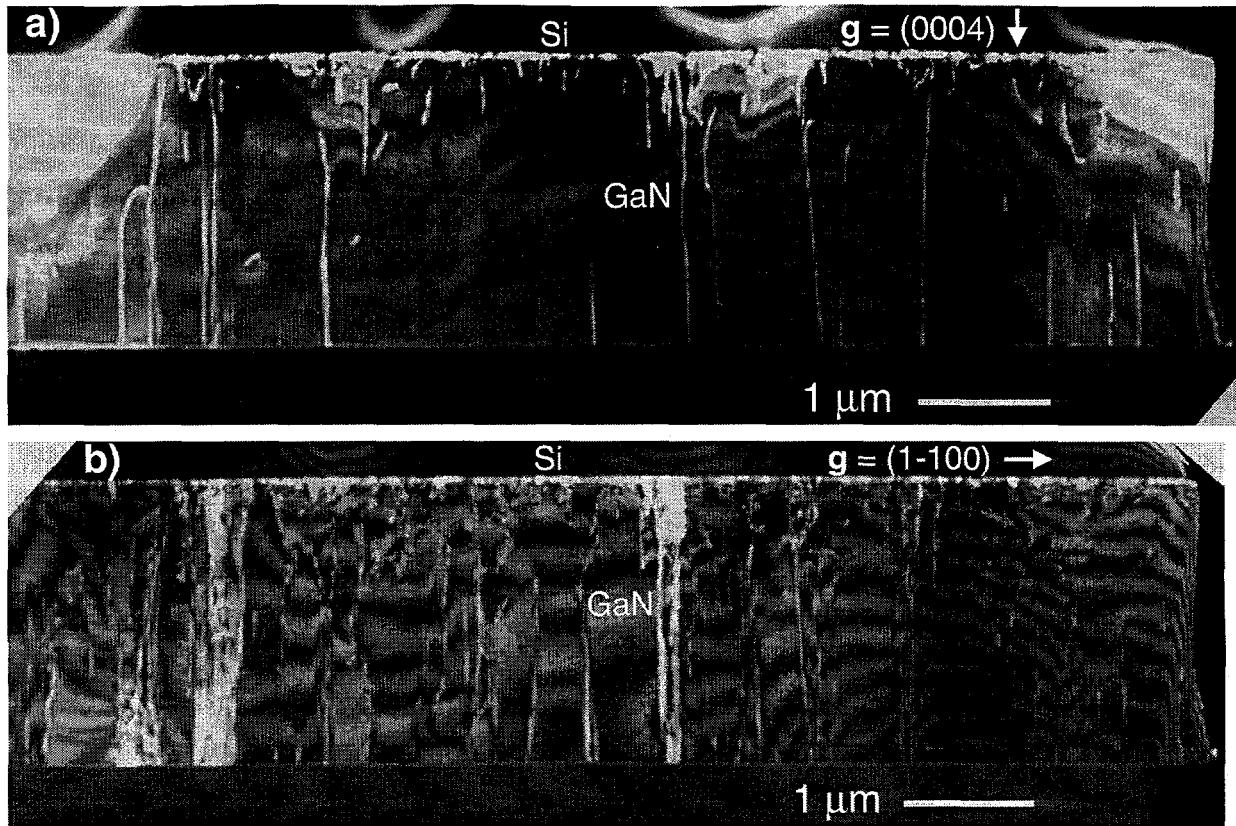
Figure 2. Weak-beam TEM images obtained near [11-20] orientation. a)  $g = (0004)$ , with cores of dislocations having  $\mathbf{b} = \mathbf{a} + \mathbf{c}$  illuminated. b)  $g = (1-100)$ , with cores of all dislocations illuminated. A crack running through the layer and into the Si substrate is seen at far right.

Dislocations thread from the buffer layer to the surface of the GaN layer. Examination in cross-section with different diffracting beams can be used to determine the Burger's vectors of individual dislocations, which for hexagonal close-packed lattices are: **a** (or  $1/3<11-20>$ , in the basal lattice plane), **c** ( $<0001>$ , along the hexagonal axis), or **a+c** ( $1/3<11-23>$ , mixed character). Two diffracting conditions are shown in Figure 2. The upper image (a) uses the (0004) reflection to illuminate the cores of dislocations with Burger's vectors having a c-axis component. The lower image (b) uses a reflection sensitive to those with a basal plane component. Detailed examinations with several reflections indicate that almost all dislocations can be detected in Figure 2b) and have a basal-plane component. Those with the c-axis component seen in Fig. 2a (~1/3 of the total) are almost all of mixed character. The additional ones seen in Fig. 2b (~2/3 of the total) have purely basal-plane Burger's vectors, **b** = **a**; since the dislocation lines are fairly straight along the c-axis growth direction, these are termed edge dislocations. Very few of the dislocations have **b** = **c** corresponding to pure screw dislocations. This distribution of dislocation character is like that found in GaN grown on sapphire [6].

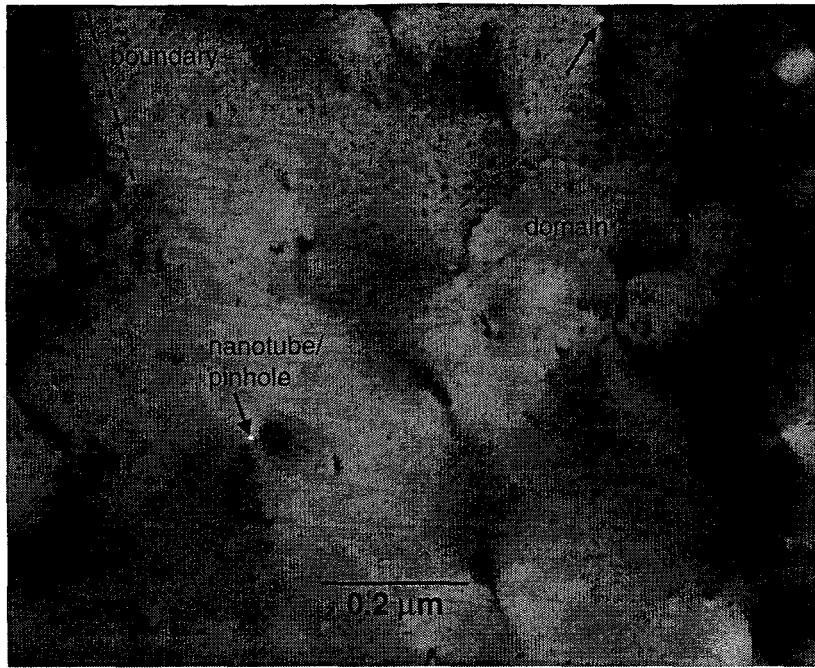
Figure 3. Plan-view TEM image of GaN layer at the surface, obtained near [0001] orientation using  $g = (1-100)$  two-beam conditions in bright-field. Dislocations appear as short black-white segments, and often form continuous curves at boundaries between domains of material with slightly differing orientations; two are noted with nearby dashed lines. Two void-like defects (nanotubes or pinholes) are also noted with arrows.

Plan-view TEM gives additional insight into the dislocation arrangement. A specimen was prepared by placing thinned epoxy on the specimen surface to penetrate the cracks, removing excess epoxy from the surface, and carefully backthinning with the specimen attached to a grid for structural support. The thinned area is at the surface of the GaN layer and allows defects threading to it to be detected. In Figure 3, the dislocations are viewed nearly end-on and appear as short black-white segments. They often lie along continuous curves that form boundaries between domains of material with slightly differing orientations. A similar arrangement is found for threading dislocations in GaN grown on sapphire [6]. Plan-view images allow more surface area to be examined than in cross-section and give the most accurate determination of dislocation density at the surface:  $8 \times 10^9$  disl/cm<sup>2</sup> for this specimen. This density is like that found for GaN grown on sapphire, although lower values have been achieved [6].

By examining this greater surface area, an additional defect is found at a low density. Two void-like defects were identified in Figure 3 (small white spots, arrowed) by examining their contrast changes with objective lens focus in the TEM. Such defects have been termed “nanotubes” if they have extended length into the GaN, or “pinholes” if they are pits located at surface [7]. Since we do not have depth information, we cannot determine which of the two classifications apply. Other images taken under high resolution conditions show that the {1-100} lattice planes form facets around the voids. Their areal density is  $\sim 1 \times 10^8$ /cm<sup>2</sup>, again comparable to that found in GaN grown on sapphire [7].

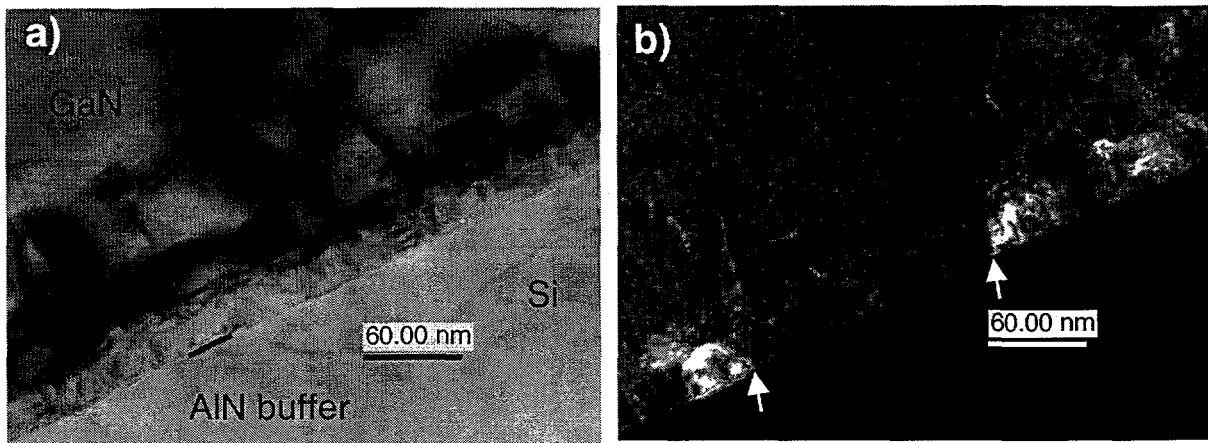
Figure 4. a) Bright-field, (3-300) two-beam image of AlN buffer on Si substrate near [11-20] orientation with dislocations extending into GaN layer above. b) Corresponding weak-beam image showing 20-40 nm grains in the buffer with contrast between them indicating slight orientation differences. Two dislocations appear to originate from grain boundaries in the buffer (arrowed).

The buffer layer was found to be continuous over extended distances in cross-section images. Its thickness varies somewhat as seen in Figure 4a, but it is readily identified from the GaN overlayer. By tilting the specimen slightly to vary the contrast in bright field, or by weak-beam examinations like Figure 4b, the layer is seen to be composed of grains 20-40 nm slightly misoriented with respect to each other.

Dislocations in the GaN just above the buffer interact with each other, as seen in Figure 4. The dislocations extend into the AlN buffer at near-normal incidence. In some cases, they appear to coincide with grain boundaries in the buffer; two instances are arrowed in Figure 4b. This suggests that the misorientations between AlN buffer grains may directly produce some of the dislocations threading through the GaN. Perhaps if a buffer layer with larger grains were formed, the GaN would have fewer defects.

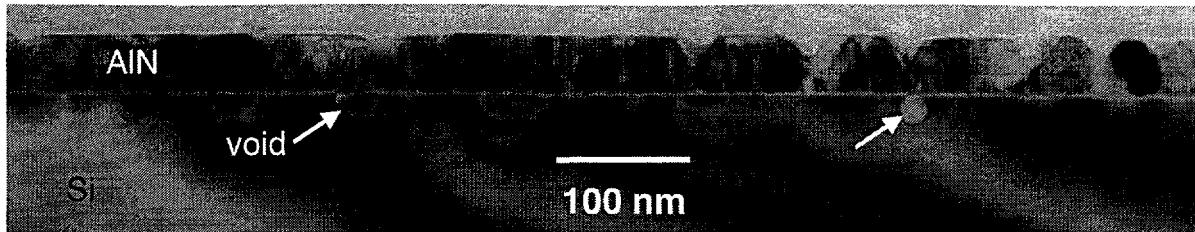
Figure 5. Cross-section TEM image of 40 nm AlN buffer grown on (111) Si, seen in [11-20] orientation with  $g = (0002)$  two-beam conditions. Grains in the AlN buffer are faceted at the top surface, and two voids (arrowed) can be seen just below the interface in the Si.

A cross-section TEM specimen was also made of a 40 nm-thick AlN buffer layer grown alone on (111) Si at 1100°C. The layer was again found to be continuous, as seen in Figure 5. Our examinations indicated two other features of this layer. First the individual grains composing the buffer exhibit faceting on the growth surface; the facets appear to be {1-101} lattice planes. Secondly, a few voids were found in the Si immediately beneath the interface, which suggests that Si may be diffusing into the AlN.
