EVALUATION OF ALUMINUM SURFACE TREATMENTS FOR EPOXY BONDING APPLICATIONS USING MODE I FRACTURE TESTING

Brian T. Werner, Adriana Pavia Sanders, Nalini Menon, Fitzjames Ryan, Rodrigo E. Susperreguy
Sandia National Laboratories, Livermore, CA

Aluminum Bonding Reliability

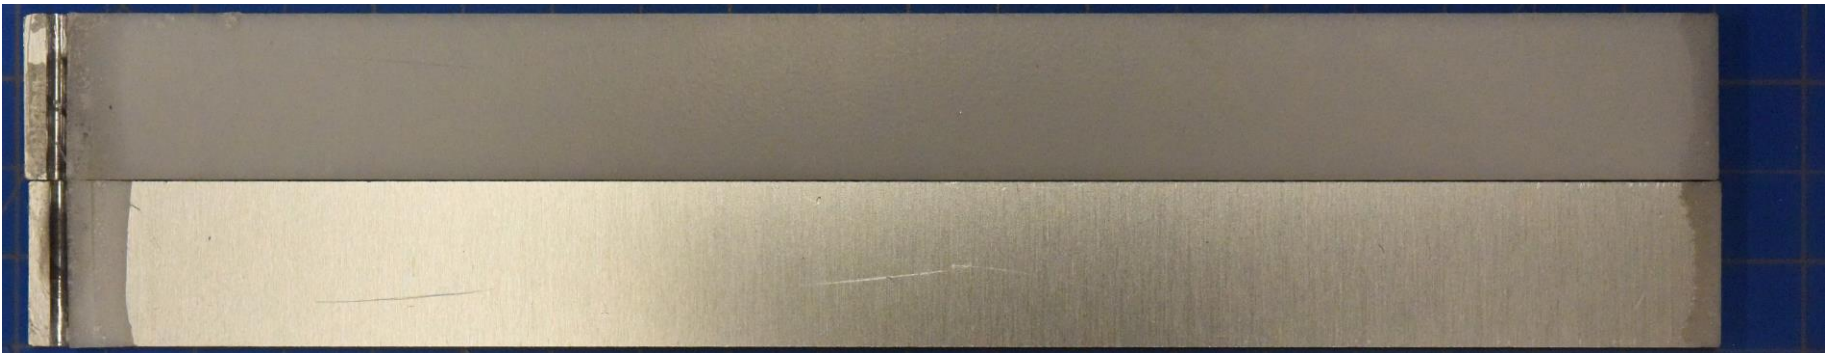
Adhesive failure of 6061-T6/ANA interface for unprimed SAA II w/HWS at -55°C

- Initial testing of unprimed SAA II w/HWS showed adhesive failure at sub-ambient temperatures
- Co-bond
 - A single ply of an 8HS weave fabric glass fiber reinforced polymer (GFRP) prepreg is cured between two aluminum adherends

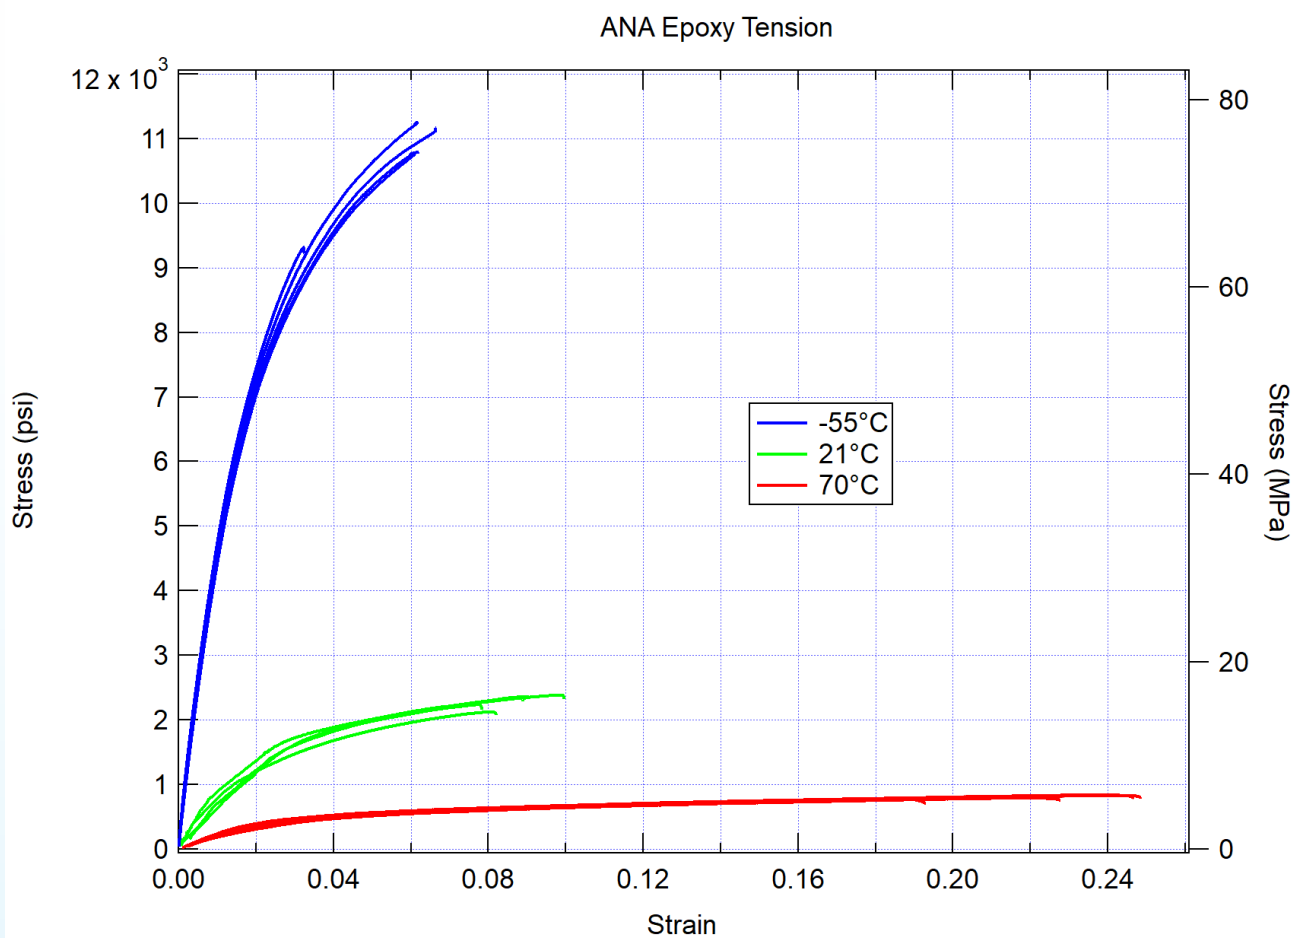
ANA Adhesive Tensile Response

- Sandia proprietary low-viscosity, ductile epoxy adhesive (ANA) that is used as a filler to significantly thick bond lines (~1.5mm)
 - Bulk properties for the epoxy vary widely across the temperature range leading to significant changes in the cohesive toughness

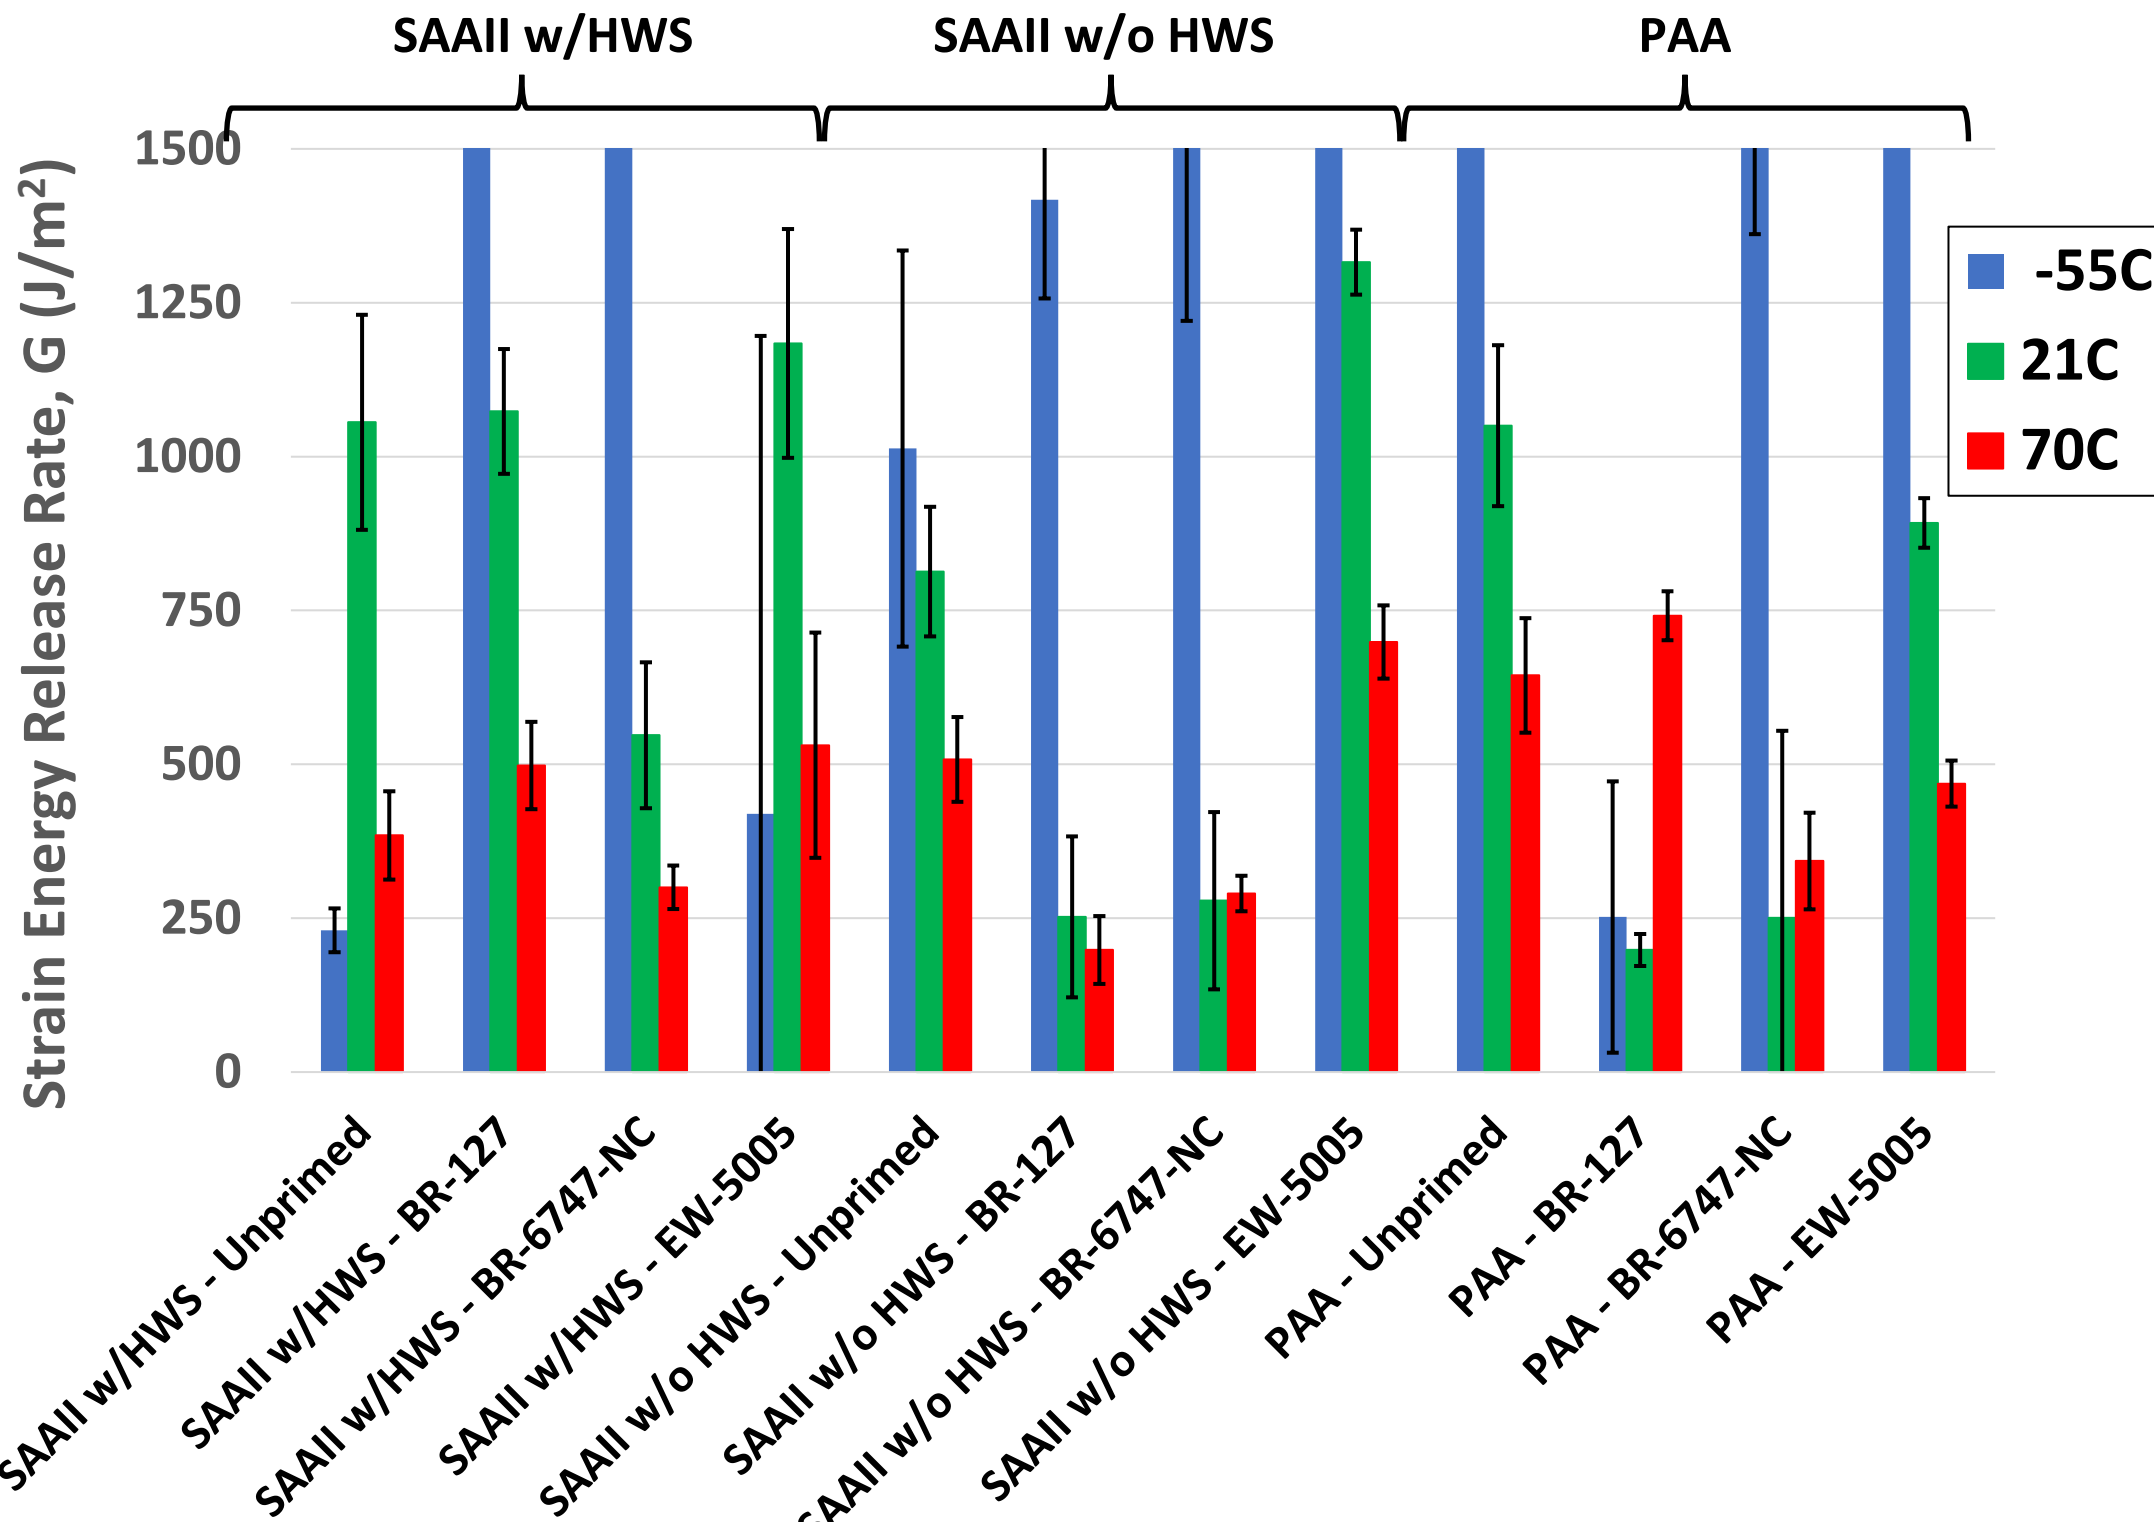
SERR comparisons for secondary bonded interfaces

- No broad rule of thumb
 - Each anodization had a matched primer that performed sufficiently well in addition to one combination that did not
 - Reinforces the necessity of testing paired adhesive/surface treatments
- ANA is extremely tough at sub-ambient temperatures which caused aluminum adherends to yield
 - Difficult to disentangle plastic work done on adherend with energy dissipated during crack growth
 - Thicker adherends would produce more quantitative data, but that was deemed unnecessary for this study

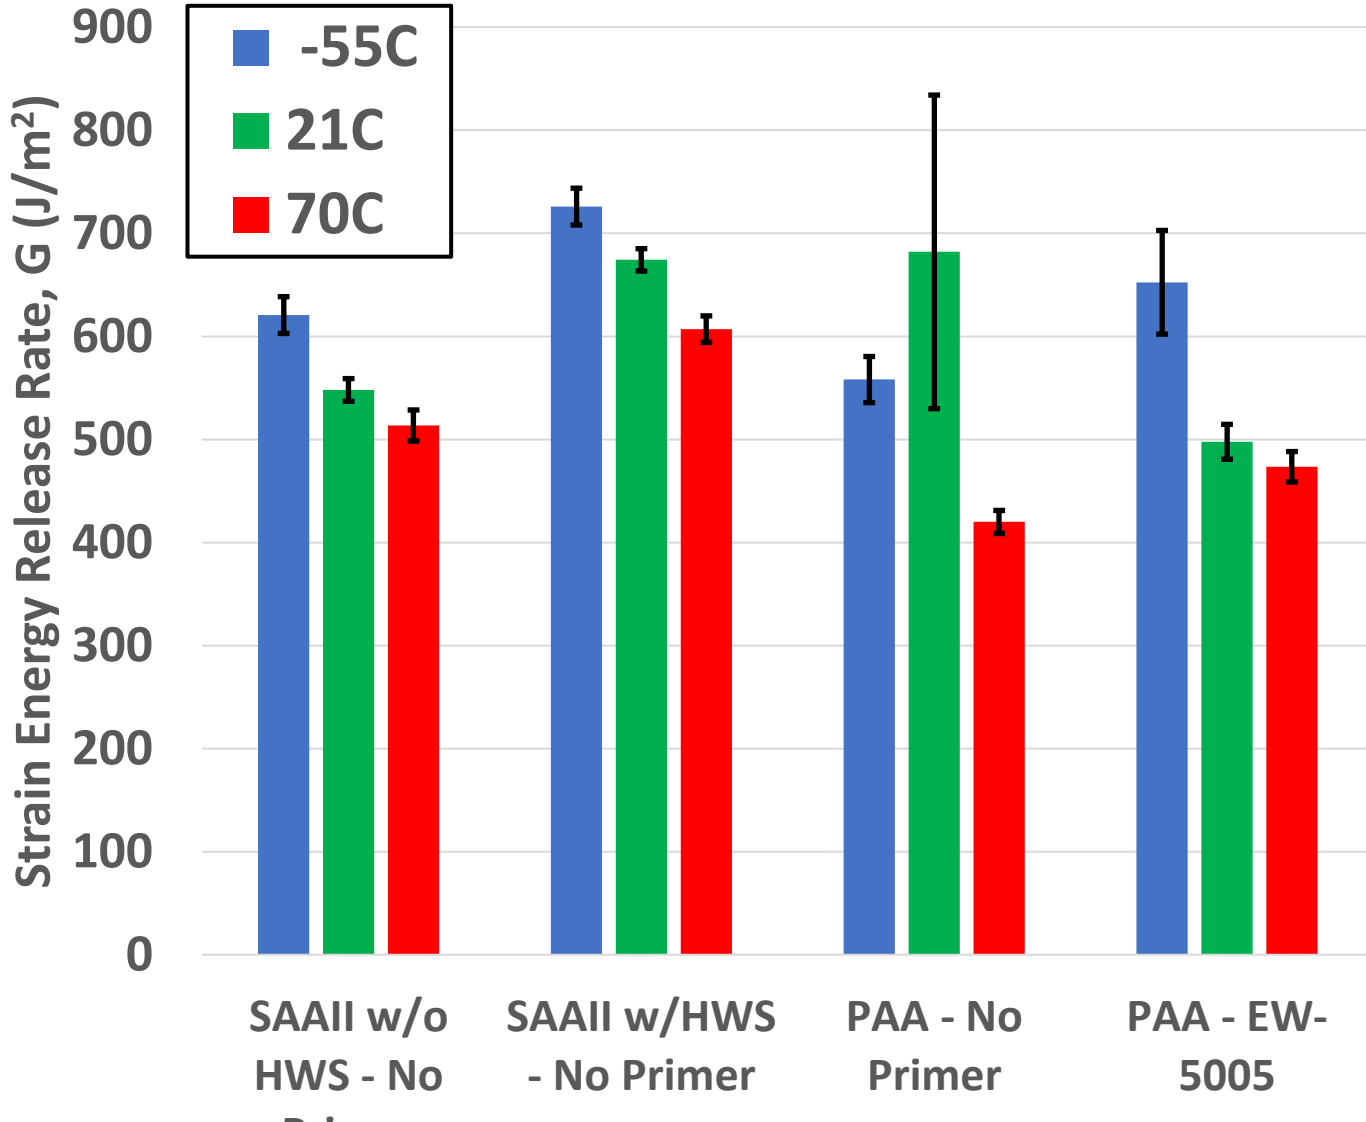
SERR comparisons for co-bonded interfaces

- Down selected to PAA with EW-5005 after secondary bond study
- Compared results to unprimed co-bonded panels with different anodizations
- All failures were cohesive within the prepreg epoxy resin – failure typically at epoxy glass fiber interface
- Small variations in SERR, most likely due to small variations in epoxy pore infiltration/bond line
