**TECHNICAL PROGRESS REPORT  
FOR  
"HIGH PERFORMANCE MATERIALS IN COAL CONVERSION UTILIZATION"**

**FOR THE PERIOD  
JANUARY 1, 1996 THROUGH MARCH 31, 1996**

**Prepared by:  
The University of Tennessee Space Institute  
B. H. Goethert Parkway  
Tullahoma, Tennessee 37388-8897**

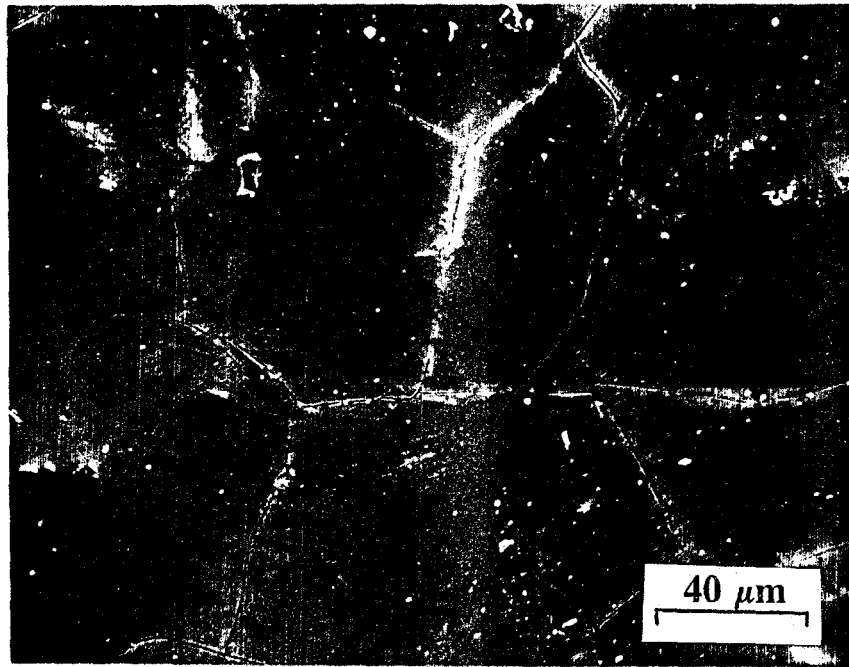
Figure 1 Scanning electron micrograph of reaction product surface formed by  $\text{Na}_2\text{CO}_3/\text{air}$  melt

An initial analysis was conducted on the as-received samples corroded with a  $\text{Na}_2\text{CO}_3$  film resulting from a 50 hours exposure at 1200 °C. Figure 1 is the surface view of a scanning electron micrograph. It shows that corrosion products had a smooth, glassy appearance with some micro-cracks. Figure 2 is the EDS plot of the corrosion products in the surface. The plot indicates the present of Na, Al and Si only. These products should be primarily  $\text{SiO}_2$  and  $\text{NaO}\cdot\text{x}(\text{SiO}_2)$  with a small amount of  $\text{Al}_2\text{O}_3$  and some residual Al.

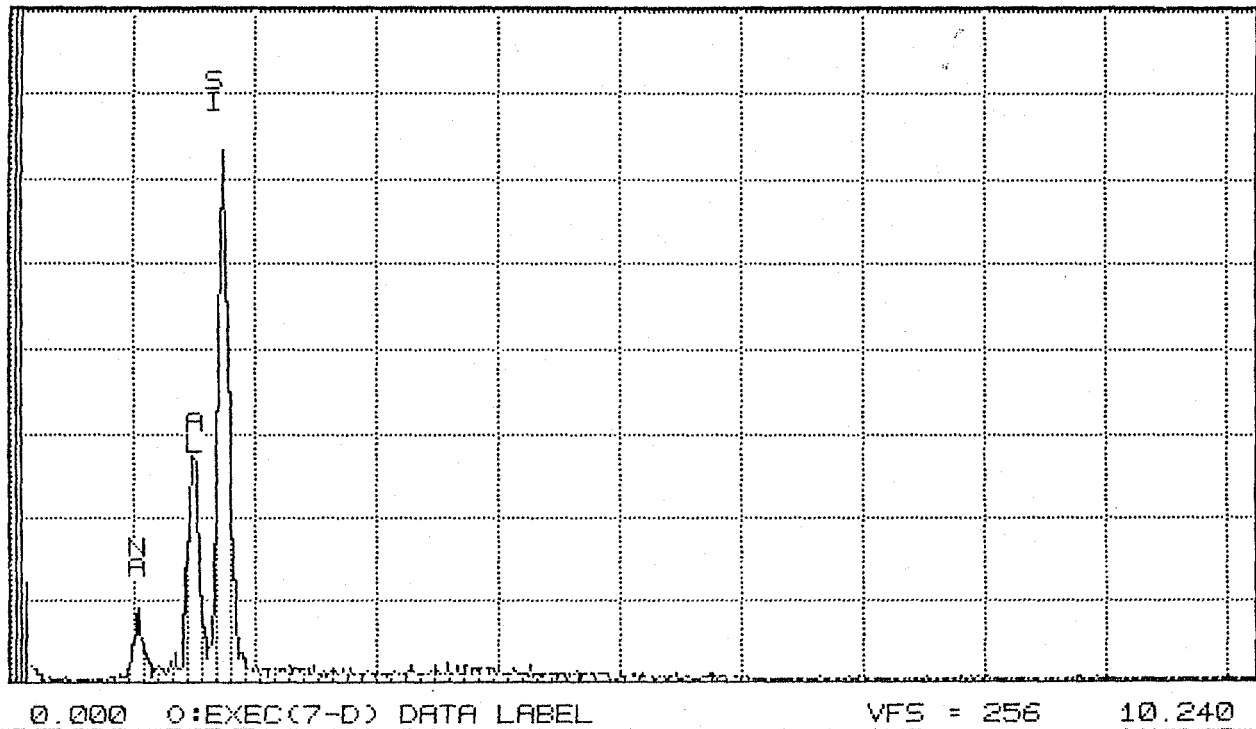
Figure 2 EDS plot of the corrosion products in the surface

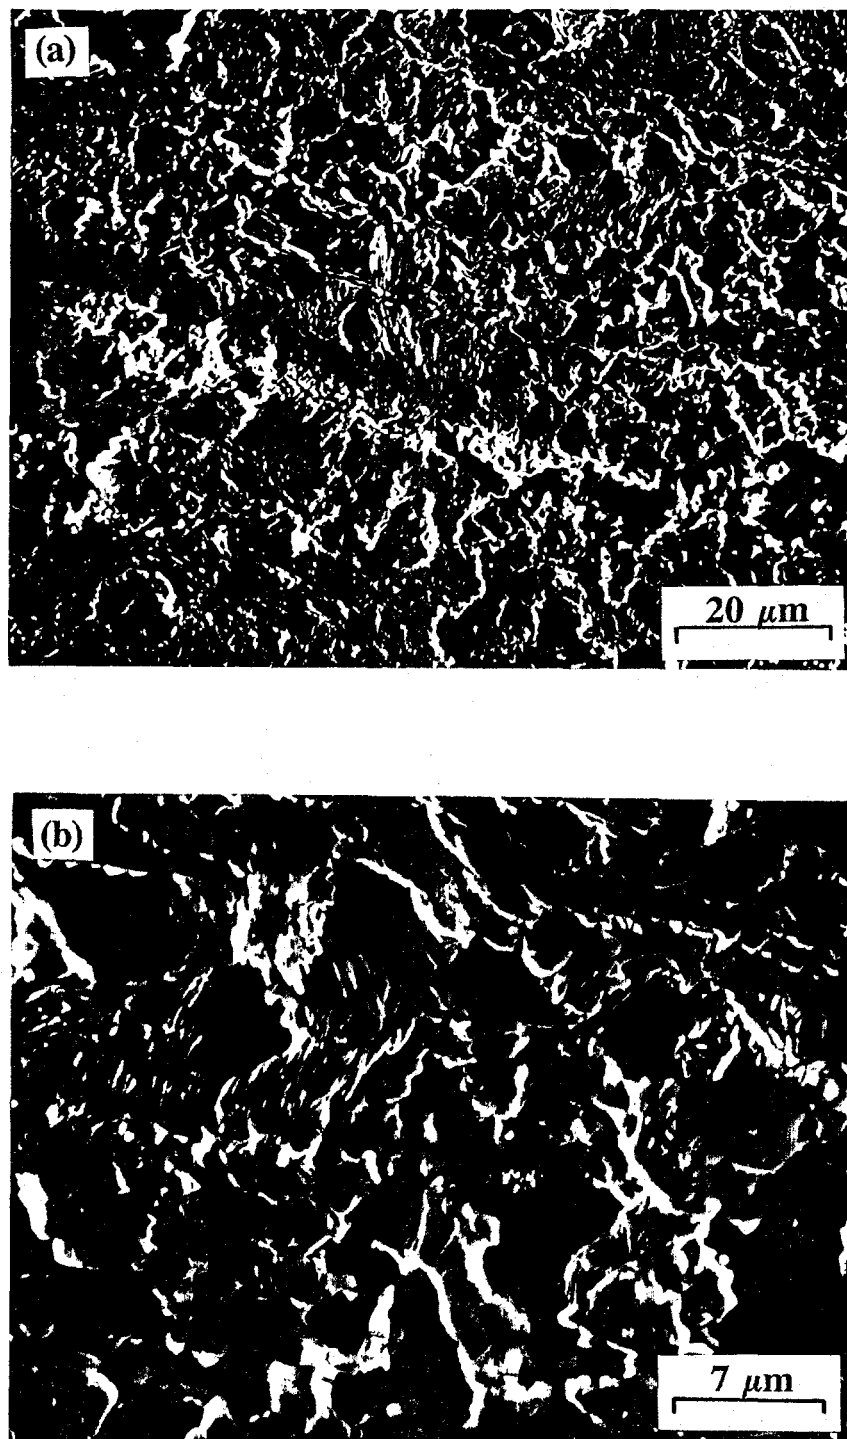
Figure 3 Scanning electron micrographs of  $\text{Na}_2\text{CO}_3$ /air-corroded surface (the corrosion products in the surface removed with HF) (a) overview; (b) detail of (a)

After the entire corrosion product layer was removed with a HF solution, the etched substrate surface showed a localized pattern of attack. All of the SiC particles were missing, leaving voids. The HF attack on the  $\text{Al}_2\text{O}_3$  was much less severe than that on the SiC. This effect is shown in Figures 3 and 4. Figures 5 and 6 are the micrographs of uncorroded sample washed by HF from next page.

solution. Compared to the uncorroded material, the corroded substrate has an extremely porous honeycomblike structure. It appears that large chunks of material had either spalled or dissolved out of the substrate (Figure 3). The HF solution, however, did not seem to dissolve the SiC (Figure 5).

As seen in Figure 7, for a certain composition (~33% Na<sub>2</sub>O + 67% SiO<sub>2</sub>) the compound Na<sub>2</sub>O•2SiO<sub>2</sub> melts at a much lower temperature (~820 °C). Also, it is possible that there is a formation of complex low melting eutectic compounds of Al<sub>2</sub>O<sub>3</sub>, SiO<sub>2</sub> and Na<sub>2</sub>O which have even lower melting points (732 °C, 740 °C and 760 °C in Figure 8) than the test temperature (1200 °C). Such situations would contribute to a loss of SiC particles from the matrix thereby leaving voids (Figure 3) during the high temperature attack of Na<sub>2</sub>CO<sub>3</sub> on the composite.

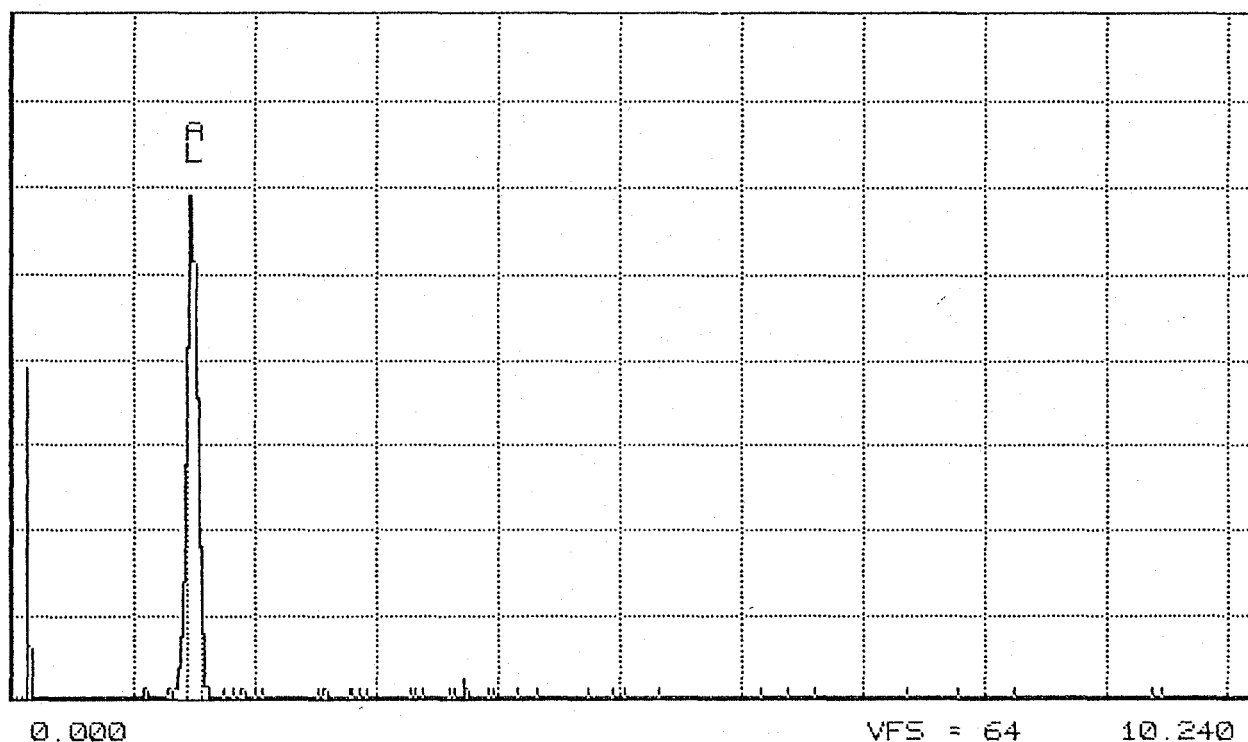
Figure 4 EDS plot of the sample shown in Figure 3

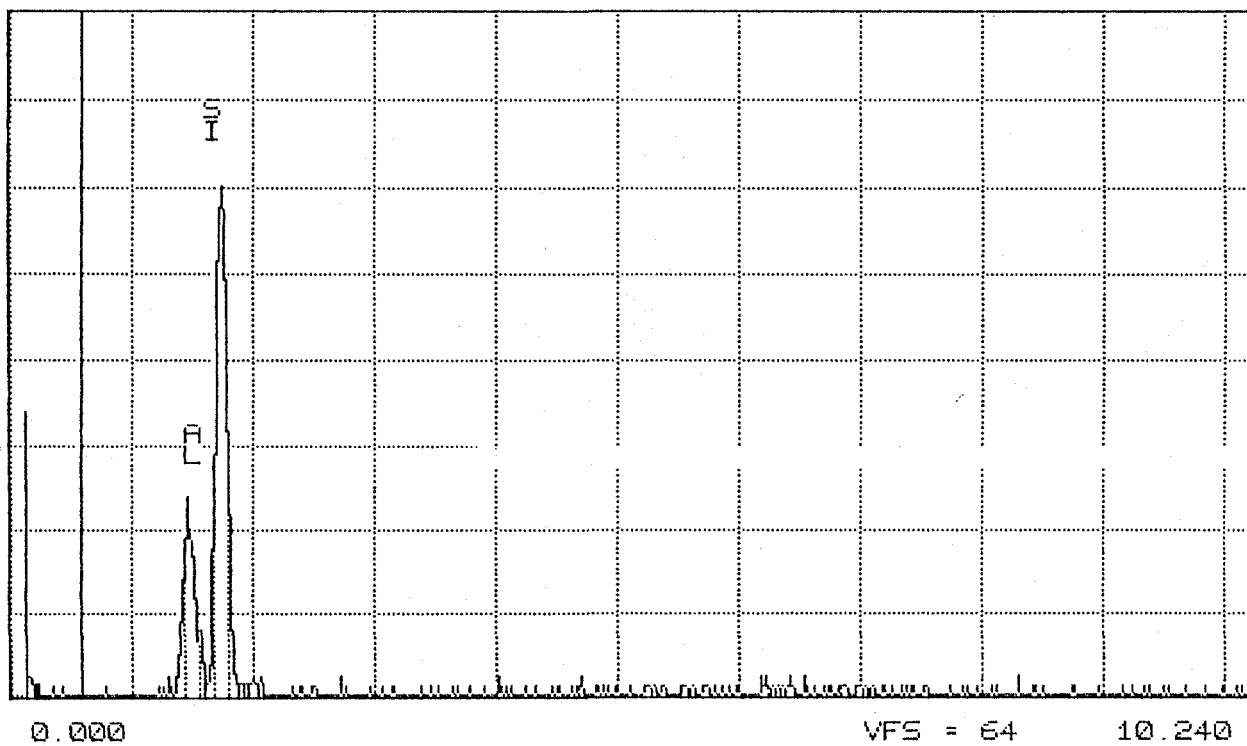
Figure 6 EDS plot of the sample shown in Figure 5

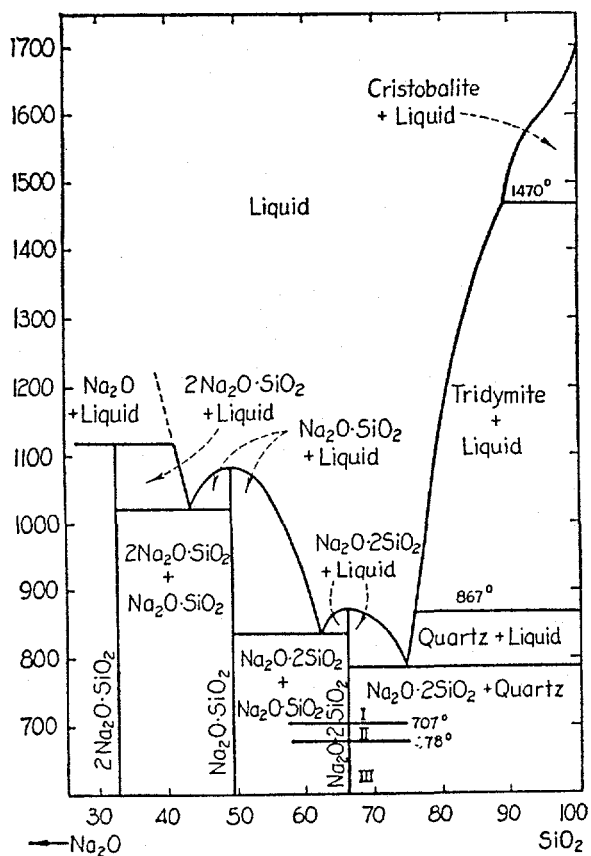
Figure 7 The phase diagram of a  $\text{Na}_2\text{O}-\text{SiO}_2$  system<sup>2</sup>

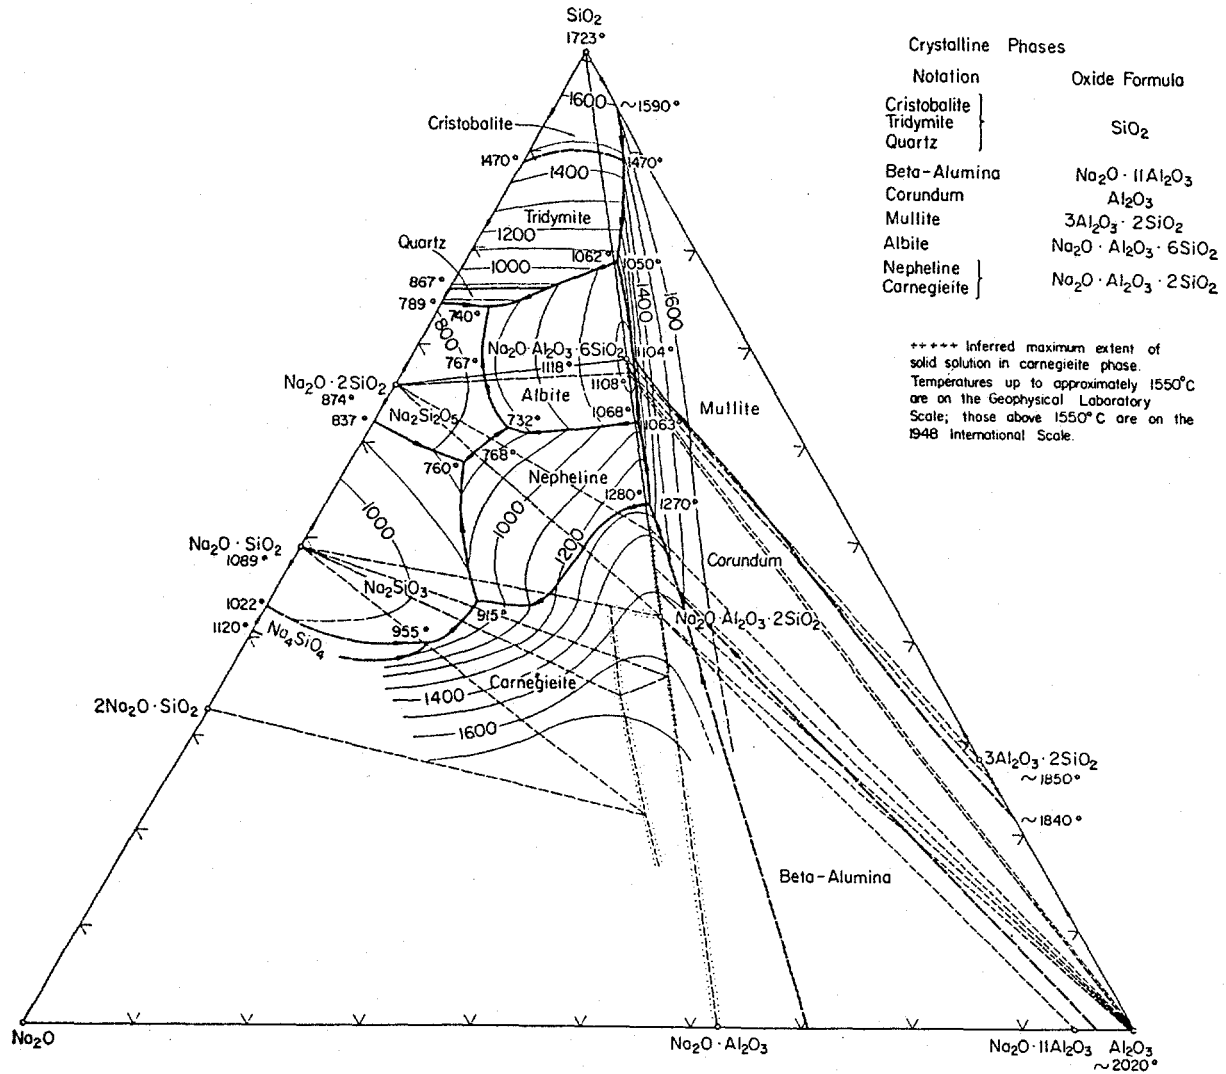
Figure 8 Phase diagram of a Na<sub>2</sub>O-Al<sub>2</sub>O<sub>3</sub>-SiO<sub>2</sub> system<sup>3</sup>
