BIOLOGICAL ASSESSMENT FOR THE EFFLUENT REDUCTION PROGRAM,
LOS ALAMOS NATIONAL LABORATORY,
LOS ALAMOS, NEW MEXICO

Saul P. Cross
Biology Team, ESH-20
August 1996
Prepared for Department of Energy, Los Alamos Area Office

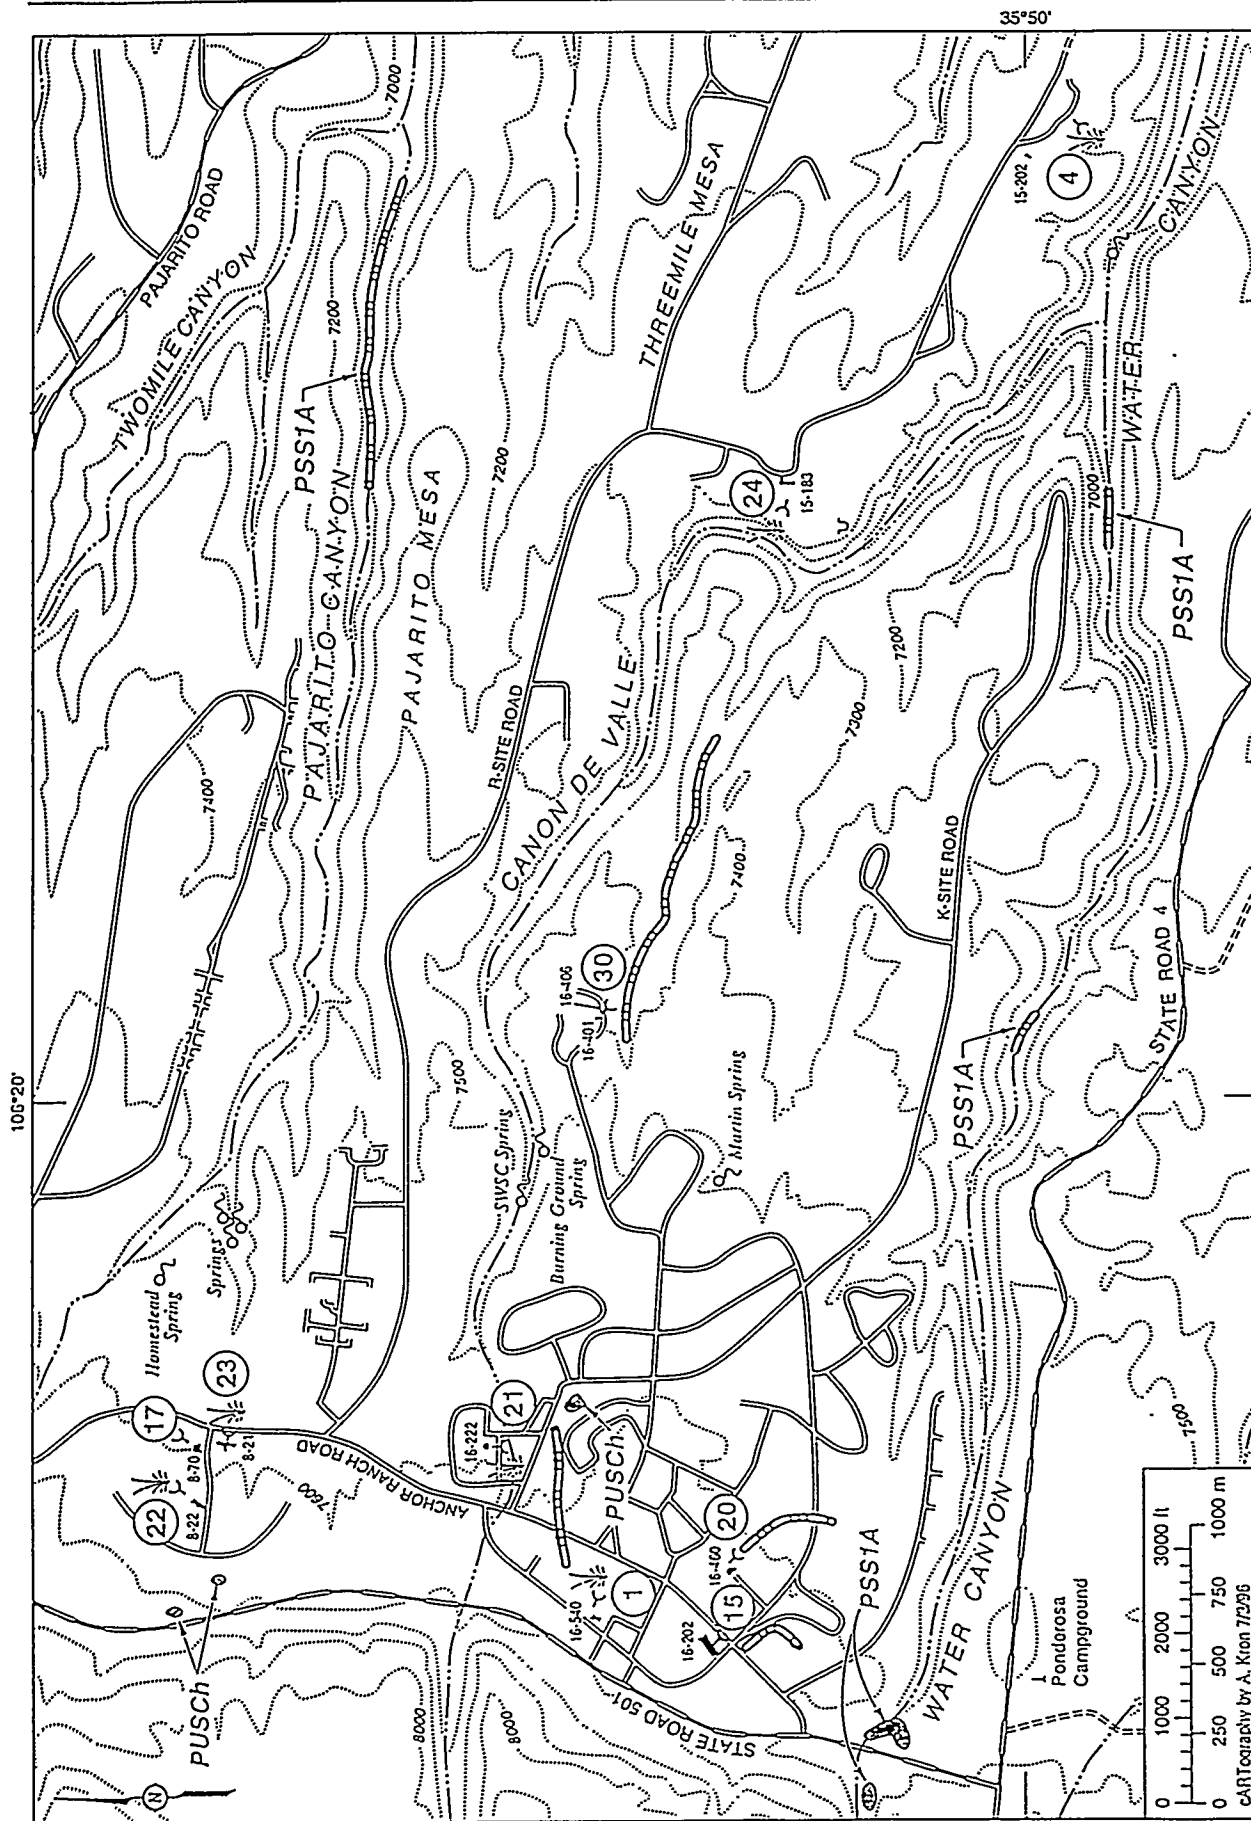
Figure A-3. Detailed map showing locations of outfalls 1, 4, 15, 17, 20, 21, 22, 23, 24, and 30.

Detailed maps of the affected environment near each outfall, including the associated wetland, contour lines, springs, and NWI wetlands are presented in Figure A-3 through Figure A-7. Figure A-1 and Figure A-2 are an index and a legend, respectively, for these maps.
