**LONG-TERM SURVEILLANCE PLAN  
FOR THE  
RIFLE, COLORADO, DISPOSAL SITE**

**September 1996**

**Prepared for  
U.S. Department of Energy  
Environmental Restoration Division  
UMTRA Project Team  
Albuquerque, New Mexico**

**Prepared by  
Jacobs Engineering Group Inc.  
Albuquerque, New Mexico**

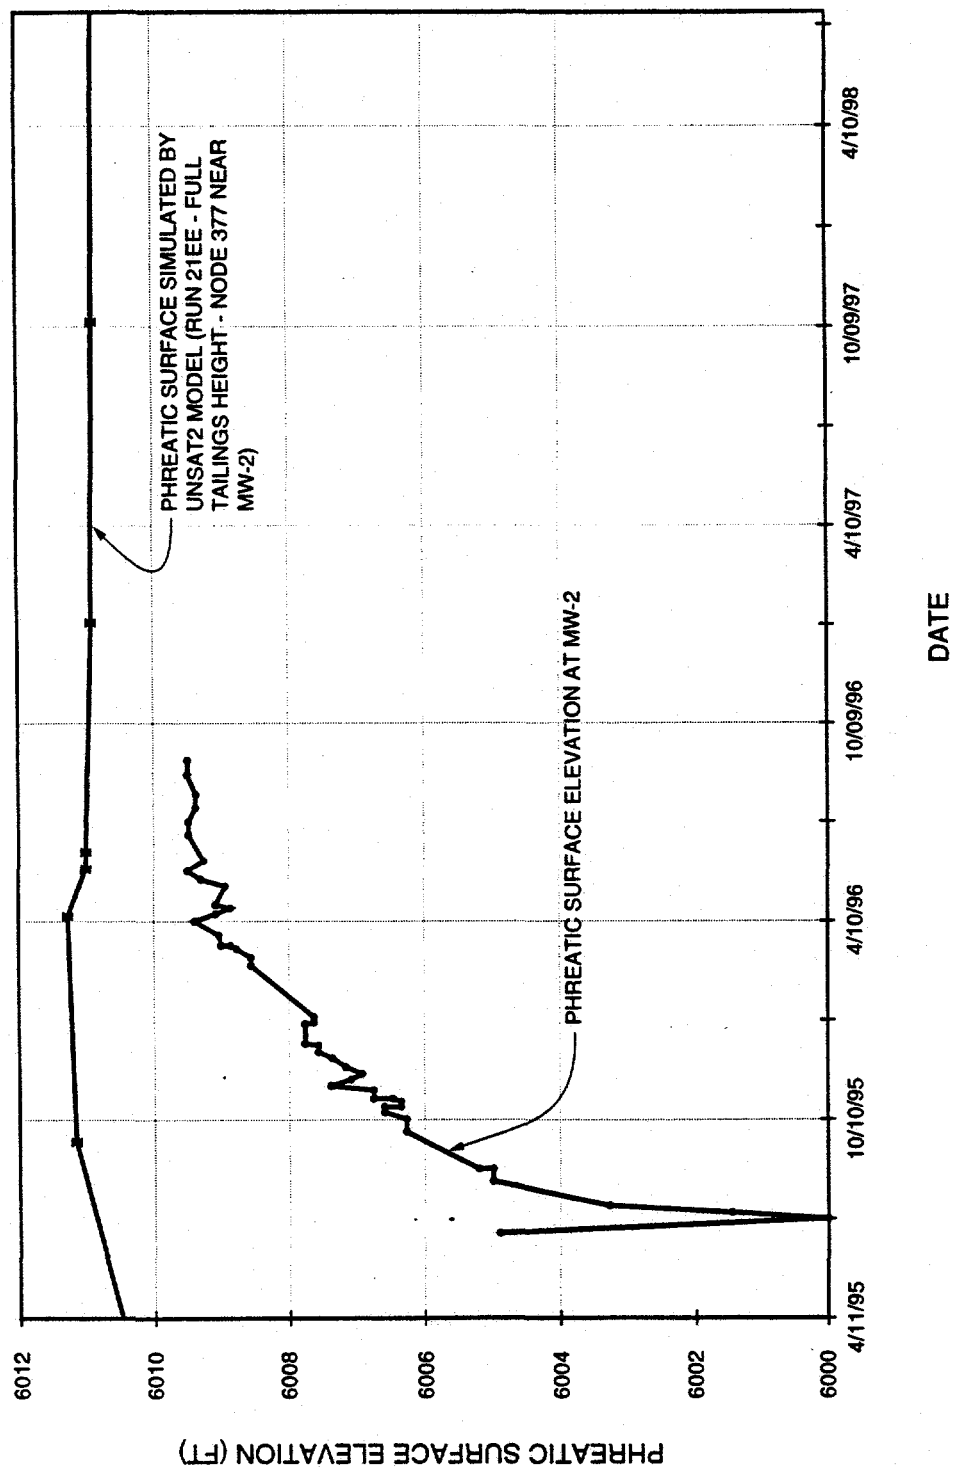
**FIGURE A-2**  
**MEASURED vs. PREDICTED LEACHATE LEVEL IN MW-2**  
**ESTES GULCH DISPOSAL SITE**

Monitoring of leachate buildup in the cell began during construction in June of 1993. Transient drainage water buildup was observed immediately in monitor well (MW) 2 and MW-3, but not in MW-1. MW-1 remained dry throughout construction, and has never (to this date, October 1996) showed any leachate buildup. This is because MW-1's bottom is at elevation 6021.4 feet, which is approximately 30 feet higher than bottom of MW-2 and MW-3. MW-2 has been used as a primary indicator of the phreatic surface in the disposal cell, because it is closest to the bottom of the cell. Computer modeling (i.e. with the UNSAT2 program) has been done to correlate water levels at the toe of the cell to water levels recorded at MW-2. A plot of water levels in MW-2, after the last pumping, versus the computer modeled water level is included in Figure A-2.

UNSAT2 computer modeling was performed to predict water levels in the monitor wells, predict long term water levels in the disposal cell, and predict when the monitor wells could be decommissioned. UNSAT2 modeling was performed and reviewed by DOE contractors, then submitted to CDPHE and NRC for review and concurrence. Since the Rifle cell was constructed at the Estes Gulch site, and not stabilized in place at the New or Old Rifle sites, test data recording moisture content, density, and consistency of the material compacted into the cell at thousands of known locations was available from

quality assurance testing records. Results of the modeling were used to predict water levels in the cell during construction, and then actual water level measurements were used to check and adjust the model. Finally, after the model was adjusted to accurately reflect known water level versus time data, it was used to predict future water levels in the Rifle cell. Final results of the computer modeling indicated that the Estes Gulch cell would perform as designed, and that a seep at the toe of the cell from internal buildup of transient drainage would not occur. Results of the computer modeling work for the Rifle disposal cell are included in MK Ferguson's report "UNSAT2 MODELING FOR MONITORING WELL CLOSURE, ESTES GULCH DISPOSAL CELL, RIFLE COLORADO, NOVEMBER 1995," MK document number 3885-RFL-R-01-05671-01, dated November 3, 1995.
