**Contingency Plan for the Old Hydrofracture  
Facility Tanks Sluicing Project  
at Oak Ridge National Laboratory,  
Oak Ridge, Tennessee**

Date Issued—October 1996

Prepared by  
CDM Federal Programs Corporation  
Oak Ridge, Tennessee  
96B-99052C

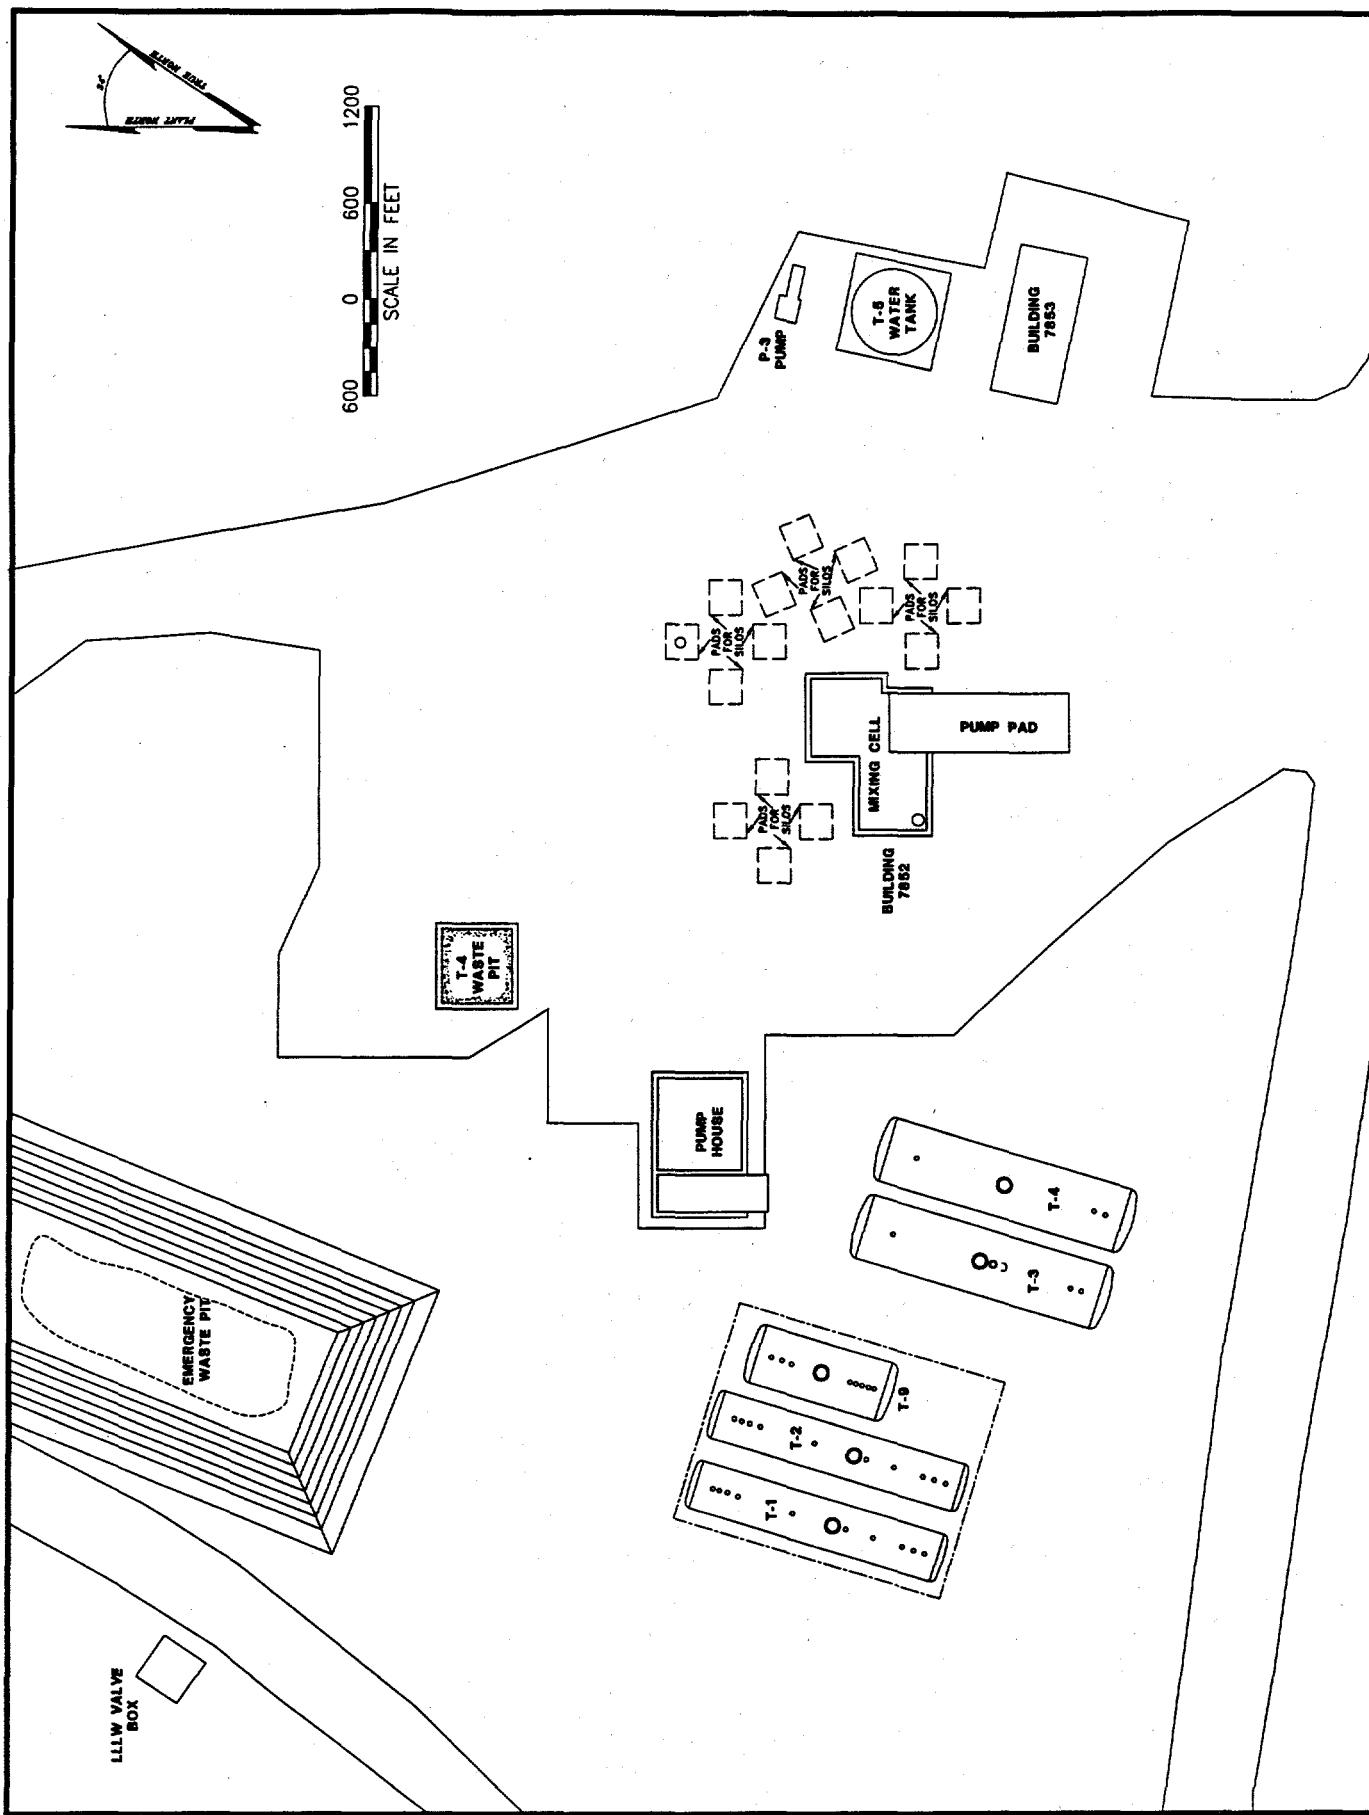
Fig. 2.2 Old Hydrofracture Facility site layout map

The five OHF tanks are buried underground, approximately 110 ft west of Building 7852 and approximately 131 yd east of White Oak Creek. The tanks lie parallel to each other in a north/south orientation (see Fig. 2.2).

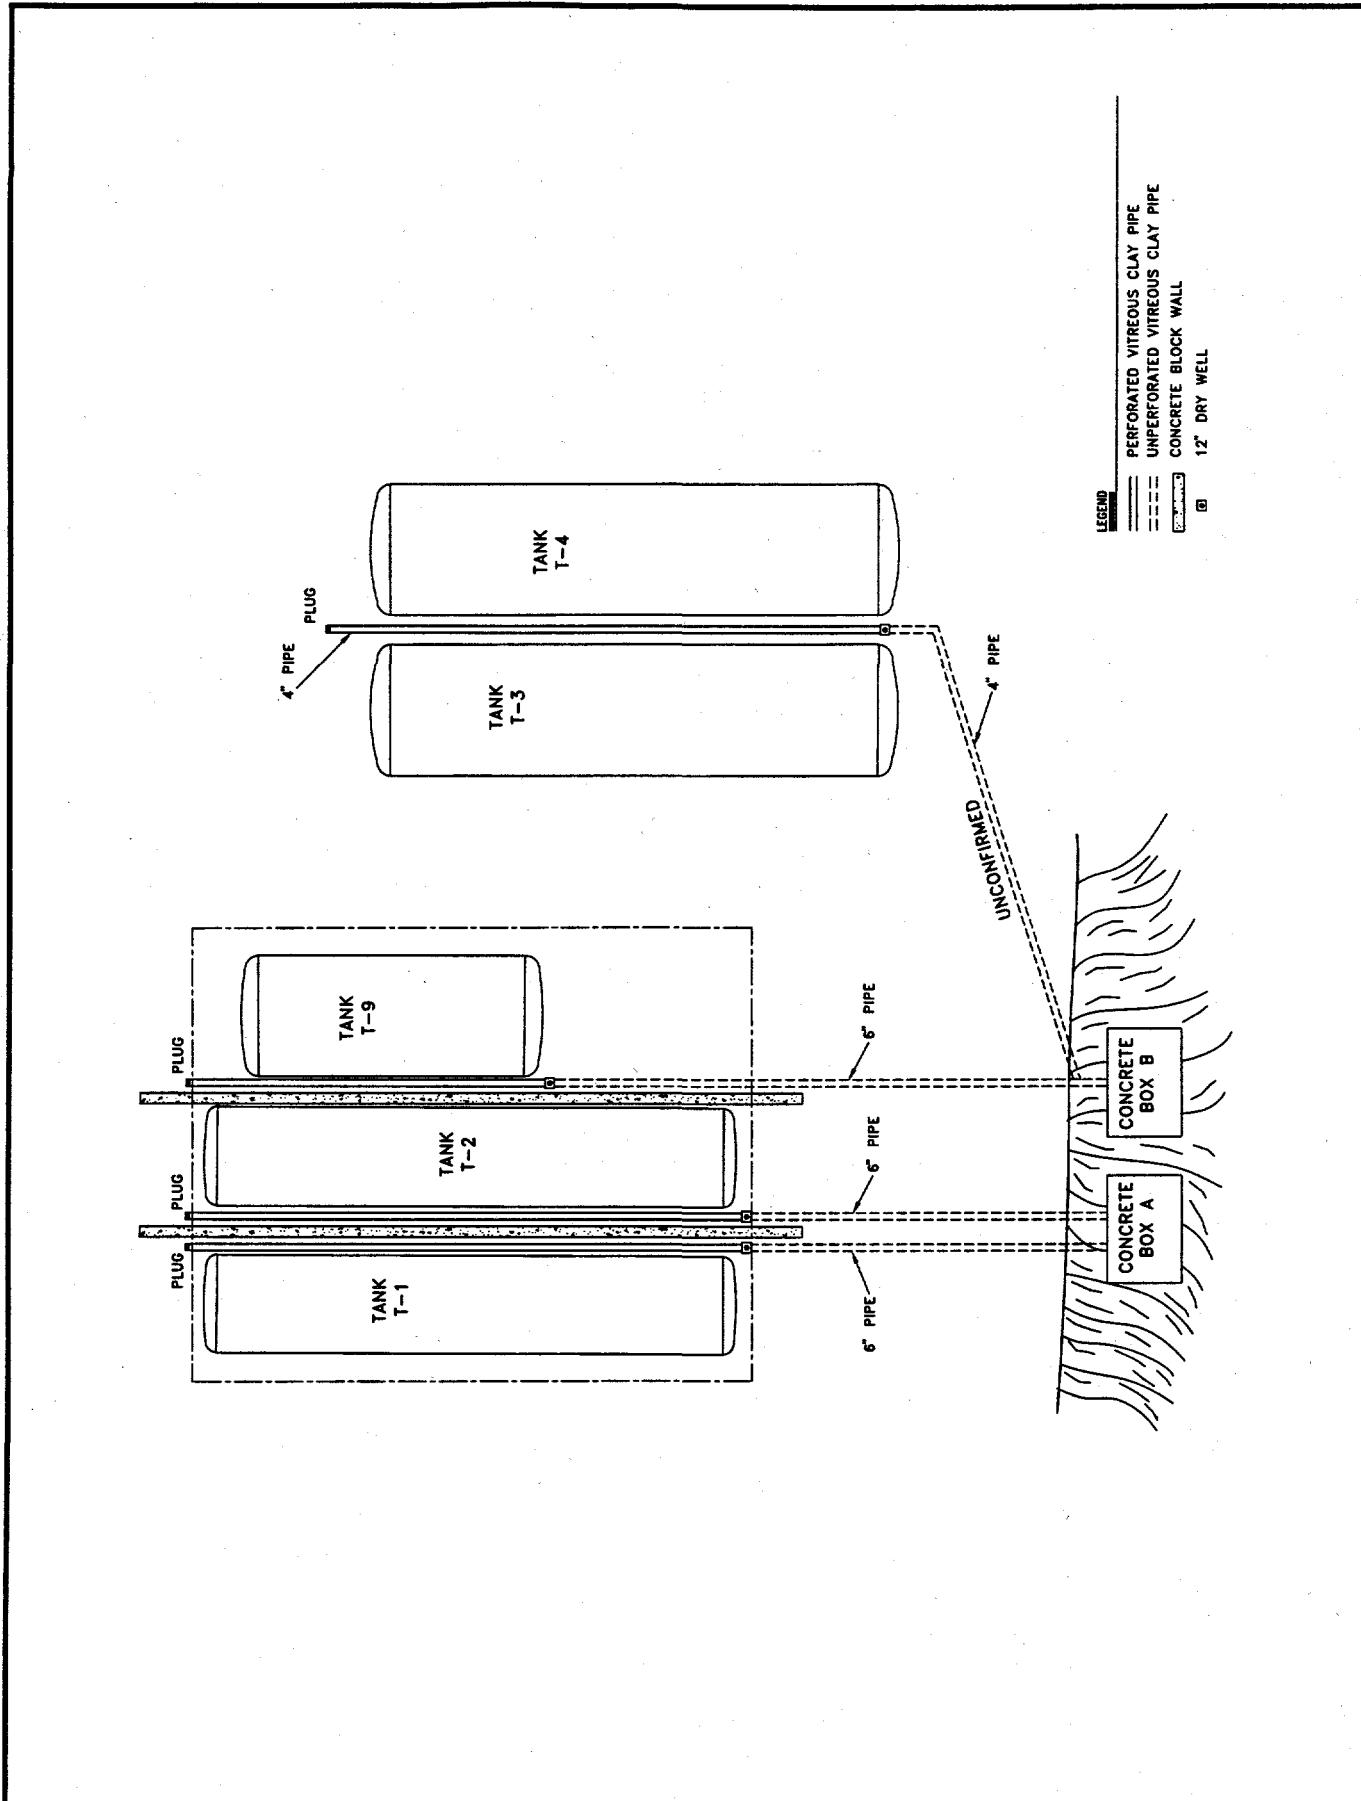
Fig. 2.3 OHF tanks dry well system - plan view

Figure 2.3 provides a plan view of the five tanks.<sup>1</sup> Tanks T-3 and T-4 are buried together in a second pit. A 4-in. perforated vitreous clay pipe laid between the two tanks drains the pit into a 12-in. dry well. A 4-in. outlet pipe exits the well approximately 2 ft above the bottom of the excavation. Anecdotal information suggests that this pipe is connected to the outlet for Tank T-9, upslope of the concrete box that encloses the end of the pipe. However, drawings confirming this piping arrangement have not been located. The concrete box designated "Box A" in the figure contains the outlet pipes for T-1 and T-2. The box designated "Box B" contains the pipe into which the T-9 and possibly the T-3/T-4 outlets are connected.

<sup>2</sup> These figures are based on engineering drawings E-004-D (1963) and EE-042-D (1966), prepared before construction. No as-built drawings verifying the dry well system layout have been located.

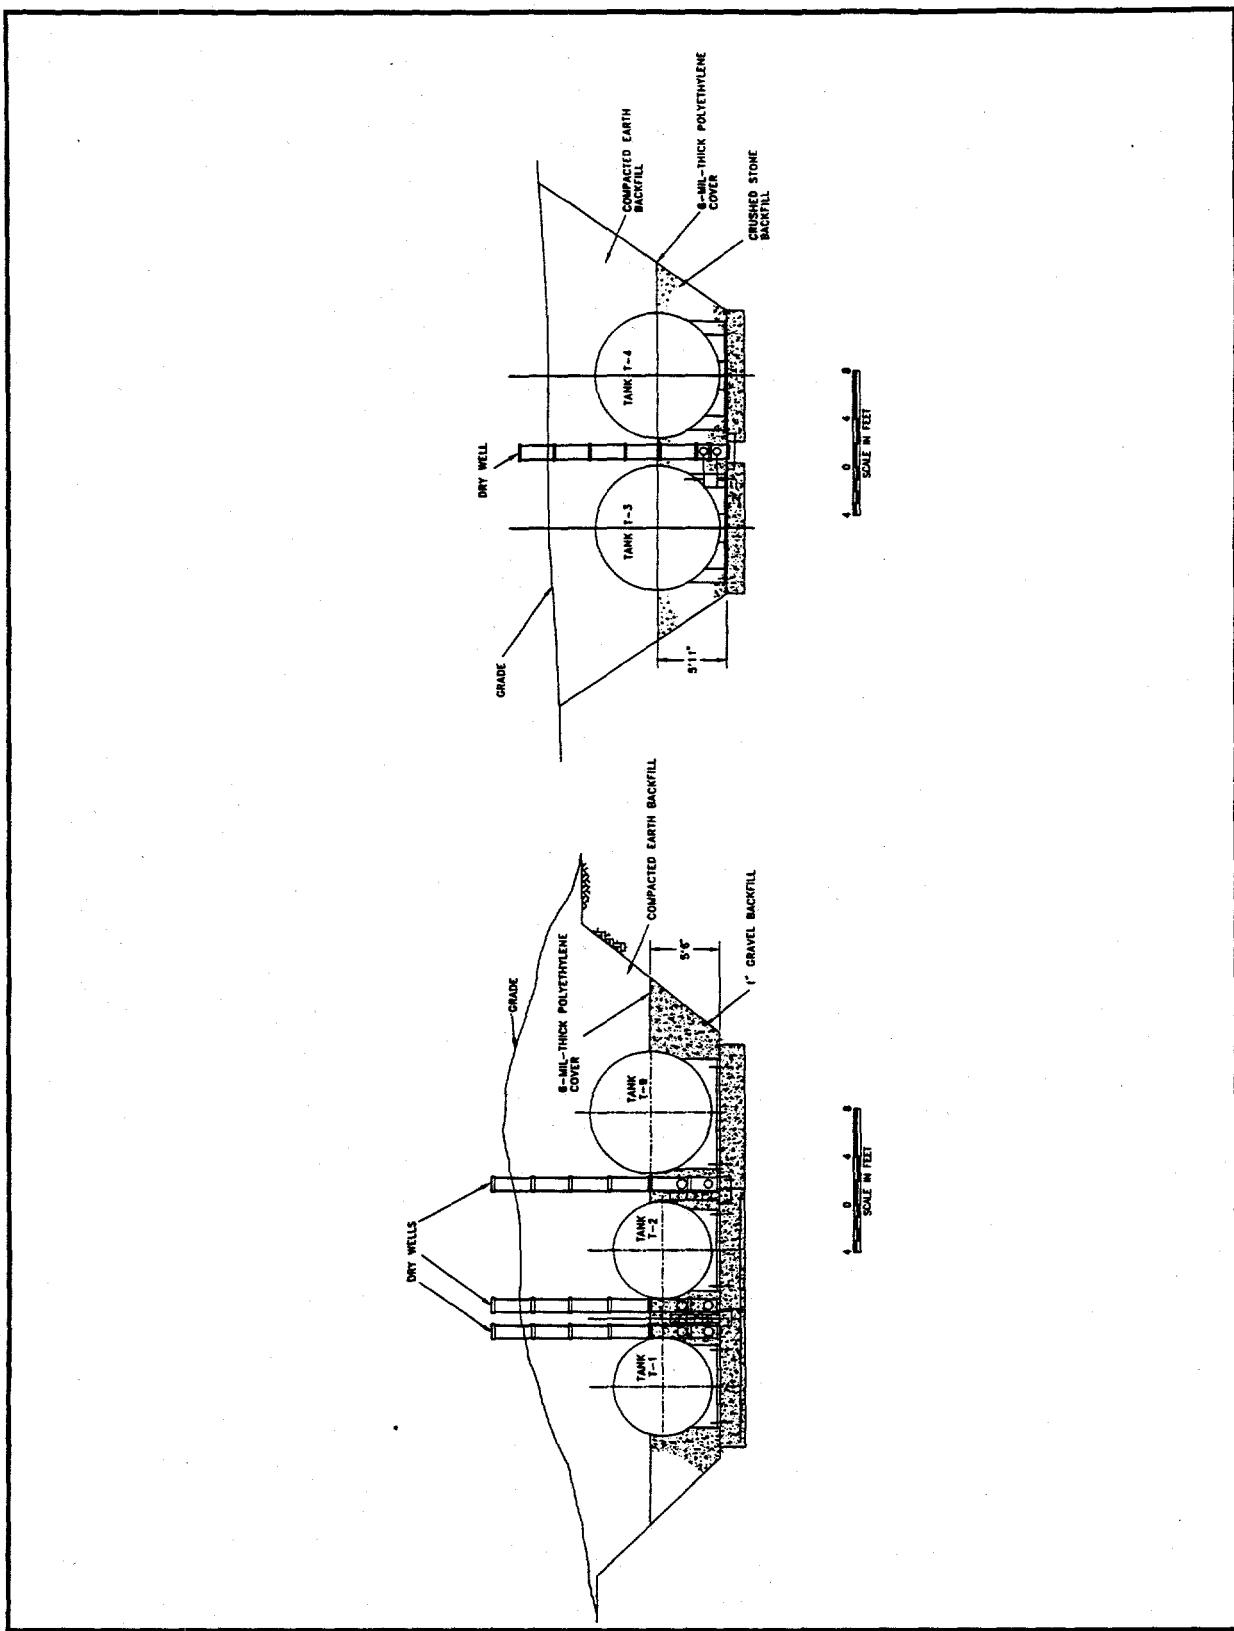
Fig. 2.4 Vertical section showing OHF tanks backfill

Following installation of the tanks, each excavation pit was filled with between 5 and 6 ft of 1-in. gravel (tanks T-1, T-2, and T-9 pit) or crushed stone (tanks T-3 and T-4 pit). A 6-mil polyethylene plastic sheet was placed atop the gravel or stone and a minimum of 4 ft of fill dirt was used to bring each pit to the finished grade. Figure 2.4 shows a vertical section of the backfilled tank pits.

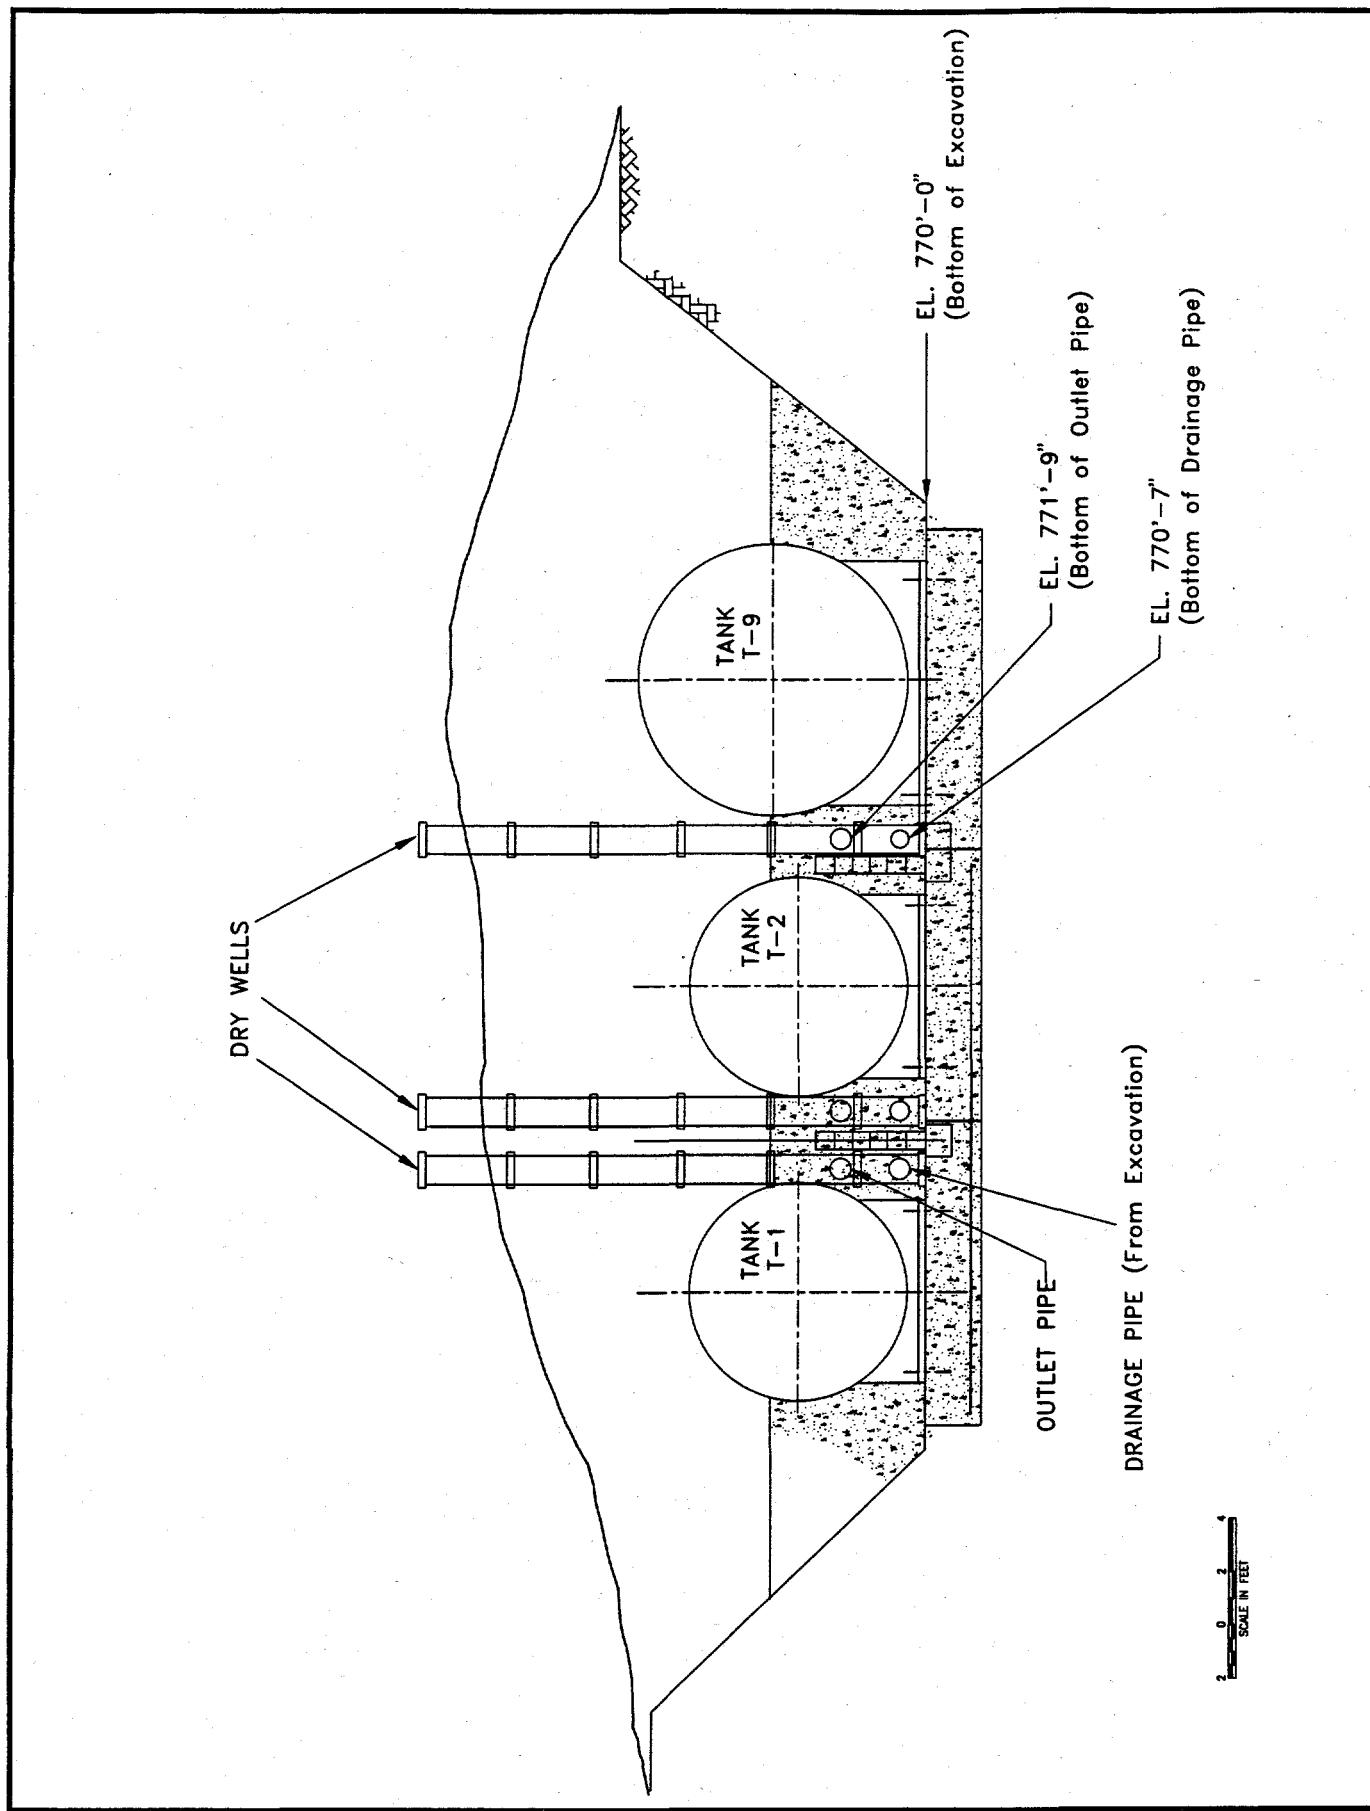
Fig. 2.5 Drainage system details for tanks T-1, T-2, and T-9

Tanks T-1, T-2, and T-9 are buried together in a single pit. Four-ft-high, 8-in.-thick concrete block walls separate the pit into three cells, one for each tank. Each cell is drained separately through a 6-in. perforated vitreous clay pipe into a 12-in. dry well. Each dry well has a (non-perforated) 6-in. vitreous clay outlet pipe that exits the well approximately 2 ft above the bottom of the excavation and extends south to the slope north of the facility access road. The outlets for the T-1 and T-2 dry wells are enclosed together in an uncovered concrete box on the slope. The outlet for the T-9 dry well is enclosed in a separate concrete box. Each outlet is fitted with a shutoff valve.

Pre-construction drawings for the facility show the drainage pipes lying several inches above the bottom of the excavations (7-in. in the T-1/T-2/T-9 excavation and 4-in. in the T-3/T-4 excavation). Based on this design, a substantial volume of liquid could collect in the bottom of the tank pits before flowing through the perforated pipes into the dry wells where it would be detected. No as-built drawings have been located to confirm this construction. Figures 2.5 and 2.6 present details of the tank drainage systems, highlighting the elevations of the drainage pipes and well outlet pipes.<sup>2</sup>

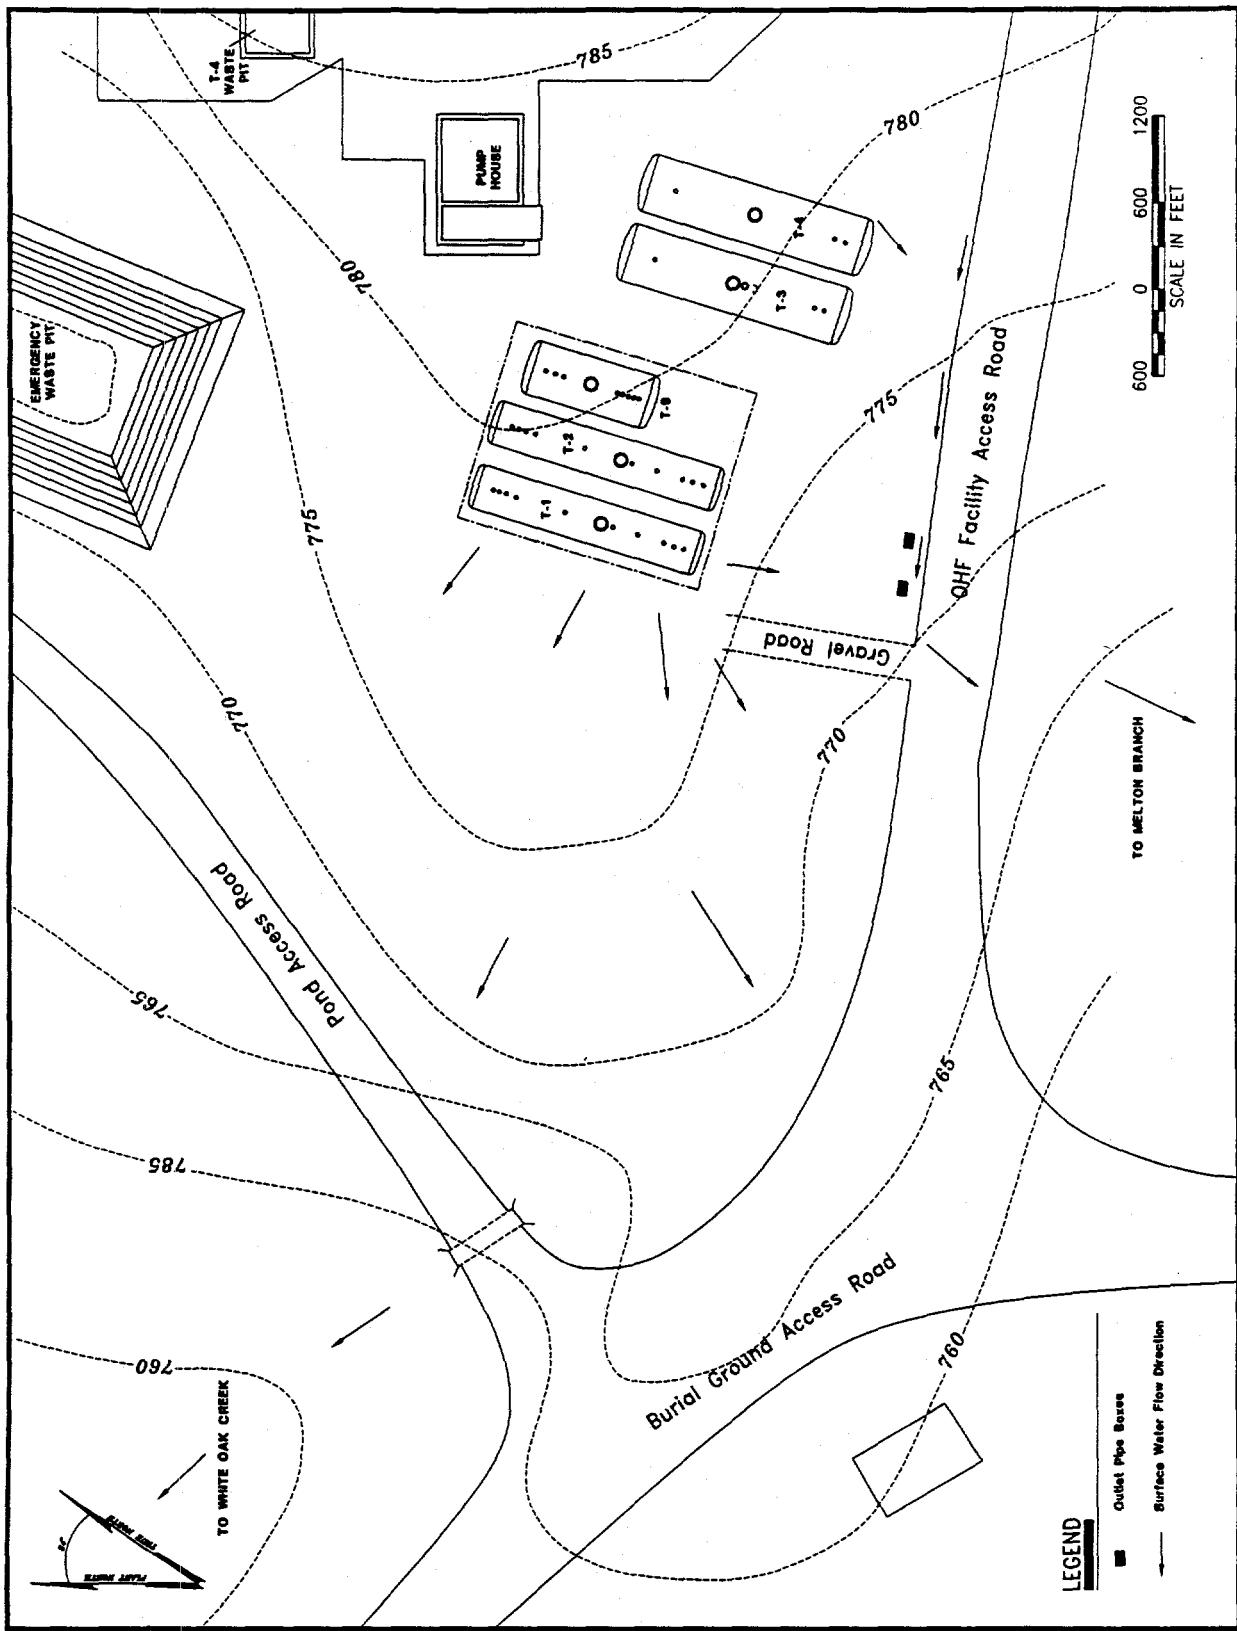
Fig. 2.7 Surface drainage at OHF tanks

The OHF is located on a surface drainage divide separating the White Oak Creek Basin and the Melton Branch Basin. As shown in Fig. 2.7, surface water runoff from the ground surface above the tanks flows into both White Oak Creek and Melton Branch, the primary tributary to White Oak Creek. From White Oak Creek, surface water flows into White Oak Lake and ultimately the Clinch River.

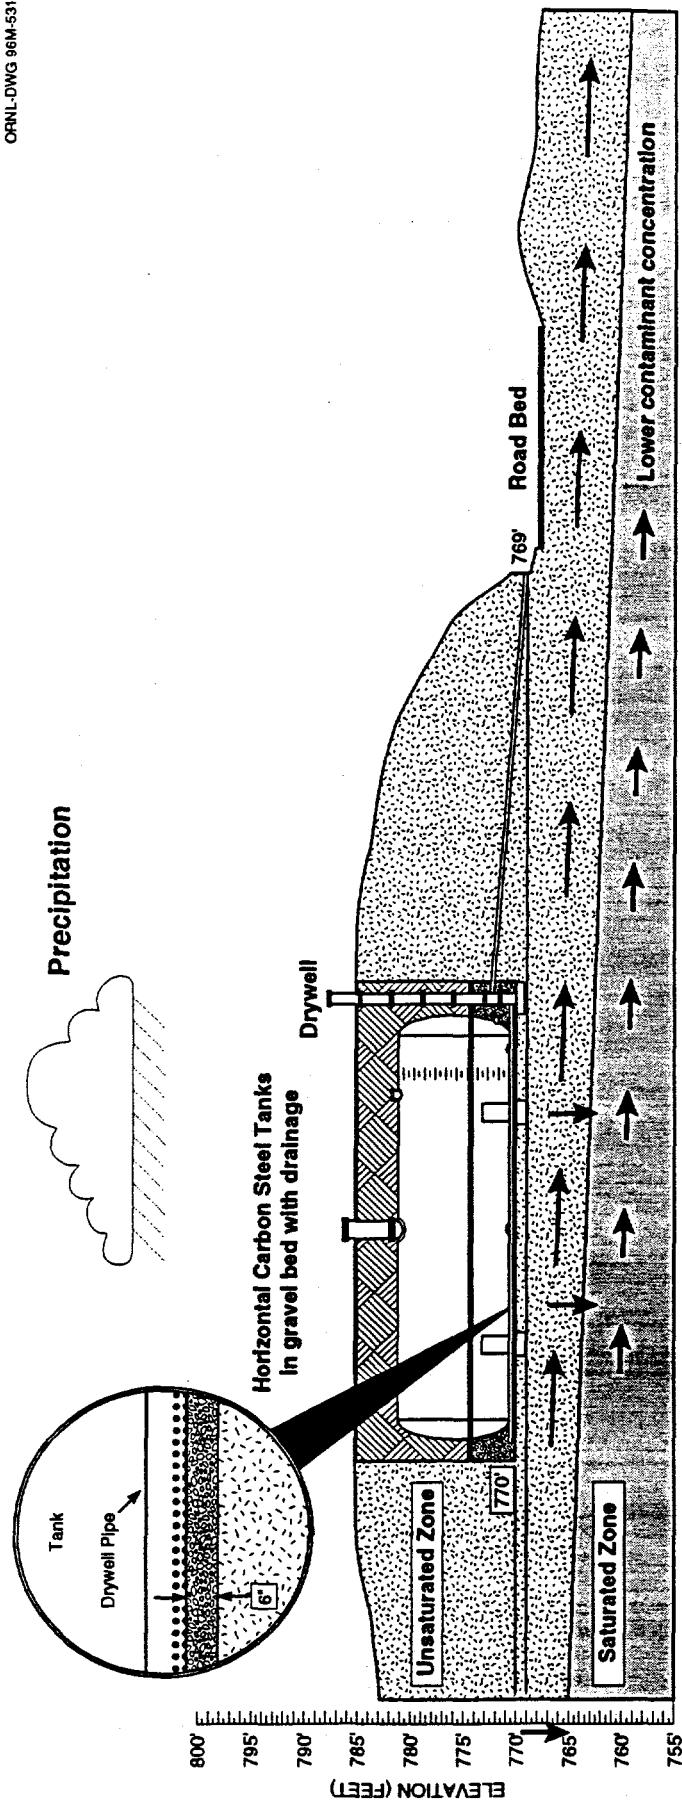
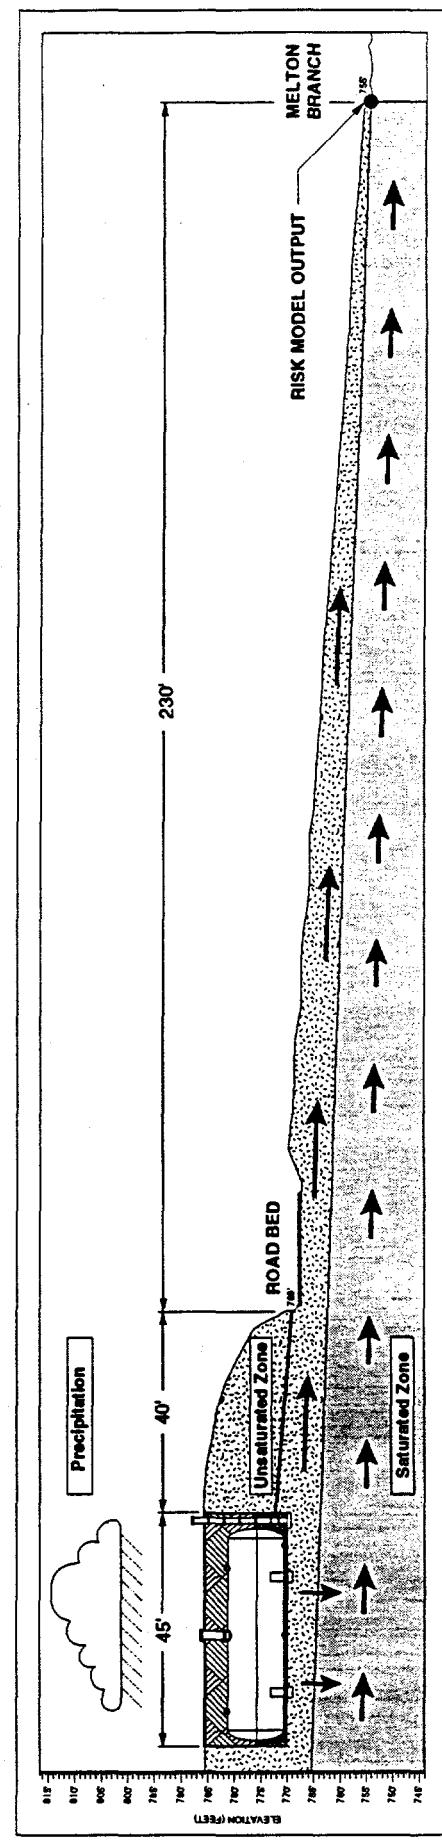
Fig. 2.8 Groundwater flow at OHF tanks

The *Conceptual Site Model for Risk Assessment for the OHF Tanks* (Energy Systems 1996b) describes the subsurface hydraulic setting for the tanks. As described in that document and as illustrated in Fig. 2.8, the OHF tanks are located in the unsaturated zone, 5–6 ft above the water table. Liquids discharged from the tank drainage beds to the subsurface would be transported either horizontally through the shallow subsurface to Melton Branch, or vertically to the saturated zone. Groundwater flow at the OHF is southeast toward Melton Branch. In evaluating the contaminant flow through the saturated zone, the conceptual model assumes a hydraulic gradient of 0.01 and a hydraulic conductivity of  $5.0 \times 10^{-5}$  cm/second.

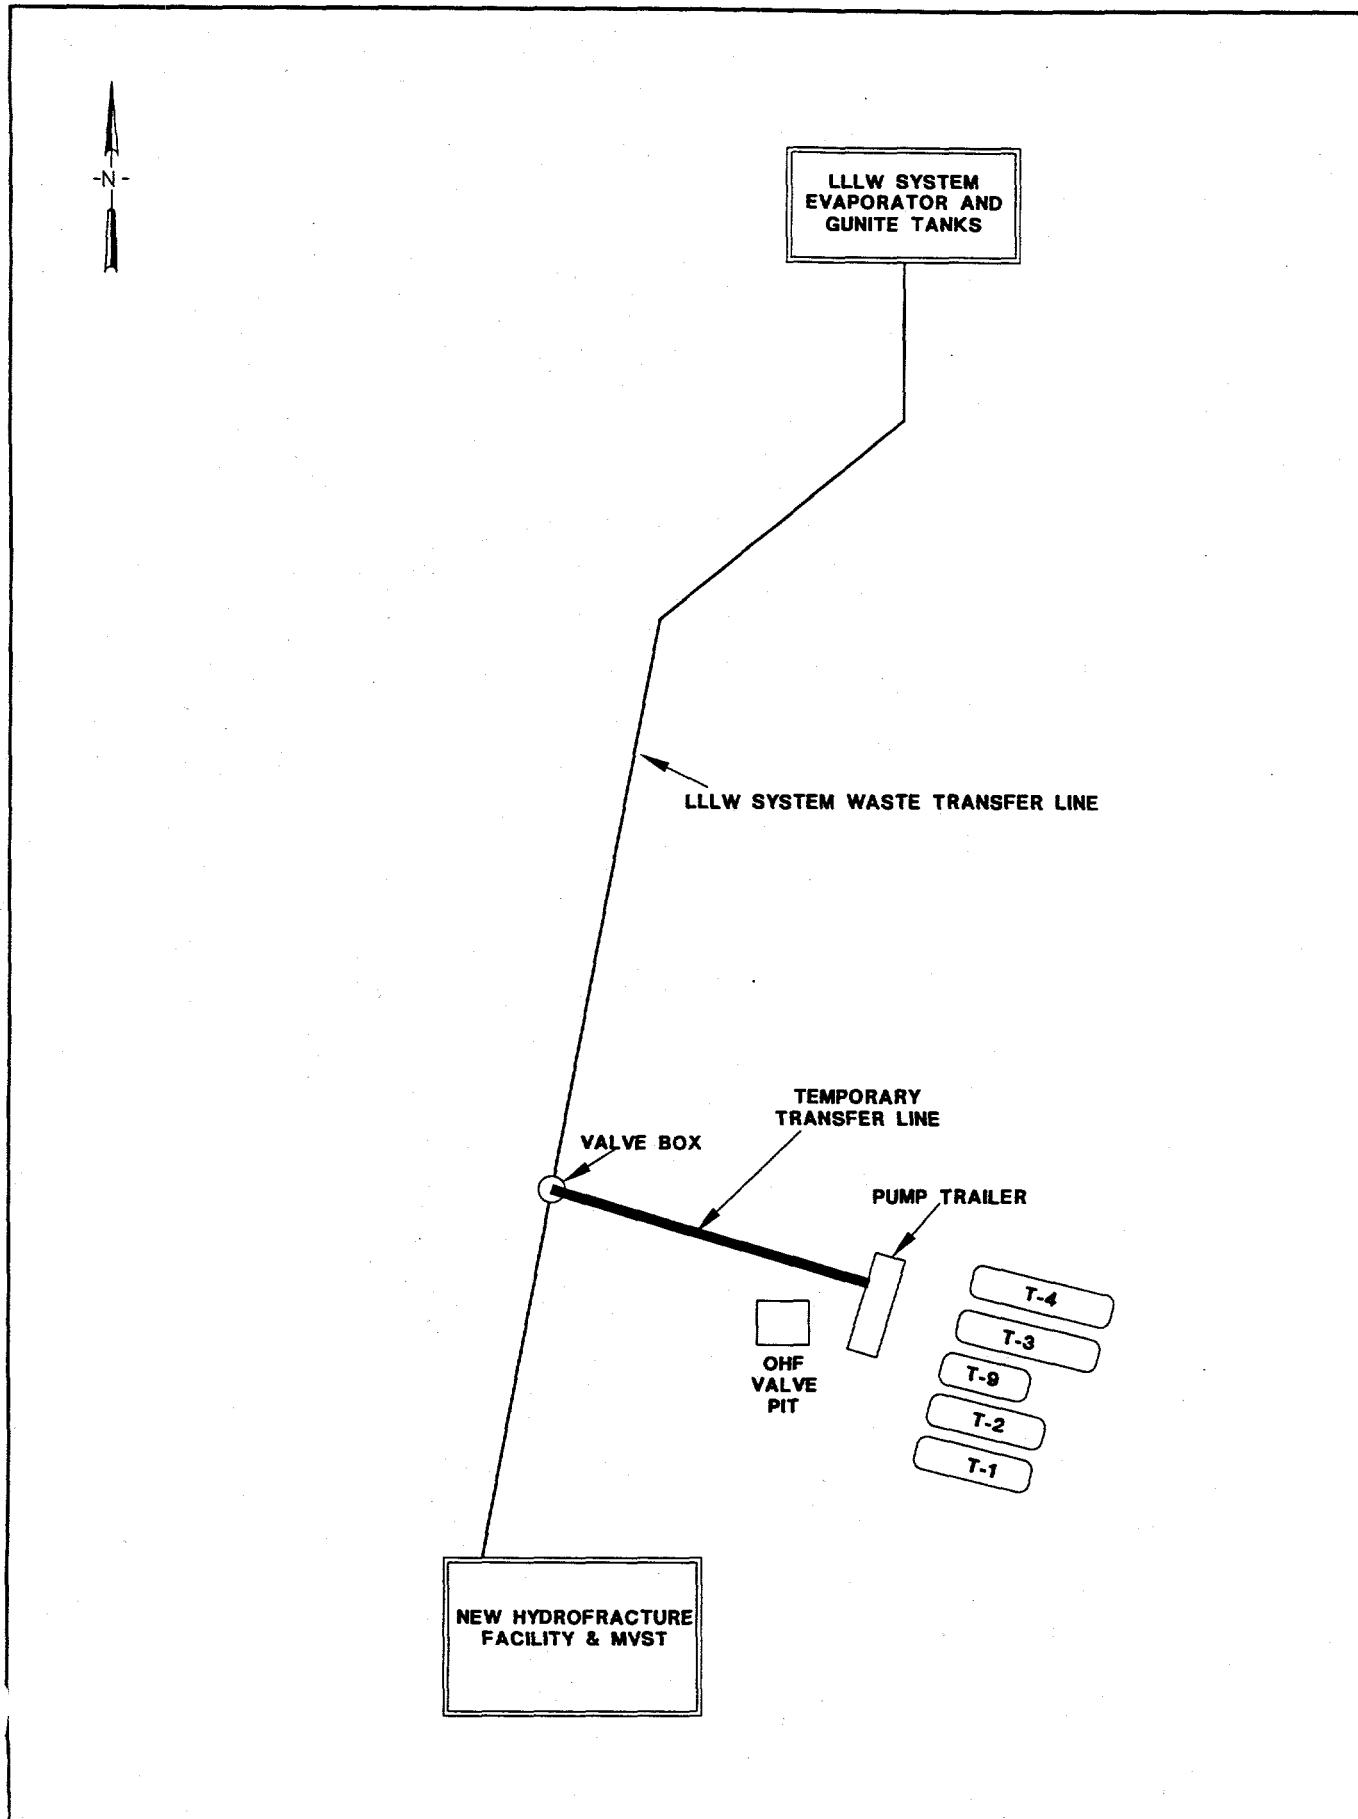
Fig. 3.1. Temporary waste transfer line location

A new temporary pipeline will be installed to pump the tank contents to a valve box located approximately 50 ft west and 285 ft north of the OHF pump/valve vault's northwest corner, where it will enter an existing pipeline that connects the active ORNL LLLW evaporator tanks to the MVST (Fig. 3.1). The valve box will need to be modified to accommodate the new pipeline.

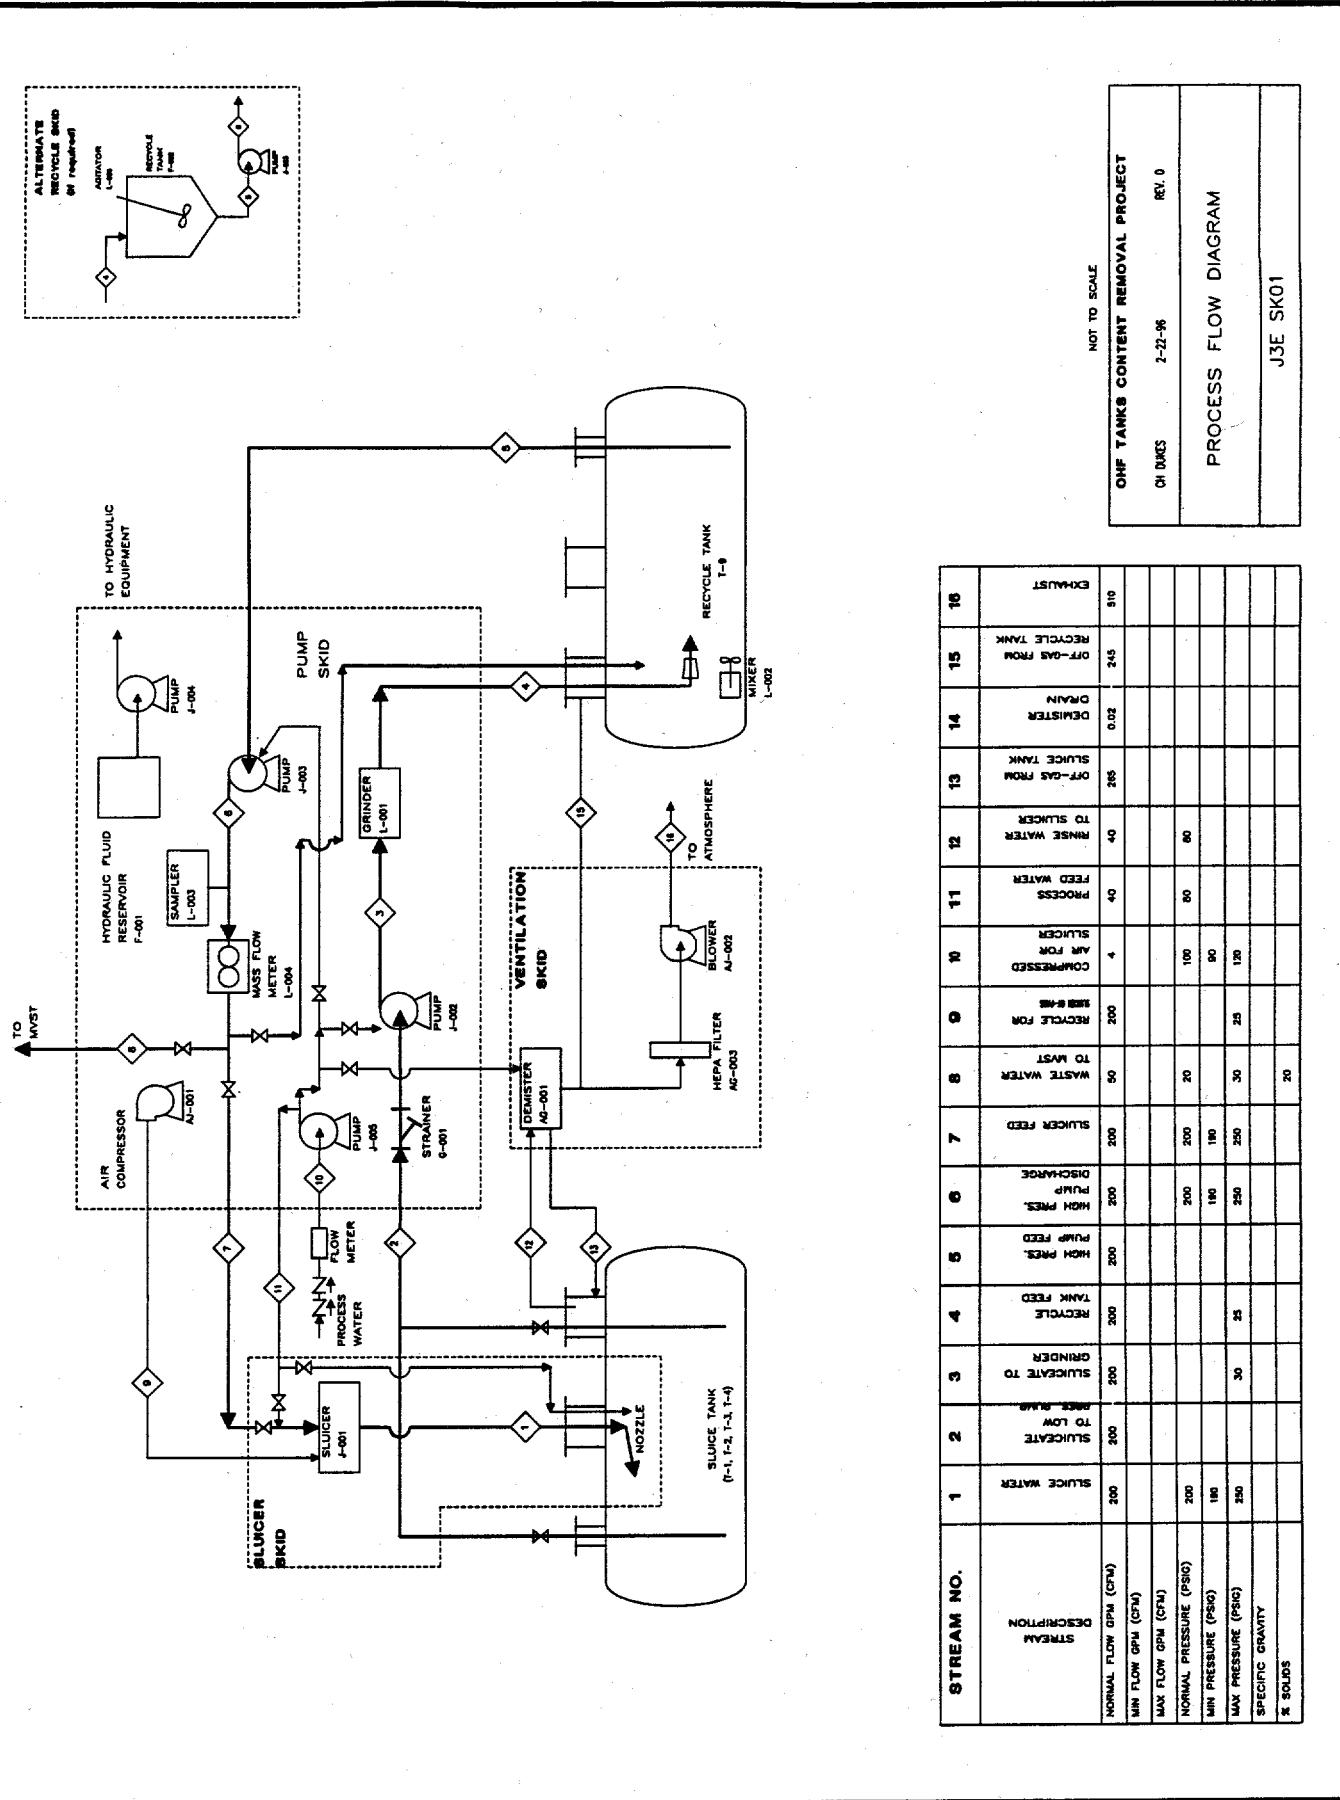
Fig. 3.2 Sluicing operation flow diagram

The contents of tanks T-1, T-2, T-3, and T-4 will be removed by resuspending the sludge in process water or supernatant (if approved by the ORNL Nuclear Criticality Safety Section), referred to as "sluice water," and pumping it to the MVST. Resuspension of the sludge will be accomplished by spraying process water or supernatant into the tank, referred to as the "sluice tank," pumping it out to a recycle tank (tank T-9), and recirculating it through the sluice and recycle tanks by spraying and pumping. When the solids content of the supernatant reaches a predetermined level, recirculation will be halted and the sluice water will be pumped to the MVST. At that point, one "sluice pass" will have been completed. Successive sluice passes will proceed until the sludge removal goal is achieved. The tanks will be cleaned one at a time. A process flow diagram, reprinted from the *Preliminary Engineering Report, Old Hydrofracture Facility Tanks Content Removal Project* (Energy Systems 1996c), is presented as Fig. 3.2.

The tanks will be sluiced using a modified, commercially available tank cleaning system, which is portable and will be moved from tank to tank. The basic components include a sprayer nozzle, pumping system with doubly contained piping, ventilation system, instrumentation for remote operation, and a video camera and light source.

Figure 3.2 presented the process flow diagram for the sluice and pump project, reproduced from the *Preliminary Engineering Report, Old Hydrofracture Facility Tanks Content Removal Project* (Energy Systems 1996c). As shown in the figure, sluice water will be sprayed through the sluicer nozzle into the sluice tank. From the sluice tank, the sluice water will be suctioned through a low pressure pump (with associated strainer and grinder) and discharged under low pressure (25–30 psig) to the recycle tank (T-9). From the recycle tank, it will be suctioned through a high pressure pump and discharged under high pressure (200 psig) to the sluicer, from which it is sprayed back into the sluice tank. A sampler and mass flow meter are included in the discharge line of the high pressure pump. Sluice water will be cycled through the sluice and recycle tank until the sludge in the sluice tank is resuspended to a level that will be specified for the project, at which point it will be transferred to the MVST. The pumps, strainer, grinder, sampler, and mass flow meter, along with assorted additional equipment, will be installed on a trailer referred to as the pump skid.
