NP-7189
ARMOUR RESEARCH FOUNDATION

IRRADIATION TESTING OF OPERATING ELECTRONIC EQUIPMENT
BY FAST NEUTRONS AND GAMMAS

Final Report

April 30, 1958

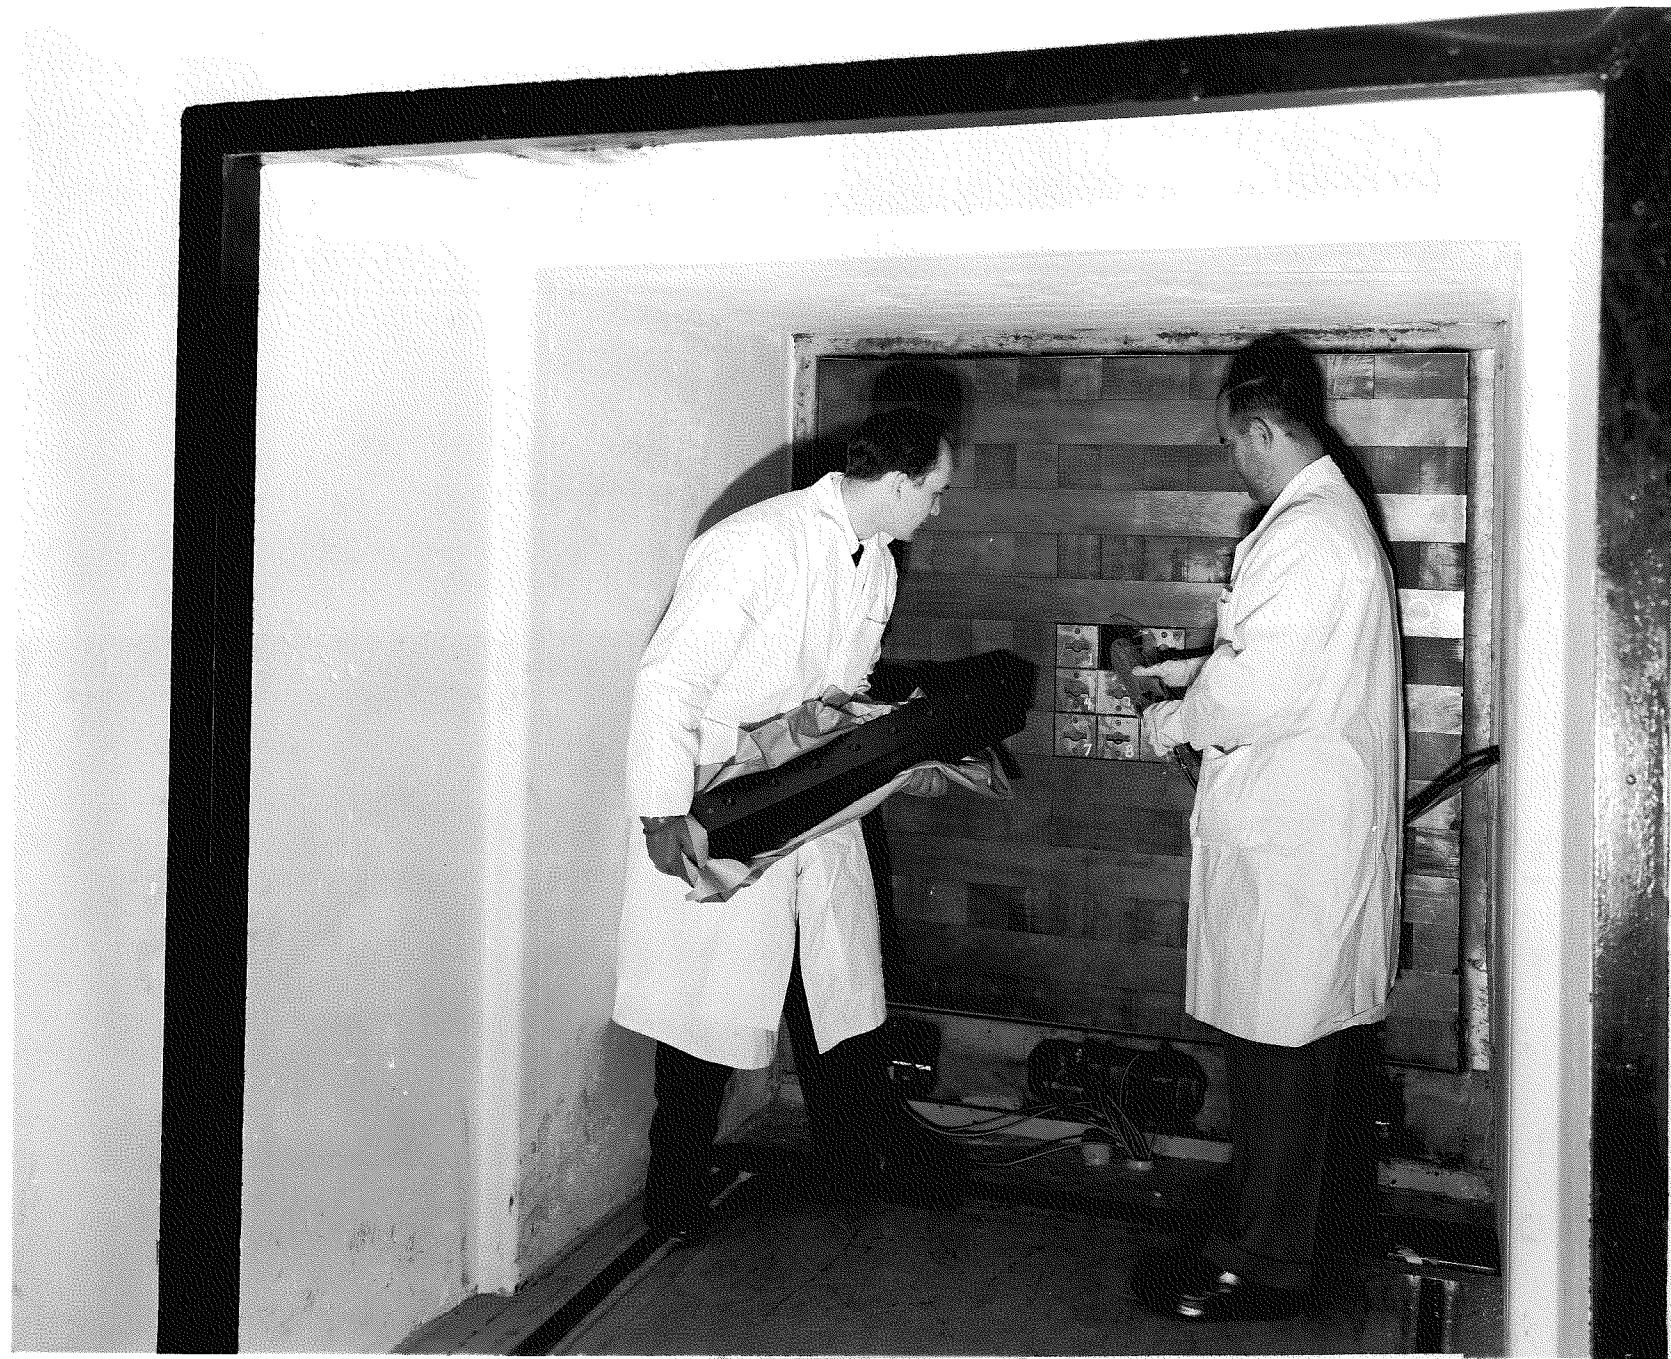
Fig. 2 Face of Graphite Thermal Column

The south end of the biological shield opens to expose (Figure 2) the face of the graphite thermal column. The north end has a similar arrangement but has been left open to allow either another graphite thermal column or a large water tank to be positioned against the face of the reflector.
