### FINAL CONSTRUCTION QUALITY ASSURANCE REPORT

Y-12 INDUSTRIAL LANDFILL V, AREA 2

OAK RIDGE, TENNESSEE

NOVEMBER 1996

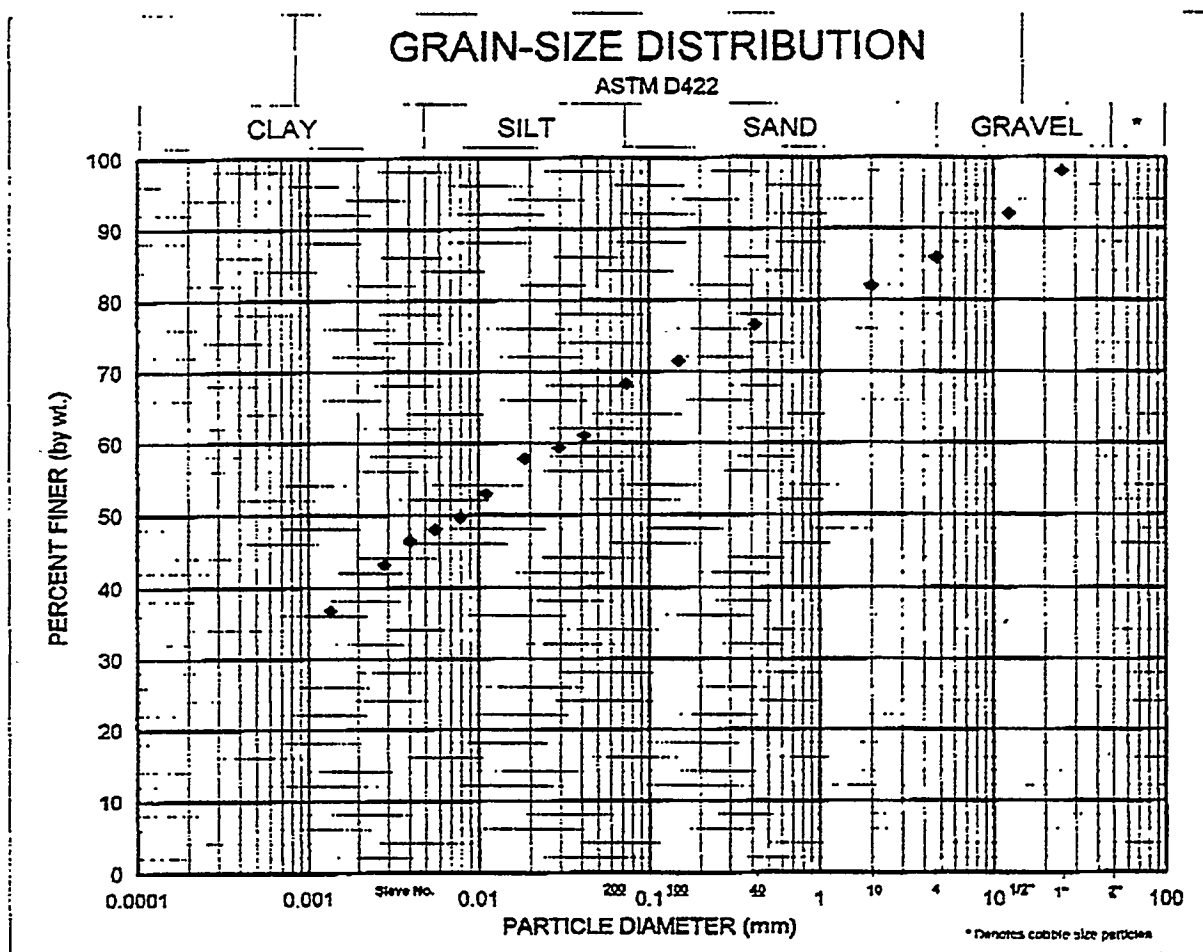
Geotek Project No.: 94-3832  
 Project Name: ILFV-A2-Y12  
 Date: 06/14/96  
 Client: Martin Marietta  
 Sample I.D.: 1-12  
 Depth (ft.): N/A  
 Description: SILTY CLAY w/ fine sand, chert, ferrous oxide nodules, red brown.

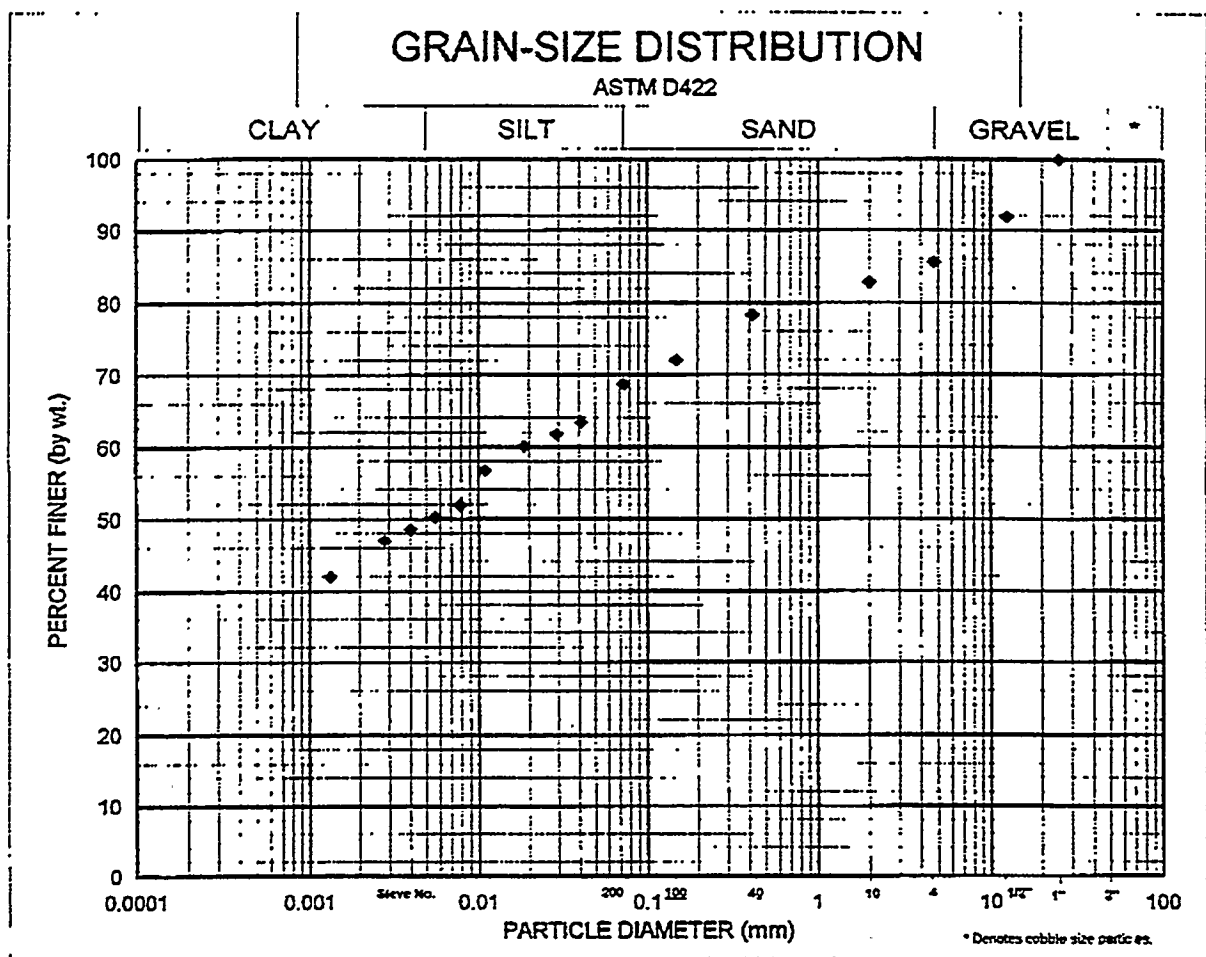
Geotek Project No.: 94-3832  
Project Name: ILFV-A2-Y12  
Date: 06/14/96  
Client: Martin Marietta  
Sample I.D.: 1-17  
Depth (ft.): N/A  
Description: SILTY CLAY w/ fine sand, chert, ferrous oxide nodules, yellow red.

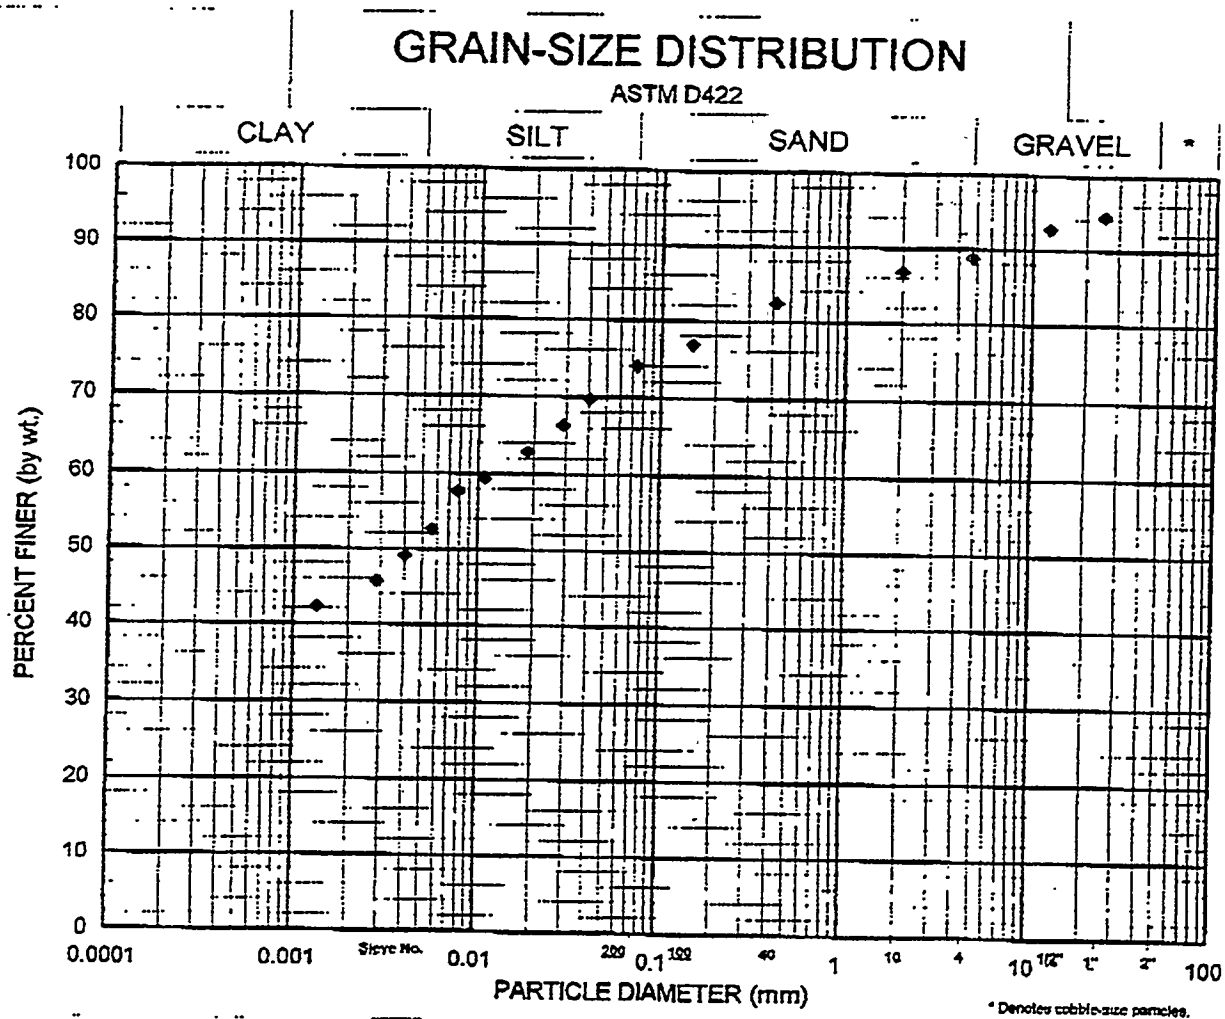
Geotek Project No.: 94-3832  
Project Name: ILFV-A2-Y12  
Date: 06/26/96  
Client: Martin Marietta  
Sample I.D.: 1-21  
Depth (ft.): N/A  
Description: CLAY w/ silt, fine sand, and chert, yellow red brown.

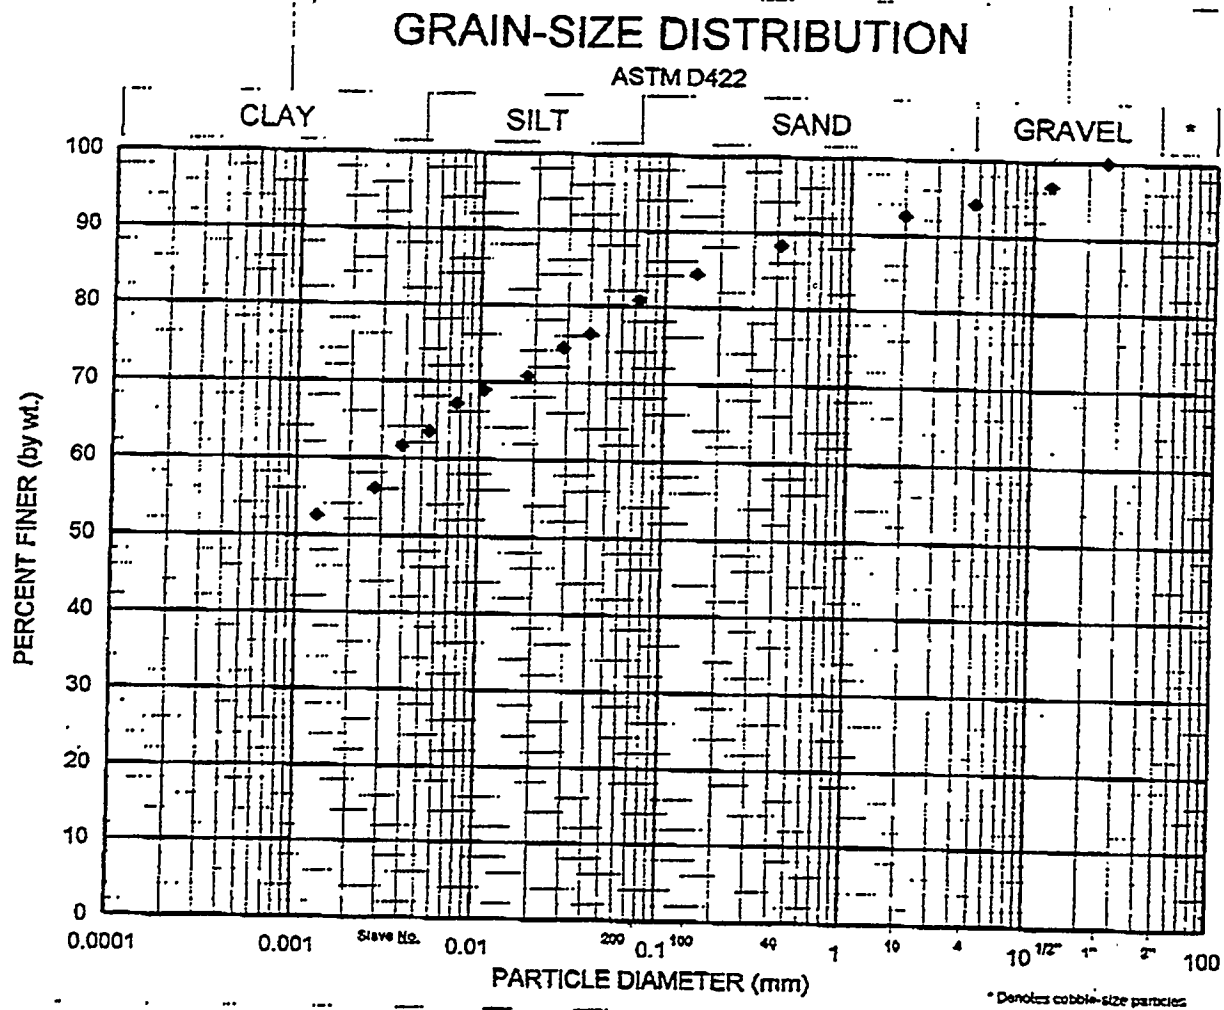
Geotek Project No.: 94-3832  
Project Name: ILFV-A2-Y12  
Date: 06/26/96  
Client: Martin Marietta  
Sample I.D.: 1-25  
Depth (ft.): N/A  
Description: CLAY w/ silt, fine sand traces, and chert, yellow tan red.

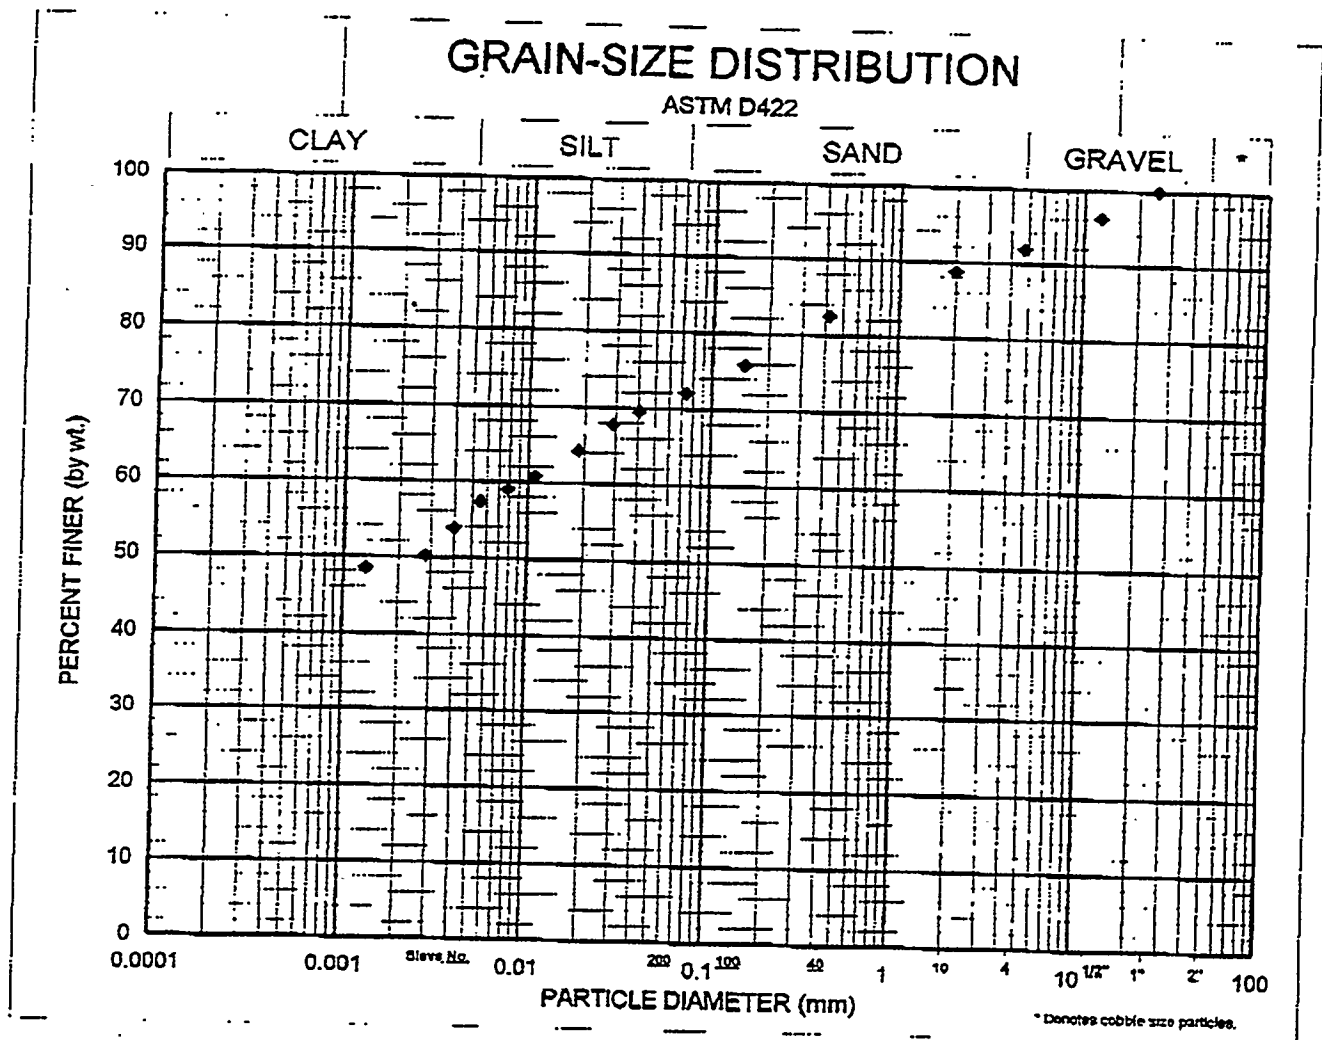
Geotek Project No.: 94-3832  
Project Name: ILFV-A2-Y12  
Date: 06/28/96  
Client: Martin Marietta  
Sample I.D.: 1-30  
Depth (ft.): N/A  
Description: CLAY w/ fine sand, silt, and chert, yellow red brown.

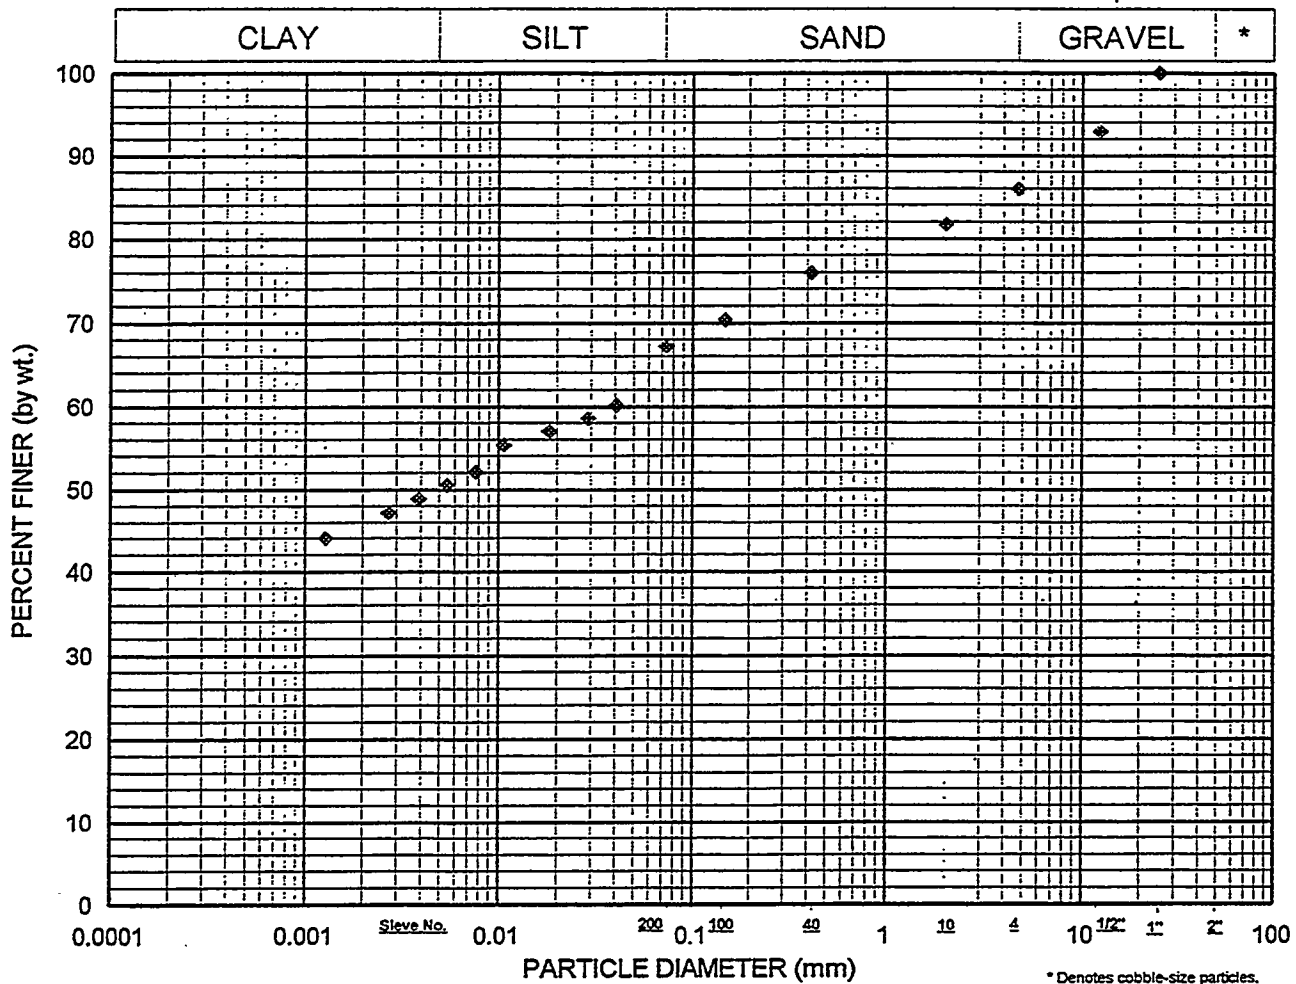
## GRAIN-SIZE DISTRIBUTION

Geotek Project No.: 94-3832  
 Project Name: ILFV-A2-Y12  
 Date: 06/28/96  
 Client: Martin Marietta  
 Sample I.D.: 1-35  
 Depth (ft.): N/A  
 Description: CLAY w/ fine sand, silt, and chert, yellow red tan.

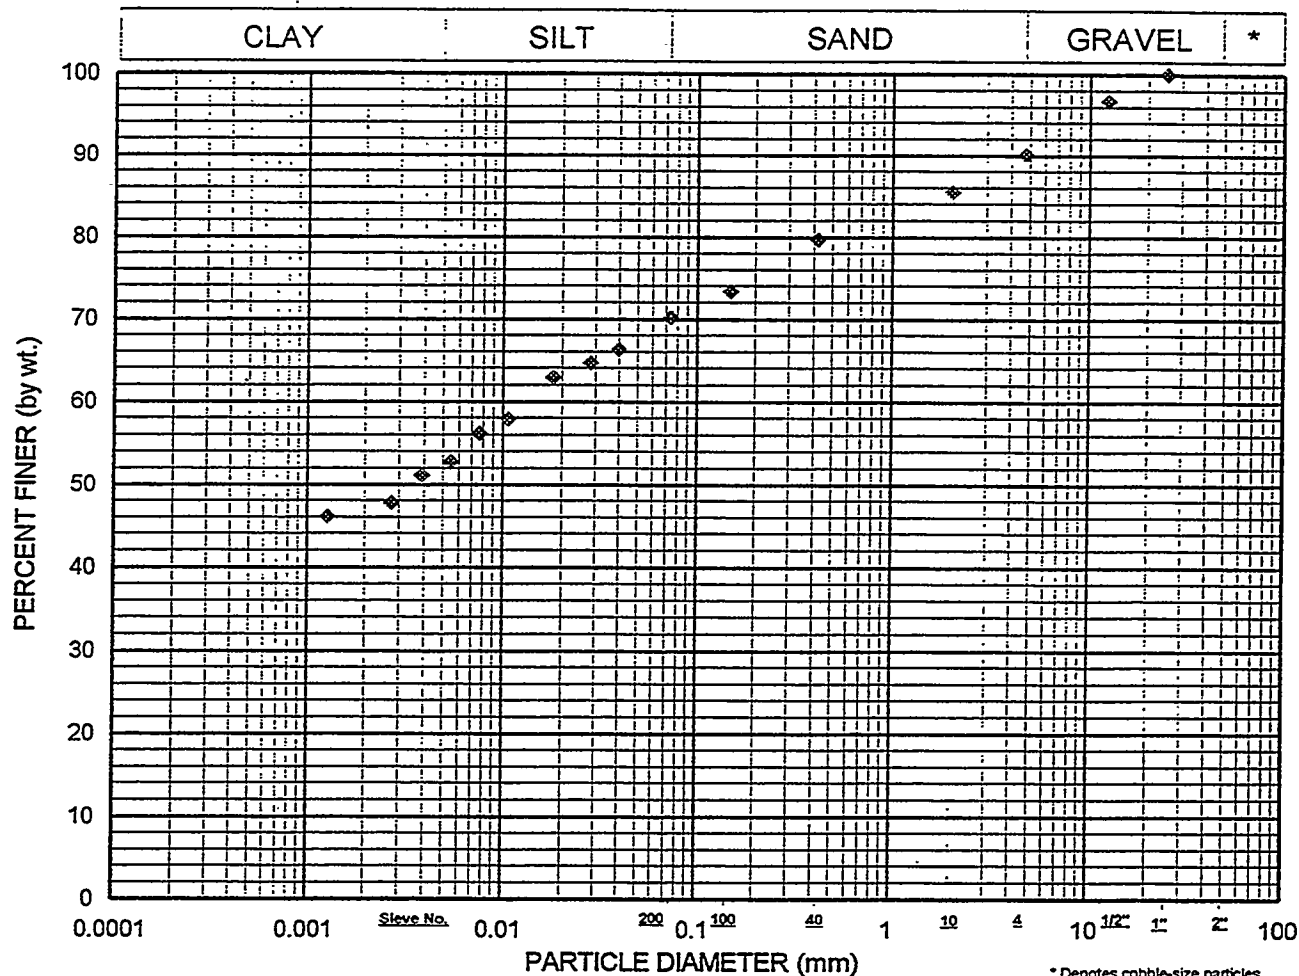
## GRAIN-SIZE DISTRIBUTION

Geotek Project No.: 94-3832  
 Project Name: ILFV-A2-Y12  
 Date: 06/28/96  
 Client: Martin Marietta  
 Sample I.D.: 1-40  
 Depth (ft.): N/A  
 Description: CLAY w/ fine sand, silt, and chert, yellow red tan.

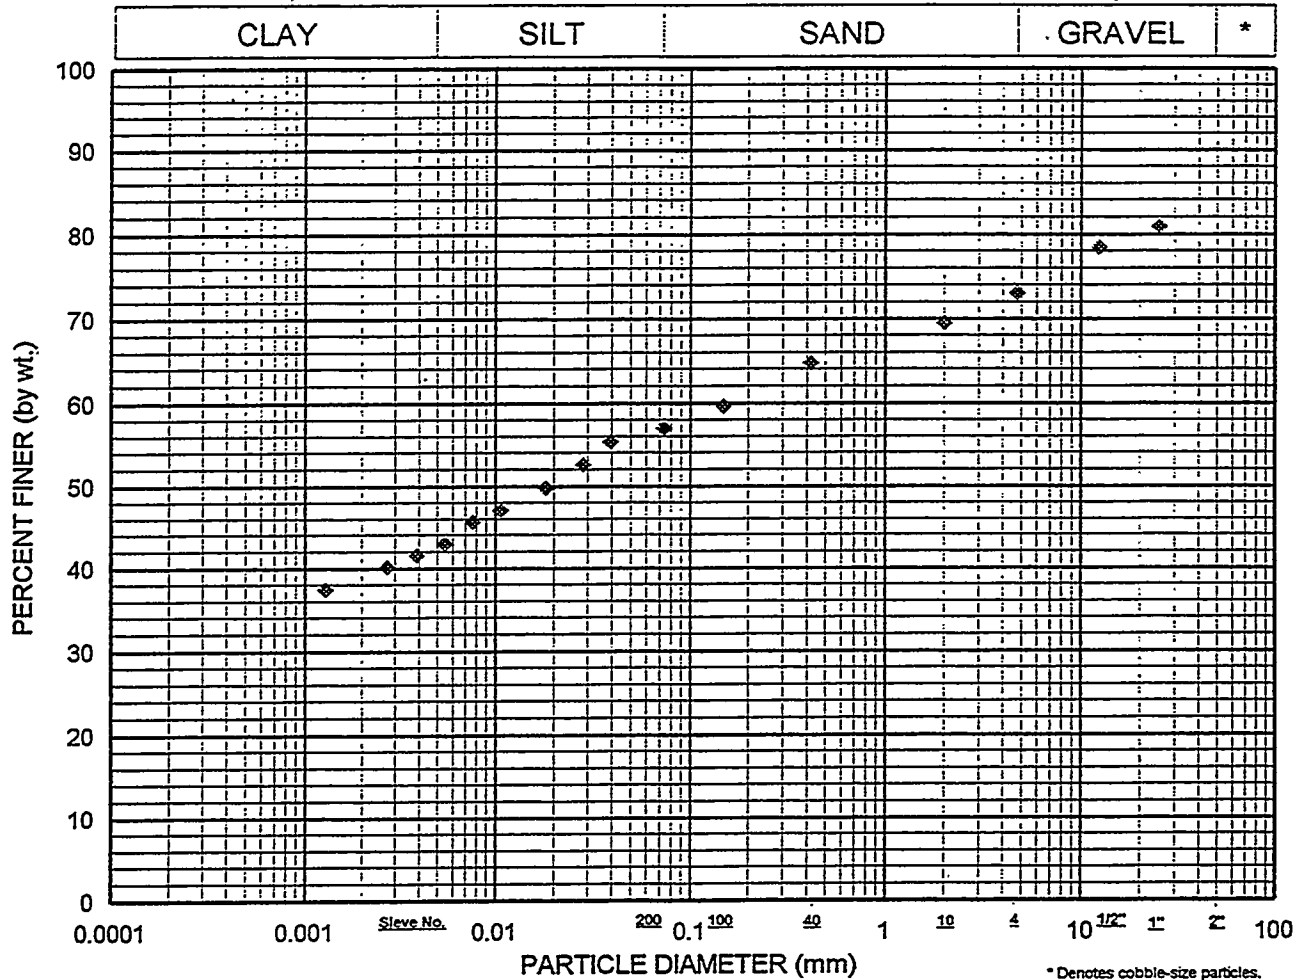
## GRAIN-SIZE DISTRIBUTION

Geotek Project No.: 94-3832  
 Project Name: ILFV-A2-Y12  
 Date: 06/28/96  
 Client: Martin Marietta  
 Sample I.D.: 1-45  
 Depth (ft.): N/A  
 Description: CLAY w/ chert, sand, and silt, yellow red tan.

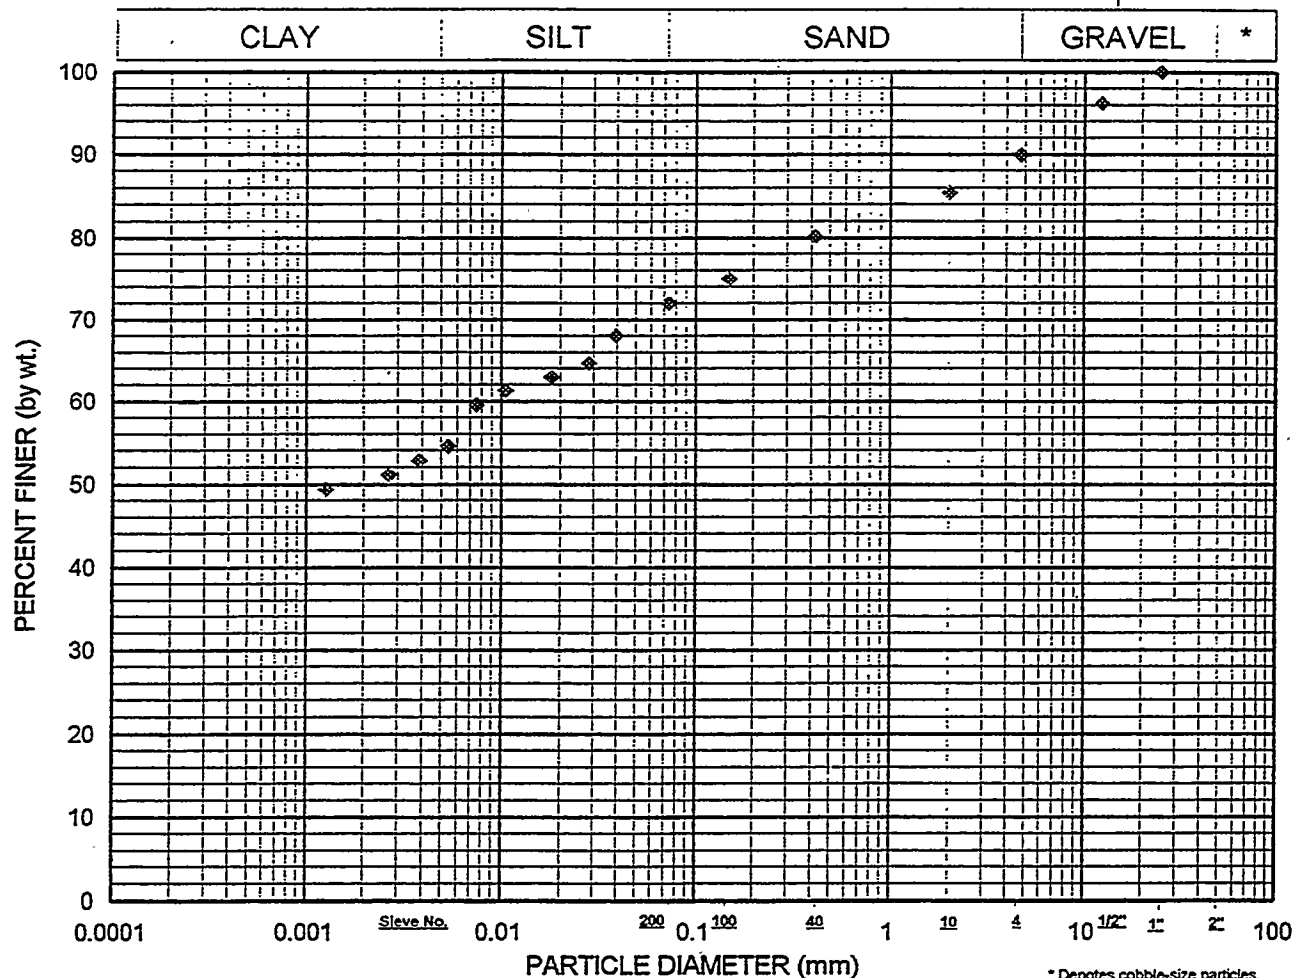
## GRAIN-SIZE DISTRIBUTION

Geotek Project No.: 94-3832  
 Project Name: ILFV-A2-Y12  
 Date: 06/28/96  
 Client: Martin Marietta  
 Sample I.D.: 1-50  
 Depth (ft.): N/A  
 Description: CLAY w/ silt, sand, and chert, yellow red tan.

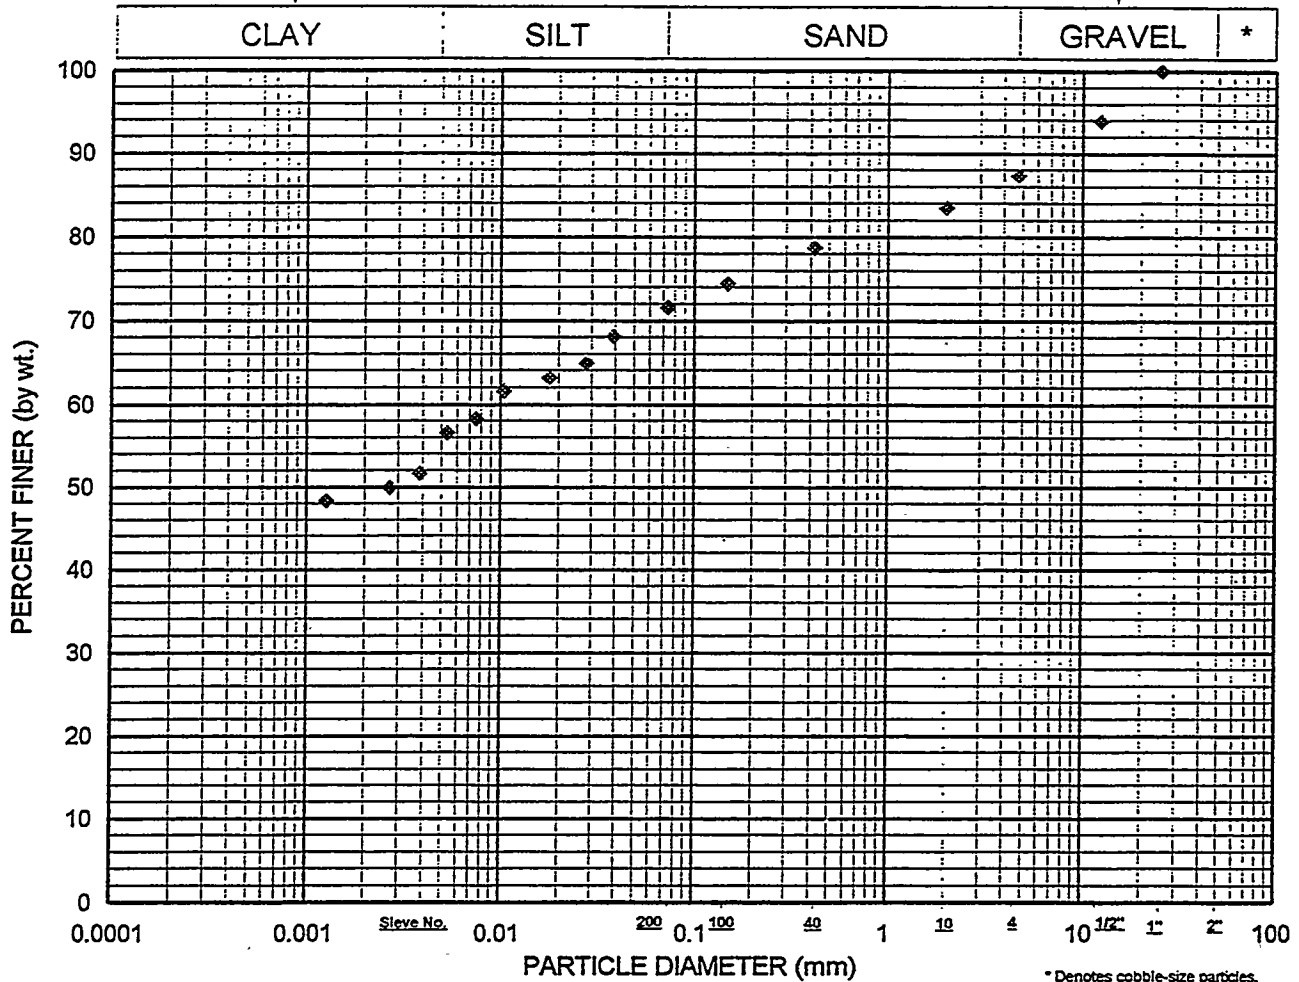
## GRAIN-SIZE DISTRIBUTION

Geotek Project No.: 94-3832  
 Project Name: ILFV-A2-Y12  
 Date: 06/28/96  
 Client: Martin Marietta  
 Sample I.D.: 1-55  
 Depth (ft.): N/A  
 Description: CLAY w/ silt, sand, and chert, yellow red tan.

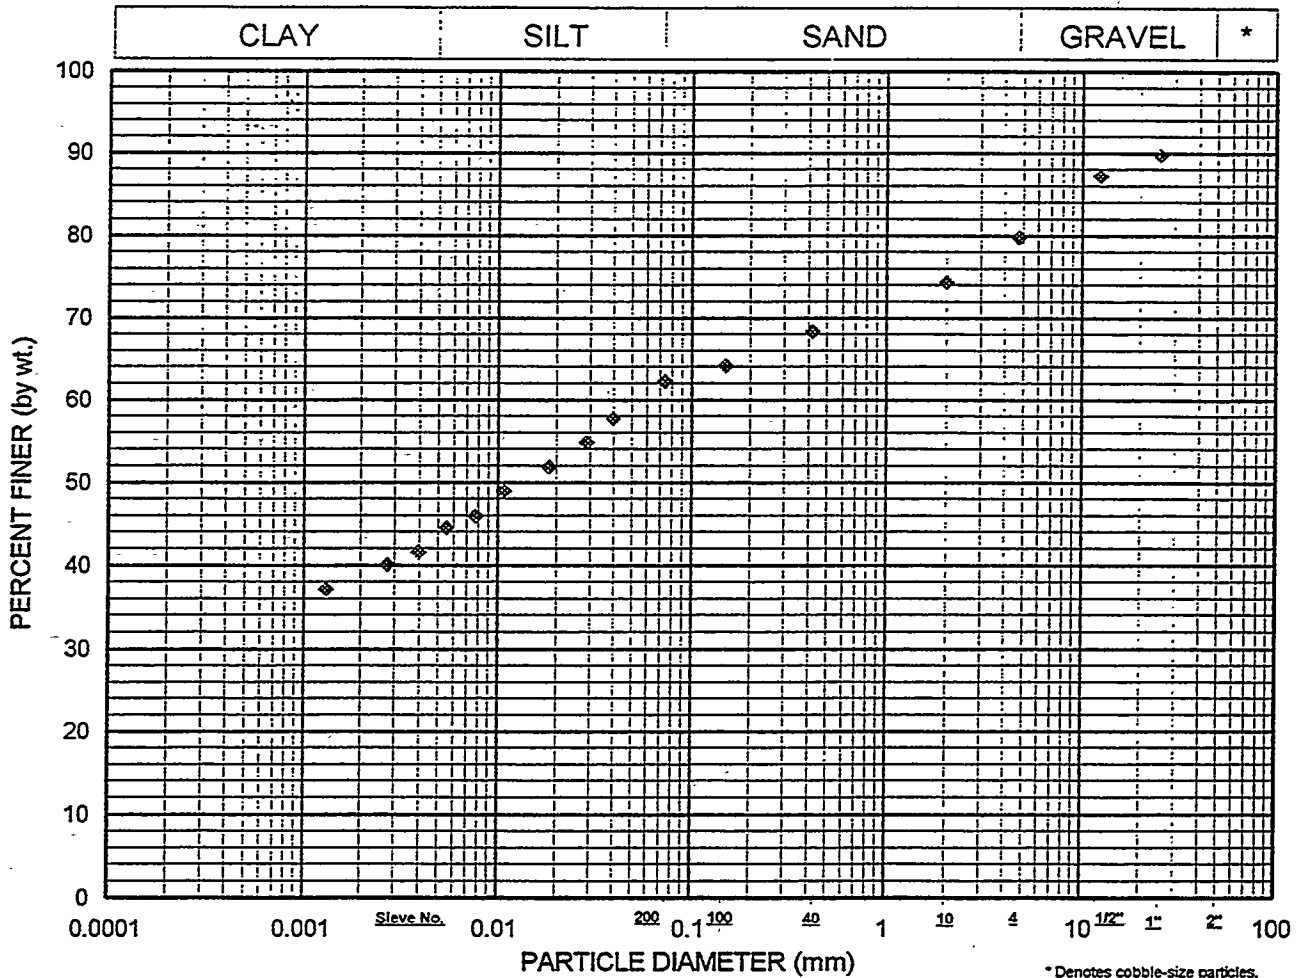
## GRAIN-SIZE DISTRIBUTION

Geotek Project No.: 94-3832  
 Project Name: ILFV-A2-Y12  
 Date: 06/28/96  
 Client: Martin Marietta  
 Sample I.D.: 1-60  
 Depth (ft.): N/A  
 Description: CLAY w/ silt, sand, and chert, yellow brown & red tan.

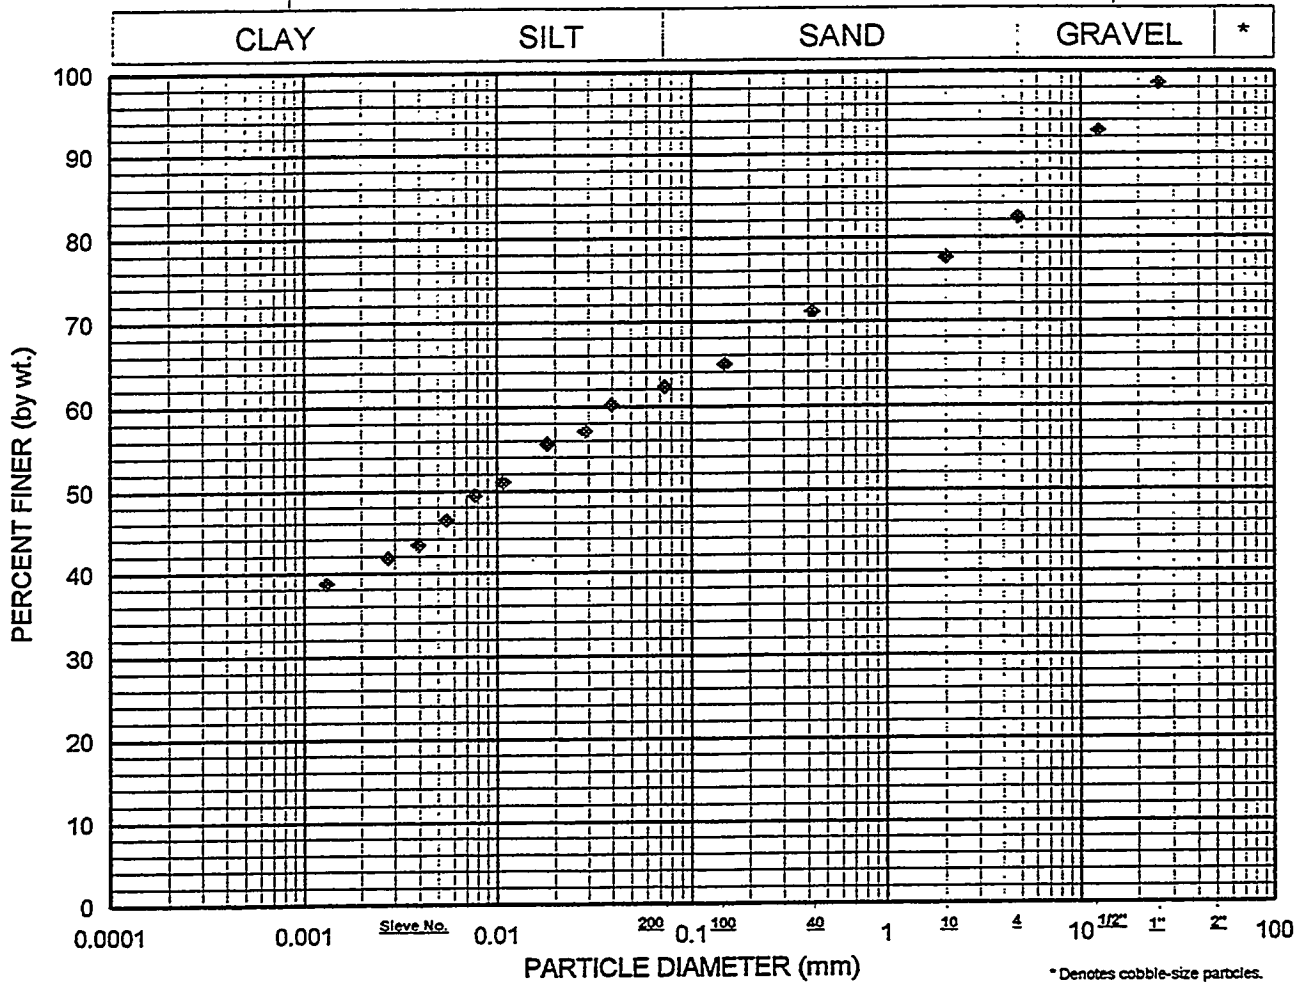
## GRAIN-SIZE DISTRIBUTION

Geotek Project No.: 94-3832  
 Project Name: ILFV-A2-Y12  
 Date: 06/28/96  
 Client: Martin Marietta  
 Sample I.D.: 1-65  
 Depth (ft.): N/A  
 Description: CLAY w/ sand, chert and silt, yellow brown & red tan.

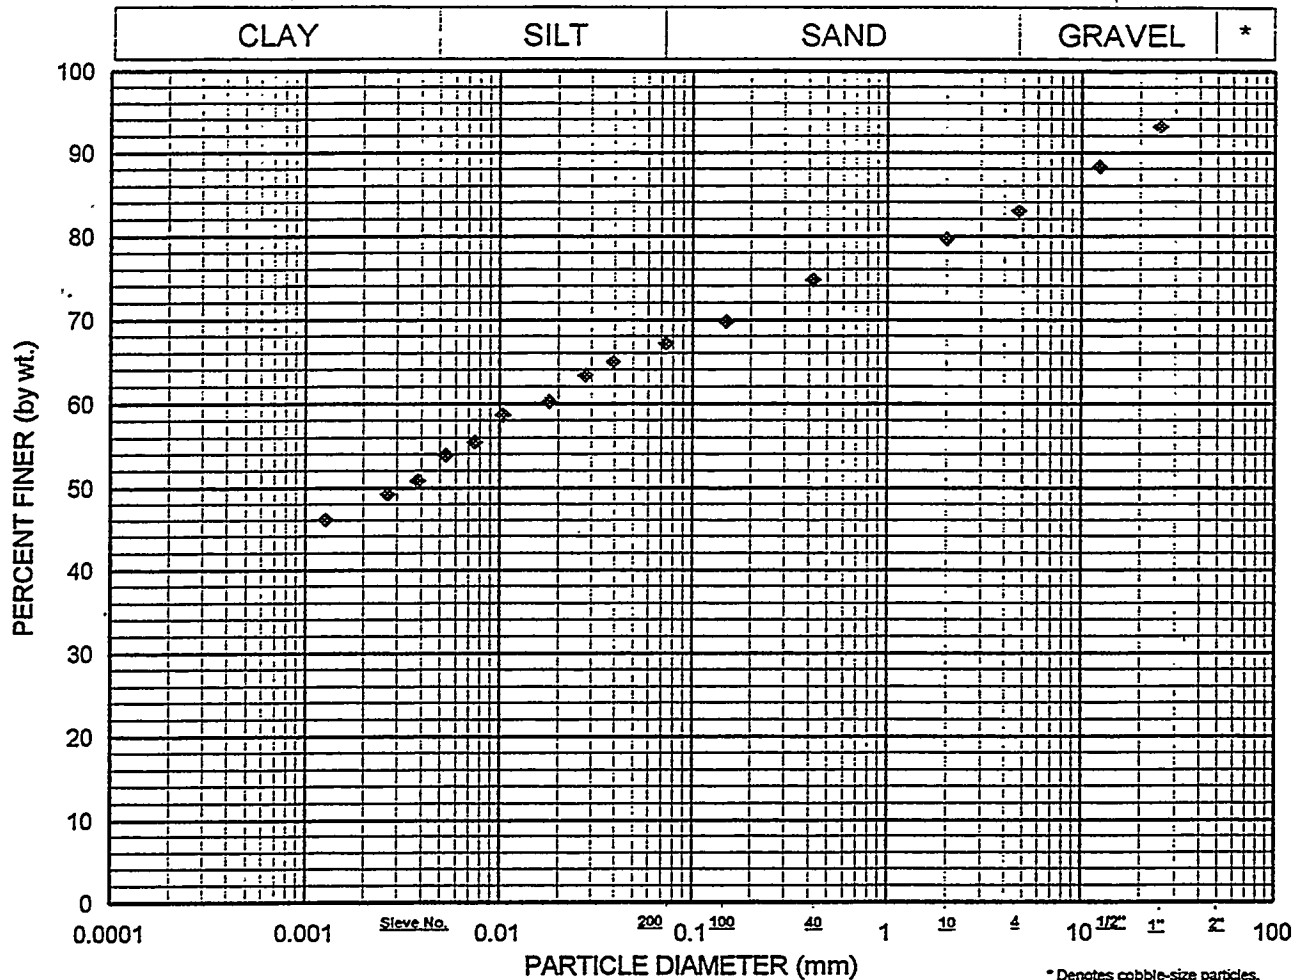
## GRAIN-SIZE DISTRIBUTION

Geotek Project No.: 94-3832  
 Project Name: ILFV-A2-Y12  
 Date: 06/28/96  
 Client: Martin Marietta  
 Sample I.D.: 1-75  
 Depth (ft.): N/A  
 Description: CLAY w/ chert, fine sand and silt, yellow brown & red tan.

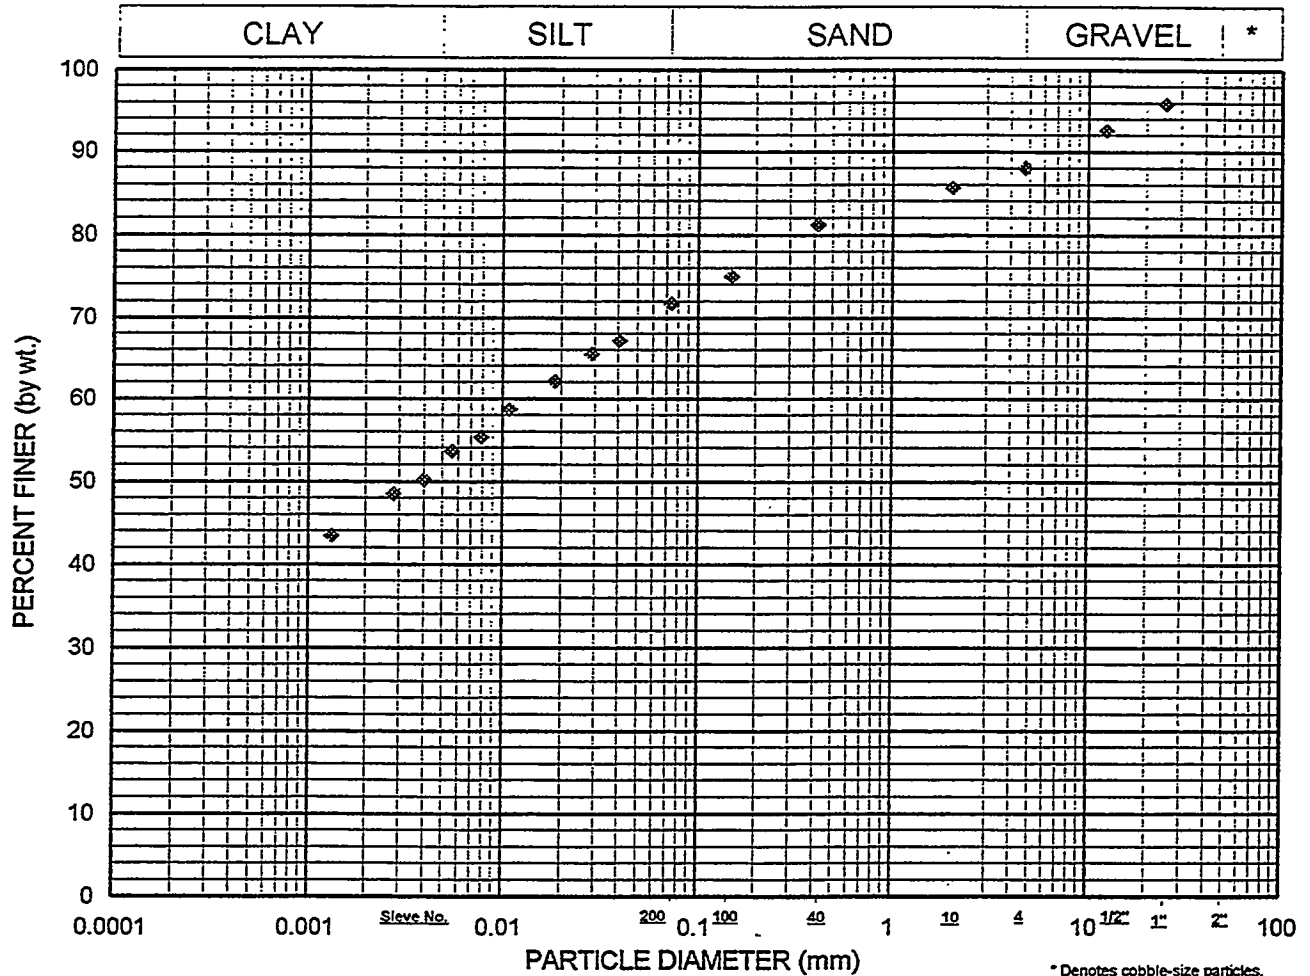
## GRAIN-SIZE DISTRIBUTION

Geotek Project No.: 94-3832  
 Project Name: ILFV-A2-Y12  
 Date: 07/16/96  
 Client: Geotek Drilling  
 Sample I.D.: 1-100  
 Depth (ft.): N/A  
 Description: CLAY w/ silt, fine sand, chert, yellow red brown.

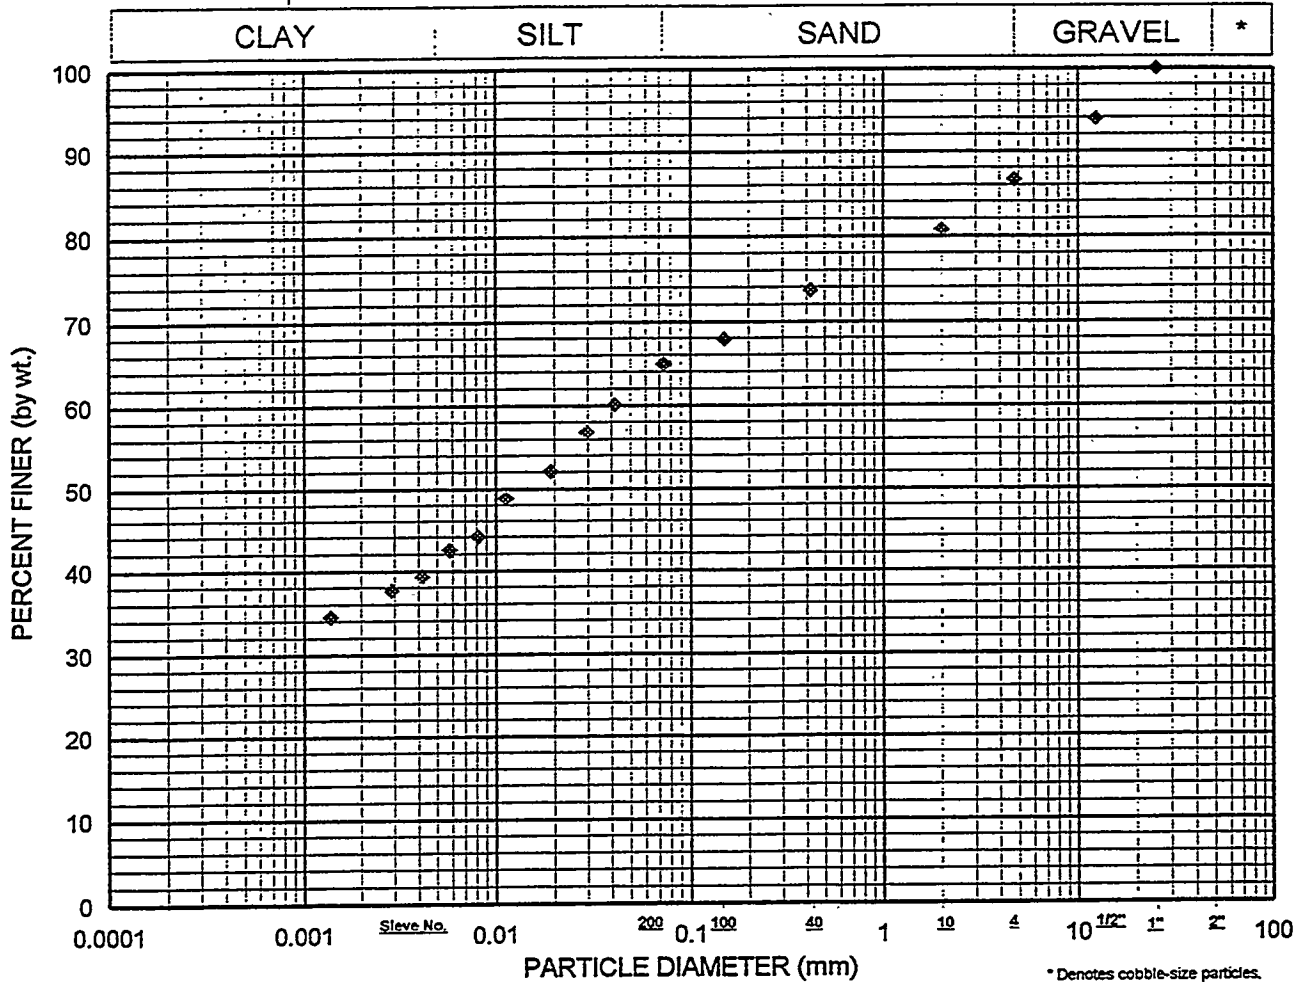
## GRAIN-SIZE DISTRIBUTION

Geotek Project No.: 94-3832  
 Project Name: ILFV-A2-Y12  
 Date: 07/30/96  
 Client: Geotek Drilling  
 Sample I.D.: 1-125  
 Depth (ft.): N/A  
 Description: CLAY w/ silt, fine sand traces, little chert, yellow tan brown.

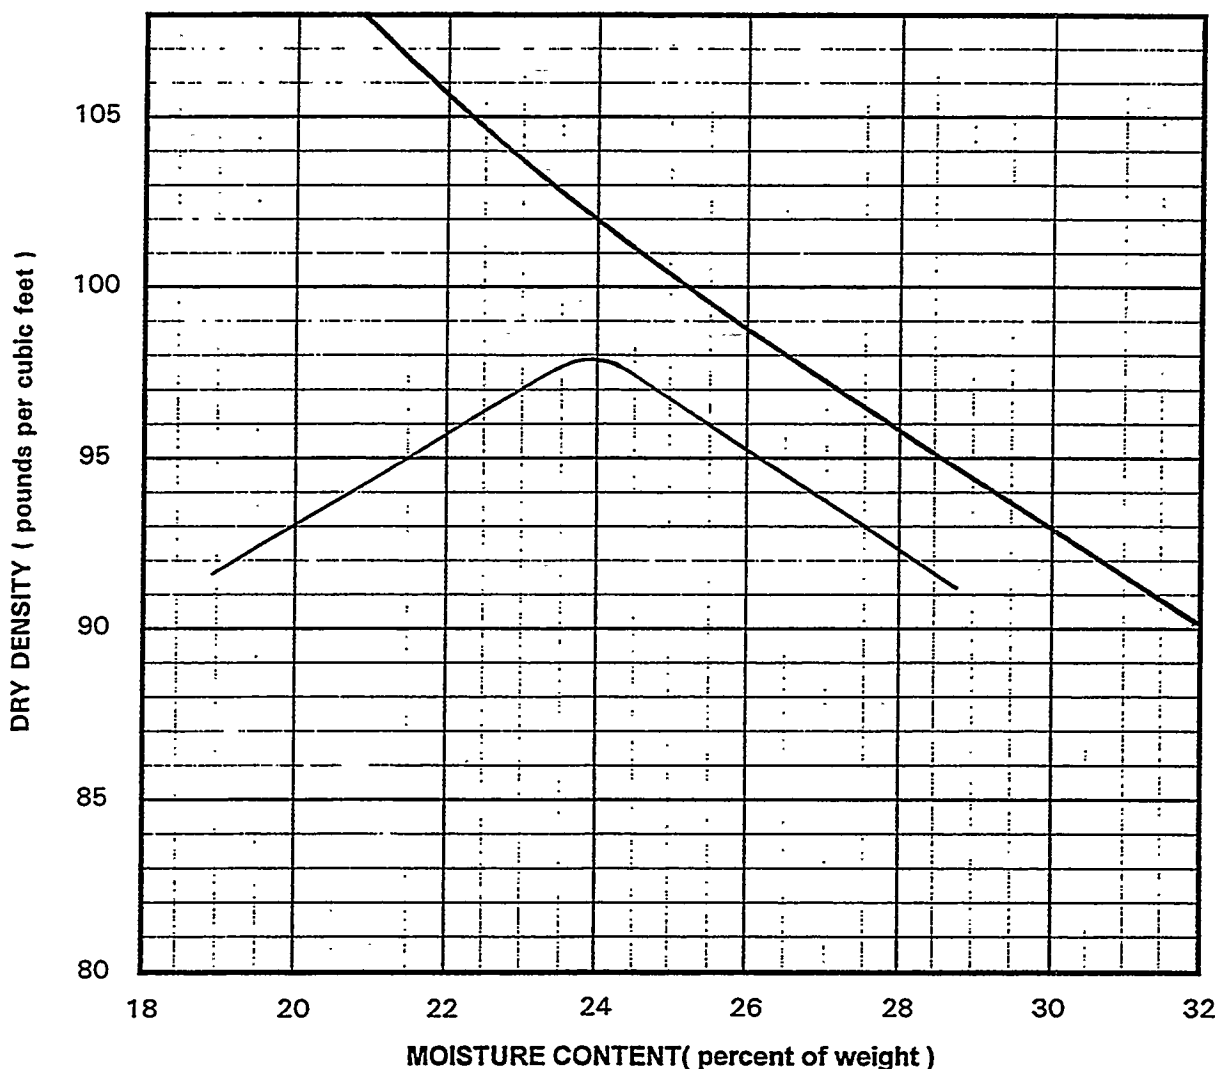
Zero Air Voids Curve for  
Specific Gravity at 2.70

MAXIMUM DRY DENSITY: 97.9

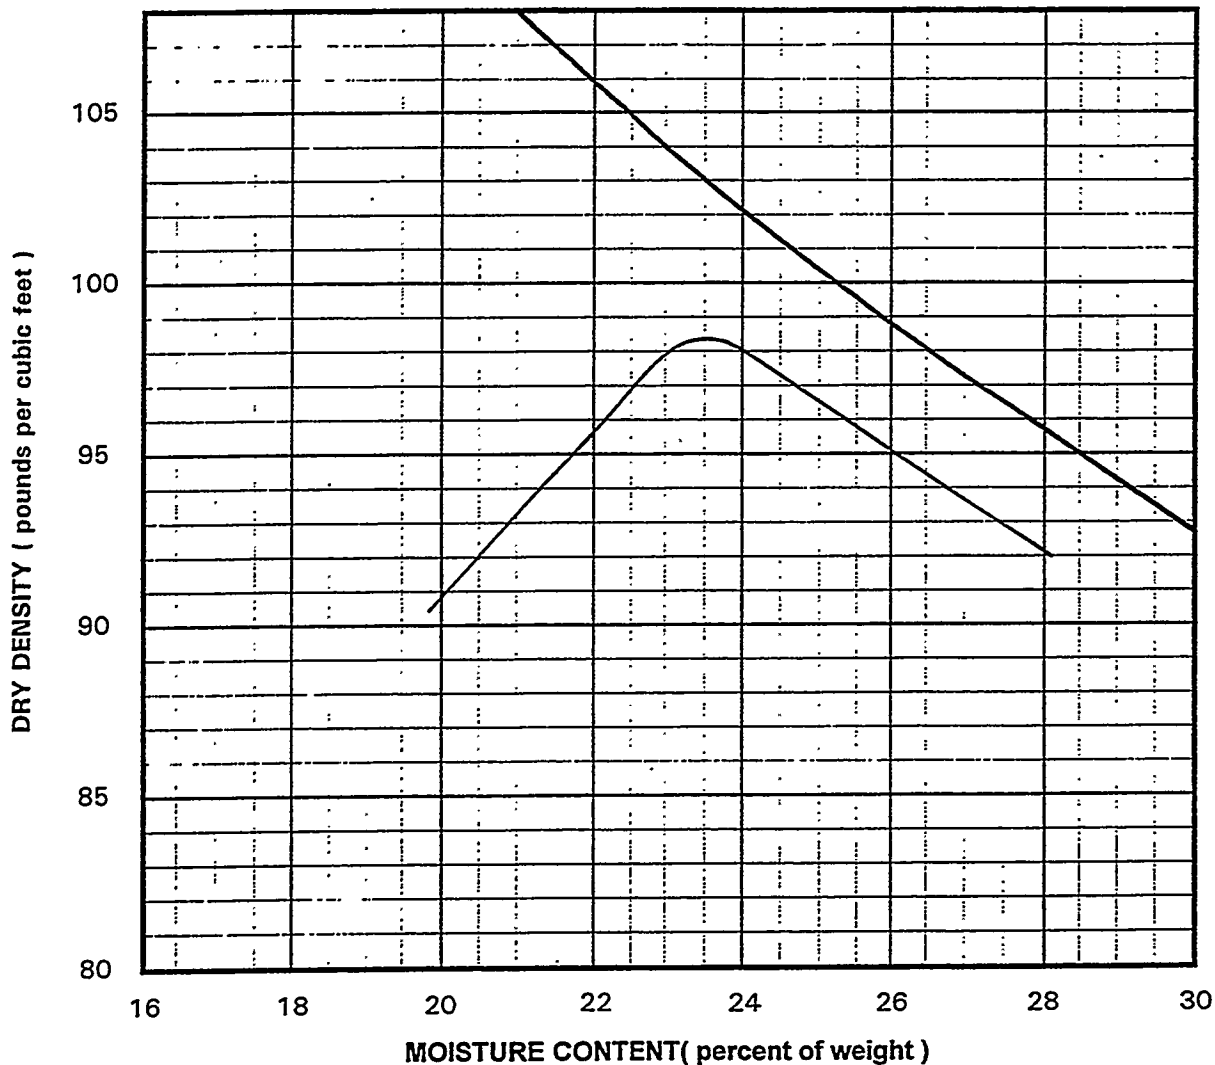
Zero Air Voids Curve for  
Specific Gravity at 2.70

MAXIMUM DRY DENSITY: 98.4
