### FINAL CONSTRUCTION QUALITY ASSURANCE REPORT

Y-12 INDUSTRIAL LANDFILL V, AREA 2

OAK RIDGE, TENNESSEE

NOVEMBER 1996

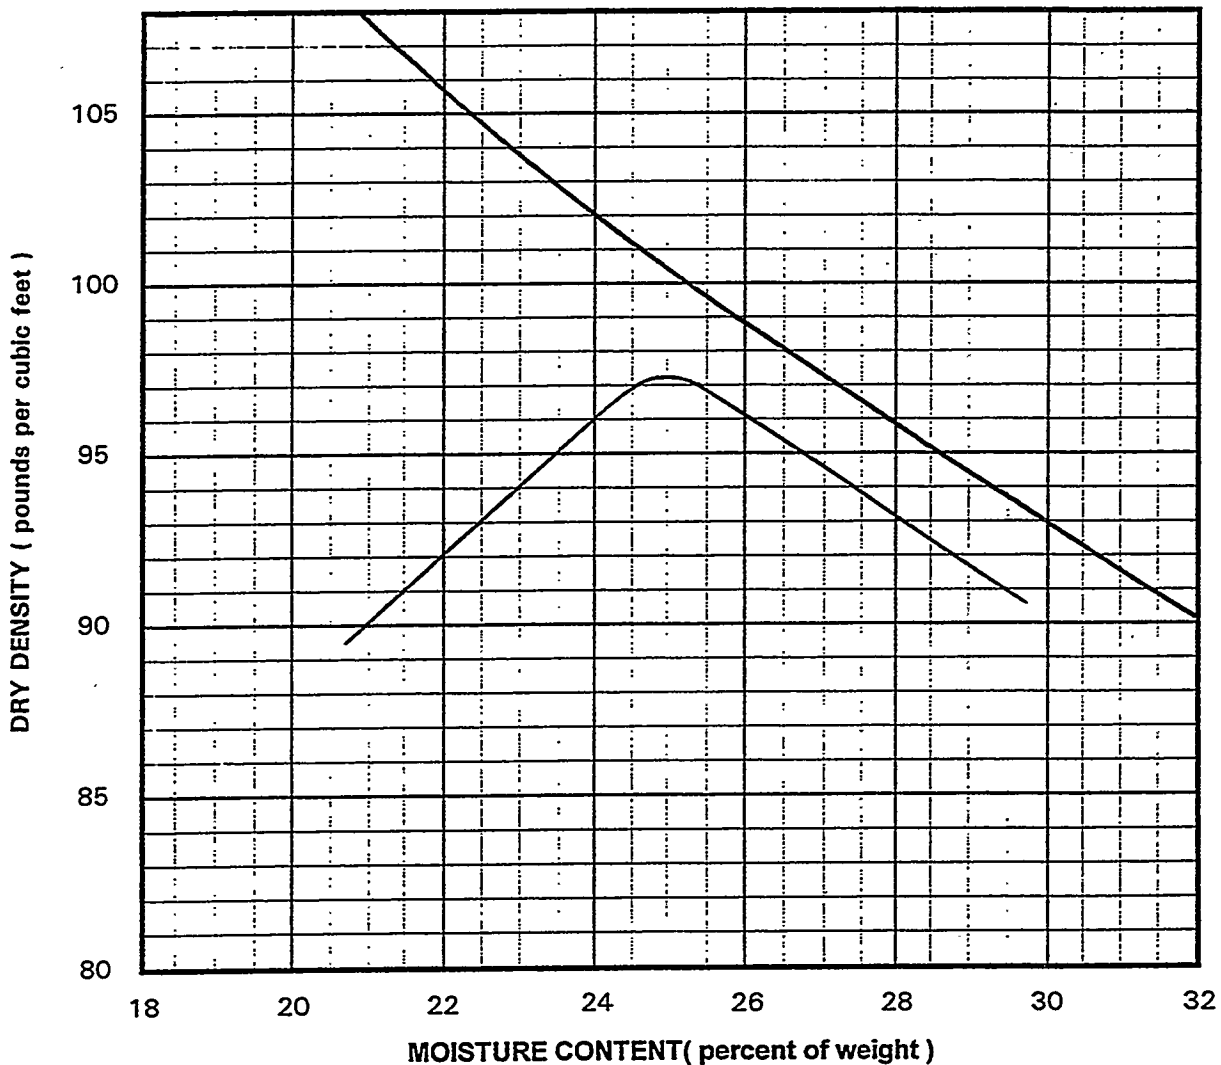
Zero Air Voids Curve for  
Specific Gravity at 2.70

MAXIMUM DRY DENSITY: 97.2

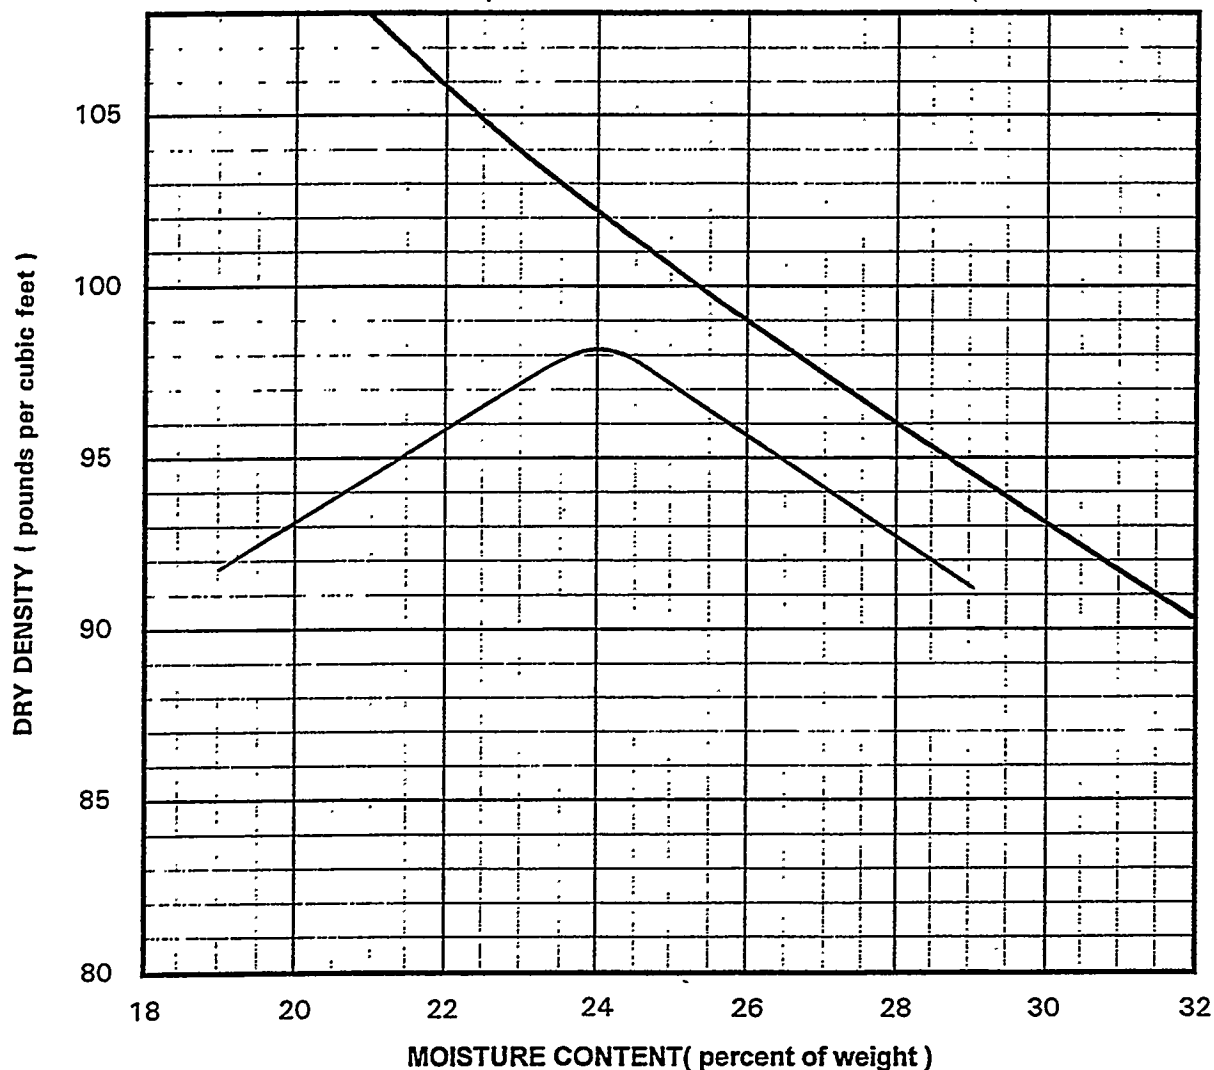
Zero Air Voids Curve for  
Specific Gravity at 2.70

MAXIMUM DRY DENSITY: 98.1

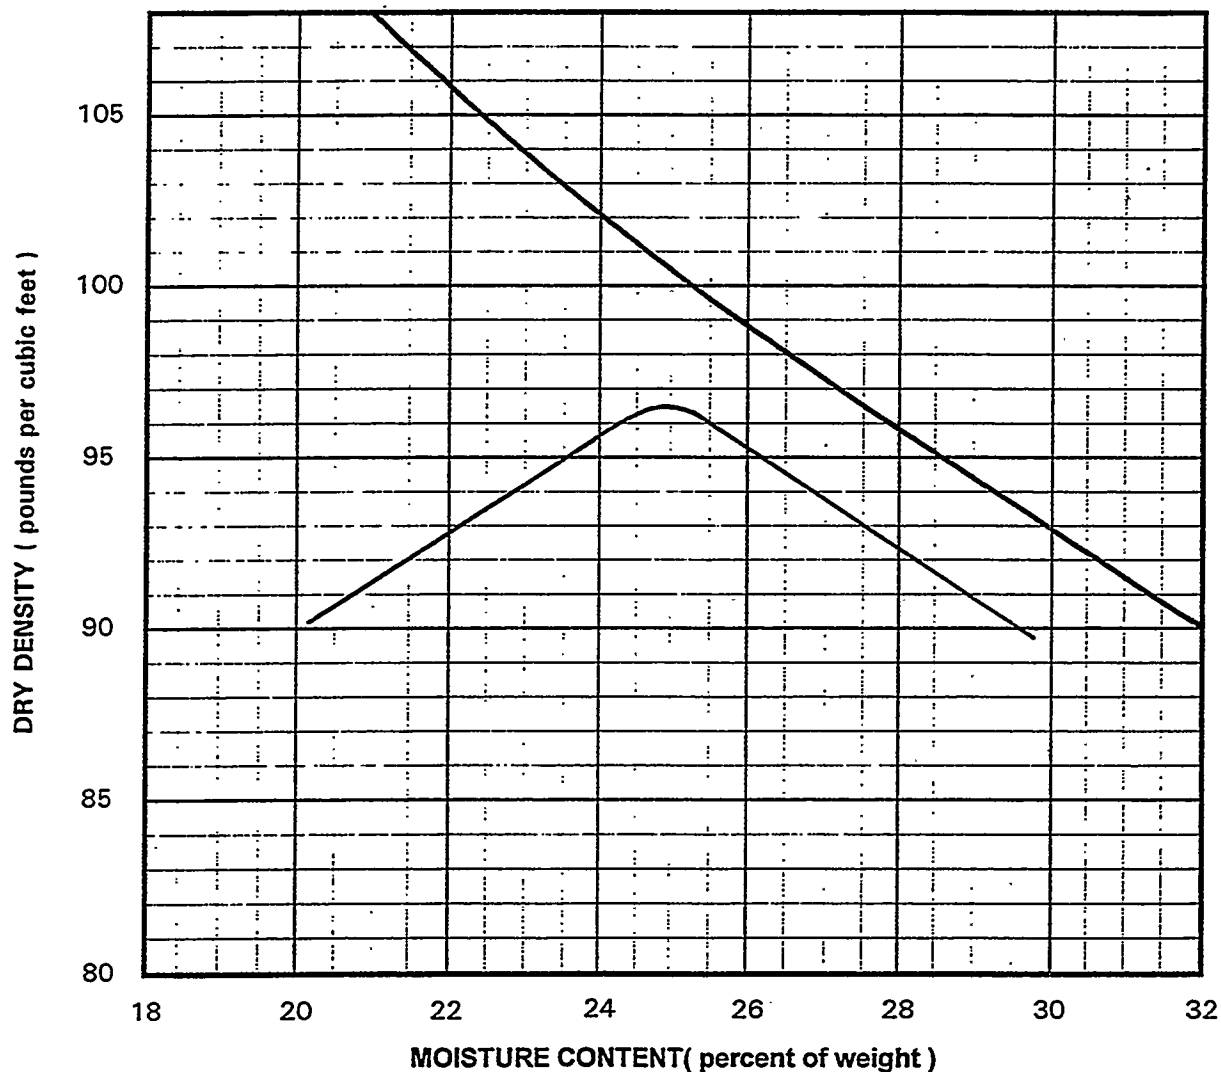
Zero Air Voids Curve for  
Specific Gravity at 2.70

MAXIMUM DRY DENSITY: 96.6

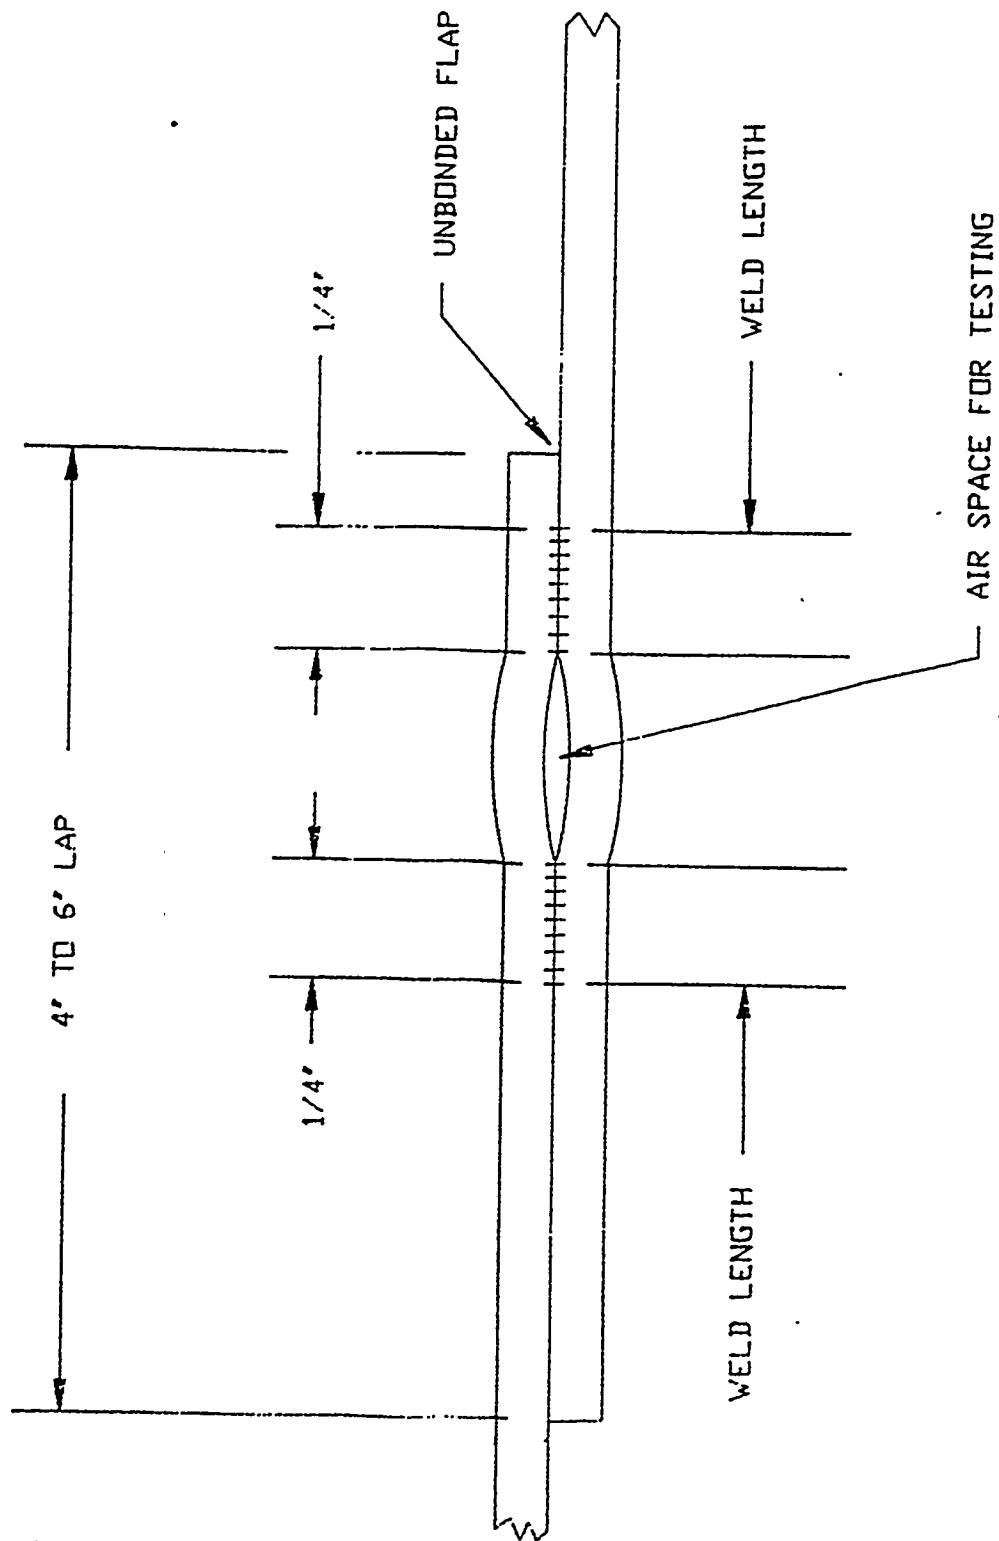
FUSION WELD  
(HOT WEDGE METHOD)

Test patches were cut at the seams and bones or coupons cut from each patch. Field tests, consisting of shear and peel tests per ASTM D4437 were performed on the bones and samples were sent to an independent lab for verification. Each test sample, repair, and corner of panel seams, were patched using liner material and heat gun, vacuum tested per ASTM D4437, and extrusion welded.

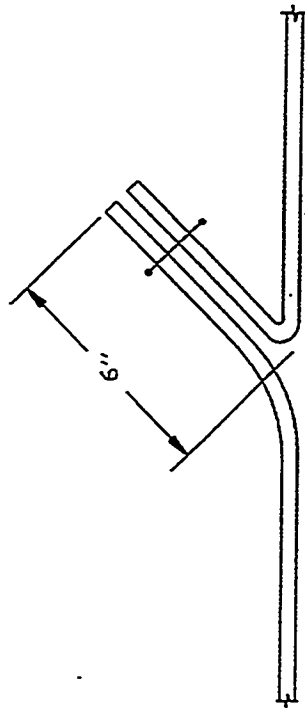
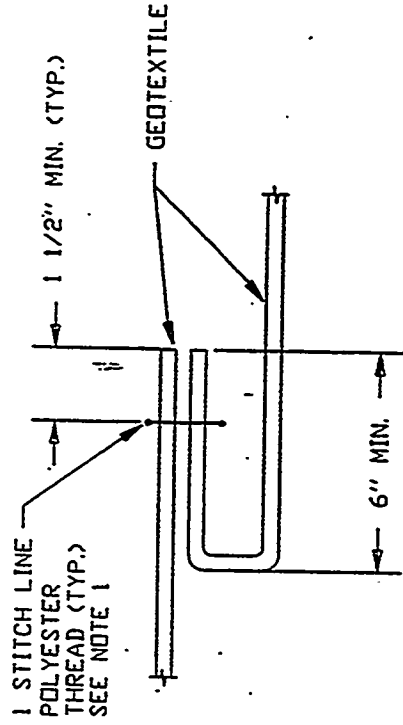
### GEOTEXTILE - SEWN FIELD SEAM

POSITION FOR SEWING

NOTE: 1. THREAD TO BE TERAPOLY TEX 210  
MFG. BY ATLANTIC THREAD AND  
SUPPLY INC.

FINAL POSITION

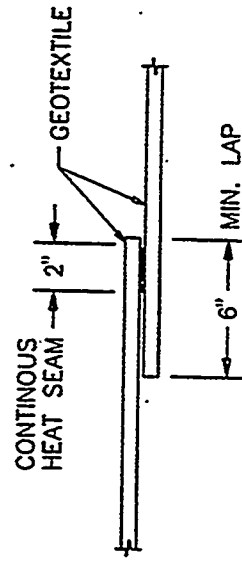
### GEOTEXTILE - HEAT FIELD SEAM

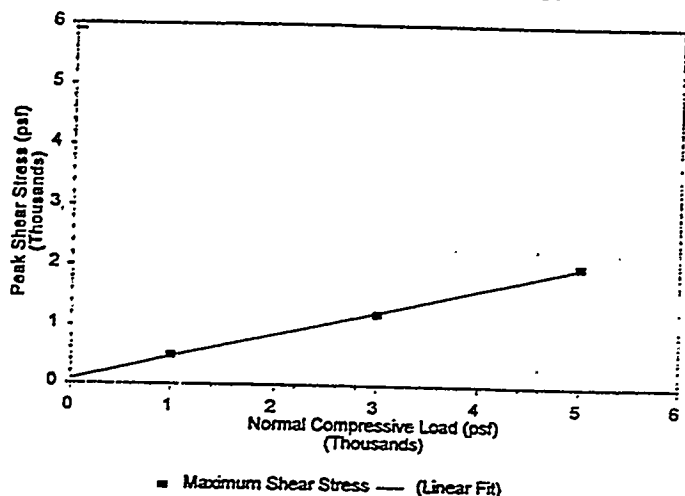
**Serrot Corp. Interface Friction Test**  
40 mil PPE GM vs. Nonwoven Cushion GT

Upper Box: 40 mil Polypropylene GM

Lower Box: Synthetic Industries 1751  
Nonwoven Cushion Geotextile

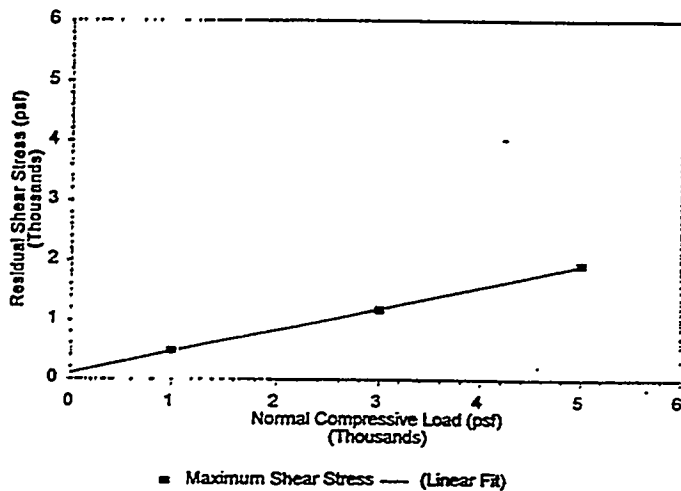
**Serrot Corp. Interface Friction Test**  
40 mil PPE GM vs. Nonwoven Cushion GT

Upper Box: 40 mil Polypropylene GM

Lower Box: Synthetic Industries 1751  
Nonwoven Cushion Geotextile

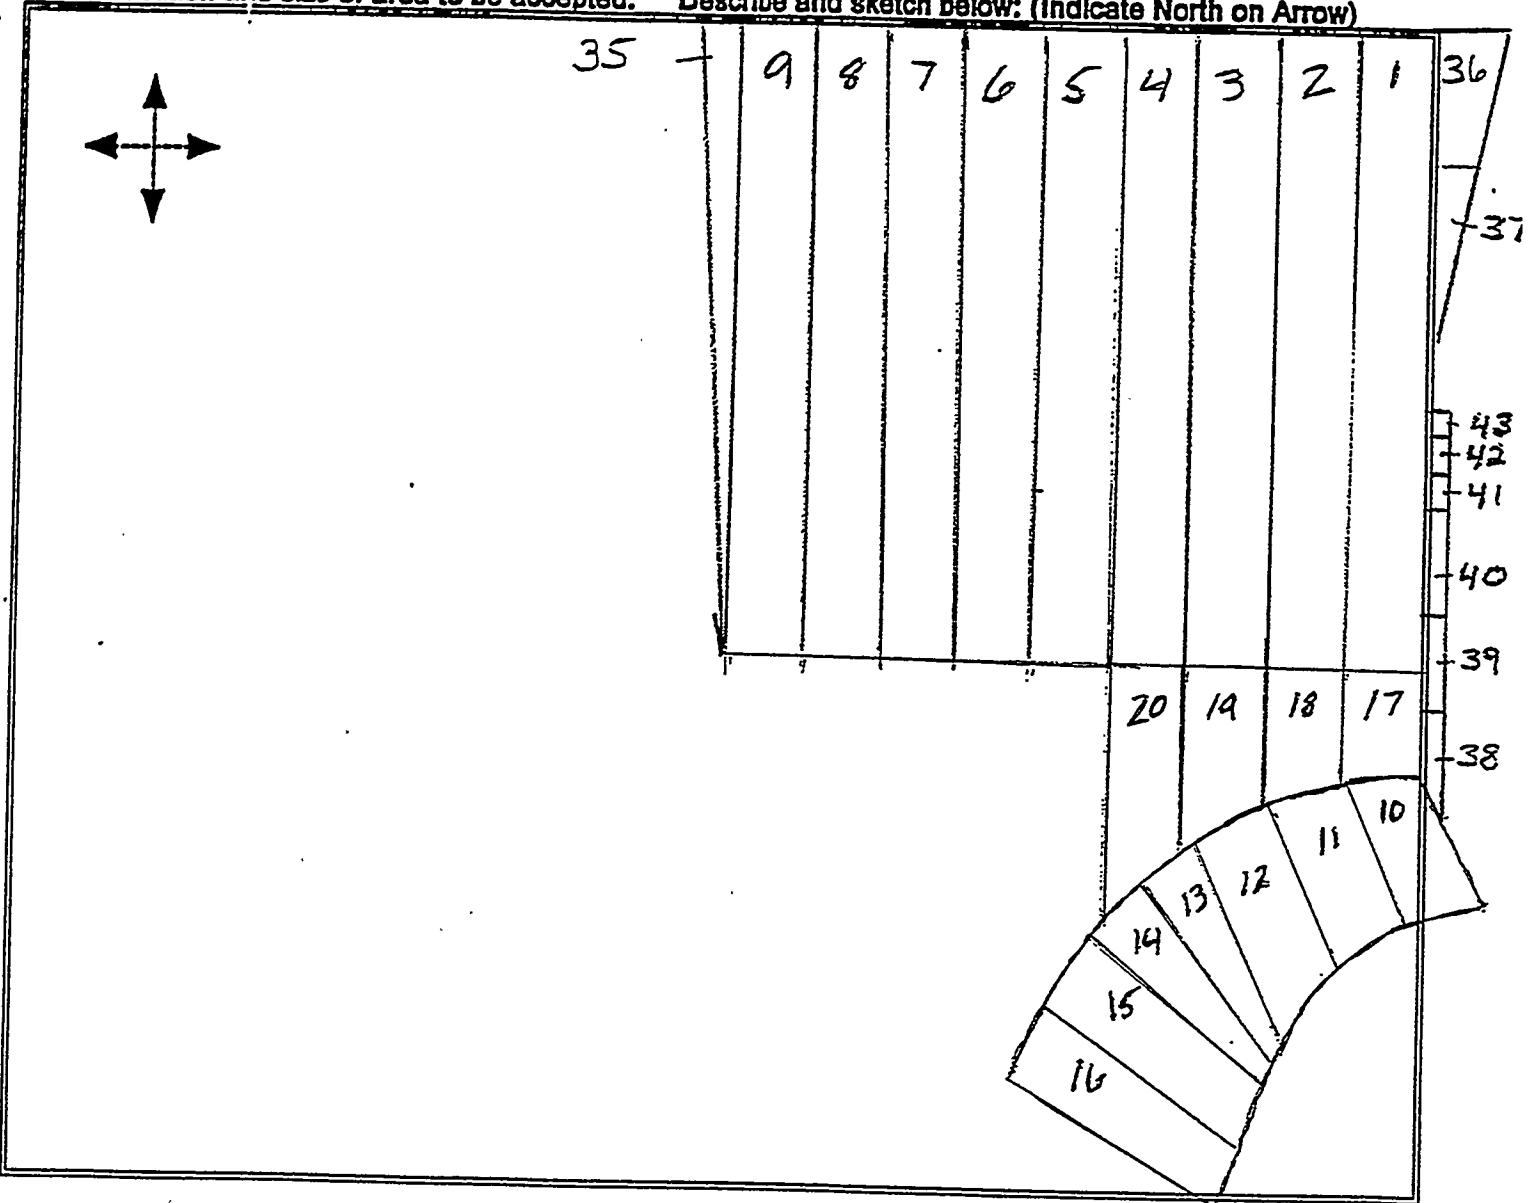
Location and size of area to be accepted. Describe and sketch below: (Indicate North on Arrow)
