DENTING OF INCONEL STEAM GENERATOR TUBES IN PRESSURIZED WATER REACTORS

FINAL REPORT

DANIEL VAN ROOYEN AND JOHN R. WEEKS

DEPARTMENT OF NUCLEAR ENERGY BROOKHAVEN NATIONAL LABORATORY
UPTON, NEW YORK 11973

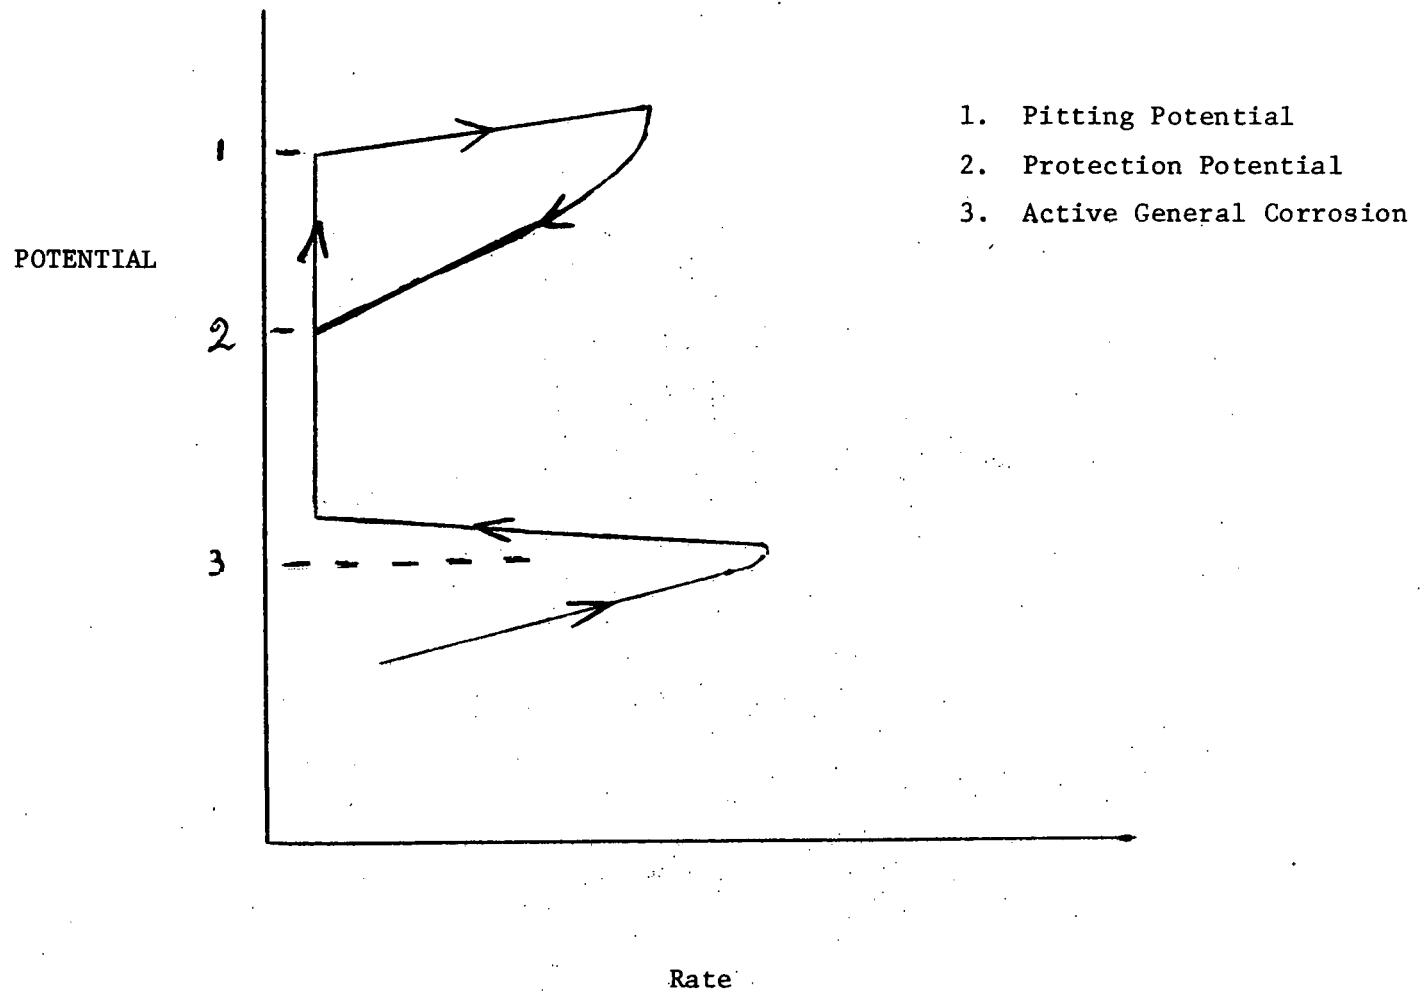
Figure 1

Effect of Potential Changes on Corrosion Rate

Page
FIGURE 1 Effect of potential changes on corrosion rate-----	25

In the depolarizing sense, the triggering of denting could be analogous to pitting of stainless steel in Cl^- , which can be started at an elevated electrochemical potential, but which, on slightly lowering this potential, continues because of the local acidity and higher Cl^- inside the pit, and only ceases at the "protection potential" in the bulk solution. (See schematic representation in Figure 1). The "protection" level of denting, then is felt to be near the potential at which $\text{H}_2\text{O} \rightarrow \text{H}_2$ polarization curve intersects the anodic curve.
