NUREG/CR-5764
PNL-7594

Auxiliary Feedwater System Risk-Based Inspection Guide for the Ginna Nuclear Power Plant

Prepared by
R. Pugh, B. F. Gore, T. V. Vo, N. E. Moffitt

Pacific Northwest Laboratory
Operated by
Battelle Memorial Institute

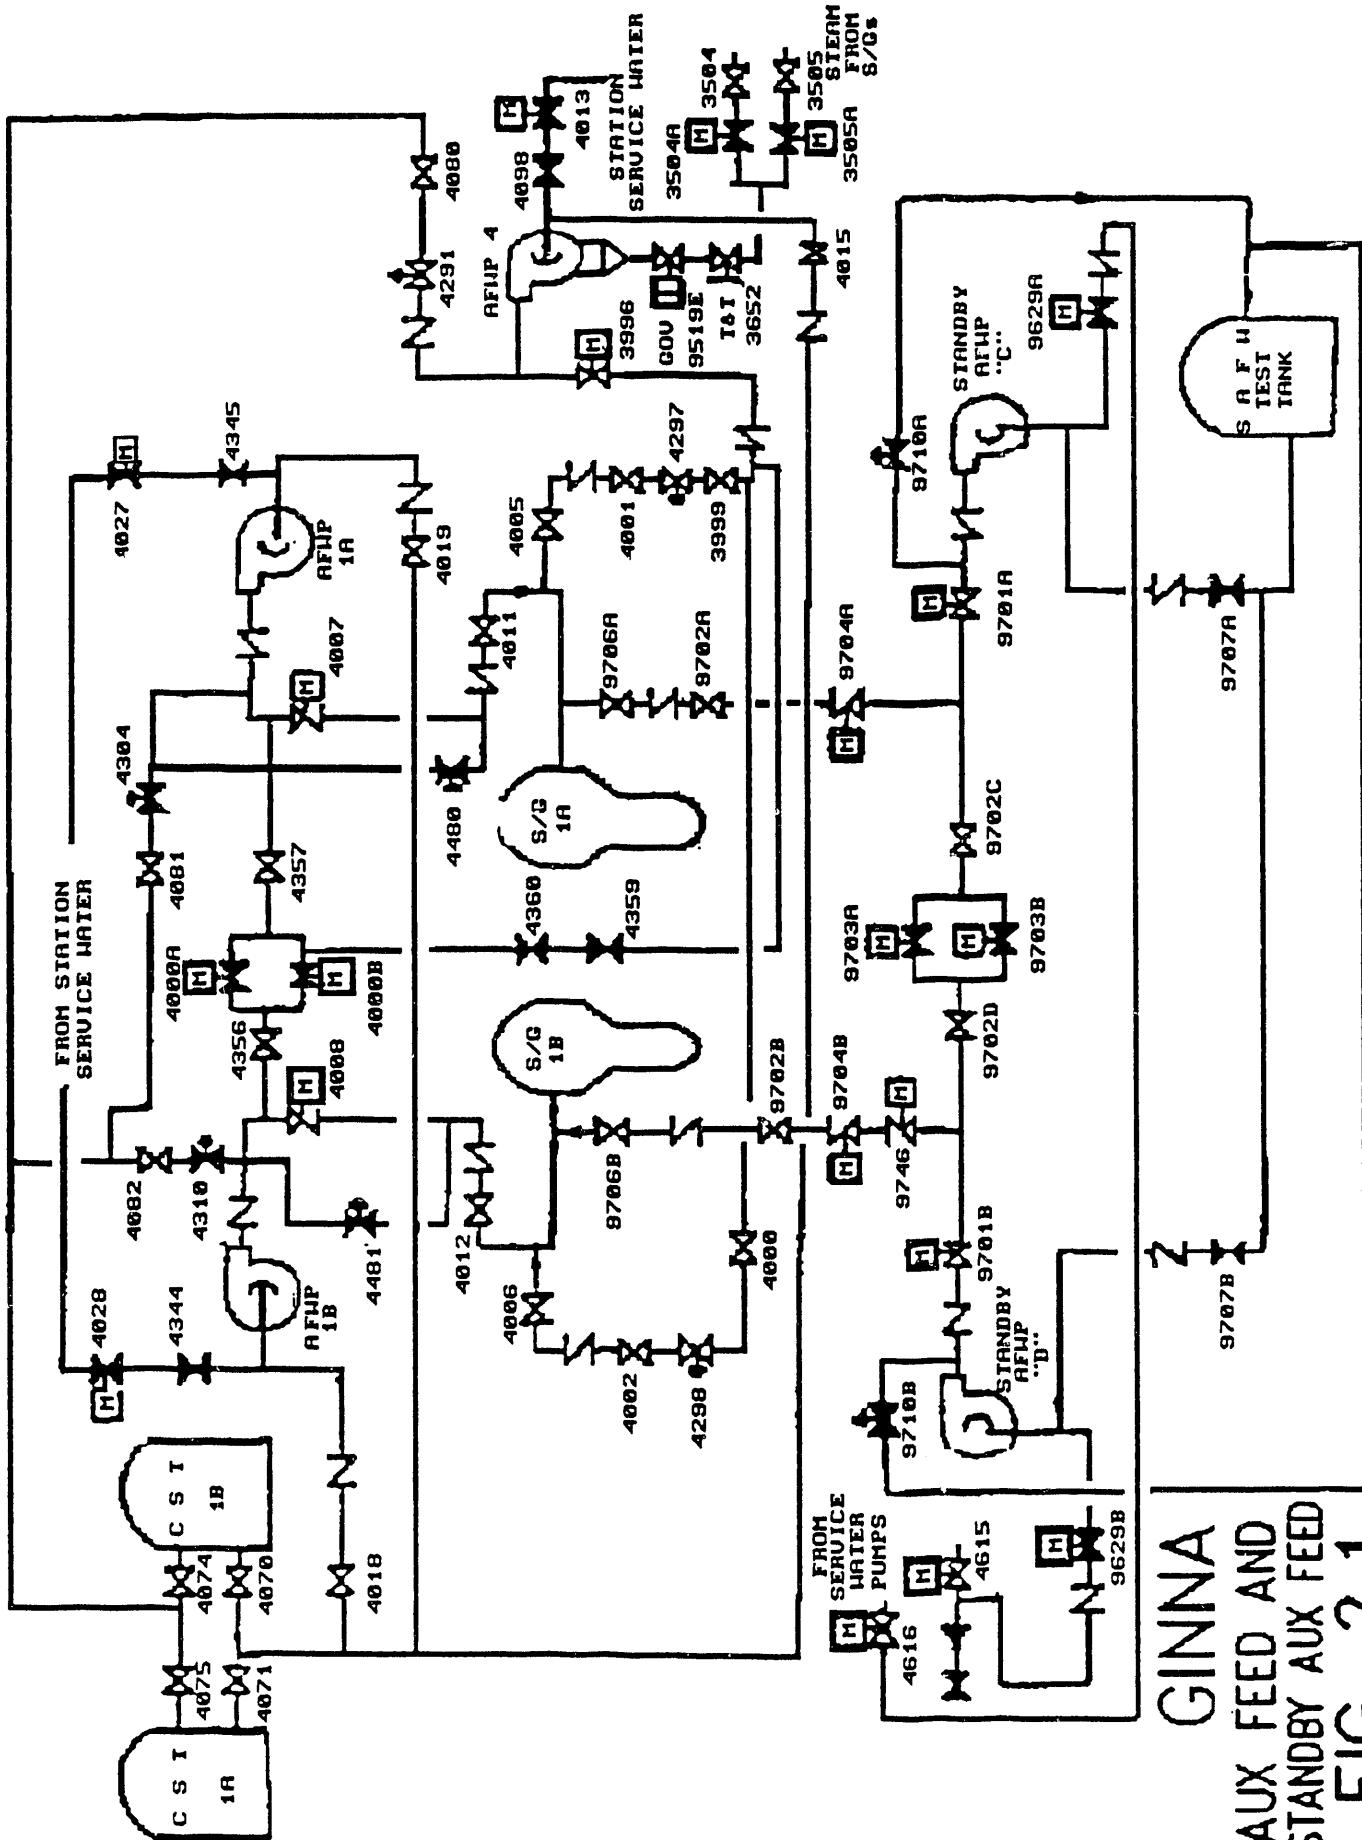
GINNA
AUX FEED AND
STANDBY AUX FEED
FIG. 2.1

Each auxiliary feedwater pump discharge is provided with a check valve. This is followed by two flow control valves in parallel (an open MOV and a closed pneumatic valve), a second check valve, and a manual isolation valve. Each motor-driven pump normally supplies feedwater to only one steam generator, but the headers may be cross-connected. The turbine-driven pump normally supplies both steam generators through an open MOV, a check valve, and in each train, a manual valve, a pneumatic flow control valve, a second manual valve, a check valve and a manual isolation valve.

The CSTs are the normal source of water for the AFW System and are required to store sufficient demineralized water to remove decay heat from the reactor for 2 hours after a reactor scram from full power. AFW suction may also be switched manually to the Station Service Water (SWS) system using alternative suction valves. Because the CST is not seismically qualified, the

The AFW system provides feedwater to the steam generators (SG) to allow secondary-side heat removal from the primary system when main feedwater is unavailable. The system is capable of functioning for extended periods, which allows time to restore main feedwater flow or to proceed with an orderly cooldown of the plant to where the residual heat removal (RHR) system can remove decay heat. A simplified schematic diagram of the AFW system is shown in Figure 2.1.

Because all three trains of the AFW system are vulnerable to a high energy pipe break, a Standby AFW system has been provided, also. It provides a reliable means of residual heat removal in the event that all other sources of feedwater are lost. A simplified schematic diagram of the Standby AFW system is also shown in Figure 2.1.
