Development Program to Certify Composite Doubler Repair Technique for Commercial Aircraft

Mr. Dennis P. Roach
FAA Airworthiness Assurance NDI Validation Center
Sandia National Laboratories
Albuquerque, NM 87185-5800

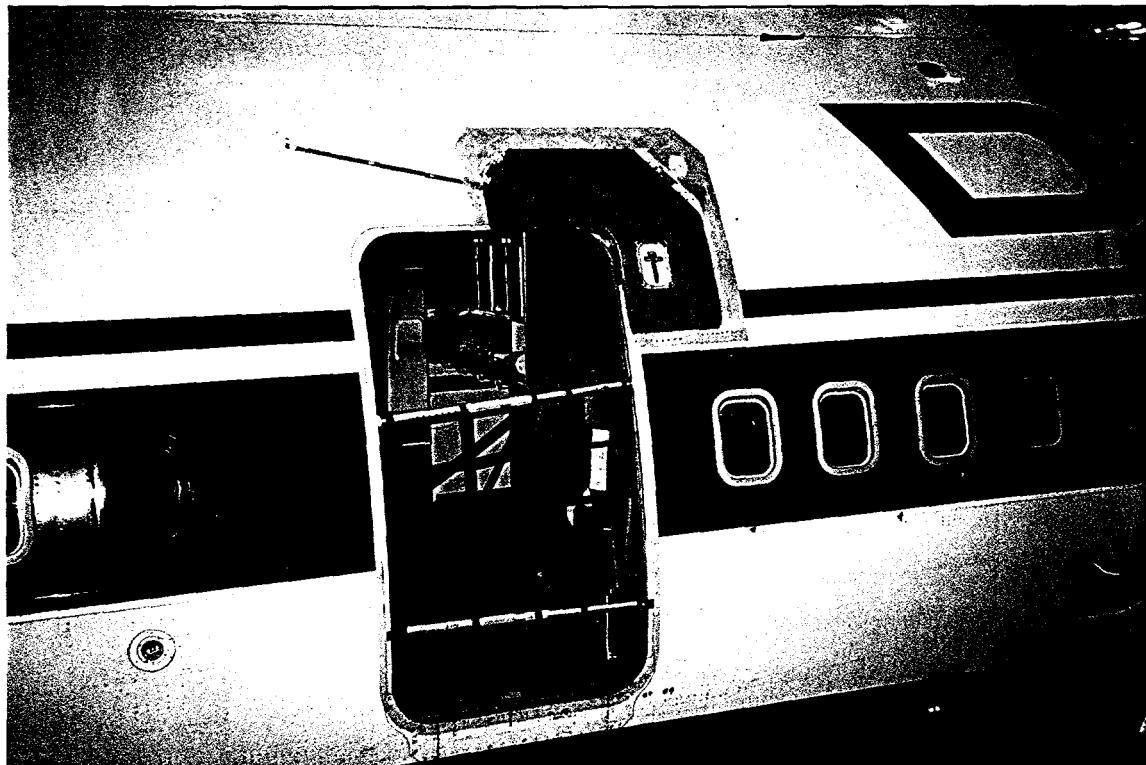
Figure 10 : Finished Product - Composite Doubler Following Cure Process

The best proof that the composite doubler repair technique is viable on commercial aircraft was provided by the recent installation of a doubler on a Delta Air Lines L-1011. The Sandia Lab's AANC, Textron Specialty Materials and Delta Air Lines performed the installation and inspection of the L-1011 door corner composite doubler. It was installed in lieu of the standard repair of four, riveted metallic plates. Figure 10 shows the Delta aircraft and the doubler installation staging area at the right side, P3 passenger door. Figure 11 shows the aircraft skin section which was cleaned and anodized - via a phosphoric acid non-tank anodize (PANTA) process - to support the doubler bonding process [1]. In order to optimize the uniformity and stability of the temperature field, the 190°F, six-hour cure cycle was used. Three heat blankets were used to provide the computer-controlled temperature profile and heat lamps were positioned on the internal fuselage structure to minimize the effects of the various heat sinks. The completed composite doubler installation is shown in Figure 12. A fiberglass environmental protection ply and a copper mesh lightning protection ply were installed on top of the Boron-Epoxy laminate. The contour around the door corner radius, the cut-out to accommodate the emergency door handle access port, and the tapered edges around the perimeter are evident.
