# Annual Radioactive Waste Tank Inspection Program - 1996<sup>(U)</sup>

Westinghouse Savannah River Company  
Savannah River Site  
Aiken, SC 29808

F. G. McNatt, Sr.

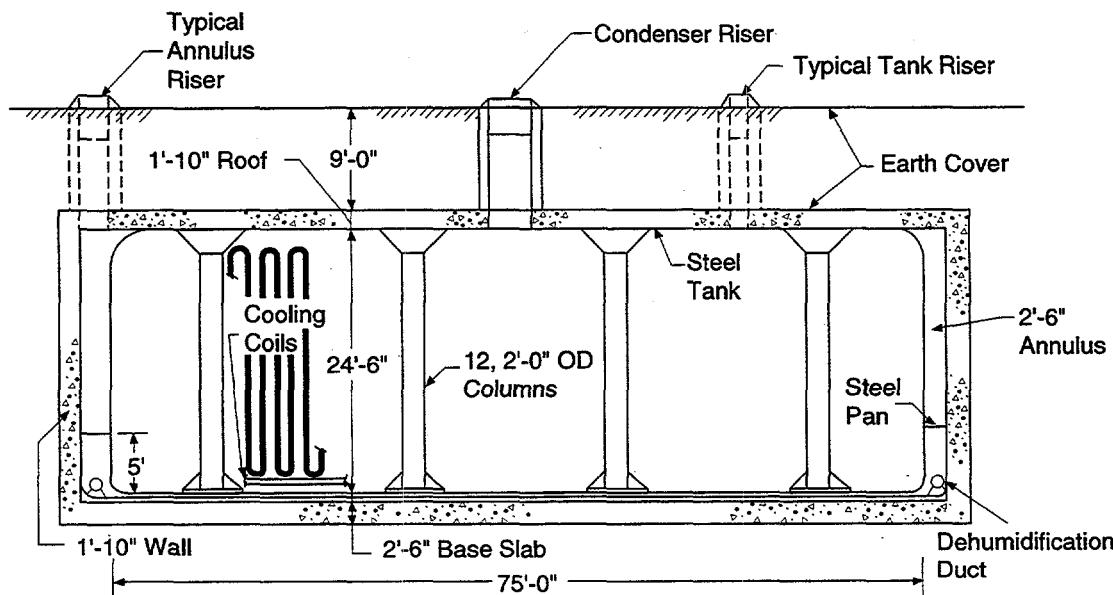
Figure 1. Cooled Waste Storage Tank, Type I (Original 750,000 Gallons).

The 12 original storage tanks constructed between 1951 and 1953 are designated Type I tanks. Tanks 1 through 8 are in F Area and Tanks 9 through 12 are in H Area. Each primary tank has a capacity of 750,000 gallons, is 75 feet in diameter and 24 1/2 feet high. Figure 1 shows the essential features of Type I tanks, including the primary tank, the secondary pan, and the concrete support structure.

A 9-foot layer of earth was placed over the tanks for radiation shielding. Cooling for each Type I tank is provided by 36 parallel (water pipe) cooling coils.

A dehumidification duct in the annulus of each tank is routed from the tank top to the bottom of the annulus where it encircles the tank. The duct has distribution outlets and its cross-sectional area decreases as the distance from the air supply increases. Access to the tank interior is provided at eight locations, and to the annular space at four locations, through riser pipes. Each of the 12 riser pipes is capped at the top with a concrete plug. Each plug is provided with two 5-inch-diameter ports equipped with removable plugs. Some of these ports provide access for inspections.

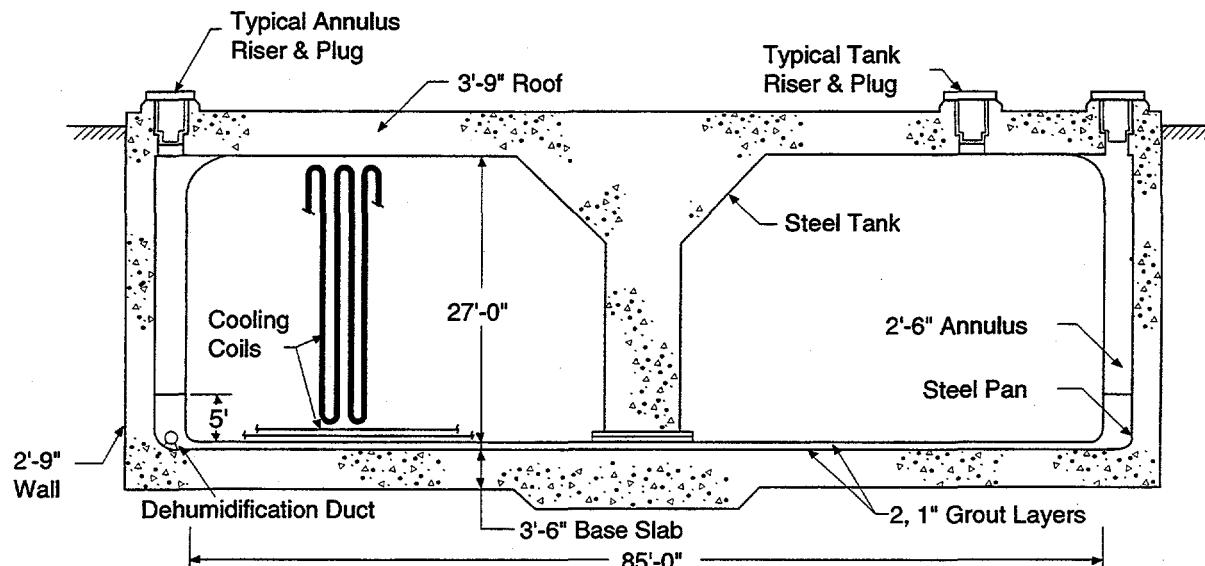
Figure 2. Cooled Waste Storage Tank, Type II (Original 1,030,000 Gallons).

Tanks 13 through 16, constructed in H Area in 1955 and 1956, are designated Type II tanks. Figure 2 is a cross section of this type. Each primary tank has a capacity of 1,030,000 gallons and is 85 feet in diameter and 27 feet high.

The primary tank is set on a 1-inch sand bed within a circular pan of 1/2-inch thick steel plate, 5 feet deep and 5 feet larger in diameter than the primary tank, thus forming an annular space 2 1/2 feet wide. The tank and pan assembly is surrounded by a cylindrical reinforced concrete enclosure with a 33-inch-thick wall and a flat concrete roof that is 45 inches thick. The tank and pan assembly and the surrounding wall are set on a foundation slab that is 42 inches thick. The roof is supported by both the wall and a central concrete column that fits within the inner cylinder of the vessel. The 45-inch-thick concrete roof provides radiation shielding; therefore, no earth overburden is required. Cooling for each Type II tank is provided by 44 parallel (water pipe) cooling coils. Access to the tank interior is provided at eight locations, and to the annular space at four locations, through riser pipes. Each of the 12 riser pipes is capped at the top with a concrete plug. Each plug is provided with two 5-inch-diameter ports equipped with removable plugs. The ports provide access for inspection. In addition to the four annulus risers, other access openings (10 to 14 additional openings per tank) have been drilled into the annulus of each of these tanks to permit inspection of seventy-three to ninety-six percent of the exterior walls of the primary vessels.

A dehumidification duct in the annulus of each tank is routed from the tank top to the bottom of the annulus where it encircles the tank. The duct has distribution outlets and its cross-sectional area decreases as the distance from the air supply increases.

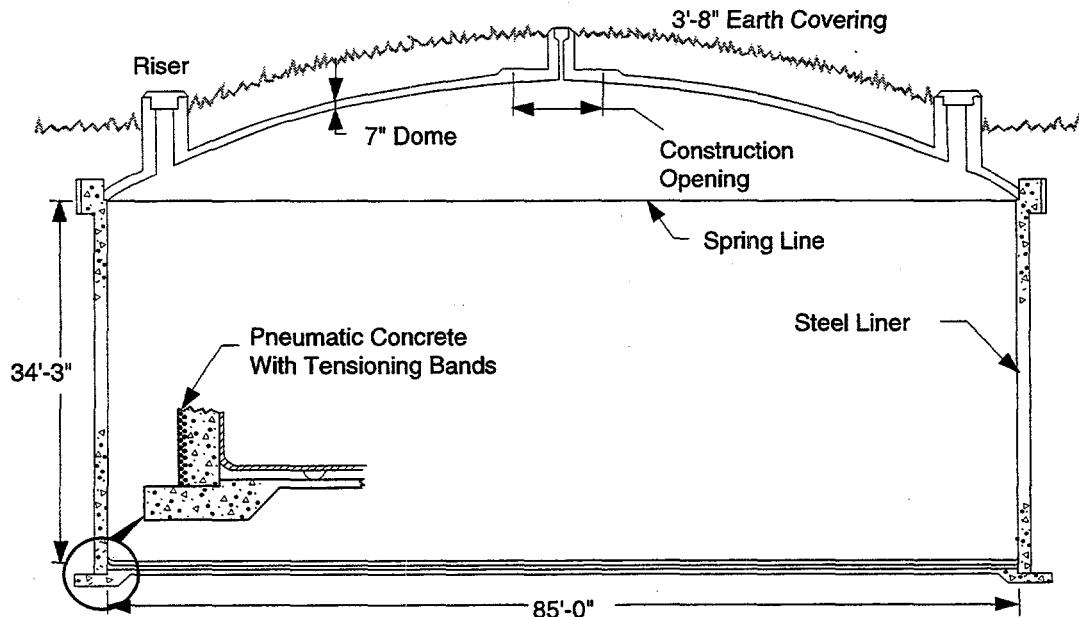
Figure 3. Uncooled Waste Storage Tank, Type IV (Prestressed Concrete Walls, 1,300,000 Gallons).

Tanks 17 through 24 are single-wall uncooled tanks. These tanks were designed for storage of waste that does not require auxiliary cooling. Tanks 17 through 20 were constructed in F Area in 1958 and Tanks 21 through 24 were constructed in H Area between 1959 and 1961. Each tank has a capacity of 1,300,000 gallons and is 85 feet in diameter and 34 feet high (Figure 3).

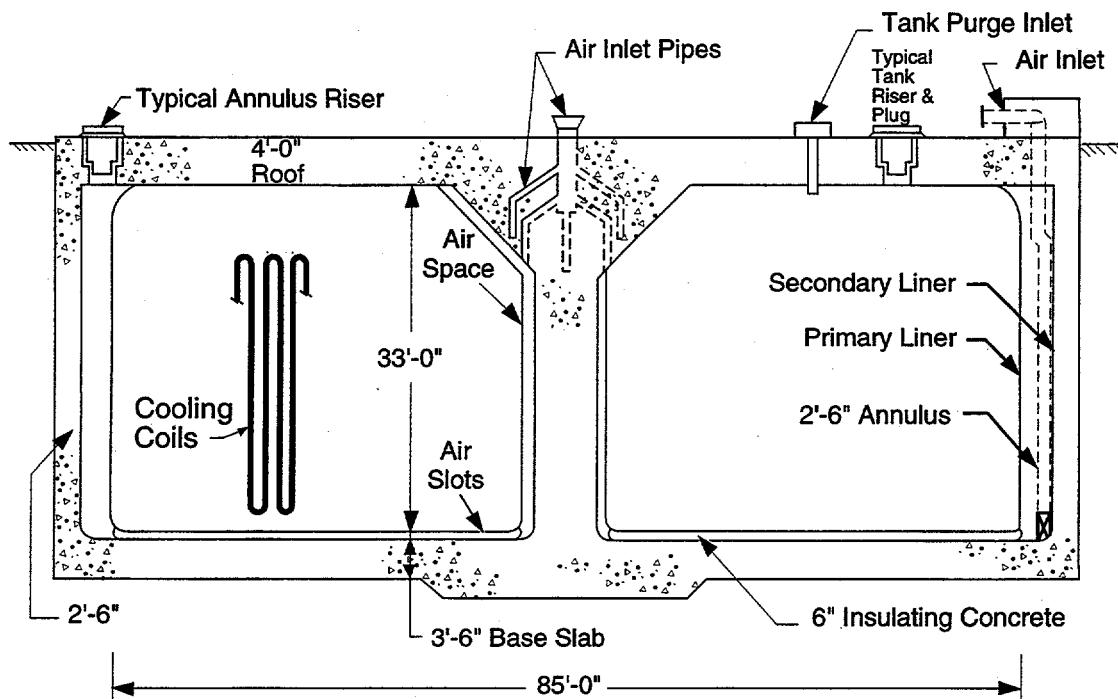
Figure 4. Cooled Waste Storage Tank, Type III (Stress Relieved Primary Liner, 1,300,000 Gallons).

The most recently constructed tanks are designated as Type III tanks (Figure 4). Twenty-seven tanks were built between 1967 and 1981. Tanks 25 through 28, 33 and 34,

The Type III tank design was developed after an investigation into the causes of the leaks from the primary vessel of the Type I and Type II tanks. The study concluded that the leak-producing mechanism was nitrate-induced stress-corrosion cracking at sites in or near the weld seams, and that stress relieving after fabrication should eliminate the cracking. For the type III tanks, means were provided for heating each finished tank to relieve the stresses generated during fabrication. In addition, some stress patterns were avoided, or minimized, by mounting the roof supporting column on the foundation pad rather than on the bottom of the primary tank (as in Types I and II), and by providing an annular clearance around the roof supporting column. Each primary tank holds 1,300,000 gallons and is 85 feet in diameter and 33 feet high.

The primary tank is set on a 6-inch bed of insulating concrete within the secondary containment vessel. The concrete bed is grooved radially so that ventilating air can flow from the inner to the outer annulus: If any waste were to leak from the tank bottom or center annulus wall, liquid would move through the grooves, facilitating detection in the outer annulus.
