NUREG/CR-5763  
PNL-7725

# Auxiliary Feedwater System Risk-Based Inspection Guide for the Callaway Nuclear Power Plant

Prepared by  
N. E. Moffitt, B. F. Gore, T. V. Vo

**Pacific Northwest Laboratory**  
Operated by  
Battelle Memorial Institute

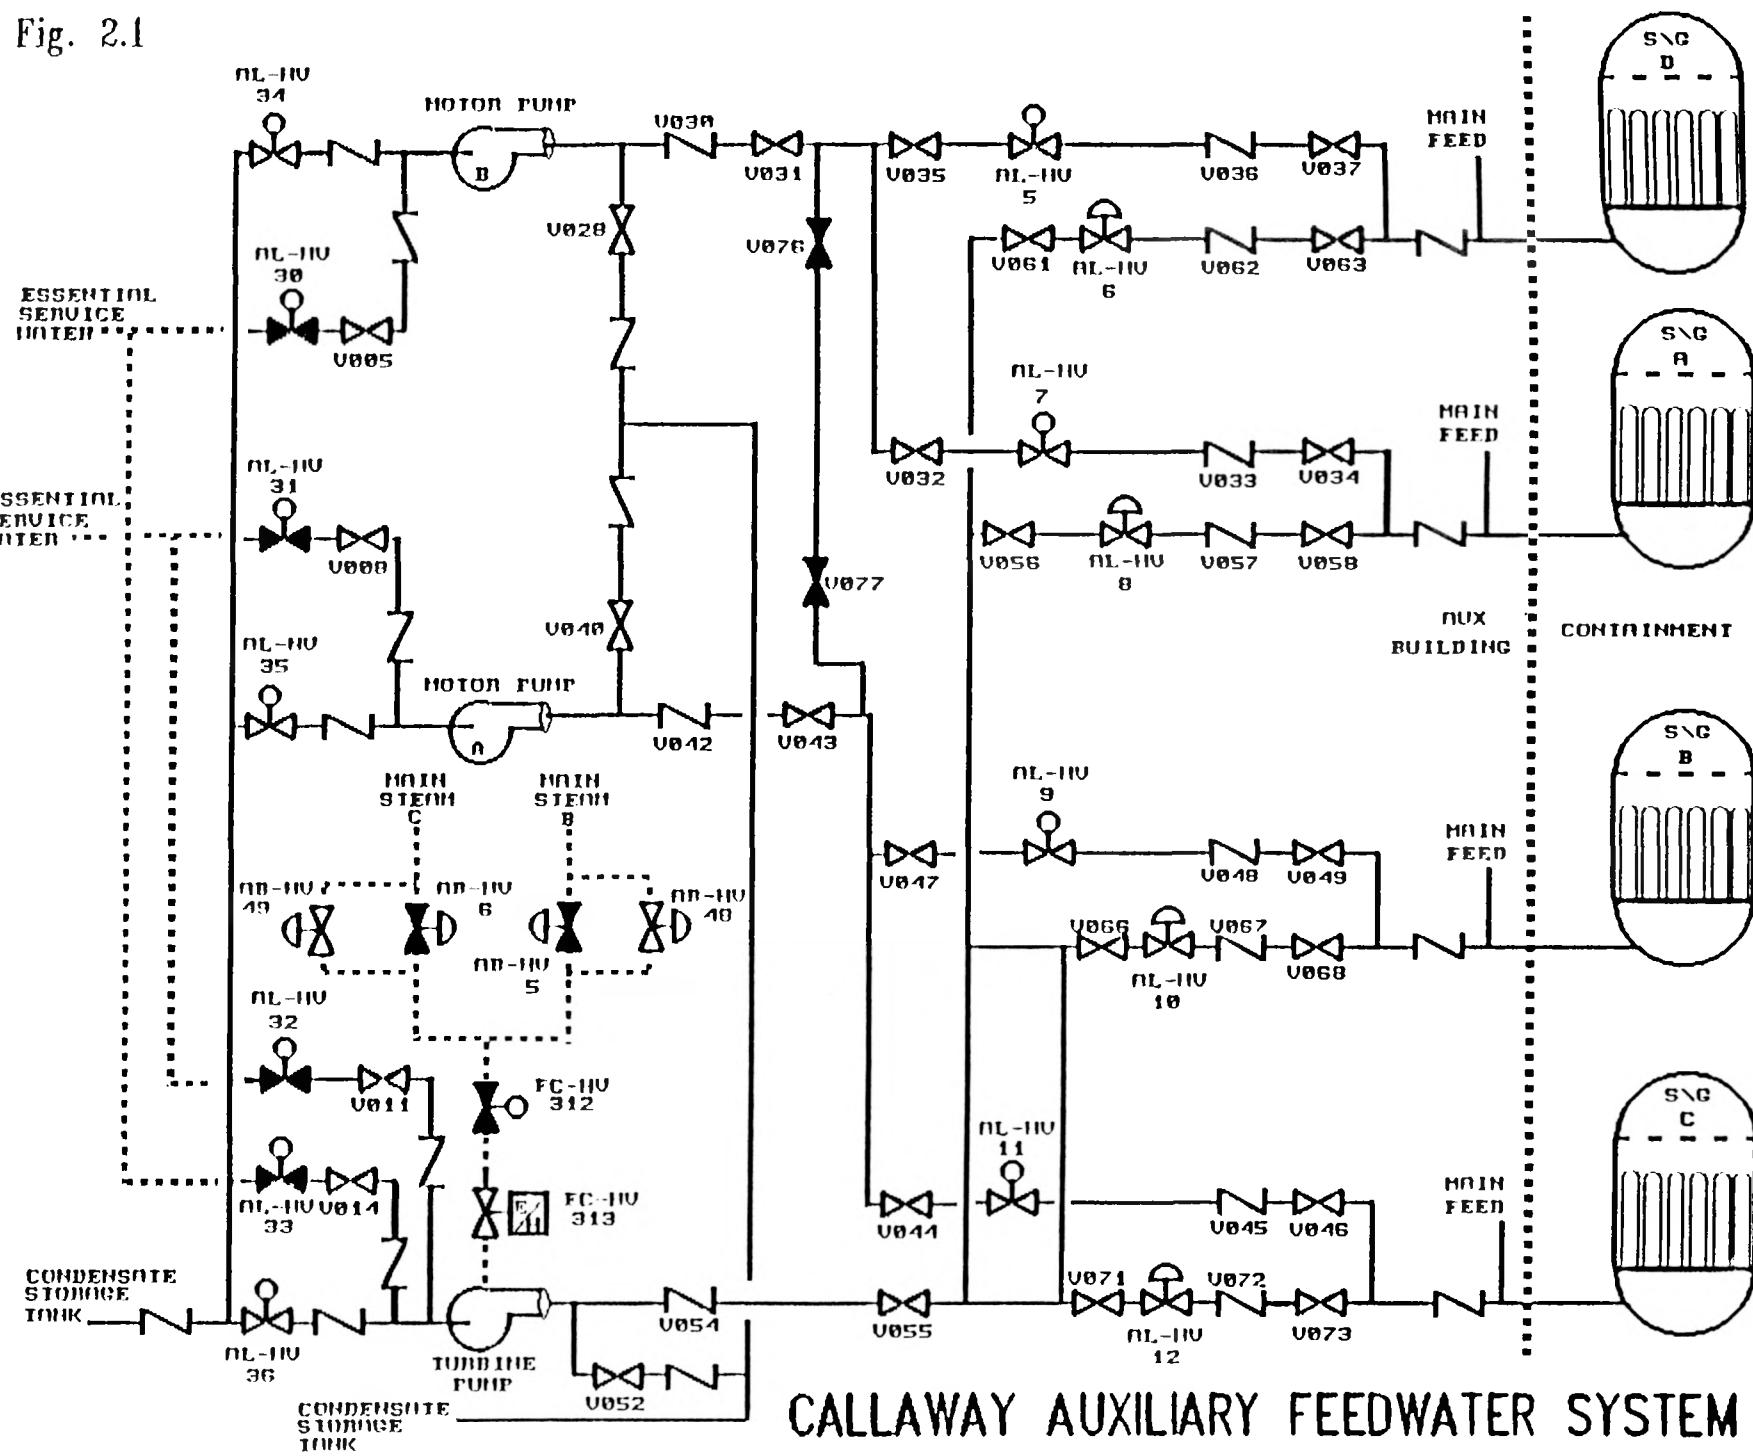
Fig. 2.1

The AFW system provides feedwater to the steam generators (SG) to allow secondary-side heat removal from the primary system when main feedwater is unavailable. The system is capable of functioning for extended periods, which allows time to restore main feedwater flow or to proceed with an orderly cooldown of the plant to where the residual heat removal (RHR) system can remove decay heat. A simplified schematic diagram of the Callaway AFW system is shown in Figure 2.1.

The system is designed to start up and establish flow automatically. All pumps start on receipt of a steam generator low-low level signal. (The motor-driven pumps start on low-low level in one SG, whereas, two SG low-low level signals are required to for a turbine-driven pump start.) The motor-driven (MD) pumps start for the following conditions: shutdown sequencer actuation, LOCA sequencer actuation, and motor-driven Auxiliary Feedwater Actuation Signal (AFAS). The single turbine-driven (TD) pump starts on an undervoltage condition on bus NB01 or NB02.

The discharges of the motor-driven pumps are normally aligned so that the A pump supplies the B and C steam generators and the B pump supplies the A and D steam generators. Cross-connect valves are provided to allow feeding of any steam generator from either pump. The cross-connect valves are locked shut and administratively controlled. The turbine-driven pump also feeds all four steam generators, but through separate lines. Each of the eight feedwater lines contains a flow limiting orifice which ensures that AFW flow will be provided to the intact steam generators if one is faulted, and limits AFW pump runout. Isolation valves in the lines from all AFW pumps are locked open manual valves. Two types of flow control valves are used in the AFW system. The motor-driven pumps discharge through motor-operated flow control valves (AL-HV-5,7,9,11) and the turbine-driven pump discharges through air operated flow control valves (AL-HV-6,8,10,12). A nitrogen accumulator provides backup to the instrument air for valve operation. Each line also contains multiple check valves to prevent leakage from the feedwater lines.
