Low-Voltage Radiography  
on Aircraft Composite Doublers

SAND97-2597C  
SAND-97-2597C

David G. Moore  
Sandia National Laboratories  
Federal Aviation Administration  
Airworthiness Assurance NDI Validation Center  
Albuquerque, New Mexico 87185  
(505) 844-7095

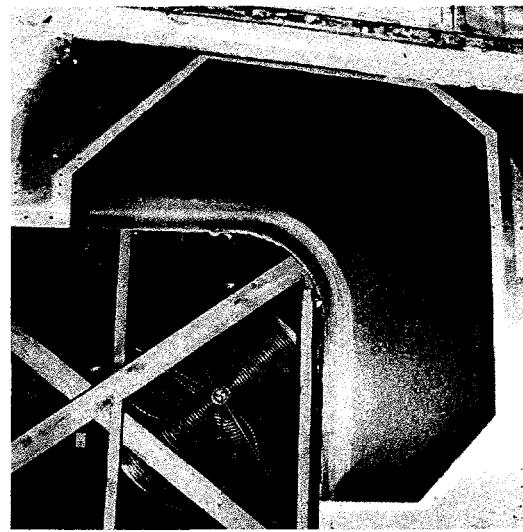
Figure 2. Full scale door surround structure with a 72 ply composite doubler (84.5 x 88.9 cm with 7 ply taper) installed.

To assist with the development of the radiographic technique on Specimen #2, Image Quality Indicators (IQI) were utilized. A number 2 penetrometer (per ASTM E801) containing different wire diameters was placed in the field of view behind the composite doubler and the aircraft skin. Table 2 displays the radiographic density values for Specimen #2. The equipment settings were: 80 kV, 12 mA, exposure time 90 seconds, SFD 1.52 m, and source offset 25.4 cm and 50.8 cm. Note: this test specimen does not have fatigue cracks.
