MITIGATION OF SUB-SURFACE CRACK PROPAGATION IN RAILROAD RAILS BY LASER SURFACE MODIFICATION*

R. J. DiMelfi¹, P. G. Sanders³, B. Hunter², J. A. Eastman³,
K. J. Sawley⁴, K. Leong² and J. M. Kramer¹

Submitted to the International Conference on Metallurgical Coatings and Thin Films, San Diego, CA, April 21-25, 1997 and also to the journal *Surface and Coatings Technology*.

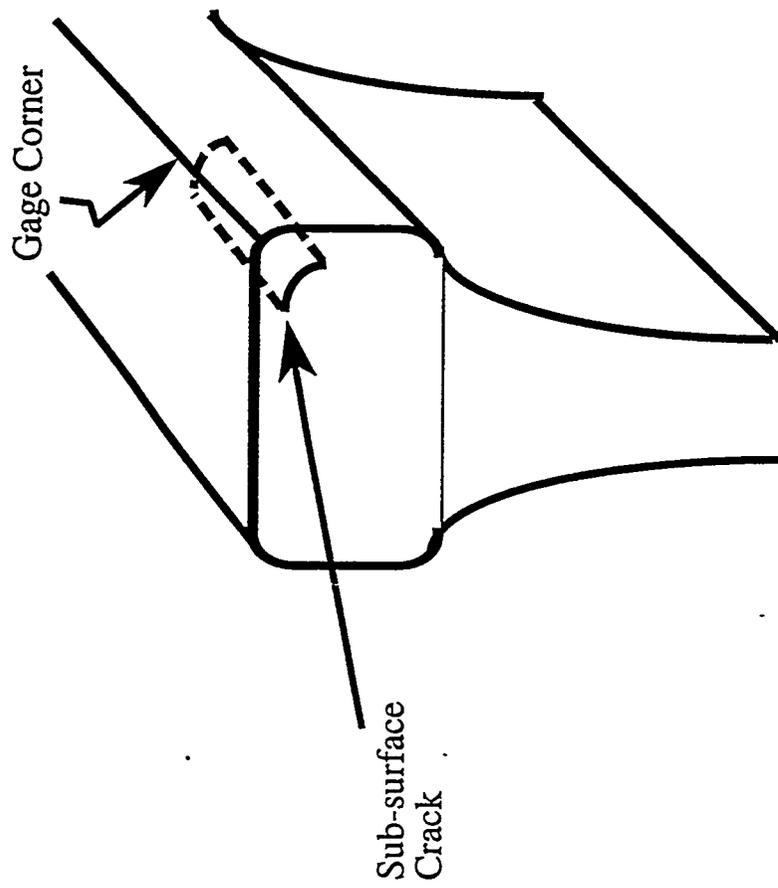
Figure 1. A schematic representation of a rail head, showing a crack propagating along the rail travel direction in the sub-surface region beneath the gage corner.

- Figure 1.** A schematic representation of a rail head, showing a crack propagating along the rail travel direction in the sub-surface region beneath the gage corner.

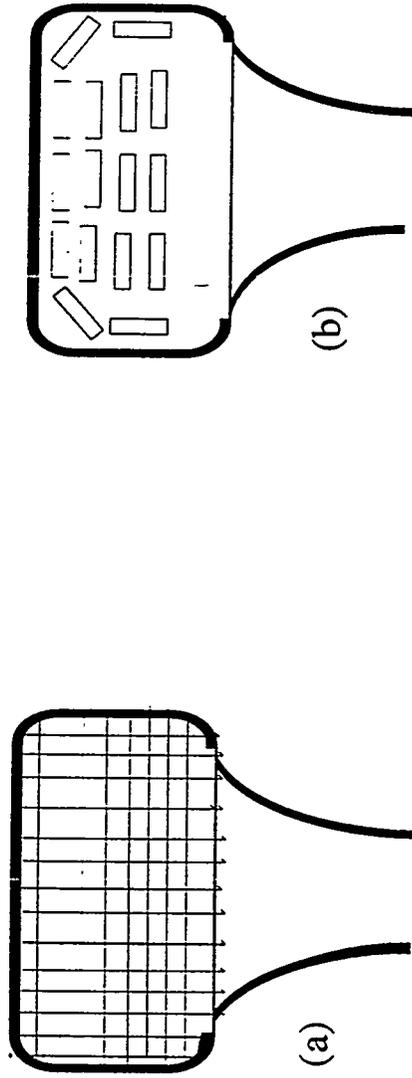
Figure 2. Schematic drawings of rail heads, showing (a) a representation of the 3 mm grid on which micro-hardness scans were performed, and (b) a representation of the end sections (viewed edge-on) of tensile samples whose tensile axes lie parallel to the rail travel direction, i.e. normal to the page. Hardness and tensile tests were performed on samples extracted from both virgin and heavily-used rail.

- Figure 2.** Schematic drawings of rail heads, showing (a) a representation of the 3 mm grid on which micro-hardness scans were performed, and (b) a representation of the end sections (viewed edge-on) of tensile samples whose tensile axes lie parallel to the rail travel direction, i.e. normal to the page. Hardness and tensile tests were performed on samples extracted from both virgin and heavily-used rail.

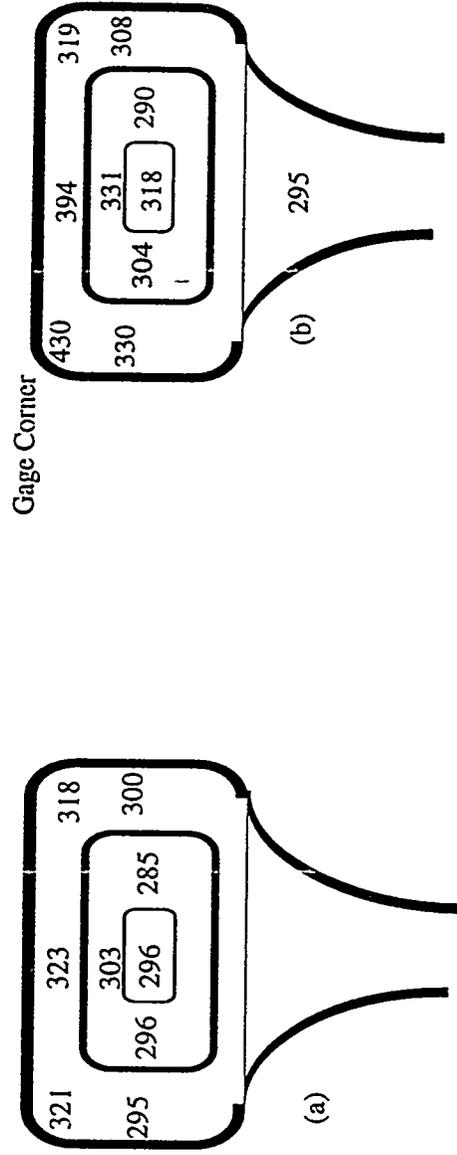
Figure 3. Schematics of rail heads showing the results of hardness (Vickers, 300 g) scans performed on the rail head cross sections of (a) virgin rail and (b) heavily-used rail. The sub-surface region of the gage corner of the heavily used rail, where significant deformation occurred during service, is substantially harder than either the virgin rail or the remainder of the heavily used rail.

- Figure 3** Schematics of rail heads showing the results of hardness (Vickers, 300 g) scans performed on the rail head cross sections of (a) virgin rail and (b) heavily-used rail. The sub-surface region of the gage corner of the heavily used rail, where significant deformation occurred during service, is substantially harder than either the virgin rail or the remainder of the heavily used rail.

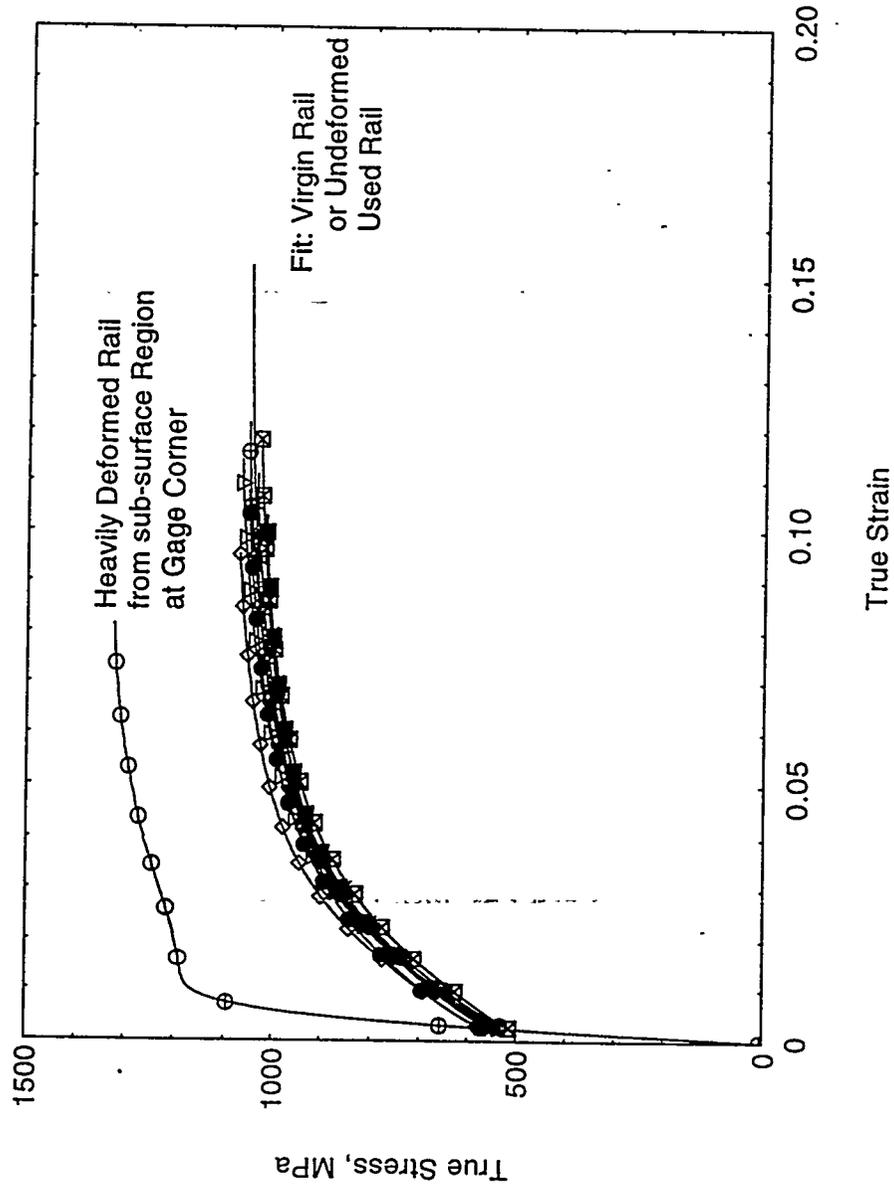
Figure 4. The tensile behavior of rail steel samples taken from both virgin and heavily used rail. The cluster of curves in the low stress region show the behavior of all virgin rail samples and heavily-used rail samples taken from regions away from the gage corner. The outlying curve in the high-stress region is the behavior of a sample taken from the sub-surface region beneath the gage corner of the heavily-used rail.

- Figure 4.** The tensile behavior of rail steel samples taken from both virgin and heavily used rail. The cluster of curves in the low stress region show the behavior of all rail samples and heavily used rail samples taken from regions away from the gage corner. The outlying curve in the high stress region is the behavior of a sample taken from the sub-surface region beneath the gage corner of the heavily-used rail.

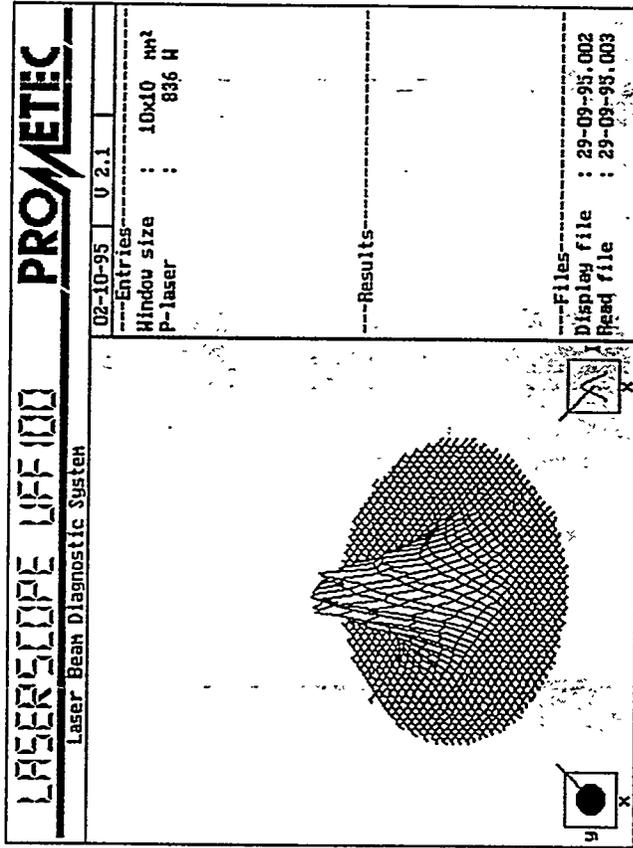
Figure 5. Isometric depiction of laser beam intensity profile.

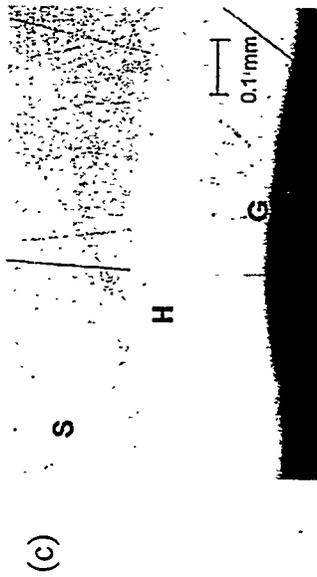
Figure 7. Optical micrographs of cross section of the laser glazed region from preliminary treatments performed on the surface of a rail head. Figures (a) and (b) show the sample etched with Vifella's etchant.

- Figure 7.** Optical micrographs of the cross section of the laser treated region from preliminary treatments performed on the surface of a rail head. Figures (a) and (b) show the samples etched with Vilella's etchant.

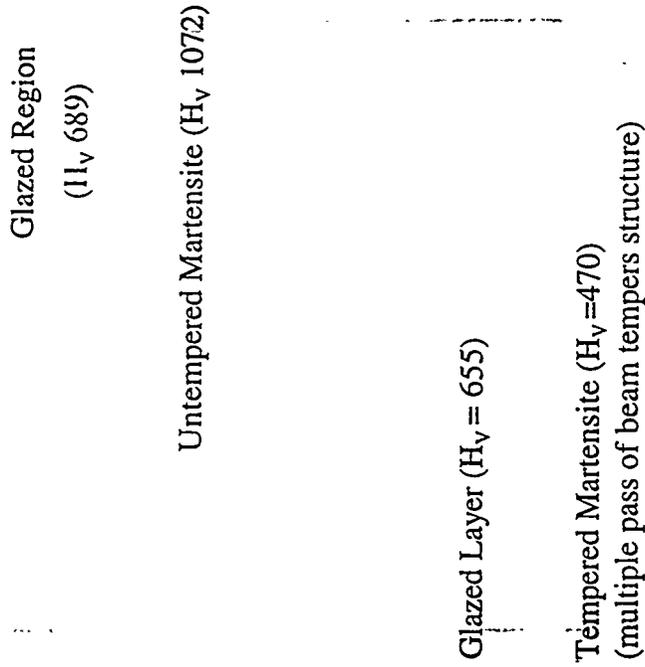
(a) 1080 (Rail) Steel Microstructure Before Glazing ($H_V = 250-300$) and Substrate 1 mm beneath Glaze

(b) Single Pass (e), 1 cm/s

(c) Multiple Pass (e), 1 cm/s

Figure 8. Optical micrographs of the cross sections of laser treated AISI 1080 steel plates. Figure (a) is the untreated substrate region, (b) shows the microstructure of the glazed region from a multiple-pass overlapping glazing treatment, and (c) shows the microstructure of a single-pass treatment. Samples are etched with Nital.

- Figure 8.** Optical micrographs of the cross sections of laser treated AISI 1080 steel plates. Figure (a) is the untreated substrate region, (b) shows the microstructure of the glazed region from a multiple-pass overlapping glazing treatment, and (c) shows the microstructure of a single-pass treatment. Samples are etched with Nital.

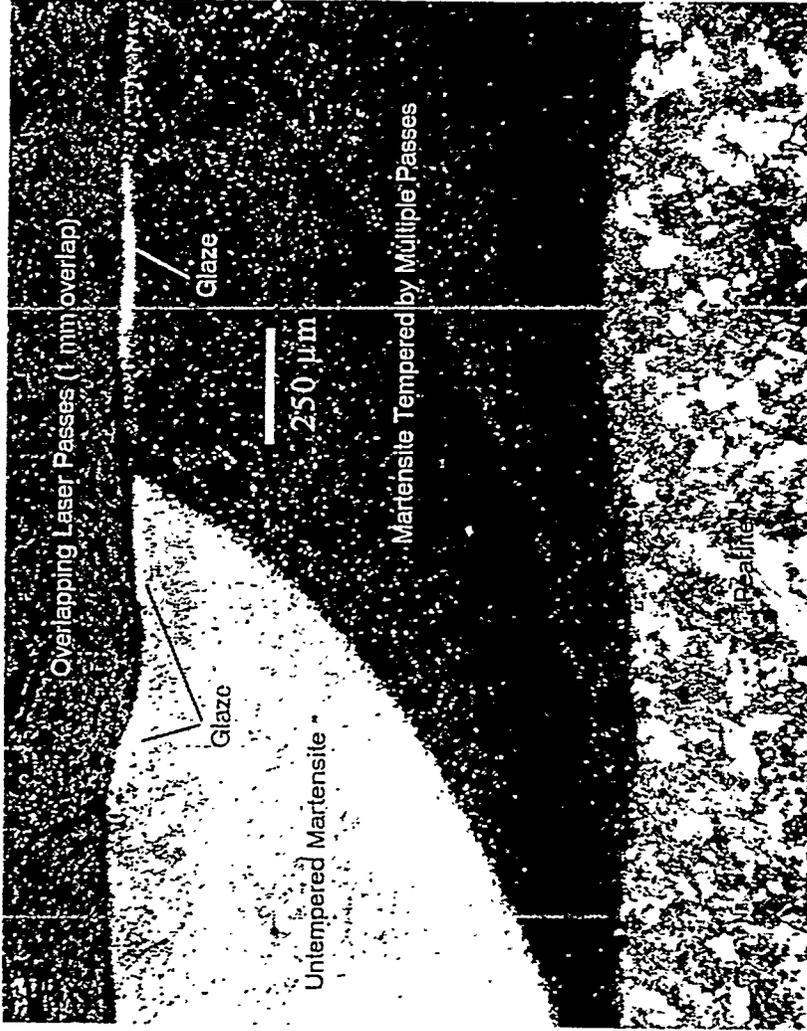
Figure 9. A micrograph of the cross section of a multiple-pass overlapping Nd:YAG laser treatment (944 W delivered power) using an elliptical (5 mm diameter) beam moving at 1 cm/s. The next-to-last pass and the last pass are shown. Heat from the last pass tempers the martensite in the next-to-last pass. The sample was etched with Nital.

- Figure 9.** A multiple-pass overlapping Nd:YAG laser treatment (944 W delivered power) using an elliptical (5 mm diameter) beam moving at 1 cm/s. The next-to-last pass and the last pass are shown. Heat from the last pass tempers the martensite in the next-to-last pass:

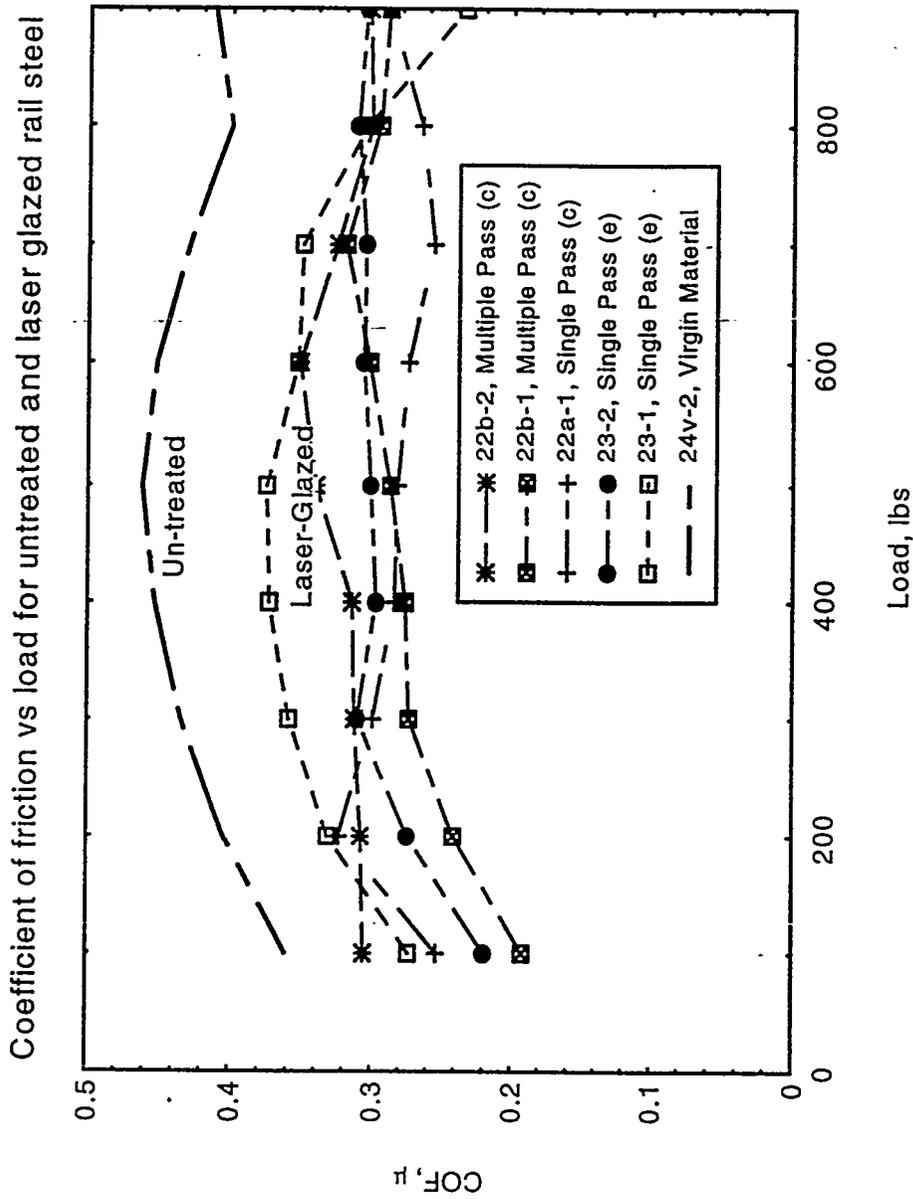
Figure 10. Measurements of the friction coefficient for laser-treated AISI 1080 steel samples, shown as a function of normal load in comparison with results typical of untreated control samples. The measurements were obtained using standard (ASTM G77-93) block-on-ring friction tests.

- Figure 10.** Measurements of the friction coefficient for laser-treated AISI 1080 steel samples, shown as a function of normal load in comparison with results typical of untreated control samples. The measurements were obtained using standard (ASTM G77-93) block-on-ring friction tests.

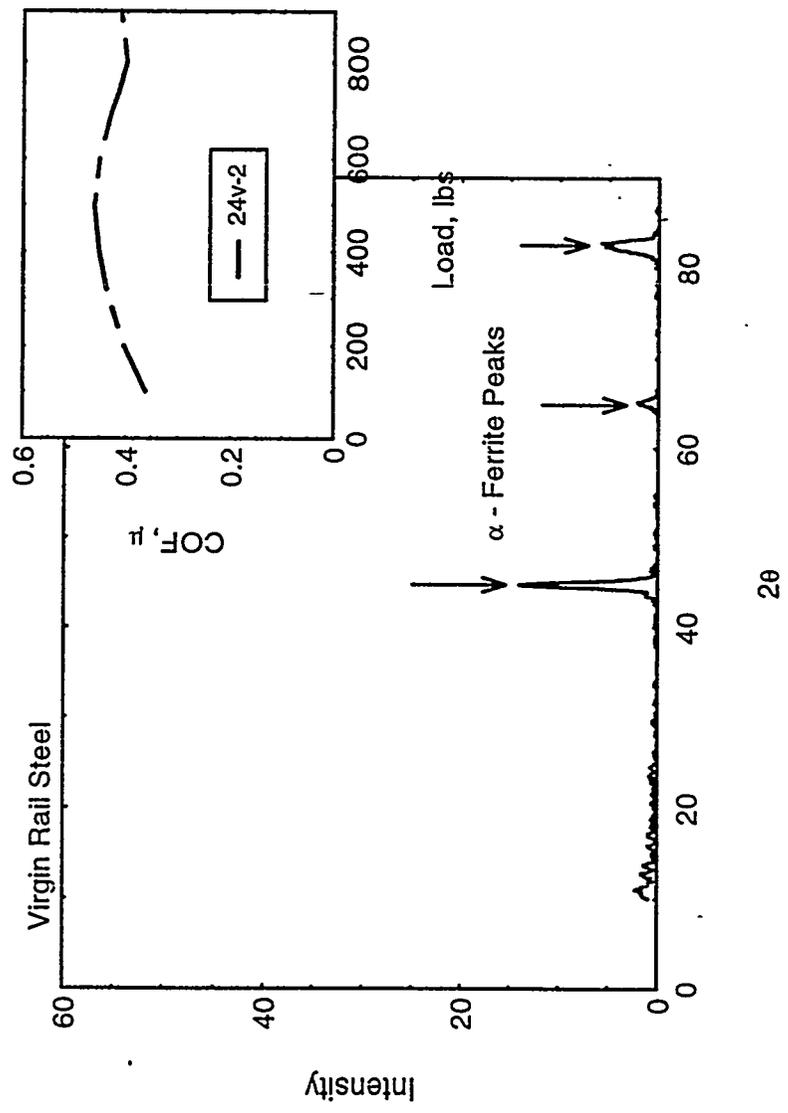
Figure 11. The results of an X-ray scan taken of the untreated surface of an AISI 1080 steel plate.

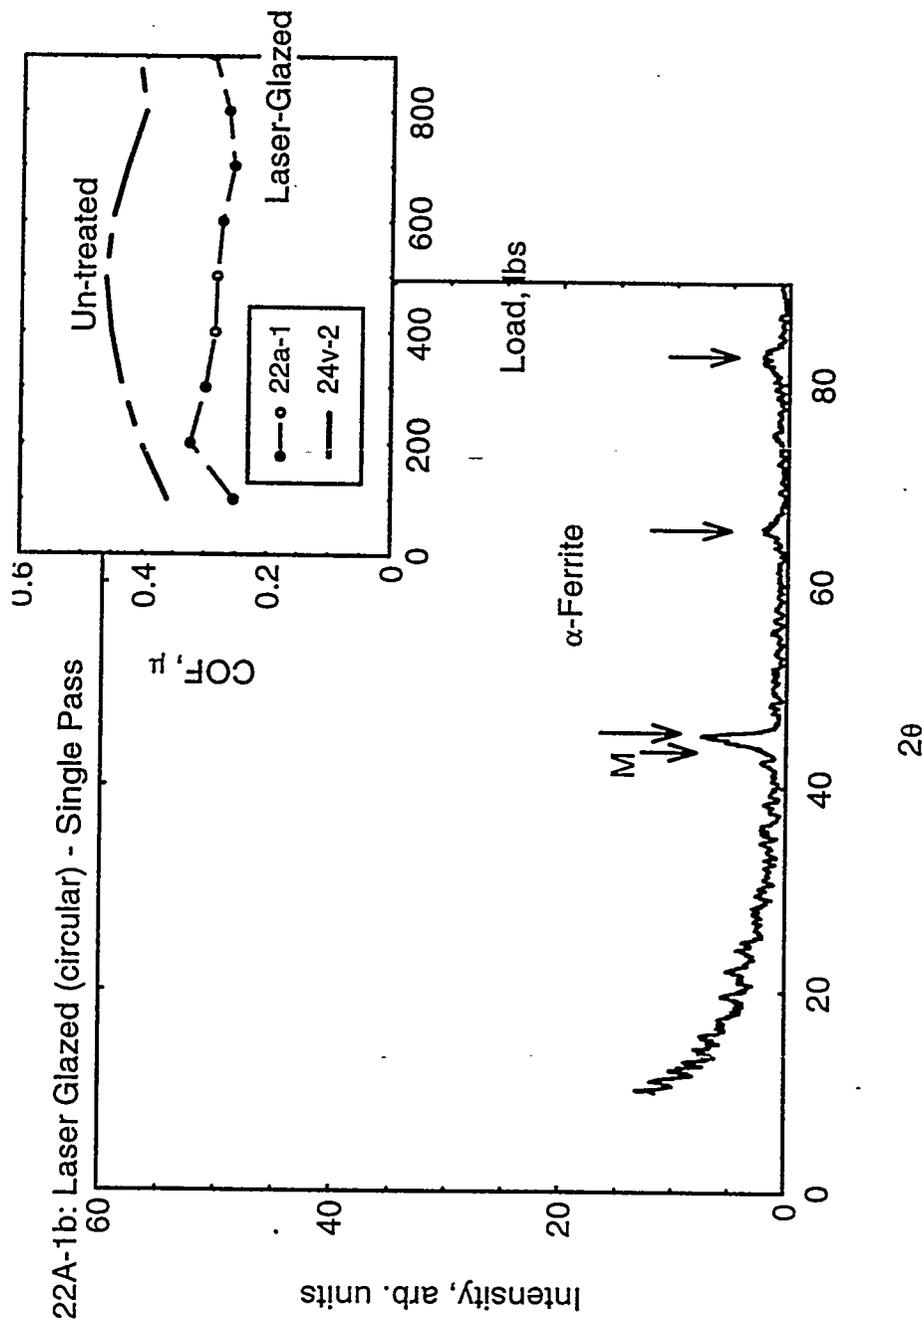
Figure 12. The results of an X-ray scan obtained from an AISI 1080 steel sample that received a single pass laser treatment with a circular beam (2 cm/s). In addition to the α -ferrite peaks also seen in the untreated sample, there are some diffuse scattering effects and the indication of a peak consistent with the presence of martensite (M).

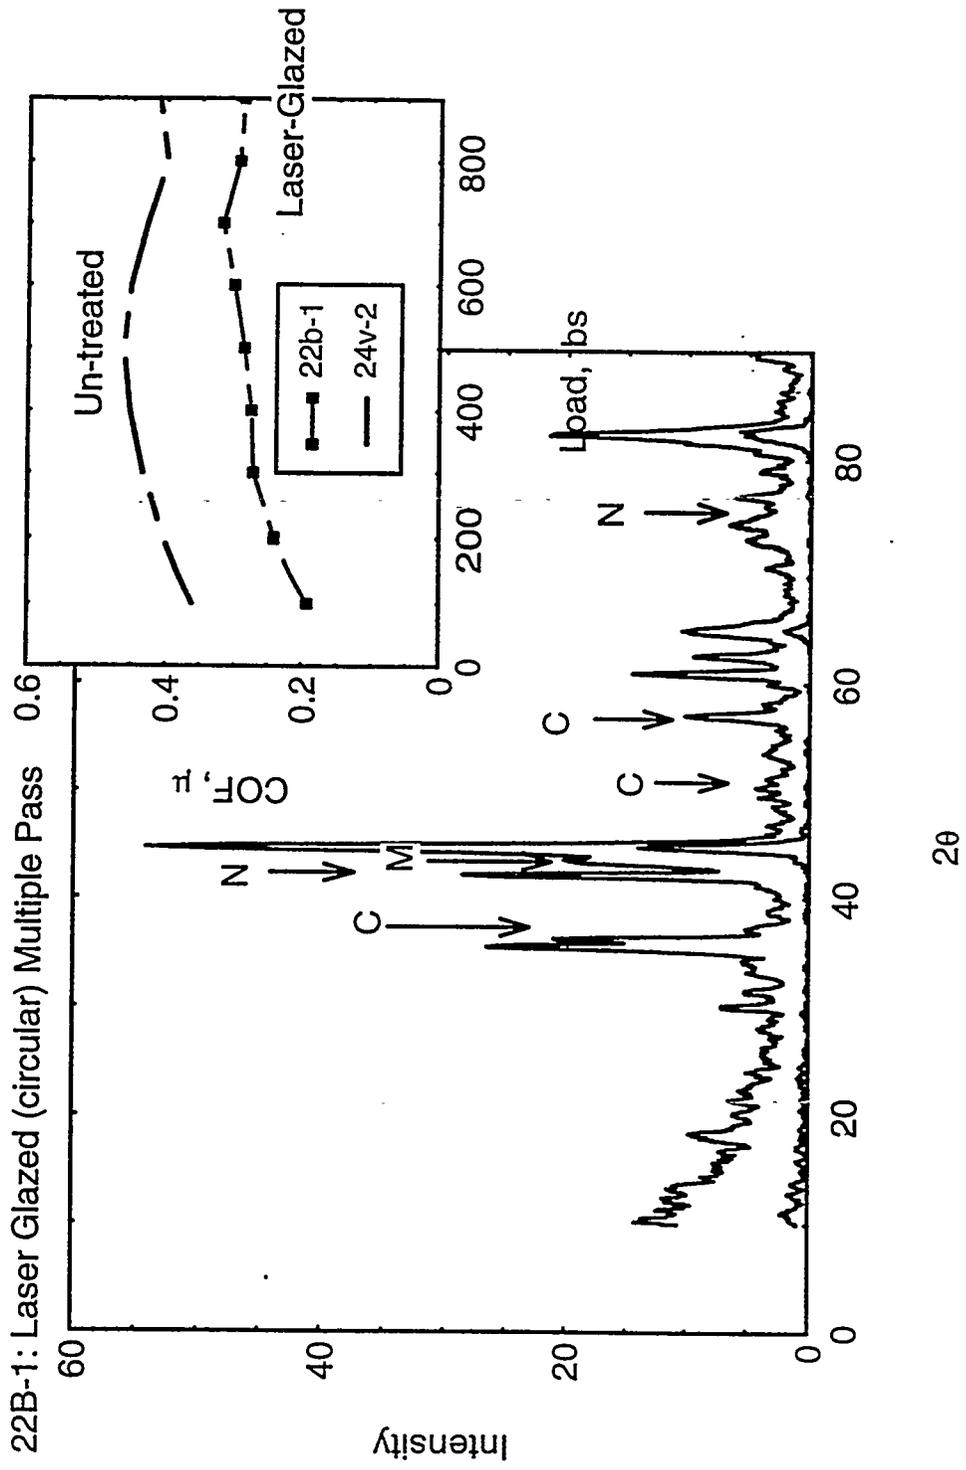
Figure 13. The X-ray scan from a sample that received a multiple overlapping-pass laser treatment with a circular beam (2 cm/s), shown along with the results of the scan from the untreated sample (Fig. 11). The α -ferrite peaks are still apparent along with peaks consistent with the presence of martensite, cementite (C), and Fe_2N (N), as well as some diffuse scattering effects. A number of peaks could not be identified.

- Figure 13.** The X-ray scan from a sample that received a multiple overlapping-pass laser treatment with a circular beam (2 cm/s) shown along with the results of the scan from the untreated sample (Fig. 11). The α -ferrite peaks are still apparent along with peaks consistent with the presence of martensite, cementite (C), and Fe_2N (N), as well as some diffuse scattering effects. A number of peaks could not be identified.

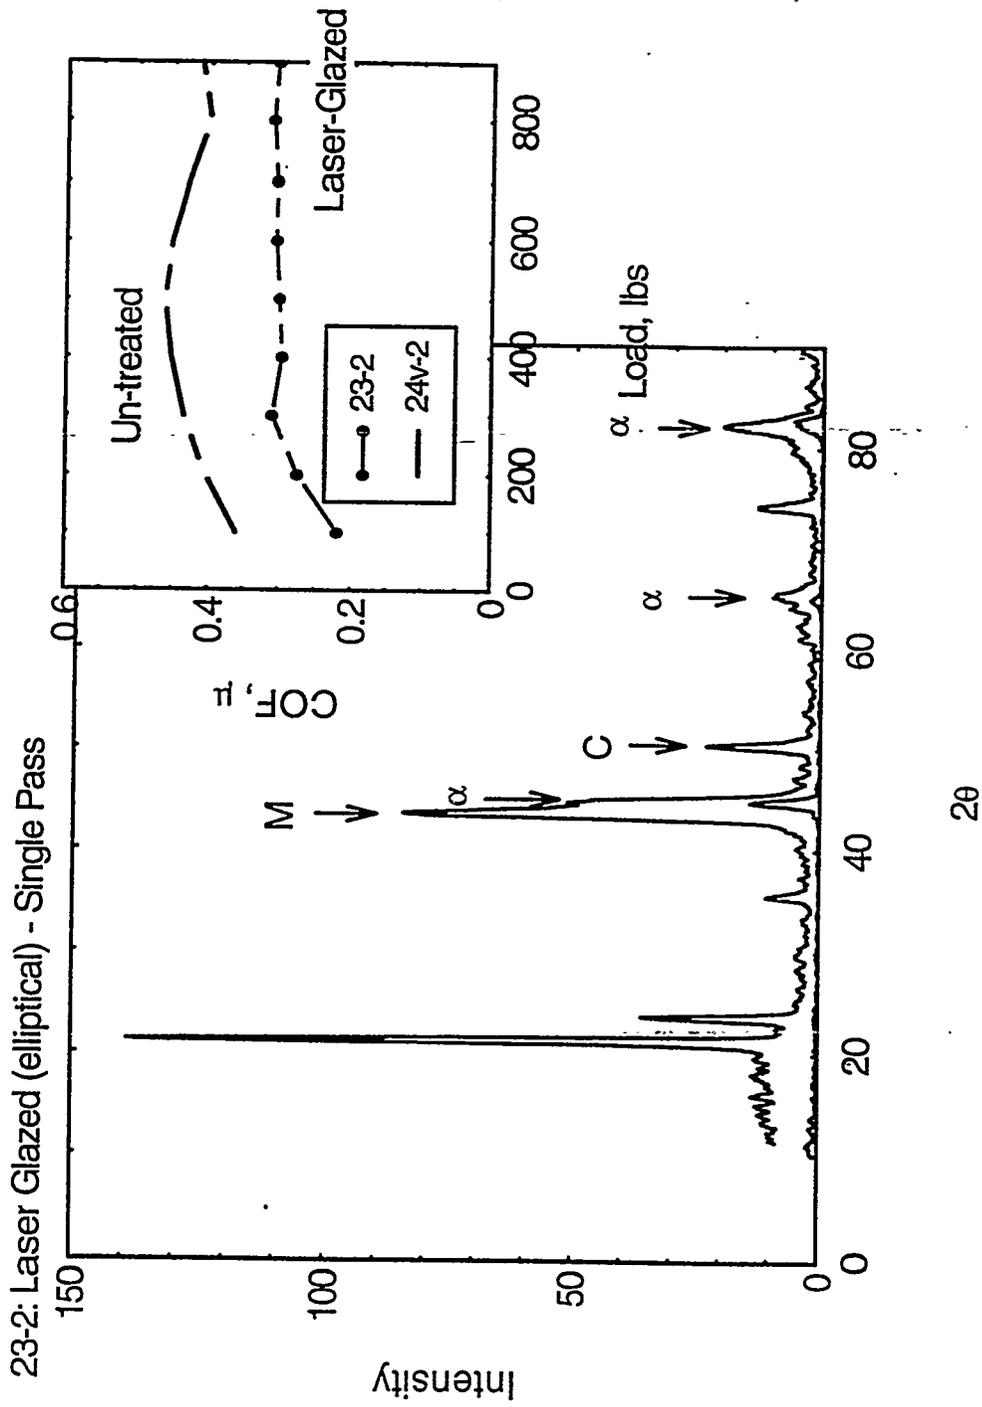
Figure 14. The results of an X-ray scan of a sample that received a single pass laser treatment with an elliptical beam (1 cm/s), shown with the scan from the untreated sample. Peaks consistent with α -ferrite, cementite (C), and martensite (M) are indicated. A number of peaks could not be identified.

- Figure 14.** The results of an X-ray scan of a sample that received a single pass laser treatment with an elliptical beam (1 cm/s), shown with scan from the untreated sample. Peaks consistent with α -ferrite, cementite (C) and martensite (M). A number of peaks could not be identified.

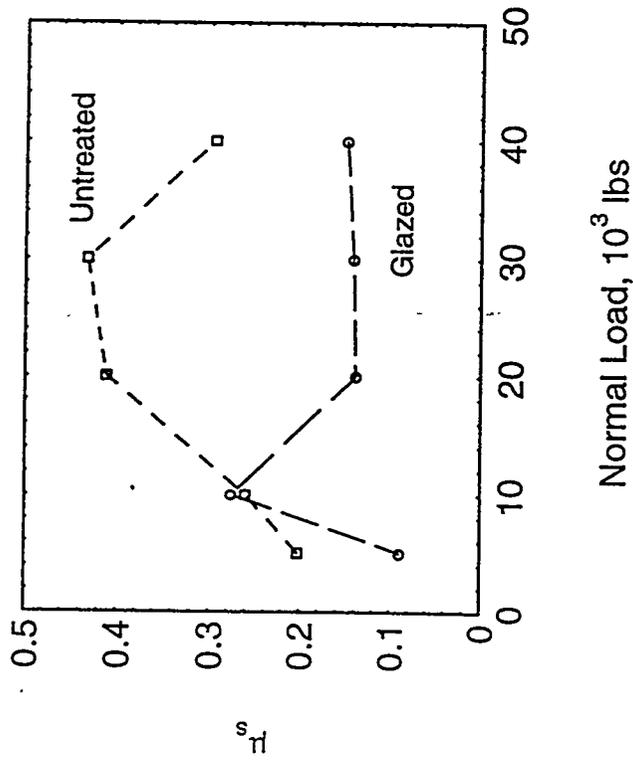
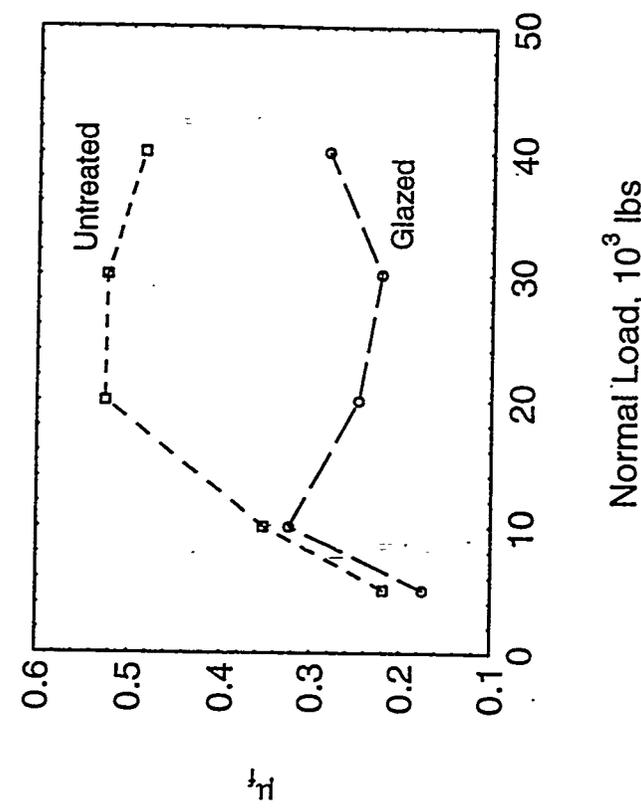
Figure 16.

The results of friction measurements made at the AAR's Cyclic Rolling-sliding Wear Machine on a rail surface given a multiple overlapping pass treatment with a circular beam (2 cm/s). Measurements of breakaway friction (left, μ_s) and freely rotating friction (right, μ_t) are shown in comparison with the results for untreated surfaces of the rail.

- Figure 16.** The results of friction measurements made at the AAR's *Cyclic Rolling-sliding Wear Machine* on a rail surface given a multiple overlapping pass treatment with a circular beam (2 cm/s). Measurements of breakaway friction (left, μ_s) and freely rotating friction (right, μ_r) are shown in comparison with the results for untreated surfaces of the rail.

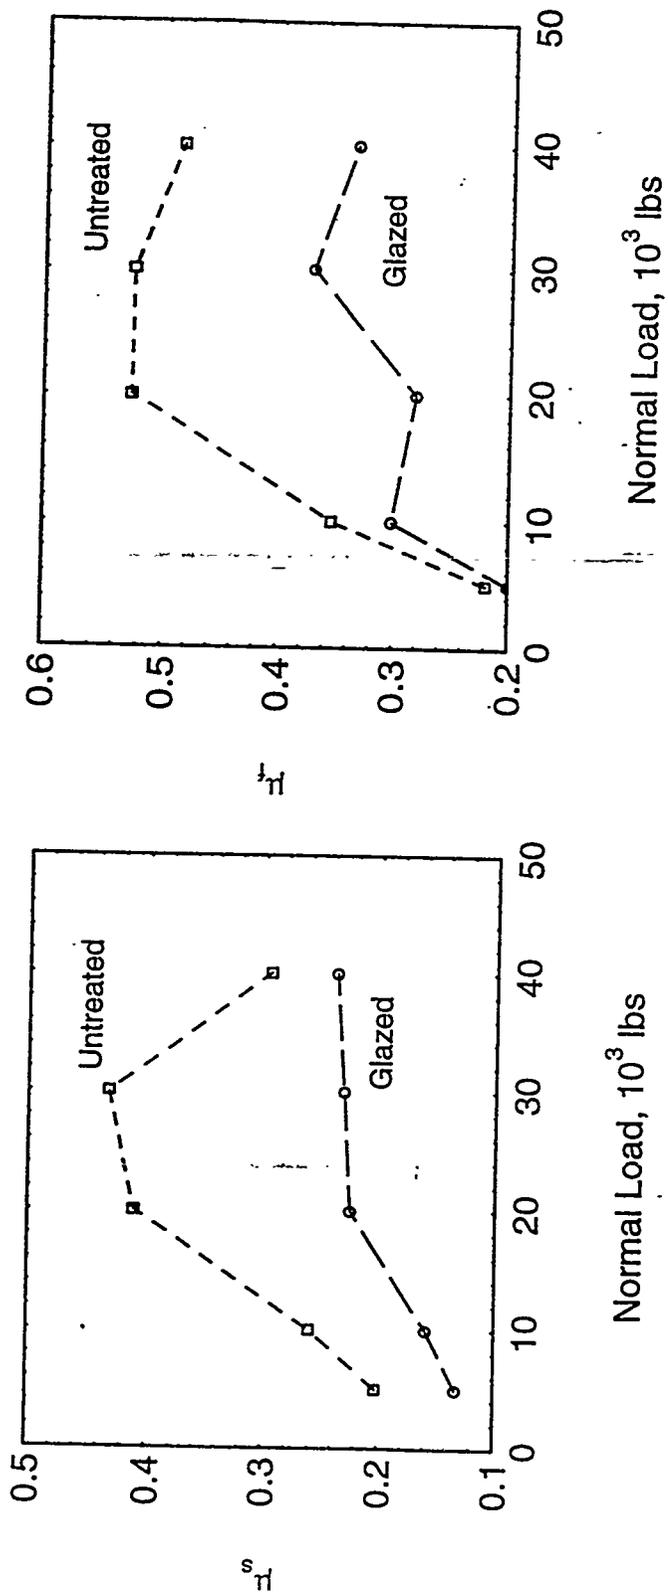
Figure 17. The results of friction measurements made at the AAR's Cyclic Rolling-sliding Wear Machine on a rail surface given a multiple adjacent-pass treatment with an elliptical beam (1 cm/s). Measurements of breakaway friction coefficient (left, μ_s) and freely rotating friction coefficient (right, μ_f) are shown in comparison with the results for untreated surfaces of the rail.

- Figure 17.** The results of friction measurements made at the AAR's *Cyclic Rolling-sliding Wear Machine* on a rail surface given a multiple adjacent pass treatment with an elliptical beam (1 cm/s). Measurements of breakaway friction (left, μ_s) and freely rotating friction (right, μ_r) are shown in comparison with the results for untreated surfaces of the rail.
