Decontamination and Dismantlement of the
JANUS Reactor at Argonne National Laboratory-East
Project Final Report

Decontamination and Decommissioning Program

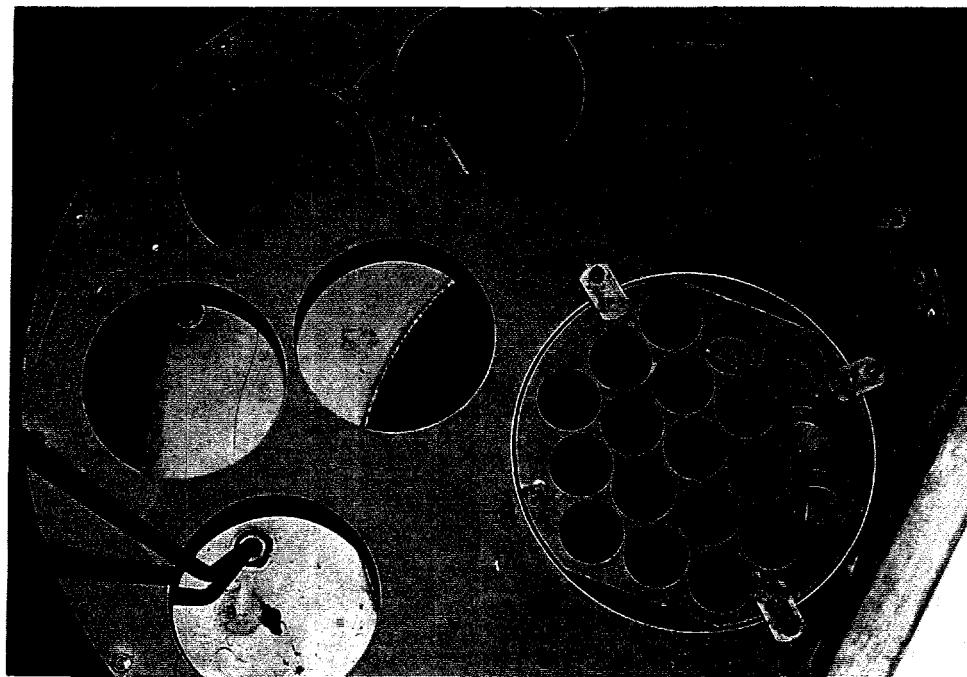
Figure 6.32 View of Reactor Internals Prior to Removal
(ANL Negative #23071K, Frame #3)

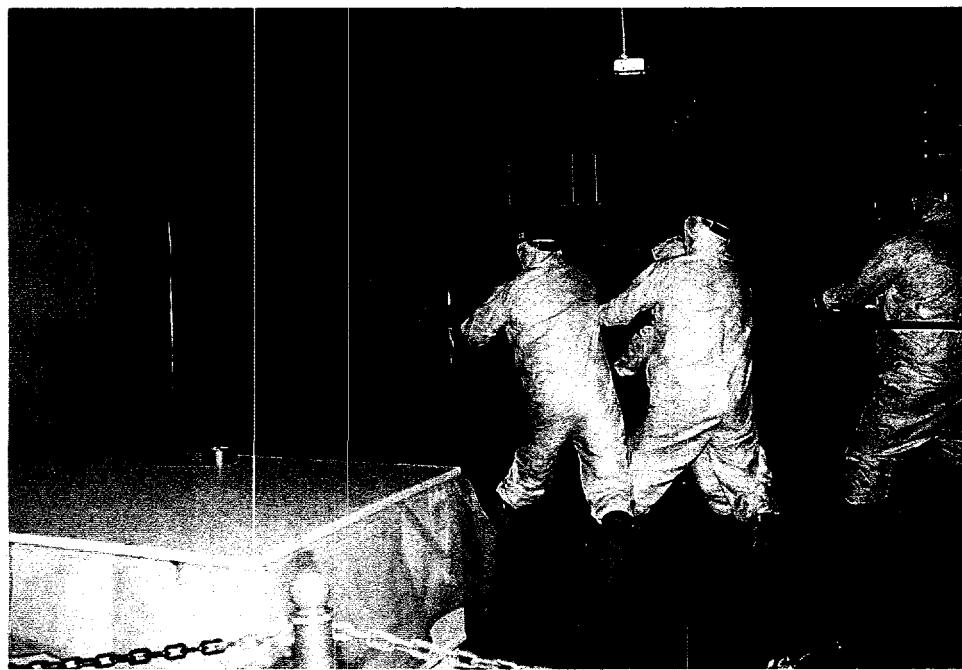
Figure 6.35 Technicians Removing Rabbit Tube Shield Plug
(ANL Negative #22981K, Frame #23A)

Prior to removal of the reactor tank, it was necessary to disconnect the rabbit tube assembly from the reactor tank and remove it. The rabbit tube was mechanically disassembled and removed from its access tube in the biological shield. Portions of the rabbit tube assembly which were located close to the reactor were packaged as low-level radioactive waste. The shield plug and outside sections of the rabbit tube were surveyed and disposed of as clean scrap. The rabbit tube assembly was removed between April 9, 1997 and April 10, 1997. Figures 6.34 and 6.35 show rabbit tube removal operations.

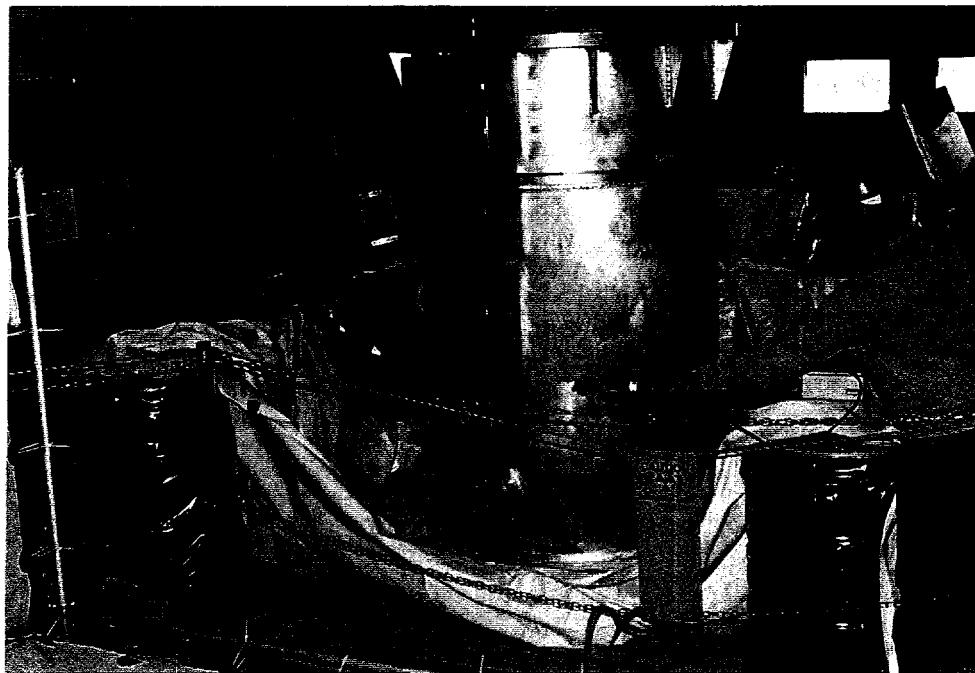
Figure 6.37 Technician Performing Radiation Surveys on Reactor Tank in Lay-Down Area
(ANL Negative #23072K, Frame #16)

This activity involved lifting the aluminum reactor tank out of the steel shell and the surrounding graphite reflector, and transferring it to a contamination-control area for size reduction and packaging. In order to lift the off-set load caused by the lead and graphite-stepped system attached to one side of the reactor tank, a special lifting rig was purchased. The reactor tank was rigged to the 10 ton (9.1 MT) overhead crane and moved to the lay-down area on April 25, 1997. Size reduction and packaging operations were completed on April 29, 1997. Figures 6.36 and 6.37 show the removal of the reactor tank.

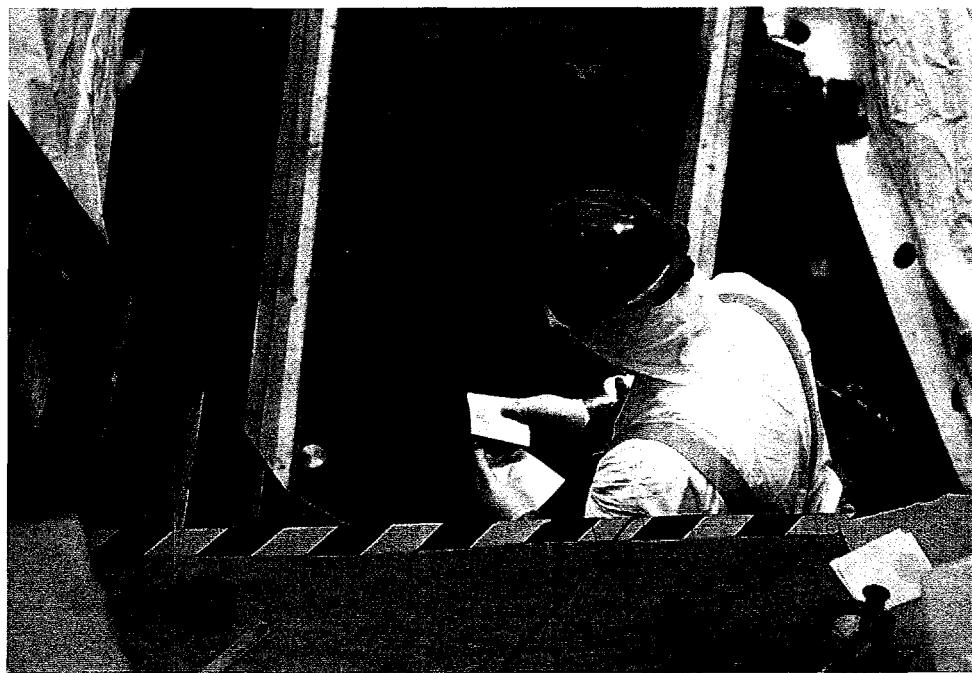
Figure 6.38 Health Physics Technician Surveying Graphite Prior to Removal
(ANL Negative #23072K, Frame #9)

After removal of the reactor tank, the graphite reflector blocks were exposed. The void area where the reactor tank had been sitting was classified as a permit-required confined space requiring air monitoring and personnel retrieval during entry. Removal of the graphite began at the top of the void left by the reactor tank and progressed working down. The graphite was placed into 55 gal (208 l) drums and lifted out with the 10 ton (9.1 MT) overhead crane. Waste was packaged for disposal into B-12 steel bins. After the height of graphite had been reduced to below the top edge of the low-dose window, the window cover was removed allowing graphite removal to continue from the low-dose room. After the opening was enlarged, the area was reclassified as non-permit-required confined space. This work started on May 8, 1997 and finished on June 3, 1997. Figures 6.38 and 6.39 show graphite removal.

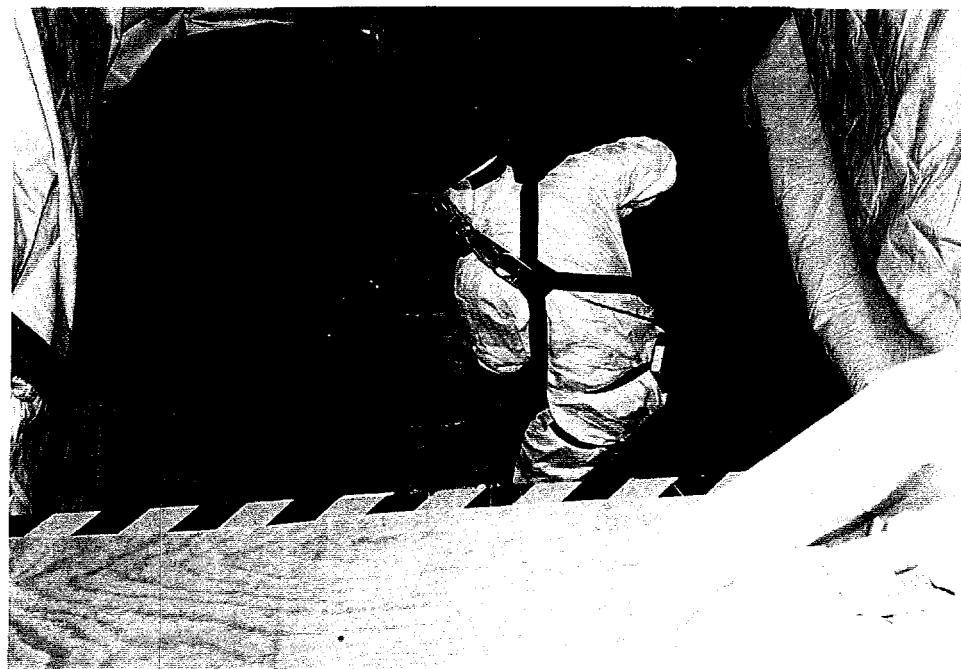
Figure 6.39 Technician Removing Graphite from Reactor Cavity
(ANL Negative #23153K, Frame #11A)

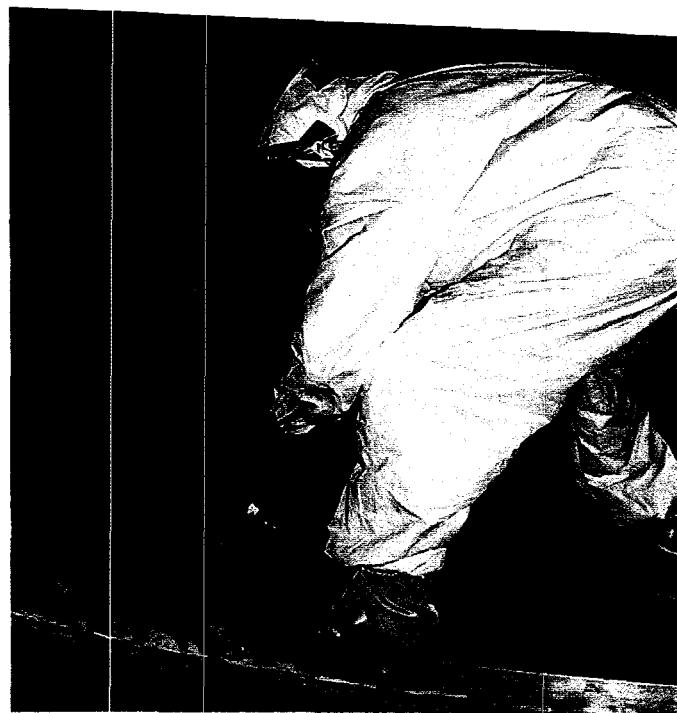
Figure 6.40 Technician Size Reducing a Section of Steel Shell for Packaging
(ANL Negative #23407K, Frame #3A)

The steel shell surrounded the graphite region of the reactor and, when the reactor was in place, it had provided a gas-tight enclosure. The steel shell was made of 0.5 in (1.27 cm) thick steel; to reduce neutron activation of the steel and surrounding concrete, a 0.125 in (0.318 cm) thick layer of boral had been riveted to the entire interior surface. During removal, the boral was stripped from the inside surface using pry bars, folded up and placed in low-level radioactive waste bins for disposal. The steel shell was then cut into pieces with a plasma arc torch and abrasive cut-off saw, and packaged as low-level radioactive waste. This activity started on May 19, 1997 and finished on September 9, 1997. Figures 6.40 and 6.41 show the removal of the steel shell.

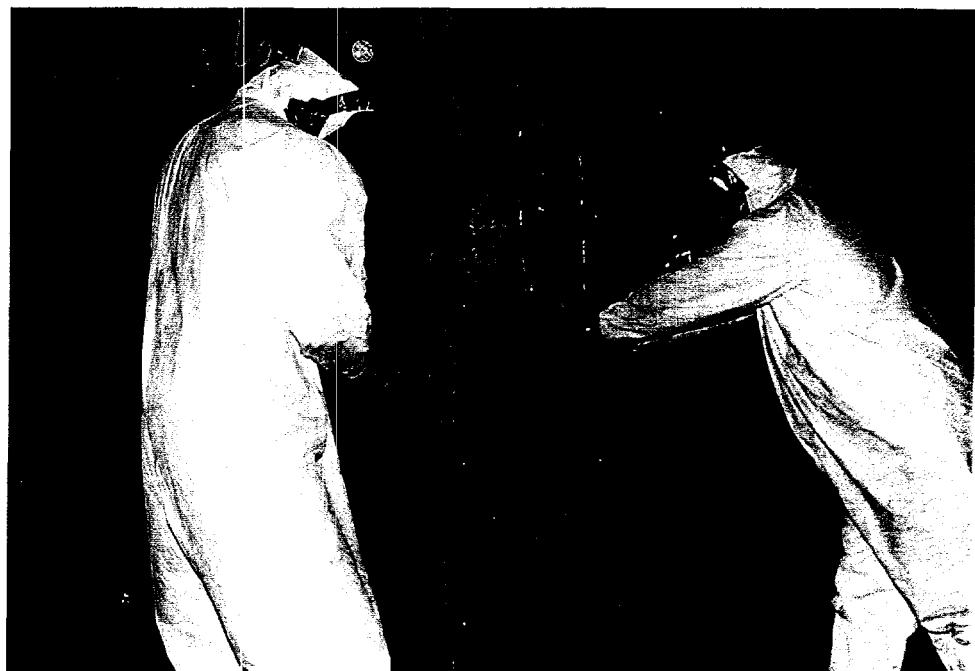
Figure 6.41 Technicians Removing a Section of Steel Shell
(ANL Negative #23407K, Frame #2A)

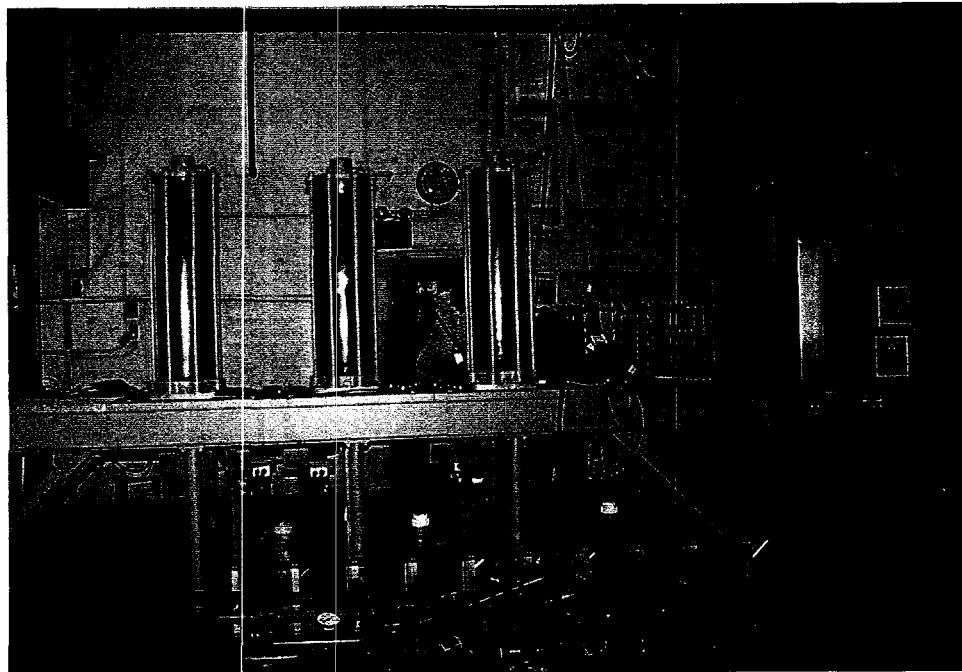
Figure 6.42 Technicians Removing Air System Piping and Shutter Drive Actuator
(ANL Negative #22683K, Frame #10)

The high-dose shutter drive consisted of three large pneumatic cylinders mounted on a support stand in the high bay, two air receiver tanks and associated piping in the HEPA filter room and associated electrical controls. To remove the shutter drive, the electrical and air systems were LO/TO, and the associated piping and electrical controls were removed. The cylinders were attached to the high-dose shutters by a steel shaft that penetrated the shielded floor plugs. Once the cylinder shafts were disconnected from the shutters, the cylinders were removed from the stand, surveyed and released as clean scrap. The air receivers were isolated and disconnected from the building air system and released as clean scrap. This task was performed between January 22, 1997 and January 28, 1997. Figures 6.42 and 6.43 show removal of the shutter drives.

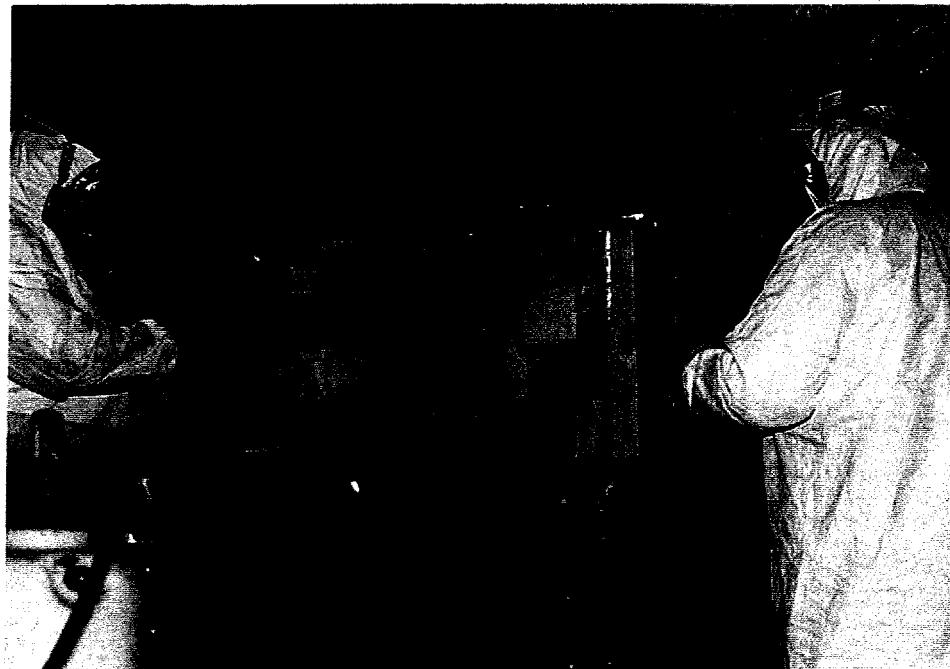
Figure 6.45 Technicians Removing Lead and Polyethylene Blocks from Inside of a
High-Dose Shutter
(ANL Negative #23322K, Frame #20)

The high-dose shutters were left in place until the graphite was removed to provide gamma shielding for personnel working in the high-dose room. The shutters and pedestals were rigged to the 10 ton (9.1 MT) overhead crane and transferred to a containment, where activated lead and polyethylene from inside the steel casing were removed. The steel casing and polyethylene were disposed of as low-level radioactive waste, and the lead was packaged as mixed waste. The grouting of voids behind the shutter guides and pedestals prevented direct removal of the high-dose shutter pedestals with the crane. Before they could be lifted free, the shutter guides had to be dismantled in place and the grout removed from around the pedestals. This work started on June 6, 1997 and finished on September 9, 1997. Figures 6.44 and 6.45 describe this work.

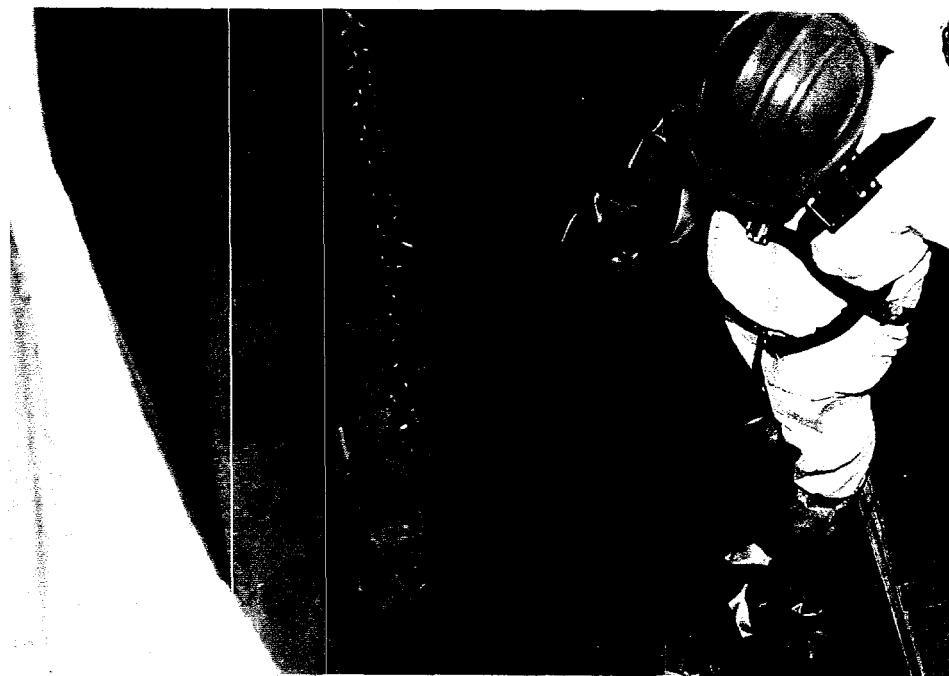
Figure 6.47 Low-Dose Shutter Being Removed
(ANL Negative #23216K, Frame #15A)

As with the high-dose shutters, the low-dose shutters were also left in place until removal of the graphite was started to provide gamma shielding for personnel working in the low-dose room. The shutters and pedestals were rigged to the 10 ton (9.1 MT) overhead crane and transferred to a lay-down area for survey and release. The low-dose shutters were disposed of as clean scrap. This work started on May 29, 1997 and completed on June 2, 1997. Figures 6.46 and 6.47 show removal of the low-dose shutters and pedestals.

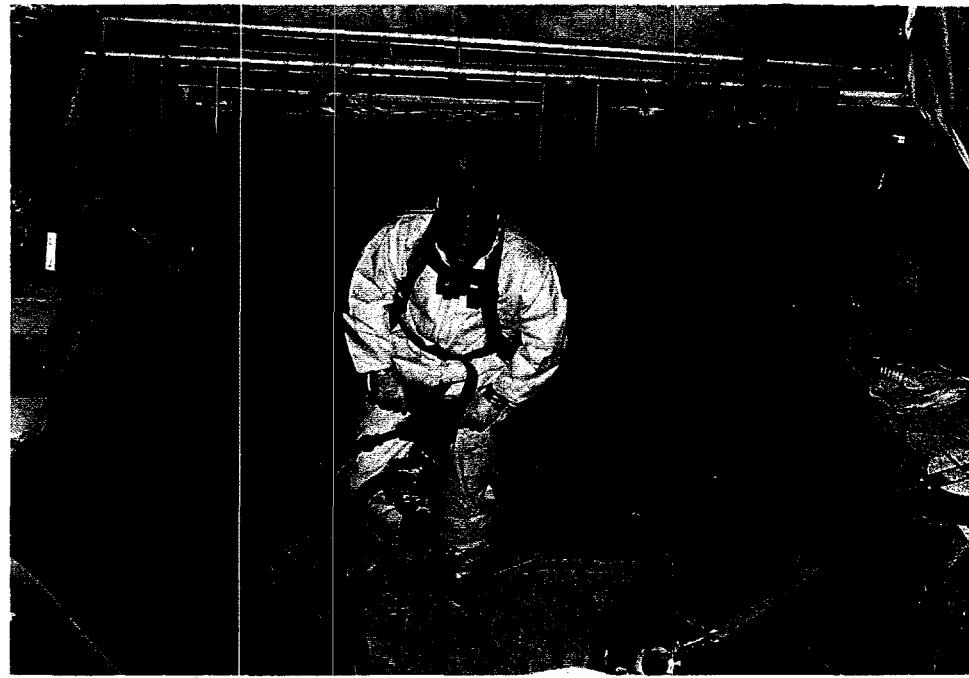
Figure 6.48 Technician Removing Concrete from South "Wing" Wall
with a 90 lb (40.82 kg) Jackhammer
(ANL Negative #23416K, Frame #10A)

The activated bioshield consisted of the concrete "bridges" located on top of the steel shell above the high- and low-dose windows, the concrete "wings" located directly north and south of the steel shell and the reactor pedestal which supported the steel shell. These concrete structures were removed utilizing electric and pneumatic jackhammers, Bristar™ expanding grout and the BROKK 150 semi-remote, portable hydraulic jackhammer. Concrete removal was performed inside a HEPA-ventilated containment enclosure to control the spread of activated concrete dust. The concrete was packaged into 55 gal (208.18 l) drums and steel waste bins for disposal as low-level radioactive waste. This work was started on May 14, 1997 and completed on September 10, 1997. Figures 6.48 and 6.49 show activated bioshield removal.

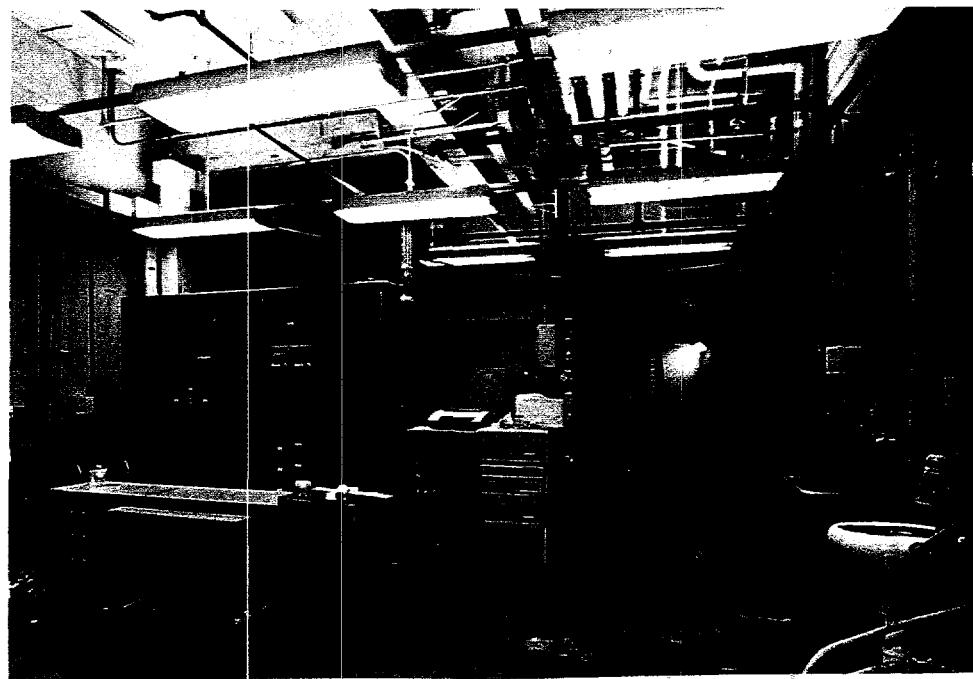
Figure 6.50 Low-Dose Control Panel Prior to Disassembly
(ANL Negative #22163K, Frame #7A)

The low-dose room control panels were located in the low-dose preparation room on the service floor of the JANUS Reactor facility and housed various controls and power supplies for performing experimental work. Prior to removal, power to the control console was LO/TO. After electrical isolation, the panels were manually disassembled, surveyed for free release and disposed of as clean scrap. This work was started on February 4, 1997 and completed on February 28, 1997. Figures 6.50 and 6.51 show the dismantlement of the low-dose control panels.

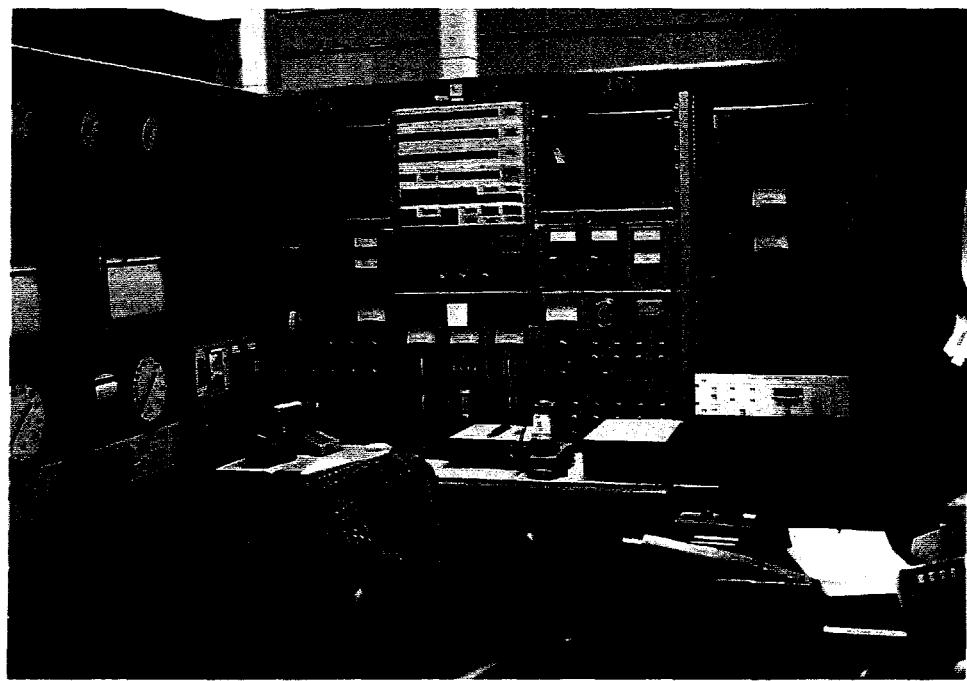
Figure 6.52 Reactor Control Panel Prior to the Start of Disassembly
(ANL Negative #22683K, Frame #5)

The reactor control consoles were located in the reactor control room on the main floor; they provided control power for reactor operation as well as instrumentation readouts for monitoring reactor operation. Power was isolated to the control panels and LO/TO, and dismantling began. On January 30, 1997, two energized emergency power circuits were cut during dismantlement work. These circuits were added after completion of the reactor facility and did not appear on any available drawings. All work was stopped and an investigation was ordered by the ANL Project manager. A detailed account of this event is provided in Section 12.0 of this report. As a result of the investigation, the dismantlement procedure was revised and additional electrical monitoring equipment was purchased prior to restarting dismantlement operations. The consoles were dismantled, surveyed for free release and disposed of as clean scrap. This work was started on January 29, 1997 and completed on January 31, 1997. Figures 6.52 and 6.53 show control room console dismantlement operations.

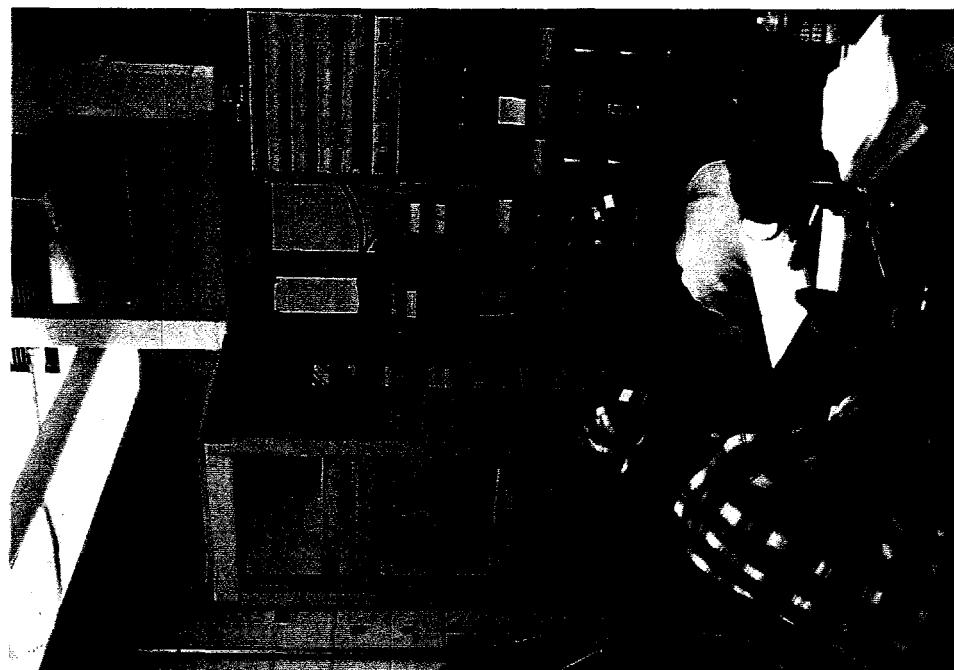
Figure 6.53 Technician Disassembling the Reactor Control Panel
(ANL Negative #22719K, Frame #4)

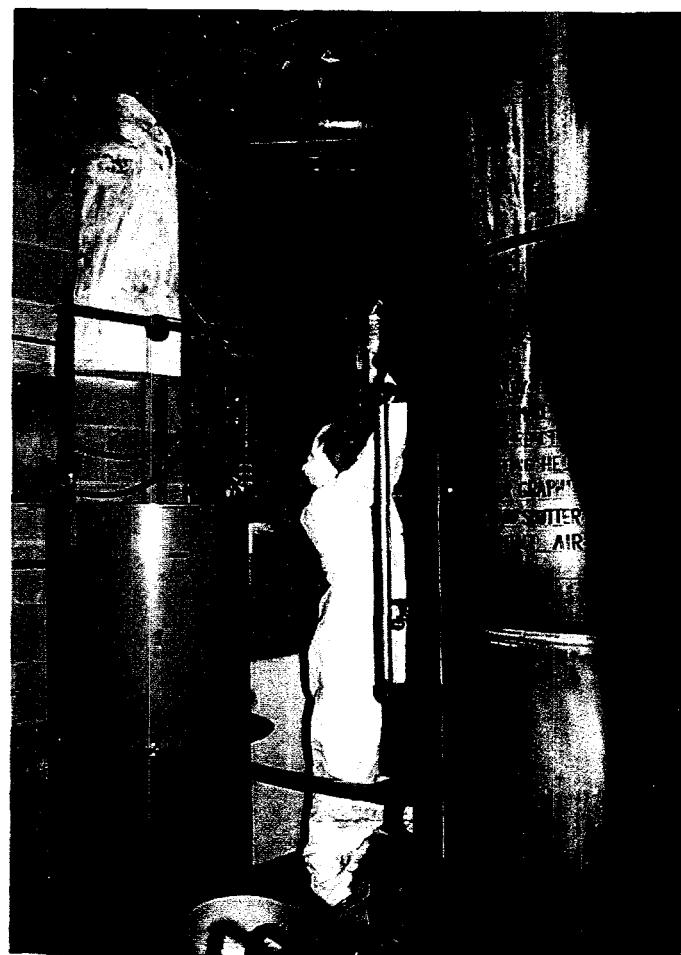
Figure 6.55 Technician Disassembling
Systems in the Reactor Equipment Room
(ANL Negative #22846K, Frame #19A)

Systems removal consisted of dismantlement of the secondary cooling system, primary water system, reactor and graphite helium system and the level control and skimmer system. These systems were primarily located in the reactor equipment room on the service floor of the JANUS Reactor facility. The following sections describe the removal of these systems. Figures 6.54 and 6.55 show removal of these systems.

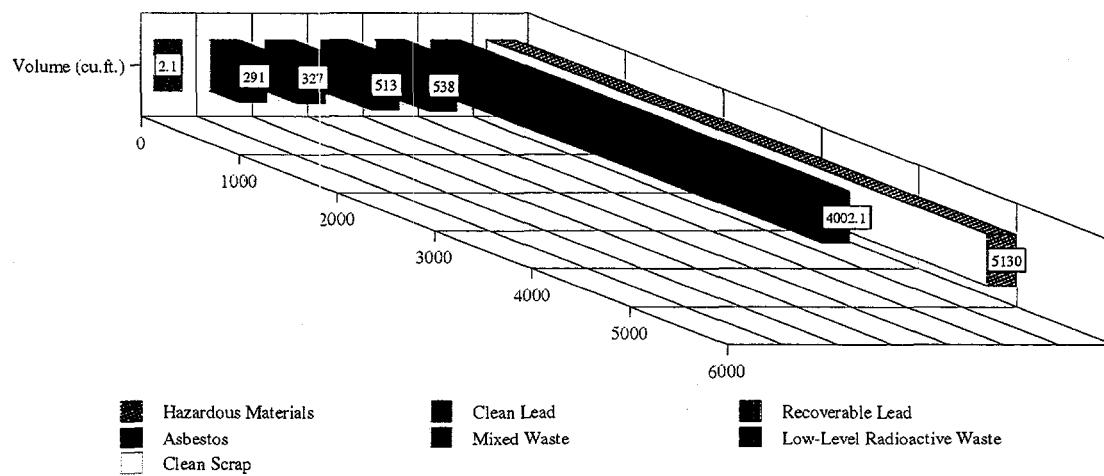
Figure 9.1 Waste Removed from JANUS Reactor Facility

A summary of waste and recoverable materials removed during the JANUS D&D Project is shown in Table 9.1. Waste volumes are shown graphically in Figure 9.1, and waste volume details are provided in Appendix I.

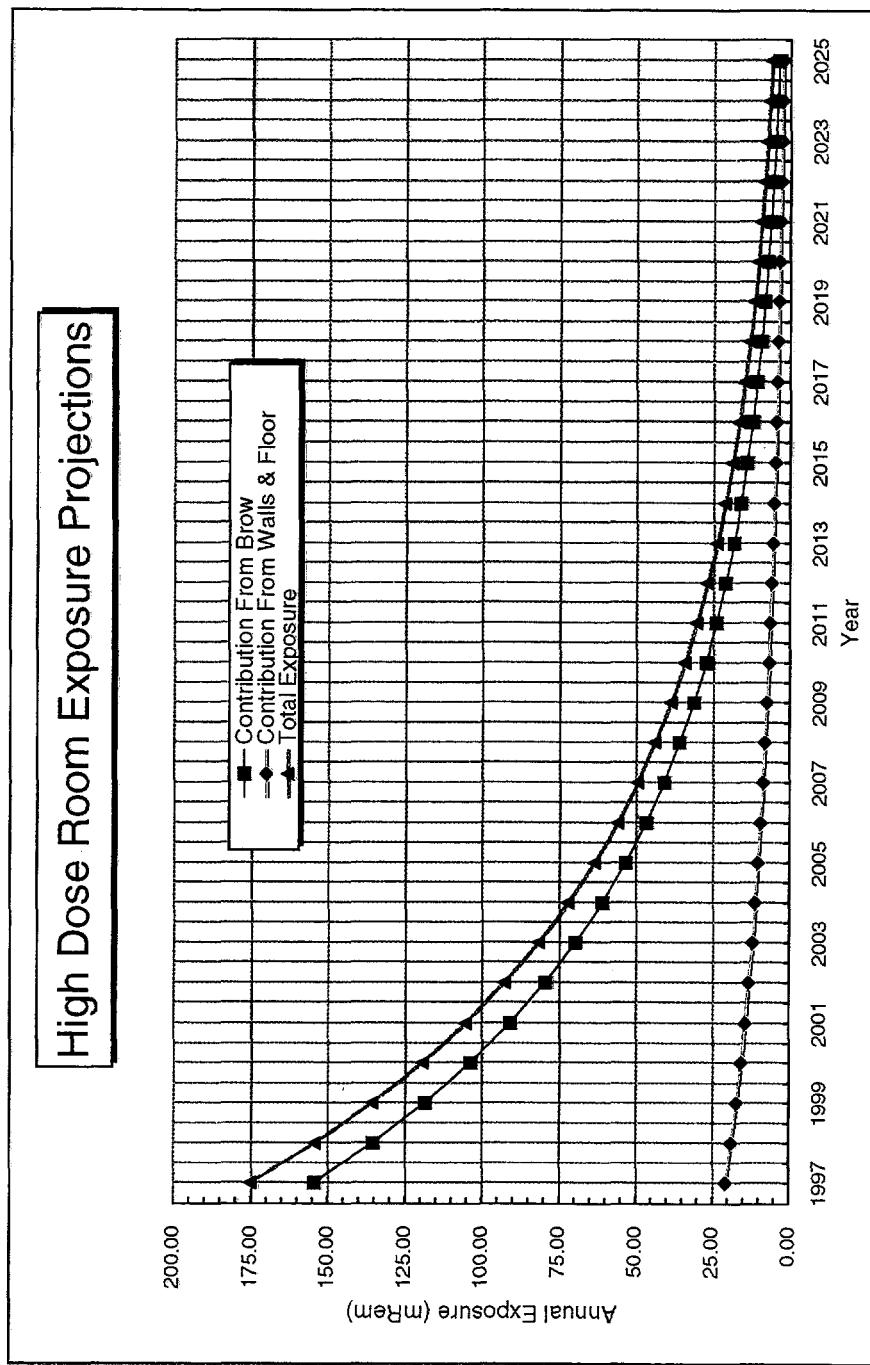
Figure 11.1 Annual Dose Projections for the High-Dose Room

The facility condition was discussed between ANL-E and DOE management. The removal of these activated components would compromise the building structure, and a large renovation cost would be incurred to bring the building into compliance with existing building codes. After alternatives were reviewed, it was decided that these areas would be isolated from personnel access by constructing a concrete block wall across the low-dose face, installing the reactor area and high-dose area floor plugs and closing the high-dose room door. ESH/HP posted signs to alert personnel of the residual activity. Figures 11.1 and 11.2 provide annual dose projections for the high-dose room and the reactor cavity.

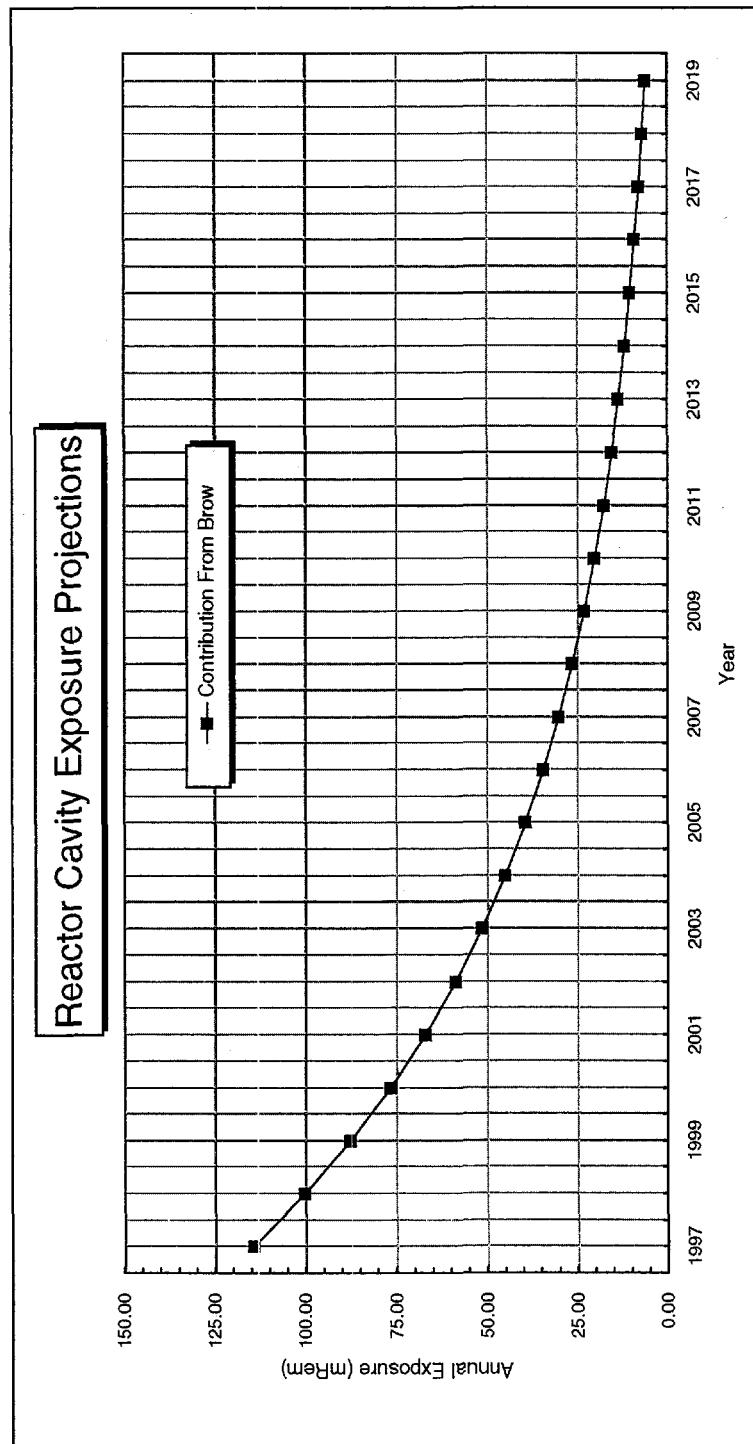
Figure 11.2 Annual Dose Projections for the Reactor Cavity
