**NUREG/CR-6412  
SAND97-3170**

# **Aging and Loss-of-Coolant Accident (LOCA) Testing of Electrical Connections**

Prepared by  
C.F. Nelson

Sandia National Laboratories

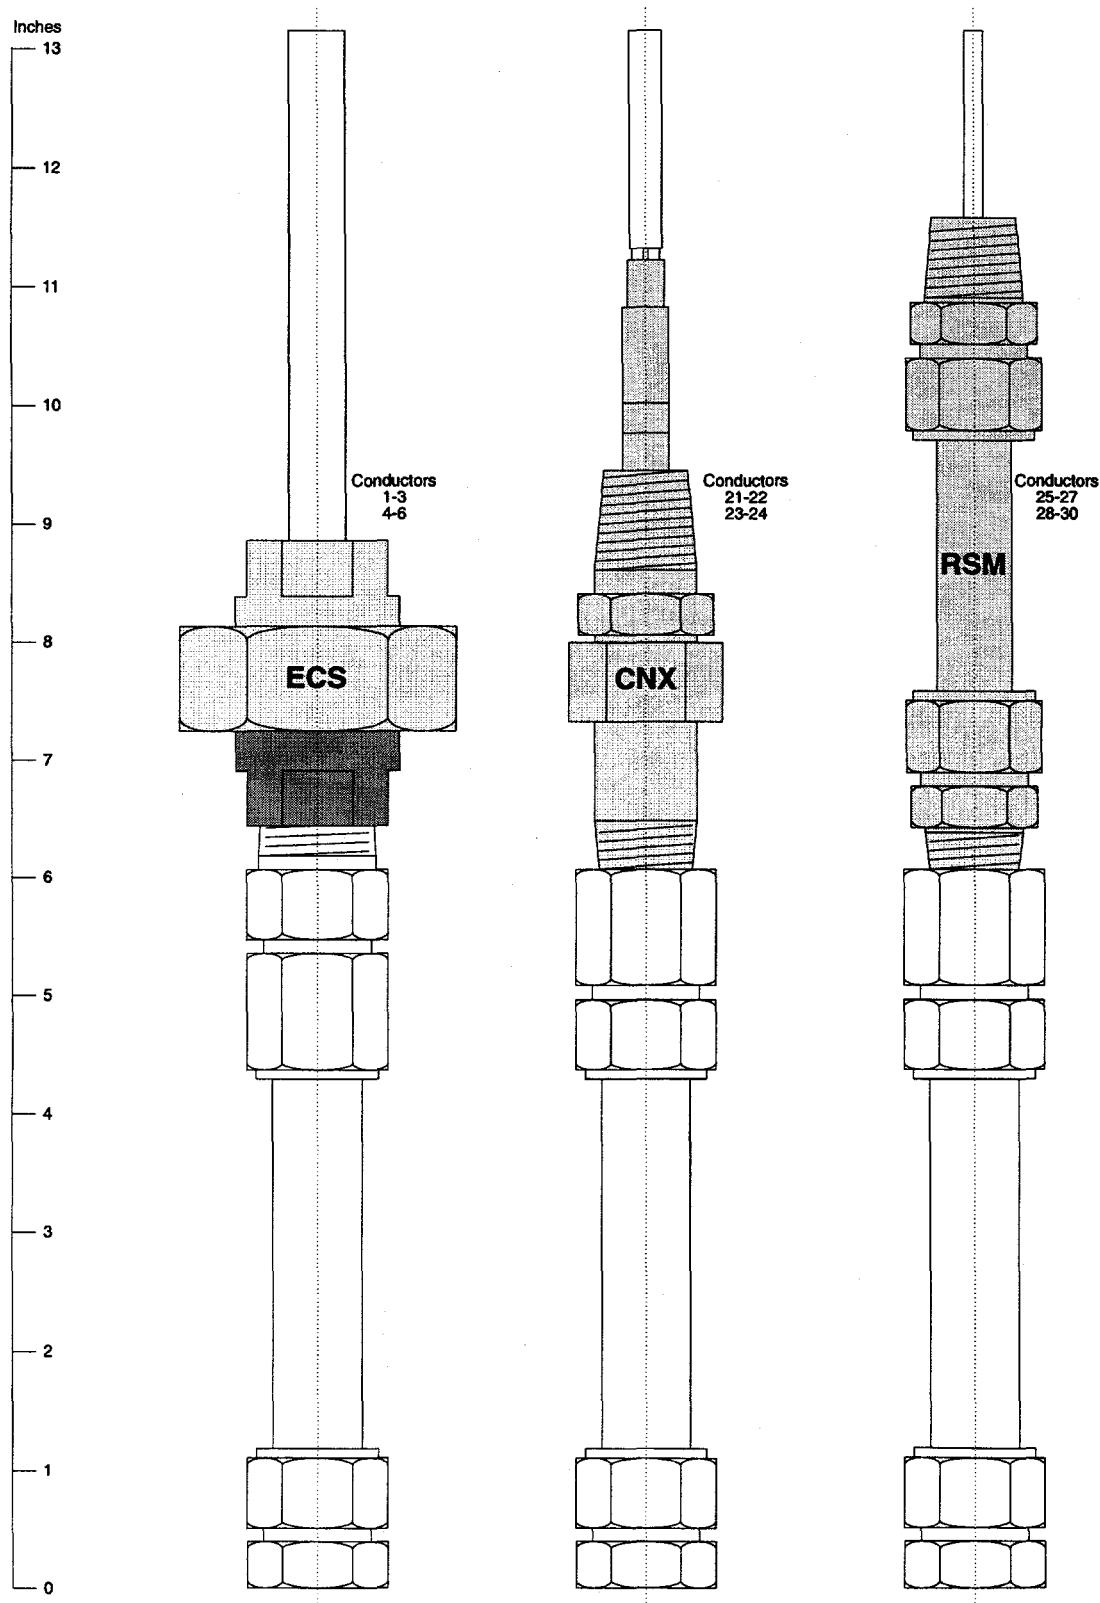
Figure 2.1: Sketches of the conduit seals tested.

Detailed information on the conduit seals and cable-to-device connectors tested is given in Table 2.1, and for the cable-to-cable connectors and in-line splices in Table 2.2. Sketches of the conduit seals tested are shown in Figure 2.1, and the cable-to-device and cable-to-cable connectors are shown in Figures 2.2 and 2.3.

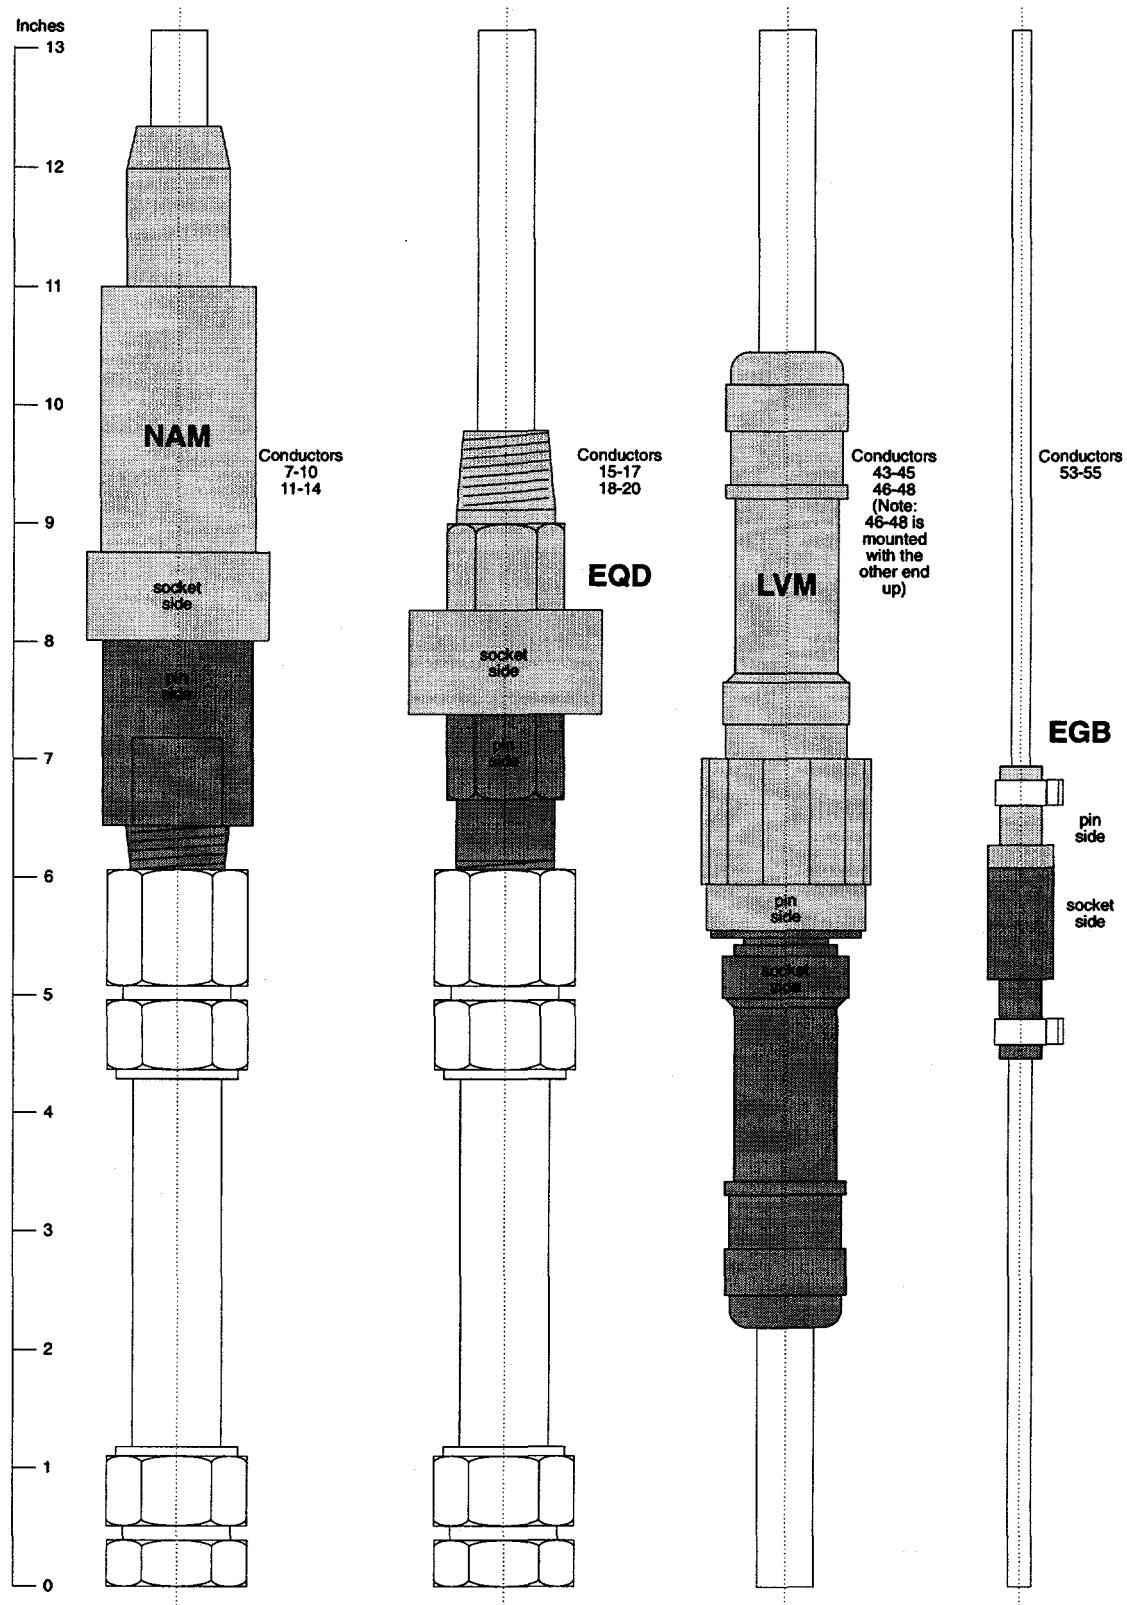
Figure 2.2: Sketches of the cable-to-device and cable-to-cable connectors tested.

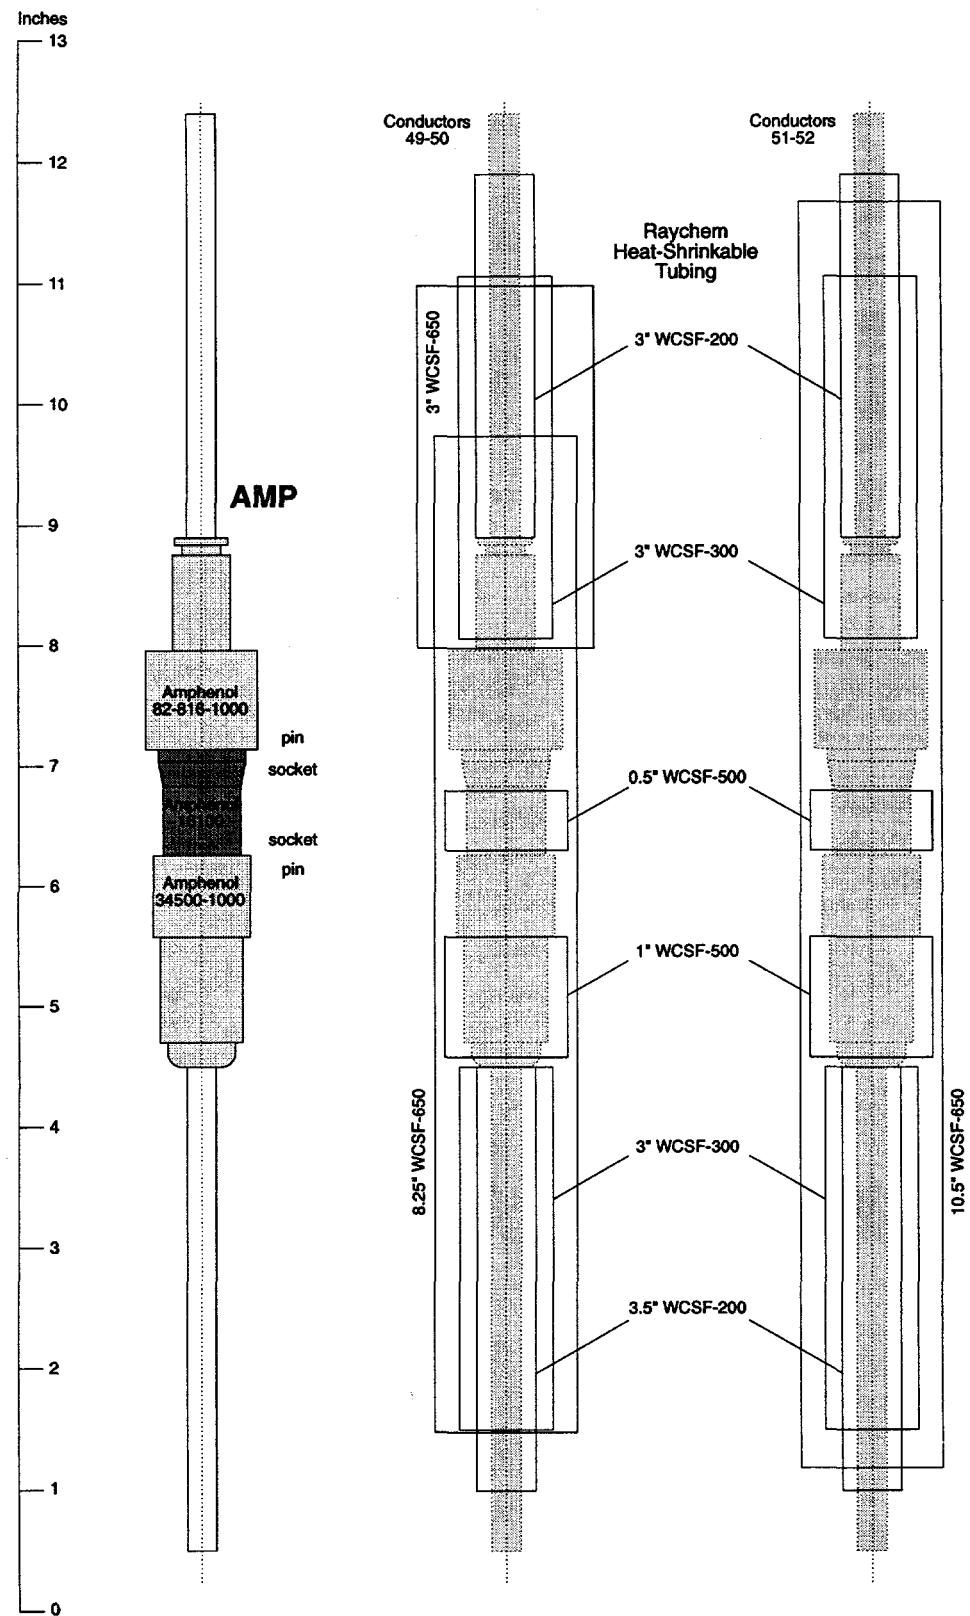
Figure 2.3: Sketch of the Amphenol coaxial connector tested showing the actual connectors and the arrangement of Raychem heat-shrinkable tubing applied for environmental protection.

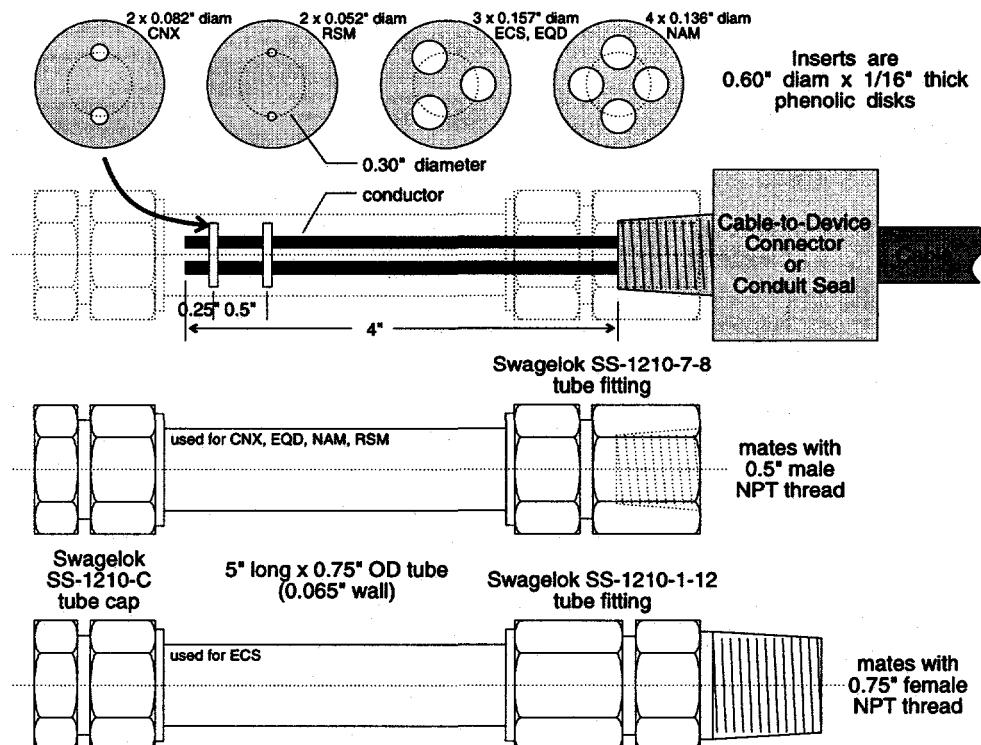
Figure 2.4: Sketch of the device enclosures used for installation of conduit seals and cable-to-device connectors.

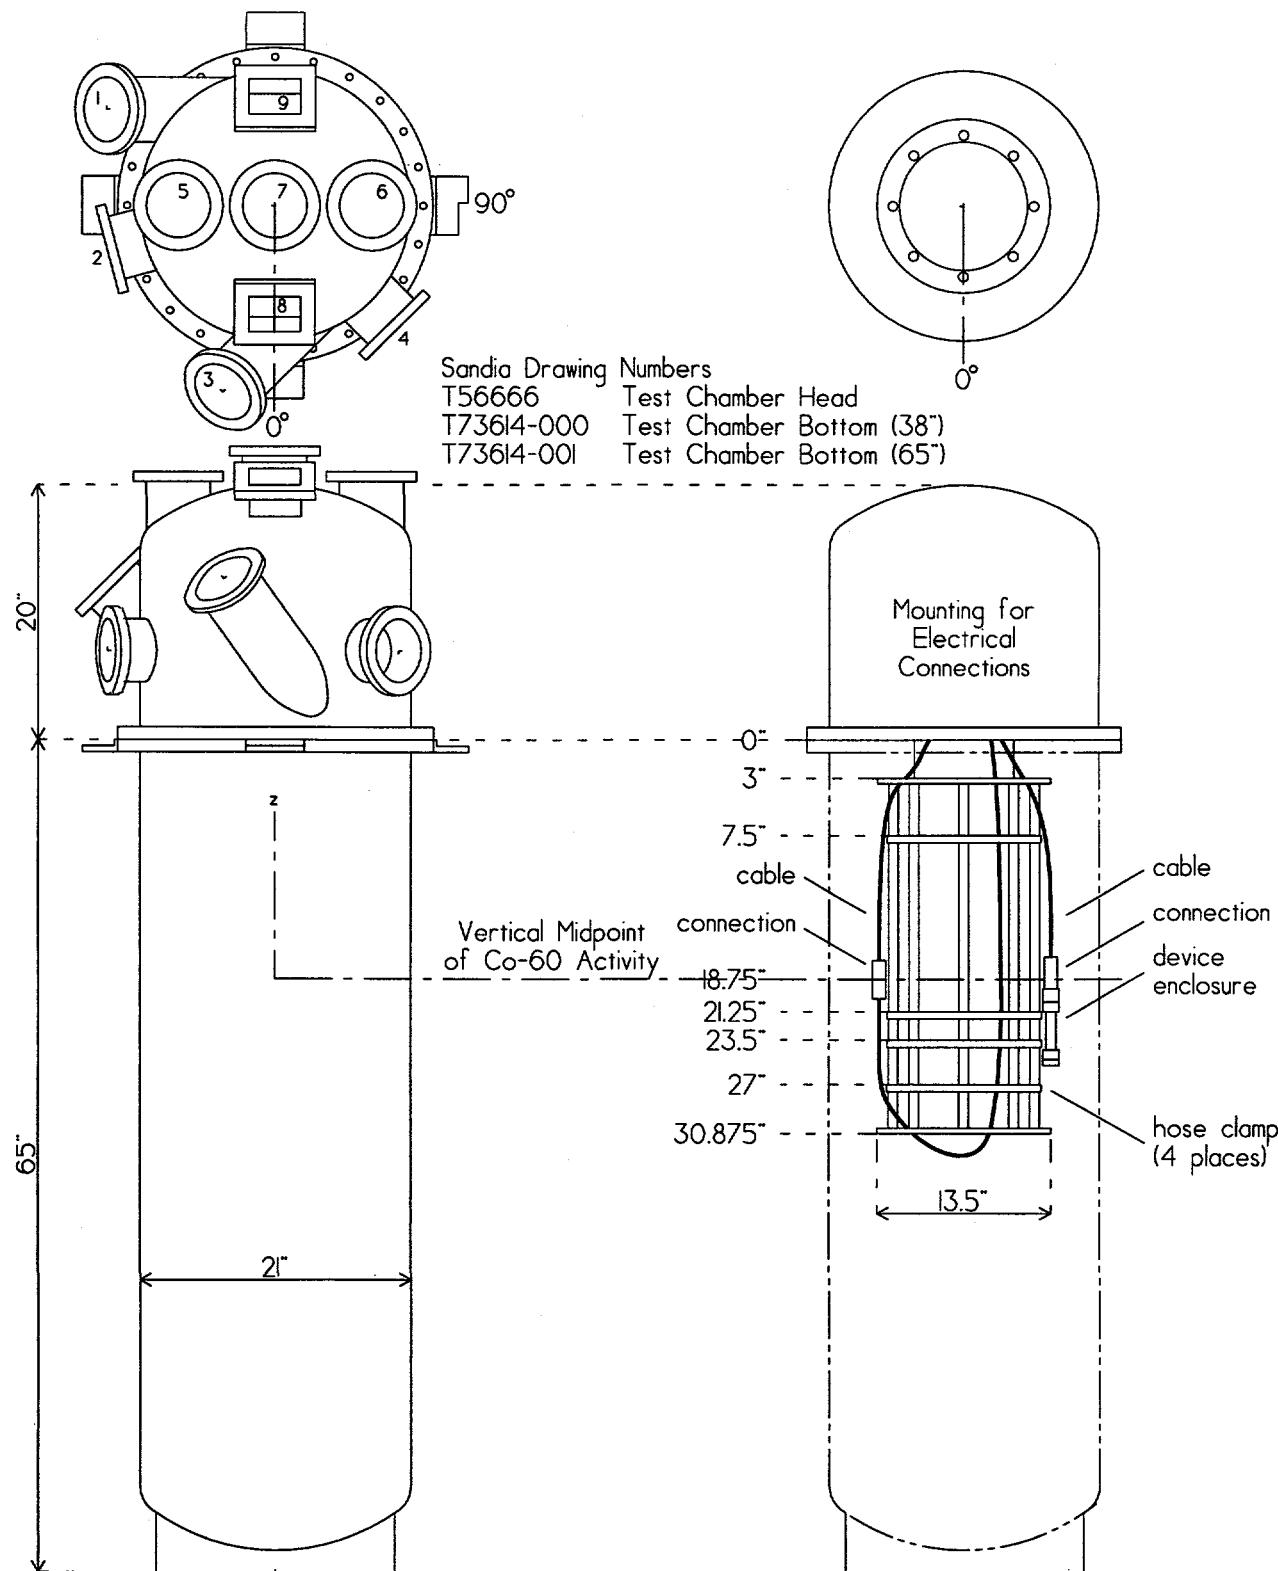
Figure 2.5: Detail of the test chamber and a sketch of the mandrel on which the electrical connections were mounted.

As shown in Figure 2.5, the test chamber head has 9 flanged ports through which test specimens and experimental apparatus (air and steam lines, heater power, thermocouples, and a pressure tap) can enter or exit the test chamber. Each of these 9 ports has a flange cover in which various openings have been machined; the potted penetrations attach to female NPT-threaded openings. Each potted penetration consists of a stainless steel tube with a Swagelok male connector on one end and a Swagelok cap on the other; a hole is drilled in the cap to allow a cable lead to pass through. After the penetration is positioned correctly on the cable, it is filled by injecting Scotchcast Electrical Resin 9 (5240) into the tube and over the cable. Note that the electrical resin is applied over the top of the cable jacket; there is no attempt to seal the individual conductors. After the electrical resin has cured, the penetration is attached to the flange cover with the Swagelok male connector.

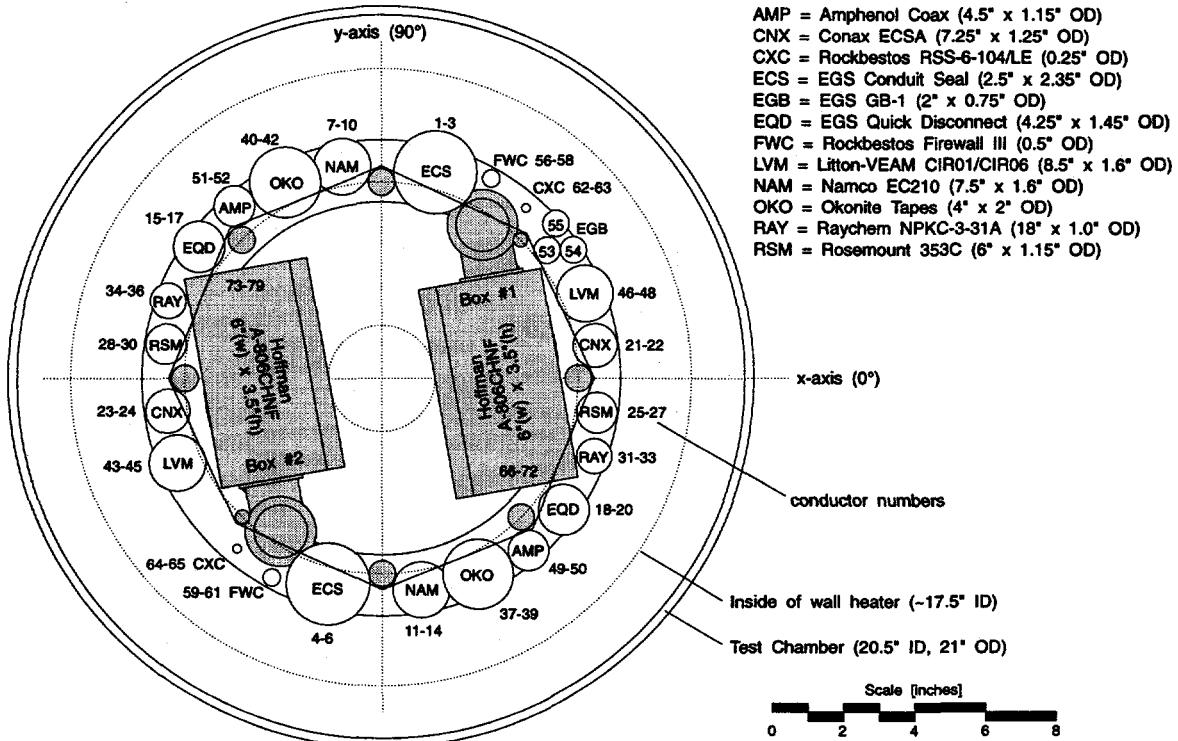
Figure 2.6: Top view of the test chamber and mandrel showing how the test specimens were arranged.

ribbons were loosely wrapped around each cable and tack welded to the hose clamps. The cable attached to the connection entered the test chamber through a potted penetration in the test chamber head and then was attached to the top hose clamp. The cable was positioned so that the connection was located at the middle of the cobalt-60 sources' active region. For connections that were attached to a device, the device enclosure was held in place by stainless steel ribbon tack welded to hose clamps located below the connection. For connections that joined two lengths of cable, the return leg of the cable continued vertically down the mandrel and then looped back up through the center of the mandrel before finally exiting the test chamber through another potted penetration in the test chamber head. Figure 2.6 shows a top view of the arrangement of the test specimens in the test chamber.

The two Hoffman A-806CHNF enclosures shown in Figure 2.6 each contain one Marathon and one States terminal block, which were tested at the same time as the connections. The terminal blocks were added to address issues related to a previous study of terminal blocks by Craft [6, 7]. Because these issues differed from the test program objectives, all information pertaining to the terminal blocks is contained in Appendix A. Appendix B contains a more complete description of the test facilities used for this test program.

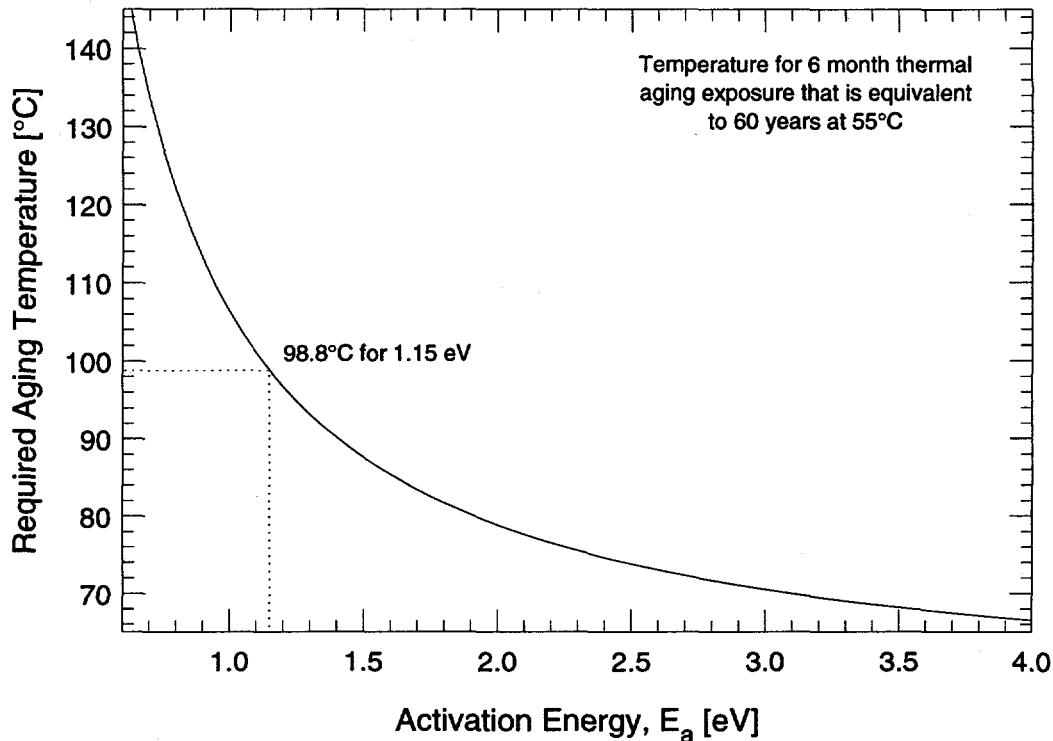
Figure 2.7: Required aging temperature as a function of activation energy,  $E_a$ .

As shown in Figure 2.7, the aging temperature required to simulate 60 years at 55°C is a function of the activation energy. Using the data in Table 2.4, an activation energy of  $E_a = 1.15$  eV was chosen to give conservative data for most of

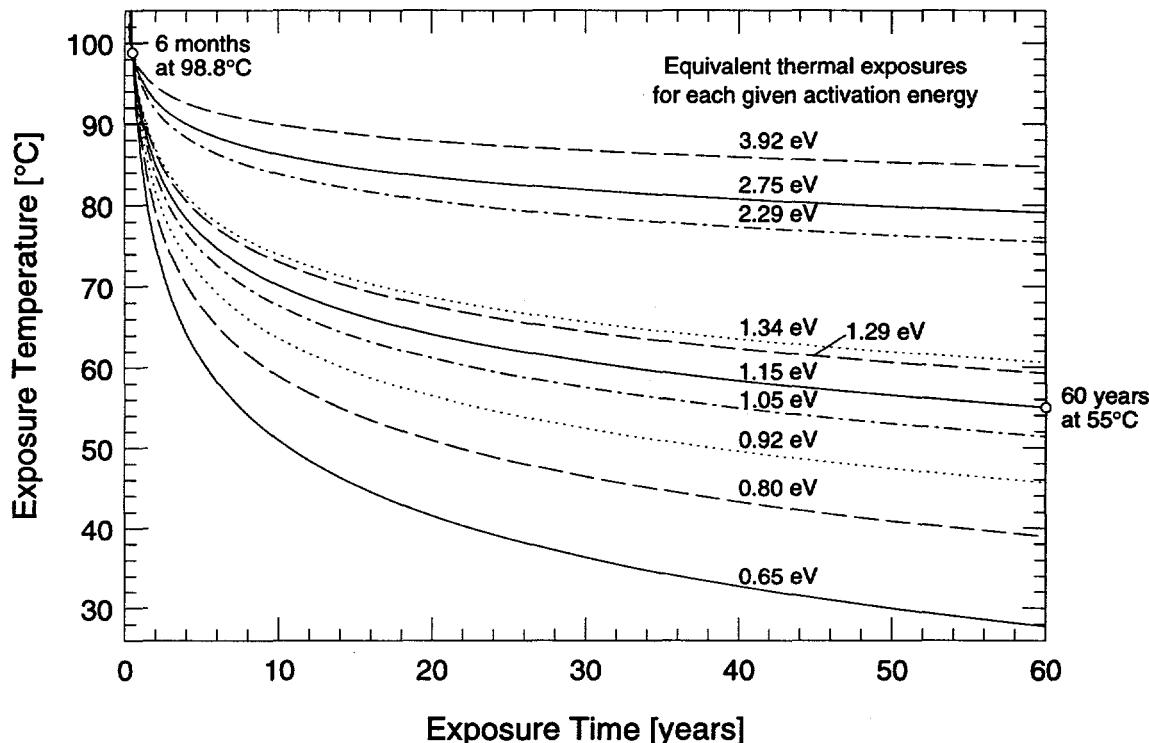
Figure 2.8: Curves of equivalent thermal exposures for the activation energies listed in Table 2.5.

the connections. For the 1.15-eV activation energy, the Arrhenius relation gives a required aging temperature of 98.8°C (209.8°F). Due to differences in activation energy, the thermal aging (for any time period other than 6 months) that is equivalent to a 6-month exposure at 98.8°C is different for each connection. Table 2.5 gives the equivalent aging temperatures for 40- and 60-year aging exposures. This is also presented by Figure 2.8, which shows curves of equivalent thermal-only exposures for the activation energies listed in Table 2.5. All these curves pass through a 6-month exposure at 98.8°C, and thus indicate the range of equivalent thermal exposures to which the different connections were exposed; the 40- and 60-year values from each curve correspond to the values in Table 2.5.

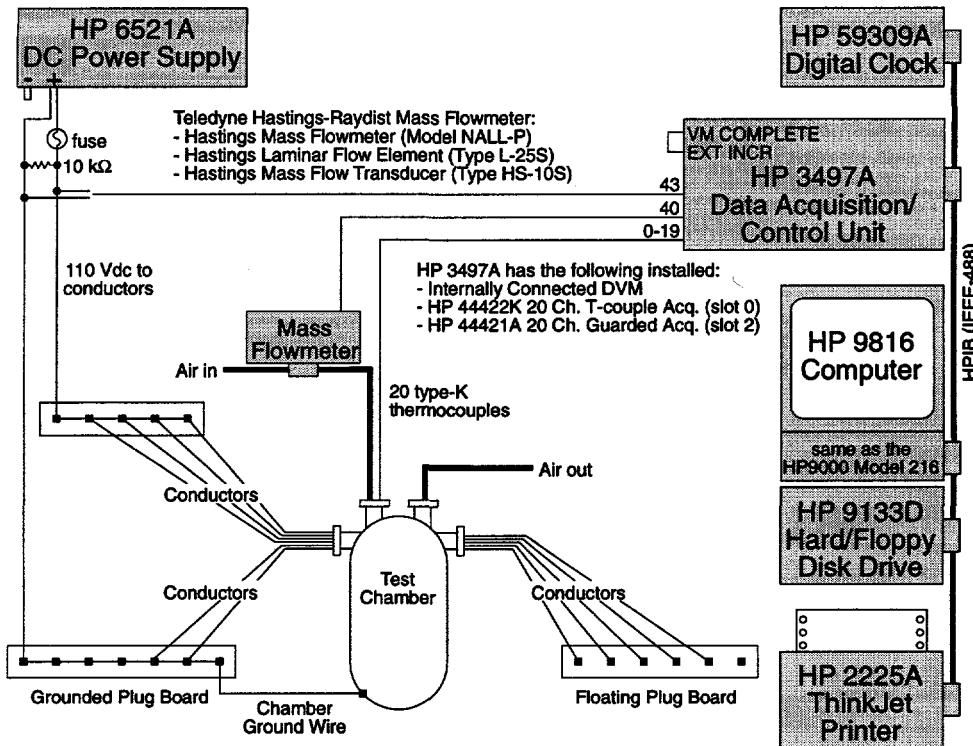
Figure 2.9: Schematic of the system used to monitor test chamber conditions during aging and accident irradiation.

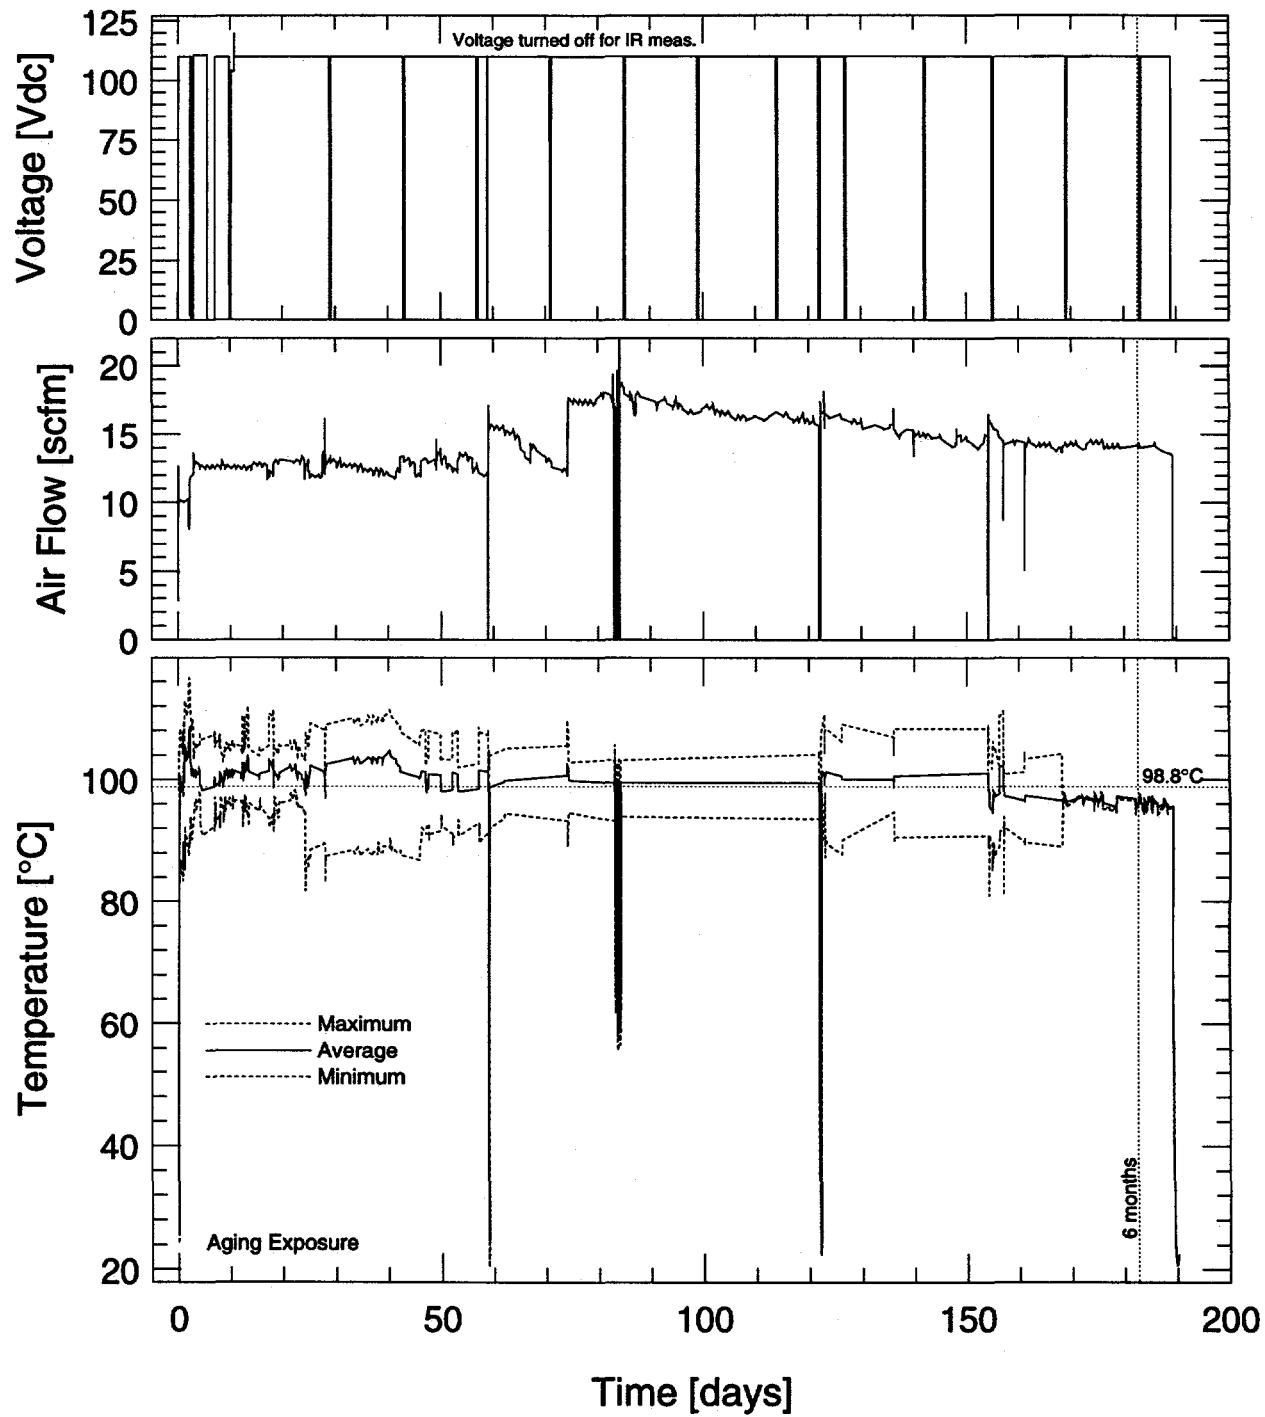
Figure 2.10: Temperature, airflow, and cable excitation during the simultaneous radiation and thermal aging exposure.

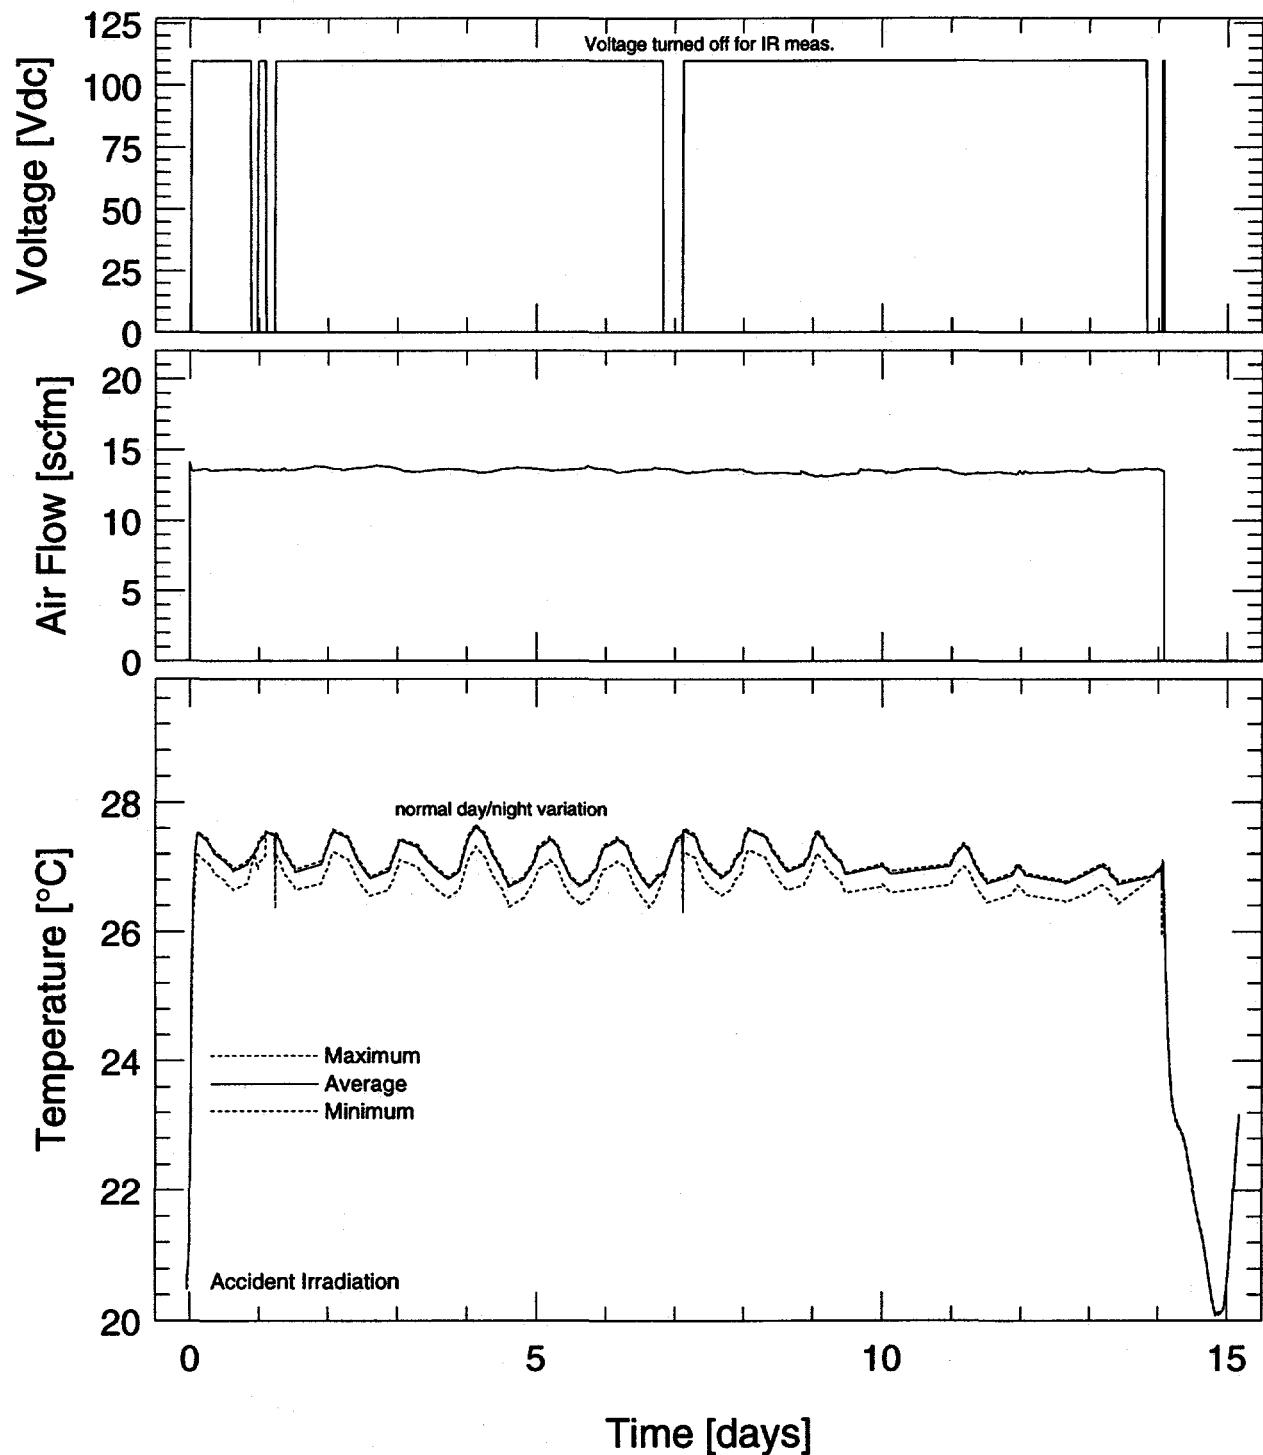
Figure 2.11: Temperature, airflow, and cable excitation during the accident radiation exposure.

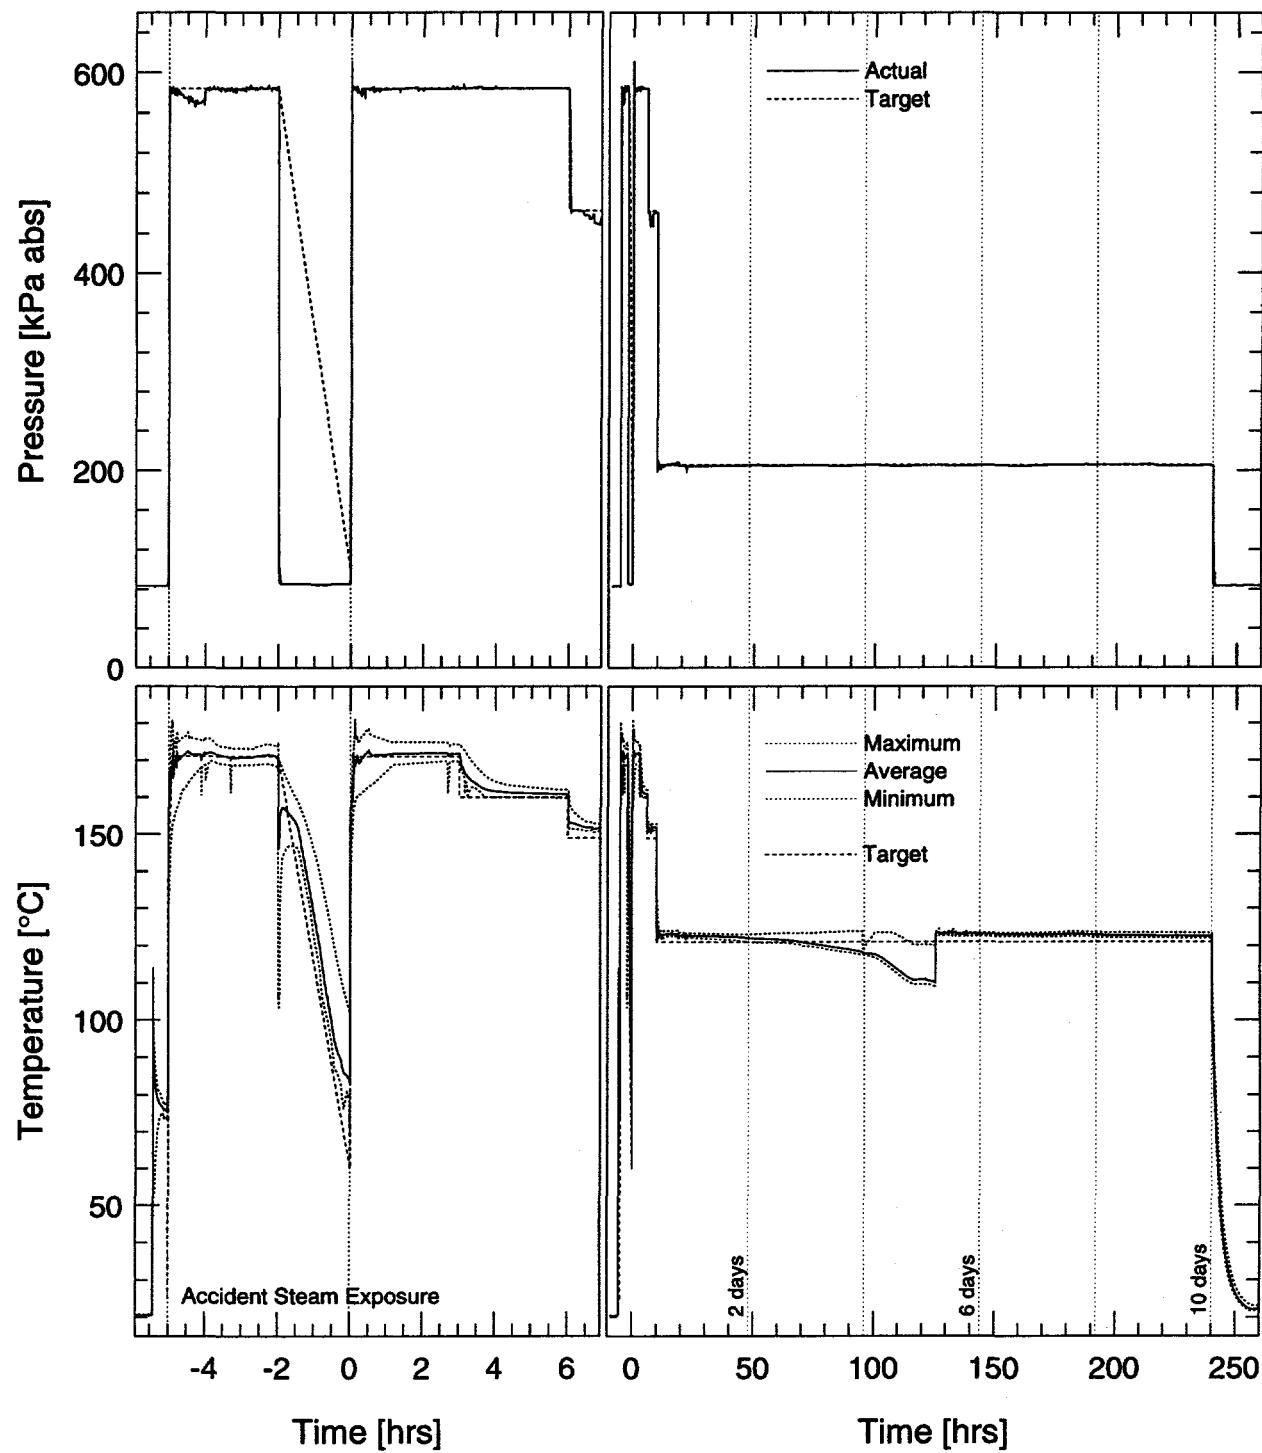
Figure 2.12: Pressure and temperature during the accident steam exposure.

test chamber and cable leads out of the LICA pool. Measurements at ambient temperature were performed before and after the accident steam exposure. The remainder of the IR measurements were acquired at the pressures and temperatures indicated in Table 2.6 and Figure 2.12.

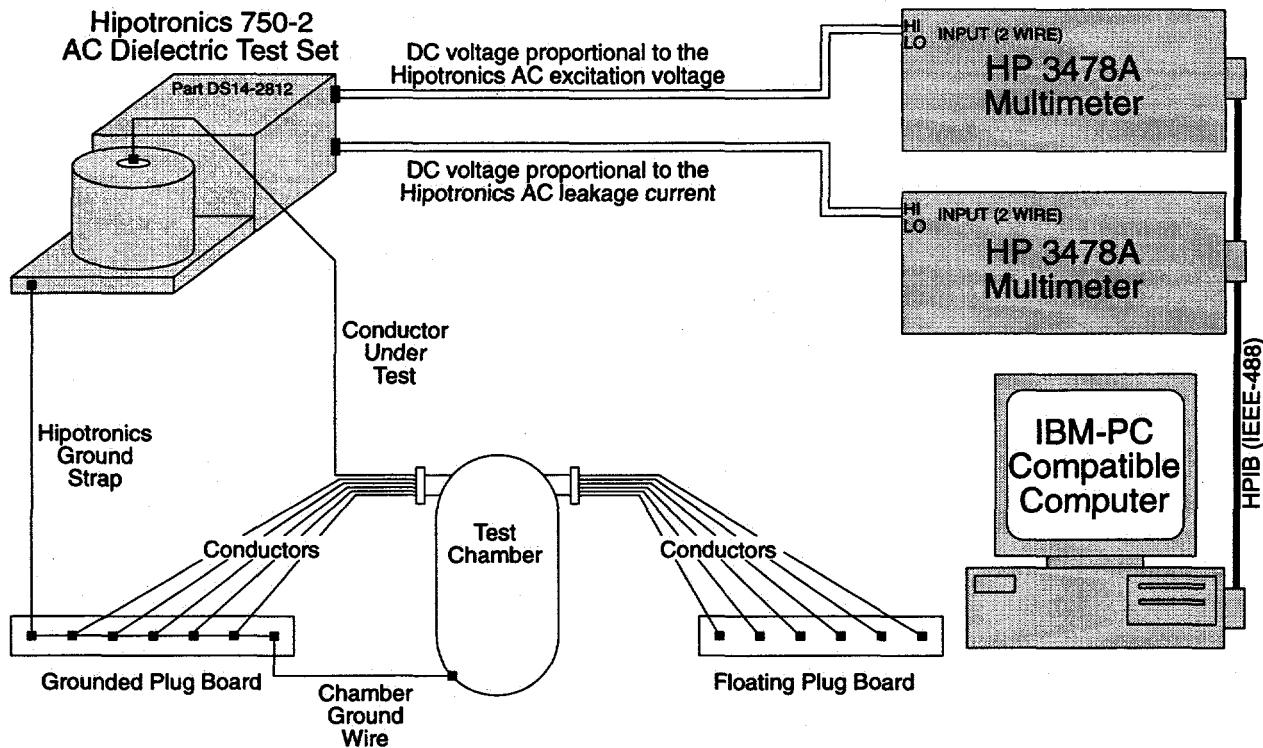
Figure 2.13: Schematic of the system used to measure ac leakage currents.

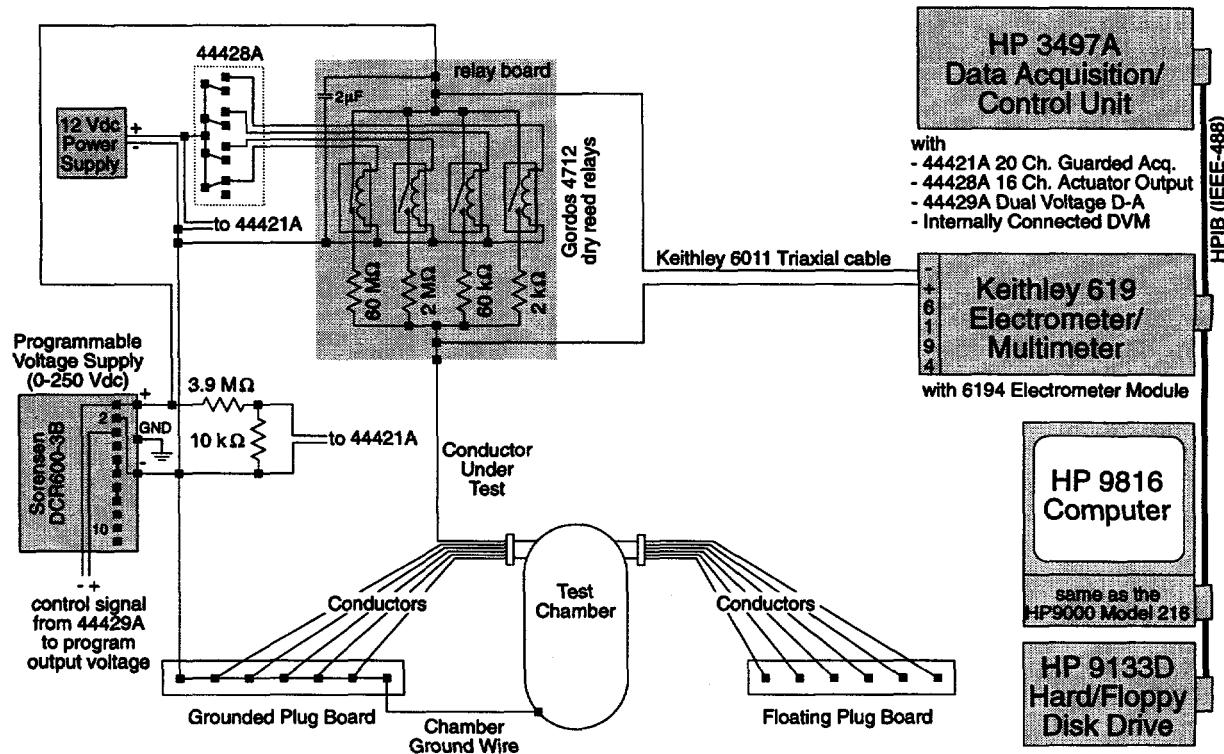
Figure 2.14: Schematic of the system used to perform discrete insulation resistance measurements.

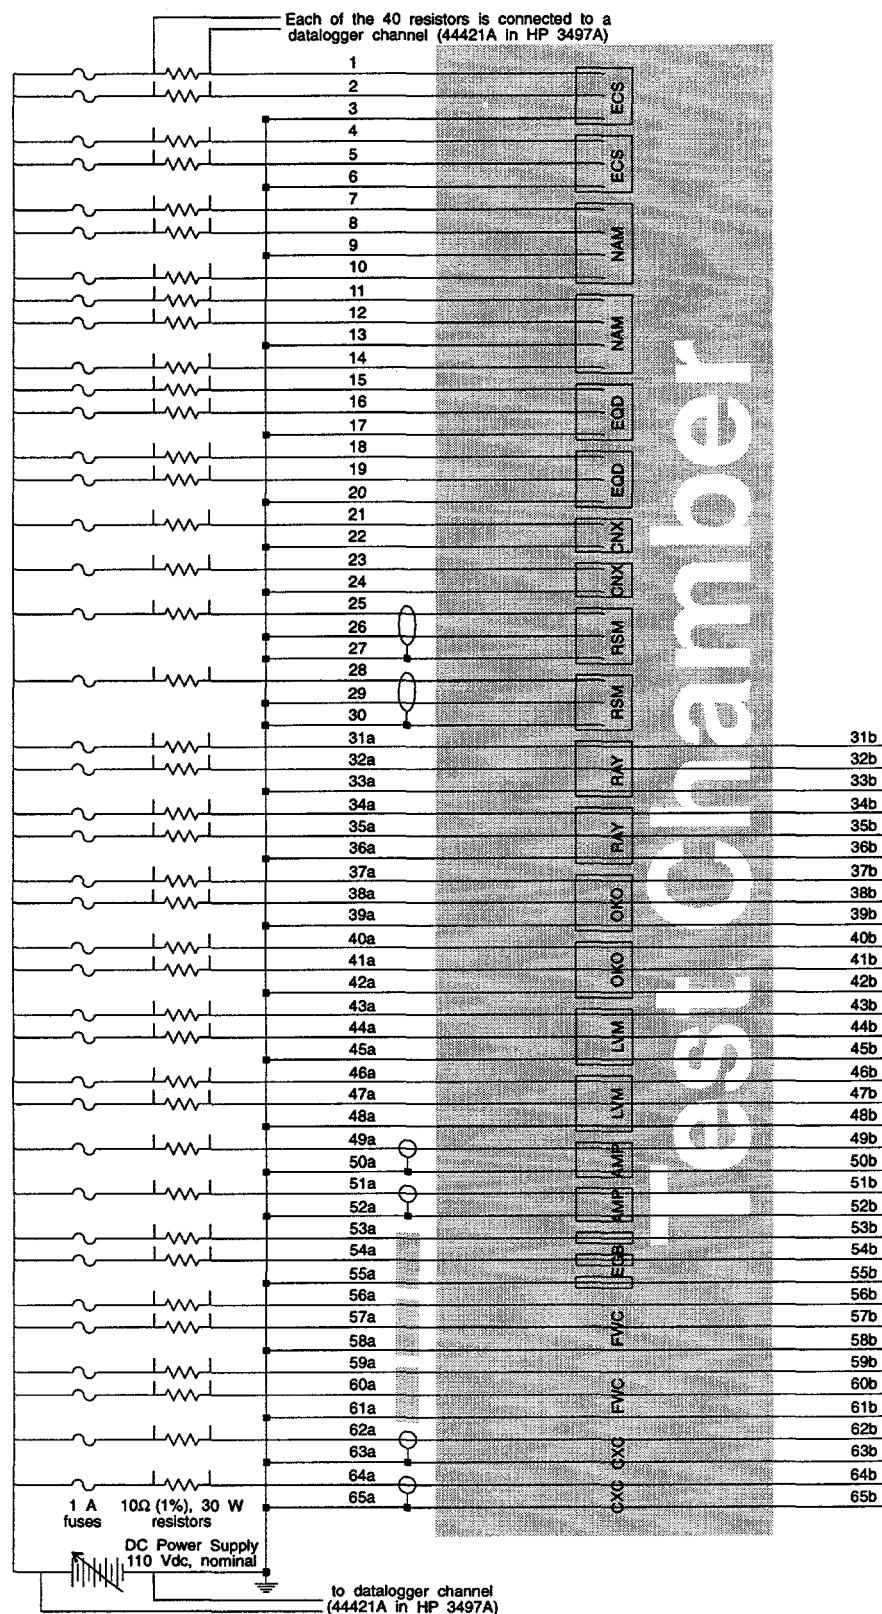
Figure 2.15: Circuitry used to measure continuous insulation resistance during the accident steam exposure.

During the accident steam exposure, IR measurements were performed using the circuit shown in Figure 2.15 in addition to the discrete IR measurements. These IRs are referred to as “continuous” IRs, even though they were not truly continuous—measurements were actually

performed at intervals ranging from 10 to 300 sec. The conductor numbers in the figure correspond to the numbers in Table 2.3. As indicated in Figure 2.15 and Table 2.3, one conductor or shield from each cable was connected to ground to provide a ground plane; no continuous IR measurements are available for these grounded conductors. Because of limitations in the accuracy of the measuring equipment, continuous IR measurements were cutoff above  $1.0 \times 10^8 \Omega$ , which is several orders of magnitude less than what could be measured with the discrete IR system. The continuous IR system is most useful for identifying short-term drops in IR values, such as during the initial transient of the accident steam exposure, that would otherwise be missed by the discrete IR system. A more complete discussion of the measurement limits of the continuous IR system appears in NUREG/CR-5772, Vol. 1 [21, Section 2.4.3].

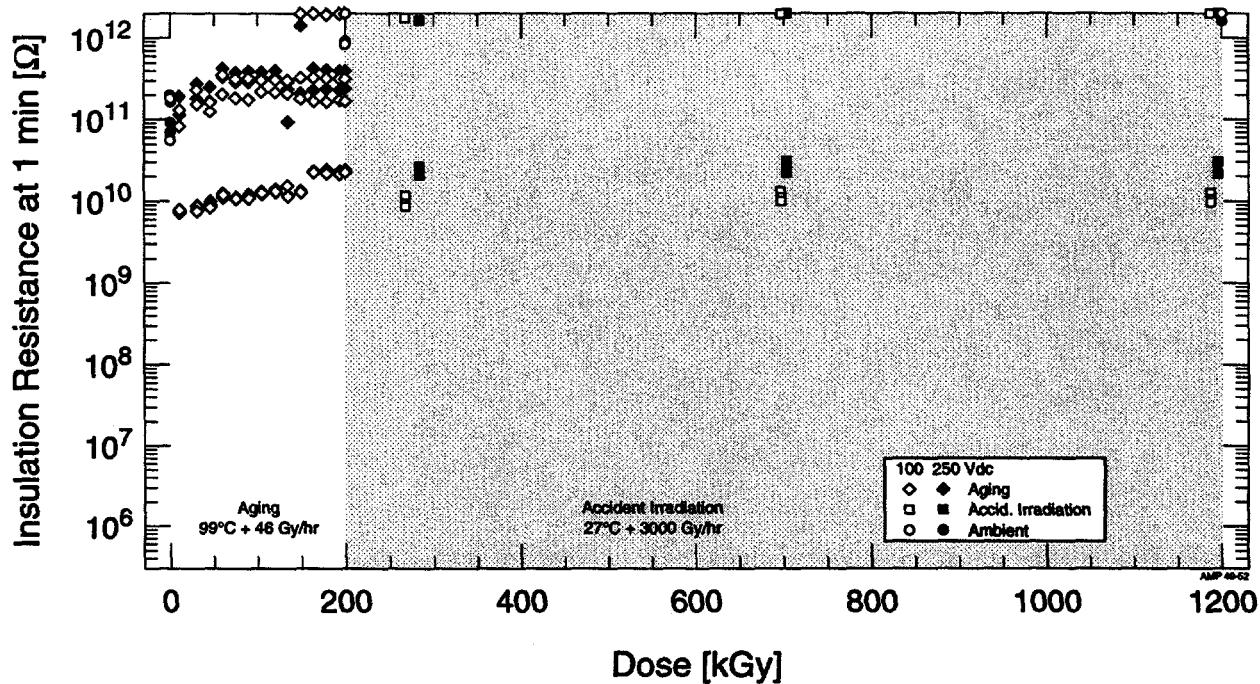
Figure 3.1: IR of the Amphenol coaxial connector conductors during aging and accident irradiation.

Only IR data were acquired during the simultaneous thermal and radiation aging exposure. These data are plotted against radiation dose in Figures 3.1-3.12.<sup>2</sup> In these figures, a data point is plotted for every IR measurement (*i.e.*, every IR measurement for each of the connection's conductors, not average data, is shown). The IR measurements during the aging exposure were performed with the test chamber and cable leads submerged in the LICA pool, except for the measurements at ambient temperature, which were performed with the test chamber and cable leads out of the LICA pool before the start of the aging exposure and between the aging exposure and accident irradiation. The ambient IR measurements were typically greater than the IR values acquired at the higher temperatures present during the aging exposure.

Only IR data were acquired during the accident radiation exposure. These data are plotted versus radiation dose in Figures 3.1–3.12 along with the aging IR data. In these figures, a data point is plotted for every IR measurement. The IR measurements during the accident irradiation were performed with the test chamber and cable leads submerged in the LICA pool, except for the measurements at ambient temperature, which were performed with the test chamber and cable leads out of the LICA pool between the aging exposure and accident irradiation and after the accident irradiation. The ambient IR measurements were typically greater than those acquired during the accident irradiation.
