**NUREG/CR-6412  
SAND97-3170**

# **Aging and Loss-of-Coolant Accident (LOCA) Testing of Electrical Connections**

Prepared by  
C.F. Nelson

Sandia National Laboratories

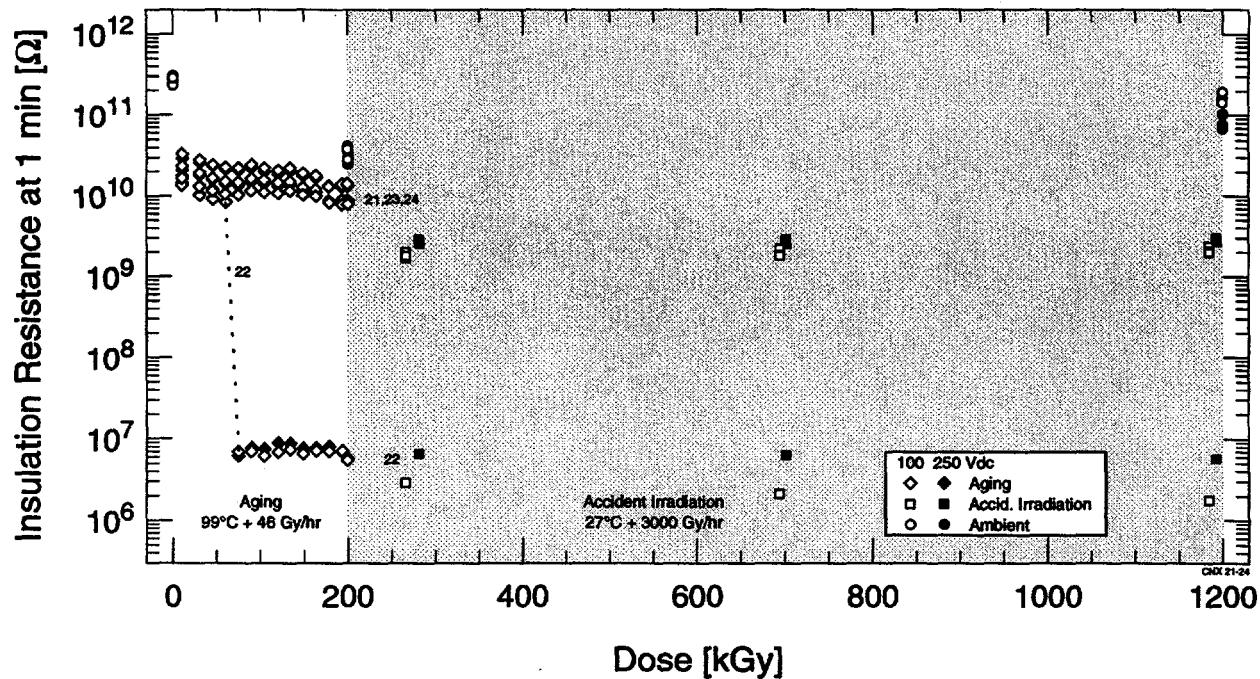
Figure 3.2: IR of the Conax Buffalo ECSA conduit seal conductors during aging and accident irradiation.

- Conductor 22 from a Conax Buffalo ECSA conduit seal also had reduced IR values during aging (see Figure 3.2); the  $8.3 \times 10^9 \Omega$  measurement at 60 kGy fell to  $7.0 \times 10^6 \Omega$  at 75 kGy and remained at these low levels for the remainder of the aging exposure. The other 3 conductors typically had IR values above  $10^{10} \Omega$ .

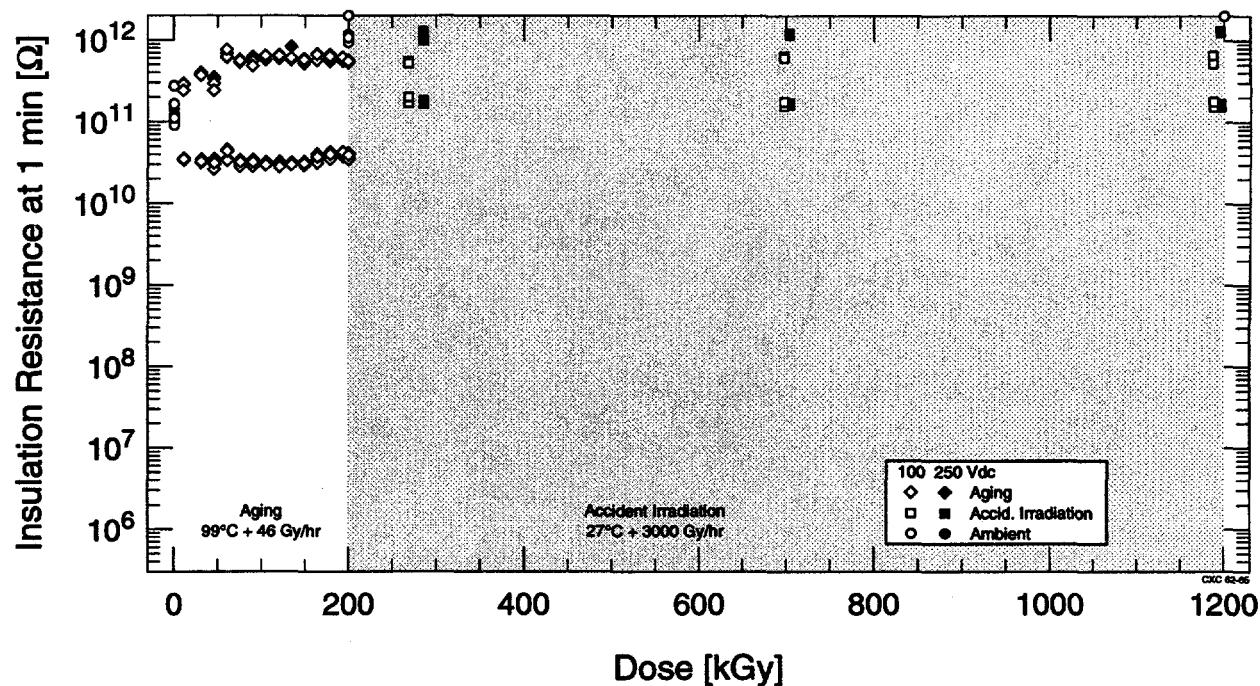
Figure 3.3: IR of the Rockbestos coaxial cable conductors during aging and accident irradiation.

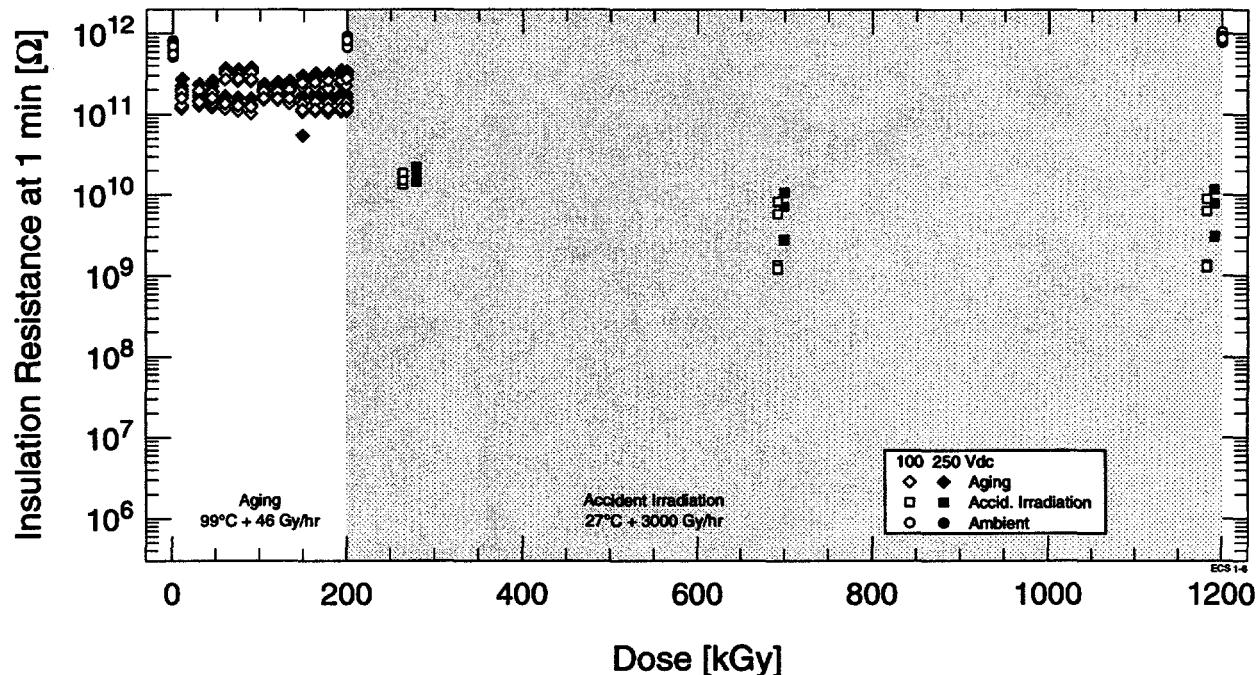
Figure 3.4: IR of the EGS conduit seal conductors during aging and accident irradiation.

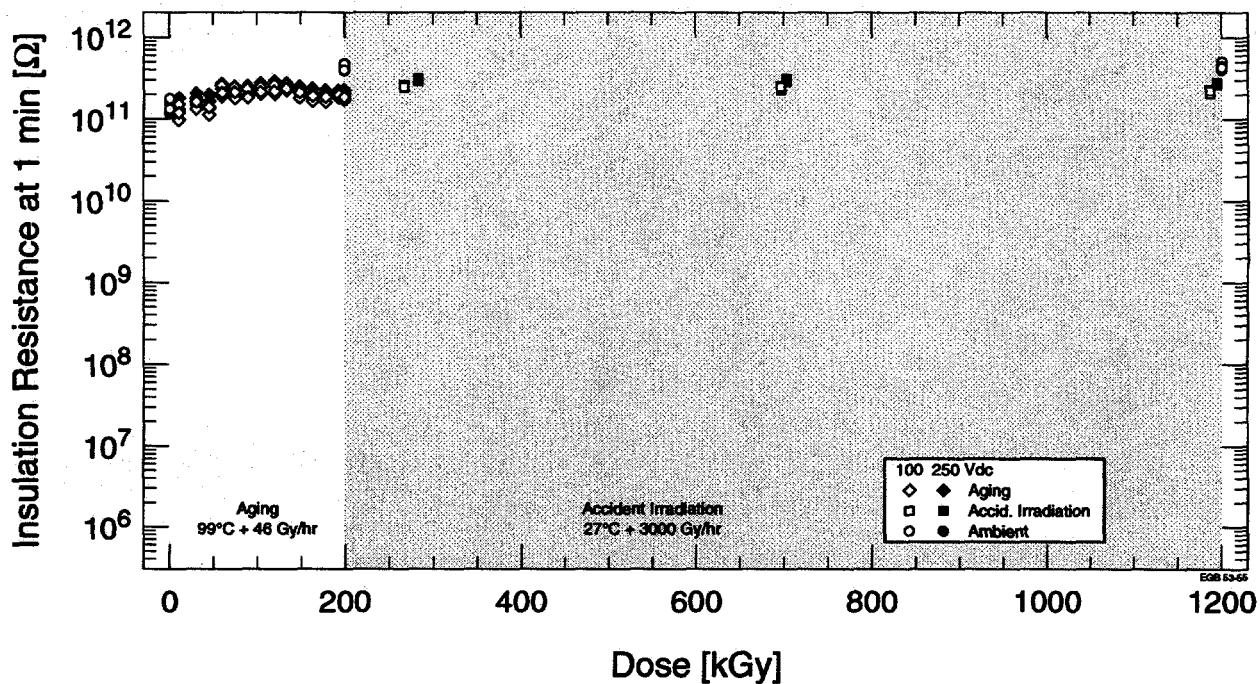
Figure 3.5: IR of the EGS Grayboot connector conductors during aging and accident irradiation.

- Two of the three EGS Grayboot connectors were installed with a snap-on plastic cover intended to prevent the connector from pulling apart; only one of the two covered connectors was cycled. After 2 months of aging, the plastic cover was very brittle and broke apart when it was removed to cycle the connector (conductor 54). The test was continued without a plastic cover over this connector. When the 2 Grayboot connectors were cycled after 4 months of aging, the lubricant between the mating halves of the connections was dried out and had the appearance of rolled-up rubber cement. However, enough lubricant remained that the two connectors could be cycled easily. These issues had no negative effect on the IR data (see Figure 3.5), which were in the range of  $10^{11} \Omega$  and above.

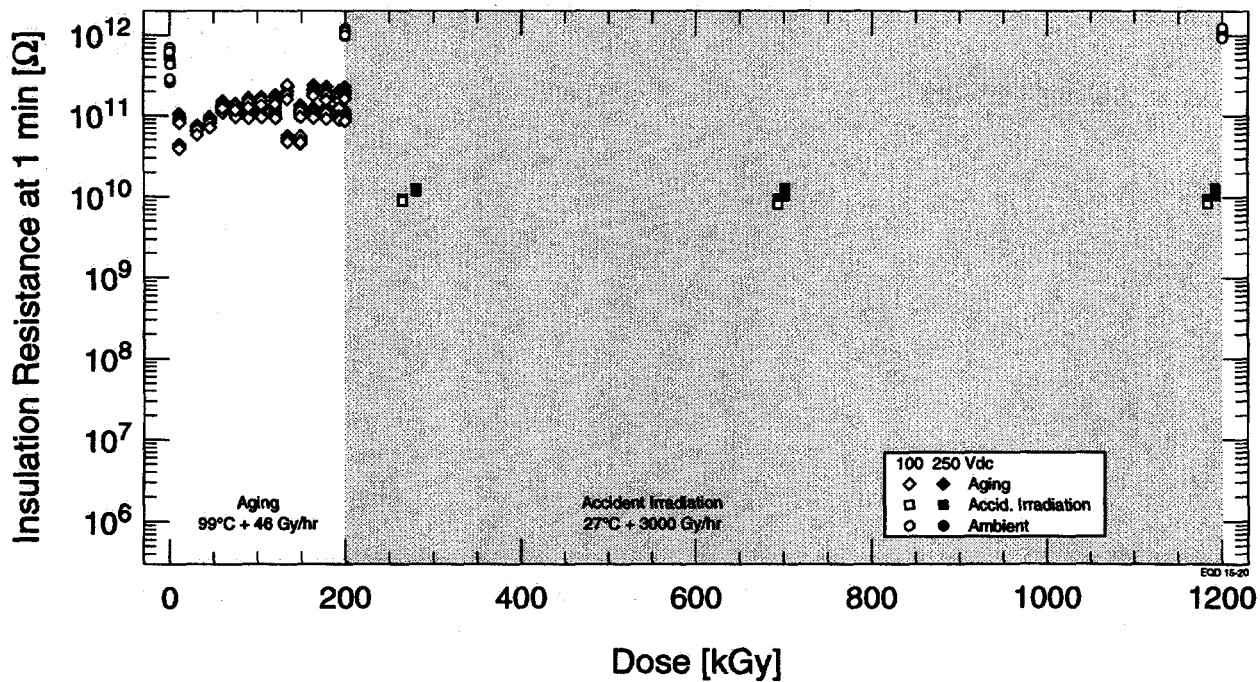
Figure 3.6: IR of the EGS quick-disconnect connector conductors during aging and accident irradiation.

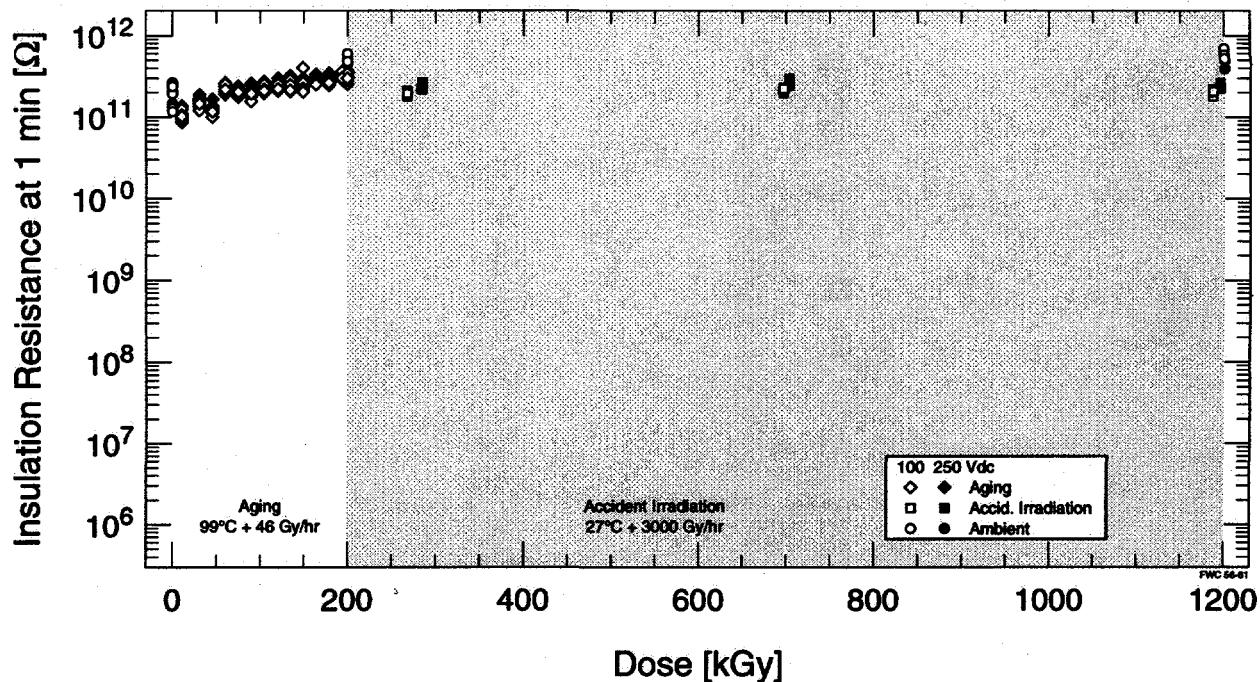
Figure 3.7: IR of the Rockbestos Firewall III cable conductors during aging and accident irradiation.

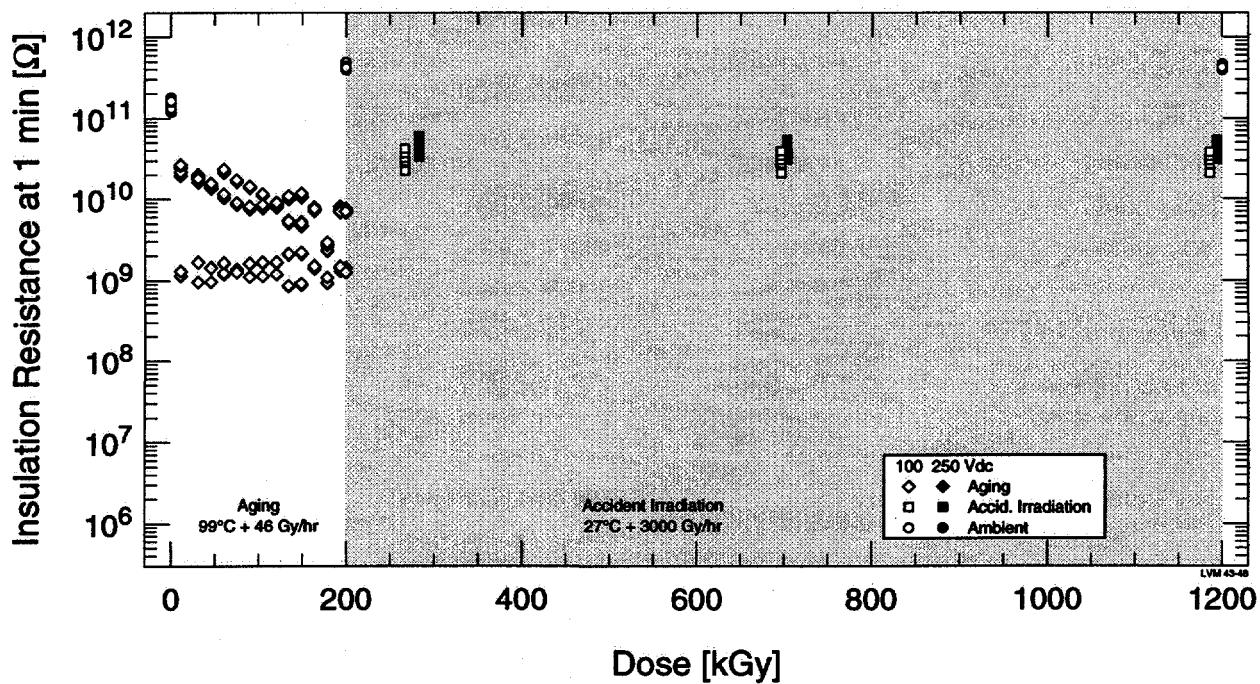
Figure 3.8: IR of the Litton-VEAM connector conductors during aging and accident irradiation.

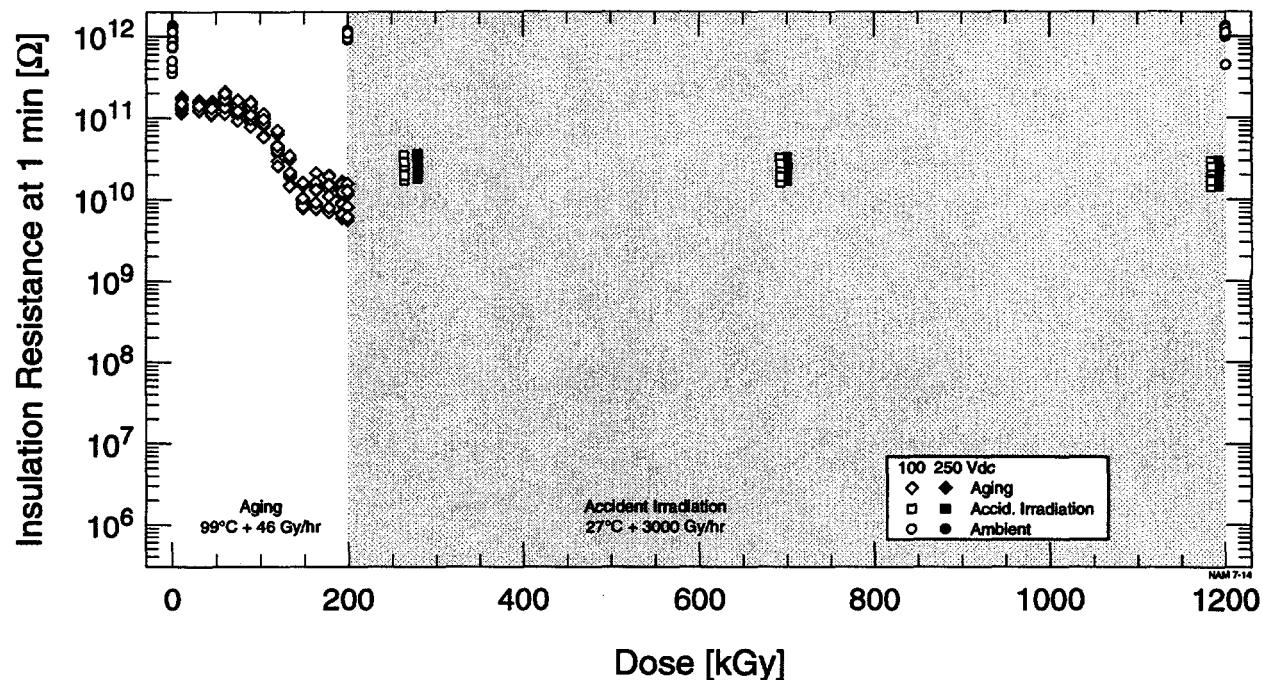
Figure 3.9: IR of the NAMCO EC210 connector conductors during aging and accident irradiation.

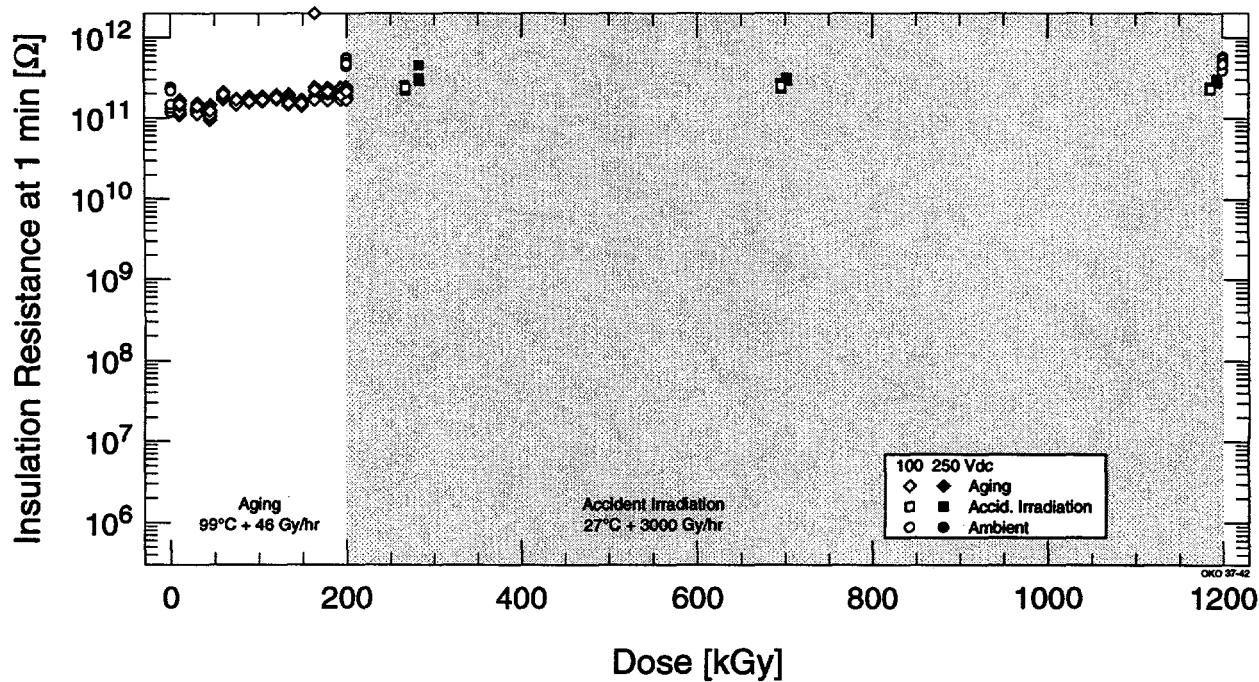
Figure 3.10: IR of the Okonite tape splice conductors during aging and accident irradiation.

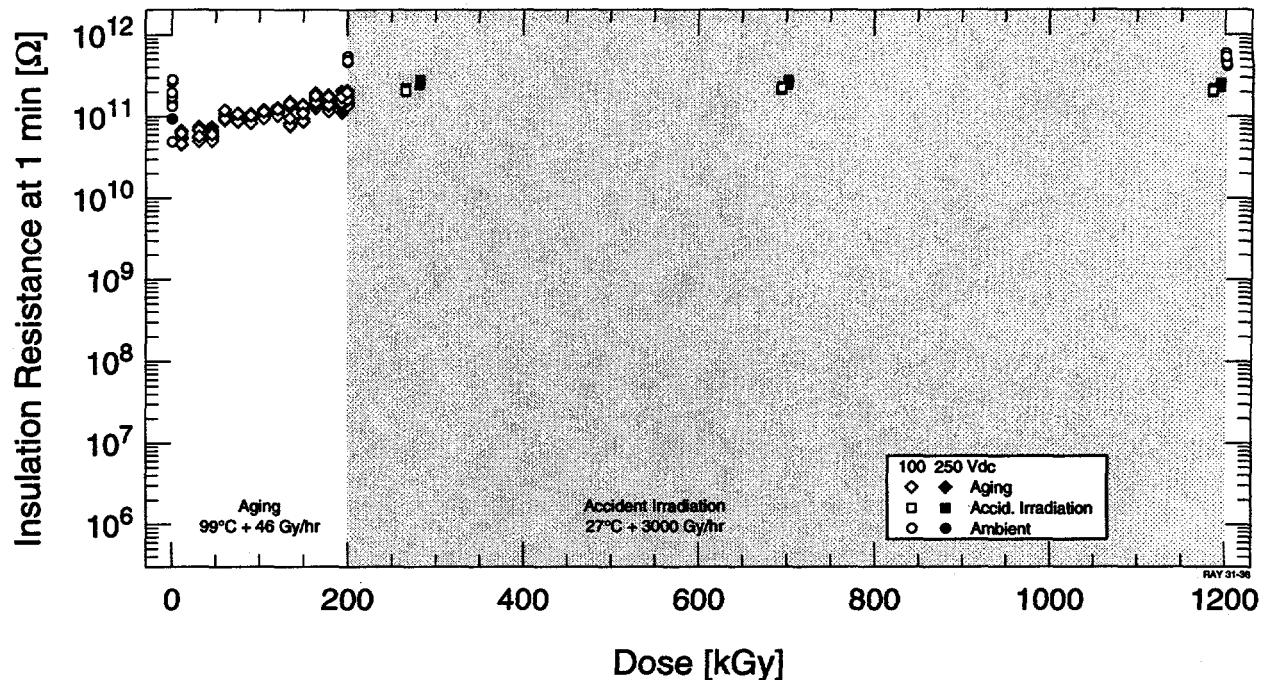
Figure 3.11: IR of the Raychem heat-shrink splice conductors during aging and accident irradiation.

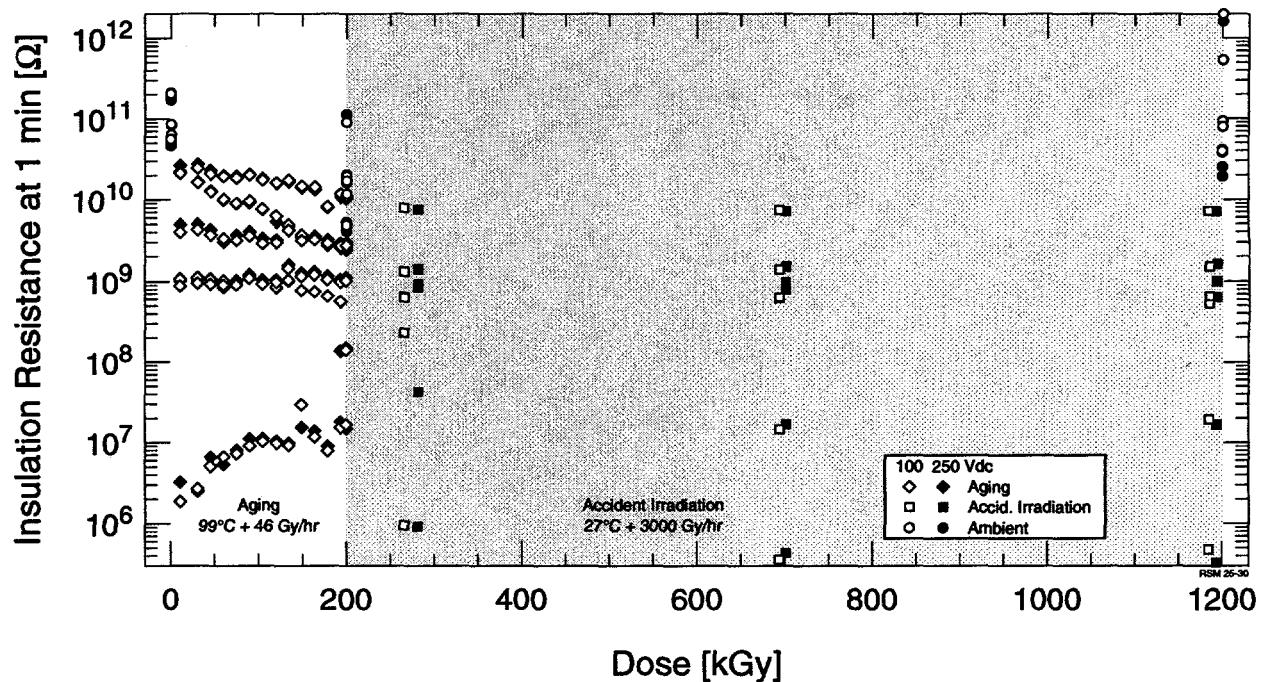
Figure 3.12: IR of the Rosemount 353C conduit seal conductors during aging and accident irradiation.

- The lowest IR values during the aging exposure were for the Rosemount 353C conduit seal (see Figure 3.12). The IR of conductor 28 (cable shield) fell immediately from an initial value of  $8.4 \times 10^{10} \Omega$  to  $1.9 \times 10^6 \Omega$  and then slowly increased to approximately  $2 \times 10^7 \Omega$  during the remainder of the aging exposure. The IR values of the other 3 conductors and 2 shields remained above  $10^8 \Omega$ .

- In all cases, the IR values during the accident irradiation remained relatively constant as the dose increased.
- Just as for the aging exposure, the lowest IR values during the accident irradiation were for the Rosemount 353C conduit seal (see Figure 3.12). Conductor 25 had IR values in the range of  $3 \times 10^5$  to  $1 \times 10^6 \Omega$  and conductor 28 had IR values near  $2 \times 10^7 \Omega$ . The other 2 conductors and 2 shields typically had IR values in the range of  $5 \times 10^8 \Omega$  and above.
- Conductor 22 from a Conax Buffalo ECSA conduit seal (see Figure 3.2) also had reduced IR values of approximately  $2 \times 10^6 \Omega$  for the duration of the accident irradiation. The other 3 conductors had IR values near  $2 \times 10^9 \Omega$ .

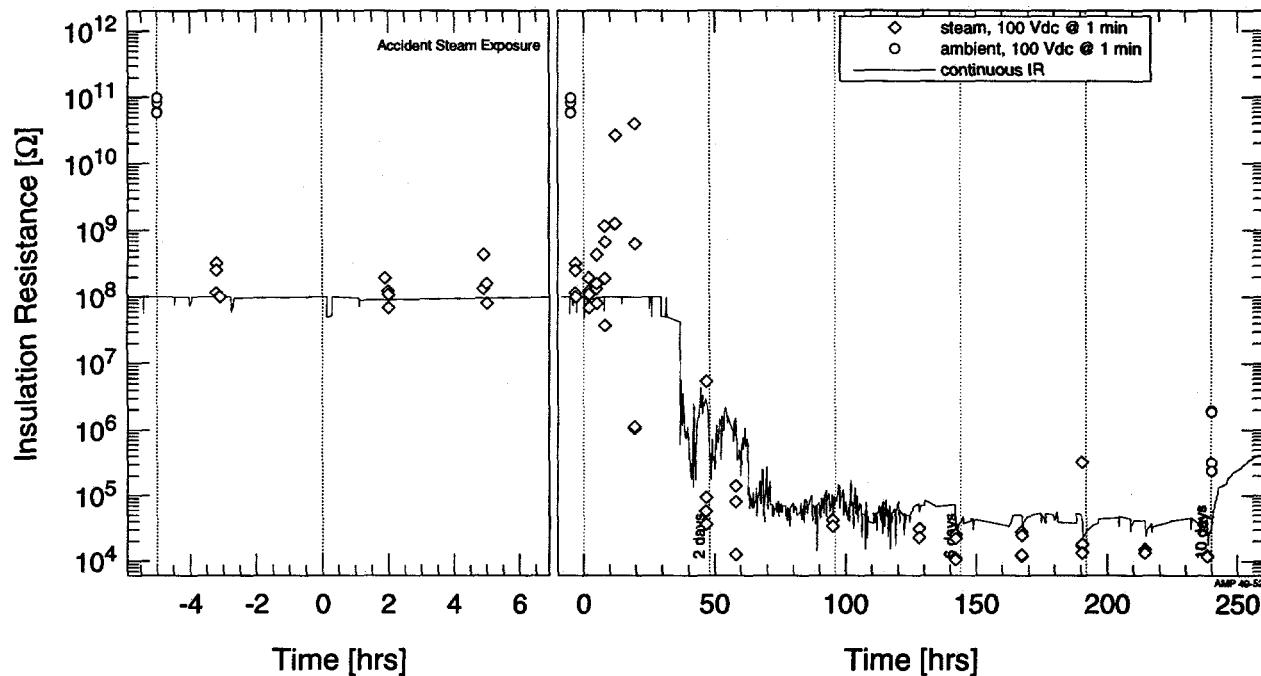
Figure 3.13: IR of the Amphenol coaxial connector conductors during the accident steam exposure.

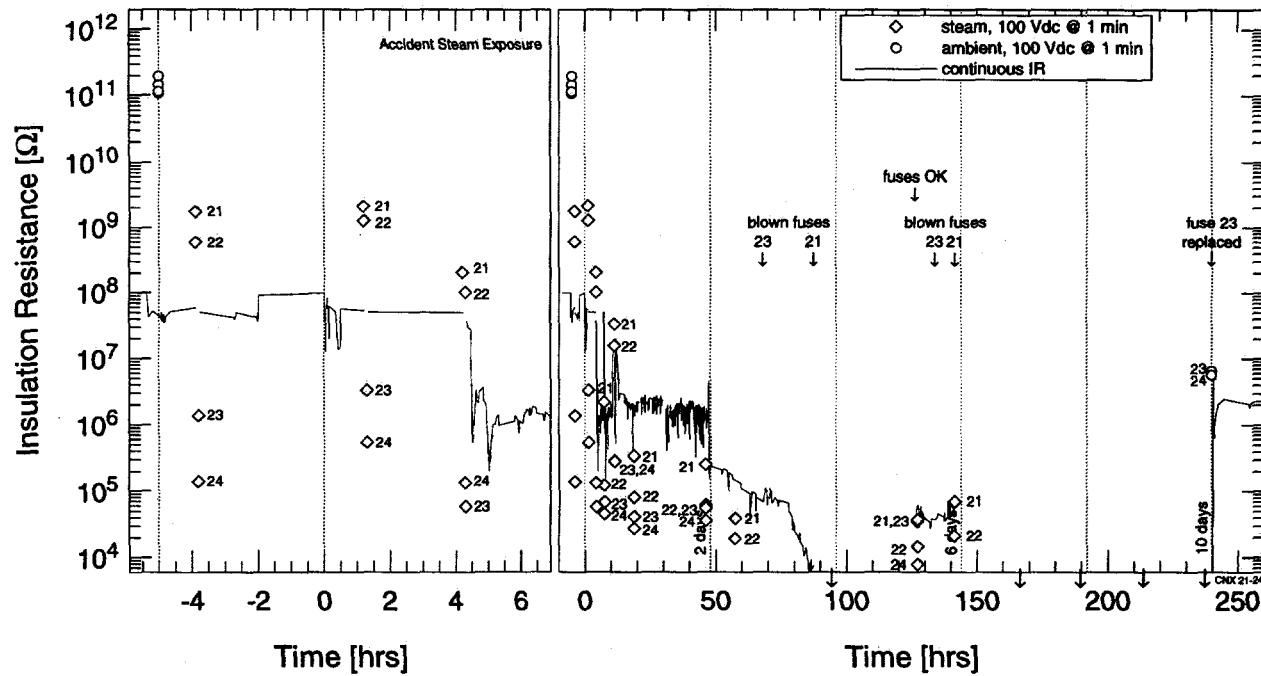
Figure 3.14: IR of the Conax Buffalo ECSA conduit seal conductors during the accident steam exposure.

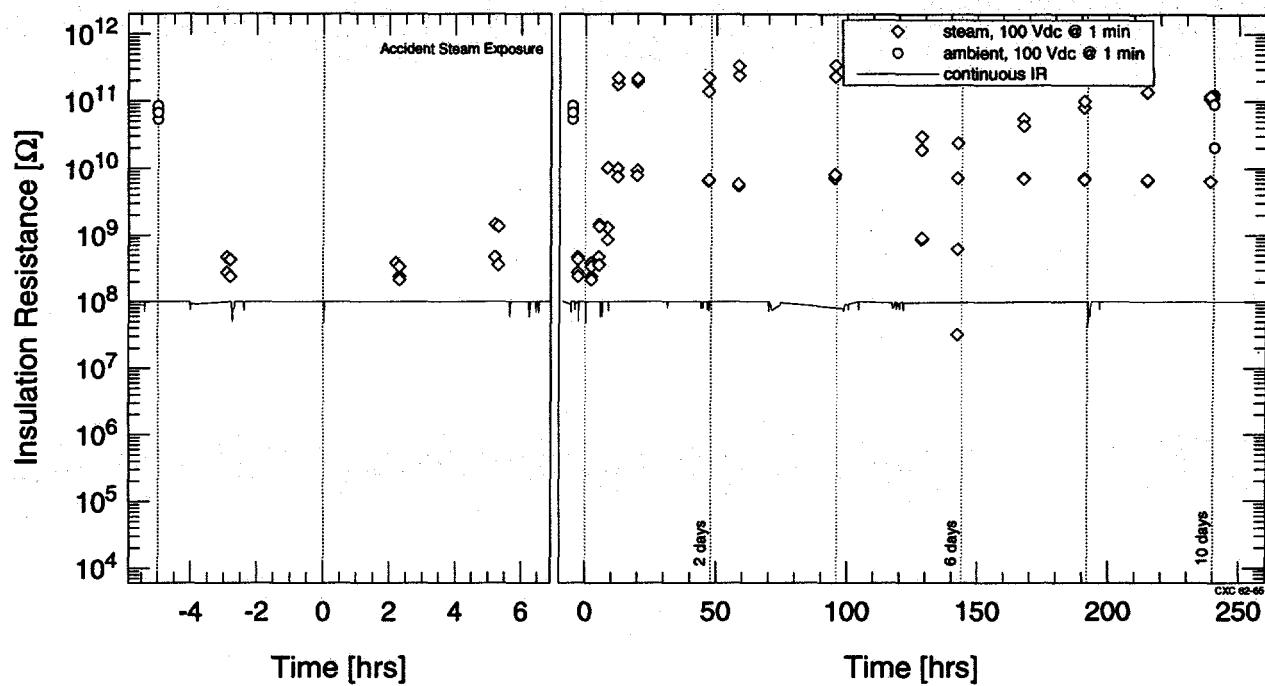
Figure 3.15: IR of the Rockbestos coaxial cable conductors during the accident steam exposure.

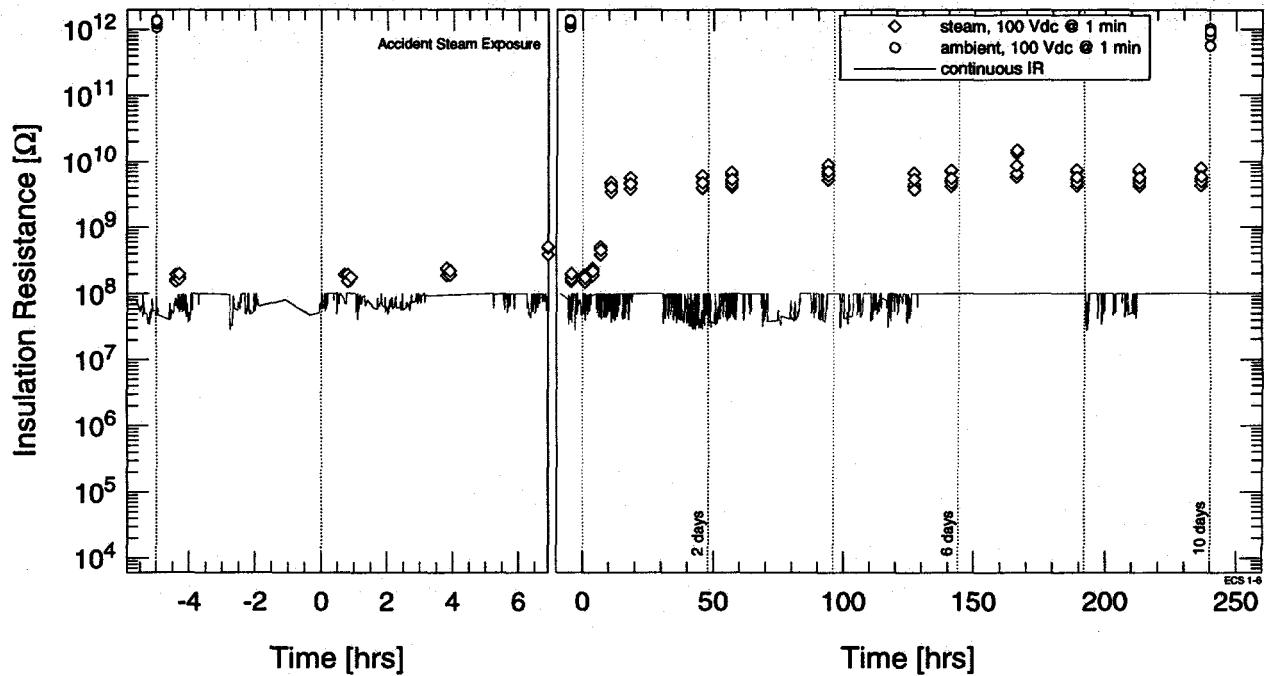
Figure 3.16: IR of the EGS conduit seal conductors during the accident steam exposure.

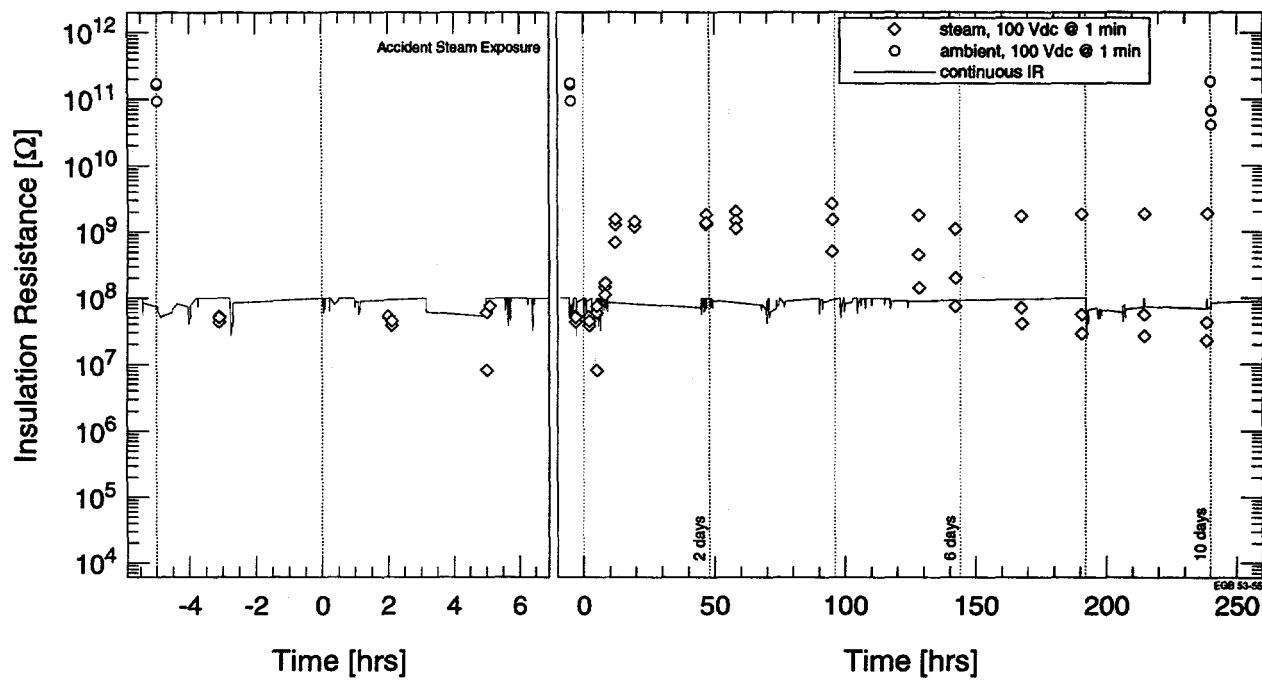
Figure 3.17: IR of the EGS Grayboot connector conductors during the accident steam exposure.

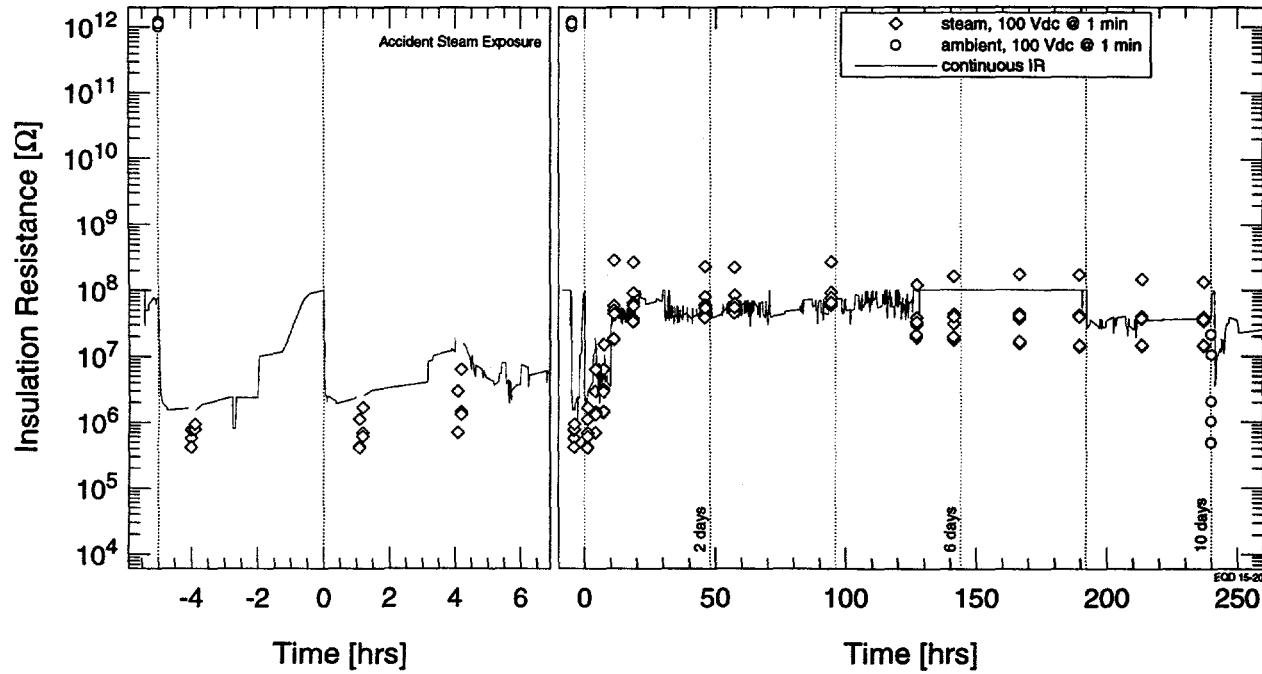
Figure 3.18: IR of the EGS quick-disconnect connector conductors during the accident steam exposure.

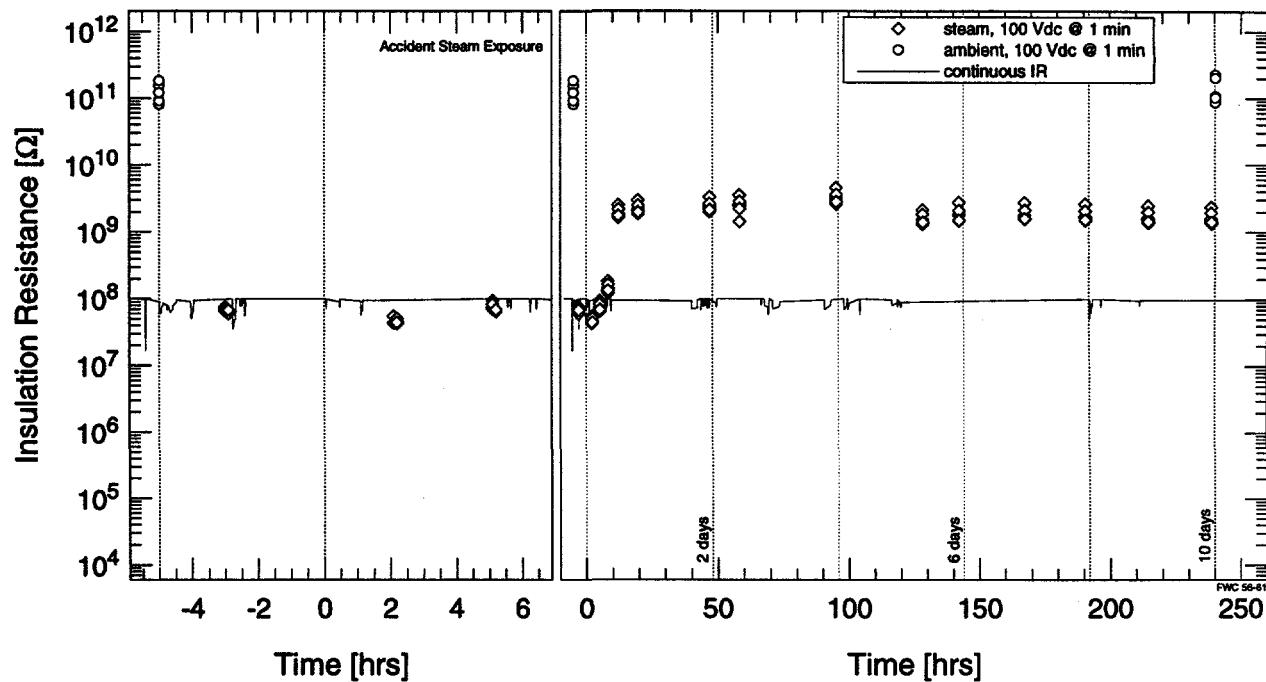
Figure 3.19: IR of the Rockbestos Firewall III cable conductors during the accident steam exposure.

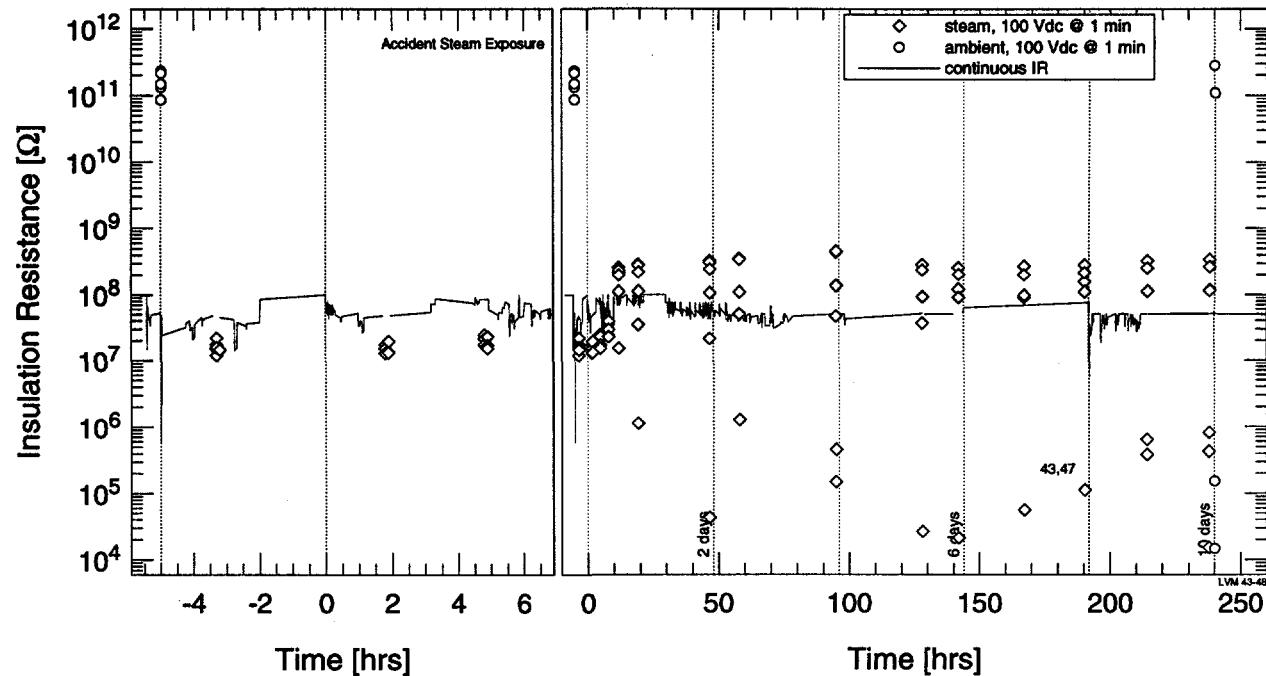
Figure 3.20: IR of the Litton-VEAM connector conductors during the accident steam exposure.

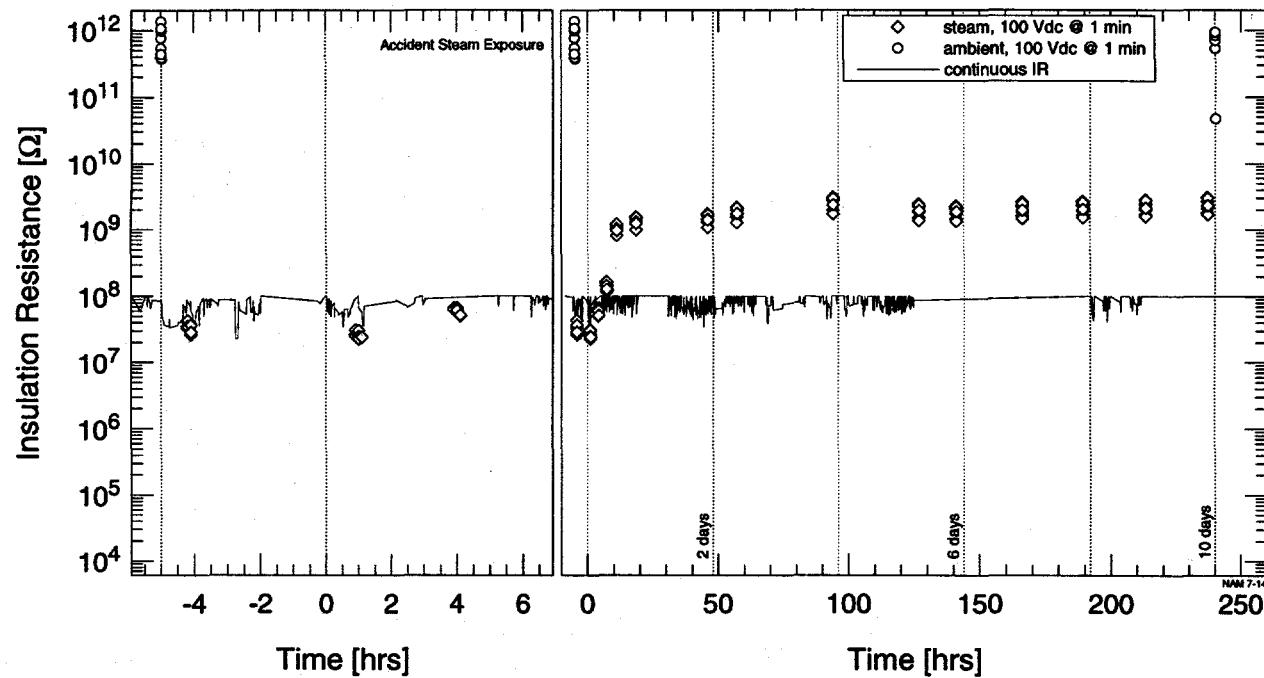
Figure 3.21: IR of the NAMCO EC210 connector conductors during the accident steam exposure.

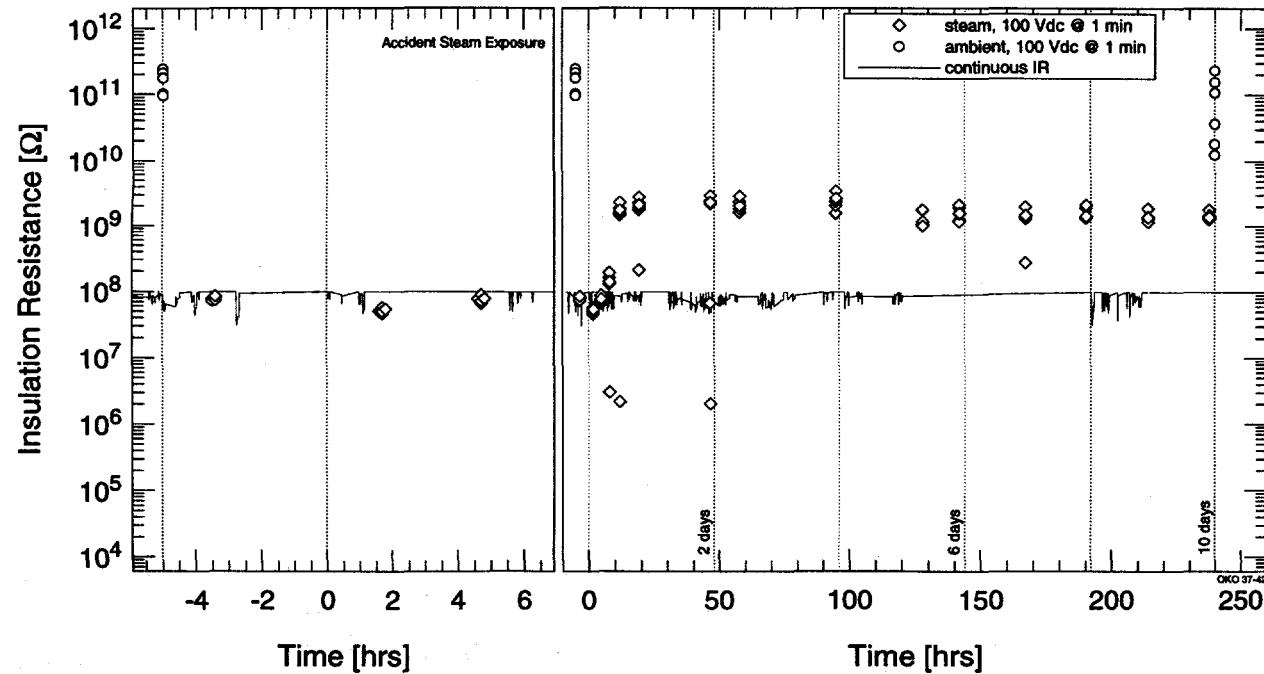
Figure 3.22: IR of the Okonite tape splice conductors during the accident steam exposure.

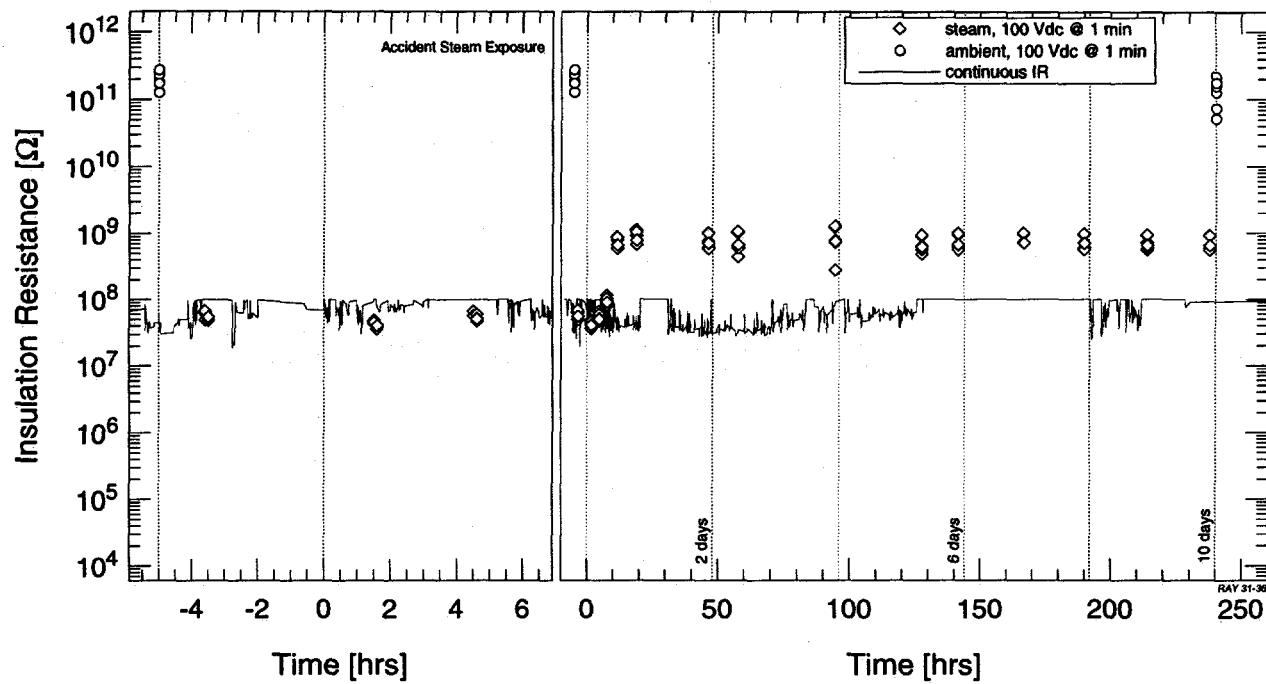
Figure 3.23: IR of the Raychem heat-shrink splice conductors during the accident steam exposure.

Several of the connections were installed using Rockbestos Firewall III cable. Of these, the measured IR of the EGS conduit seal (Figure 3.16), EGS Grayboot connector (Figure 3.17), Okonite tape splice (Figure 3.22), and the Raychem heat-shrink splice (Figure 3.23) were all very similar to that of the Rockbestos Firewall III cable in Figure 3.19. This indicates that these connections had IR values that were comparable or better than the Rockbestos cable. The measured IR of the NAMCO EC210 connector (Figure 3.21) was also very similar even though it used a different type of cable.

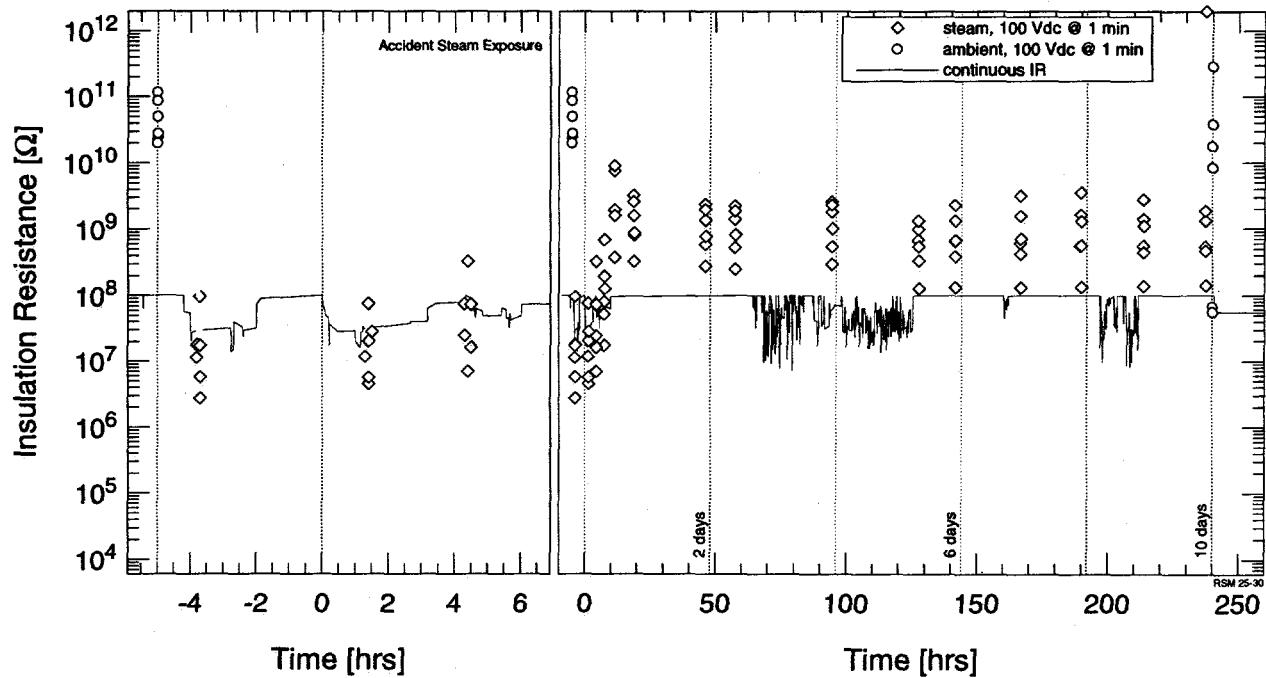
Figure 3.24: IR of the Rosemount 353C conduit seal conductors during the accident steam exposure.

The IR results for the Rosemount 353C conduit seal (Figure 3.24) during the accident steam exposure were only slightly degraded, if at all, from the values seen during the aging exposure and accident irradiation (Figure 3.12) — the reason for this “recovery” in IR is unknown.

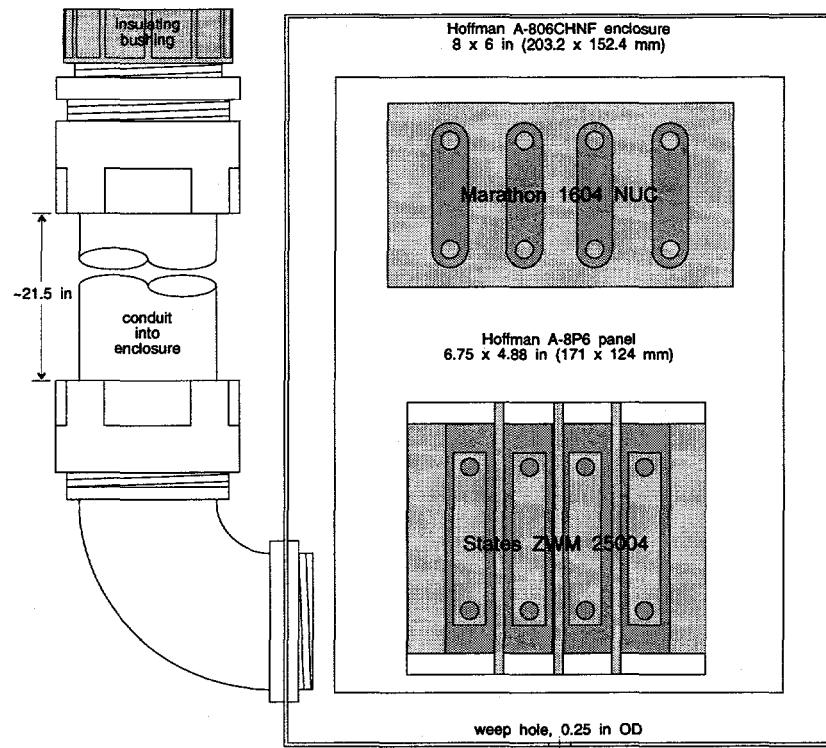
Figure A.1: Sketch of the two terminal blocks inside an enclosure.

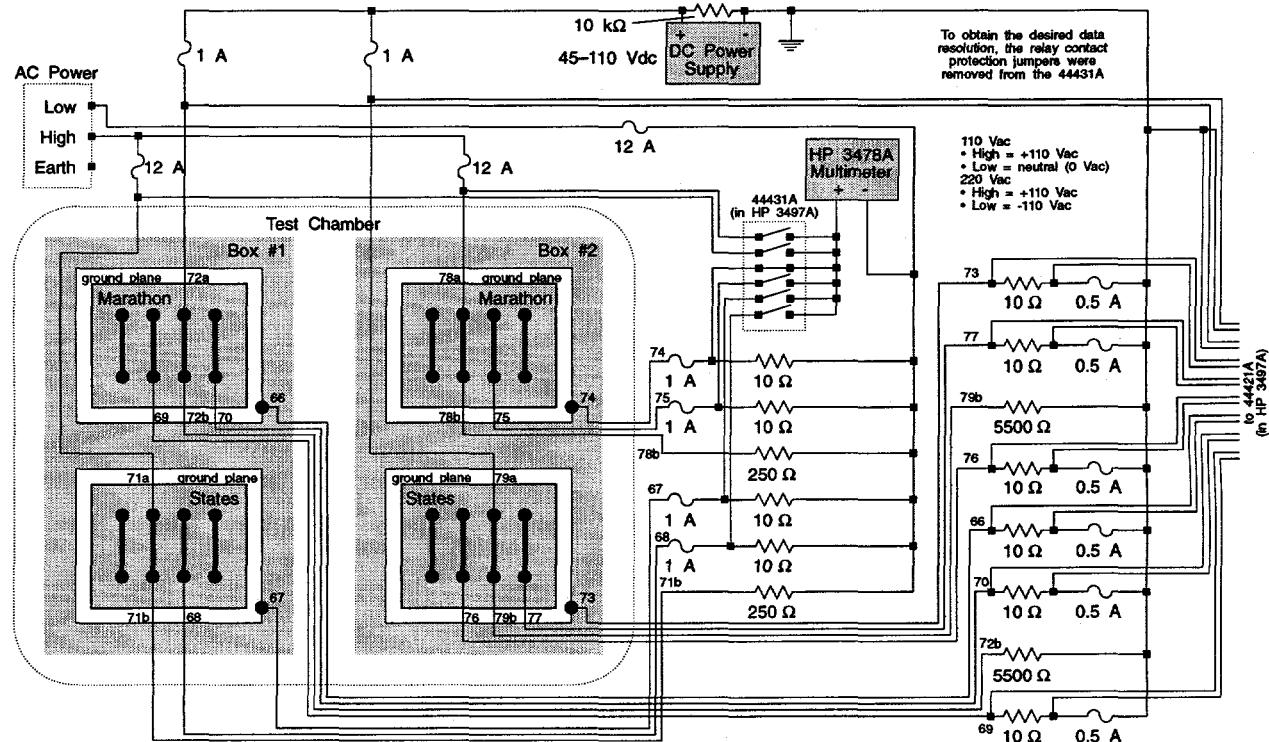
Figure A.2: Circuit used for dc and ac excitation of the terminal block conductors and to measure their "continuous" IRs during the accident steam exposure.

<sup>a</sup>See Table A.3 and Figure A.2 for identification of which cable the conductor came from and how the conductor was used.
