**NUREG/CR-6412  
SAND97-3170**

# **Aging and Loss-of-Coolant Accident (LOCA) Testing of Electrical Connections**

Prepared by  
C.F. Nelson

Sandia National Laboratories

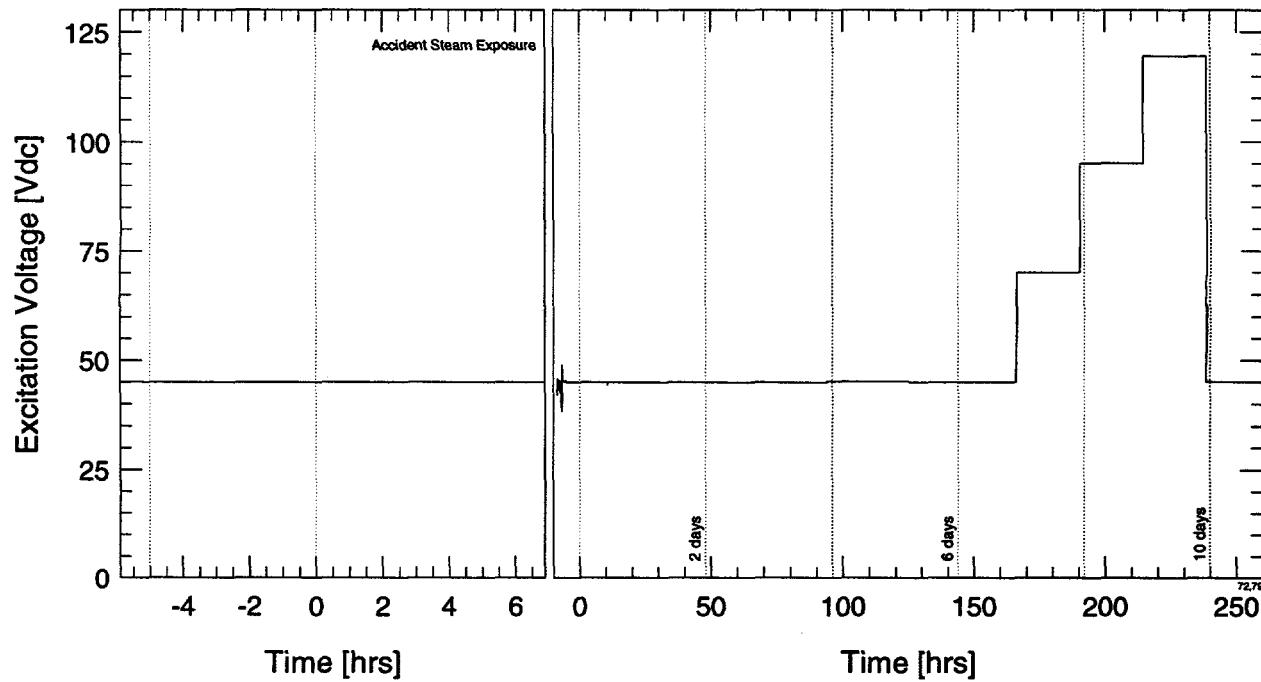
Figure A.3: Direct current excitation for the terminal block conductors during the accident steam exposure.

- The Marathon terminal block in enclosure 1 and the States terminal block in enclosure 2 were energized continuously with 45 to 110 Vdc. The actual dc energization is shown in Figure A.3.
- The States terminal block in enclosure 1 and the Marathon terminal block in enclosure 2 were switched between 110 Vac, 220 Vac, and unenergized. This allowed measurement of terminal block transient leakage currents during the accident steam exposure. The actual ac energization is shown in Figure A.4.

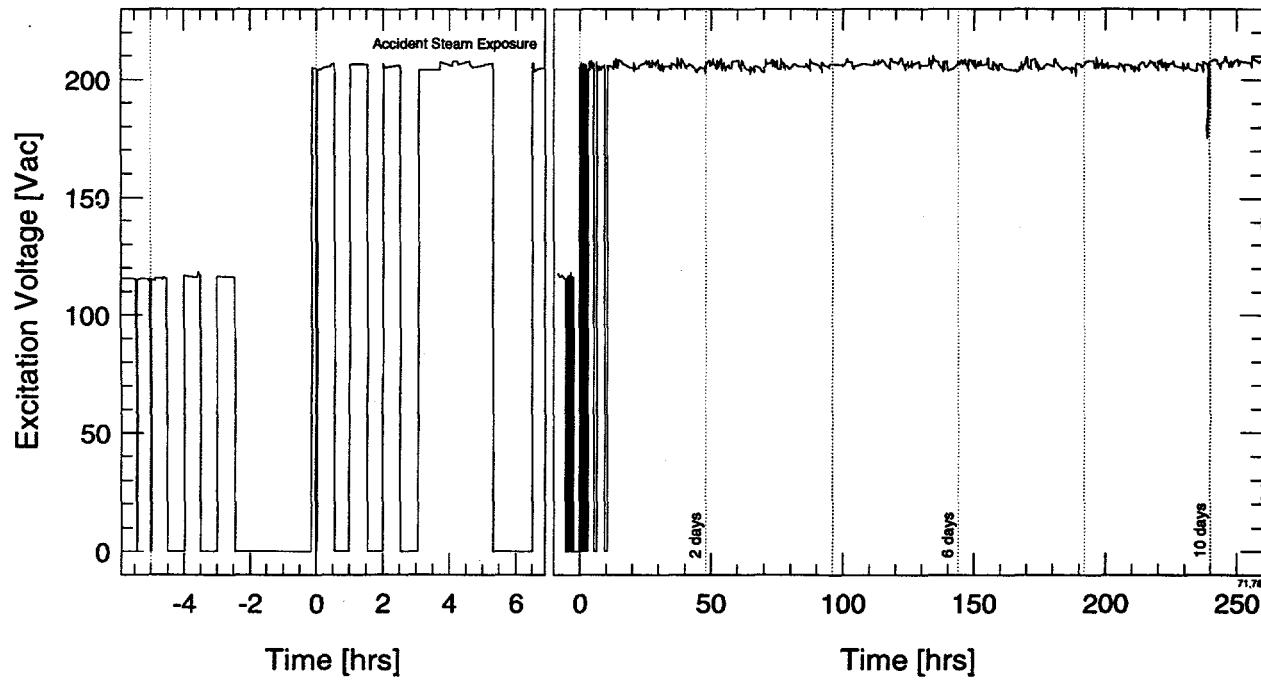
Figure A.4: Alternating current excitation for the terminal block conductors during the accident steam exposure.

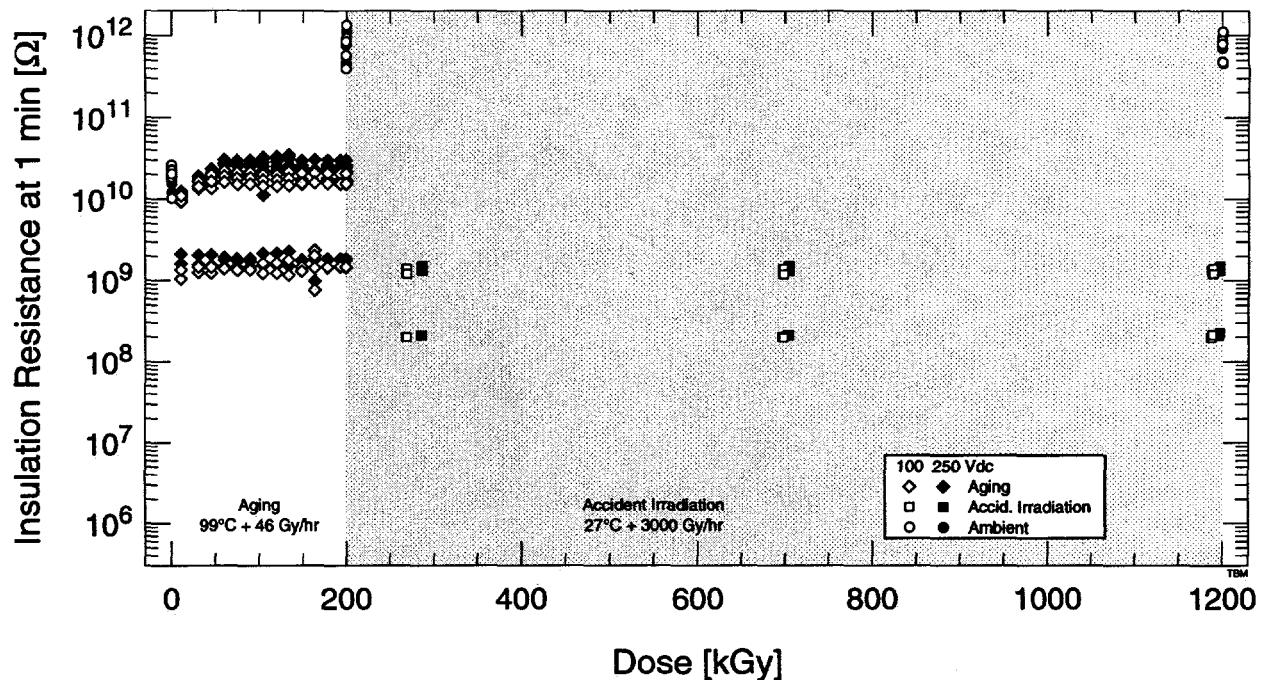
Figure A.5: IR of the 7 Marathon terminal block conductors during aging and accident irradiation.

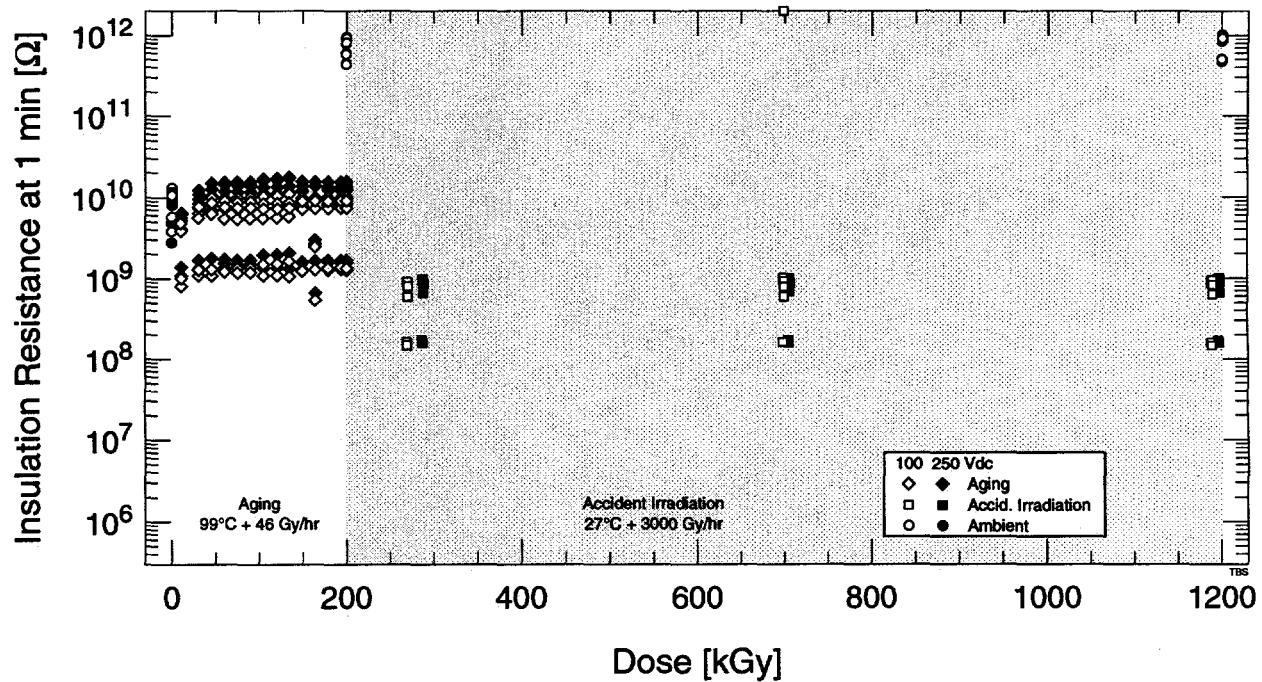
Figure A.6: IR of the 7 States terminal block conductors during aging and accident irradiation.

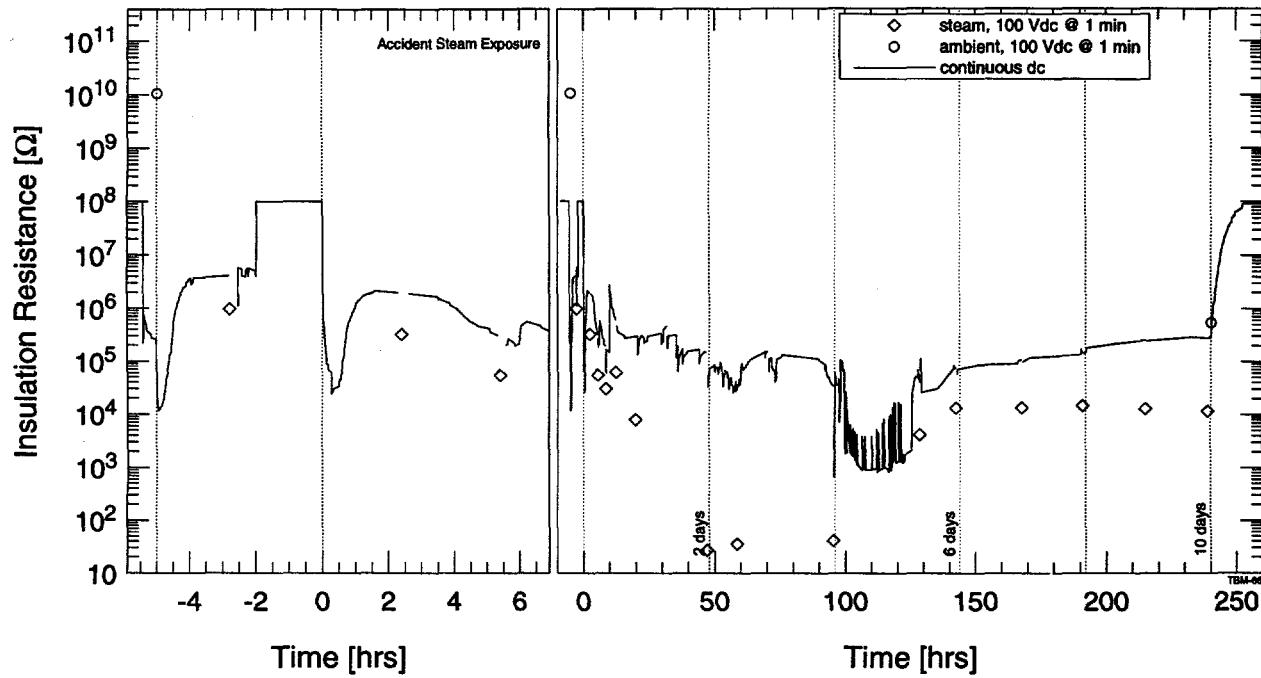
Figure A.7: IR of conductor 66 during the accident steam exposure (Marathon dc ground plane, enclosure 1).

Terminal block conductor IR data during the accident steam exposure are shown in Figures A.7–A.20. The IR fell to low values during the steam exposure due to the presence of moisture. The slow partial filling of the test chamber with condensate that occurred through

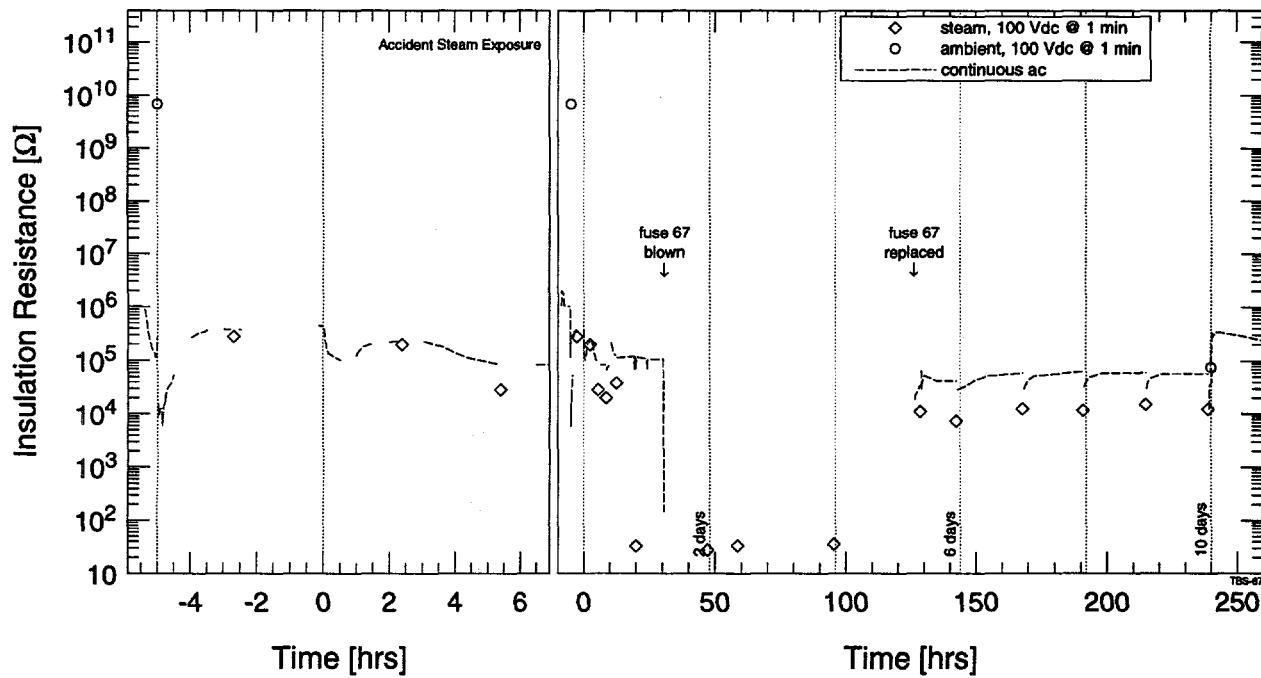
Figure A.8: IR of conductor 67 during the accident steam exposure (States ac ground plane, enclosure 1).

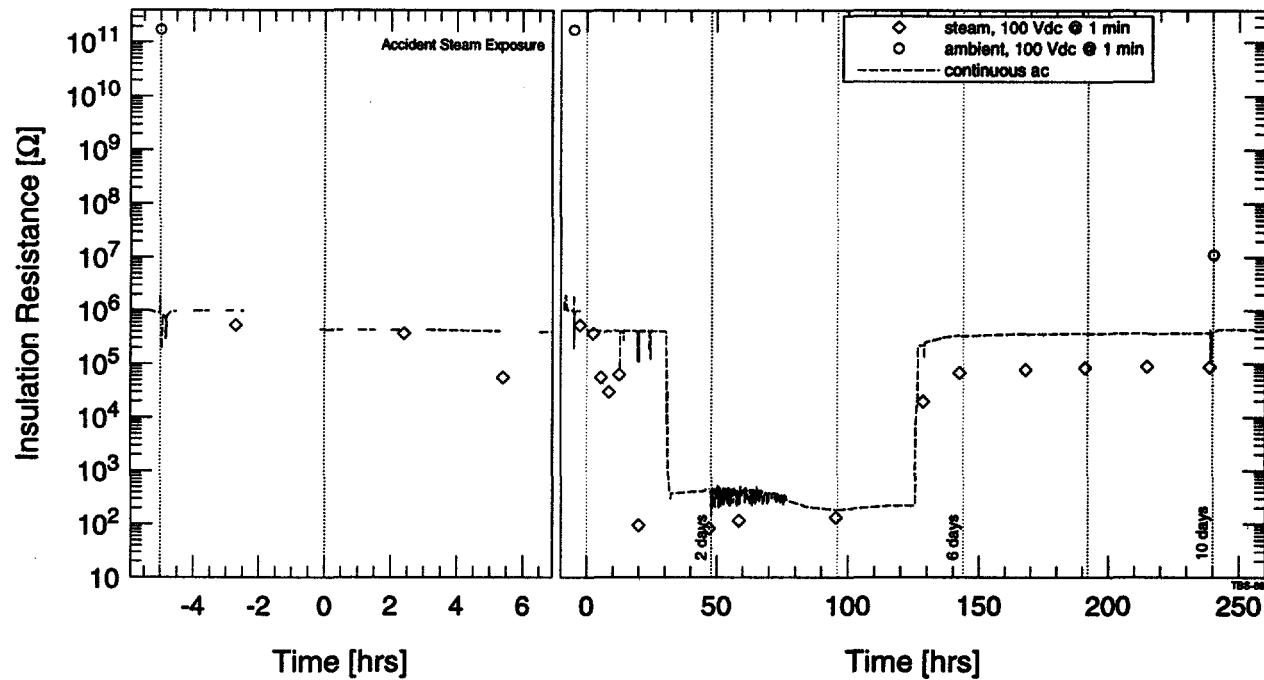
Figure A.9: IR of conductor 68 during the accident steam exposure (States ac adjacent terminal, enclosure 1).

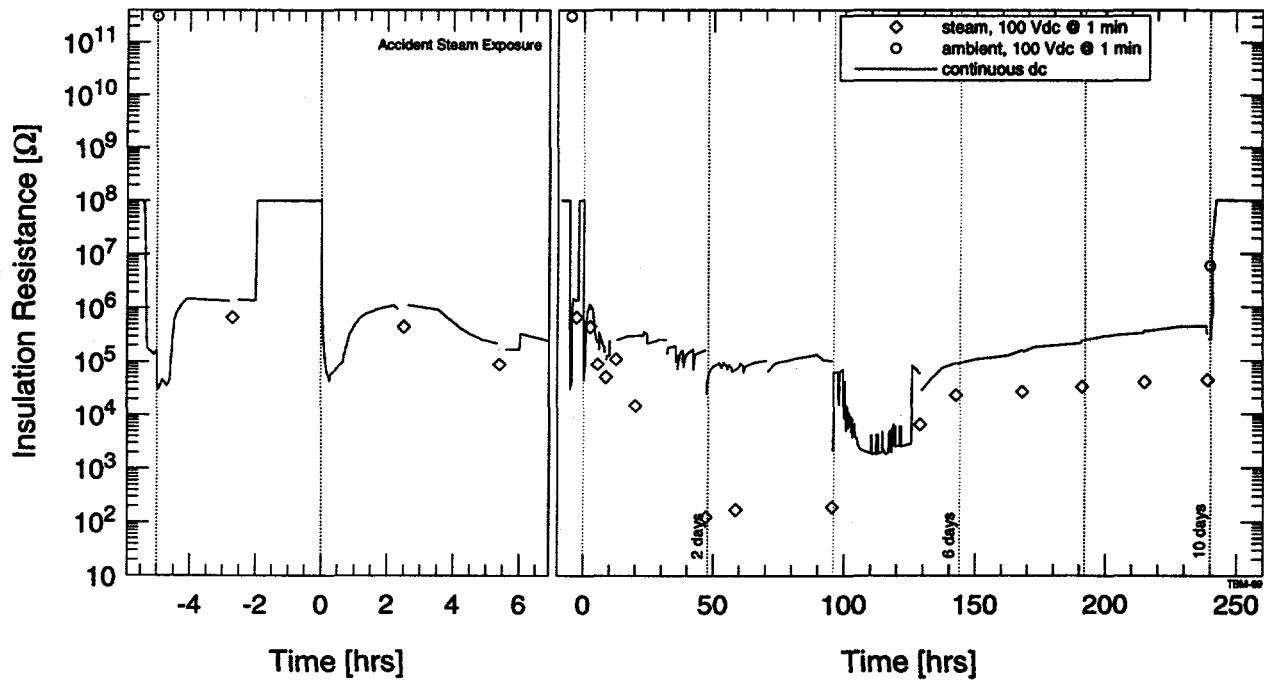
Figure A.10: IR of conductor 69 during the accident steam exposure (Marathon dc adjacent terminal, enclosure 1).

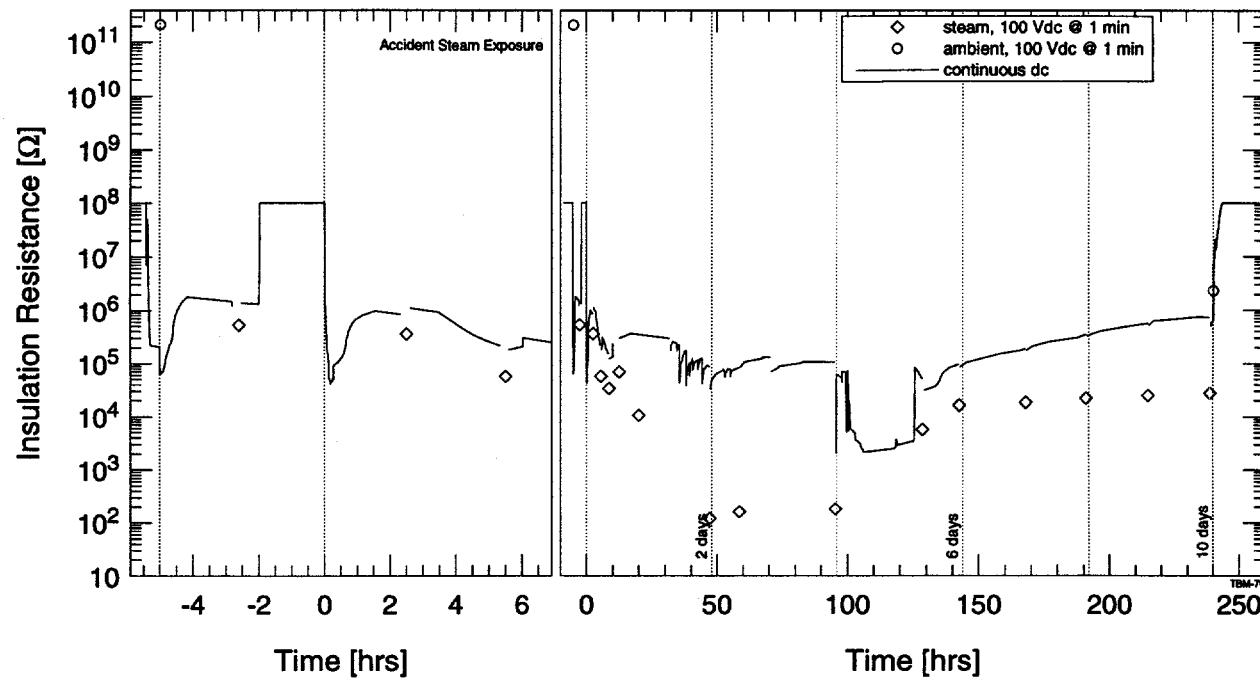
Figure A.11: IR of conductor 70 during the accident steam exposure (Marathon dc adjacent terminal, enclosure 1).

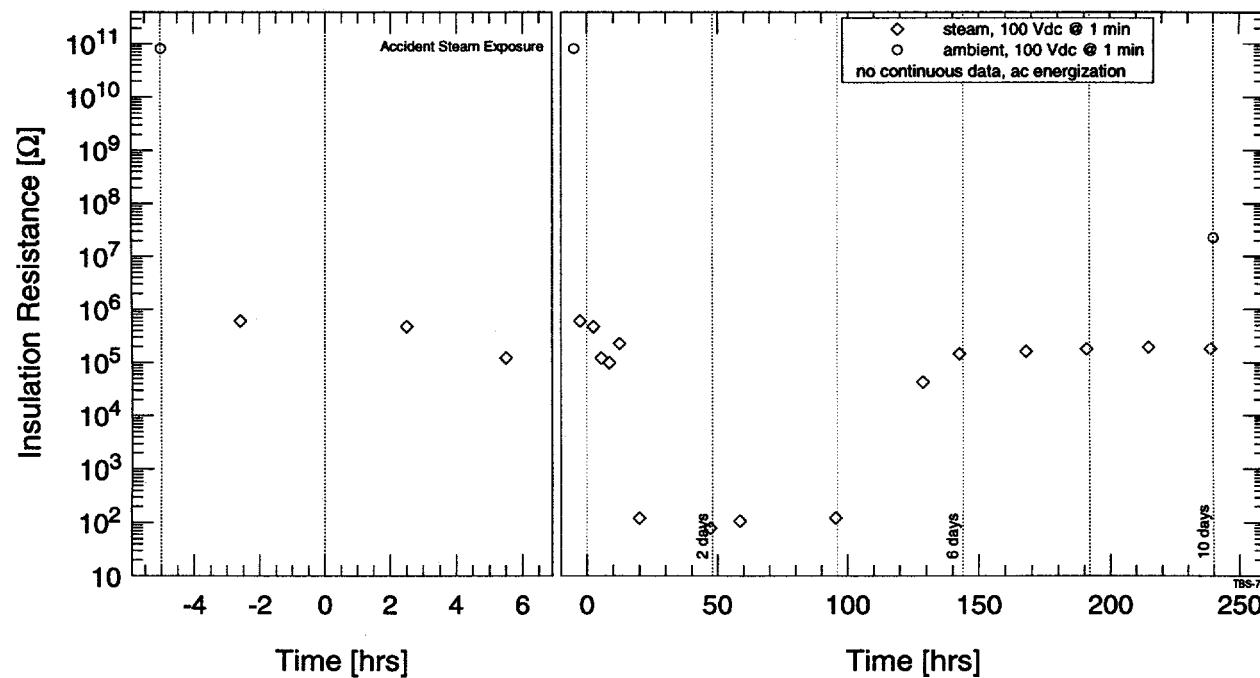
Figure A.12: IR of conductor 71 during the accident steam exposure (States ac energization, enclosure 1).

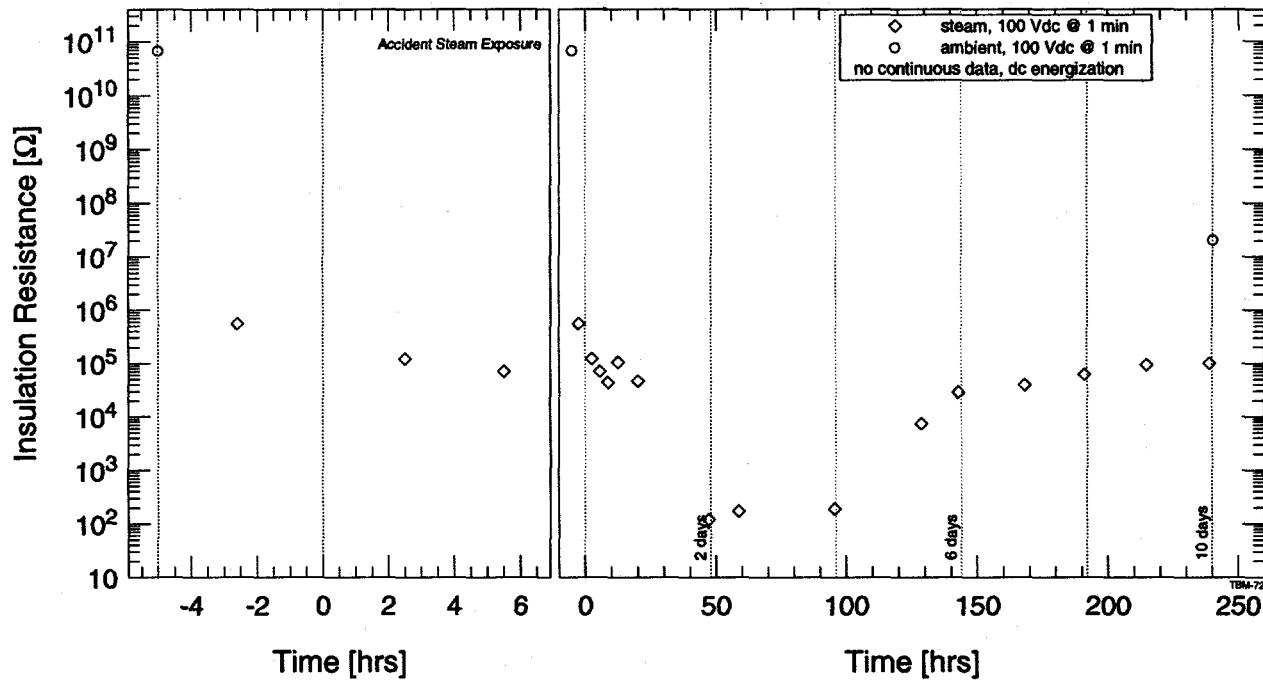
Figure A.13: IR of conductor 72 during the accident steam exposure (Marathon dc energization, enclosure 1).

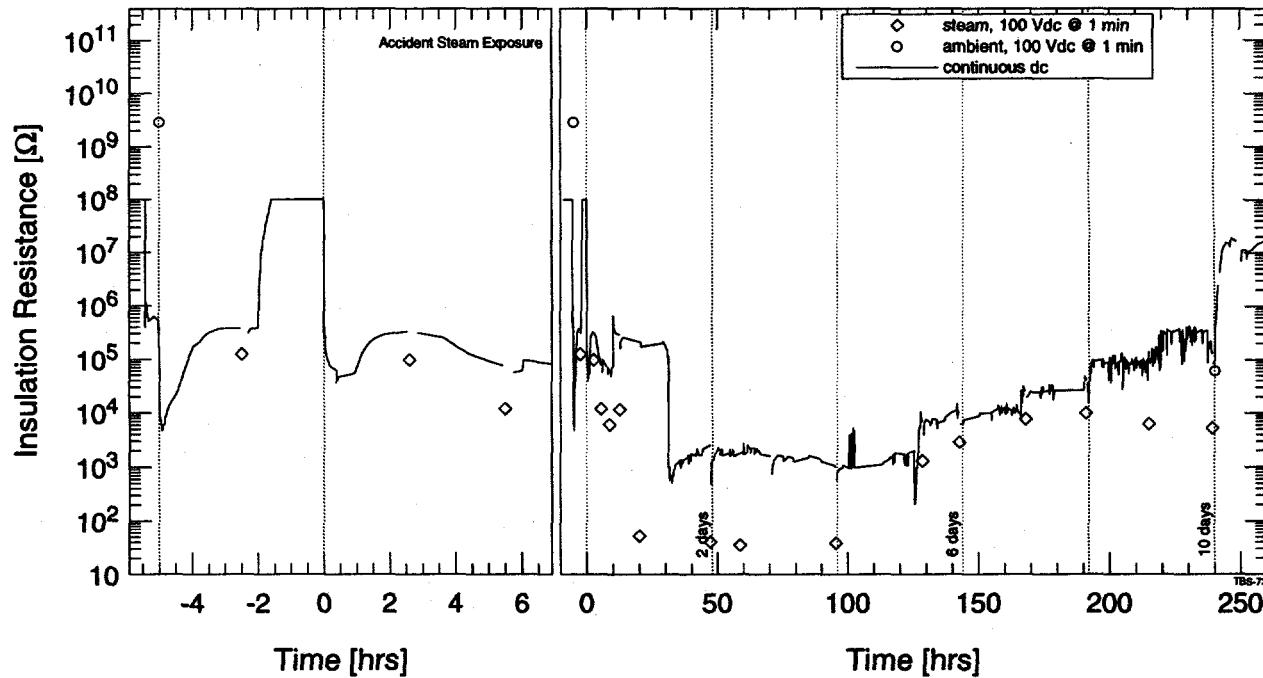
Figure A.14: IR of conductor 73 during the accident steam exposure (States dc ground plane, enclosure 2).

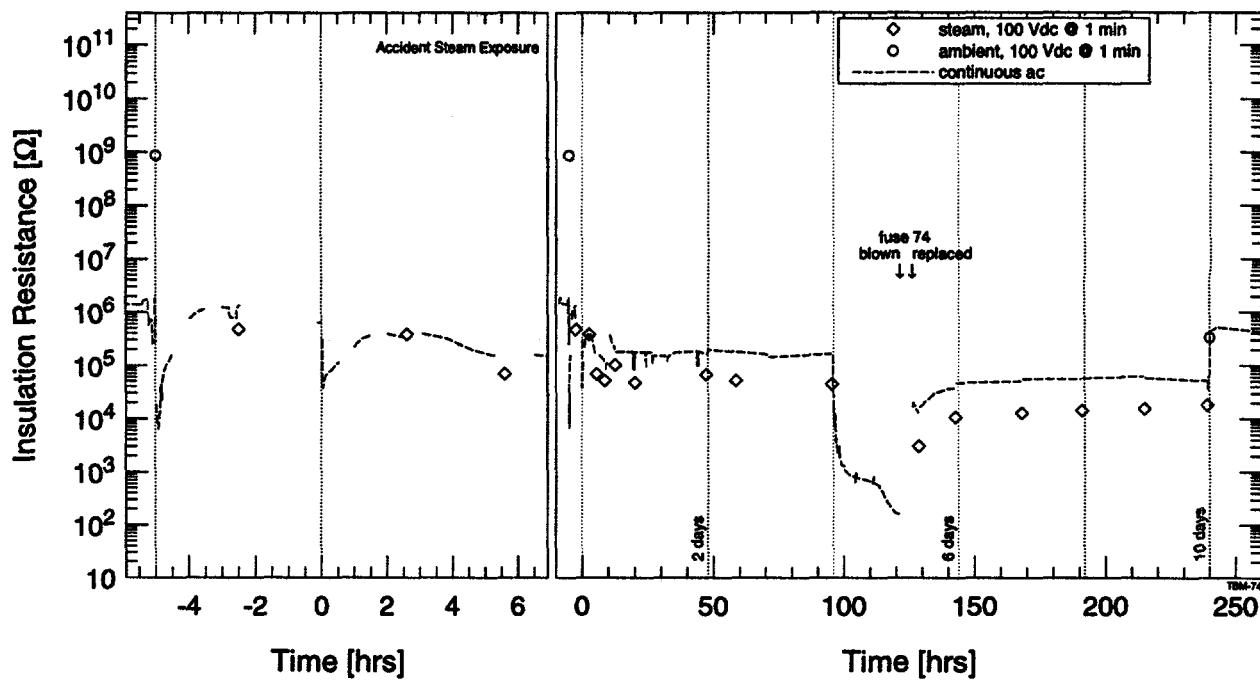
Figure A.15: IR of conductor 74 during the accident steam exposure (Marathon ac ground plane, enclosure 2).

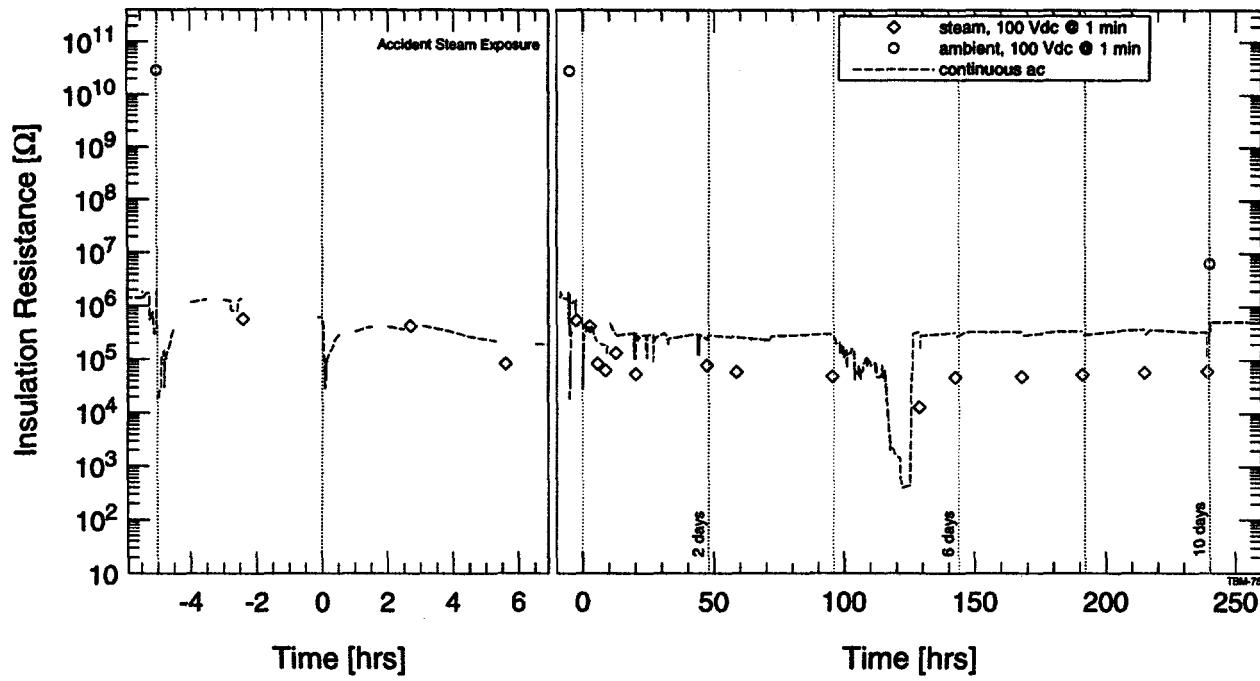
Figure A.16: IR of conductor 75 during the accident steam exposure (Marathon ac adjacent terminal, enclosure 2).

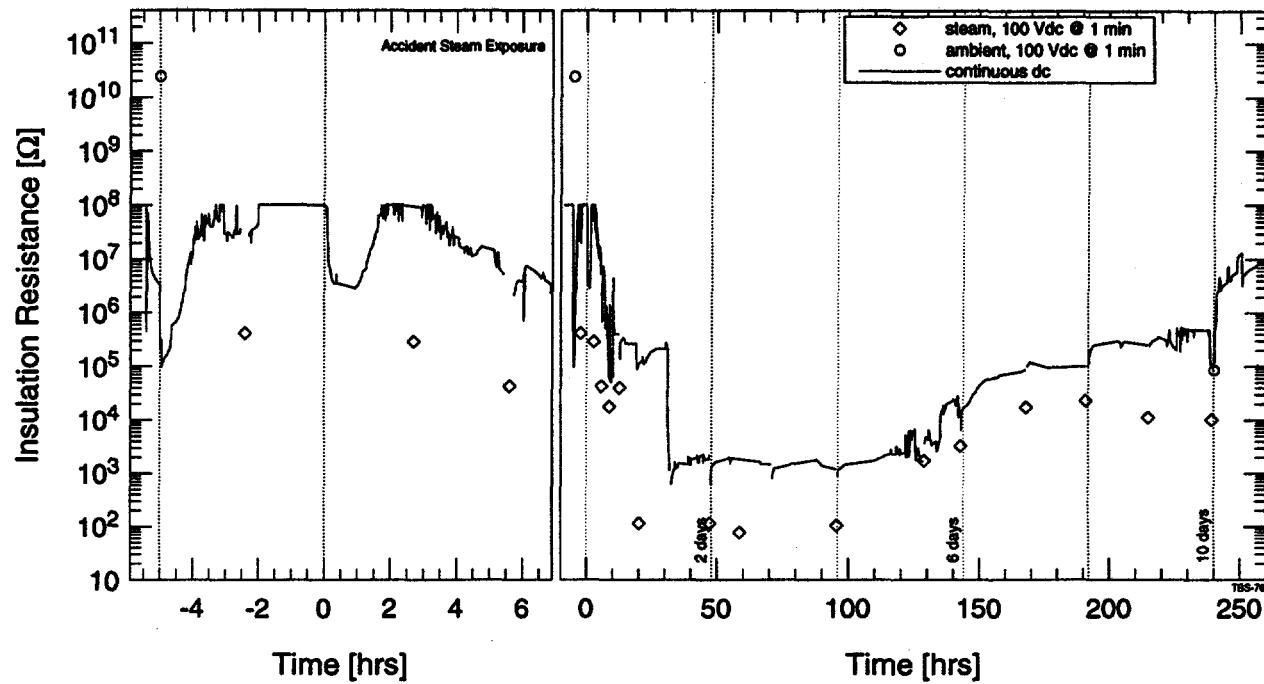
Figure A.17: IR of conductor 76 during the accident steam exposure (States dc adjacent terminal, enclosure 2).

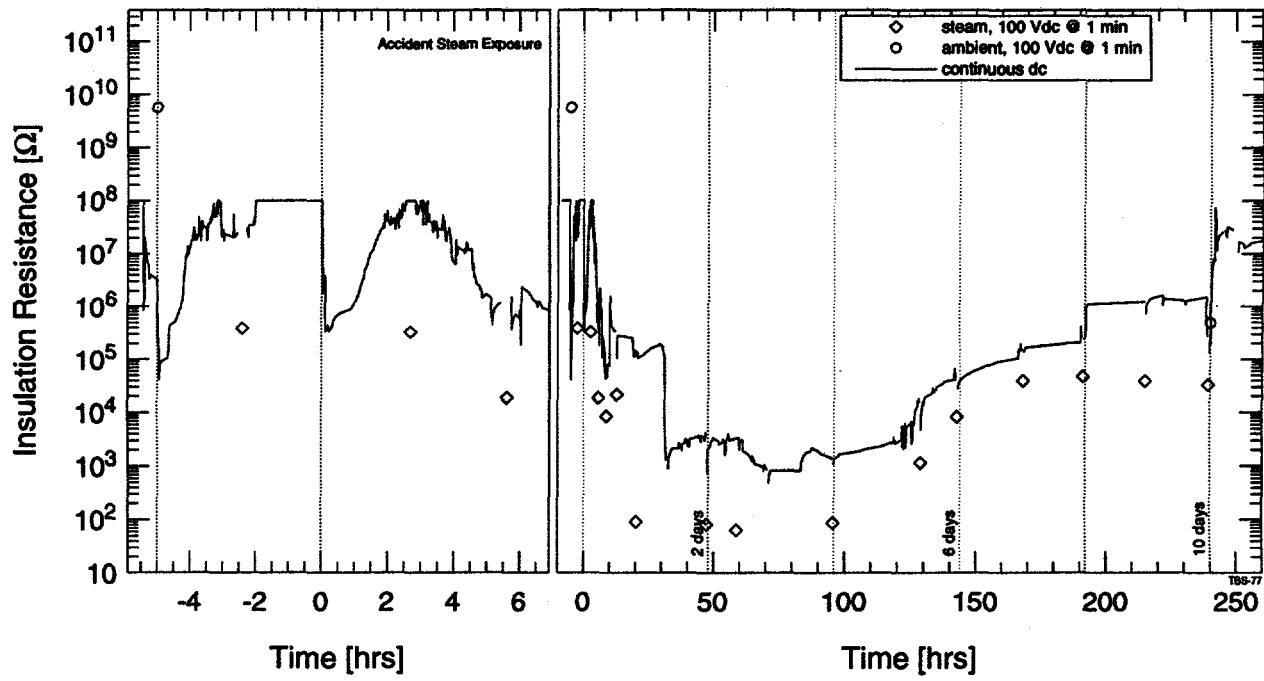
Figure A.18: IR of conductor 77 during the accident steam exposure (States dc adjacent terminal, enclosure 2).

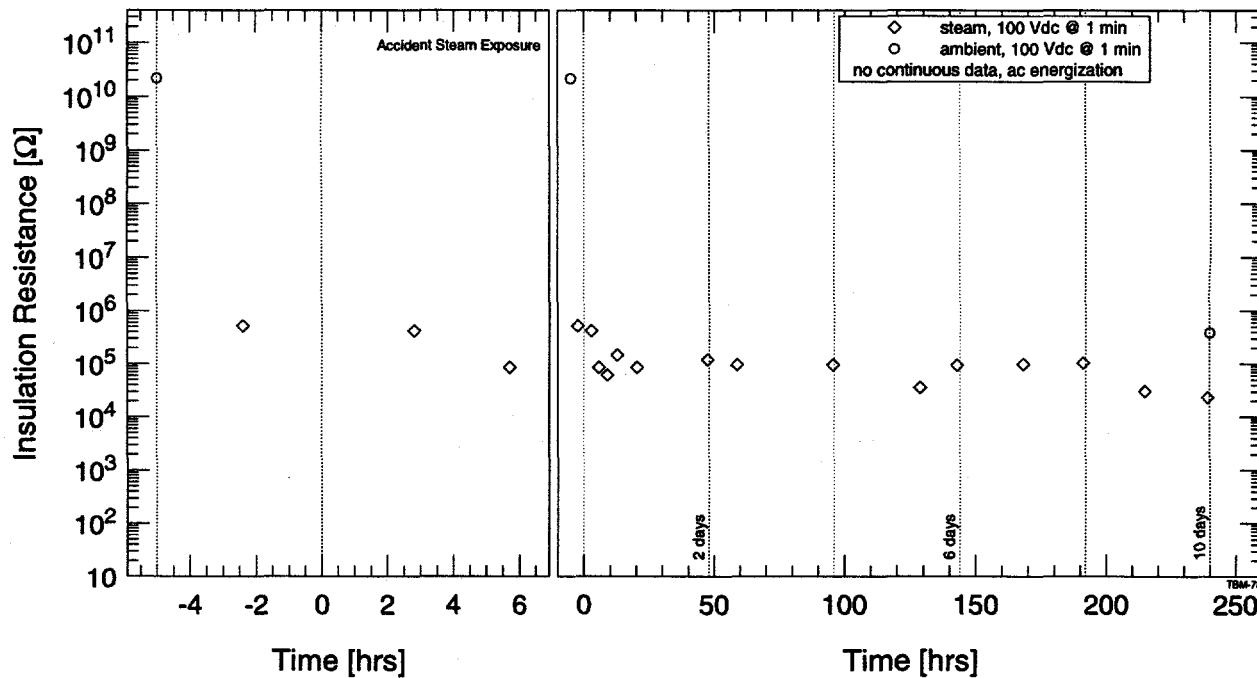
Figure A.19: IR of conductor 78 during the accident steam exposure (Marathon ac energization, enclosure 2).

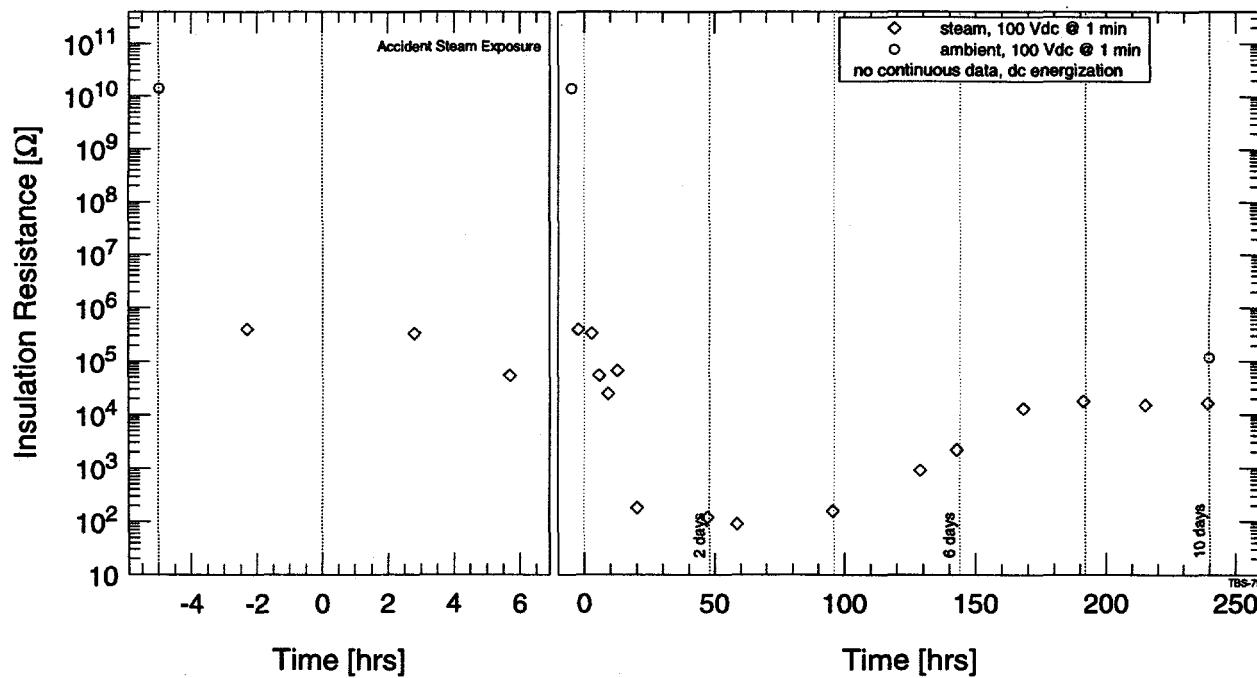
Figure A.20: IR of conductor 79 during the accident steam exposure (States dc energization, enclosure 2).

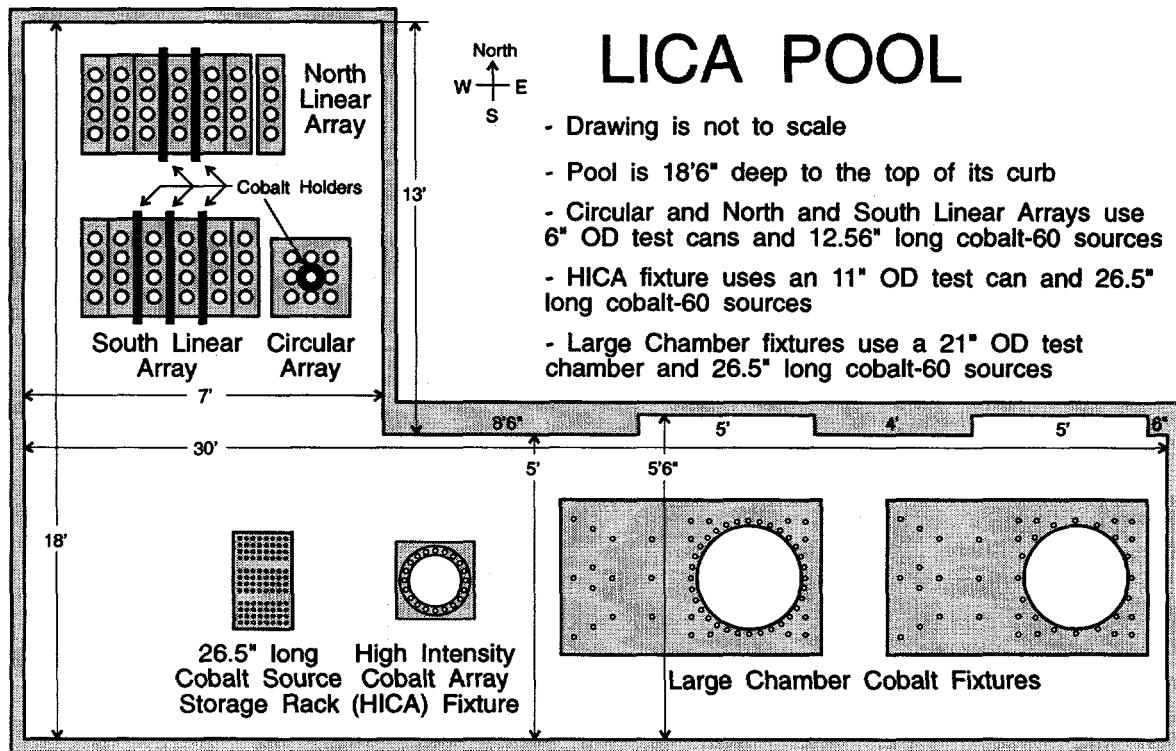
Figure B.1: Plan view of the LICA pool and fixtures.

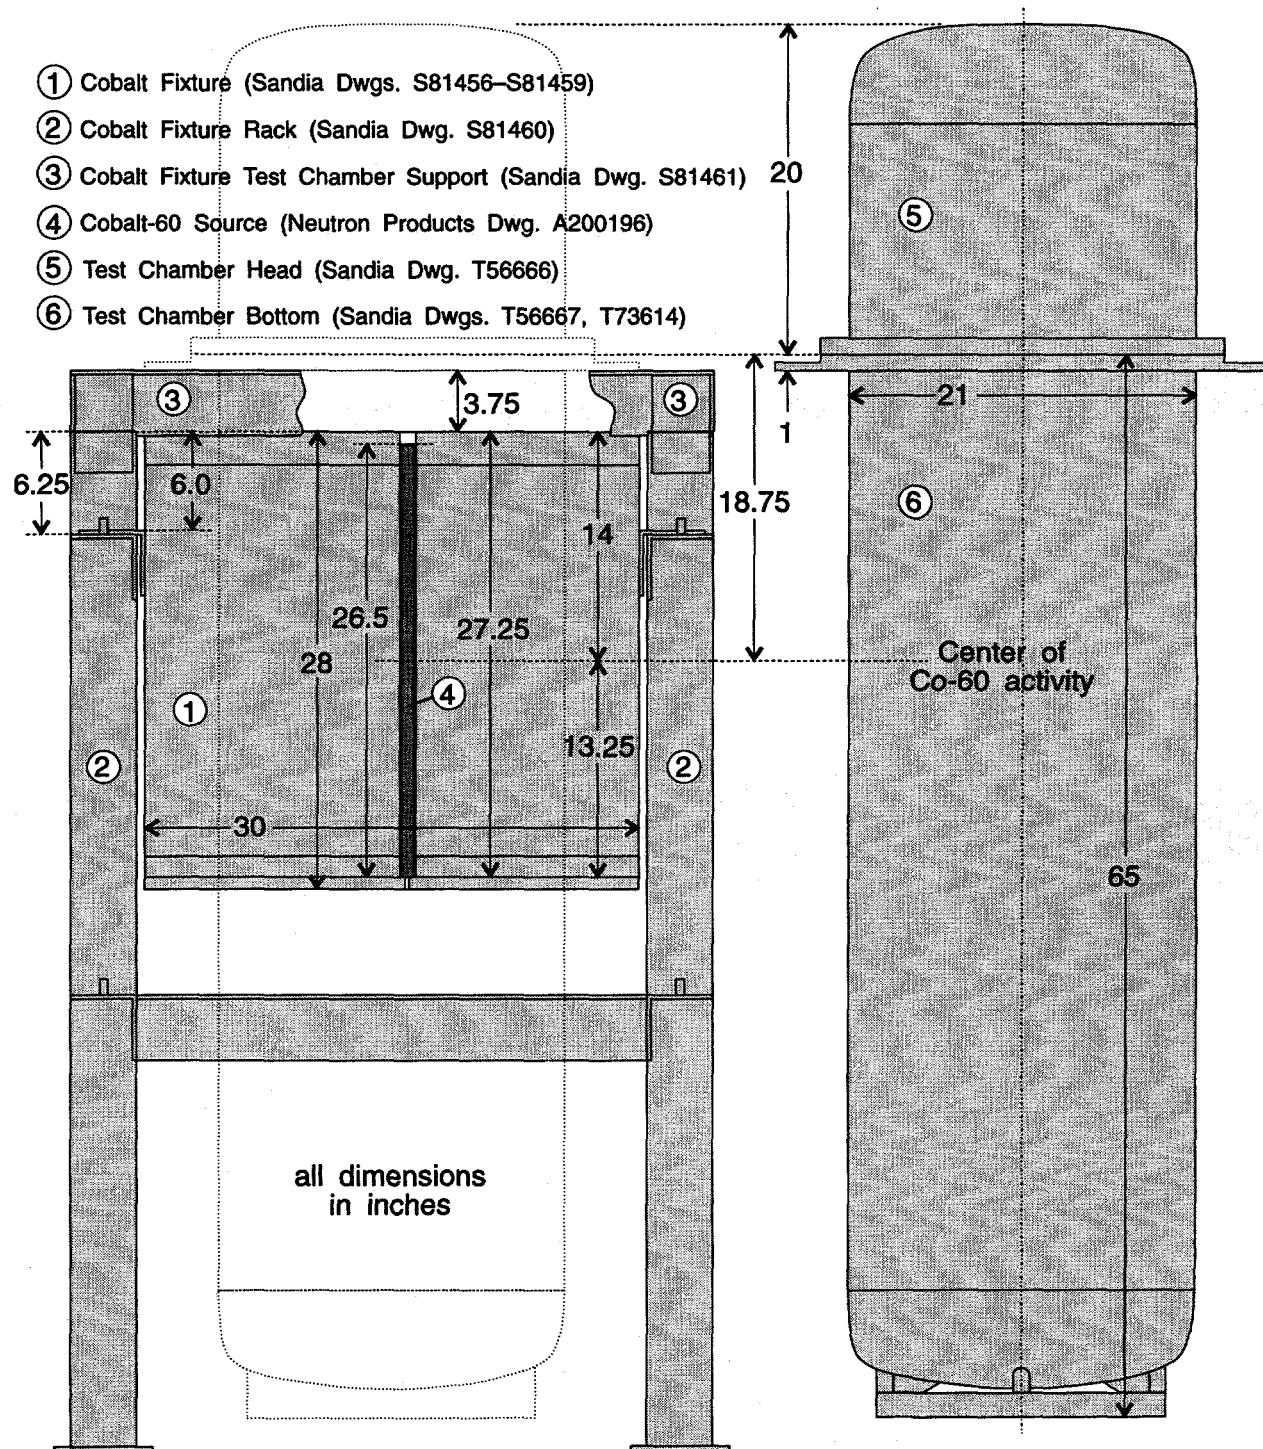
Figure B.2: Sketch of a test chamber and large chamber cobalt fixture.

In order to describe the location of objects, a coordinate system must be defined. The *fixture coordinate system* is based on the fixture that holds the cobalt sources and the test chamber. Figures B.2 and B.3 show this coordinate system. The  $z$ -axis is in the vertical direction, and thus the  $xy$ -plane is horizontal. The  $xy$ -origin is at the center of the opening into which the test chamber will fit, and the plane  $z = 0$  passes through the

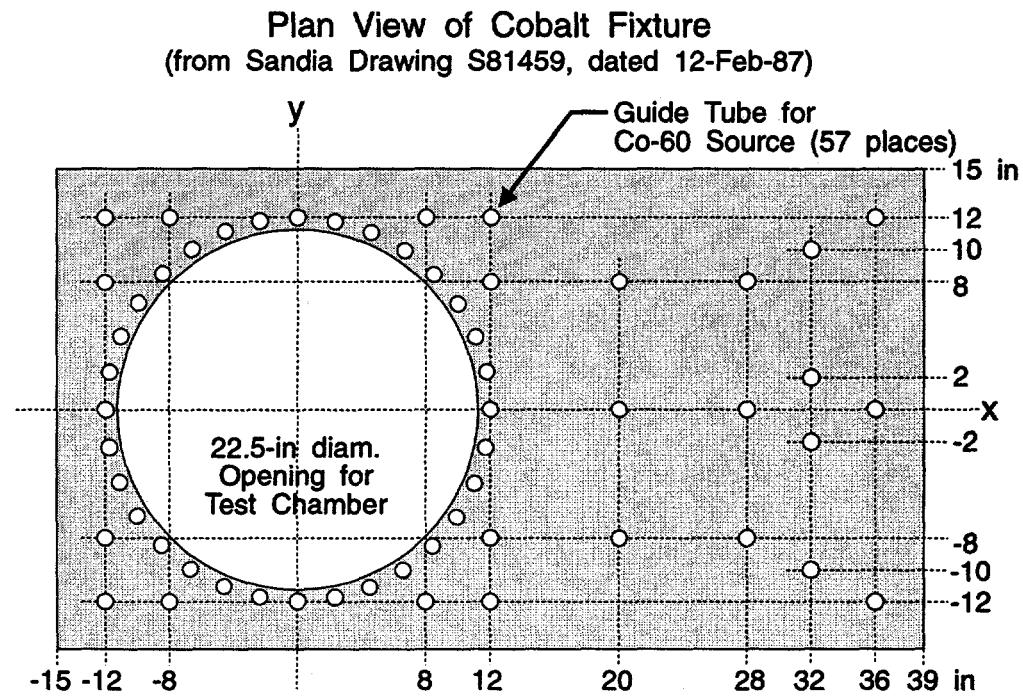
$z=0$  is at the centerline of the Co-60 sources in the vertical direction

Figure B.3: Plan view of large chamber cobalt fixture showing the fixture coordinate system and possible cobalt source locations.

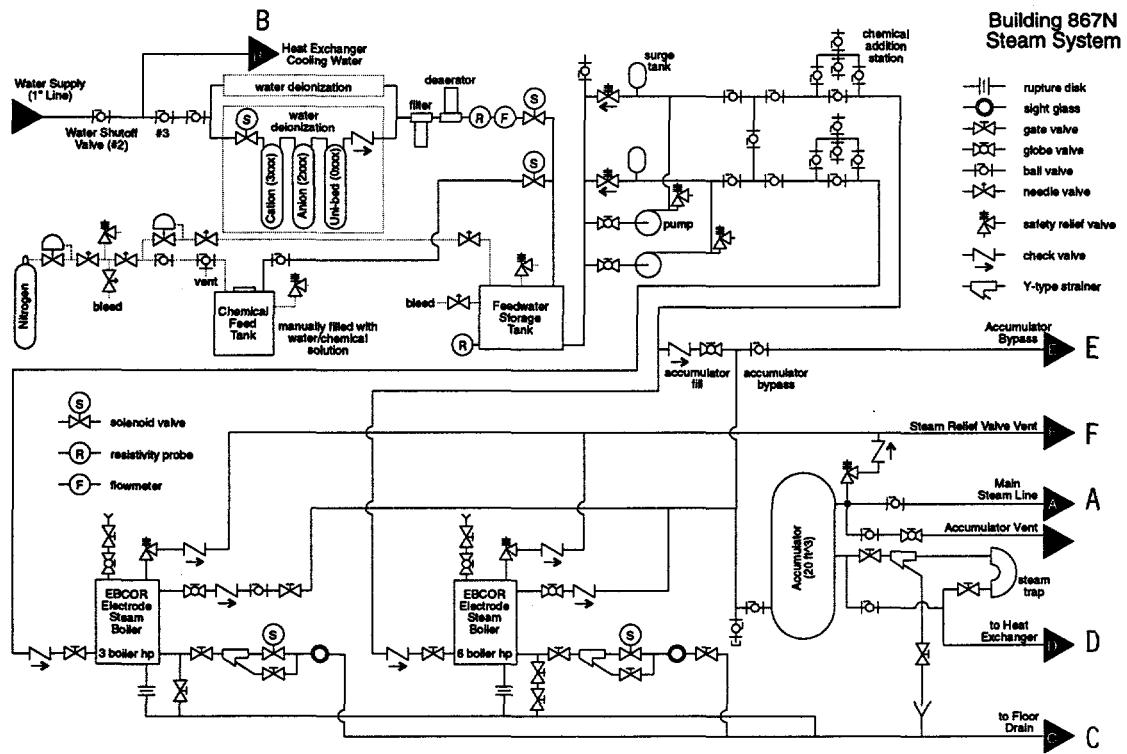
Figure B.4: Steam Exposure Facility—steam generation and storage.

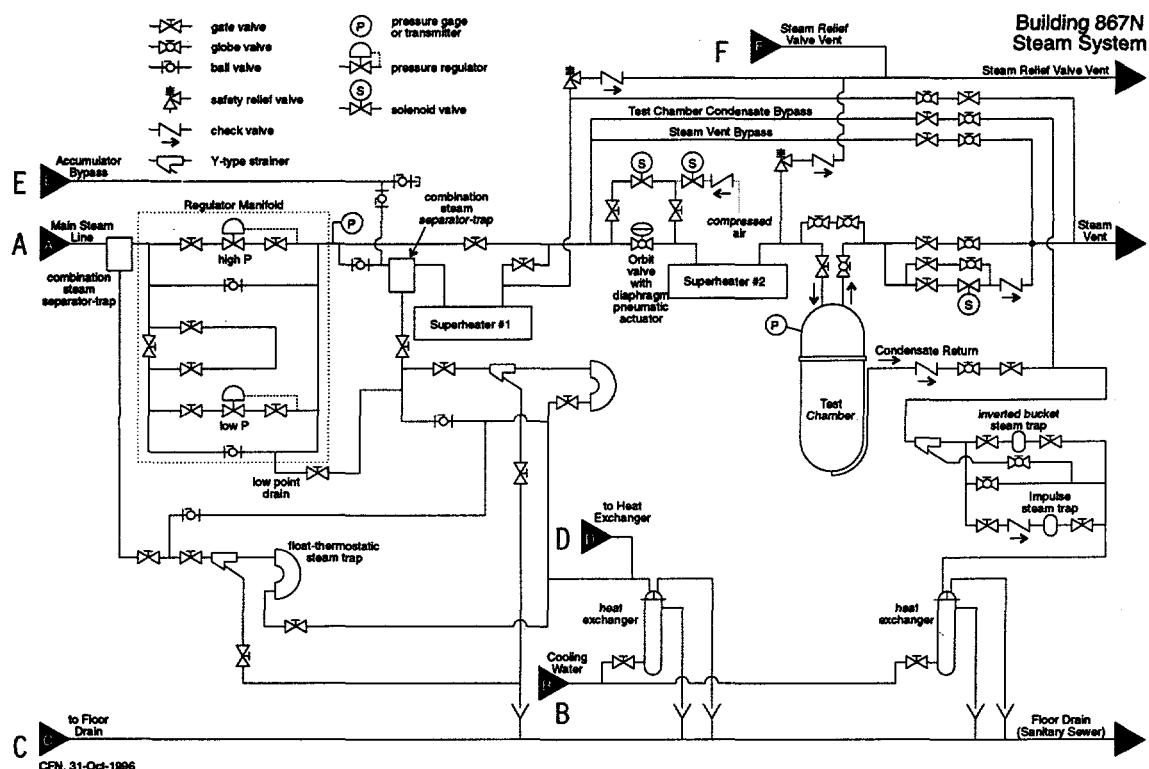
Figure B.5: Steam Exposure Facility—superheaters and steam delivery.

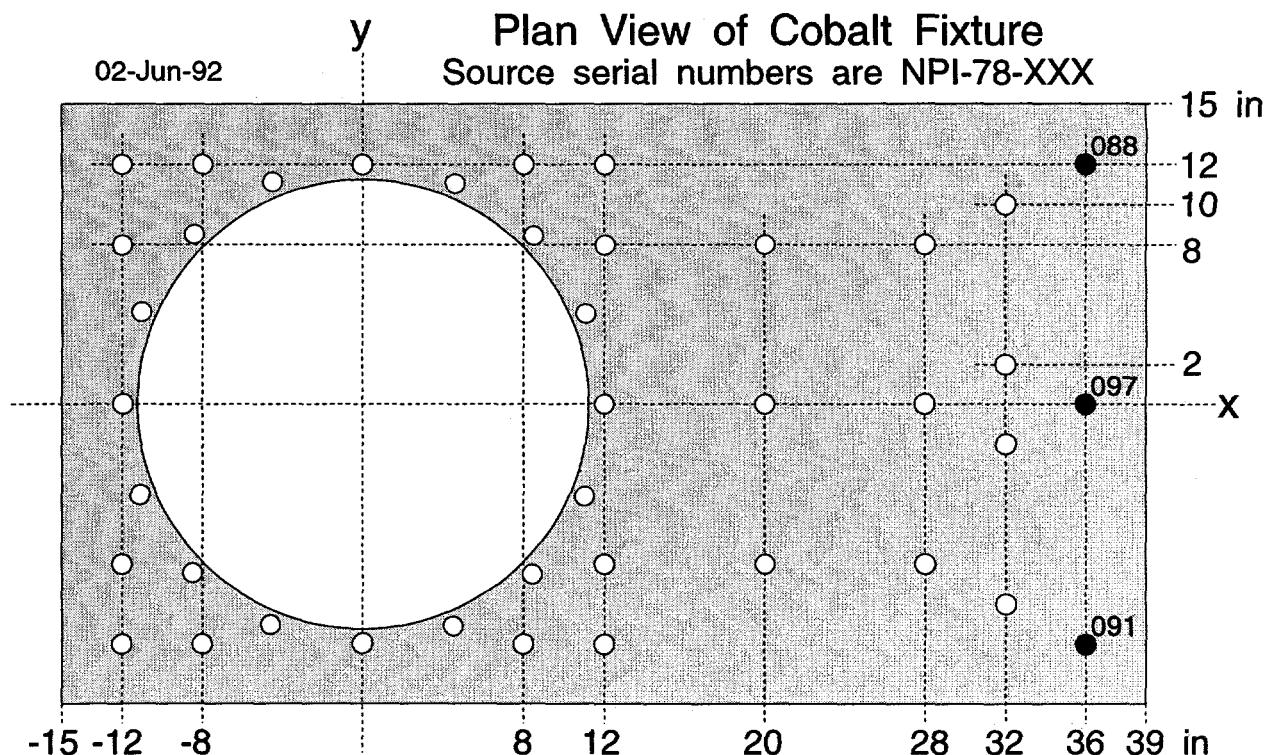
Figure B.6: Cobalt-60 source configuration for aging irradiation (black circles are guide tubes filled with a Co-60 source and white circles are empty guide tubes).
